## Inspection Photos

Location Name: TEP ROCKY MOUNTAIN LLC DIXON A Pad

Location #: 335550

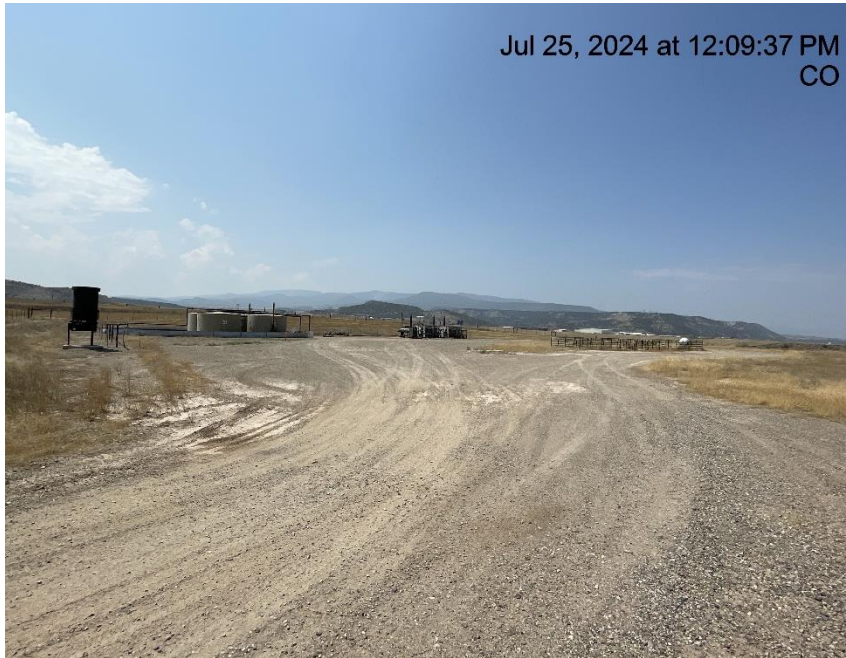
Photo # 3239 From entrance to location

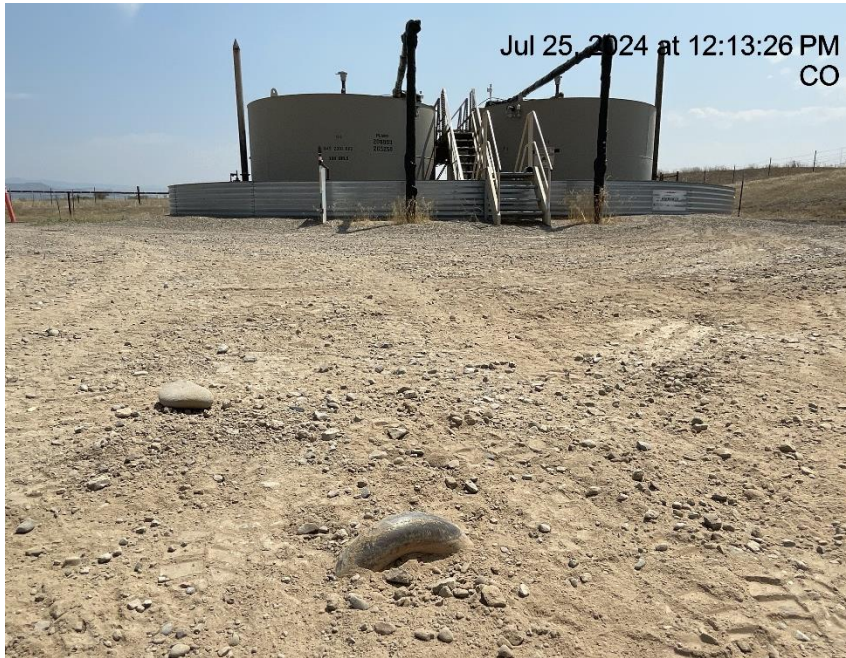
Photo # 3245 Unmarked deadman

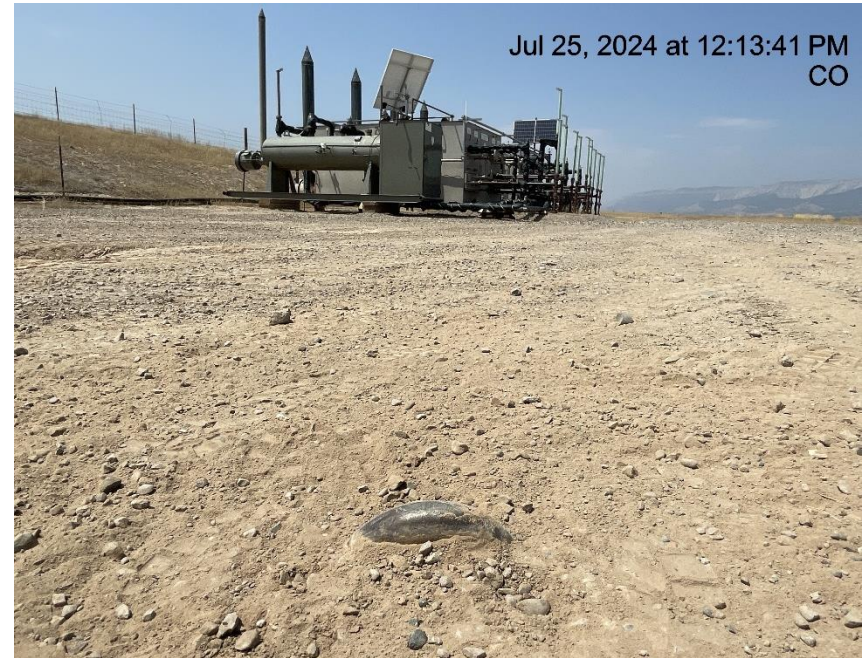
Photo # 3246 Same unmarked deadman from a different angle

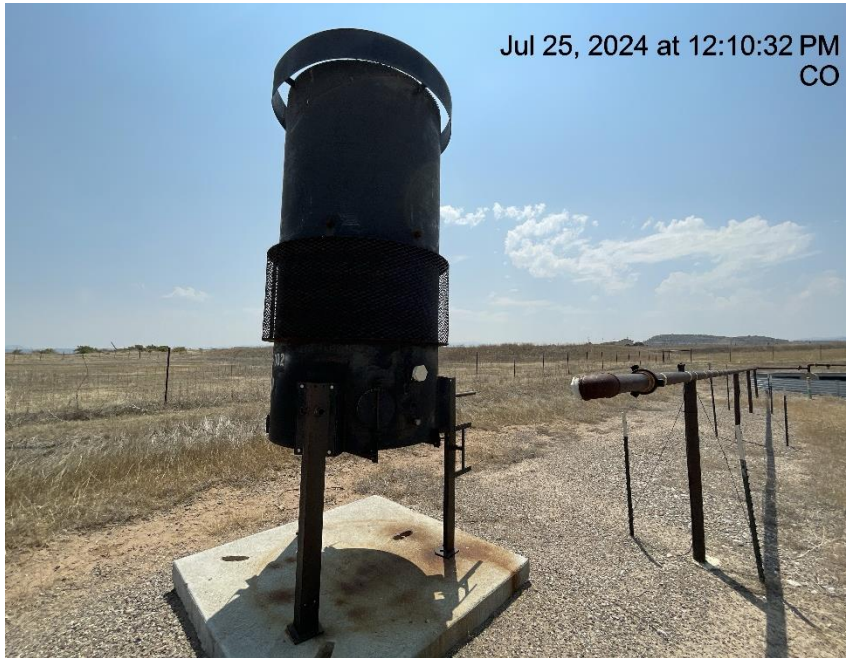
**Photo # 3247 Unused equipment/ECD disconnected & not in use**

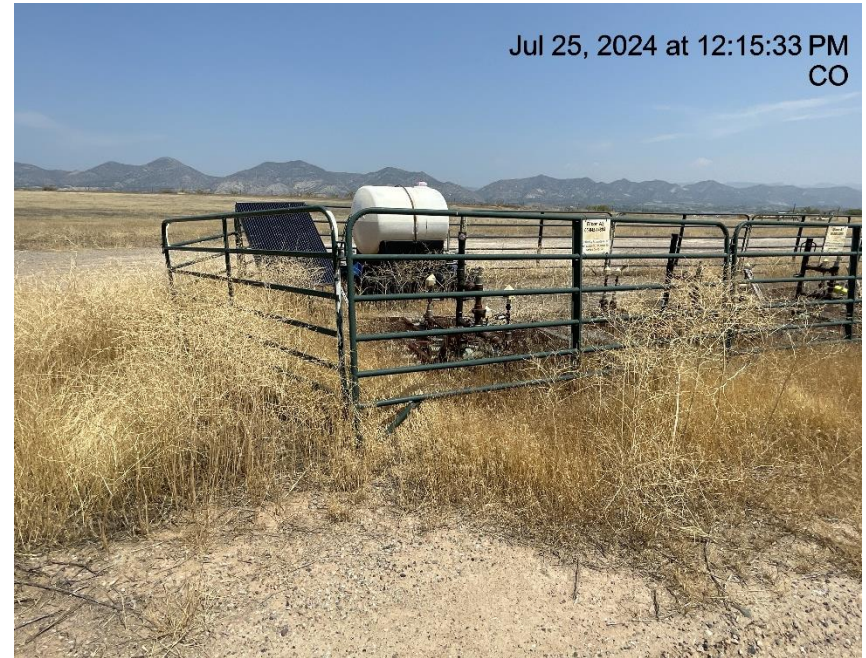
**Photo # 3248 Dead weeds/debris near wellheads & chemical tank that is causing a fire hazard**

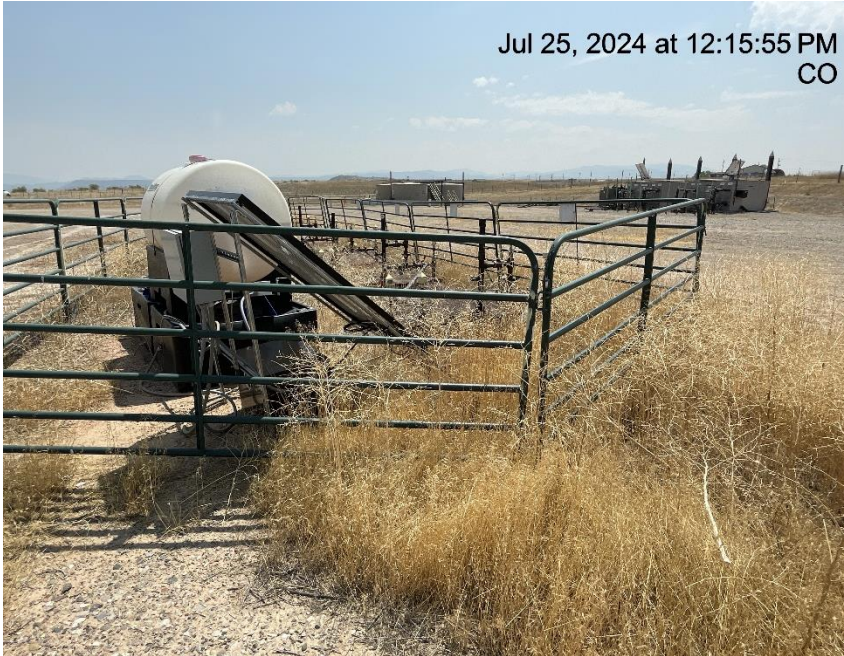
**Photo # 3249 Dead weeds/debris near wellheads & chemical tank that is causing a fire hazard**

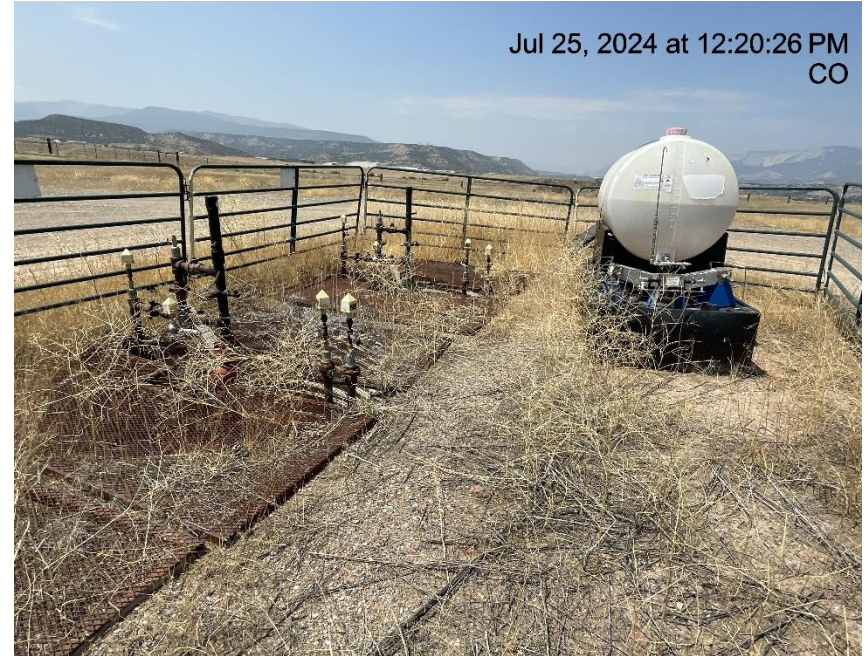
**Photo # 3250 Dead weeds/debris near wellheads & chemical tank that is causing a fire hazard**

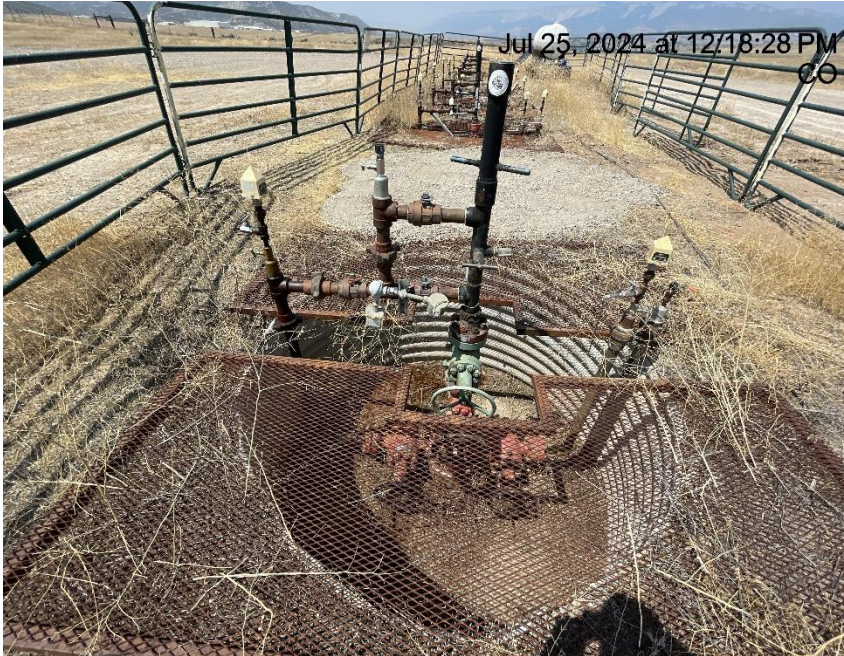
**Photo # 3251 Wellhead cellar lacks wildlife egress/does not comply with CECMC wildlife rules**

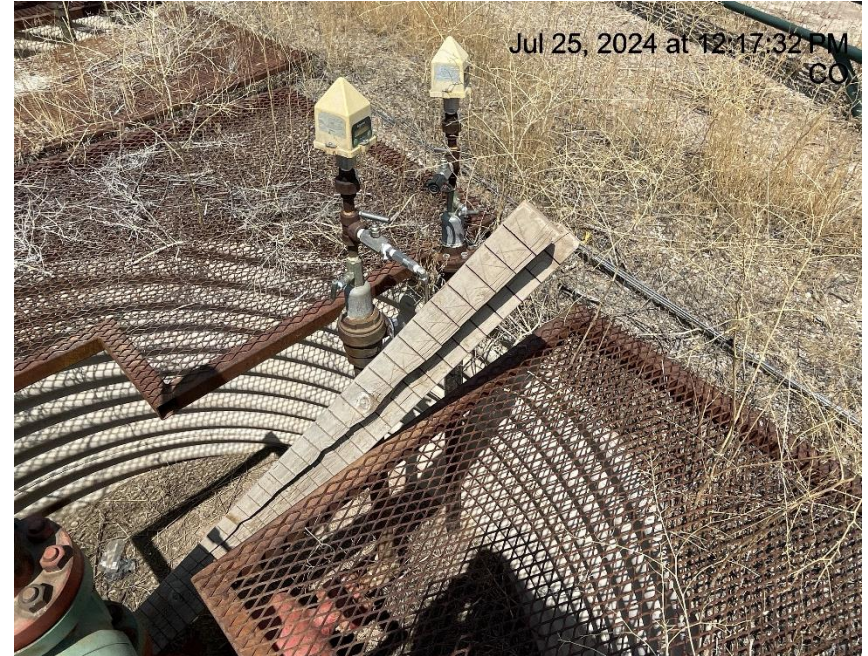
**Photo # 3252 Wildlife egress damaged/needs maintenance**

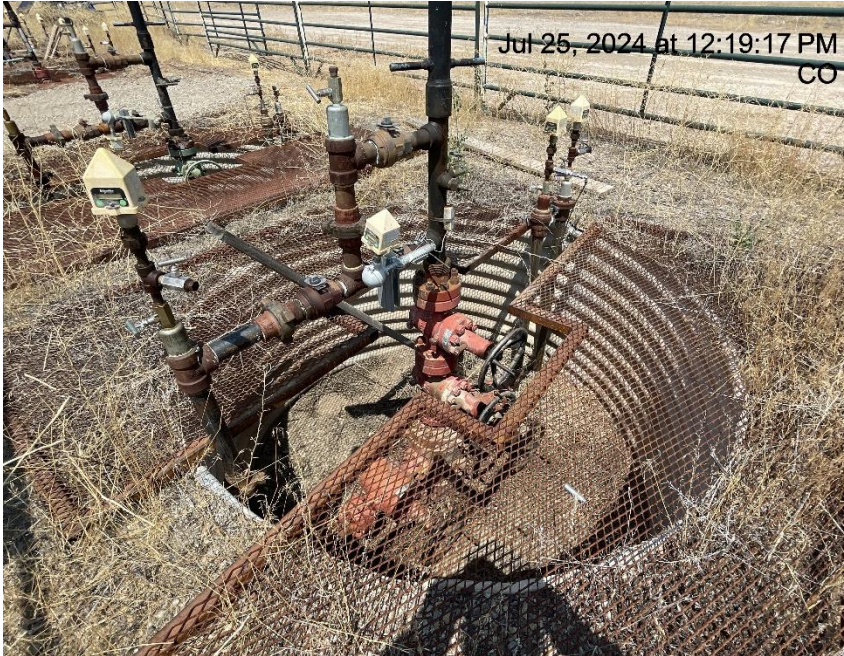
**Photo # 3253 Cellar not properly covered/wildlife & personnel hazard**

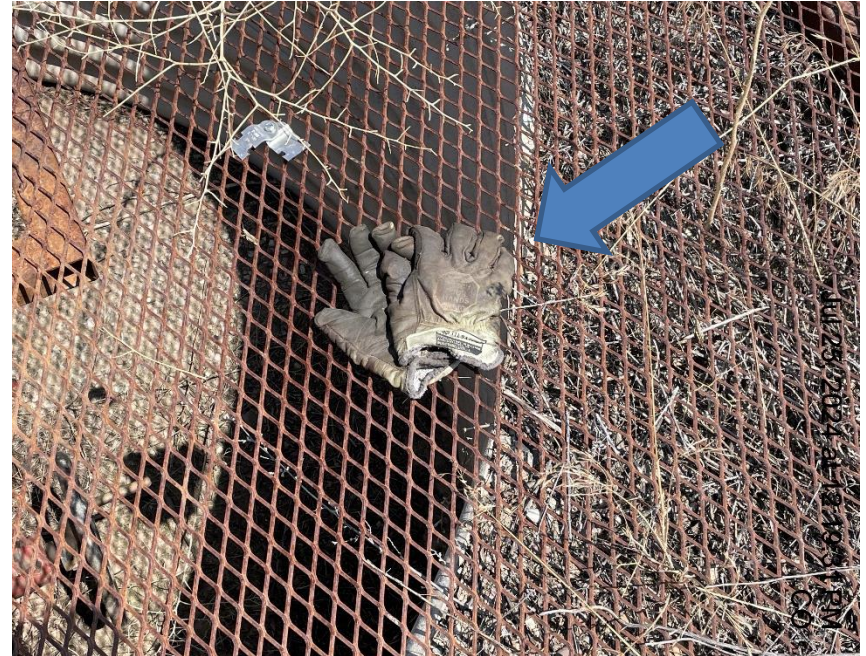
**Photo # 3254 Debris**

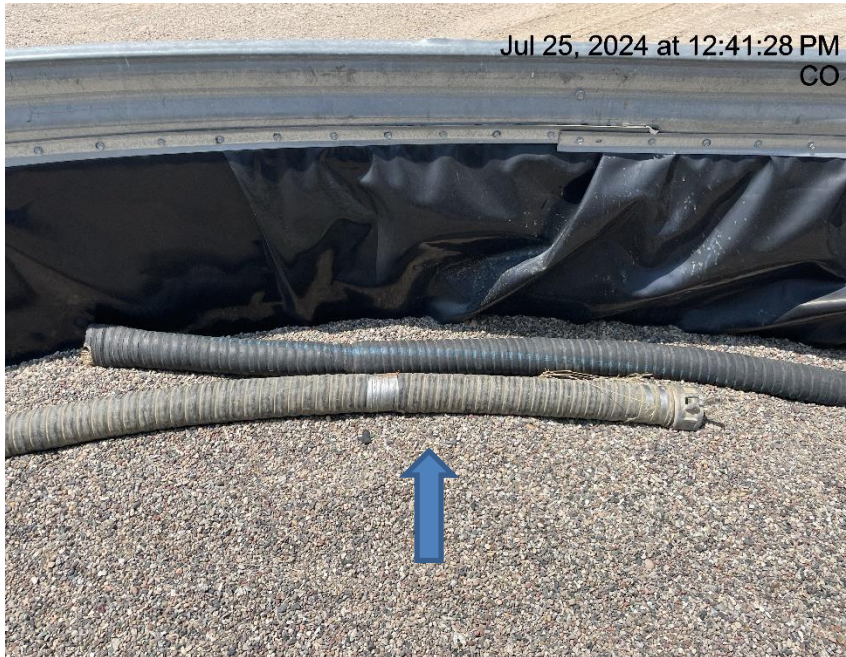
Photo # 3255 Damaged hoses/debris

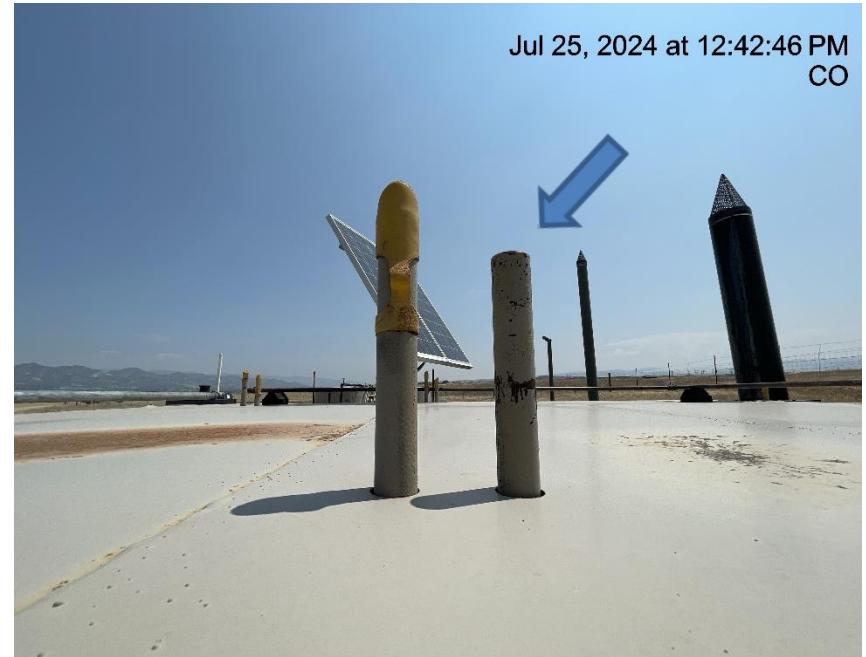
Photo # 3256 PRV vent line does not comply with CECMC pressure safety device rules

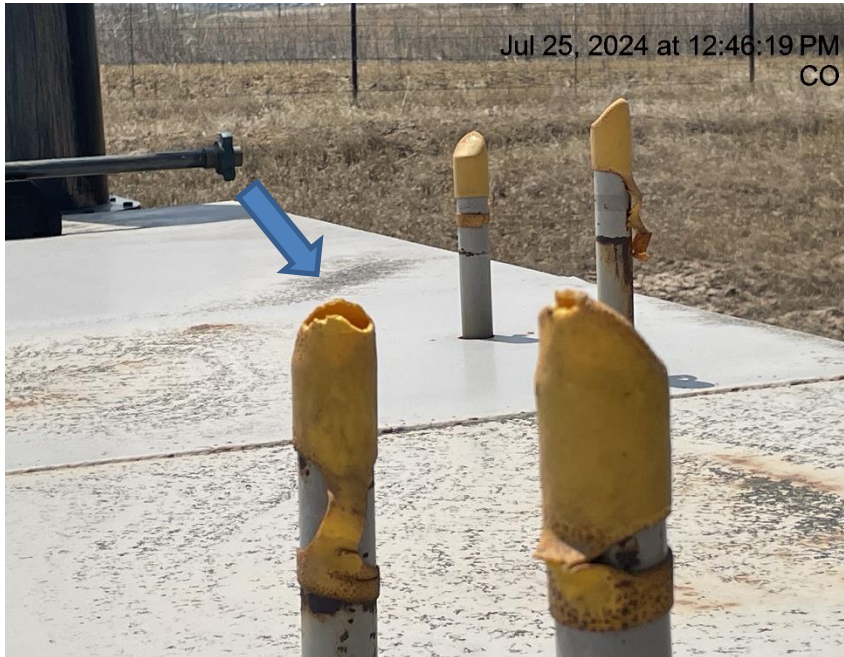
Photo # 3257 PRV vent line cap damaged/PRV vent line does not comply with CECMC pressure safety device rules

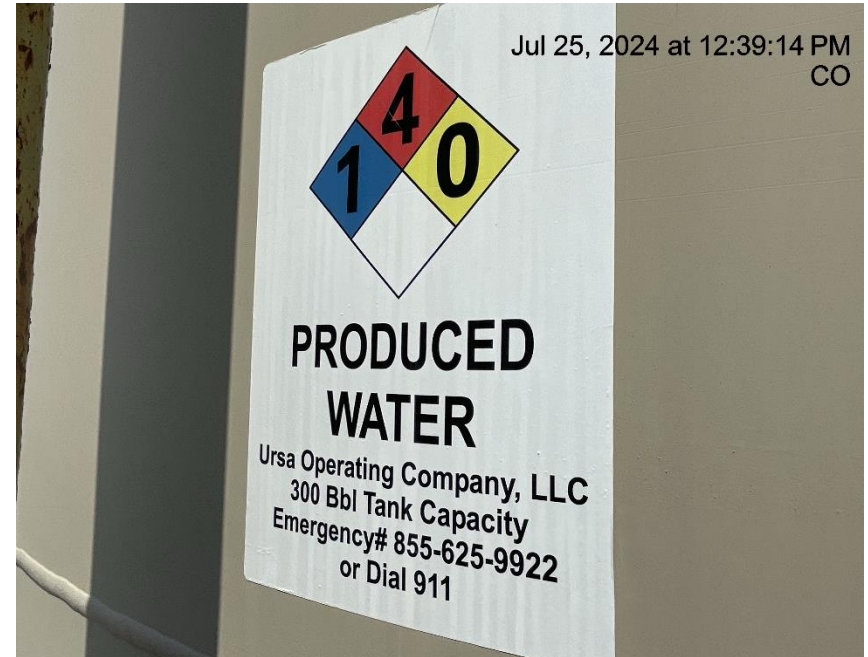
Photo # 3258 Tank label contains inaccurate info/does not comply with CECMC rules

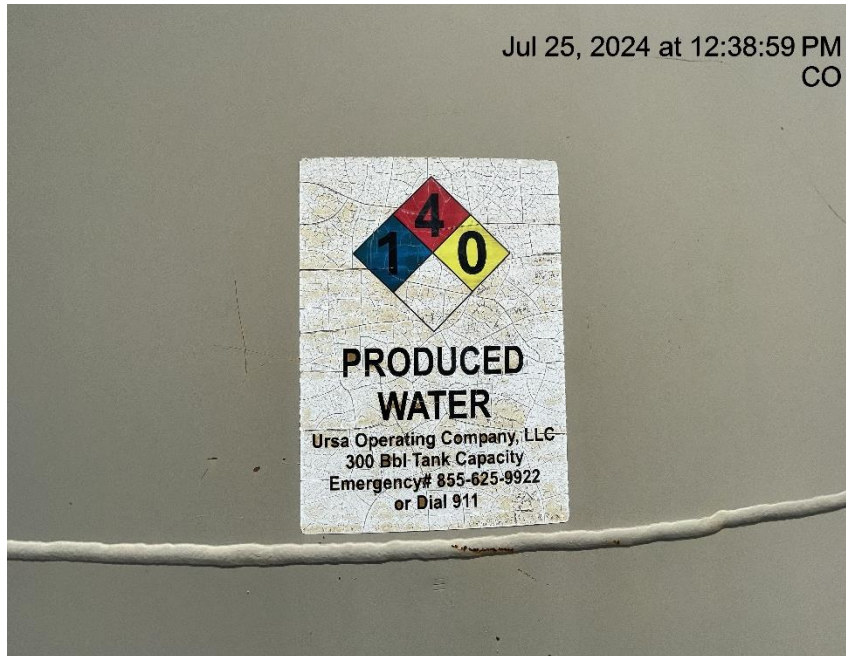
**Photo # 3259 Tank label contains inaccurate info/does not comply with CECMC rules**
