Inspection Photos
Location Name: Bullard 2
Location ID: 320234

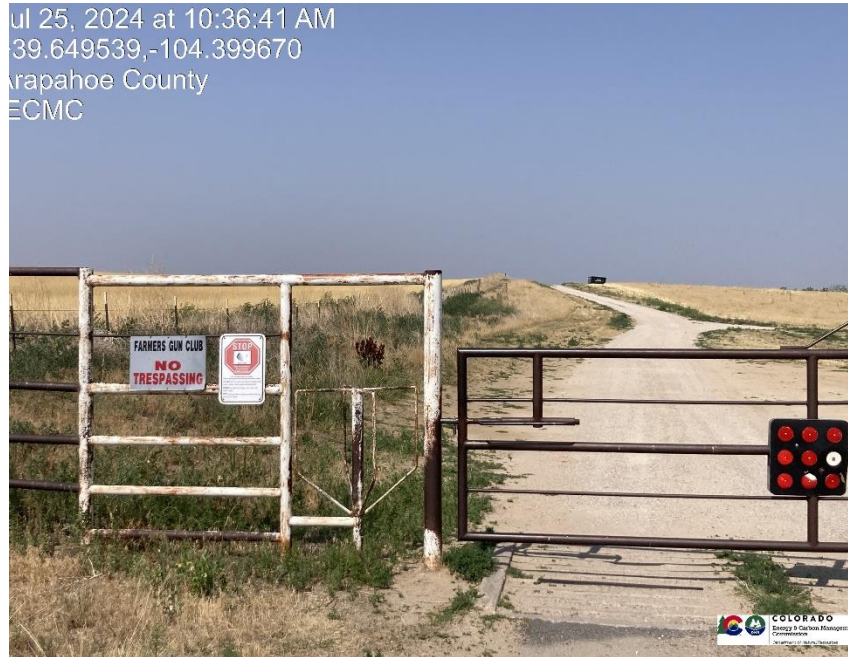
Pic 1 unable to access wellhead due to locked landowner gate
