Construction and Stormwater Inspection

Date: 7/18/24

Operator: Kerr McGee Oil & Gas Onshore LP - 47120

Location ID: 486289

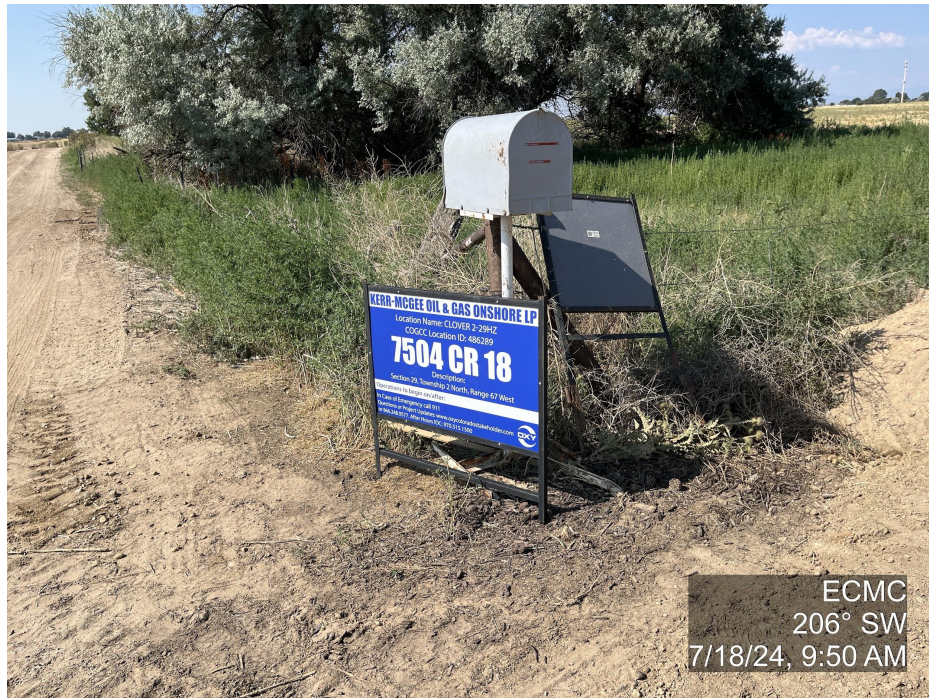
Photo 1. The photo was taken at the entrance to the well location facing Southwest. The photo illustrates the operator location sign and document mailbox.

Note - At the time of inspection the Form 2A was not in the mailbox onsite.

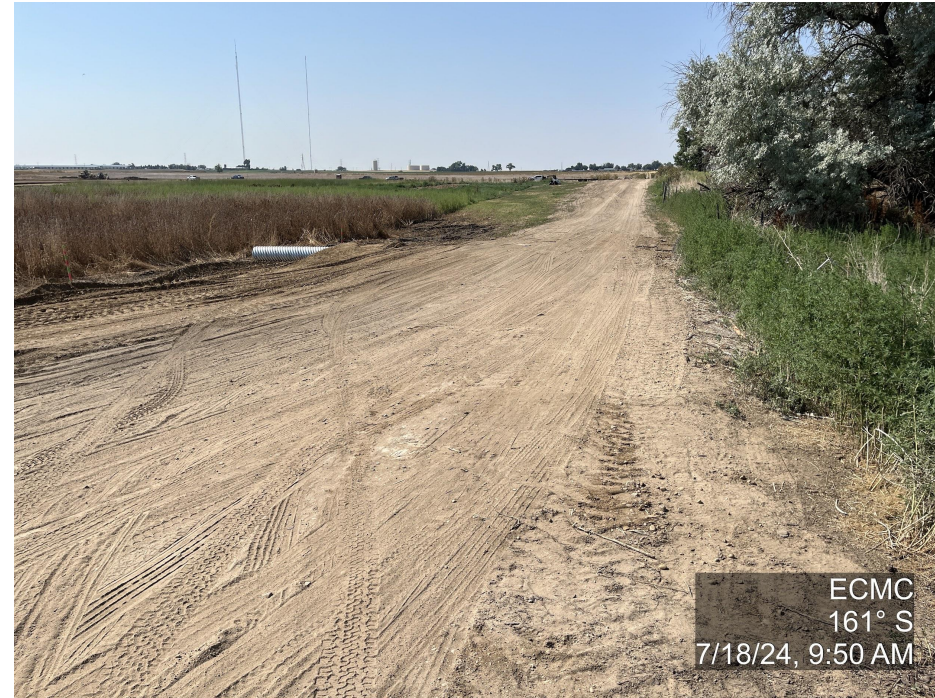
Photo 2. The photo was taken at the entrance to the well location facing South. The photo illustrates the access road is using an existing access road.

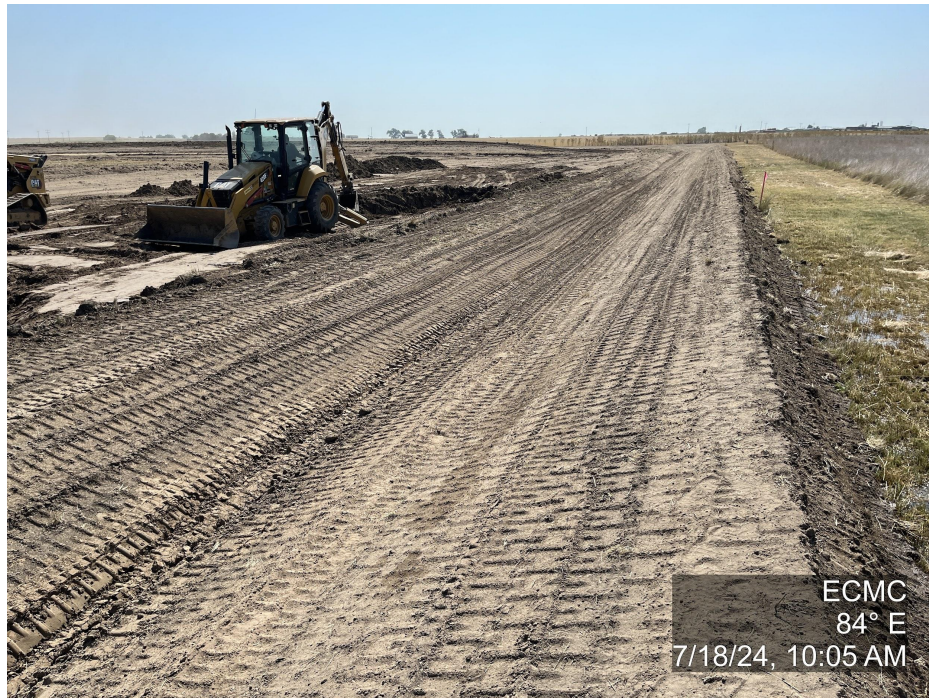
Photo 3. The photo was taken at the well location facing East. The photo illustrates apparent sediment traps under construction.

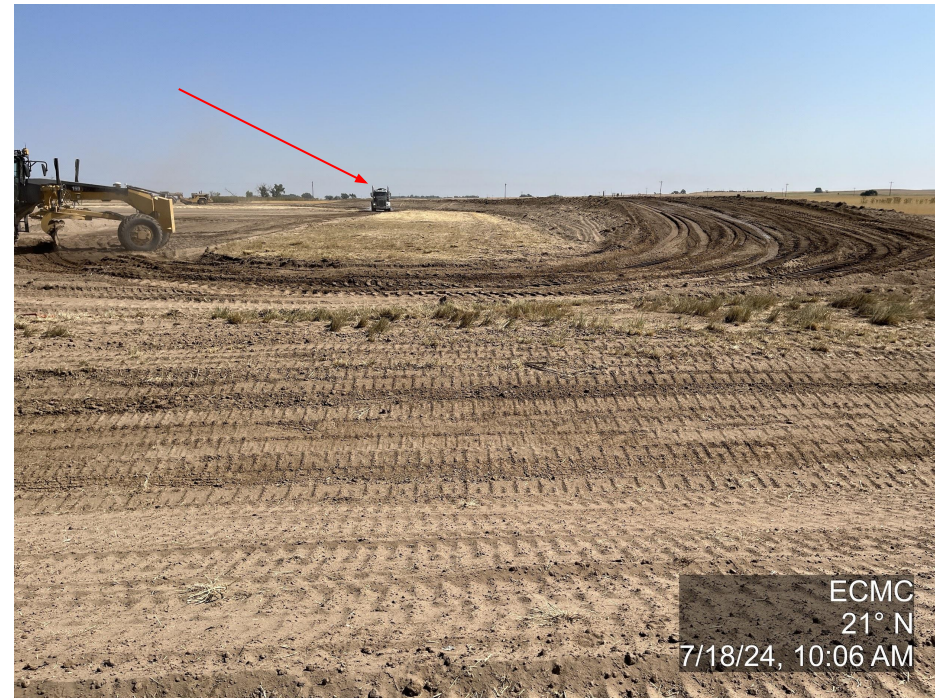
Photo 4. The photo was taken at the well location facing North. The photo illustrates the topsoil salvage in process.

Note - Indicated by the Red arrow the photo also illustrates use of a water truck for dust suppression.

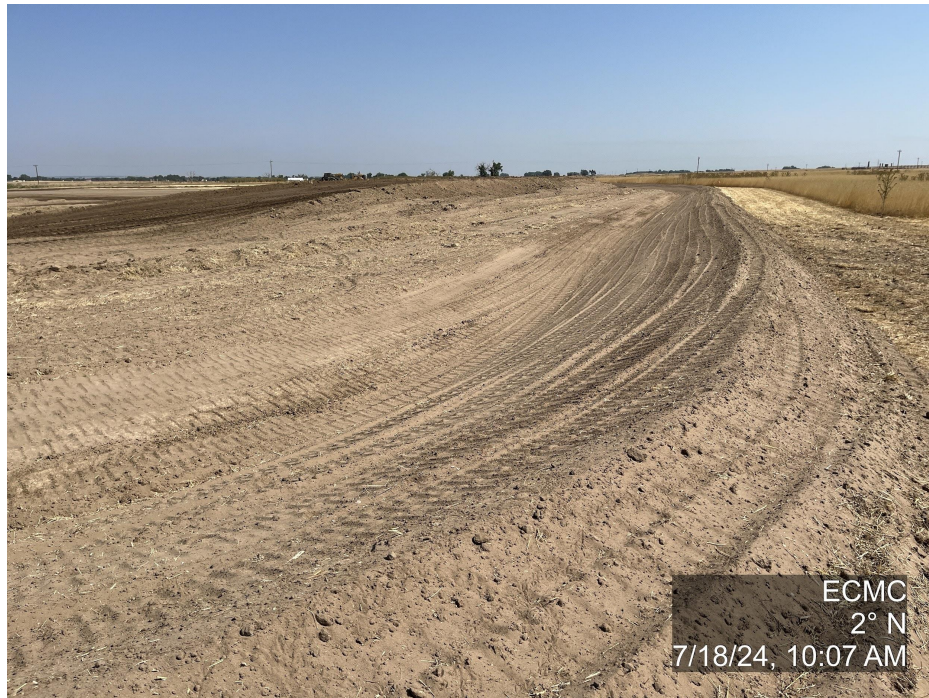
Photo 5. The photo was taken at the well location facing North. The photo illustrates topsoil salvage in process and location temporary perimeter stormwater control ditch and berm.

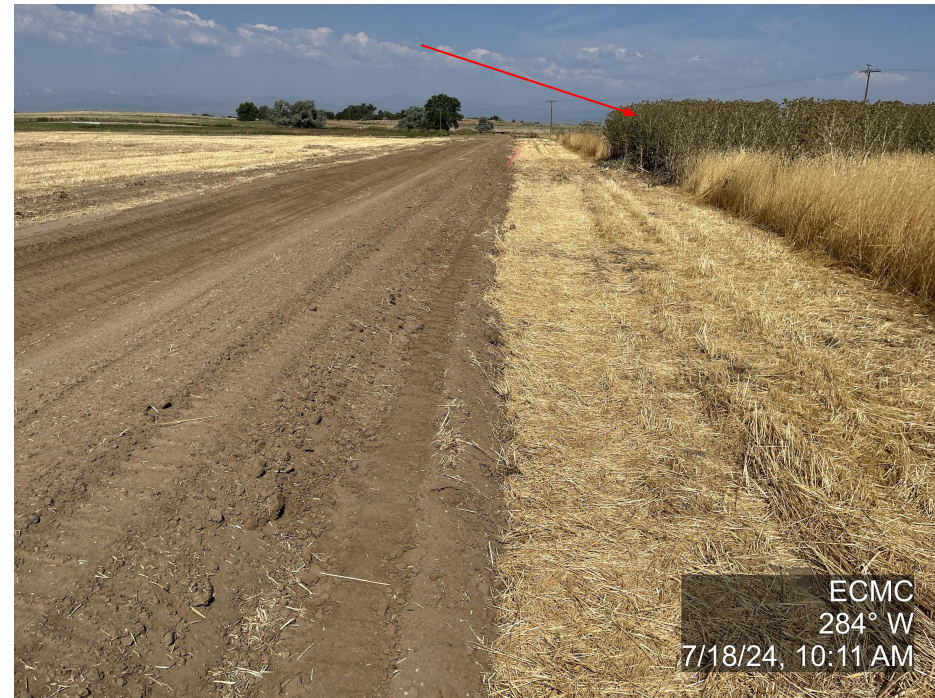
Photo 6. The photo was taken at the well location facing West. The photo illustrates the location boundary ditch and berm.

Note - Large populations of Scotch thistle were in the reference areas surrounding the location and should be considered during construction and production at the facility in the future.

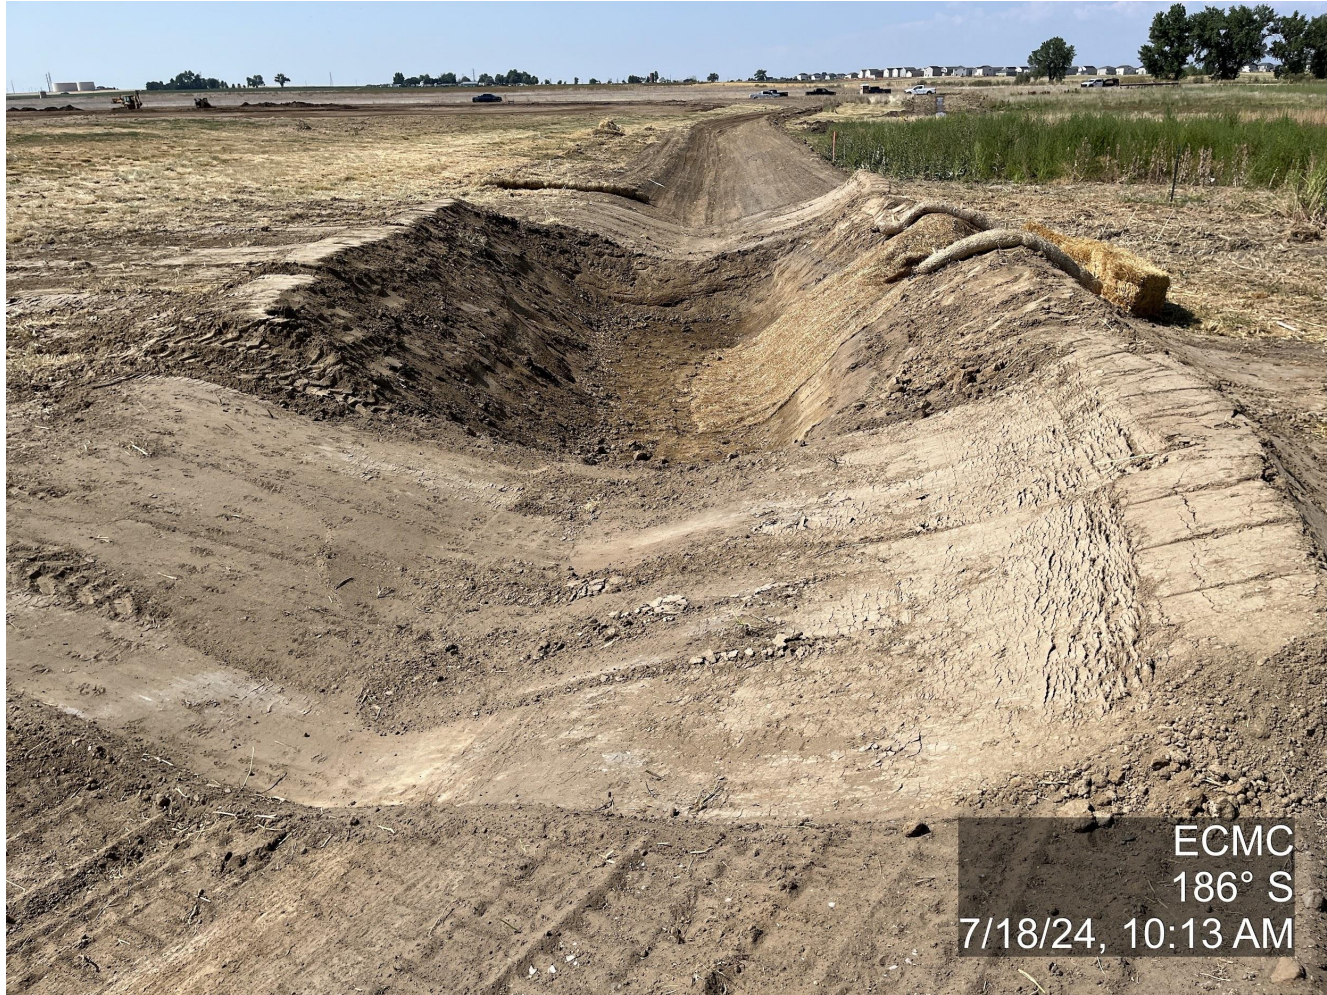
Photo 7. The photo was taken at the well location facing South. The photo illustrates a location sediment trap, with sides that appear to be appropriate and a protected outlet.

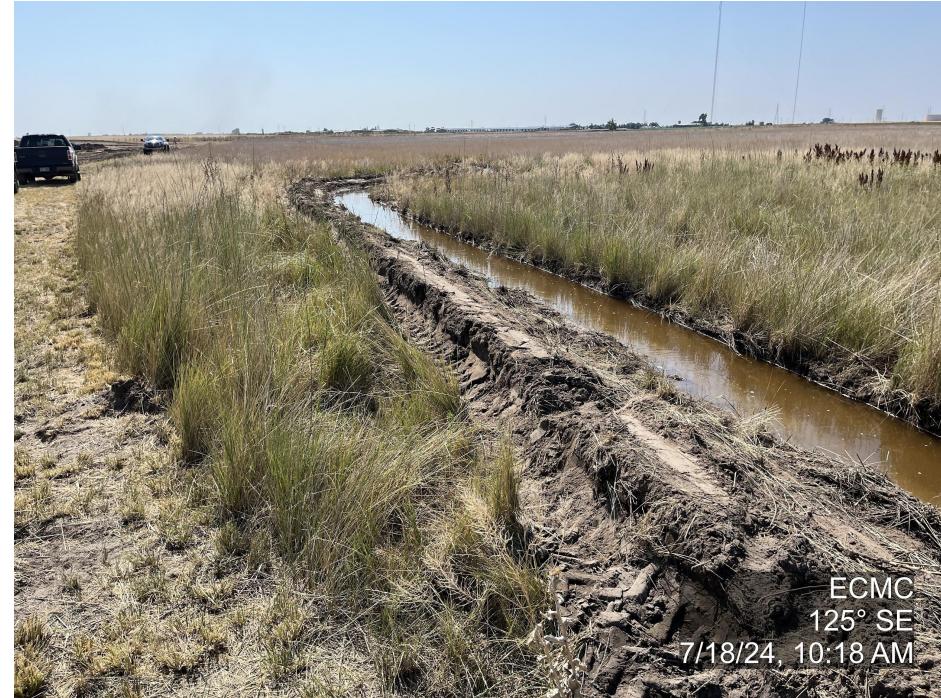
Photo 8. The photo was taken at the well location facing Southwest. The photo illustrates a ditch with flowing water that has been diverted around the new location.

Photo 9. The photo was taken at the well location facing Southeast. Refer to the comment for photo 8.

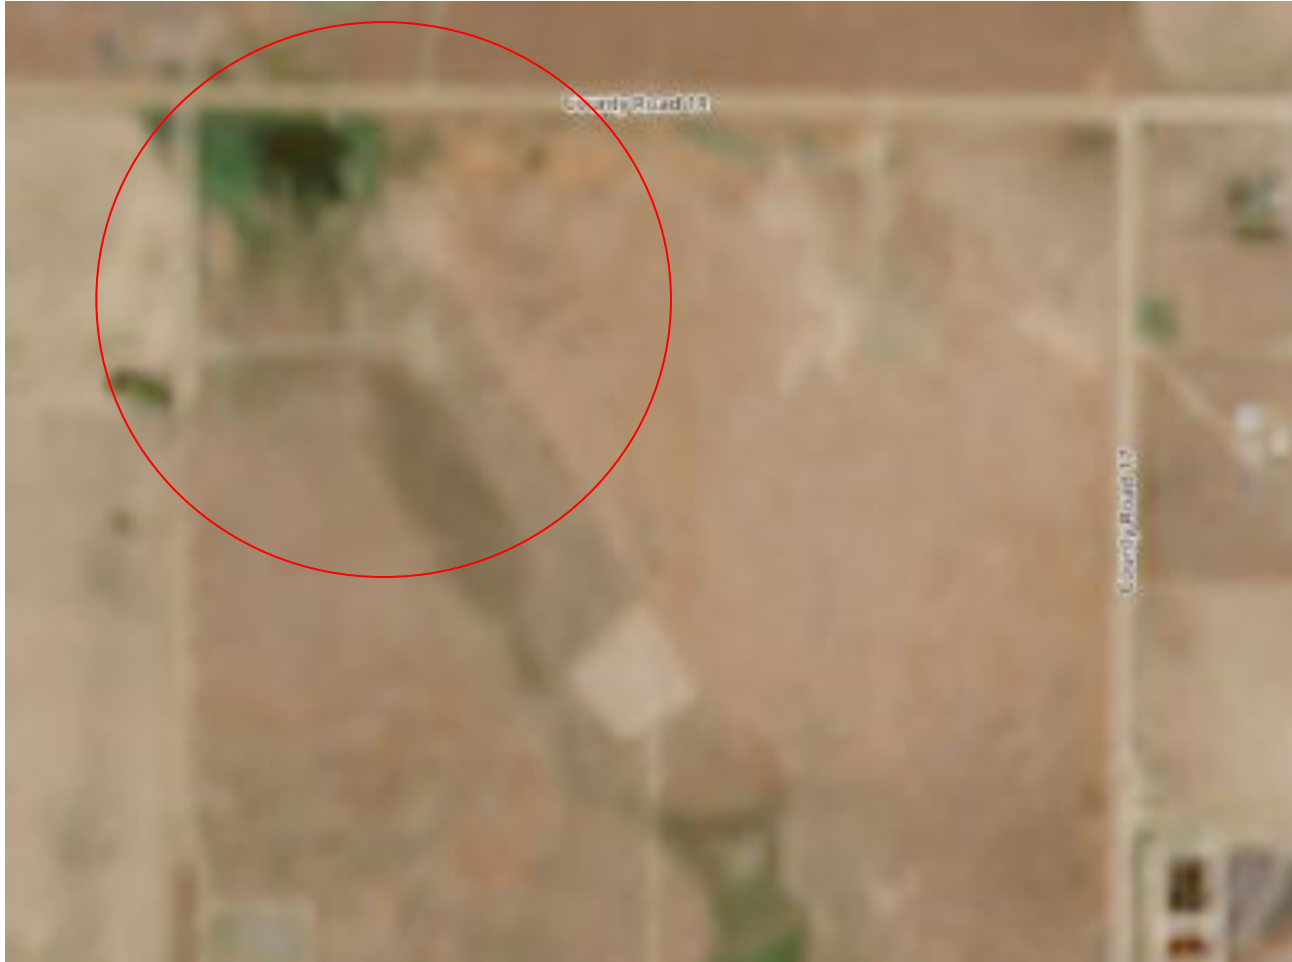
Photo 10. The photo is Copernicus imagery dated 7/4/24. The photo illustrates the location has yet to start construction.

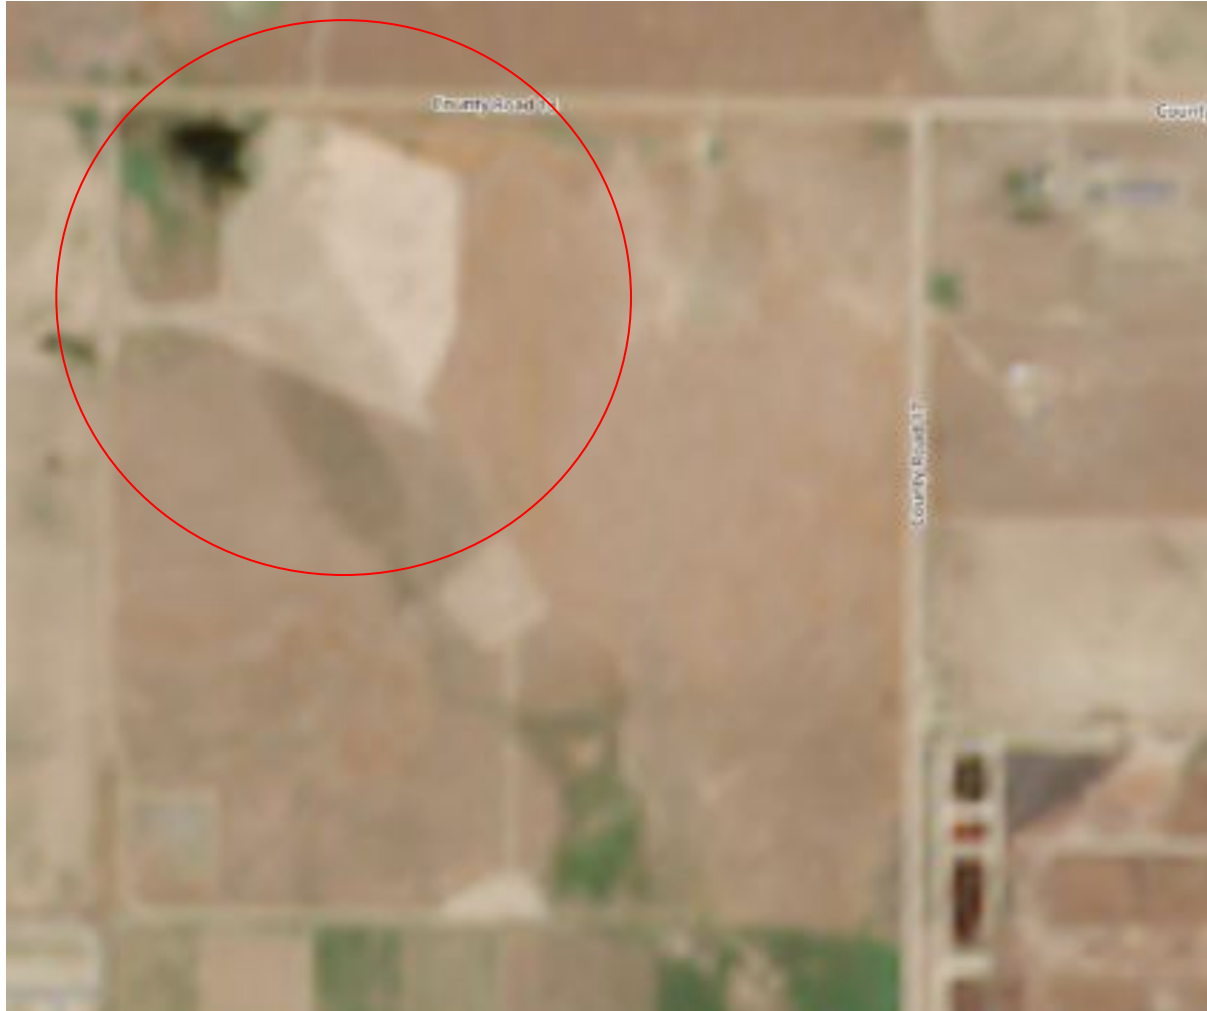
Photo 11. The photo is Copernicus imagery dated 7/11/24. The photo illustrates the location has begun construction prior to the posted start date of 7/15/24.
