# Inspection Photos

API: 071-07915

Operator: WAPITI OPERATING LLC

Inspection Date: 7/29/2024

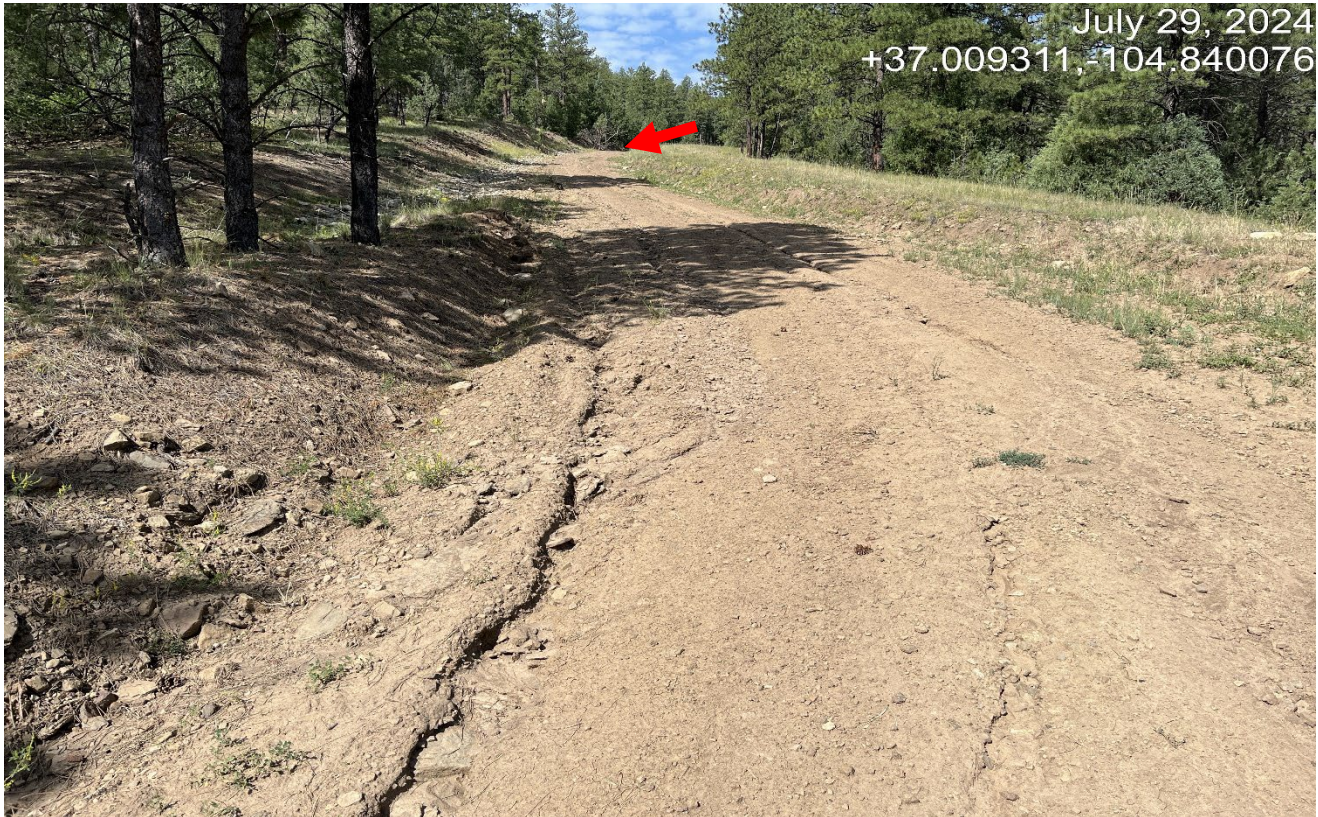
**Photo 1.** Facing west along the access road. There is erosion occurring on this section of the road which has been problematic with vehicle rutting and erosion. This section to the red arrow needs to be crowned with roadbase and gravel.

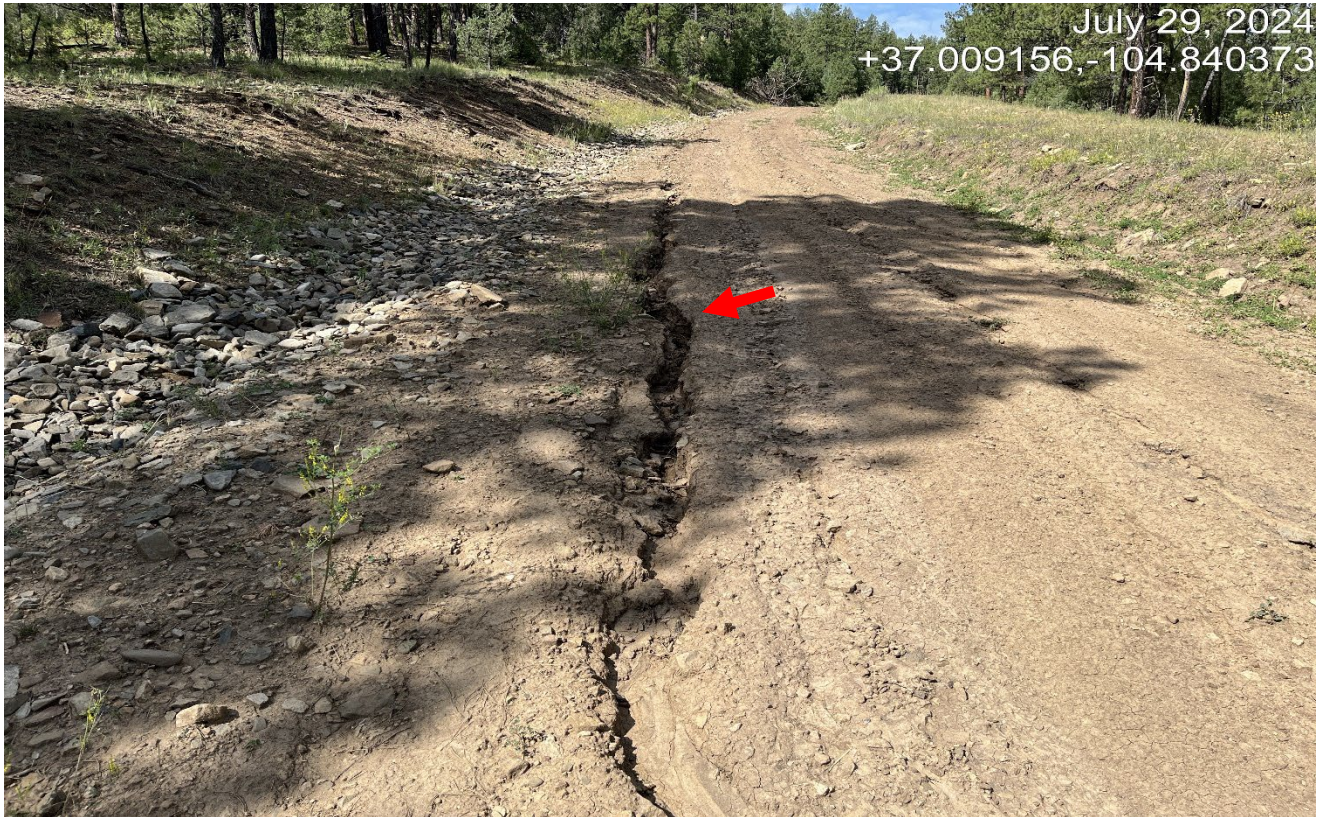
**Photo 2.** Stormwater is beginning to create a deep rill and stormwater is not being diverted off the road.

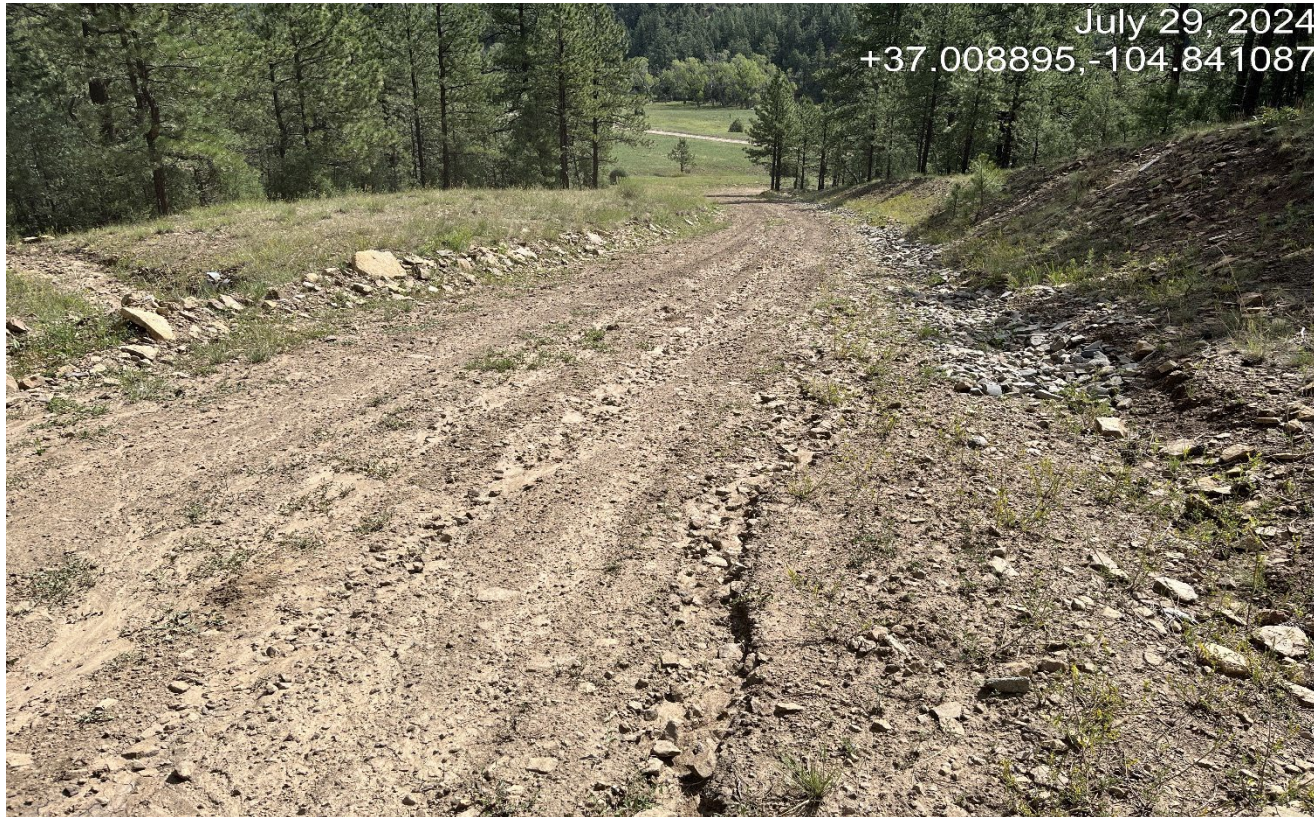
**Photo 3.** Facing back east. There is erosion occurring on this section of the road which has been problematic with vehicle rutting and erosion. This section of the road needs to be crown with roadbase and gravel.

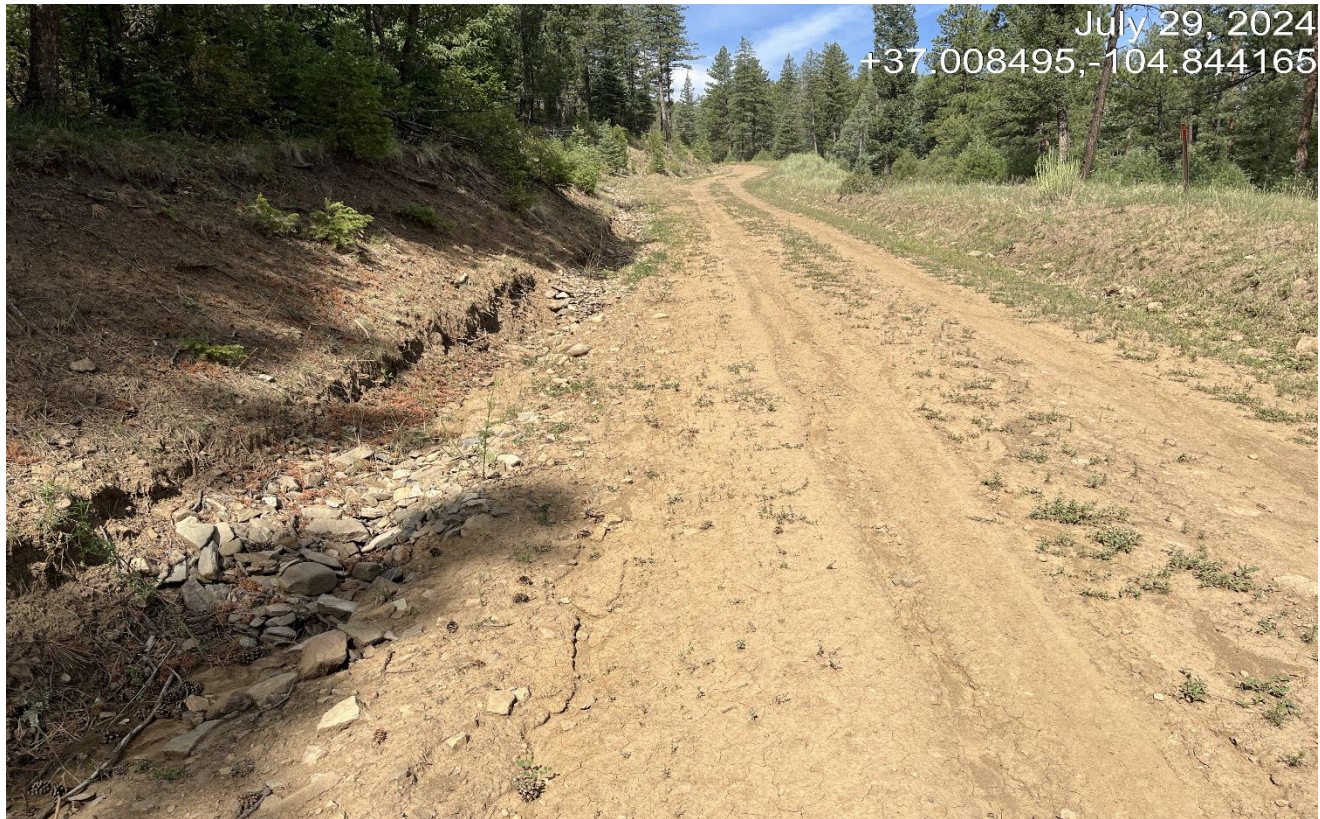
**Photo 4.** Facing west along the access road. The remainder of the road is maintained.
