Inspection Photos

API: 071-09051

Operator: WAPITI OPERATING LLC

Inspection Date: 7/29/2024

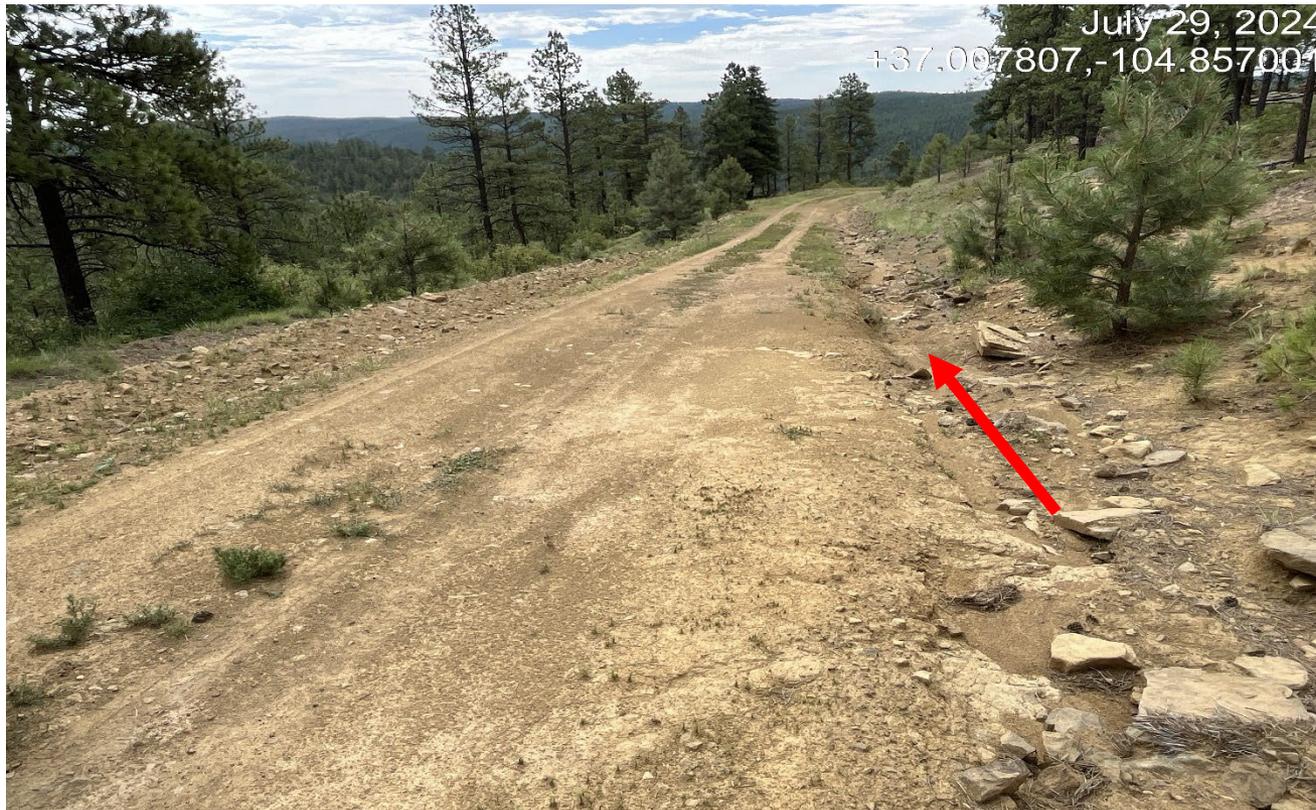
Photo 1. Facing northeast along the access road. There is a long stretch of road with no stormwater diversion which is concentrating a lot of flow to the area in the following pictures.

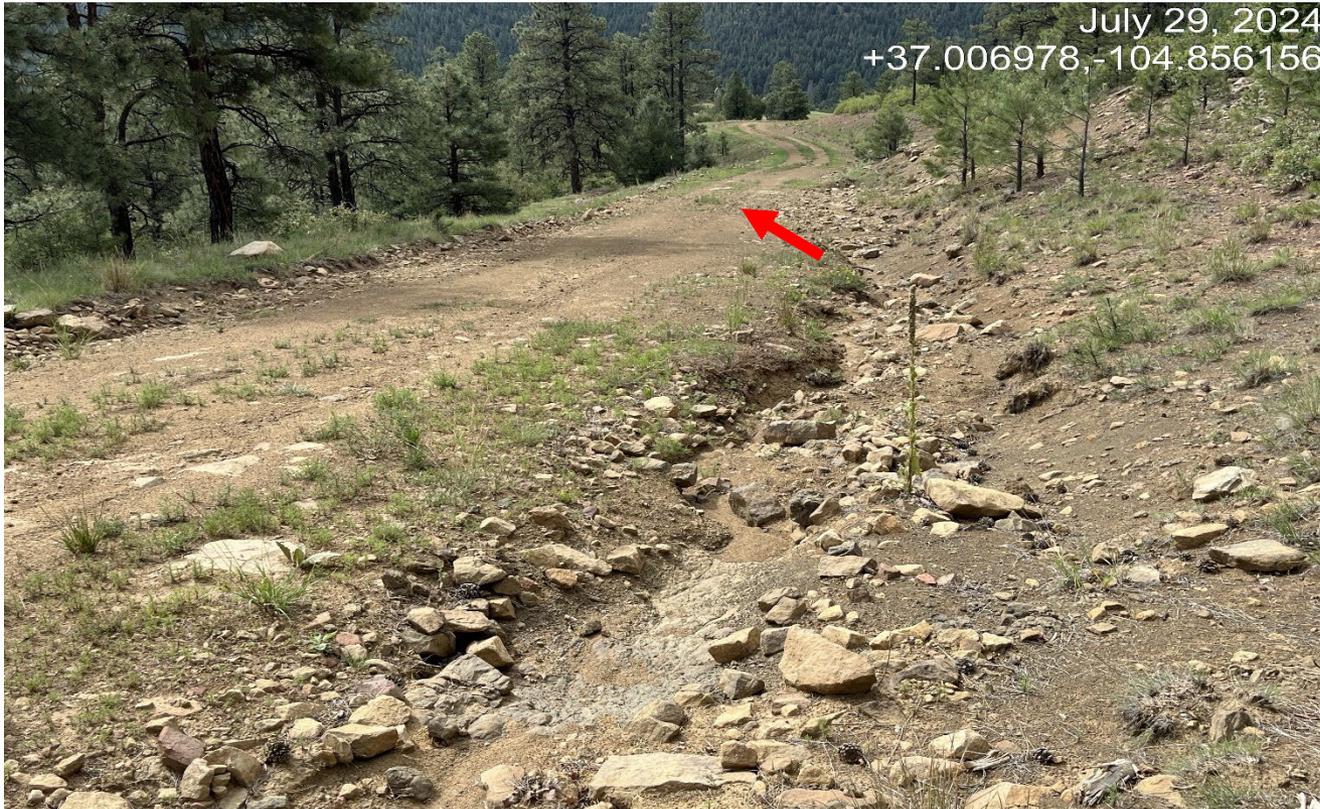
Photo 2. Facing southeast along the access road. There is erosion along the roadside which needs BMP's to control erosion. Tip: Rocks could be utilized to create check dam structures for erosion control.

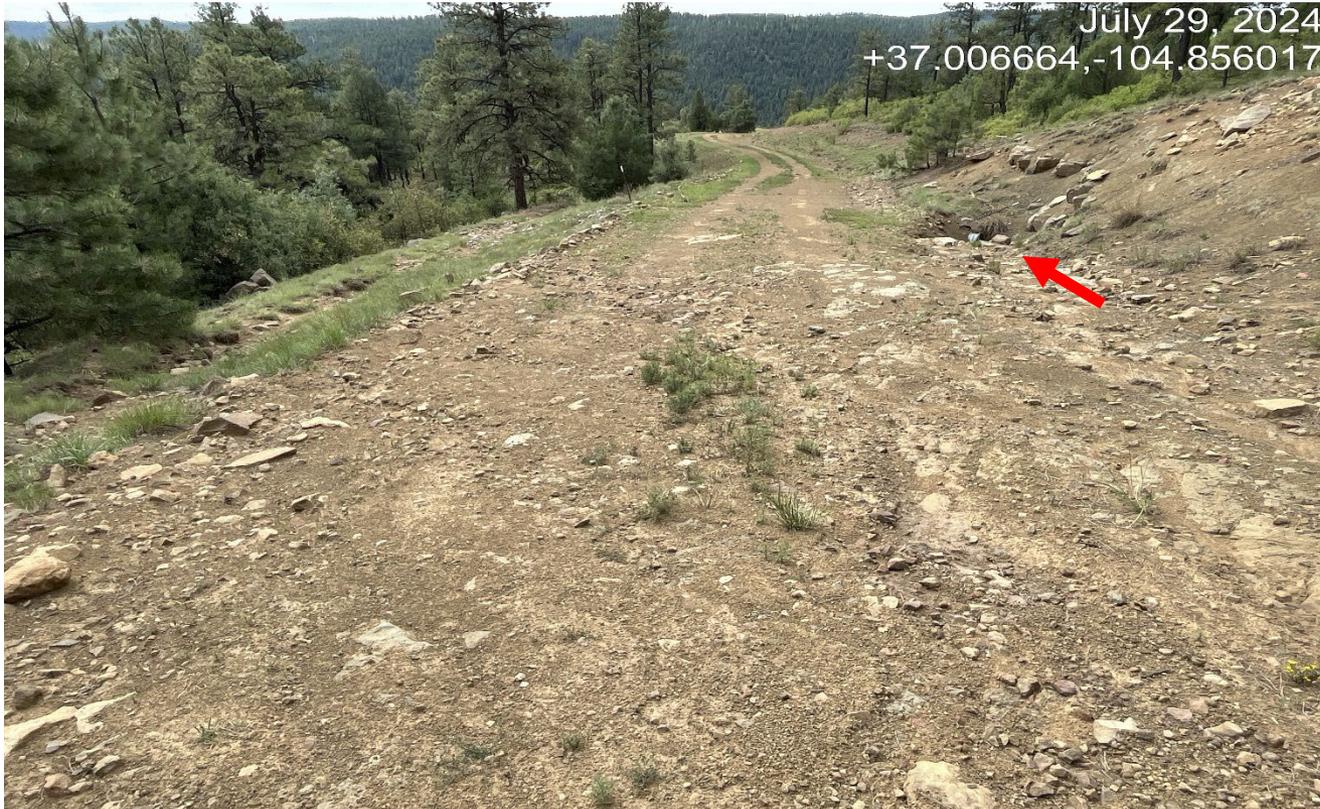
Photo 3. Stormwater is flowing across the road instead of toward the culvert at red arrow.

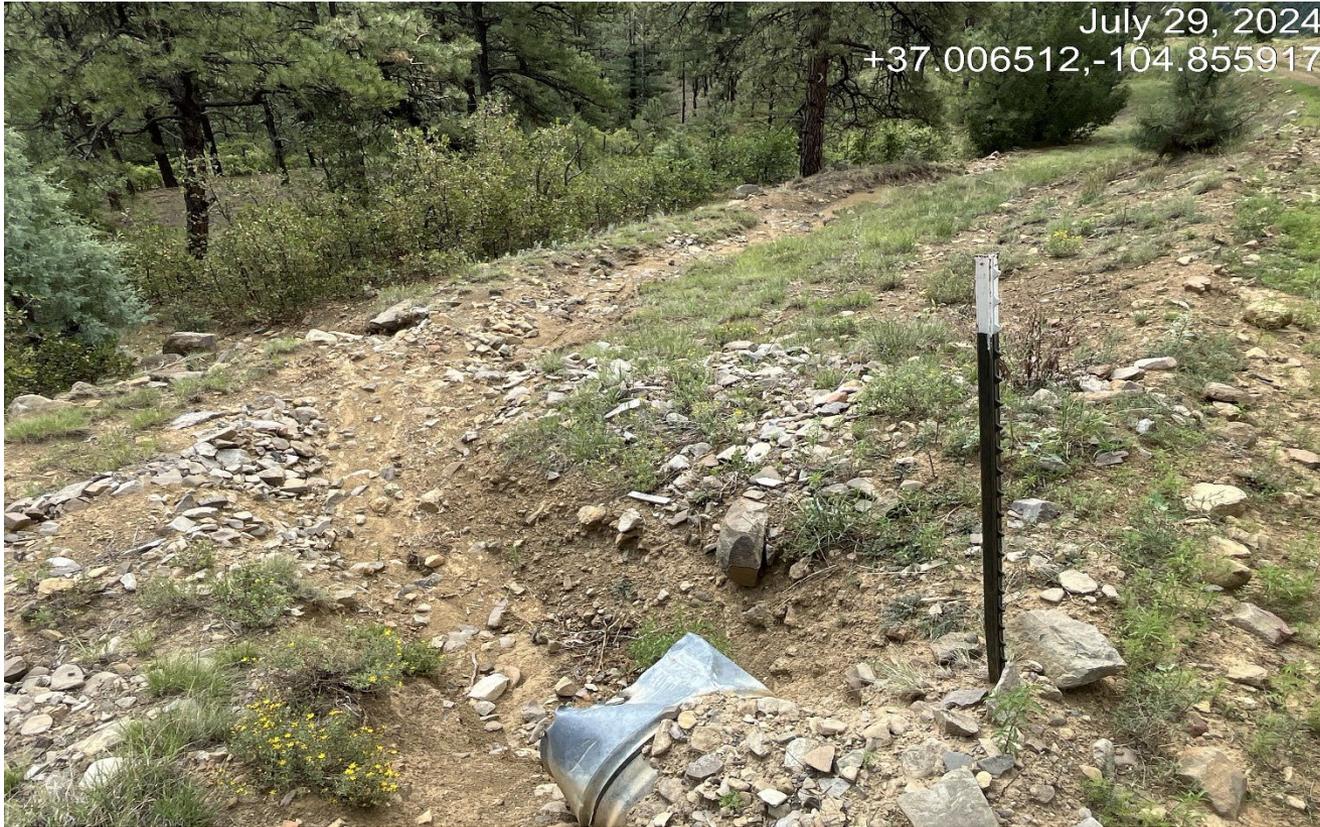
Photo 4. The culvert does not have outlet protection and erosion is occurring in this area.
