Inspection Photos

API: 071-06819

Operator: WAPITI OPERATING LLC

Inspection Date: 7/29/2024

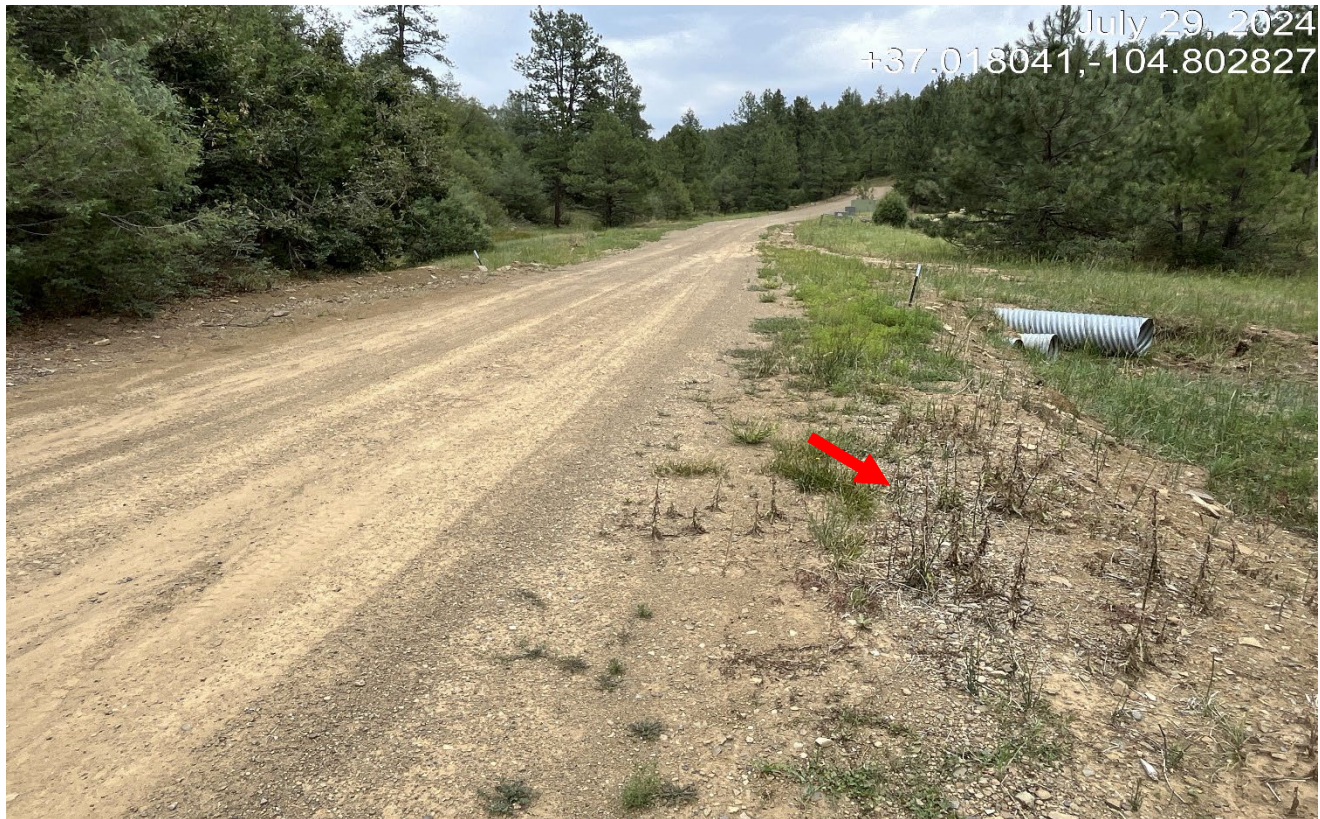
Photo 1. Facing southeast along the main access road. Noxious weeds have been controlled.

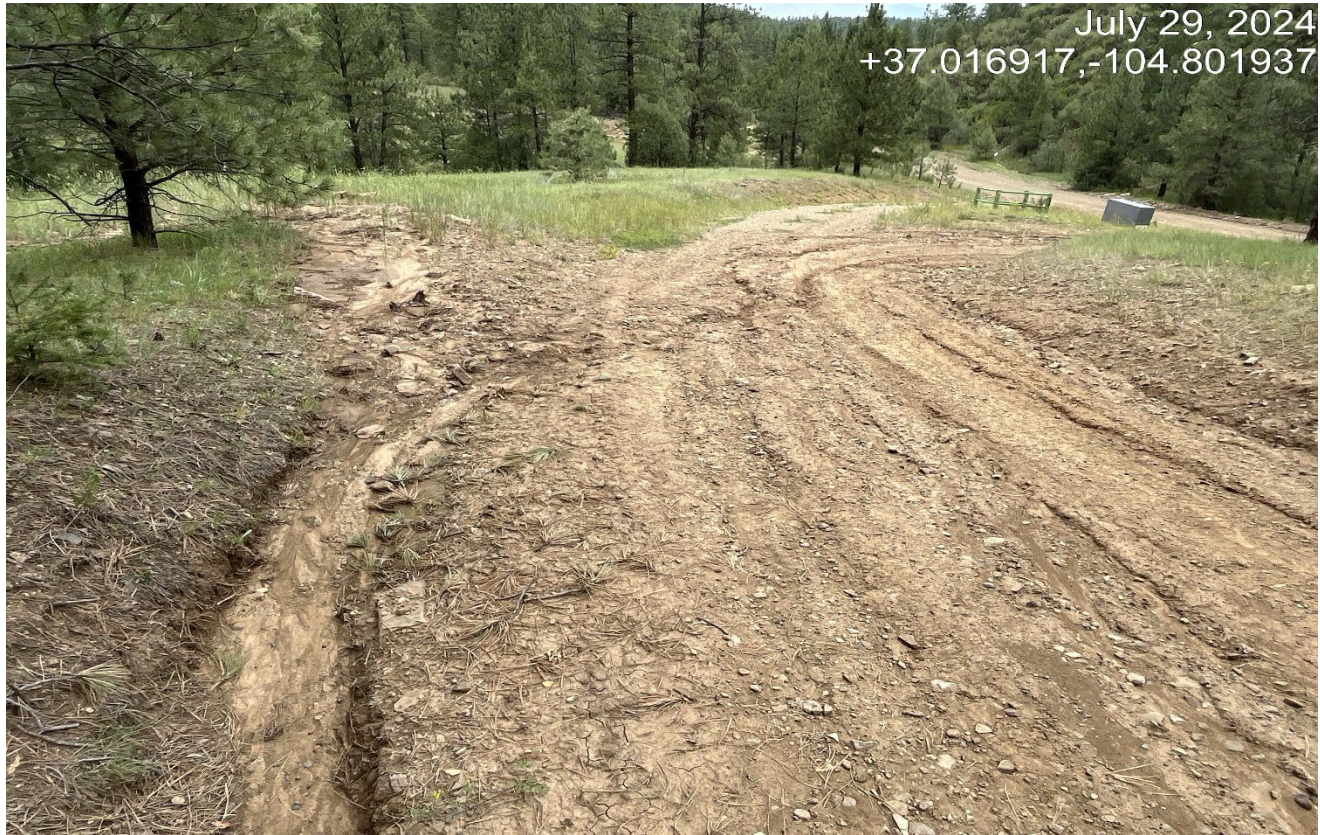
Photo 2. Facing northeast along the access road. Sediment has filled into the diversion ditch and stormwater is going back onto the road causing erosion..

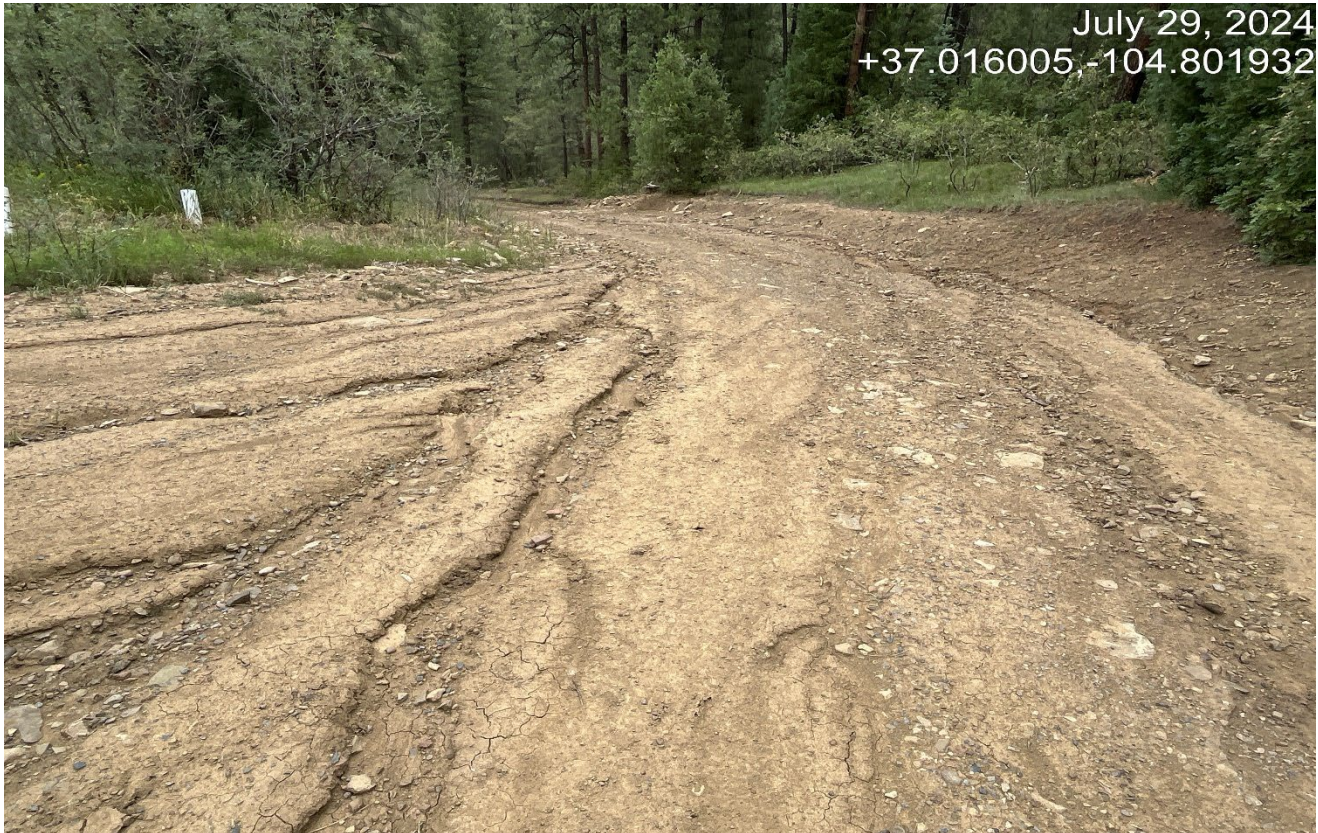
Photo 3. Facing back down the road at the wellsite. There is erosion occurring down the road causing erosion. A berm would help divert the water off the road to prevent erosion.
