# Reclamation and Stormwater Inspection

Date: 07/23/2024

Operator: KERR MCGEE OIL & GAS ONSHORE LP -  
47120

Location Name: Callen USX 65N 67W 27NWNE

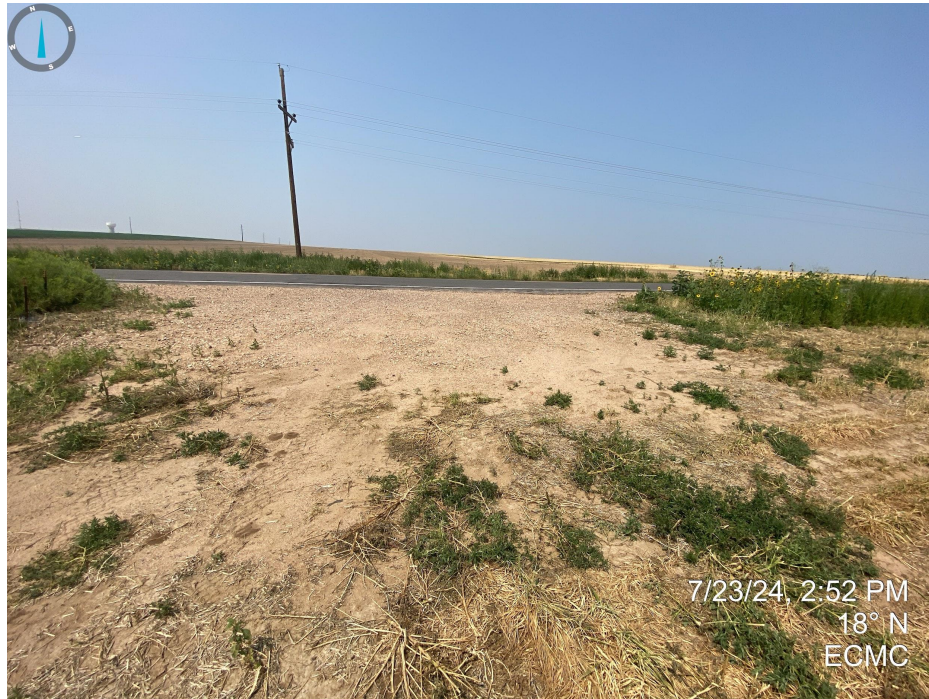
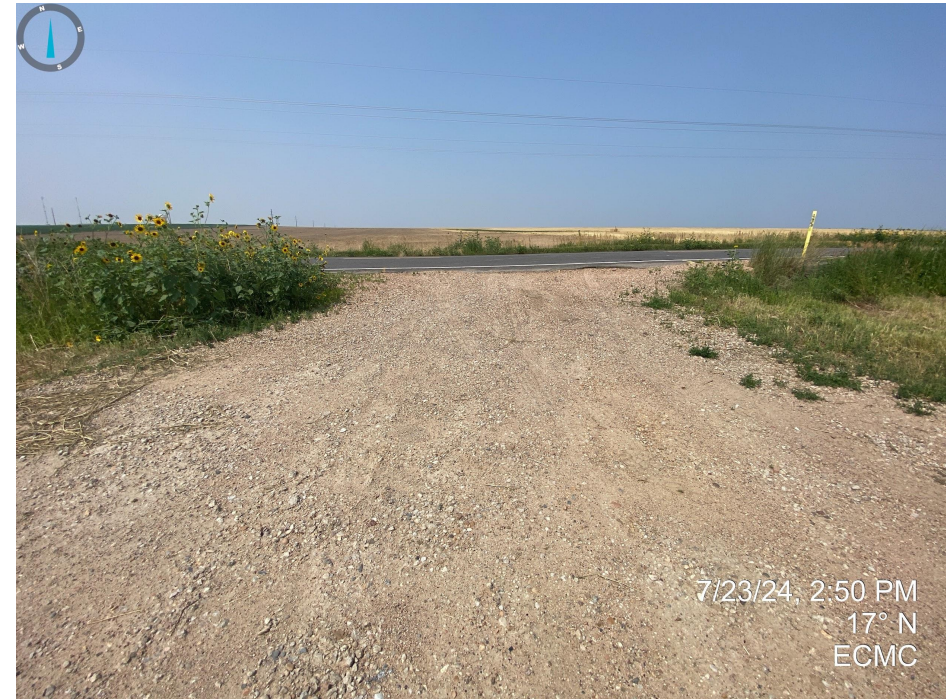
**Photo 1.** Entrance to the former tank battery has not been reclaimed, road base and culvert remain at the west (left photo) and east (right photo) entrances.

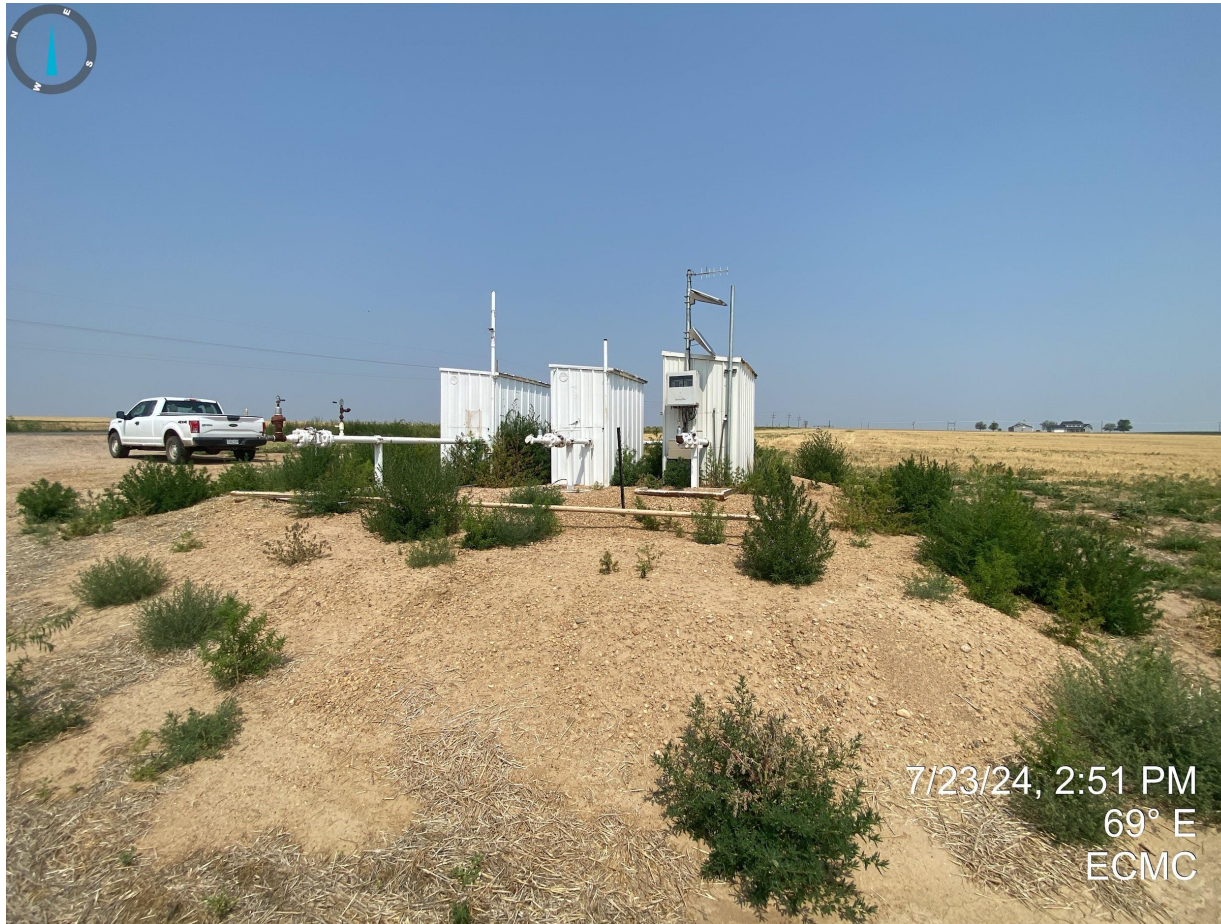
**Photo 2.** Three meter sheds and associated piping remain at the former tank battery location. The northern and southern meter sheds appear to be Kerr McGee gathering and the center meter shed appears to be PDC. All equipment must be removed and the location will need to be recontoured and reclaimed for future land use - cropland.

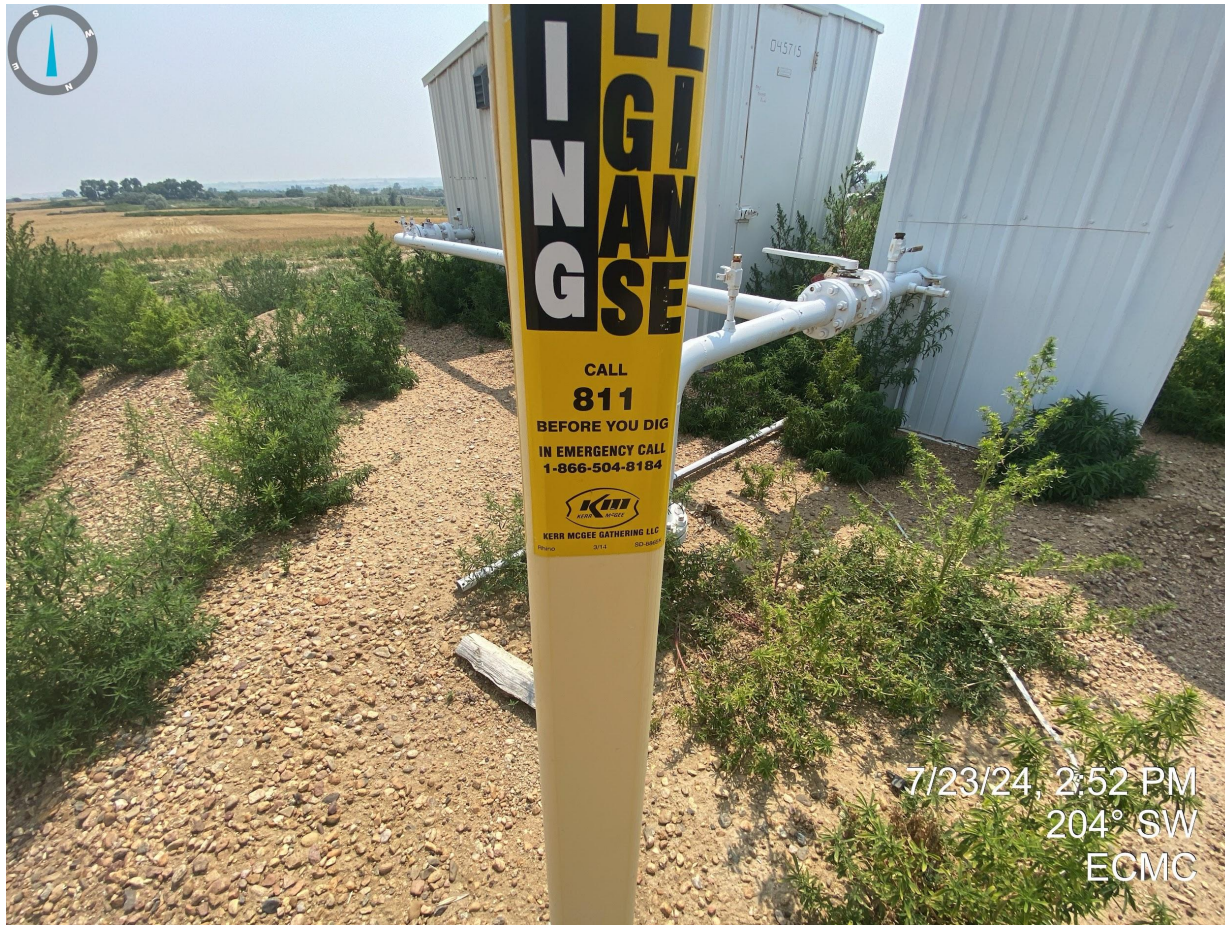
**Photo 3.** Pipeline marker indicates Kerr Mcgee Gathering LLC.

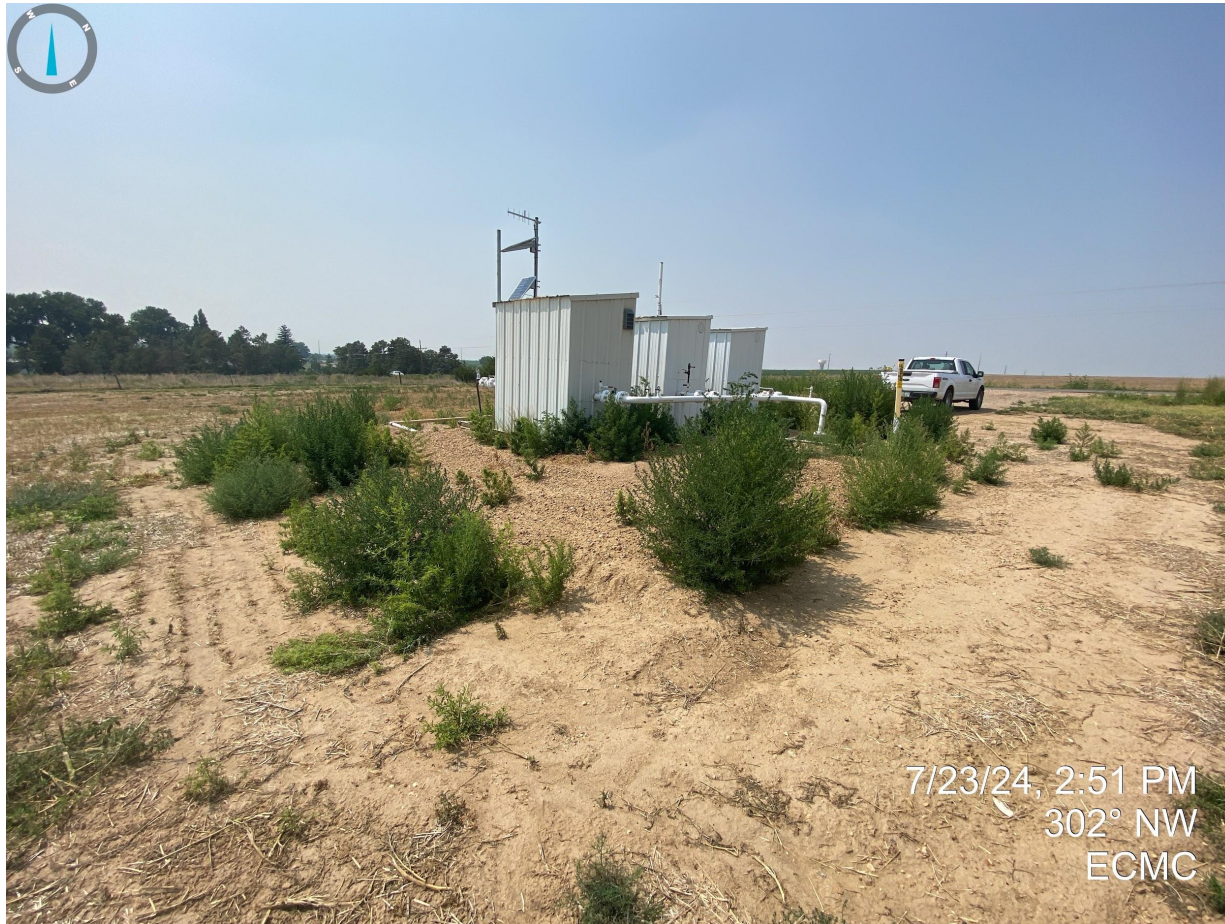
**Photo 4.** Undesirable vegetation (kochia, russian thistle) observed around the meter sheds.

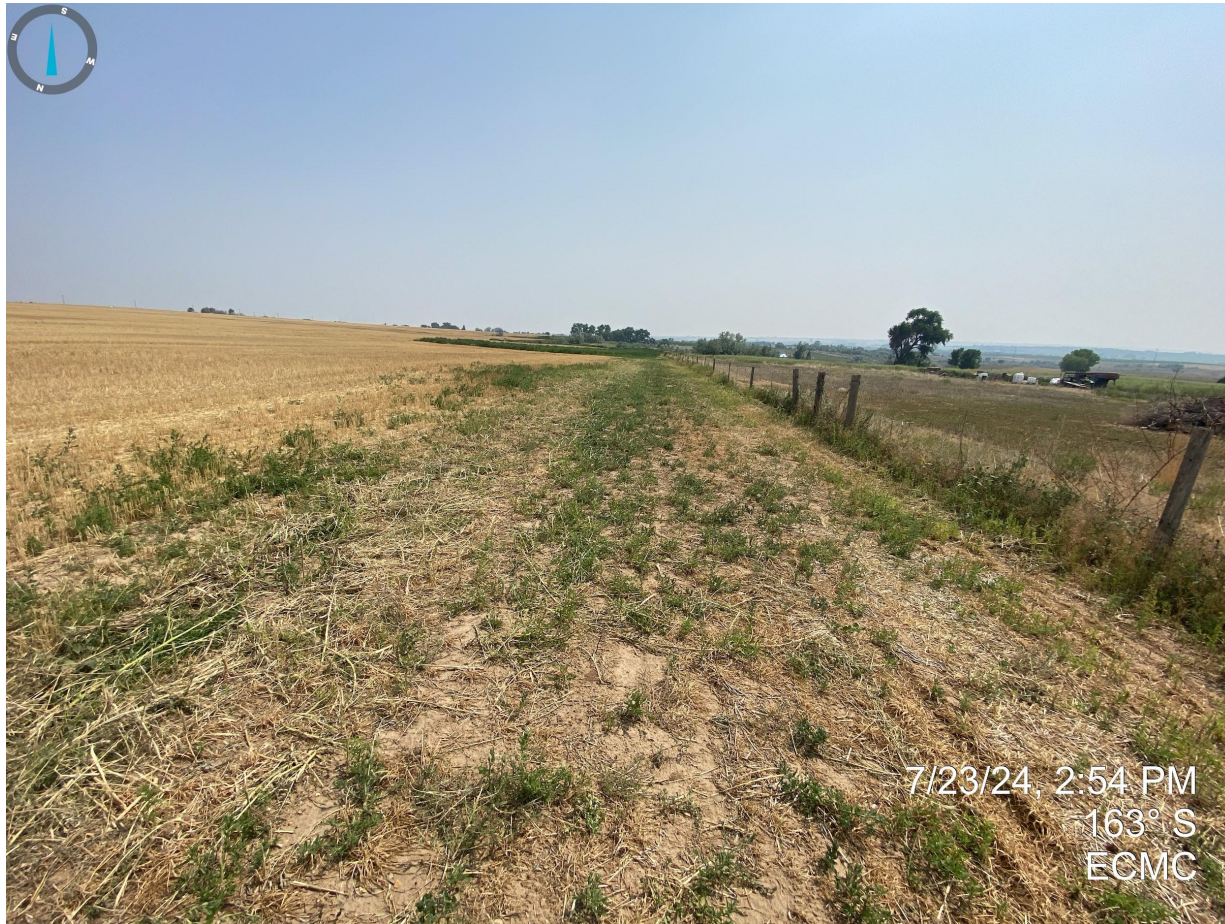
**Photo 5.** Facing south along the former access road to well API 123-25194. Evidence of undesirable vegetation observed along the access road.

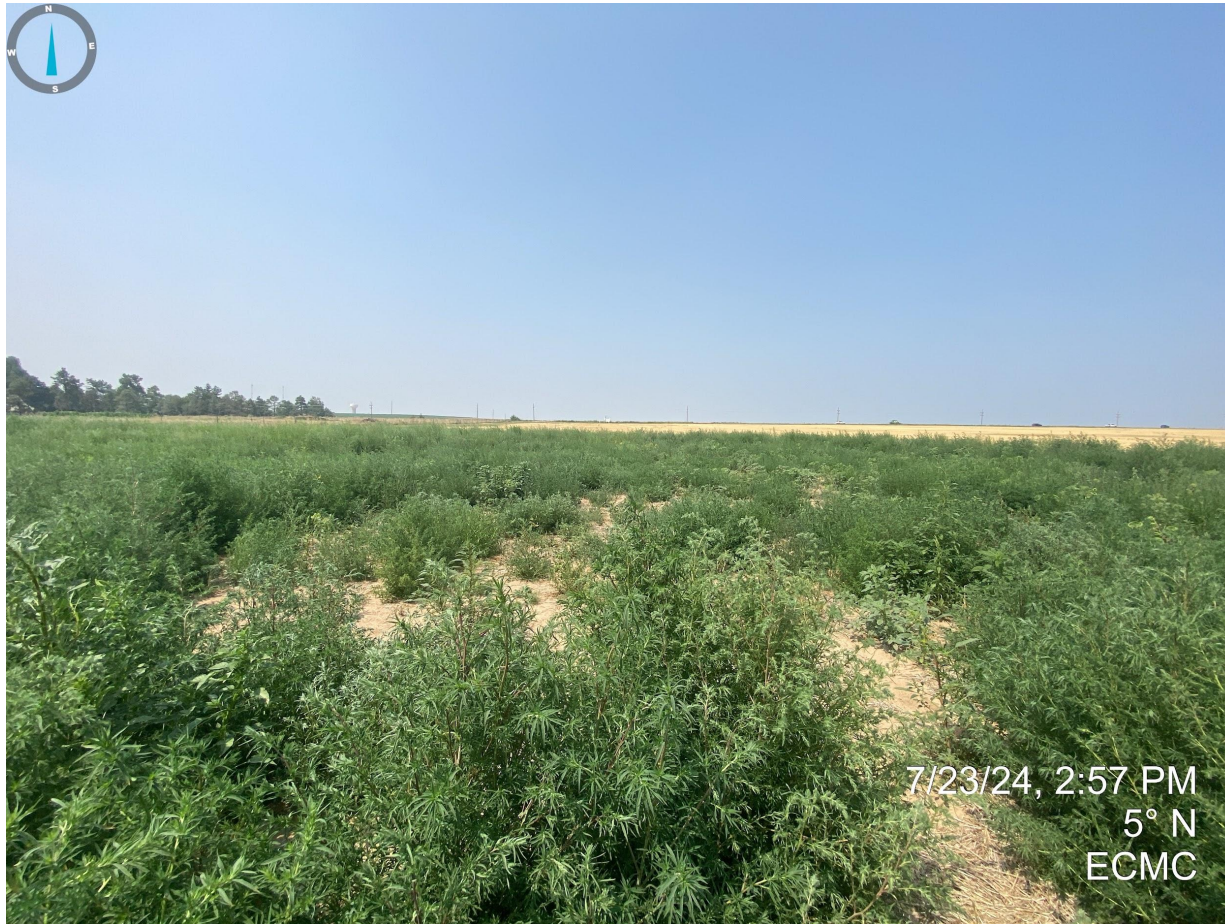
**Photo 6.** Facing north at the former well location. Undesirable vegetation, predominantly kochia, observed throughout. Additional weed management/reclamation activities required.

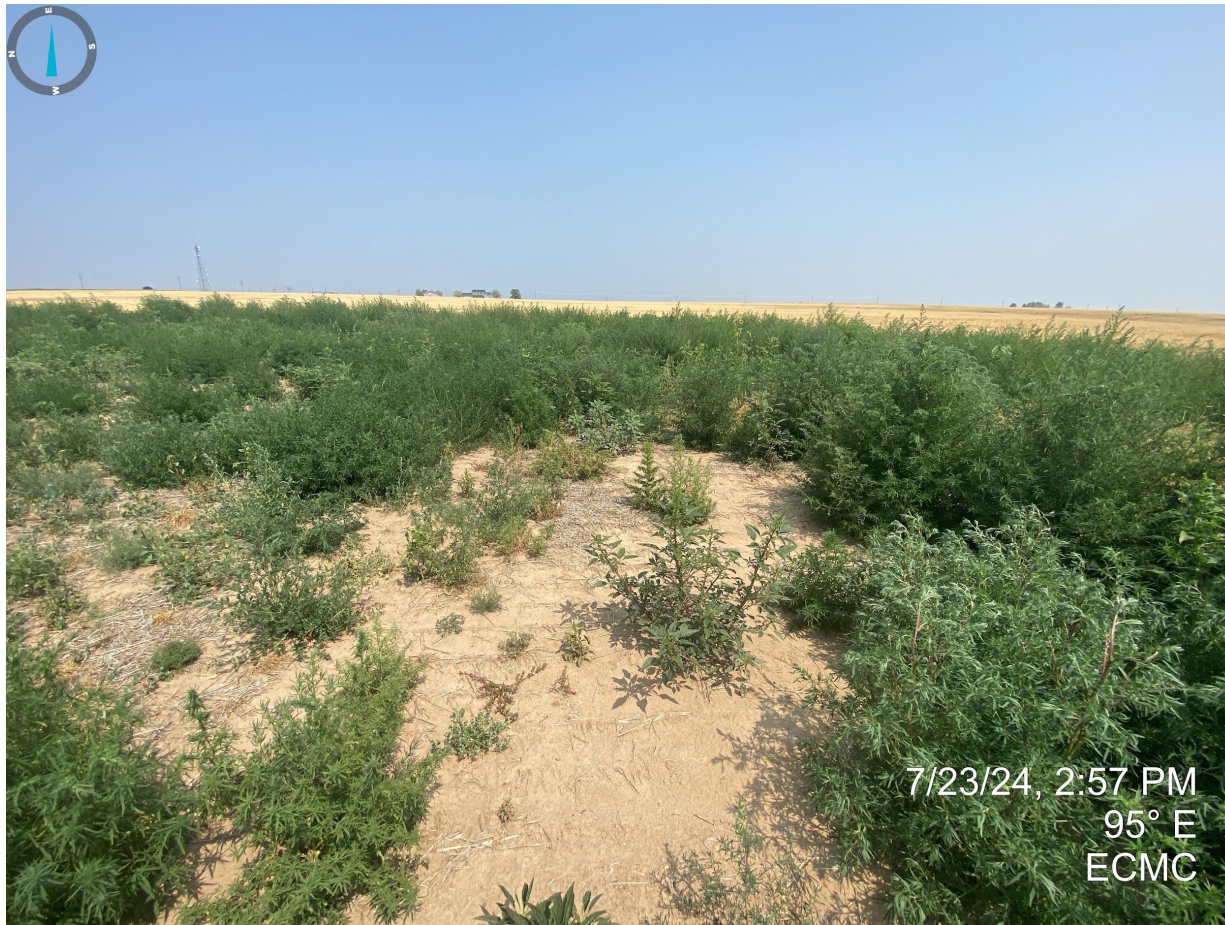
**Photo 7.** Facing east at the former well location; see comments in Photo 6.

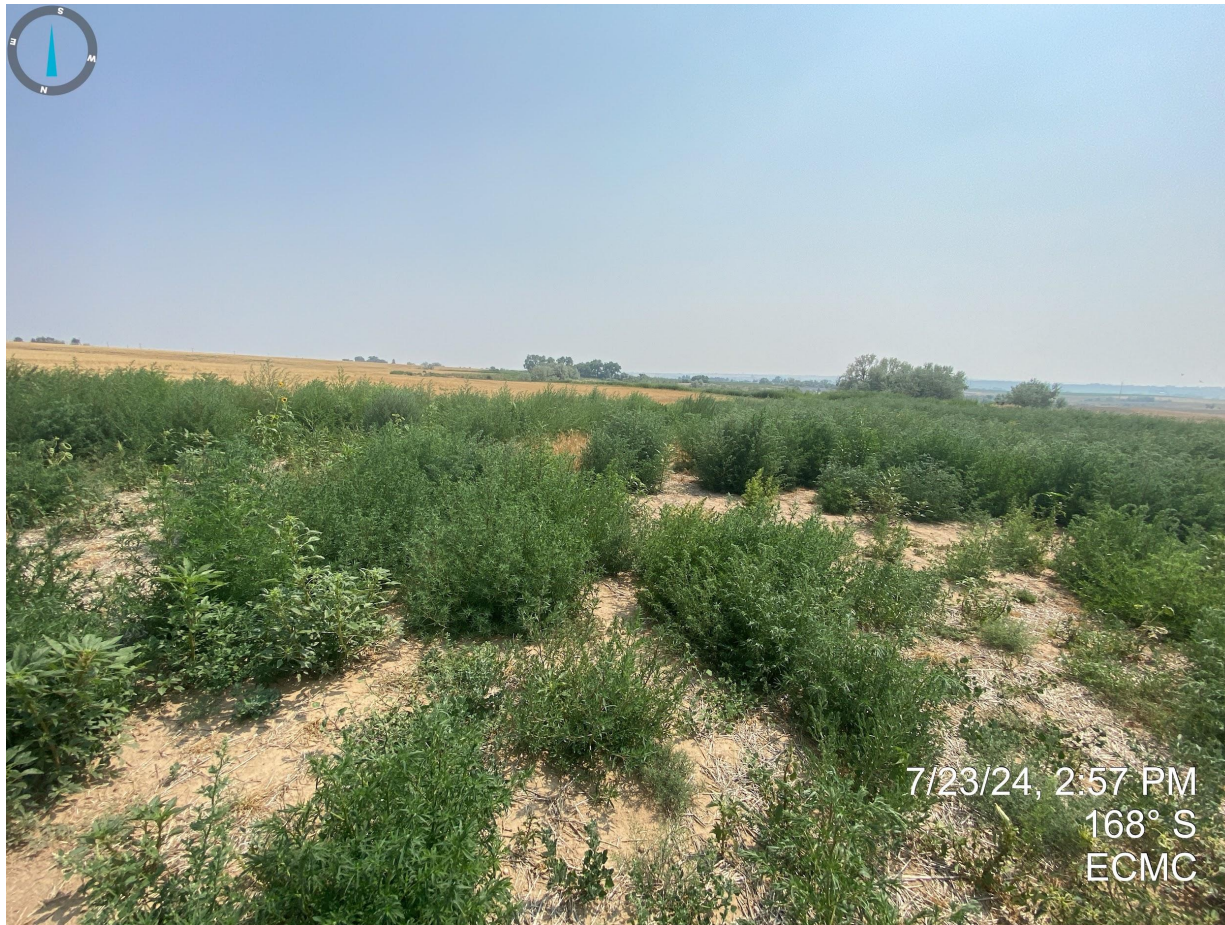
**Photo 8.** Facing south at the former well location; see comments in Photo 6.

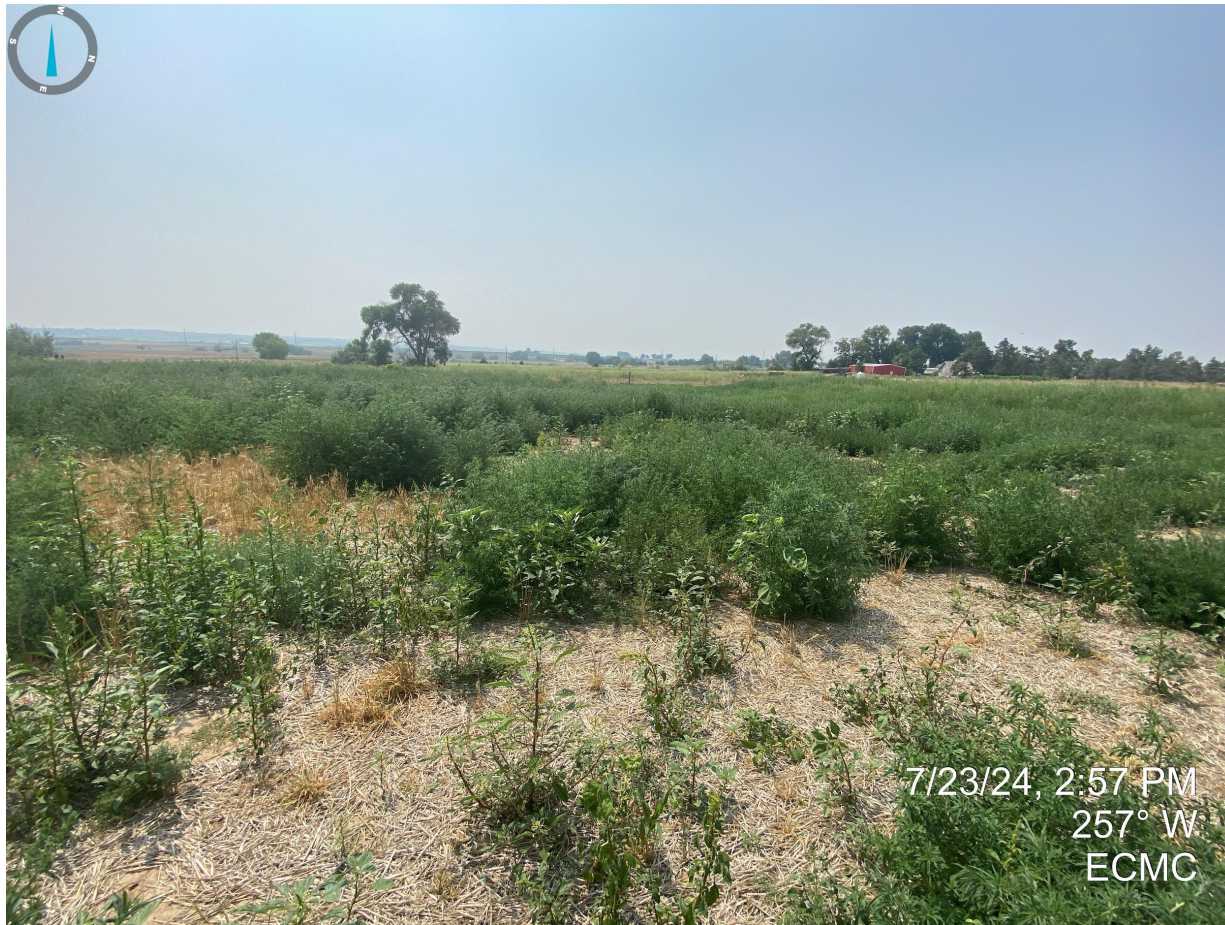
**Photo 9.** Facing west at the former well location; see comments in Photo 6.

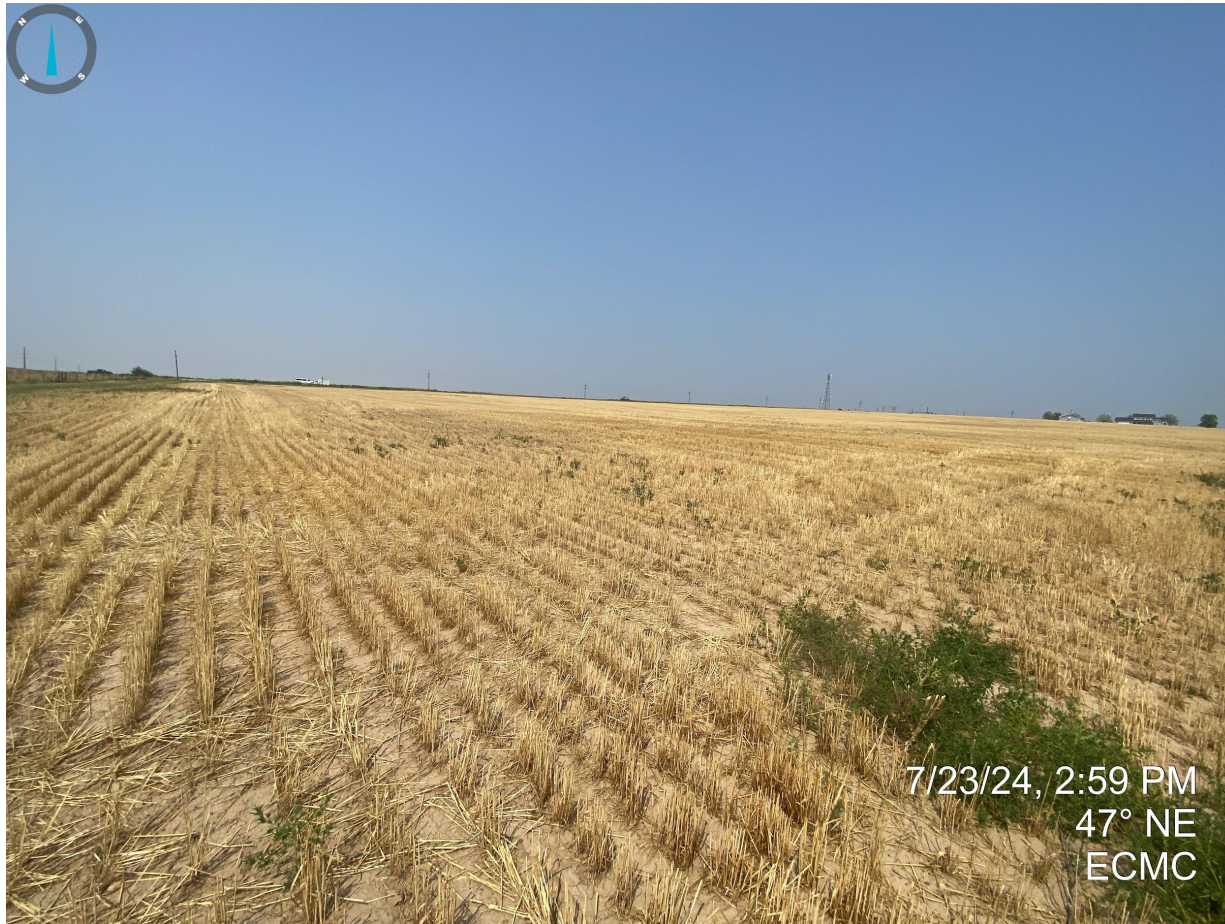
**Photo 10.** Reference area taken north of the former well location; crop has been recently harvested.
