Interim Reclamation and Stormwater Inspection

July 17, 2024

Operator: GMT EXPLORATION COMPANY LLC #10243

Location ID: 484163

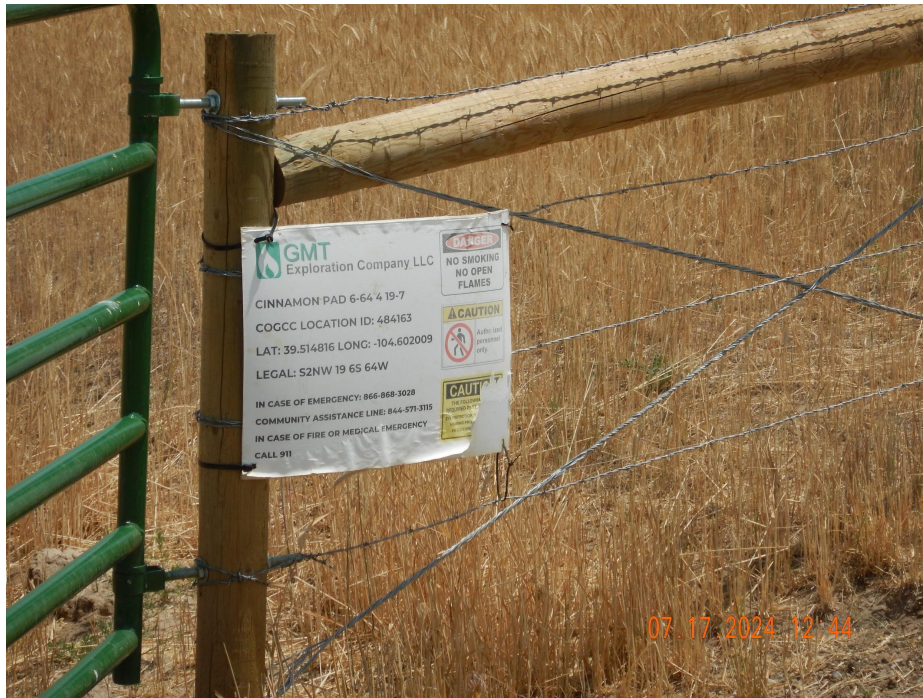
Photo 1. Photo taken from the entrance of location, illustrating the Operator sign.

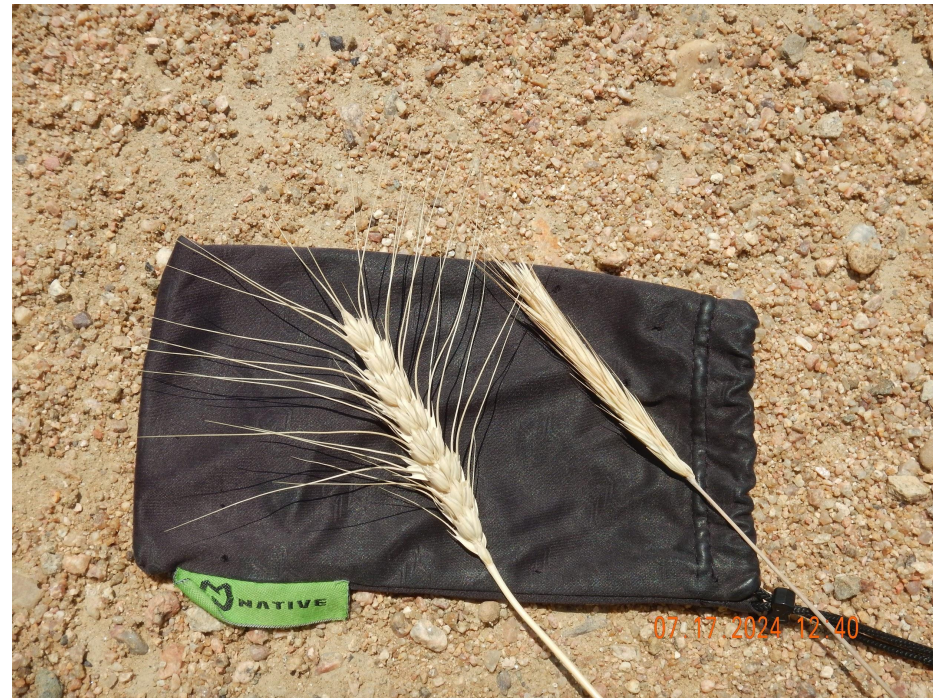
Photo 2. Photo taken of wheat (left) and cereal rye (right). Cereal rye is an aggressive, undesirable annual grass that was observed throughout portions of the perimeter location and access road.

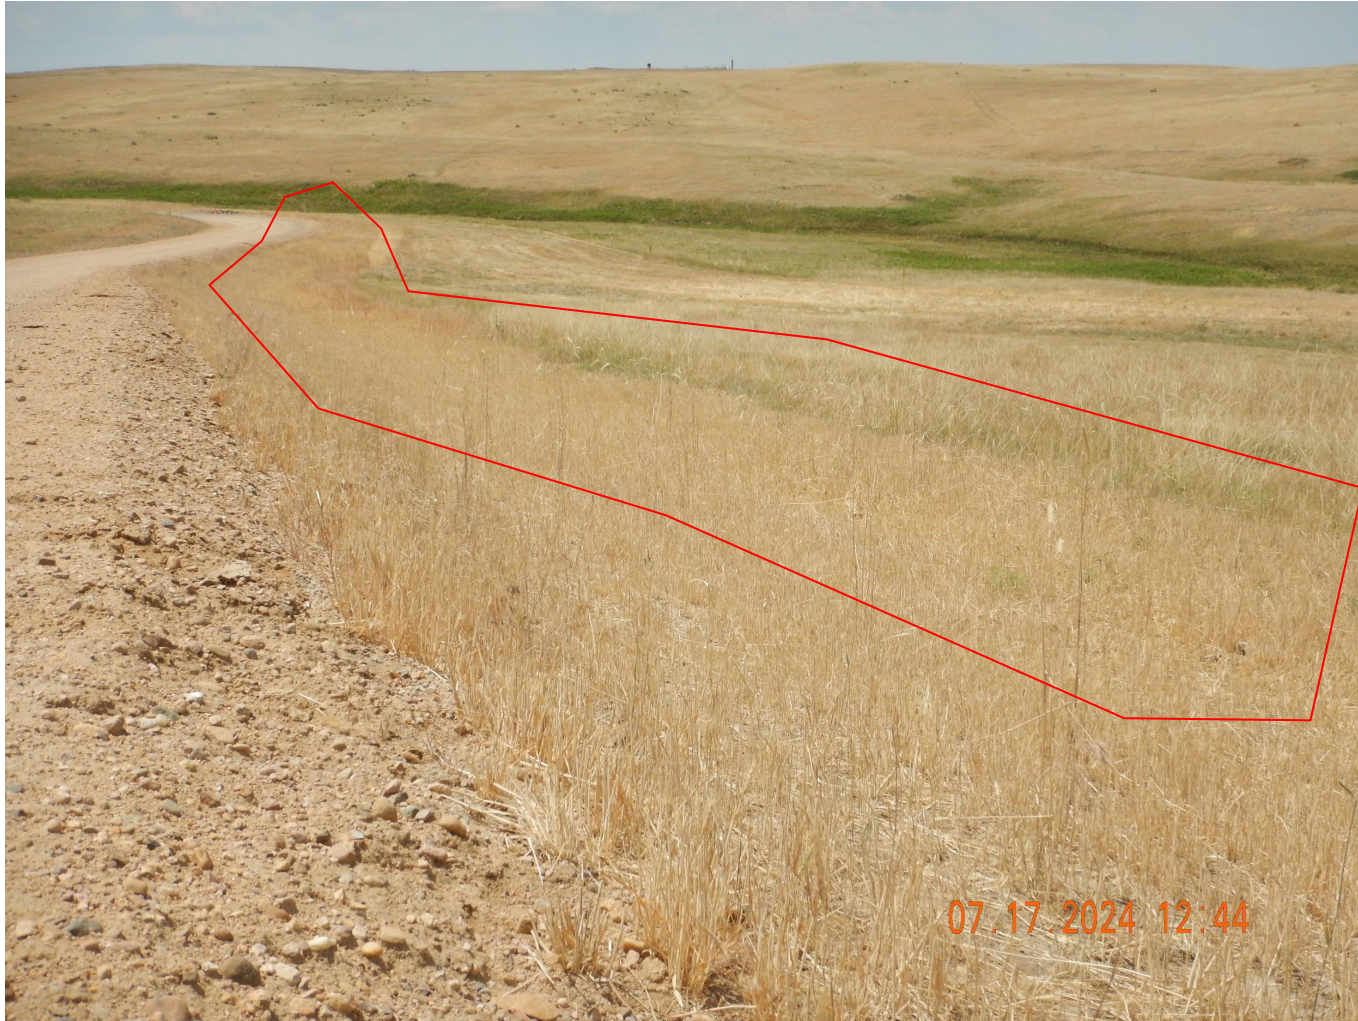
Photo 3. Photo taken along a portion of the northern access road, facing Southwest. Photo illustrates and area alongside the access road that has been disturbed and seeded. Cereal rye is observed within this area.

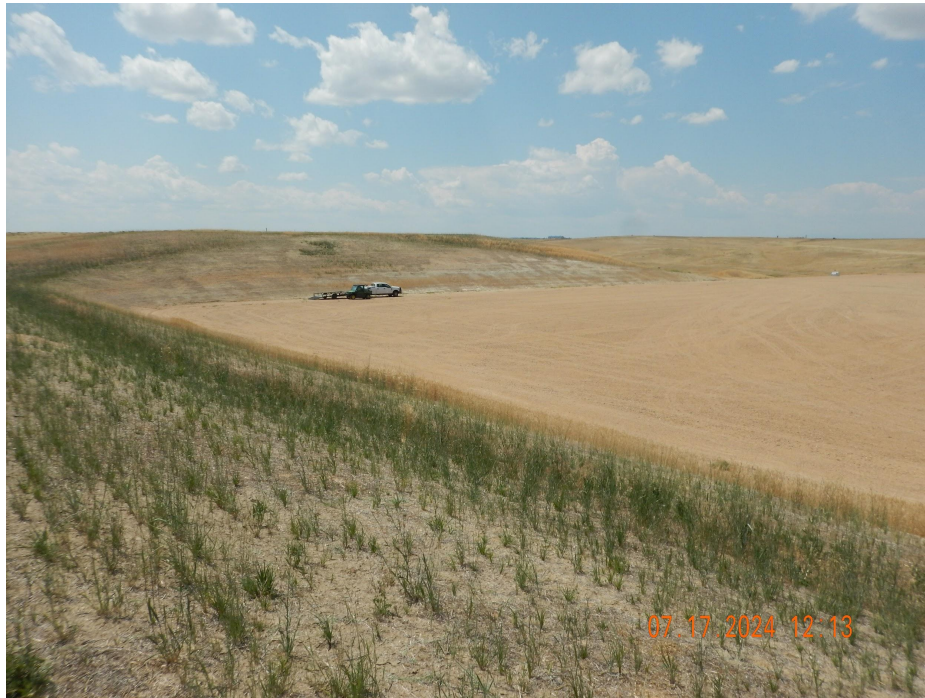
Photo 4. Photo taken from the eastern perimeter, facing Southwest. Photo illustrates the eastern and southern portions of location.

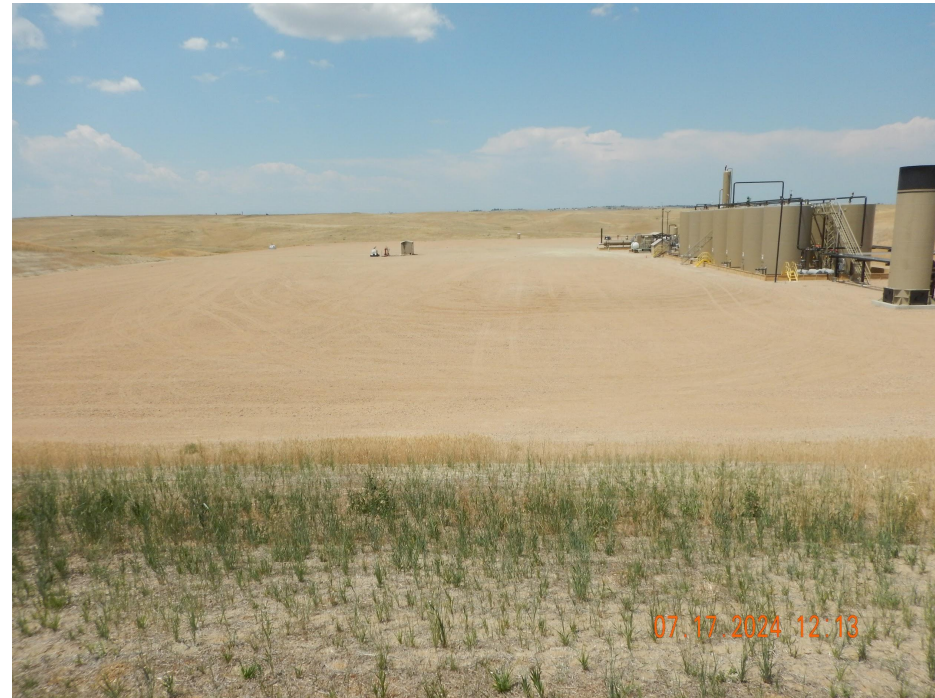
Photo 5. Photo taken from the eastern perimeter, facing West. Photo illustrates the majority of the working pad surface.

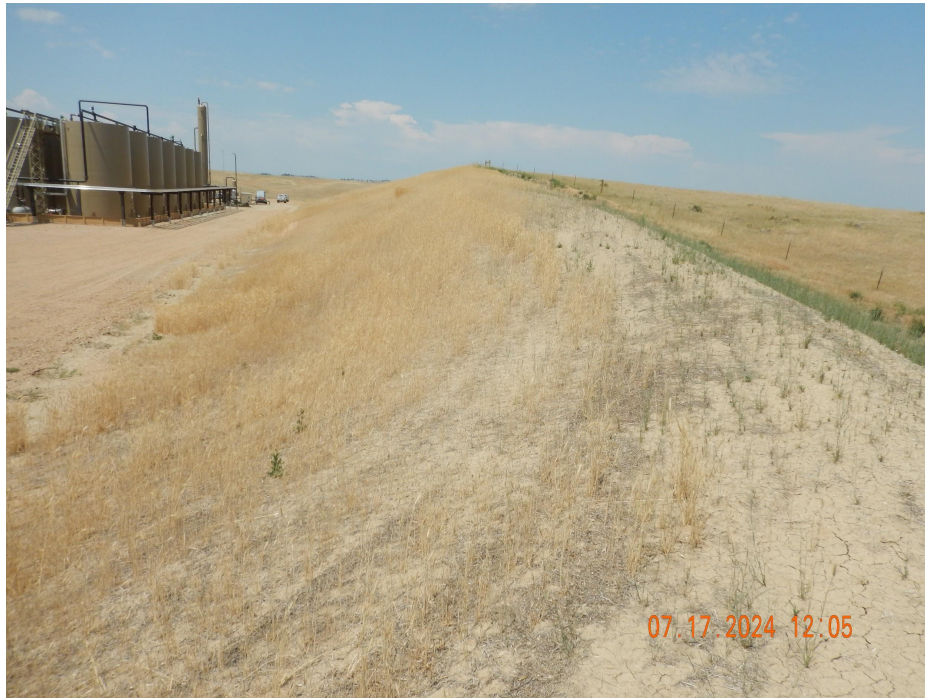
Photo 6. Photo taken from the northeastern perimeter, facing West. Photo illustrates the northern perimeter which is mostly a cut slope that is in process of being stabilized with vegetation.

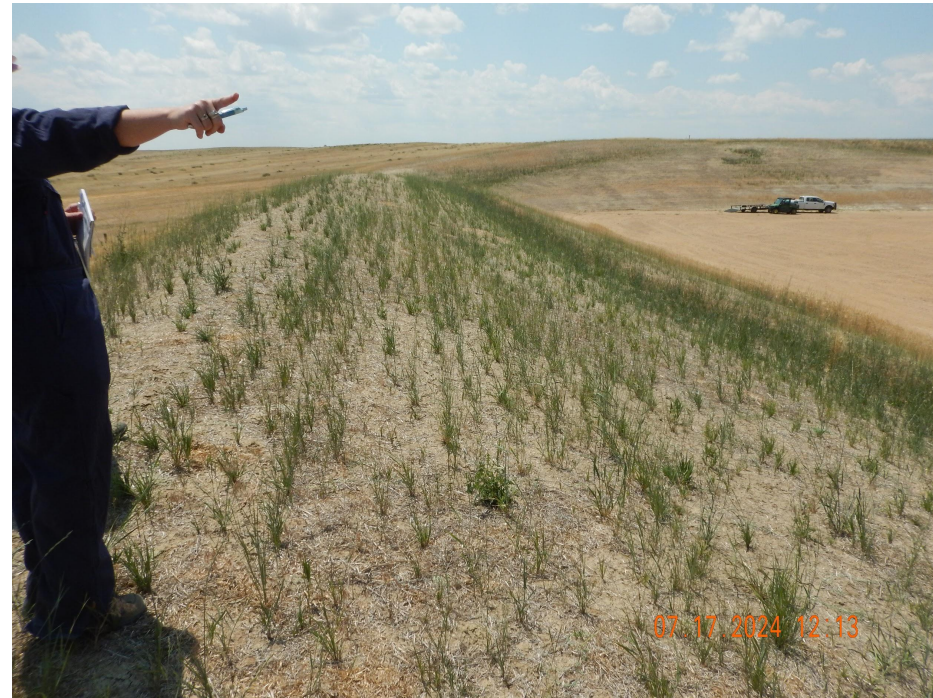
Photo 7. Photo taken from the eastern perimeter, facing South. Photo illustrates the eastern perimeter which is mostly a cut slope that is in process of being stabilized with vegetation.

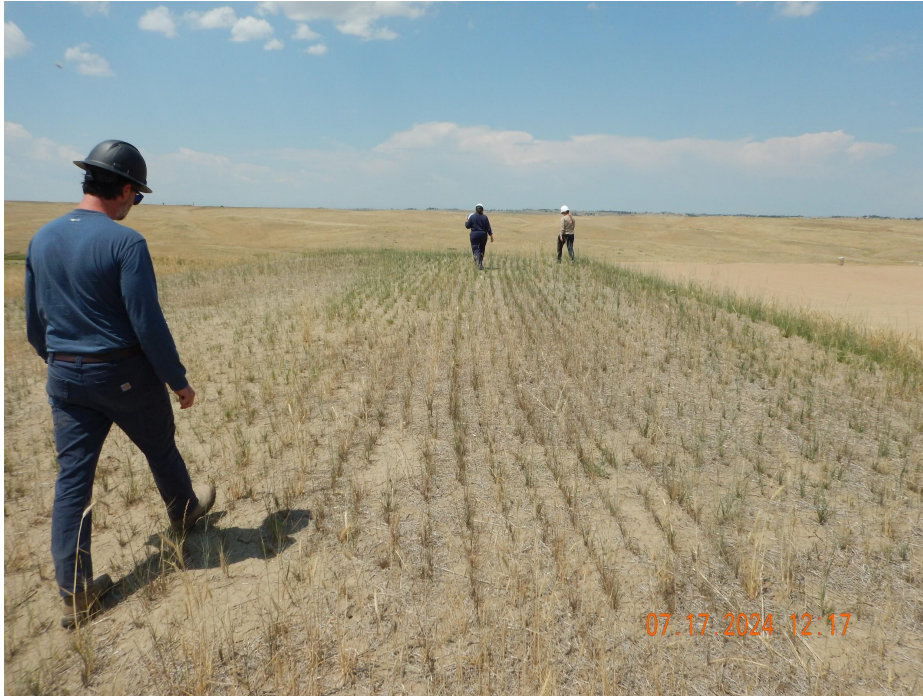
Photo 8. Photo taken from the southern perimeter, facing West. Photo illustrates the southern perimeter which is has a cut slope on the eastern half and fill slope on the western half.

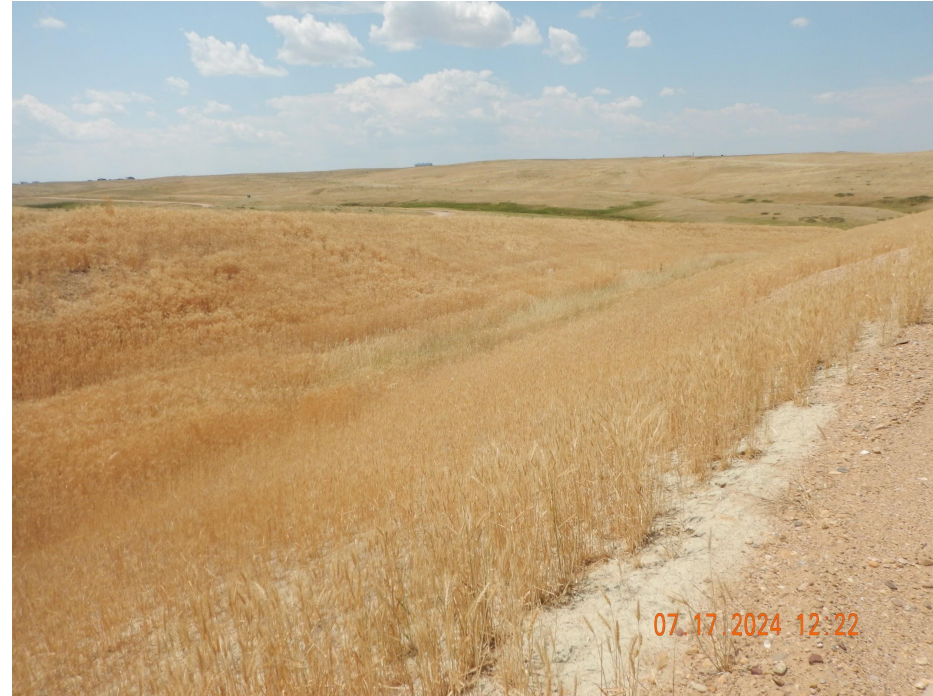
Photo 9. Photo taken from the southwestern perimeter, facing Southwest. Photo illustrates the a topsoil stockpile and fill slope that have been seeded. Note- cereal rye was observed throughout portions of the southern perimeter.

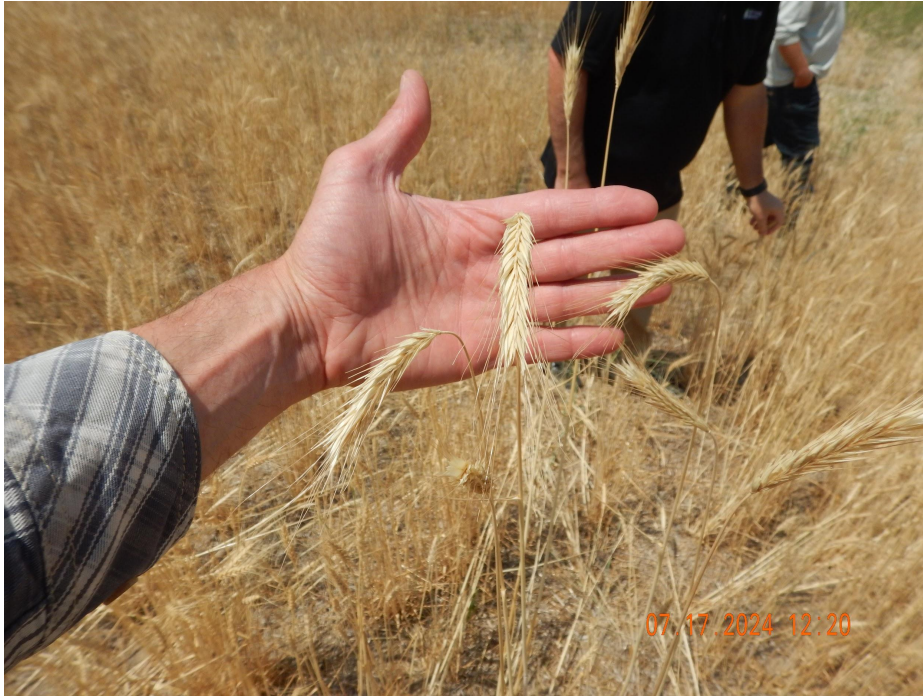
Photo 10. Photo taken from the southern perimeter, illustrating Cereal rye growth.

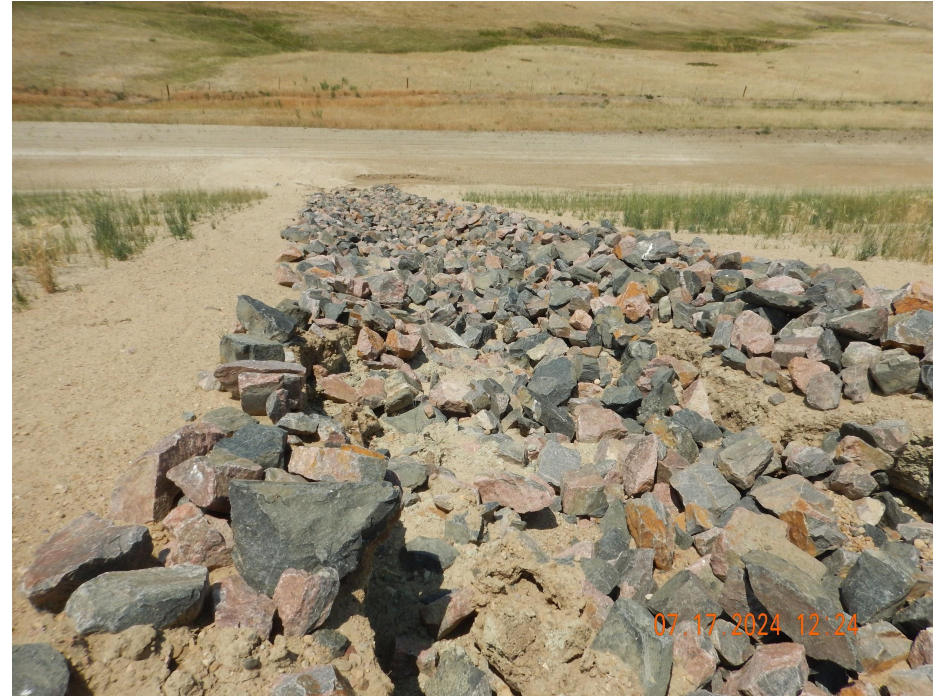
Photo 11. Photo taken from the western working pad surface, facing West. Photo illustrates a stabilized channel that is directed to a retention pond. The riprap was not lined underneath; therefore, stormwater erosion is undermining the riprap. CDPHE will be addressing this corrective action.

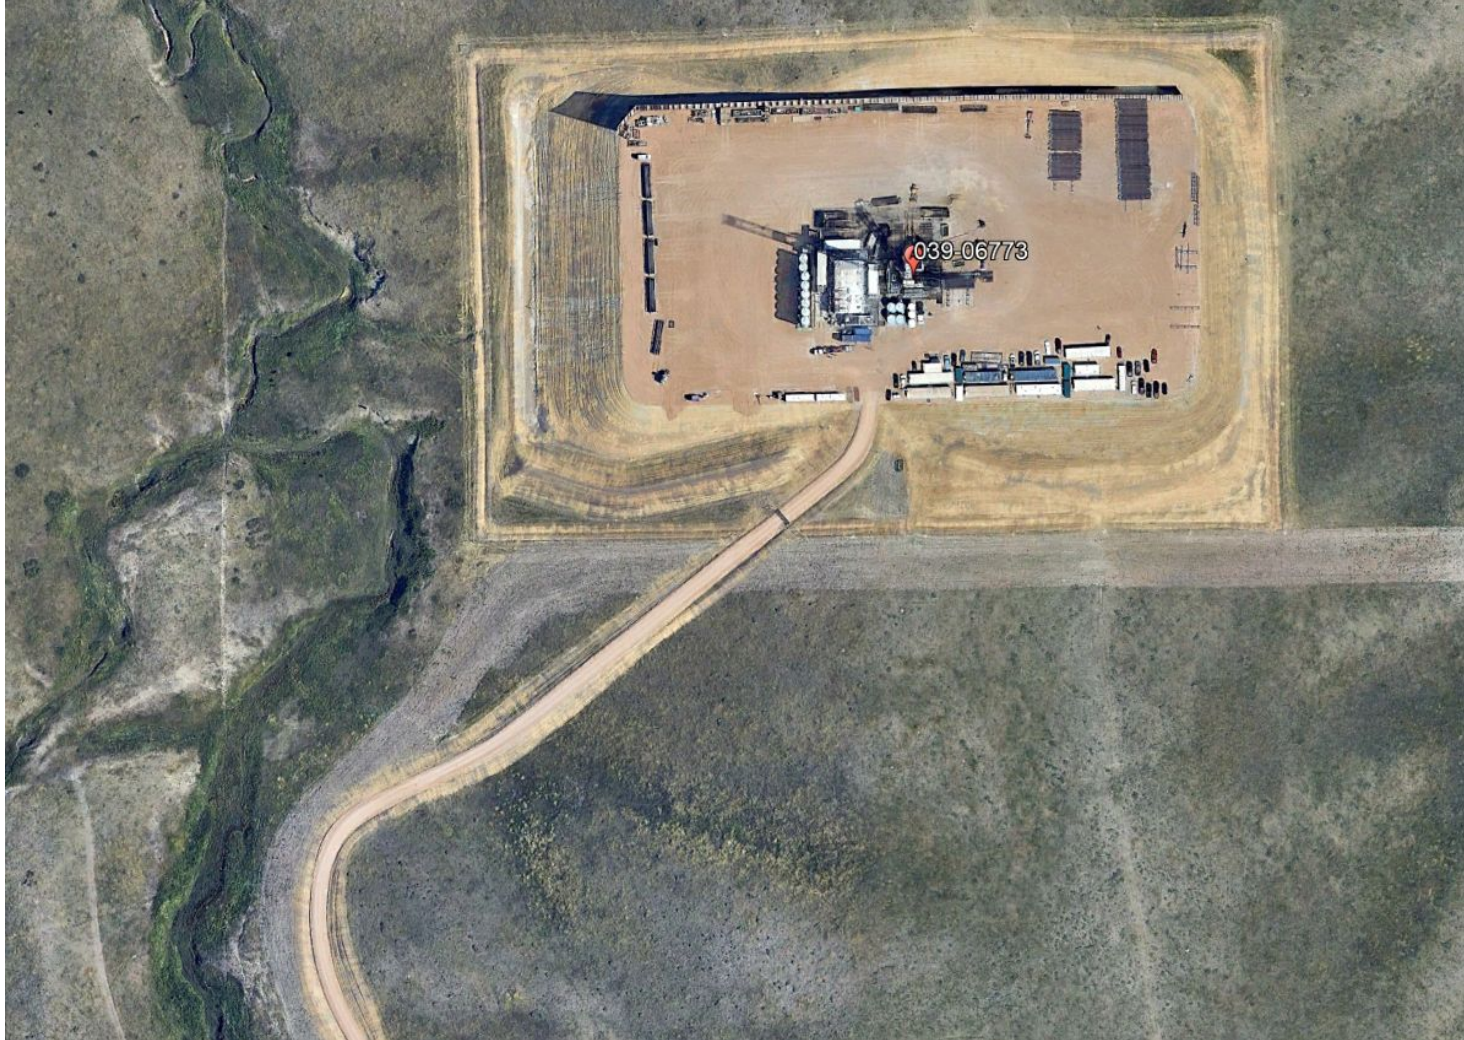
Photo 12. Google Earth aerial imagery from 9/4/2023 illustrates the location and the northern portion of the access road.
