# Interim Reclamation and Stormwater Inspection

Operator: GMT EXPLORATION COMPANY LLC #10243

Location ID: 478811

Inspection Photos  
Location Name: Vulcan/6-64 10-8 Pad  
Location ID: 478811

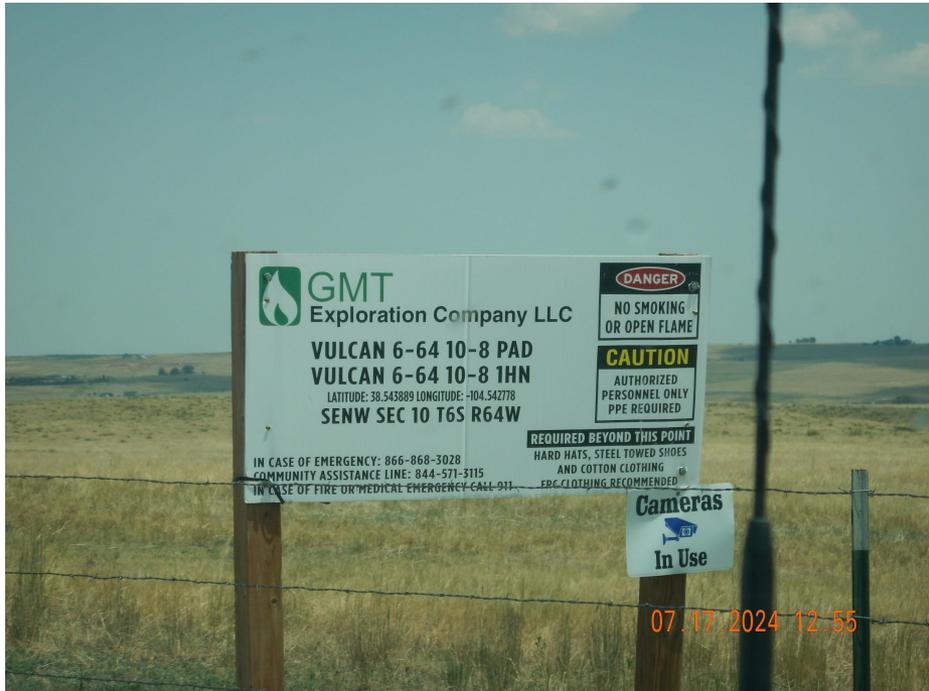
**Photo 1.** Photo taken from the entrance of location off of the county road, illustrating the Operator sign.

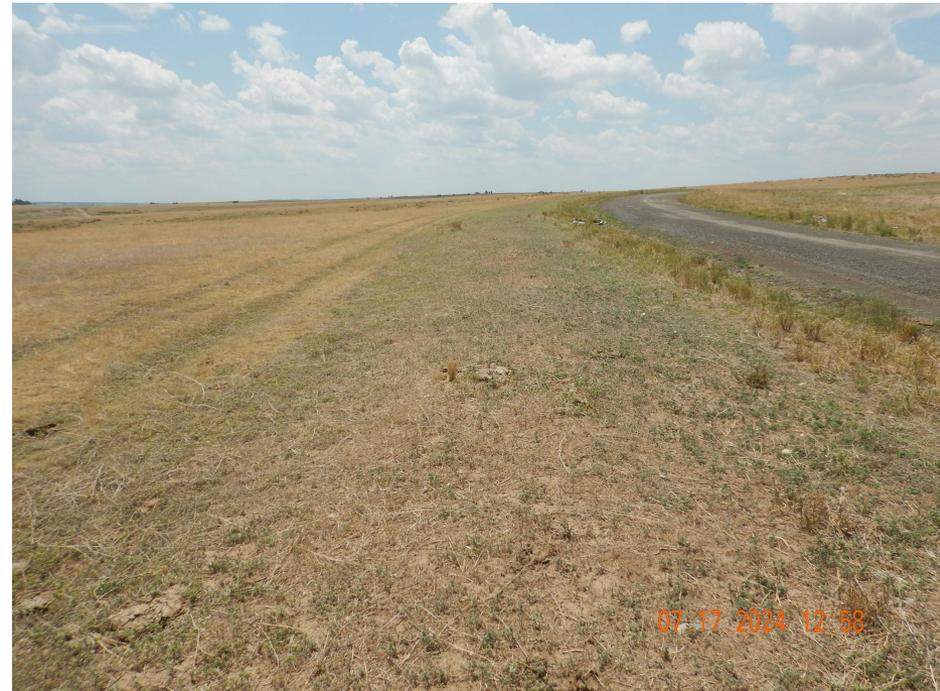
**Photo 2.** Photo taken along a portion of the access road on the southern side, facing Southwest. Photo illustrates during the construction of the access road a buffered area was disturbed. A lot of this buffered area has established with vegetation but this photo illustrates an area that is predominantly annual vegetation and bare ground.

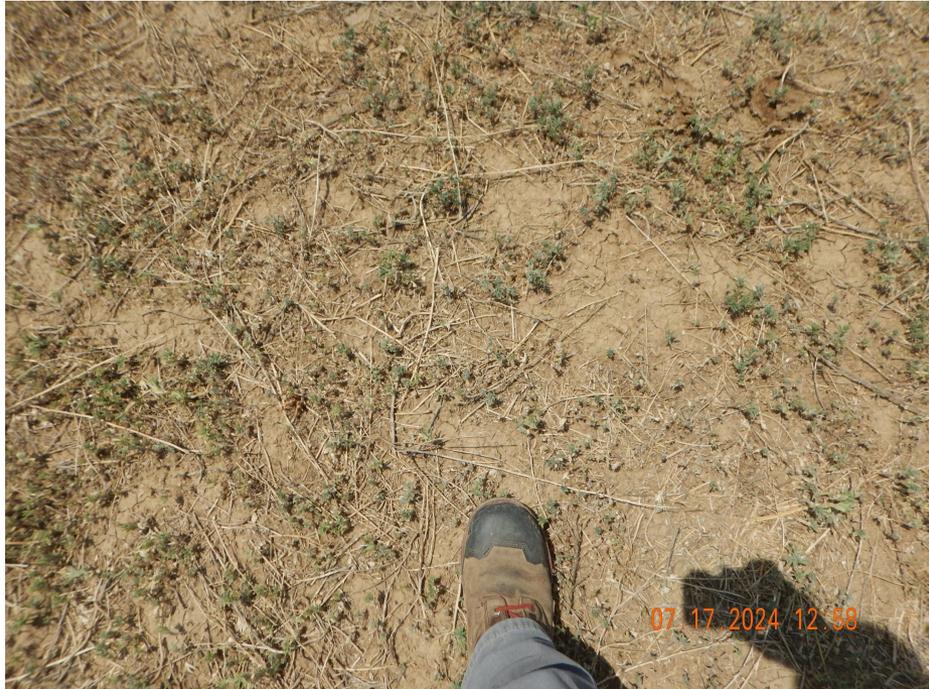
**Photo 3.** Close up photo taken from the previous photo illustrating the predominantly annual vegetation and bare ground.

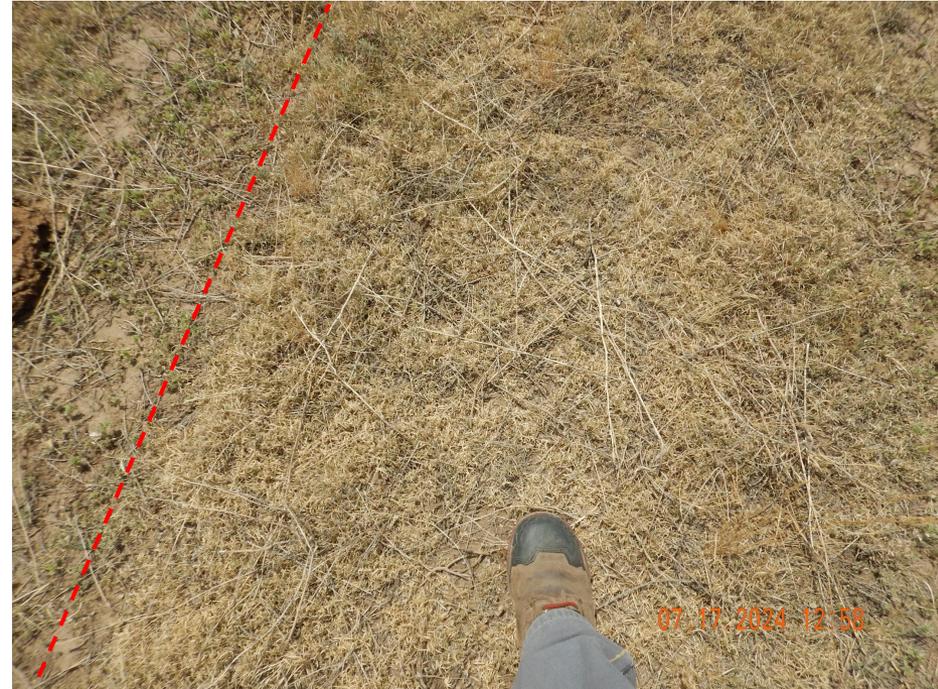
**Photo 4.** Reference area photo (right of the red-dashed line) illustrates the short-grass prairie vegetation dominated by blue grama and buffalo grass.

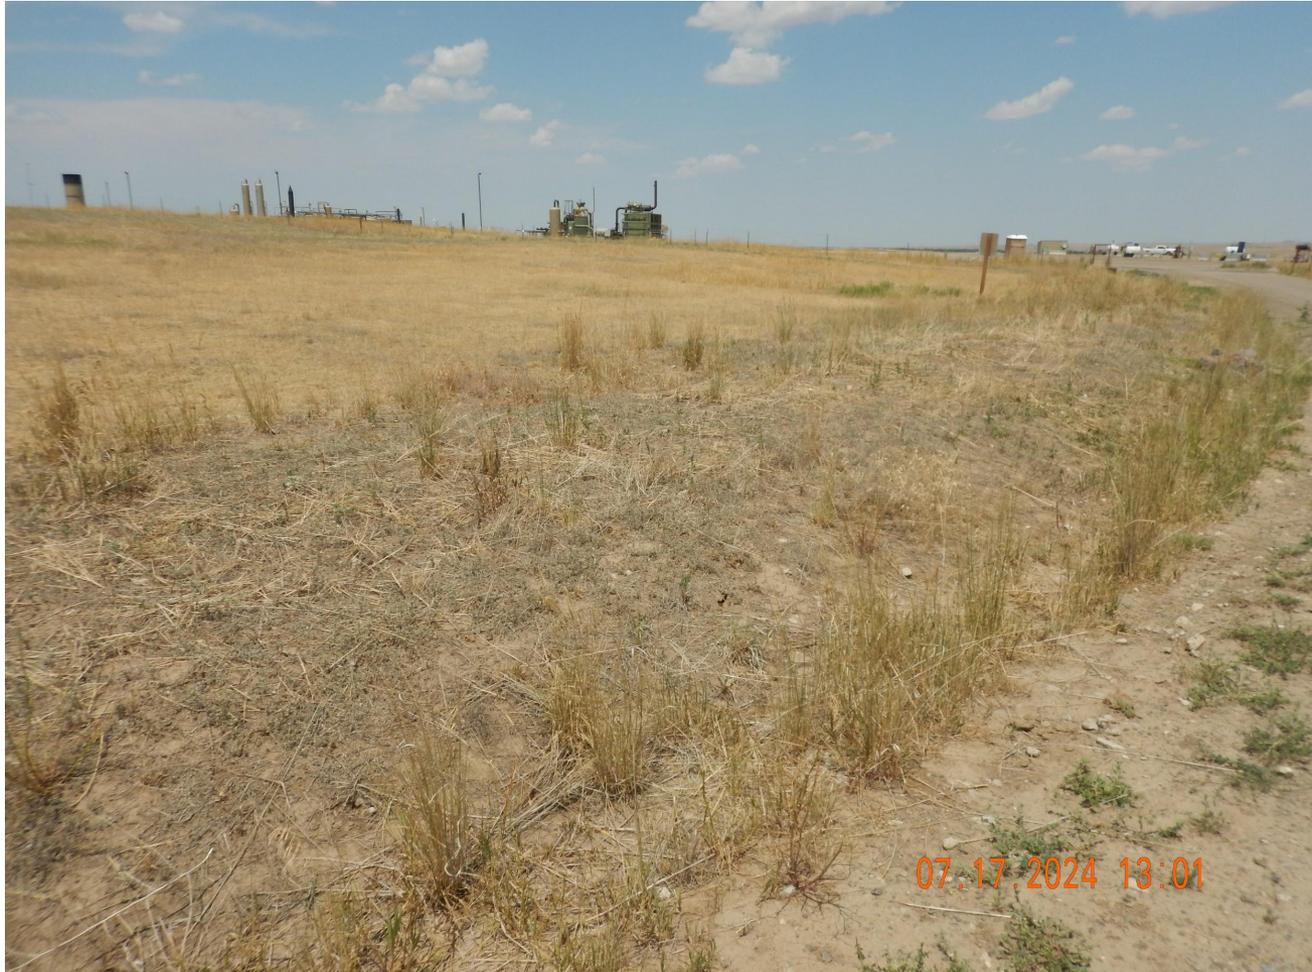
**Photo 5.** Photo taken along a portion of the northern access road, facing North. Photo illustrates during the construction of the access road a buffered area was disturbed. Photo illustrates an area that is predominantly annual vegetation and bare ground with some growth of introduced plant species, which is not reflective of reference area vegetation.

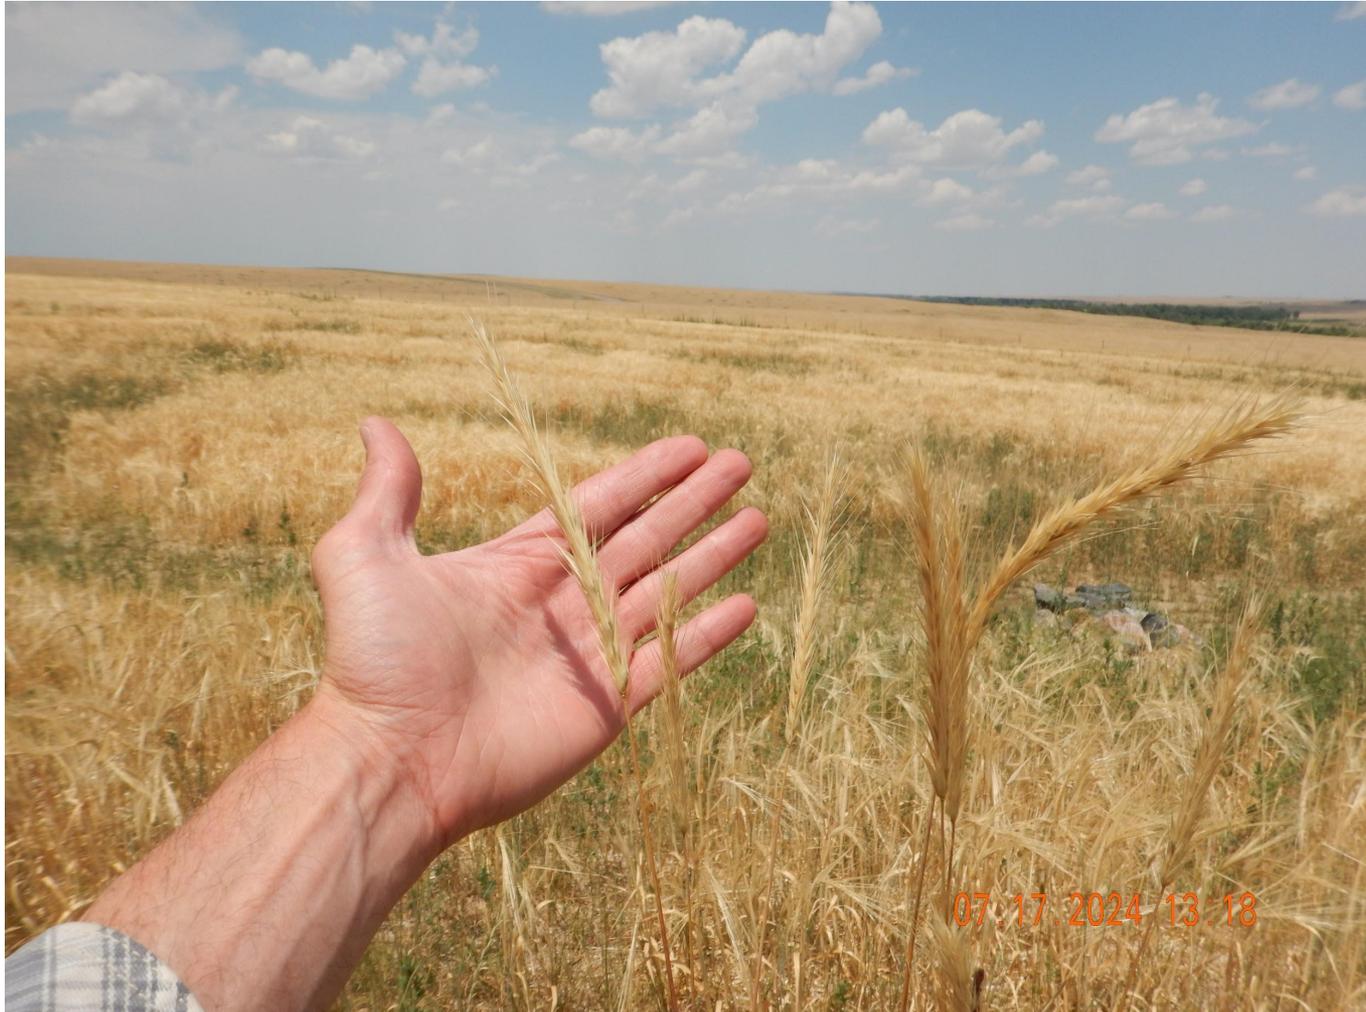
**Photo 6.** Photo taken along a portion of the northern interim reclamation area, facing North. Photo illustrates cereal rye was observed throughout interim reclamation areas.

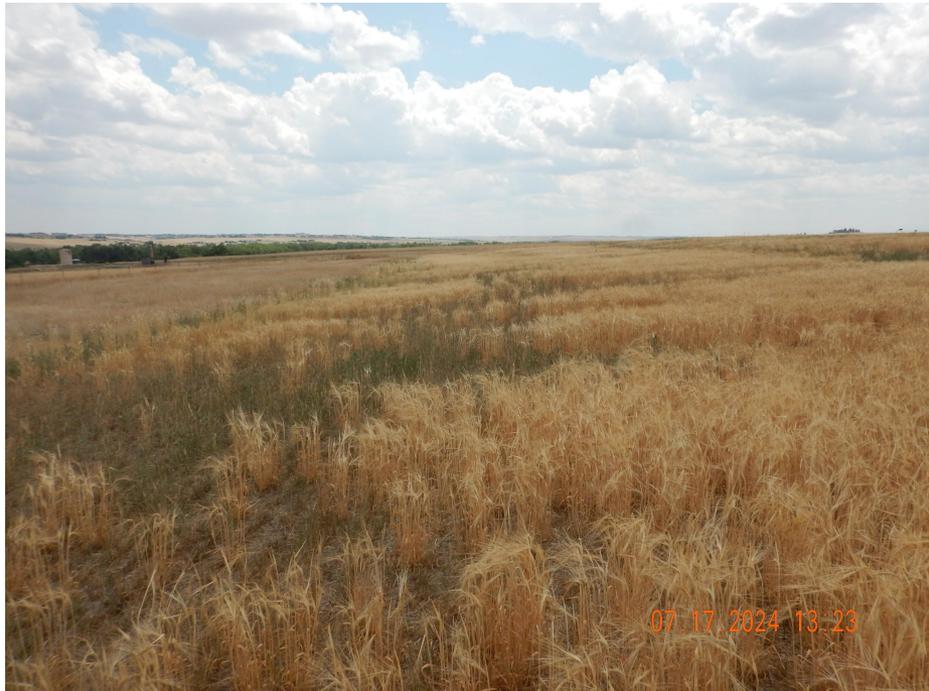
**Photo 7.** Photo taken from the northeastern interim reclamation, facing South. Photo illustrates a portion of the interim area that is established in wheatgrass likely from mulch with some desirable grass species within the understory.

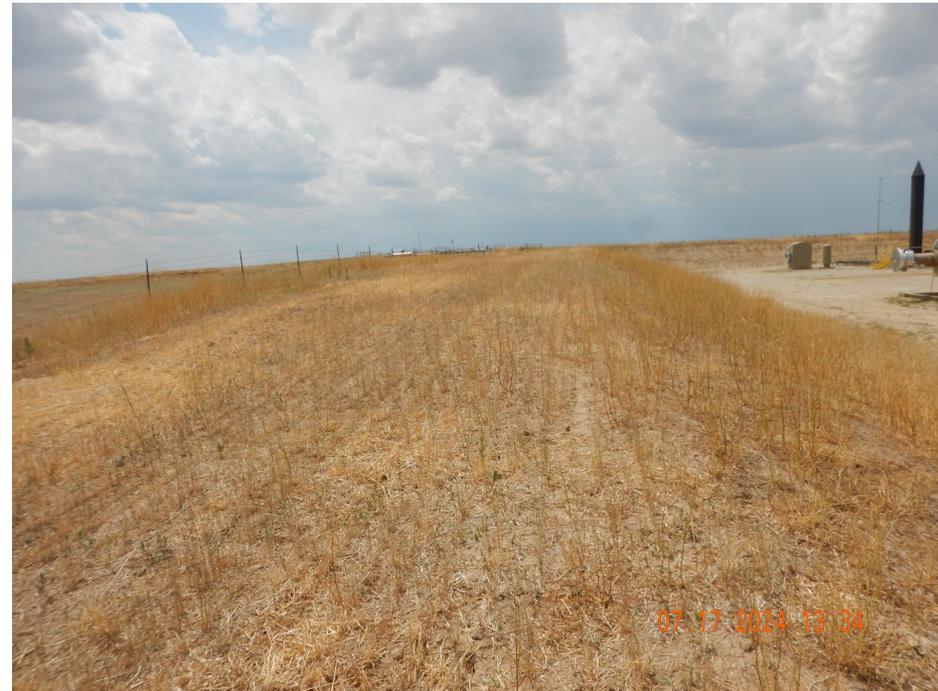
**Photo 8.** Photo taken from the southern perimeter, facing West. See comments under Photo 7.

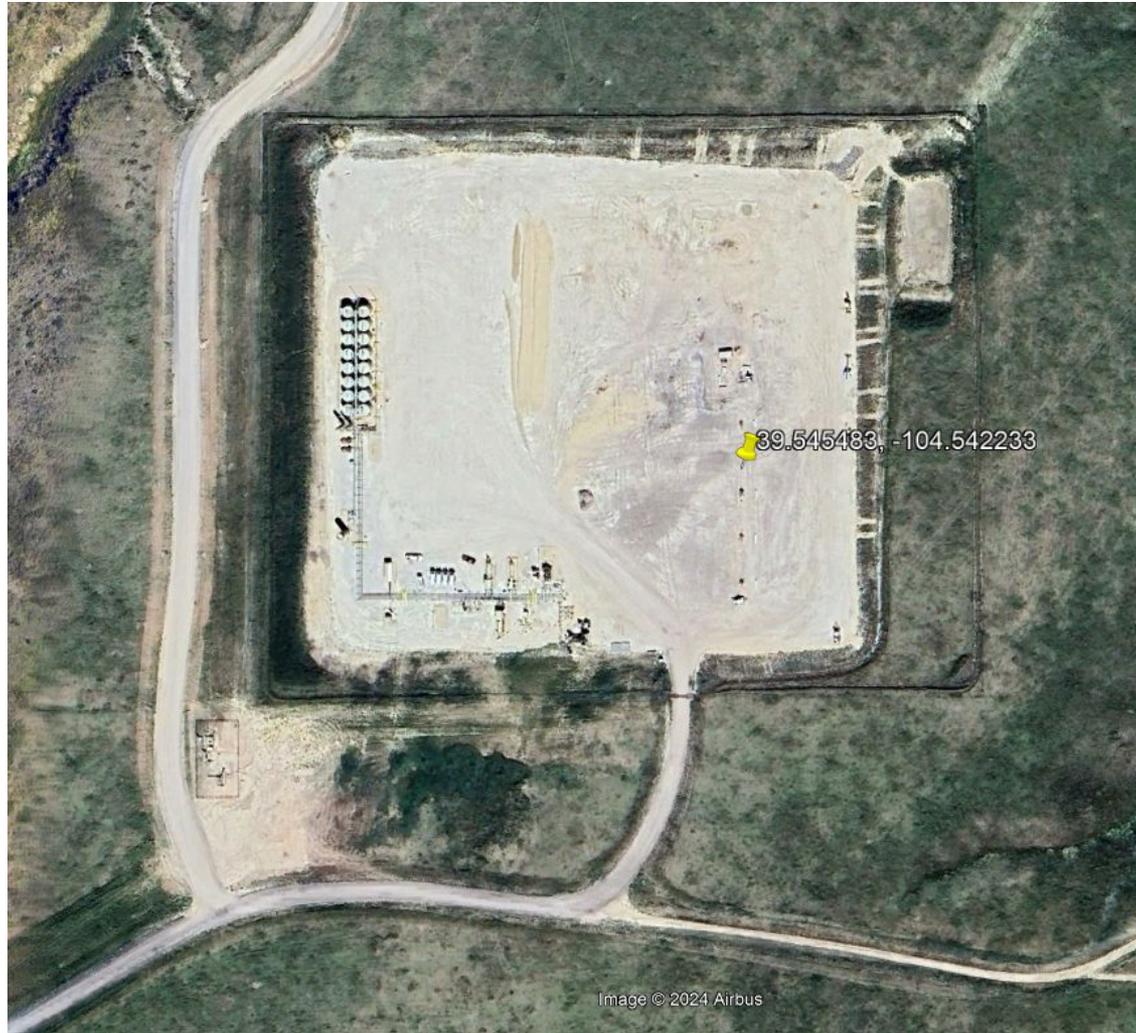
**Photo 9.** Google Earth aerial imagery from 9/4/2023 illustrates the location and the northern portion of the access road. Note- this imagery is prior to interim reclamation being completed.
