## Inspection Photos

Location Name: CAERUS PICEANCE LLC CEDAR SPRINGS RANCH 2-14 (N2W) Pad

Location #: 324114

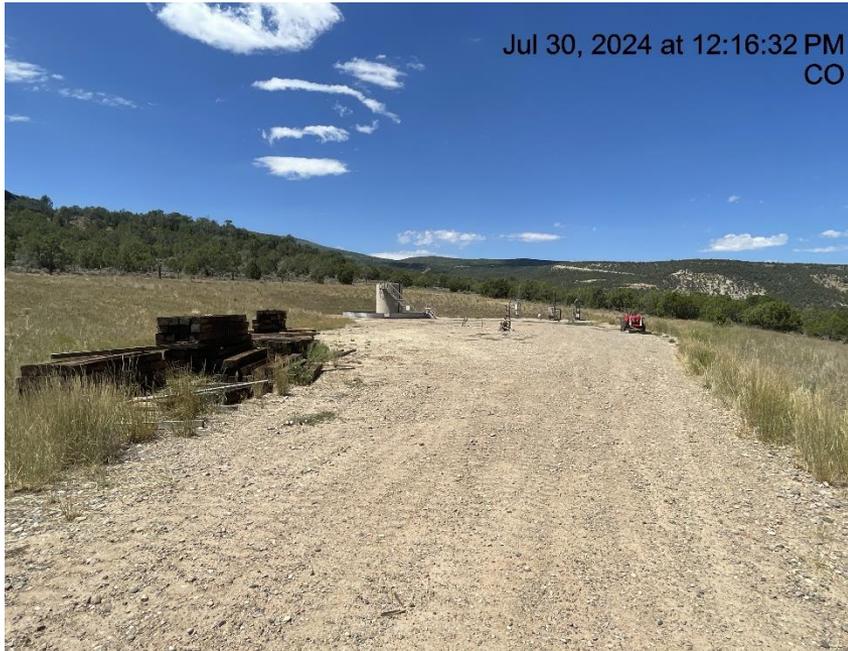
Photo # 3988 From entrance to location

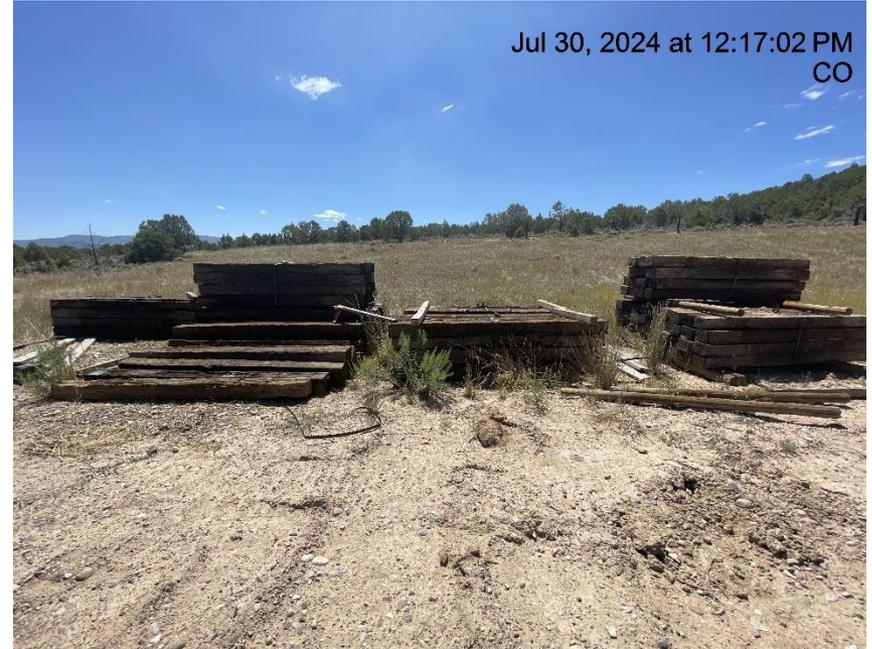
Photo # 3993 Stored supplies on location & in the interim area

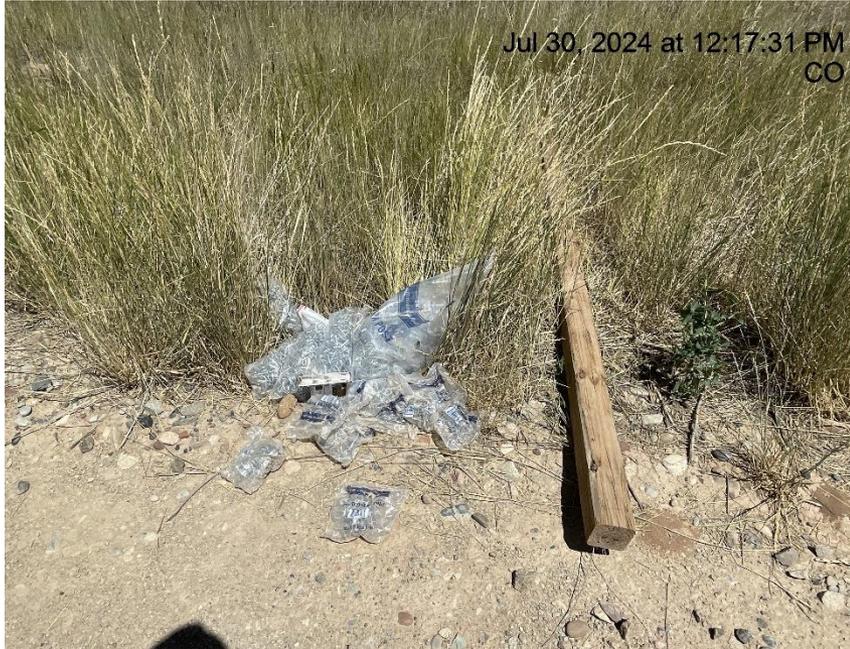
Photo # 3994 Stored supplies

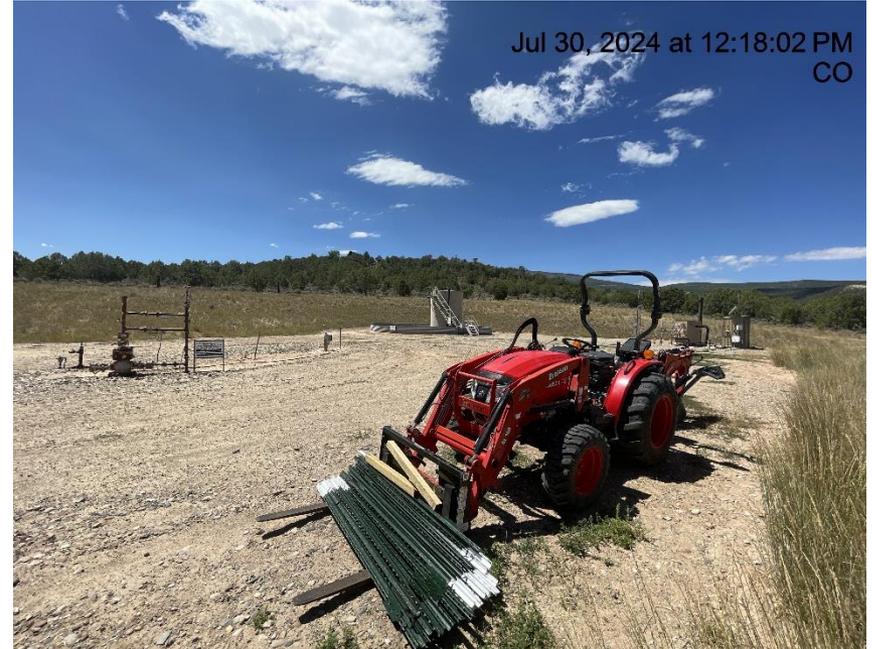
Photo # 3995 Stored equipment & supplies on location

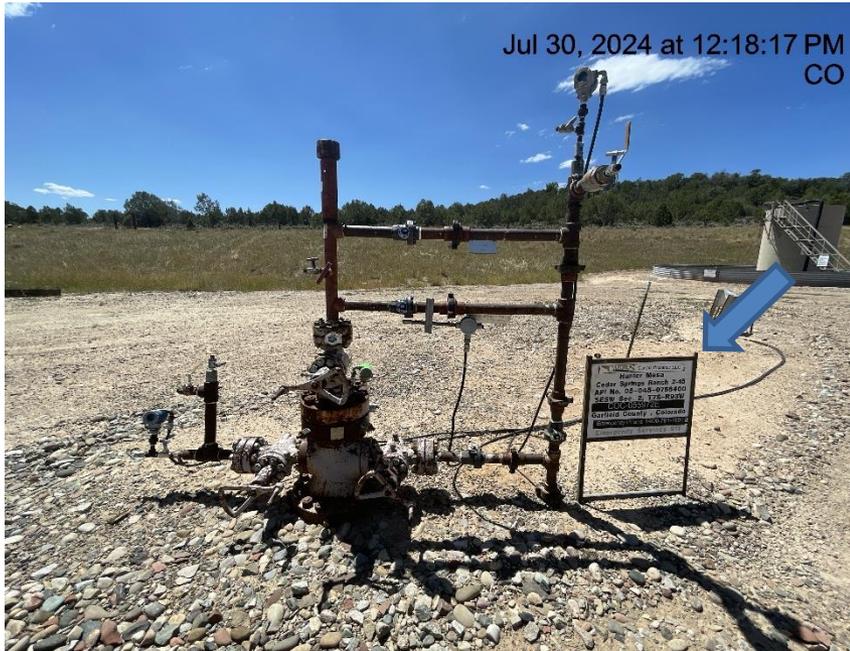
Photo # 3996 Wellhead sign has incorrect well # & API #
