Inspection Photos

Location Name: TEP ROCKY MOUNTAIN LLC GENTRY E Pad

Location #: 335547

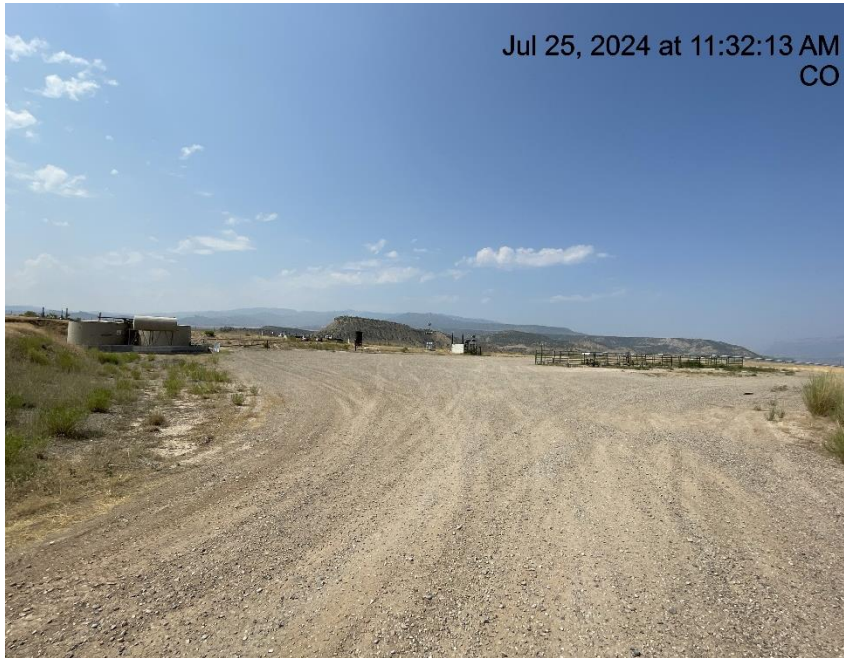
Photo # 3172 From entrance to location

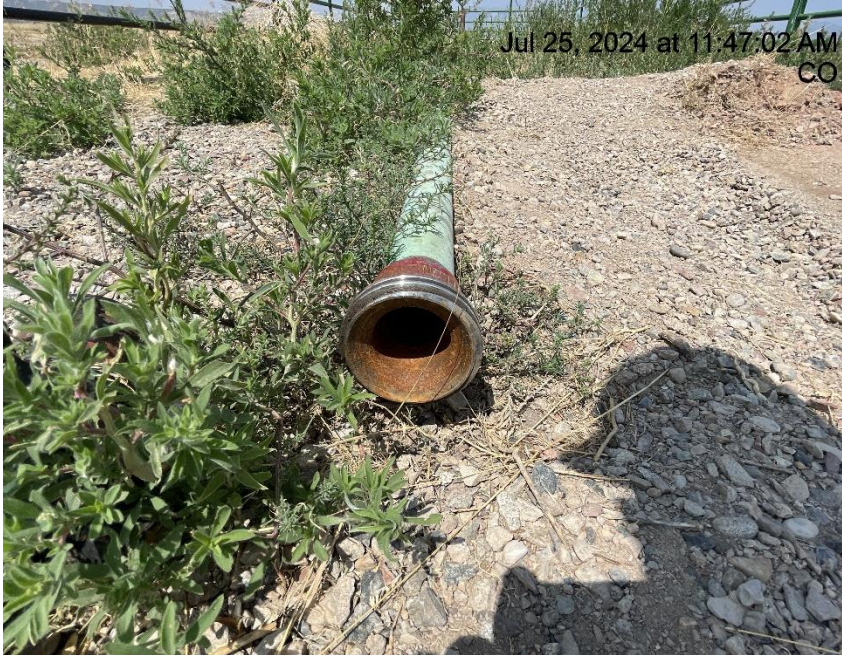
Photo # 3178 Open ended piping/available for entry by wildlife/wildlife hazard

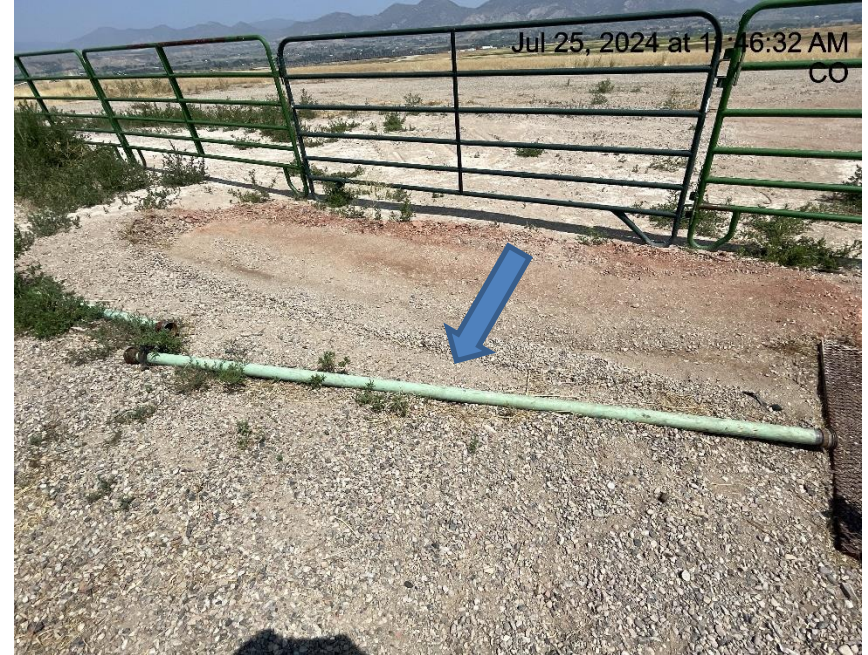
Photo # 3179 Debris

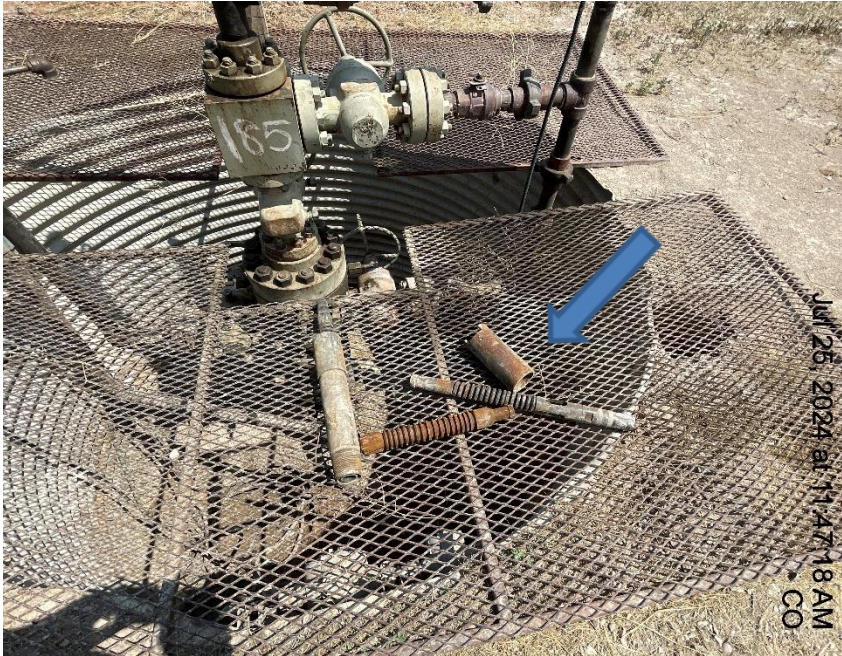
Photo # 3180 Debris

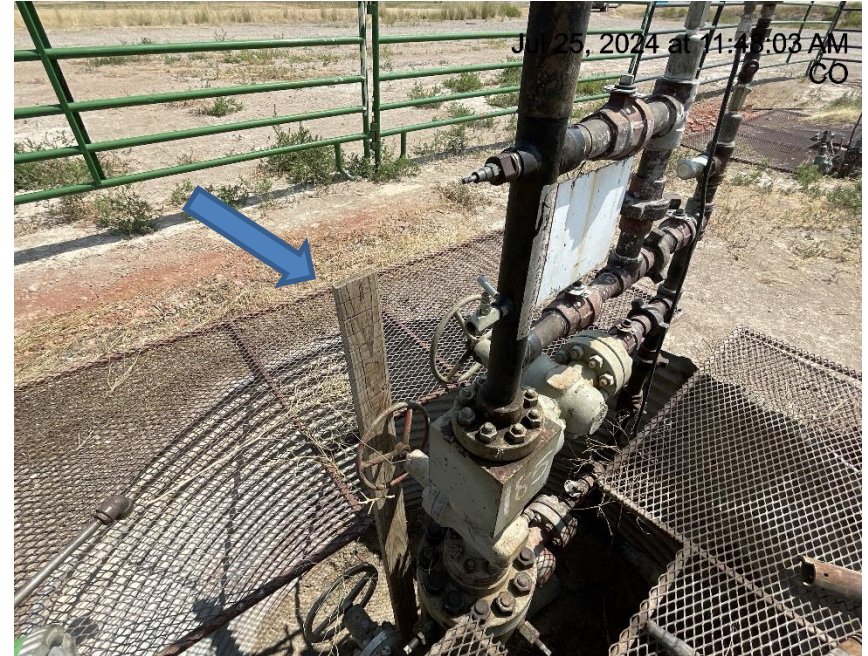
Photo # 3181 Wildlife egress on wellhead cellar not properly installed/needs adjustment

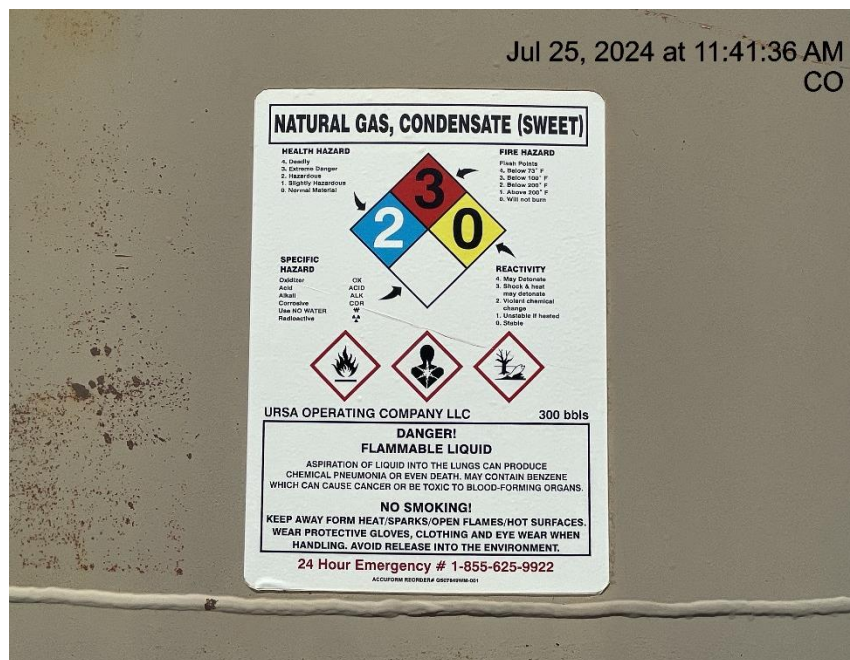
Photo # 3182 Tank label contains inaccurate info/does not comply with CECMC rules

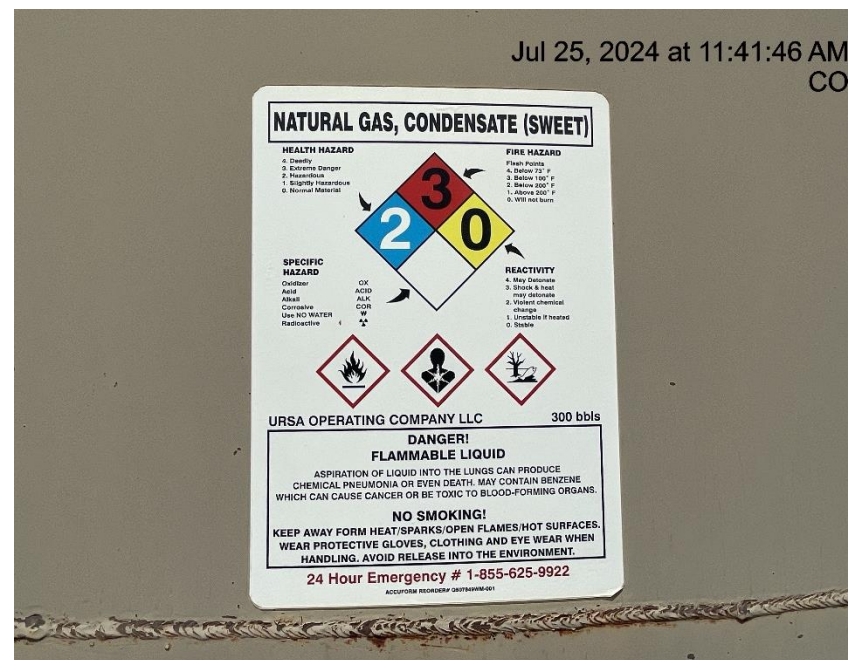
Photo # 3183 Tank label contains inaccurate info/does not comply with CECMC rules

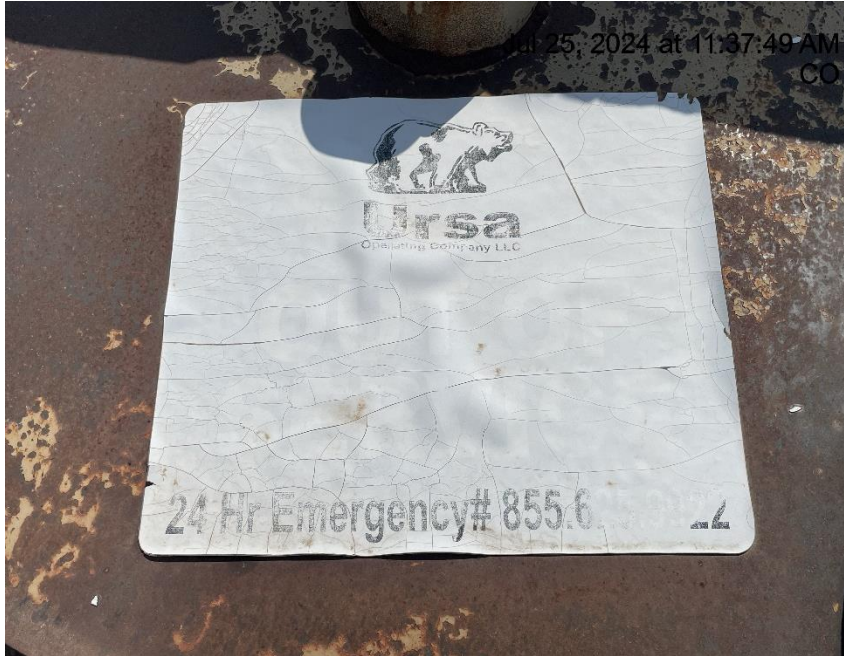
Photo # 3184 Tank label contains inaccurate info/does not comply with CECMC rules

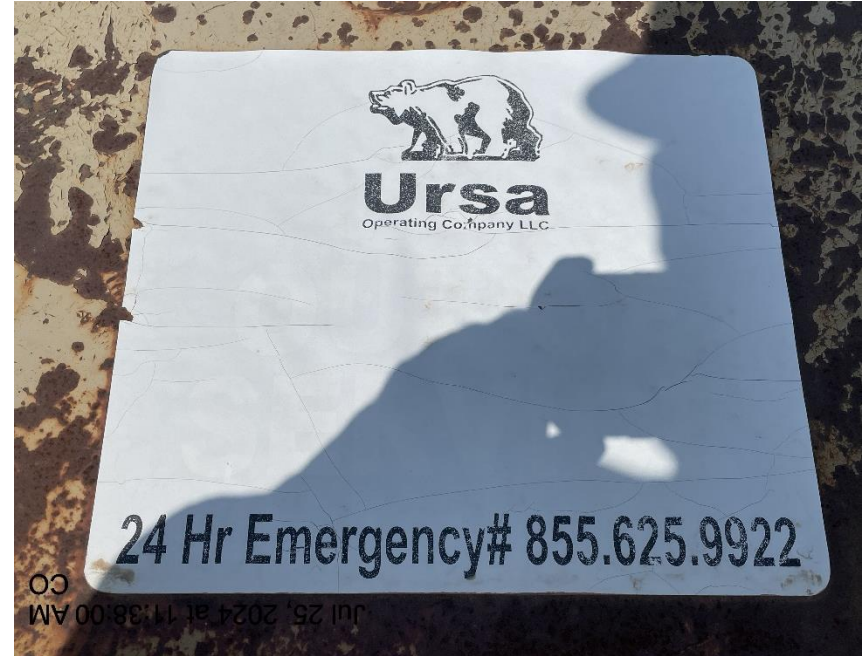
Photo # 3185 Tank label contains inaccurate info/does not comply with CECMC rules

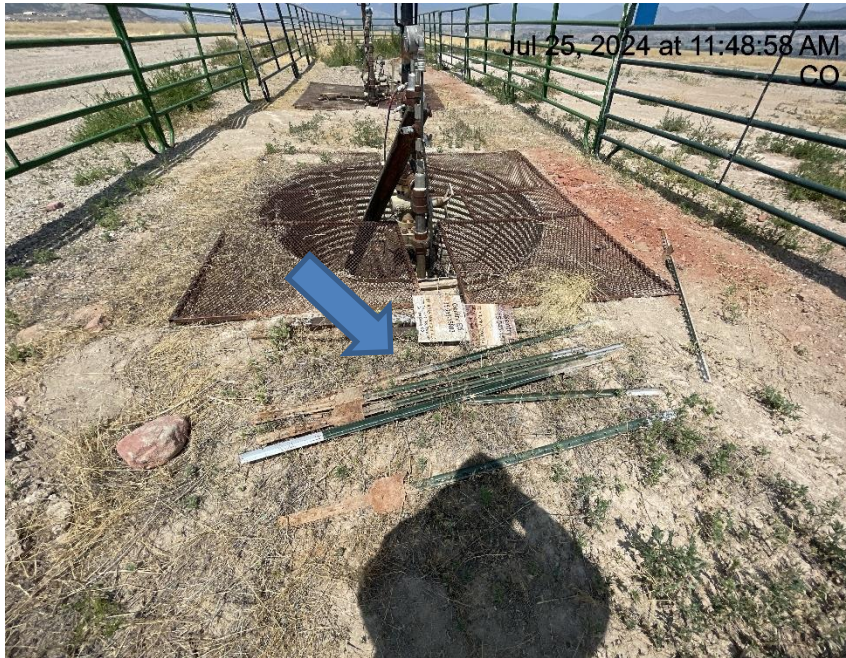
Photo # 3186 Debris

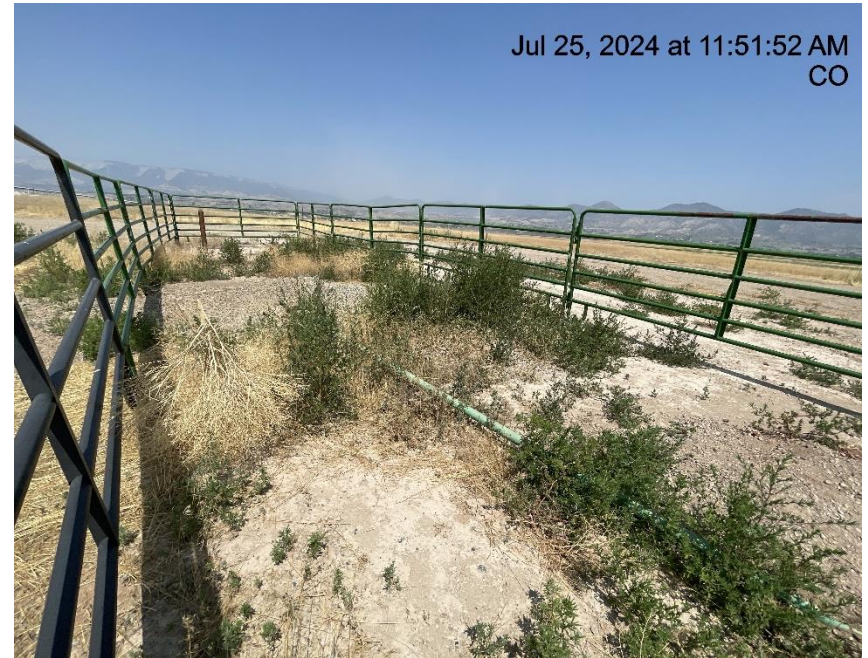
Photo # 3187 Weeds/undesirable plant species on location

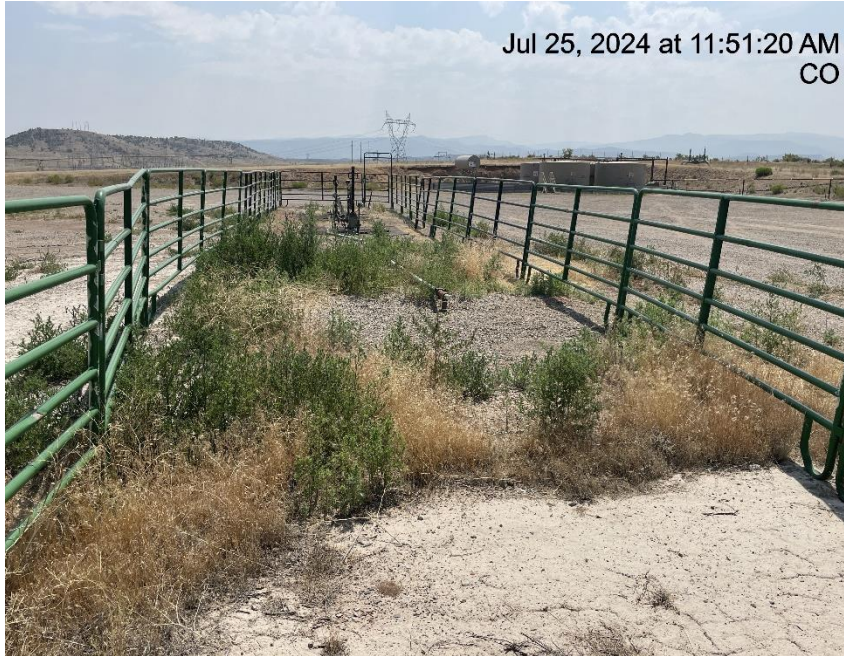
Photo # 3188 Weeds/undesirable plant species on location

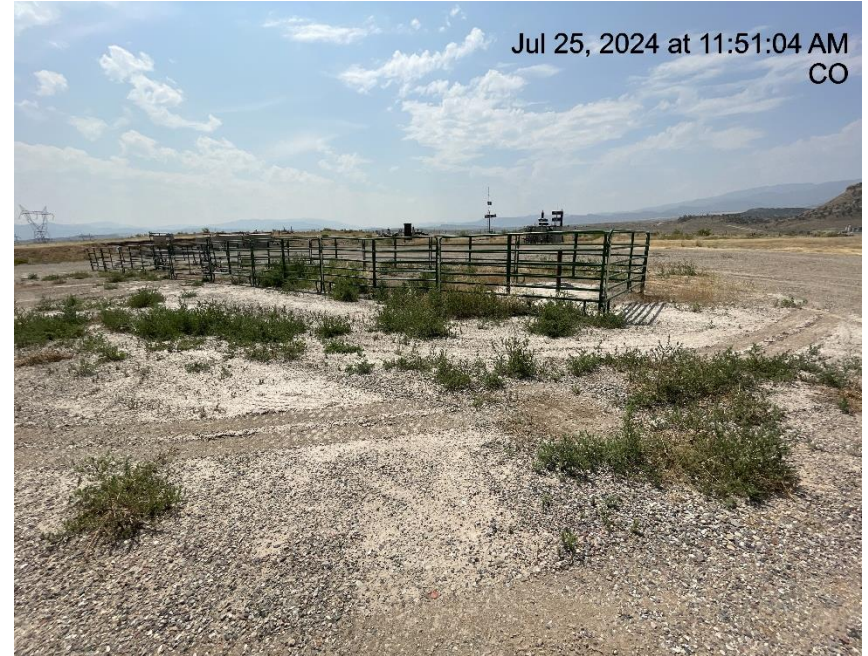
Photo # 3189 Weeds/undesirable plant species on location
