Operator: HPR

Location Name: Critter Creek 18 SW

Loc ID: 443771

Inspection: 682403417

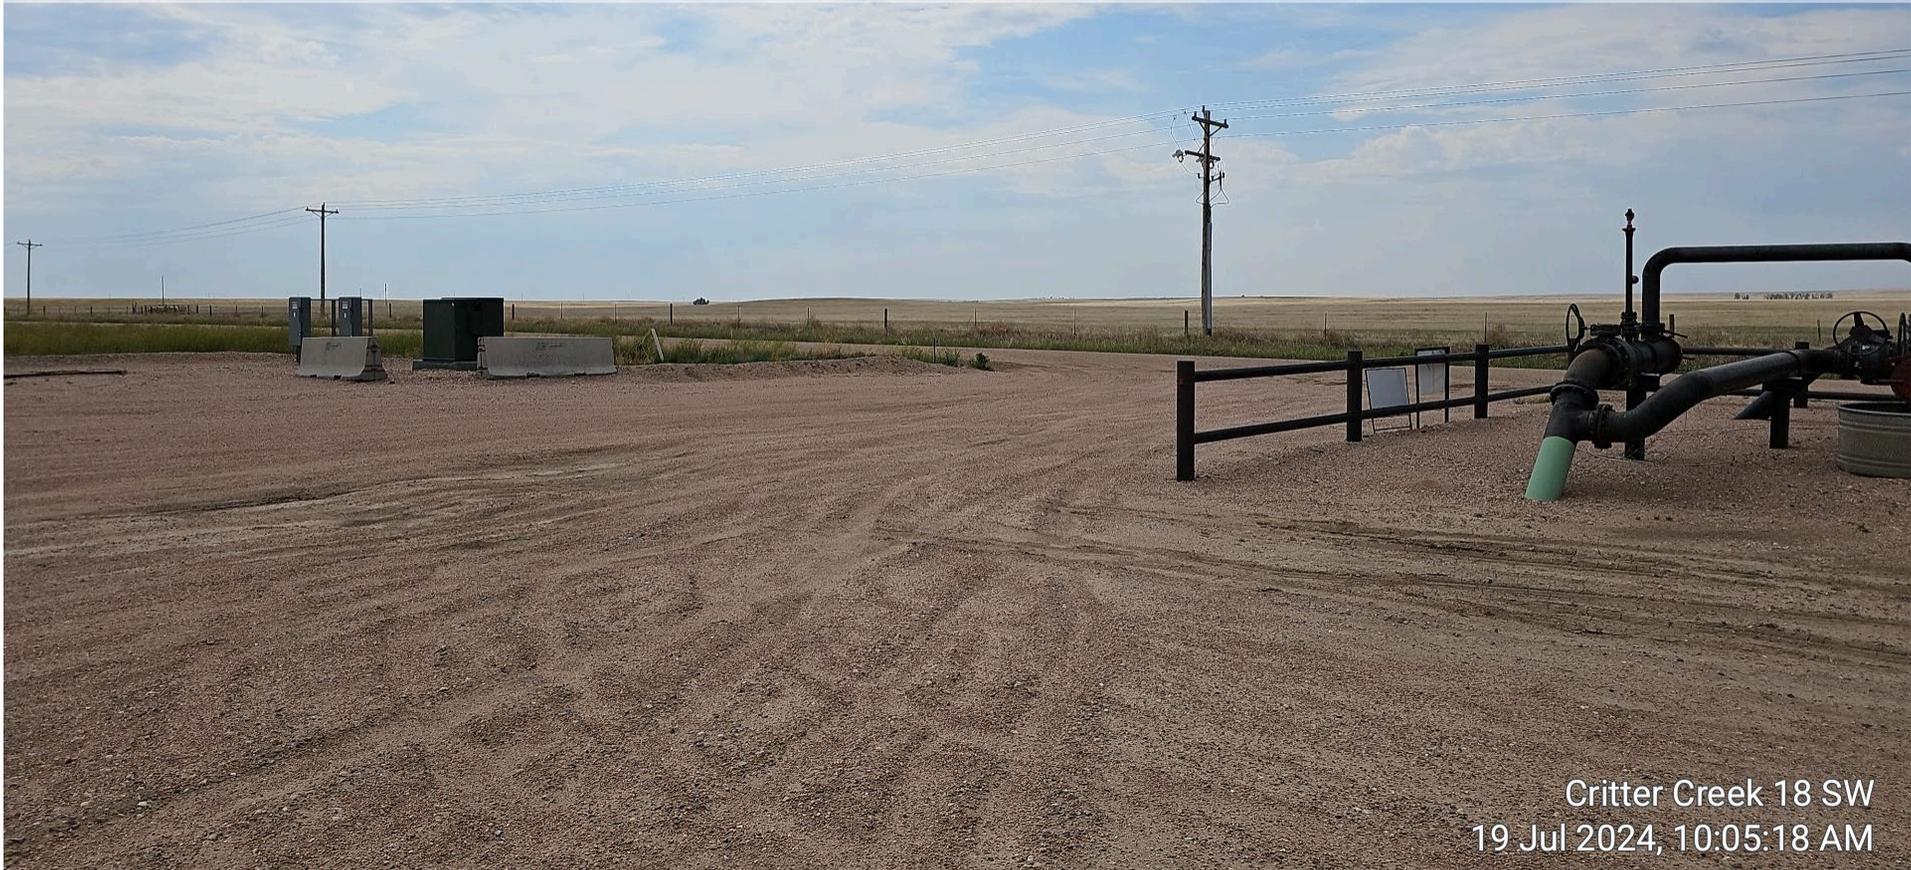
Critter Creek 18 SW
19 Jul 2024, 10:05:18 AM

CA: This location is not in compliance with Stormwater Management Rule 1002.f.(2). Operator has failed to stabilize the well pad which appears to be the cause of wind erosion sediment deposition off location. Wind erosion sediment deposition was observed off location and sediment accumulation has diminished current stormwater BMPs. In addition, stormwater runoff from the eastern location is evident. There are no stormwater or erosion control BMPs in place where stormwater runoff was observed. Vehicle ruts were observed throughout the location which is susceptible to tracking sediment off location. There were no vehicle tracking pad devices observed at either entrance point. Corrective Action: Install or repair required BMPs per Rule 1002.f.(2) and properly stabilize the well pad.

CA Resolution: Operator has completed actions pertaining to Stormwater Management to comply with ECMC Rule 1002.f.(2).
