**ECMC
Environmental
Field Inspection**

Facility 8 @ Sebold
© 17-Jul-24 02:00:47 PM
ECMC Environmental Inspection
Weeds/Debris/Trash

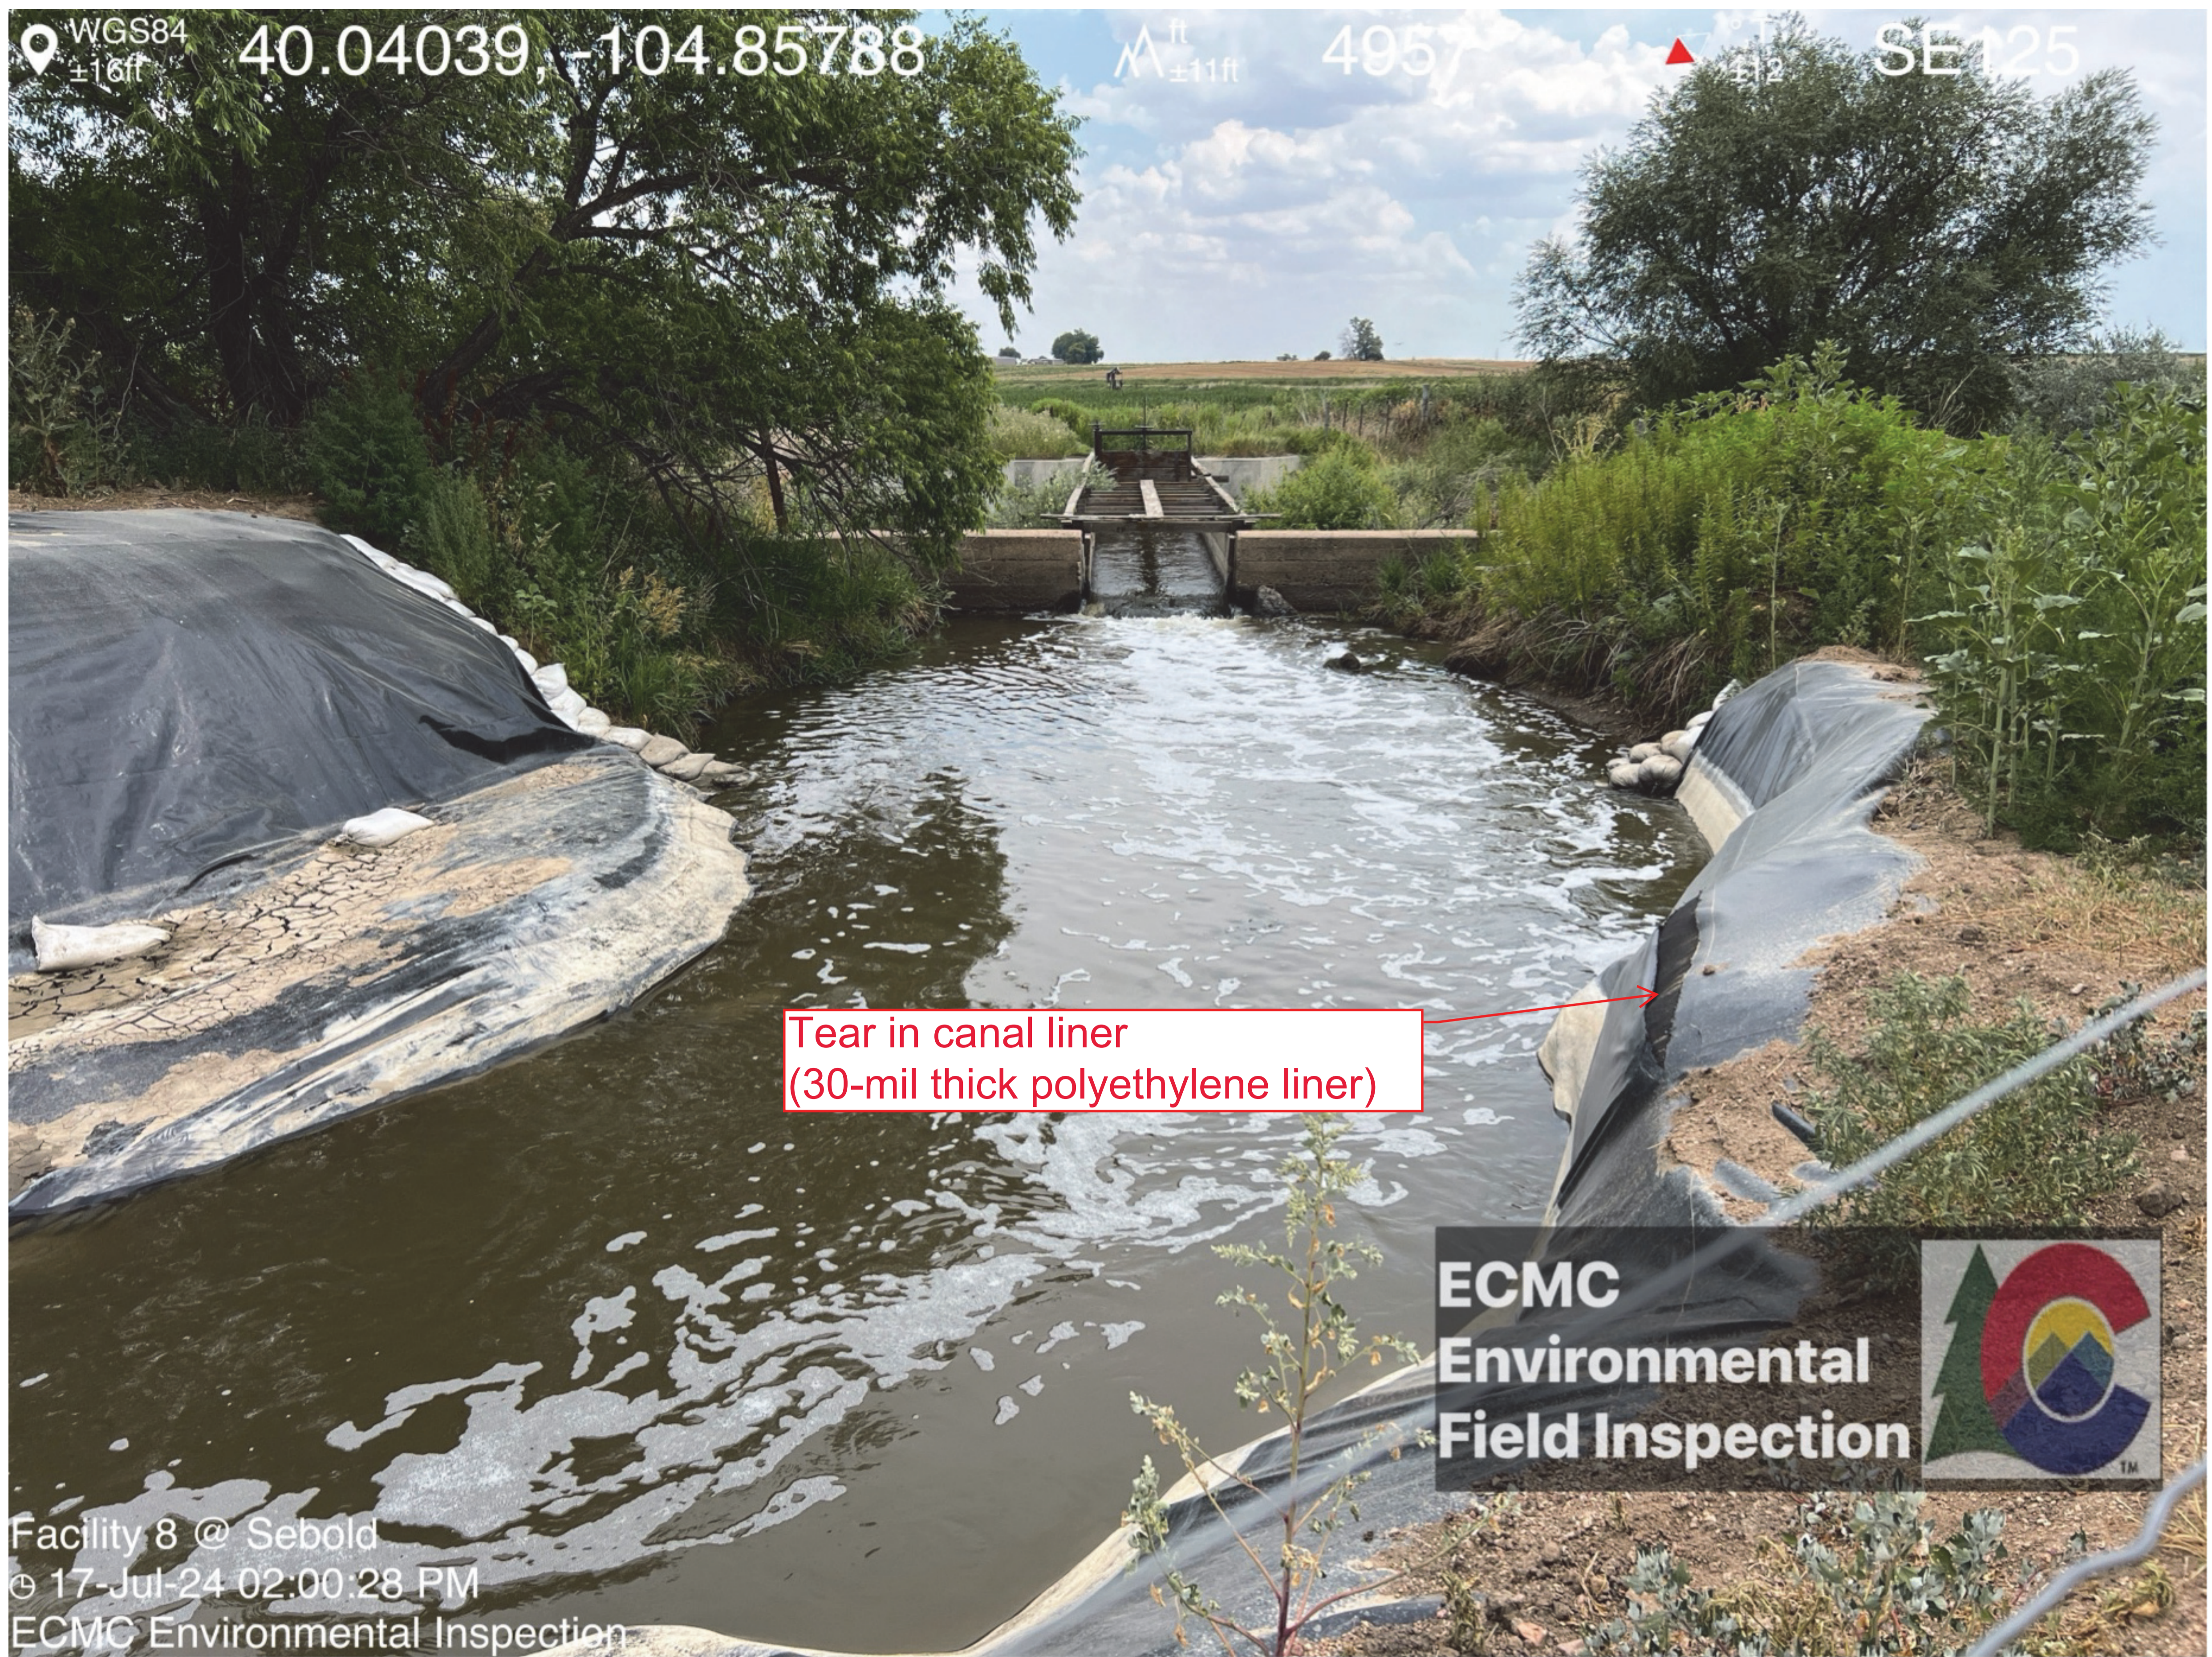
Weeds, tear in 30-mil polyethylene canal liner.

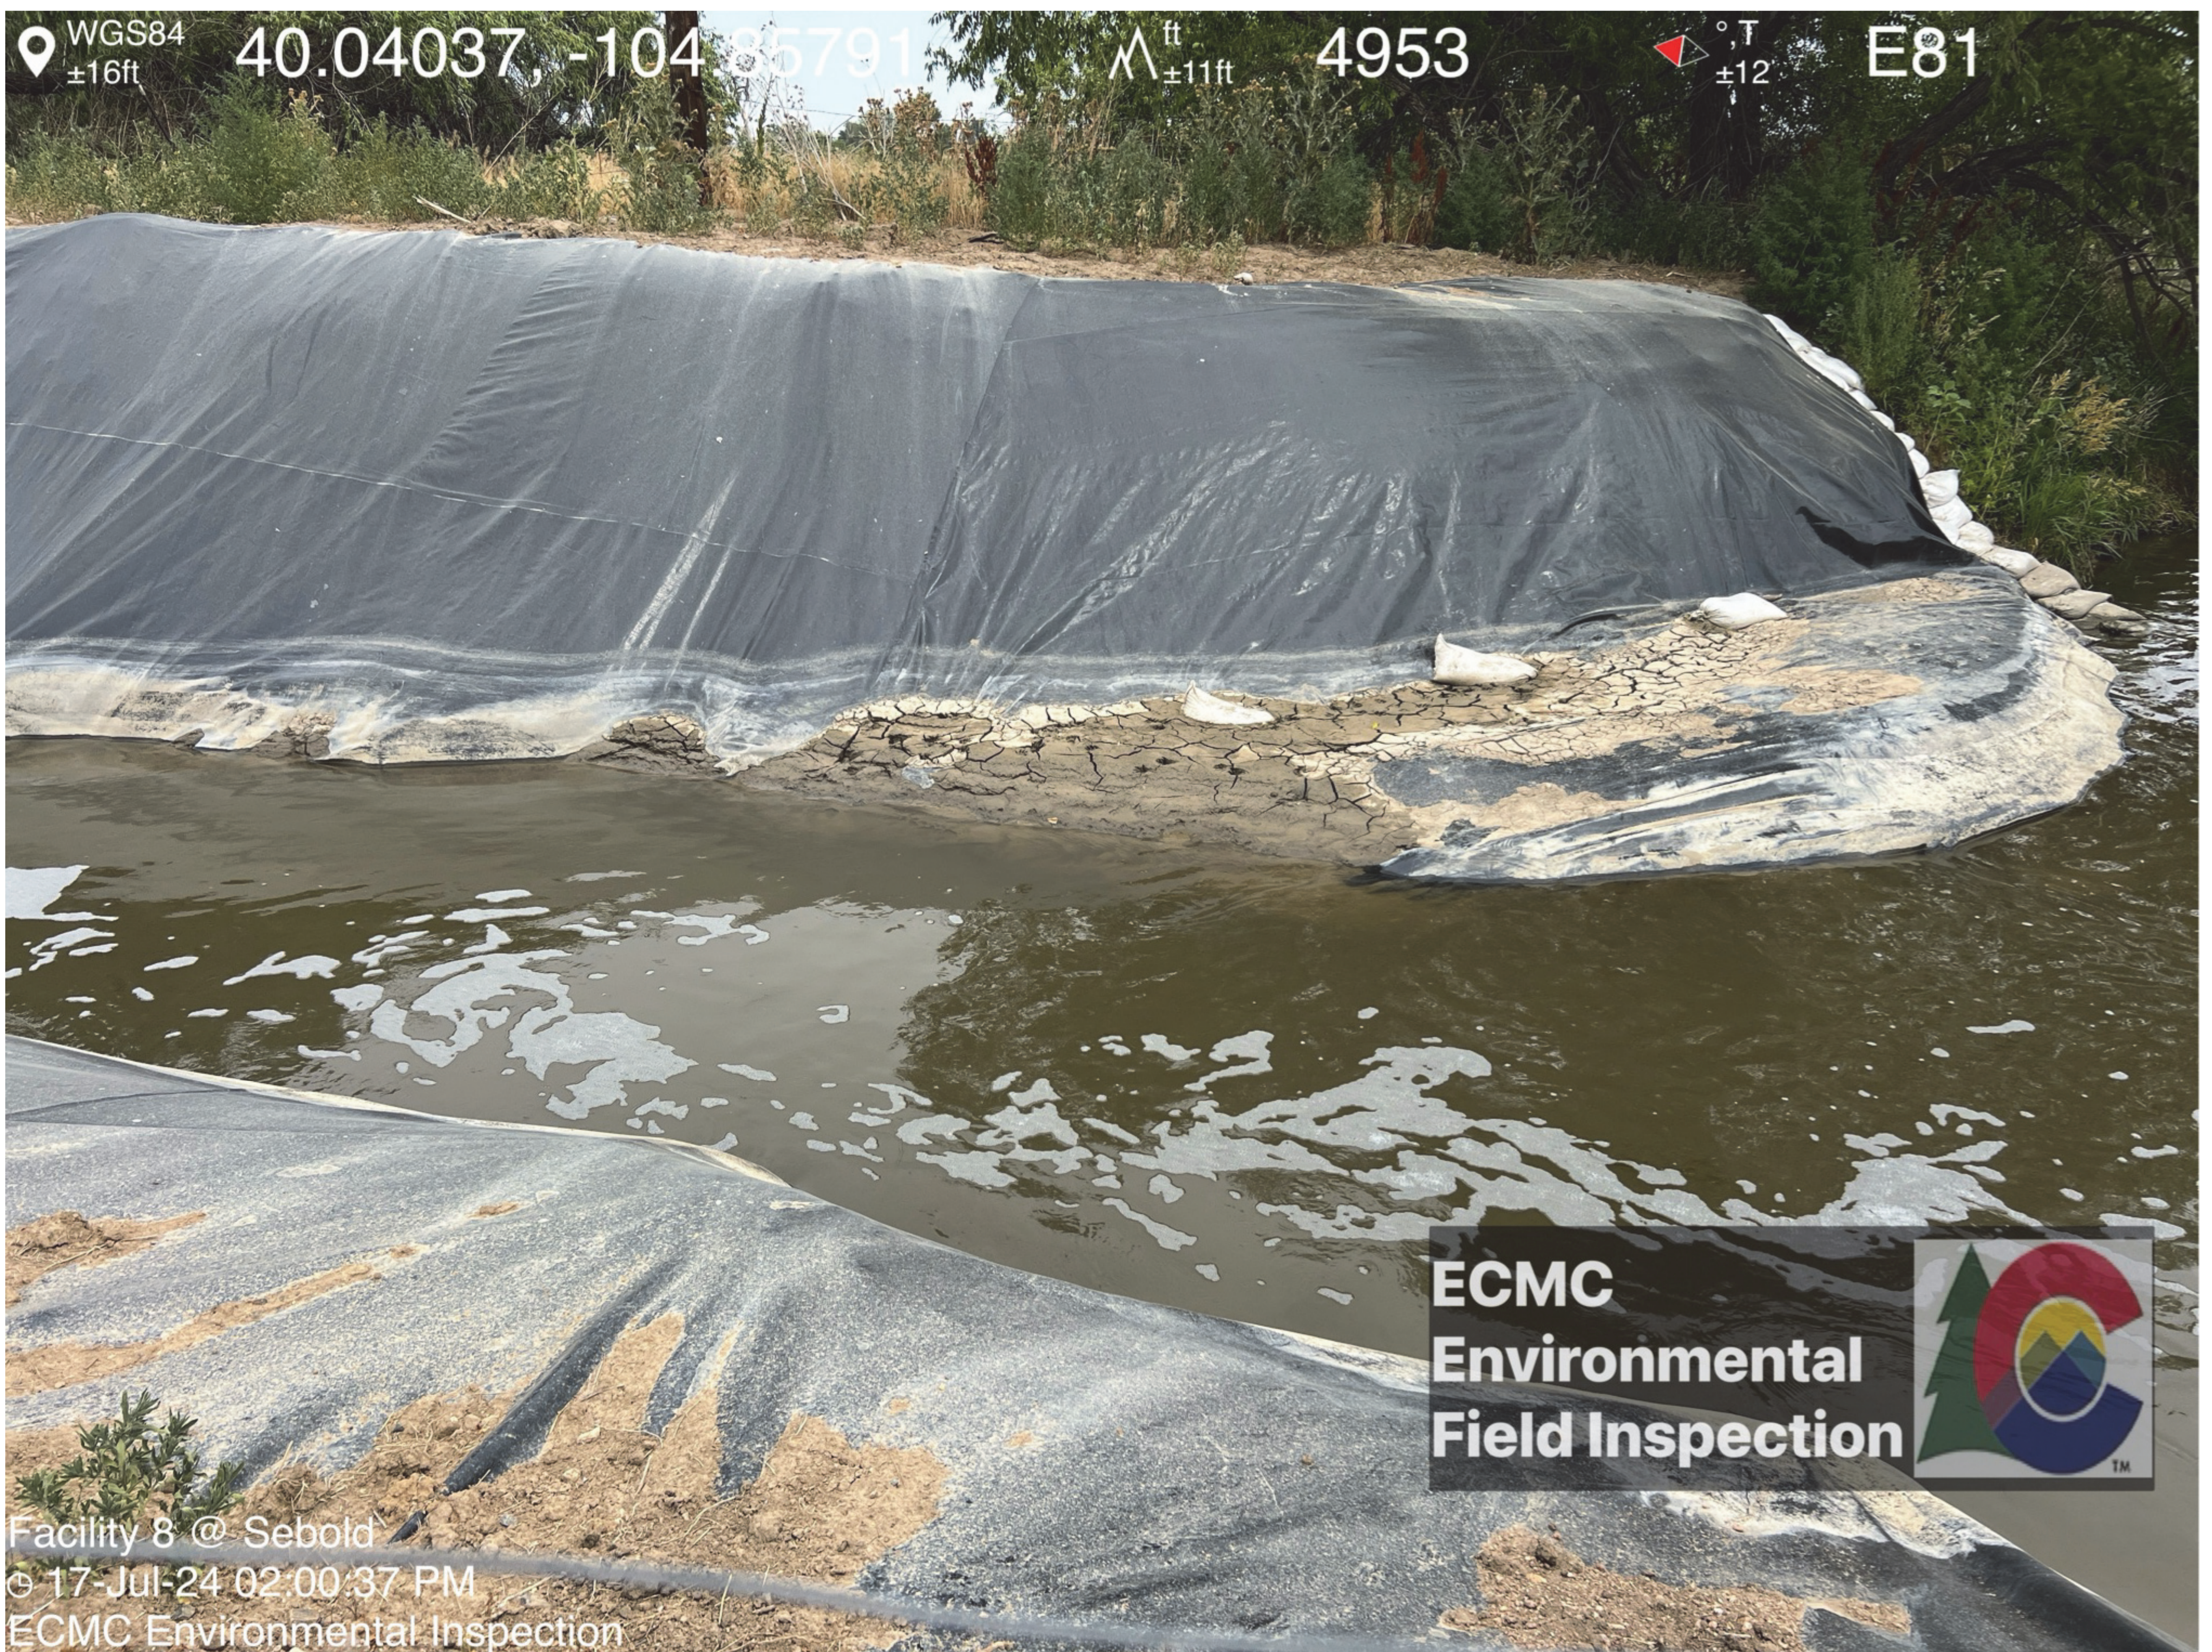
Weeds/Animal tracks

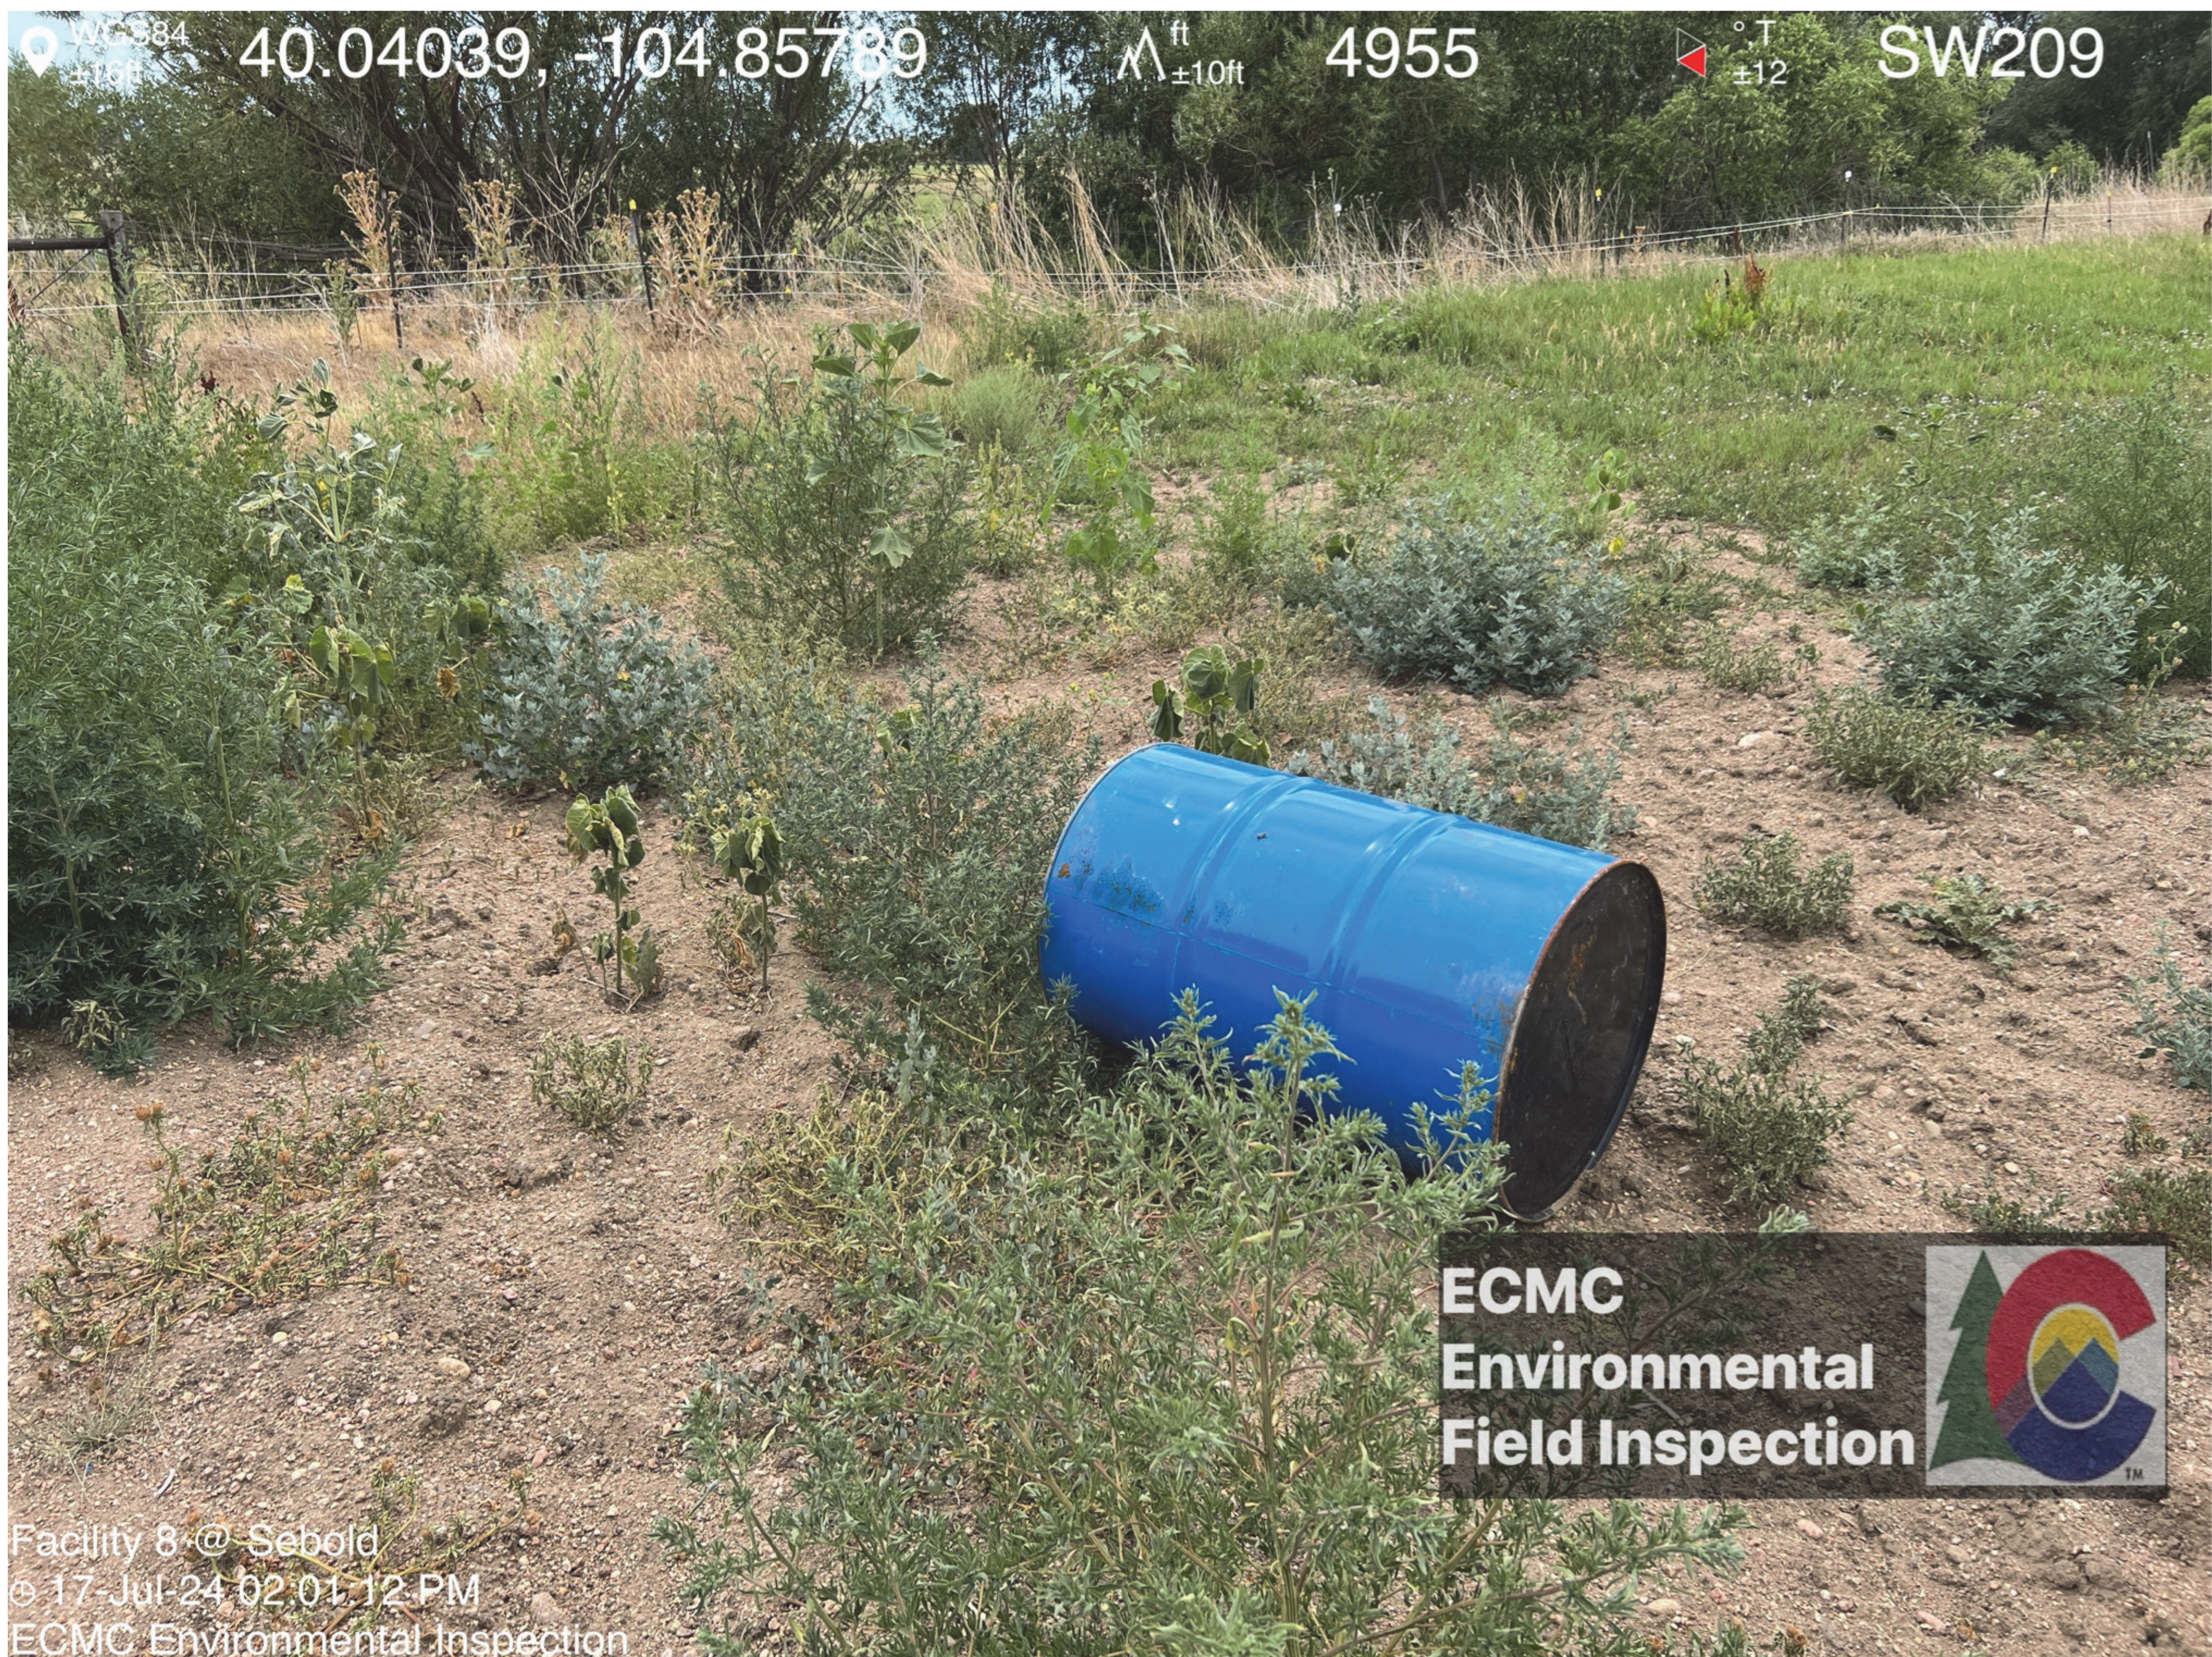
Facility 8 @ Sebold
© 17-Jul-24 02:01:12 PM
ECMC Environmental Inspection
Weeds/Debris/Trash

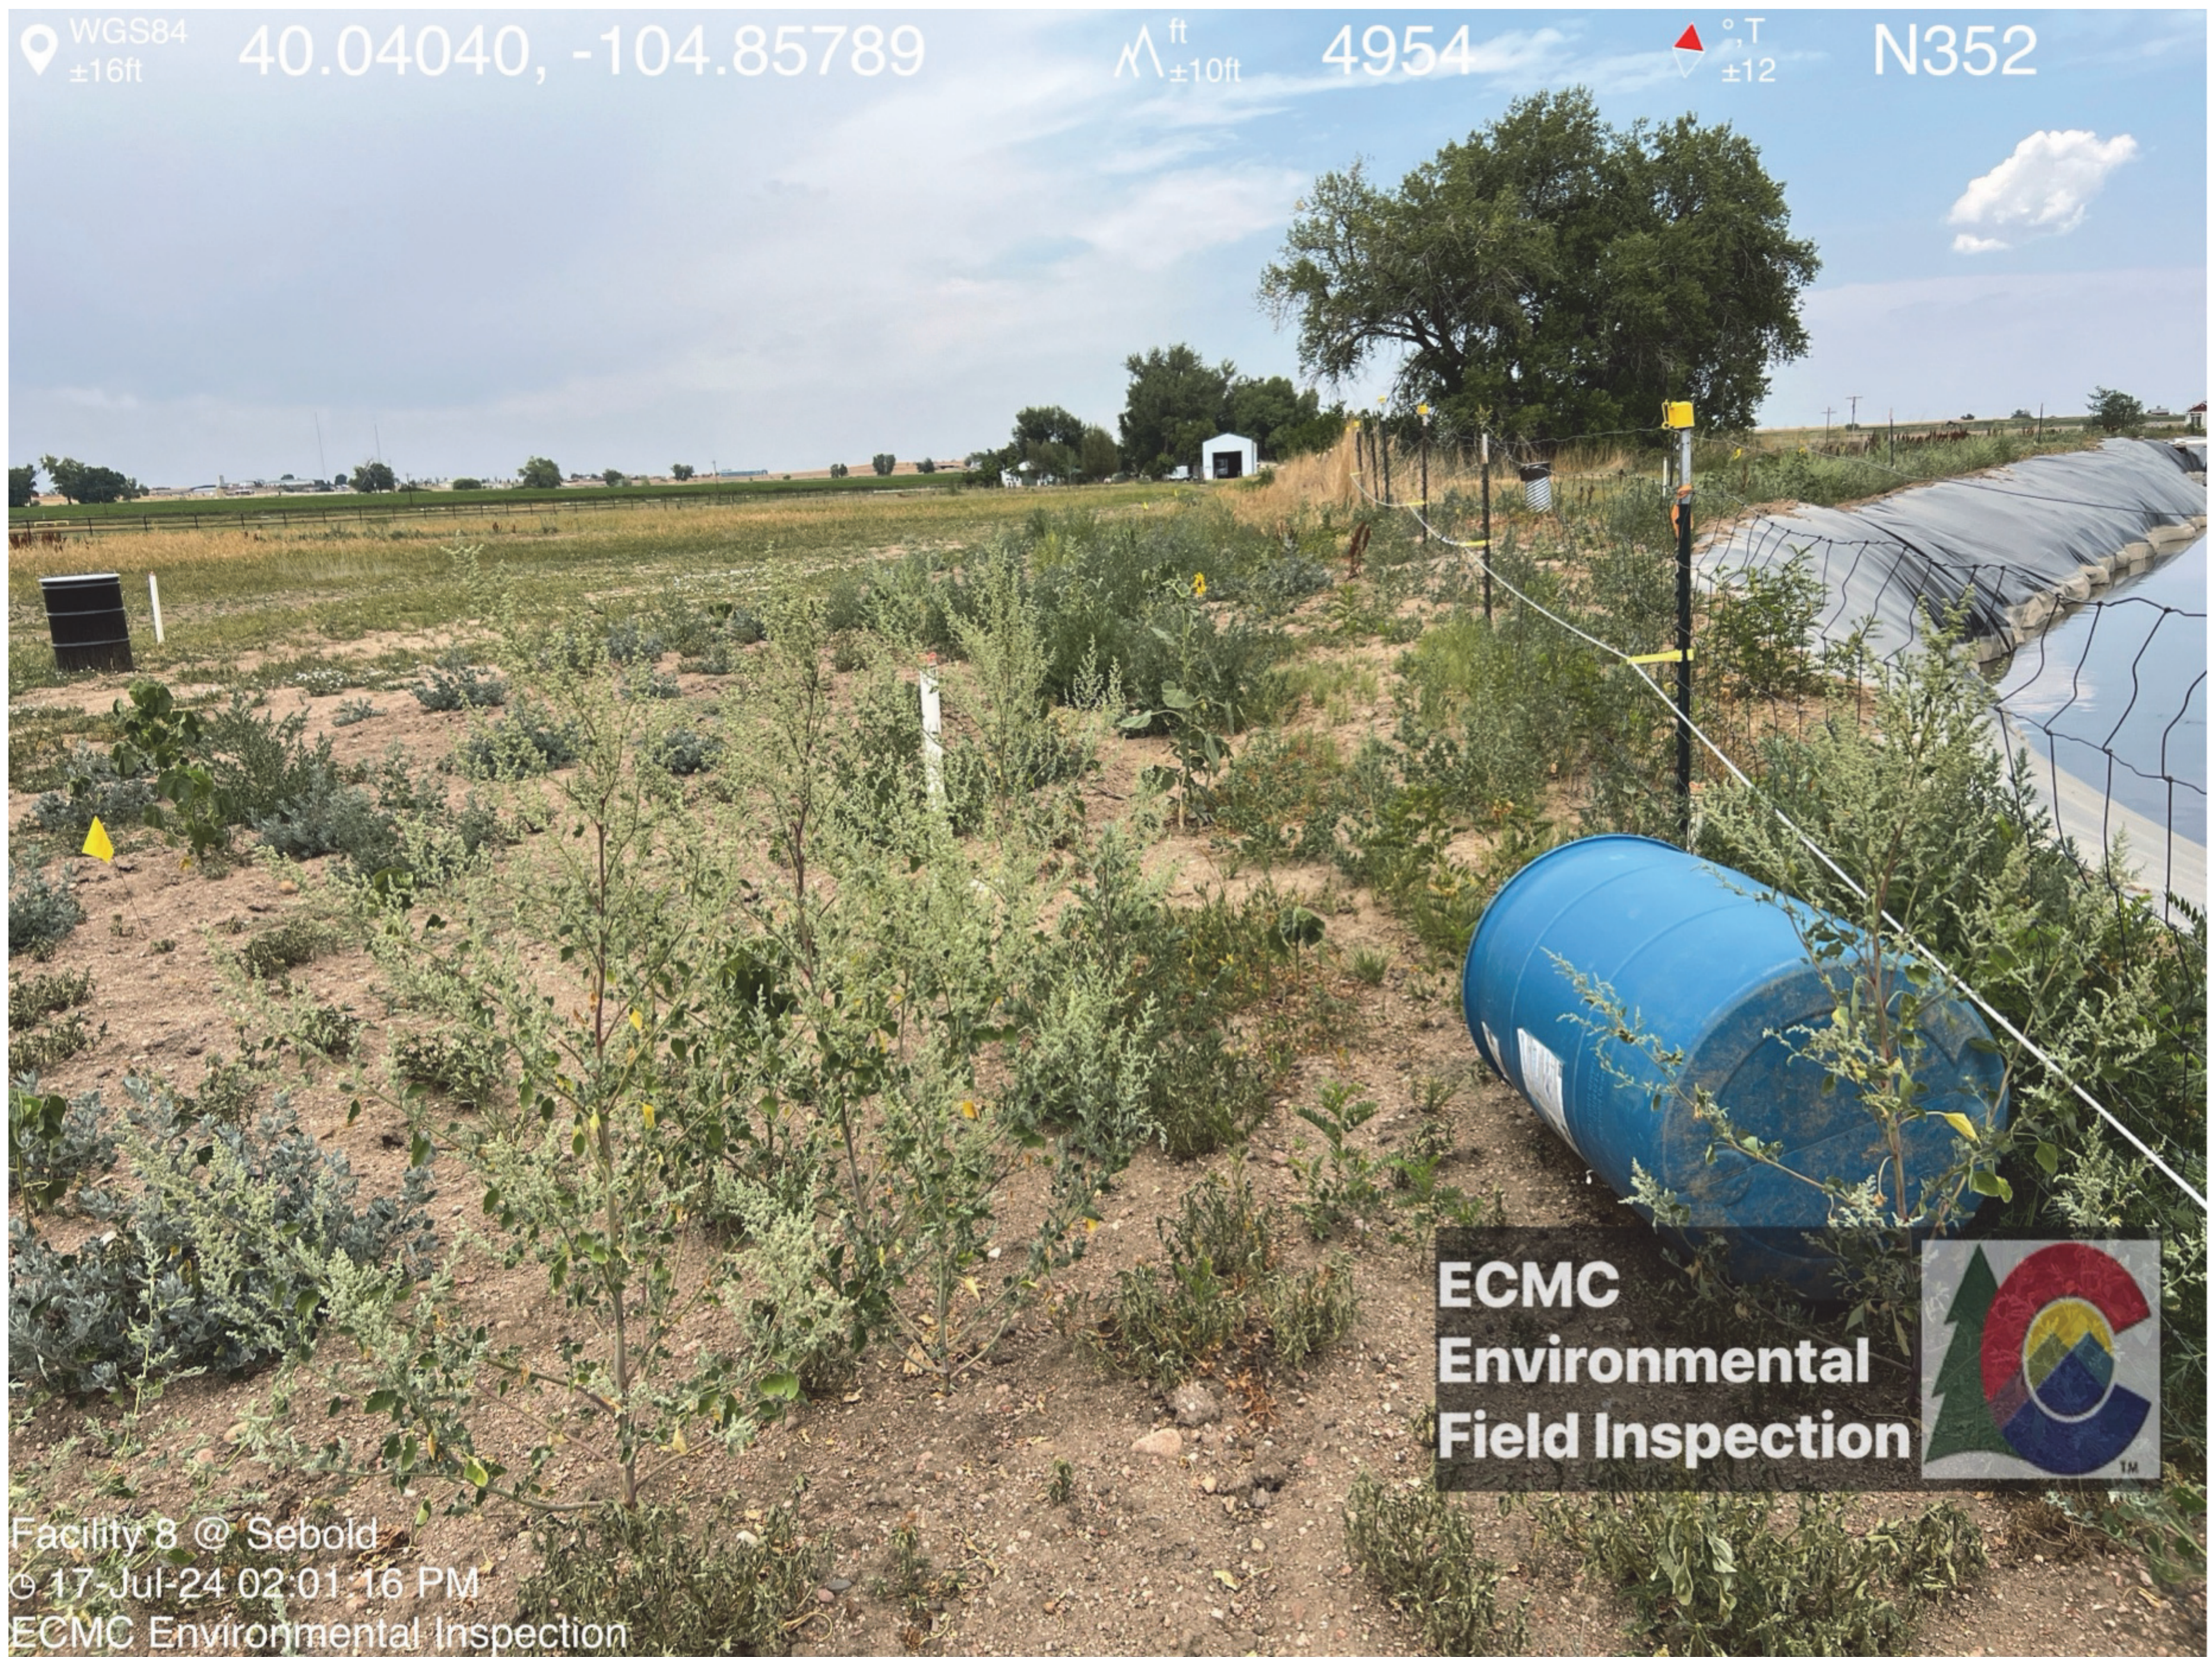
Facility 8 @ Sebold
© 17-Jul-24 02:01:16 PM
ECMC Environmental Inspection
Weeds/Debris/Trash

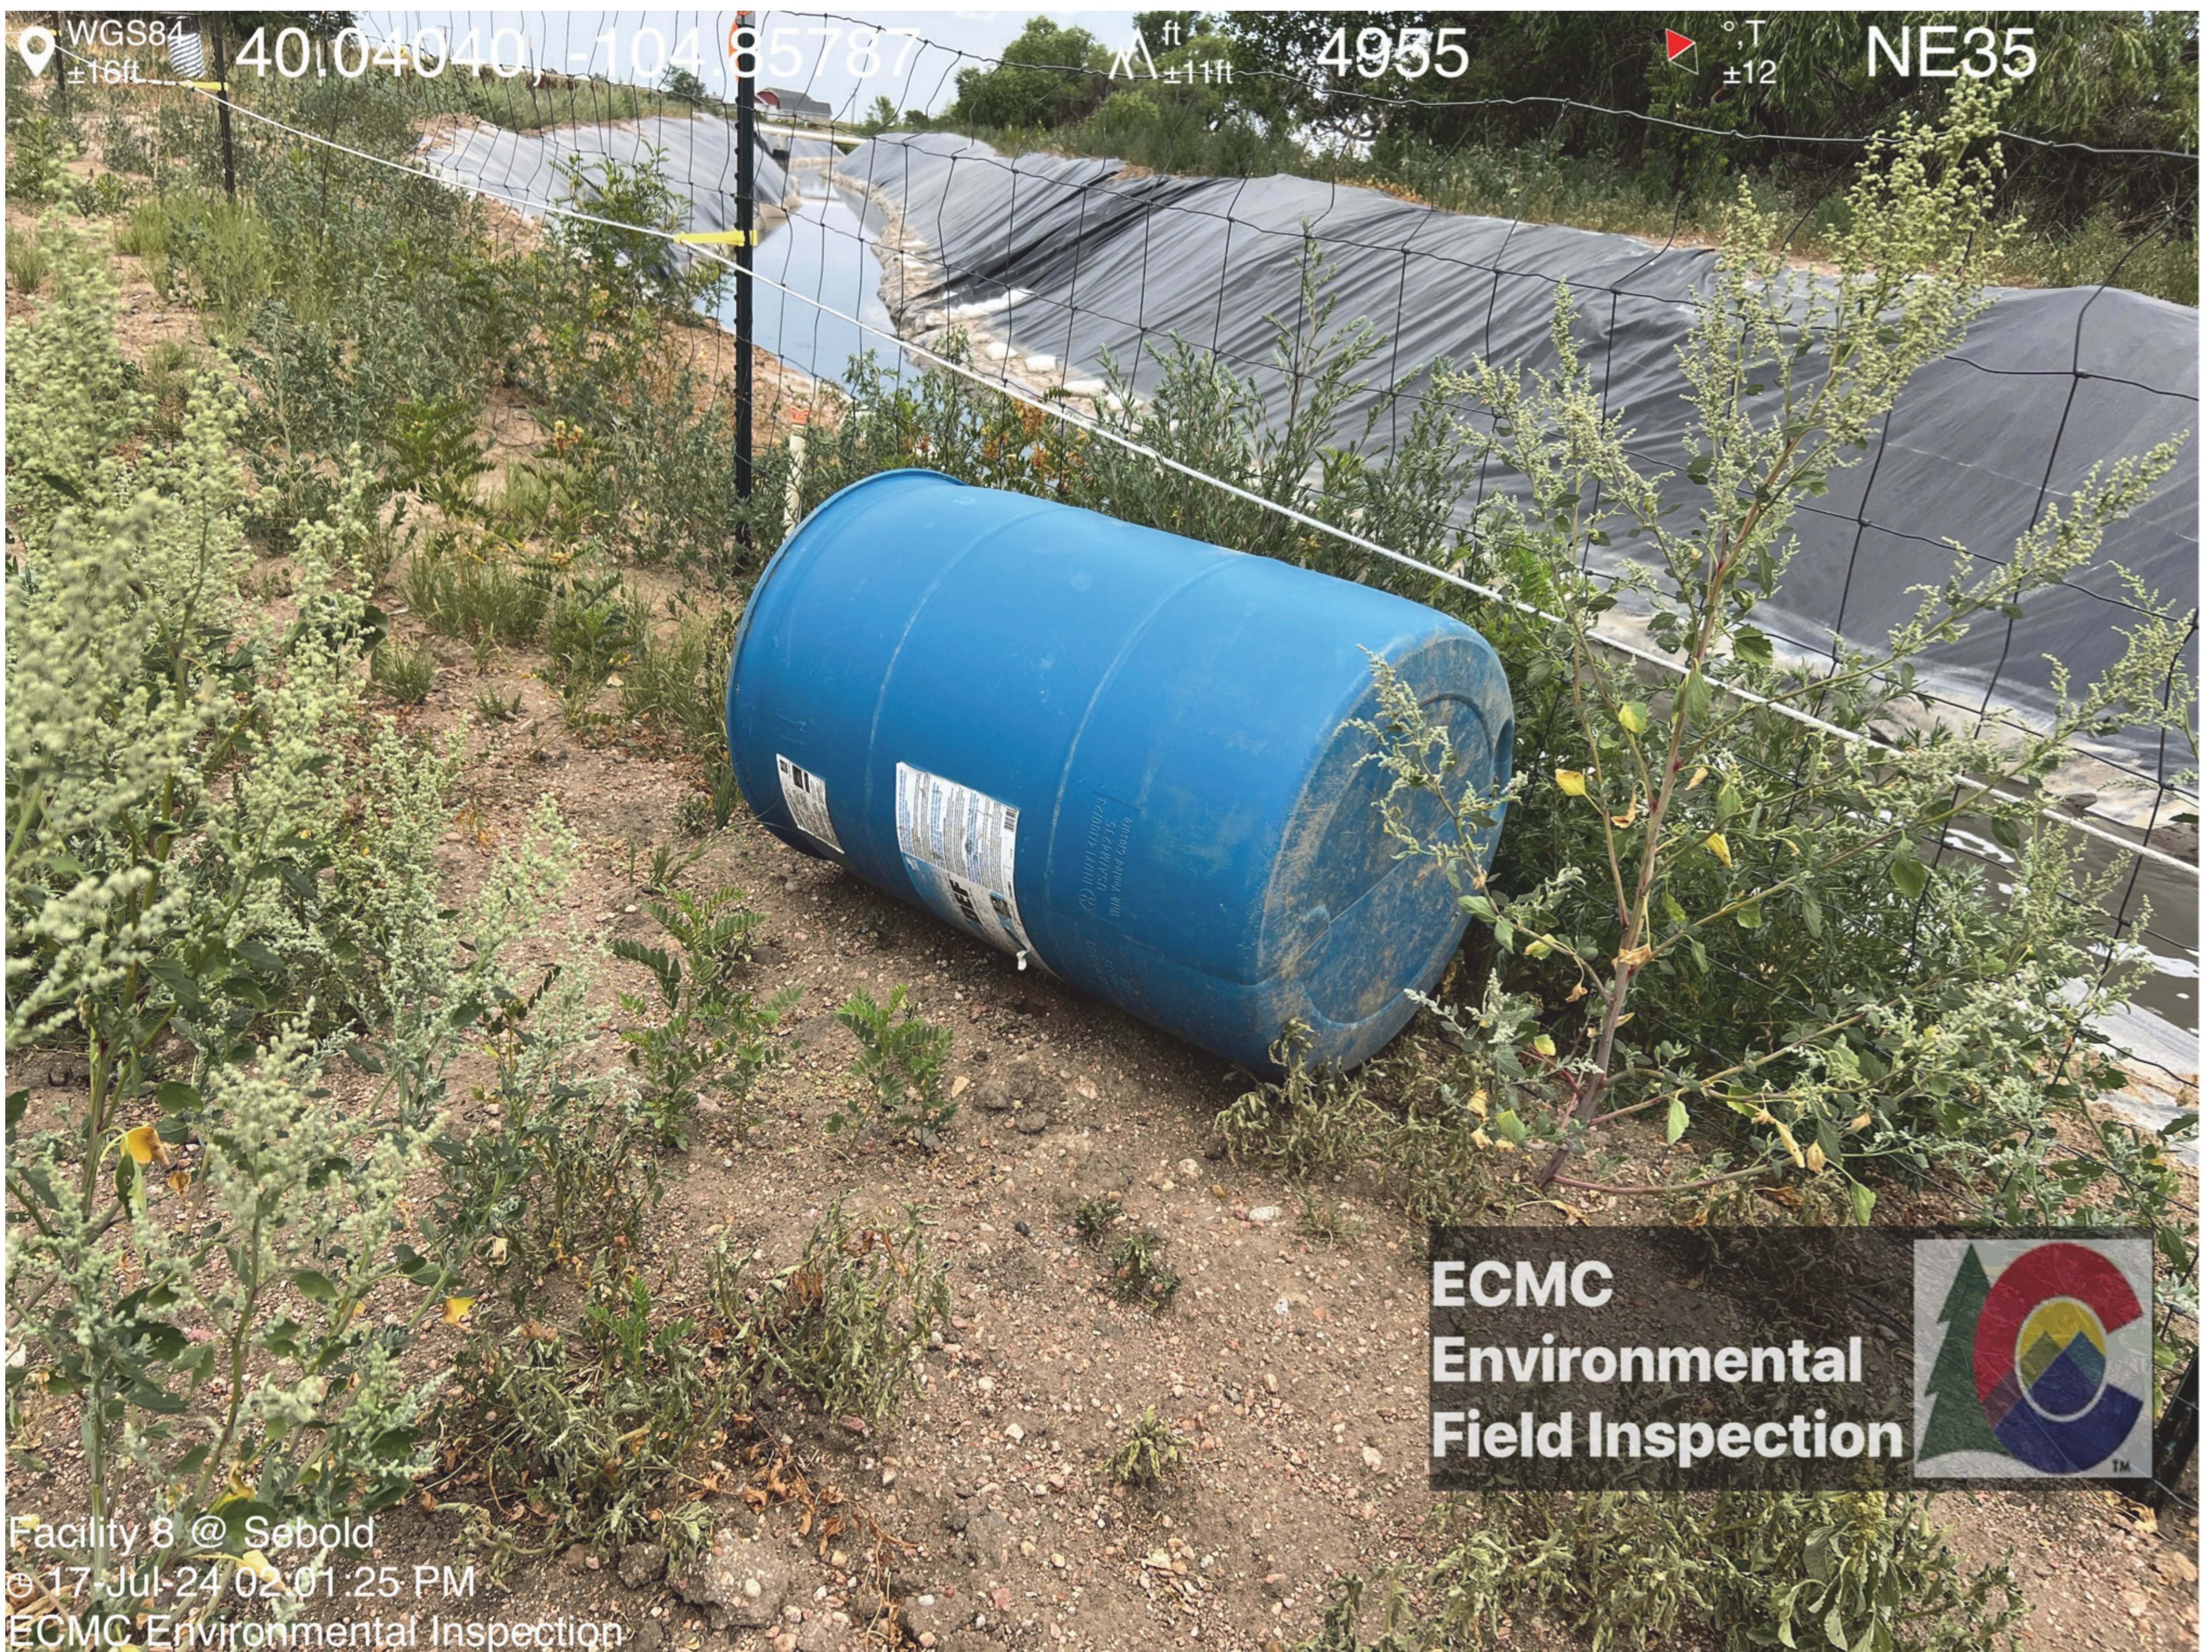
Facility 8 @ Sebold
© 17-Jul-24 02:01:25 PM
ECMC Environmental Inspection
Weeds/Debris/Trash

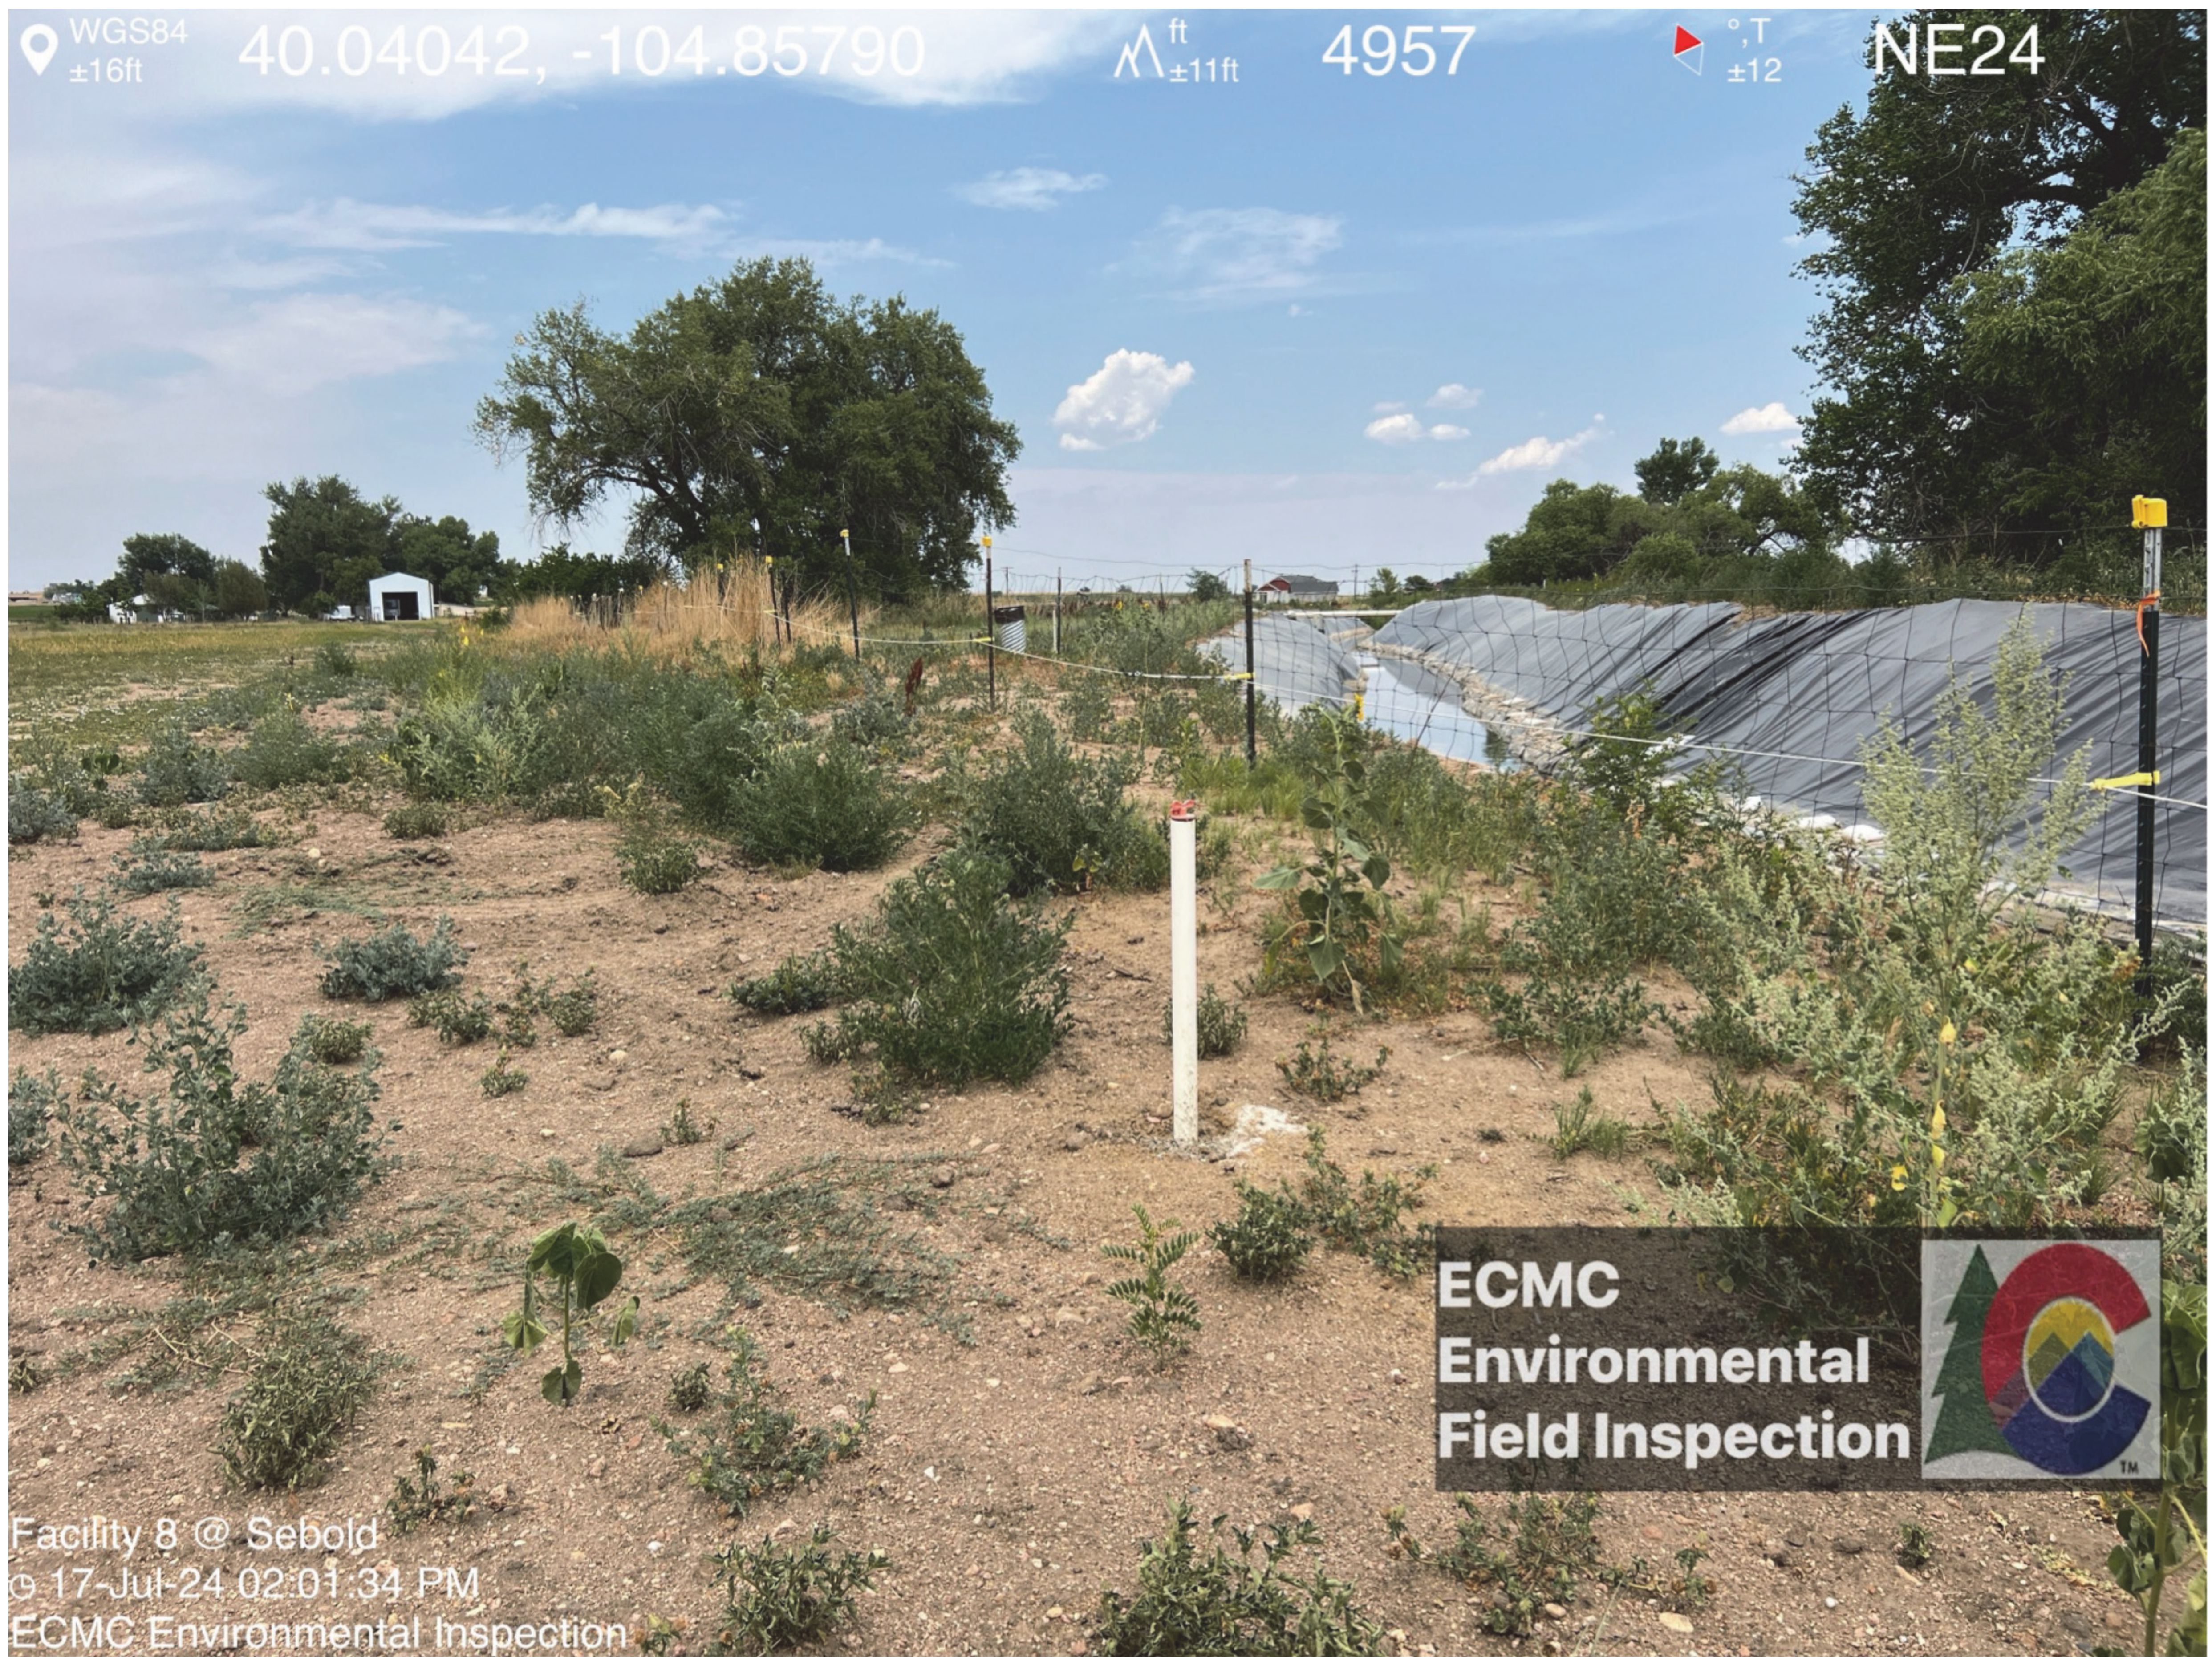
Weeds. Excavation backfilled without ECMC review/approval.
