**ECMC
Environmental
Field Inspection**

Facility 8 @ Sebold
© 17-Jul-24 02:00:47 PM
ECMC Environmental Inspection
Weeds/Debris/Trash

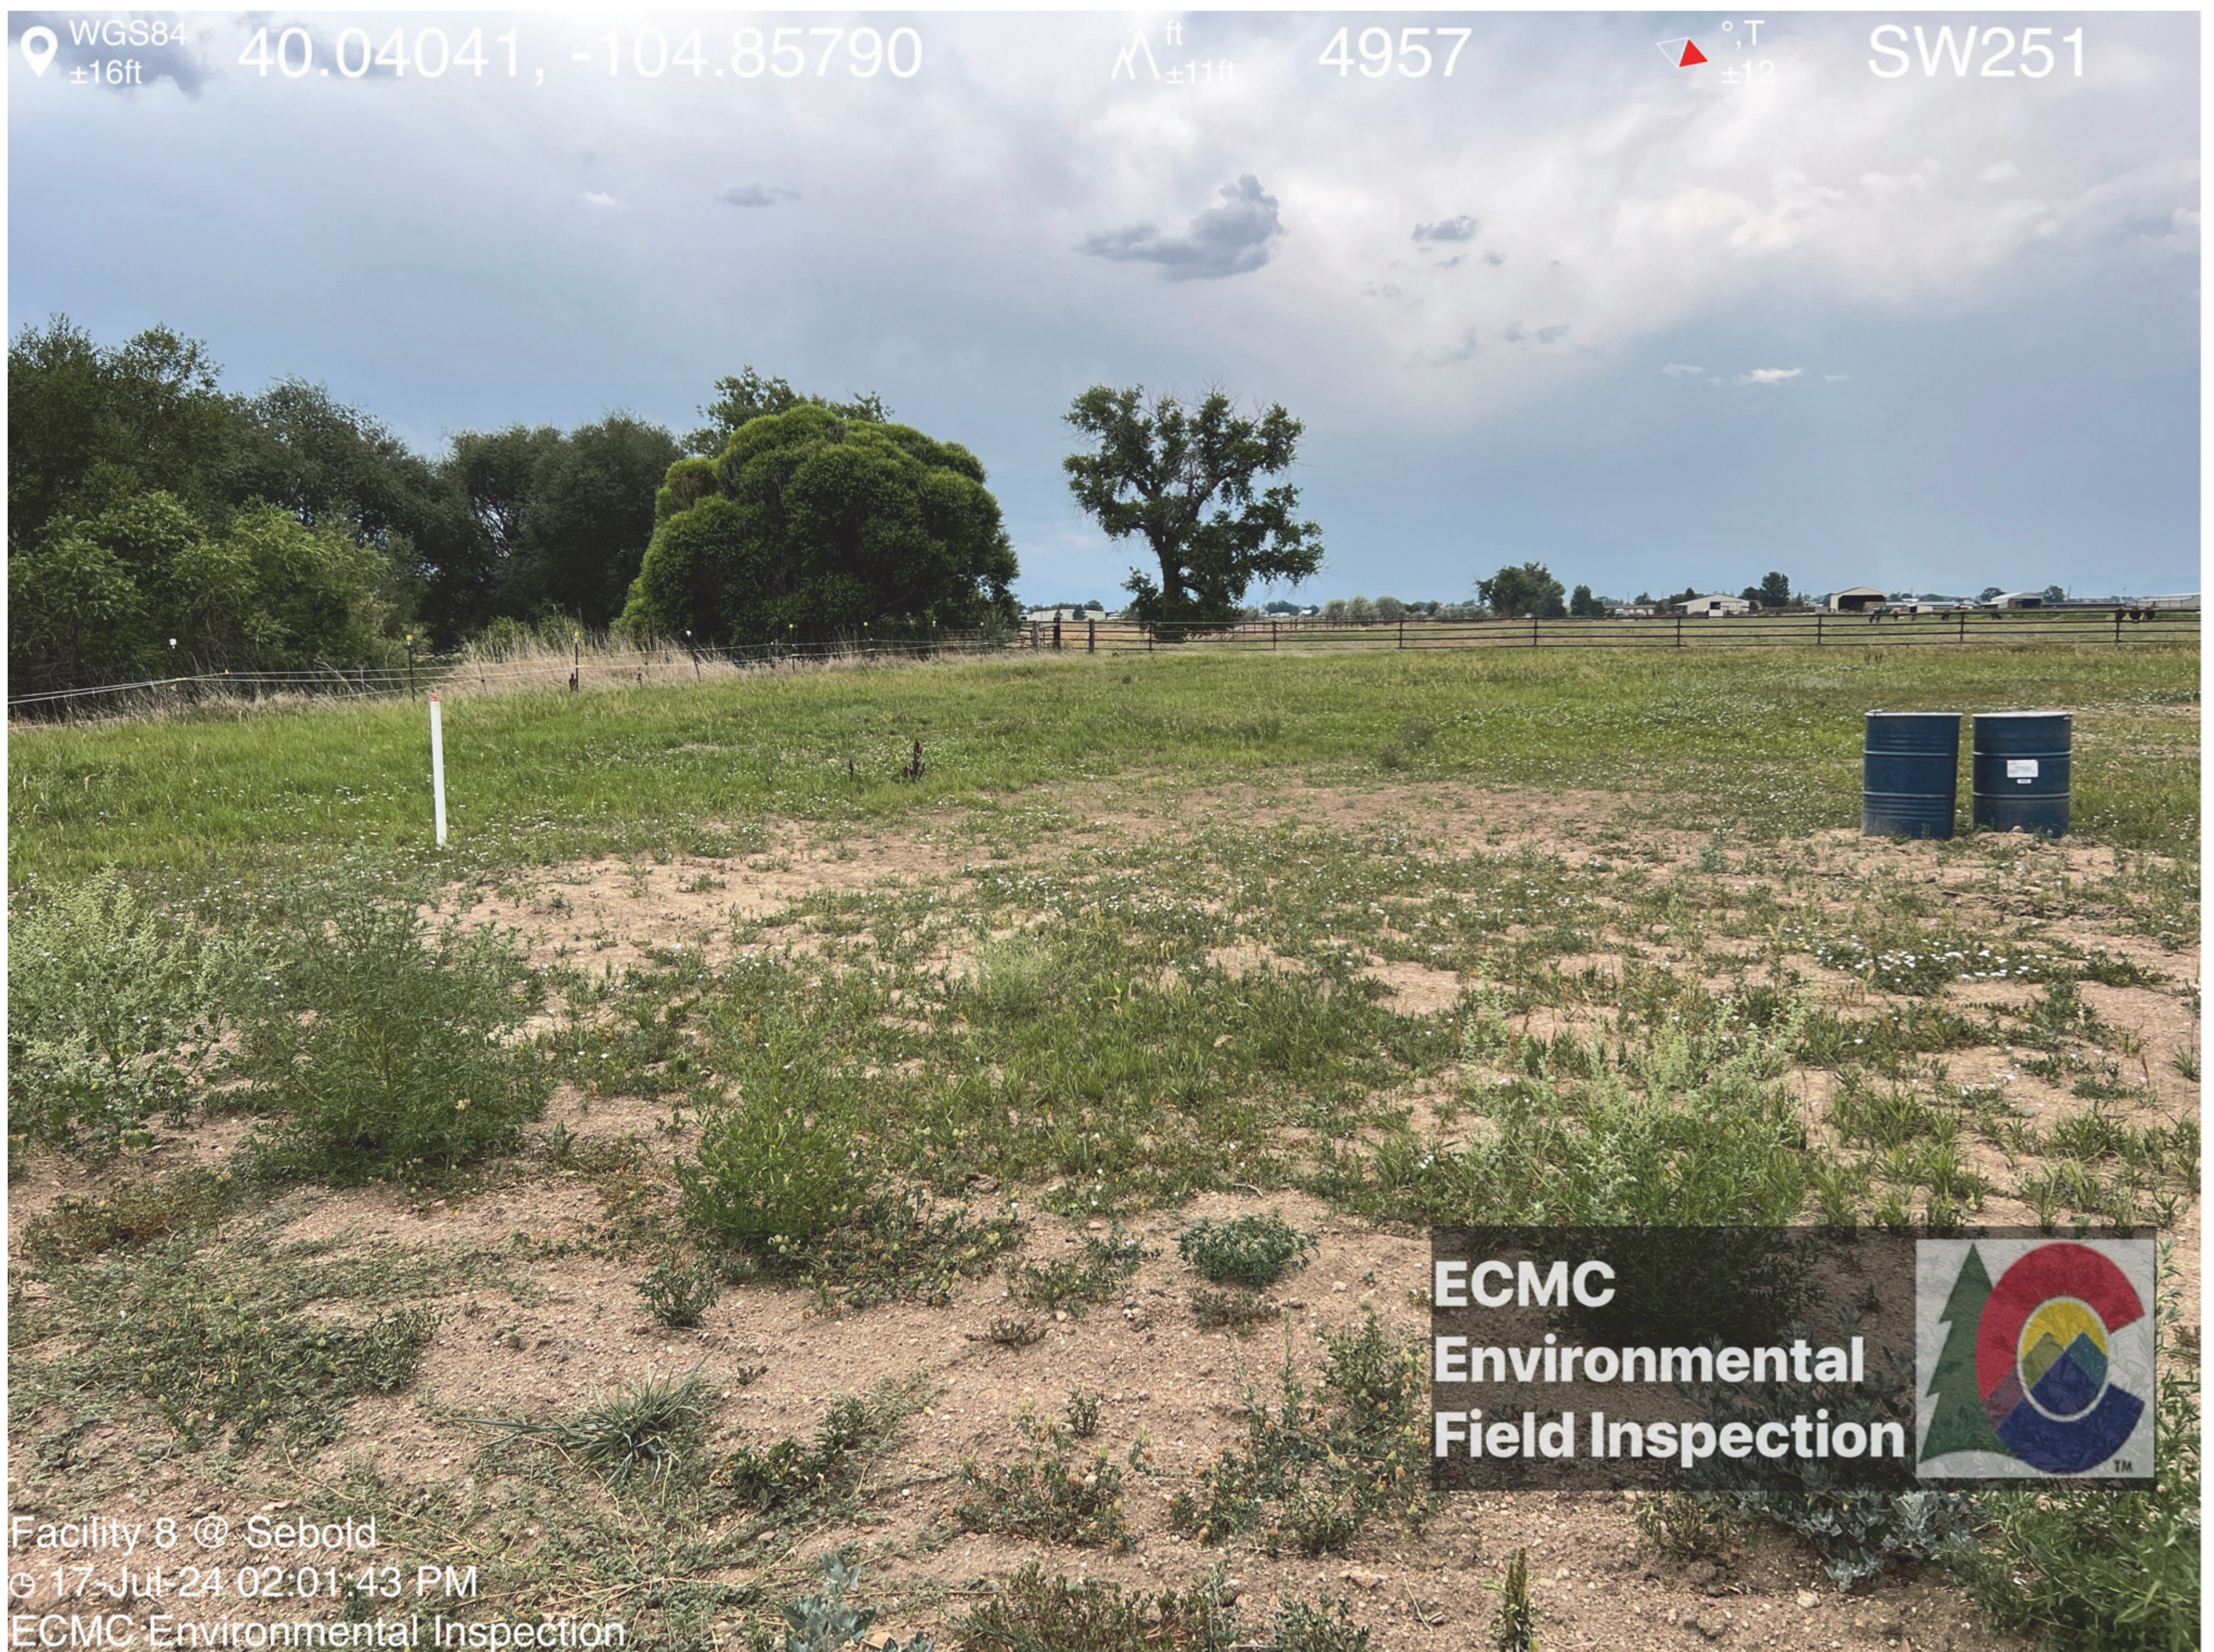
Weeds/Debris/Trash. Footprint of work area

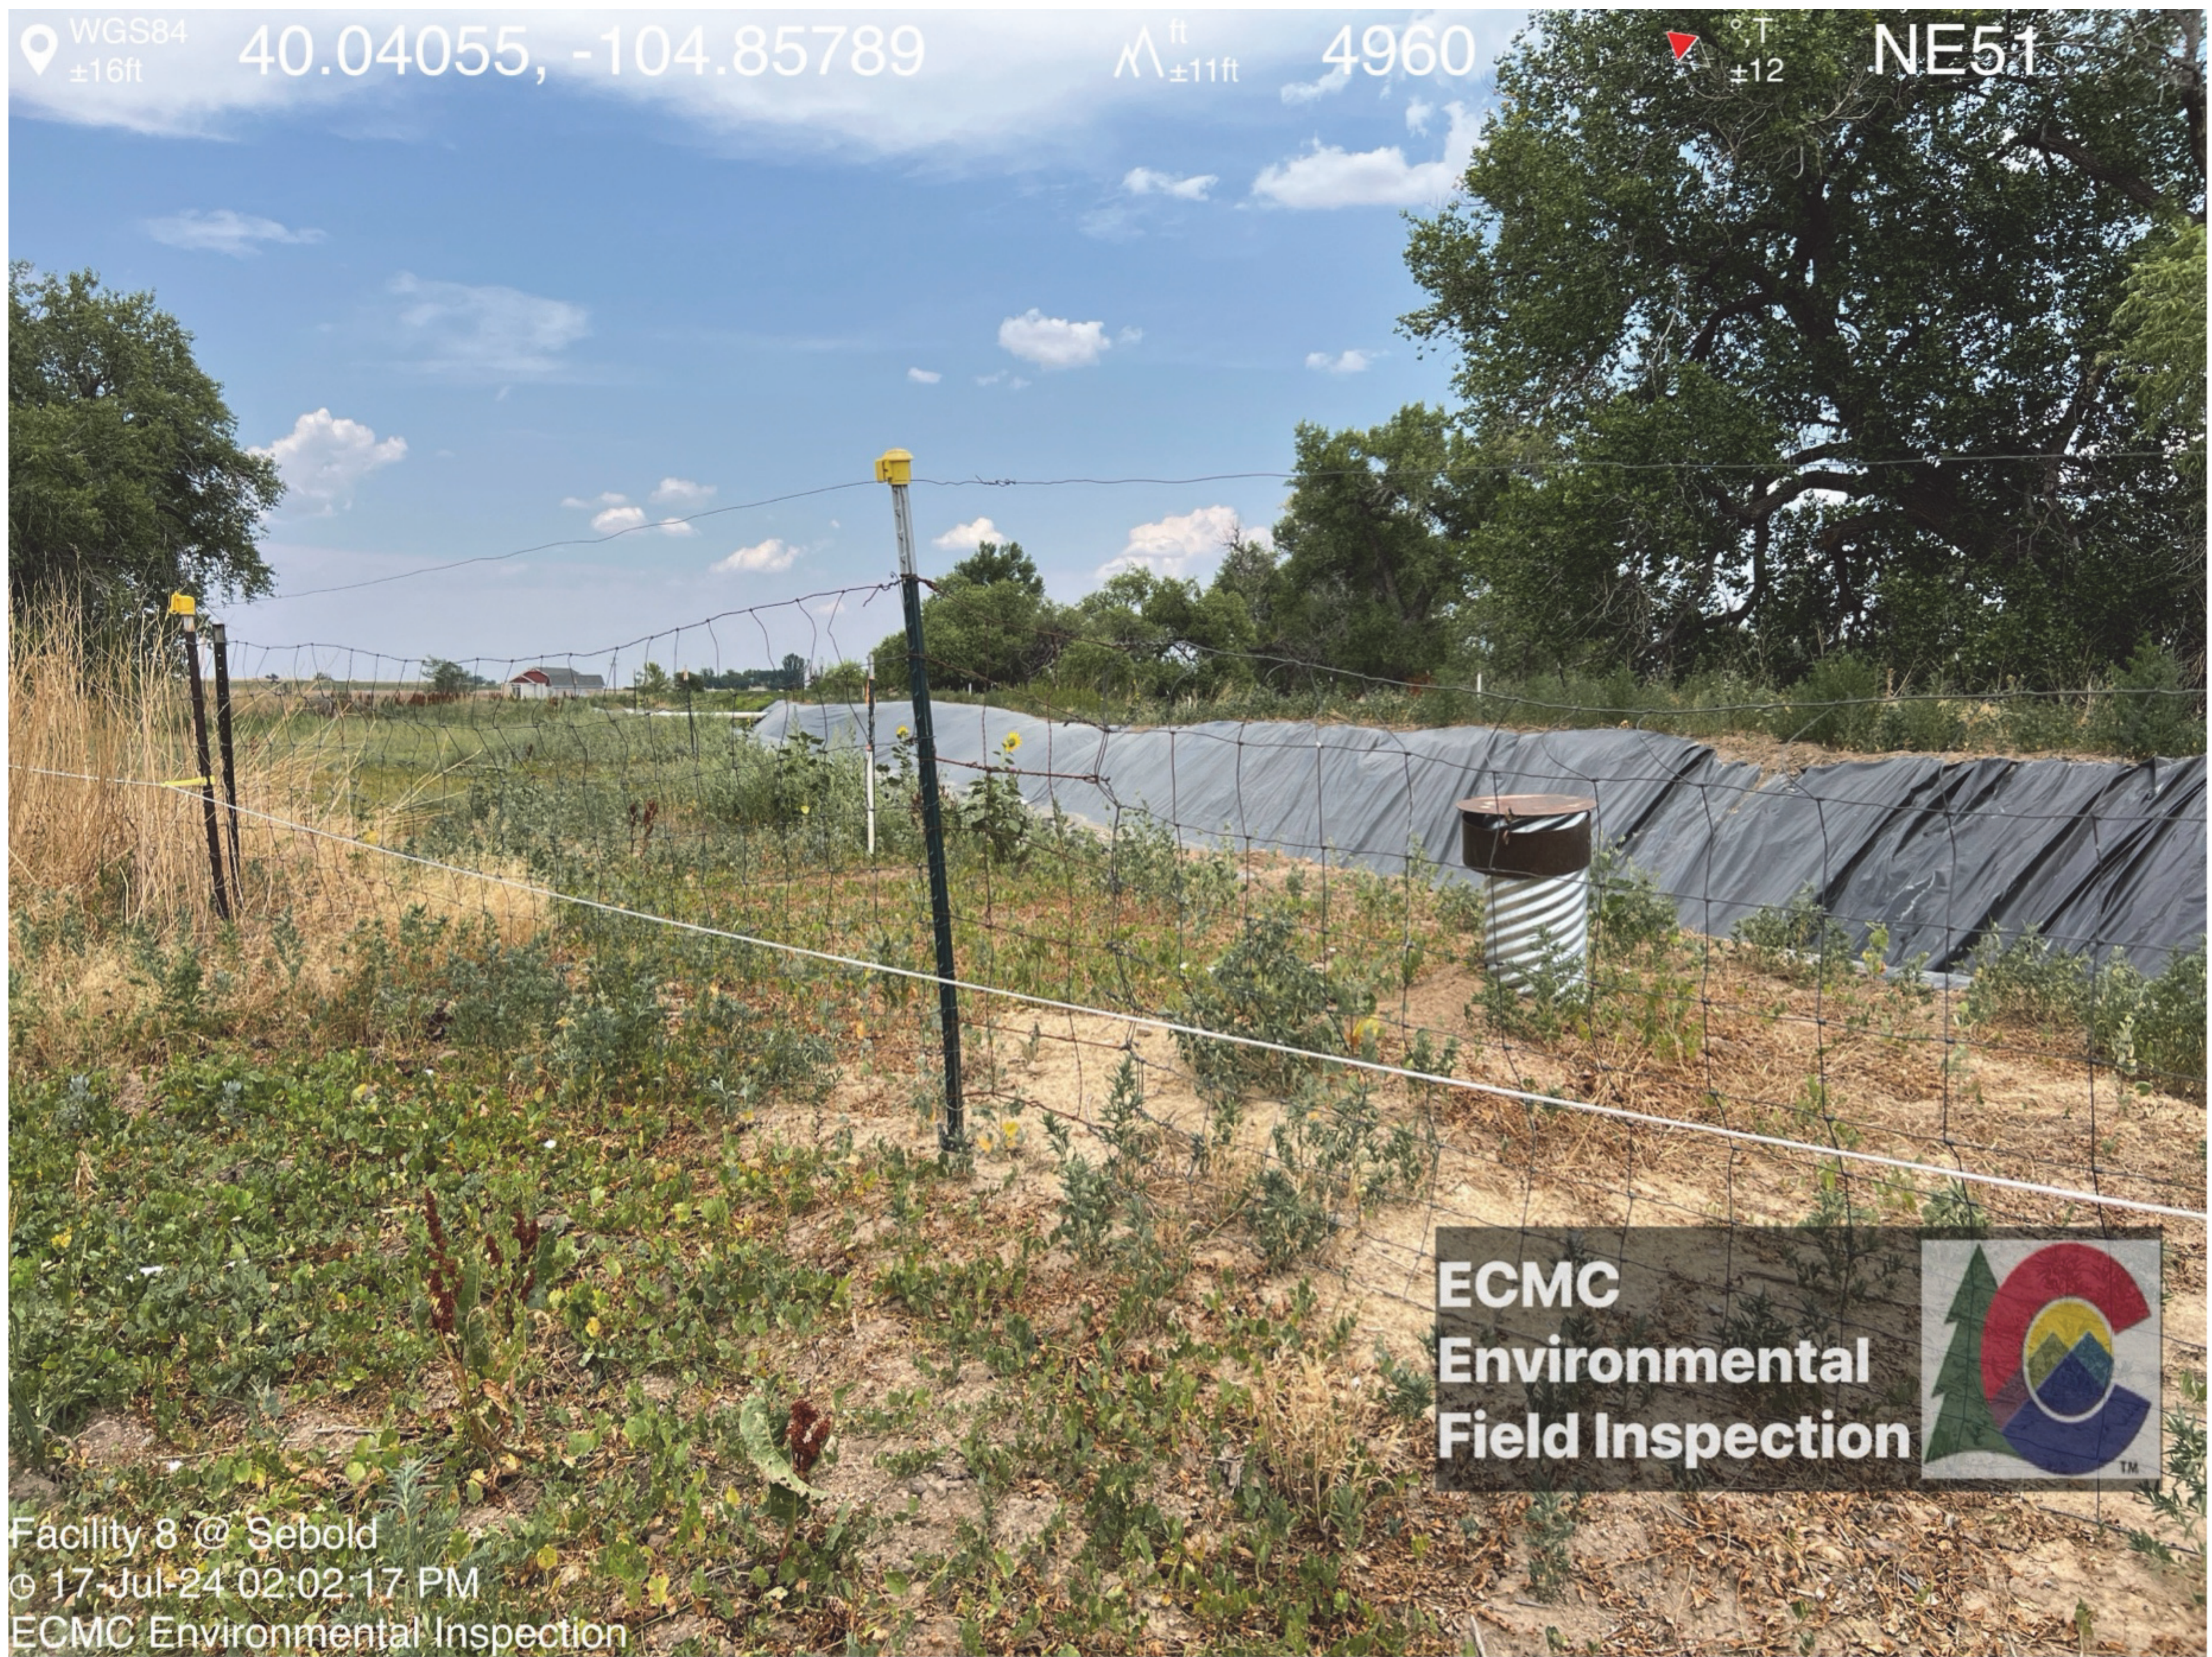
Facility 8 @ Sebold
© 17-Jul-24 02:02:17 PM
ECMC Environmental Inspection
Weeds. Footprint of work area.

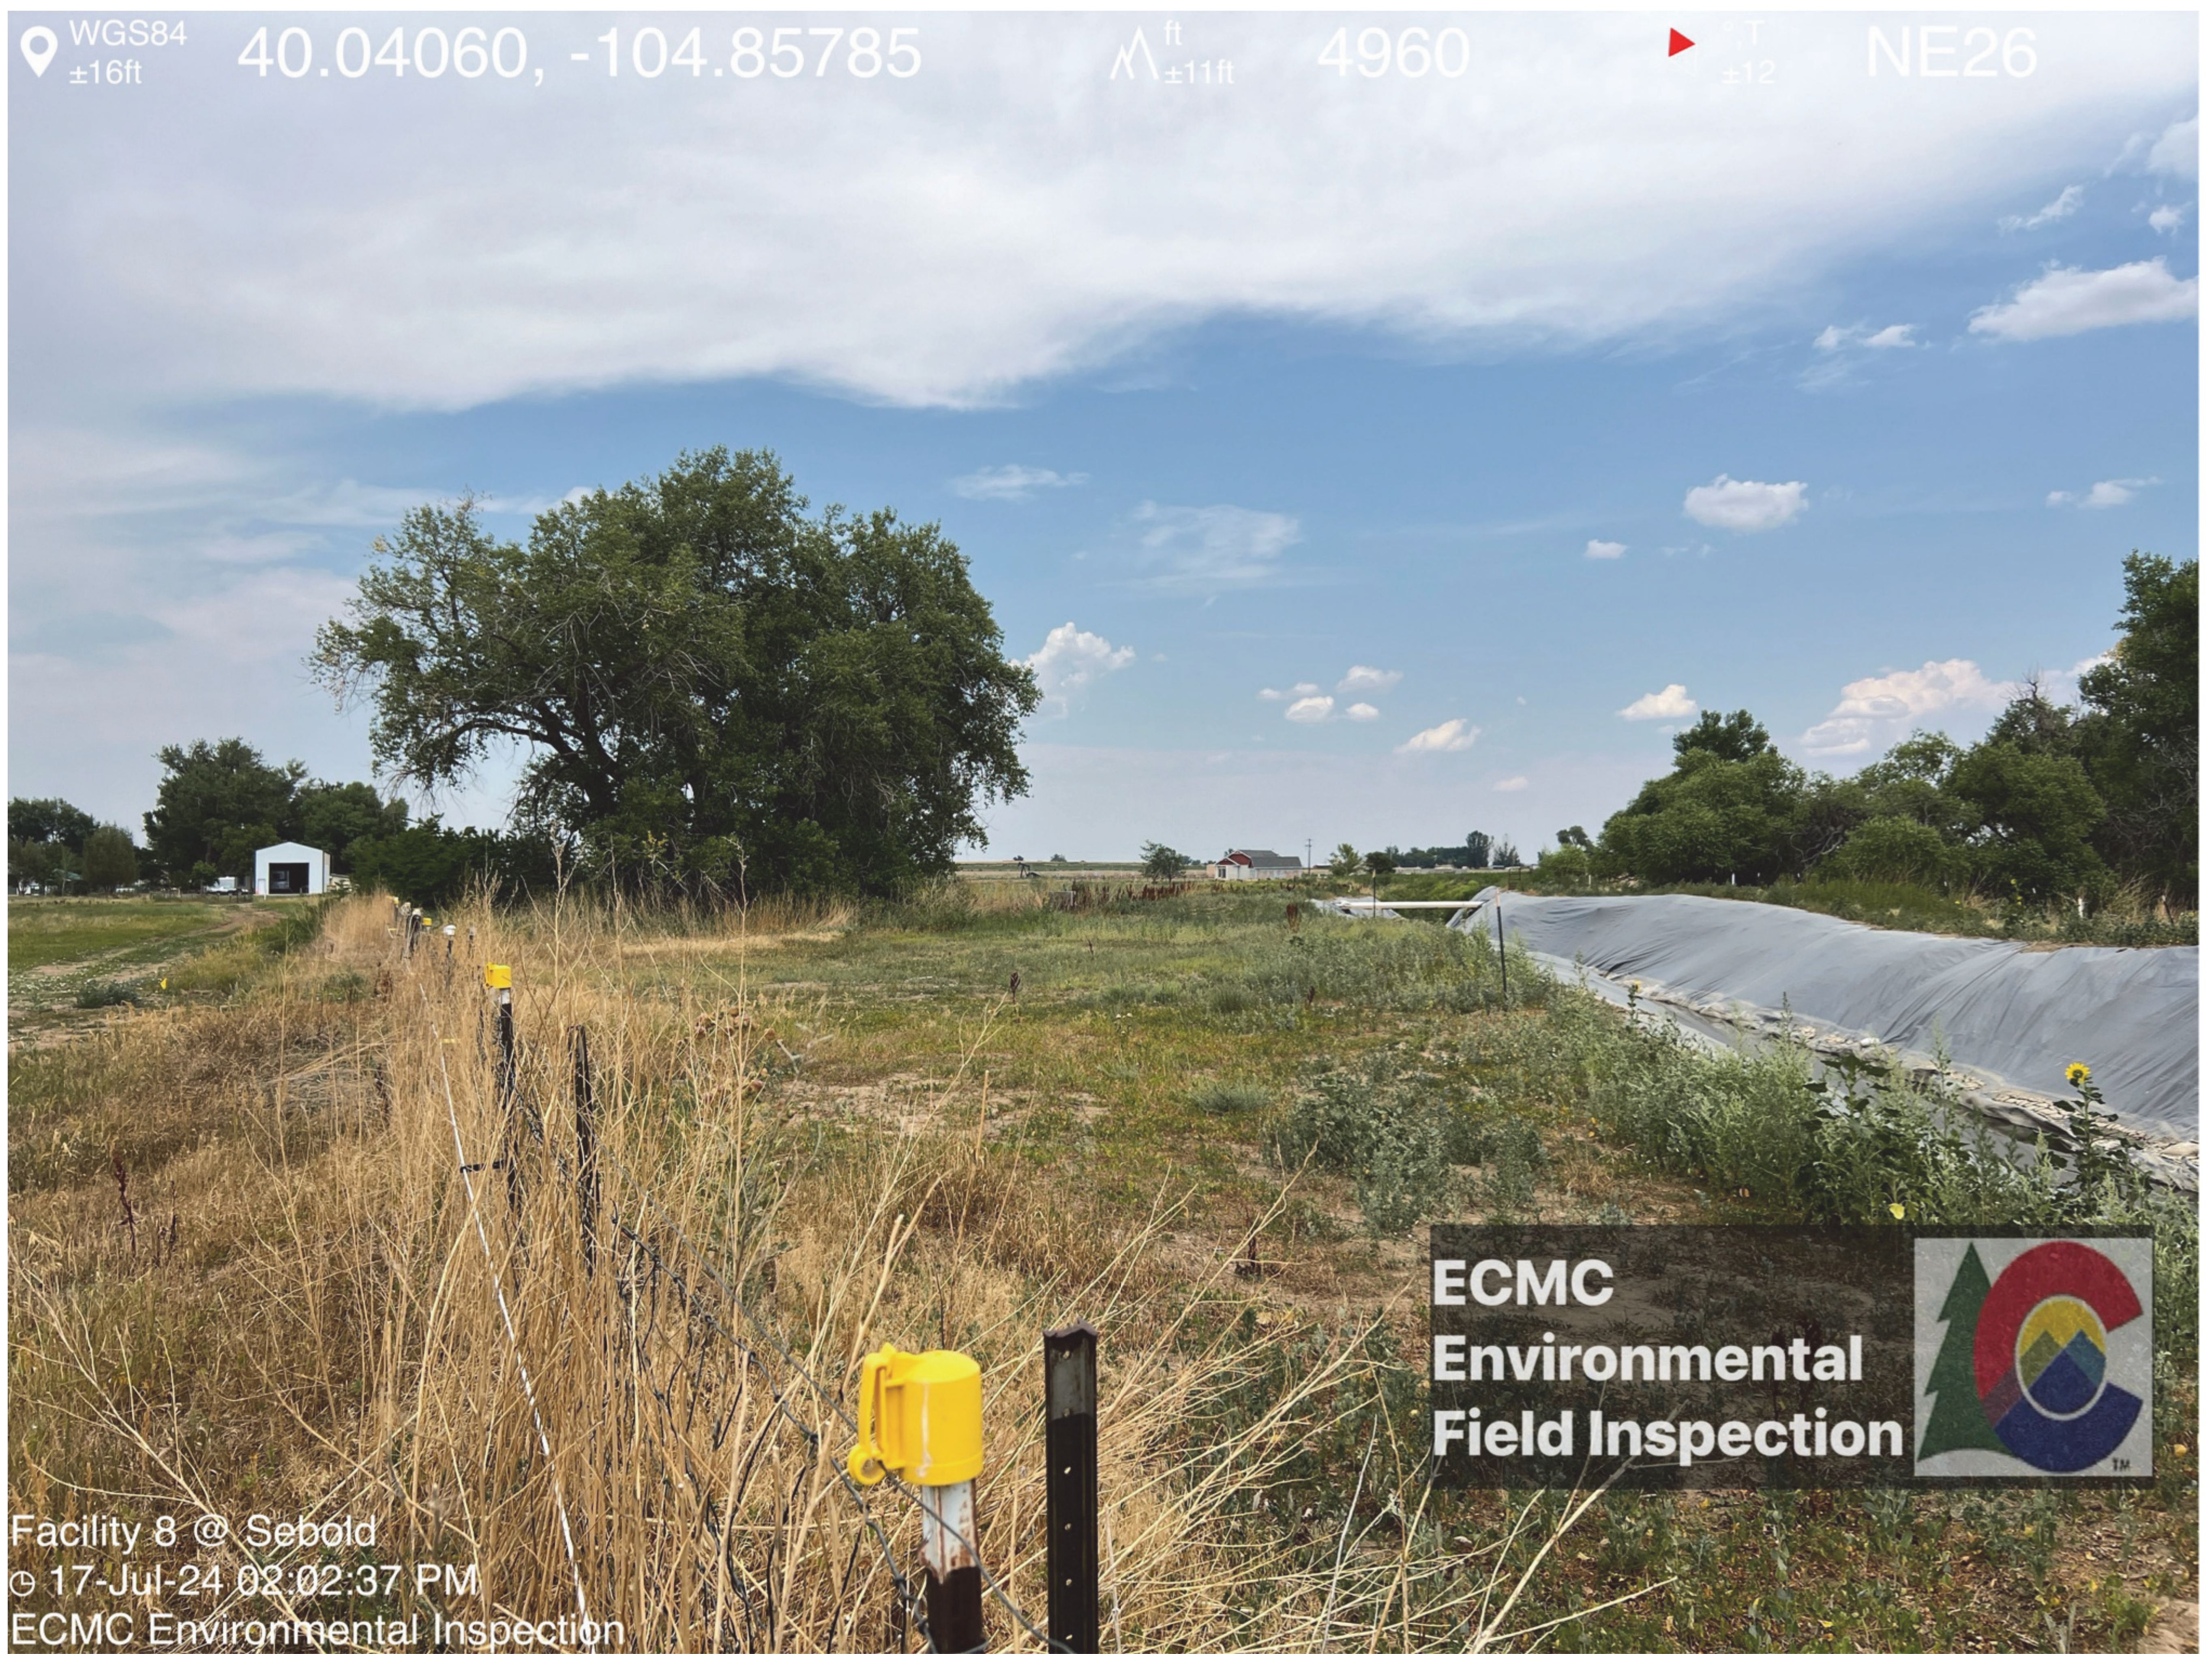
Facility 8 @ Sebold
© 17-Jul-24 02:02:37 PM
ECMC Environmental Inspection
Weeds. Footprint of work area.

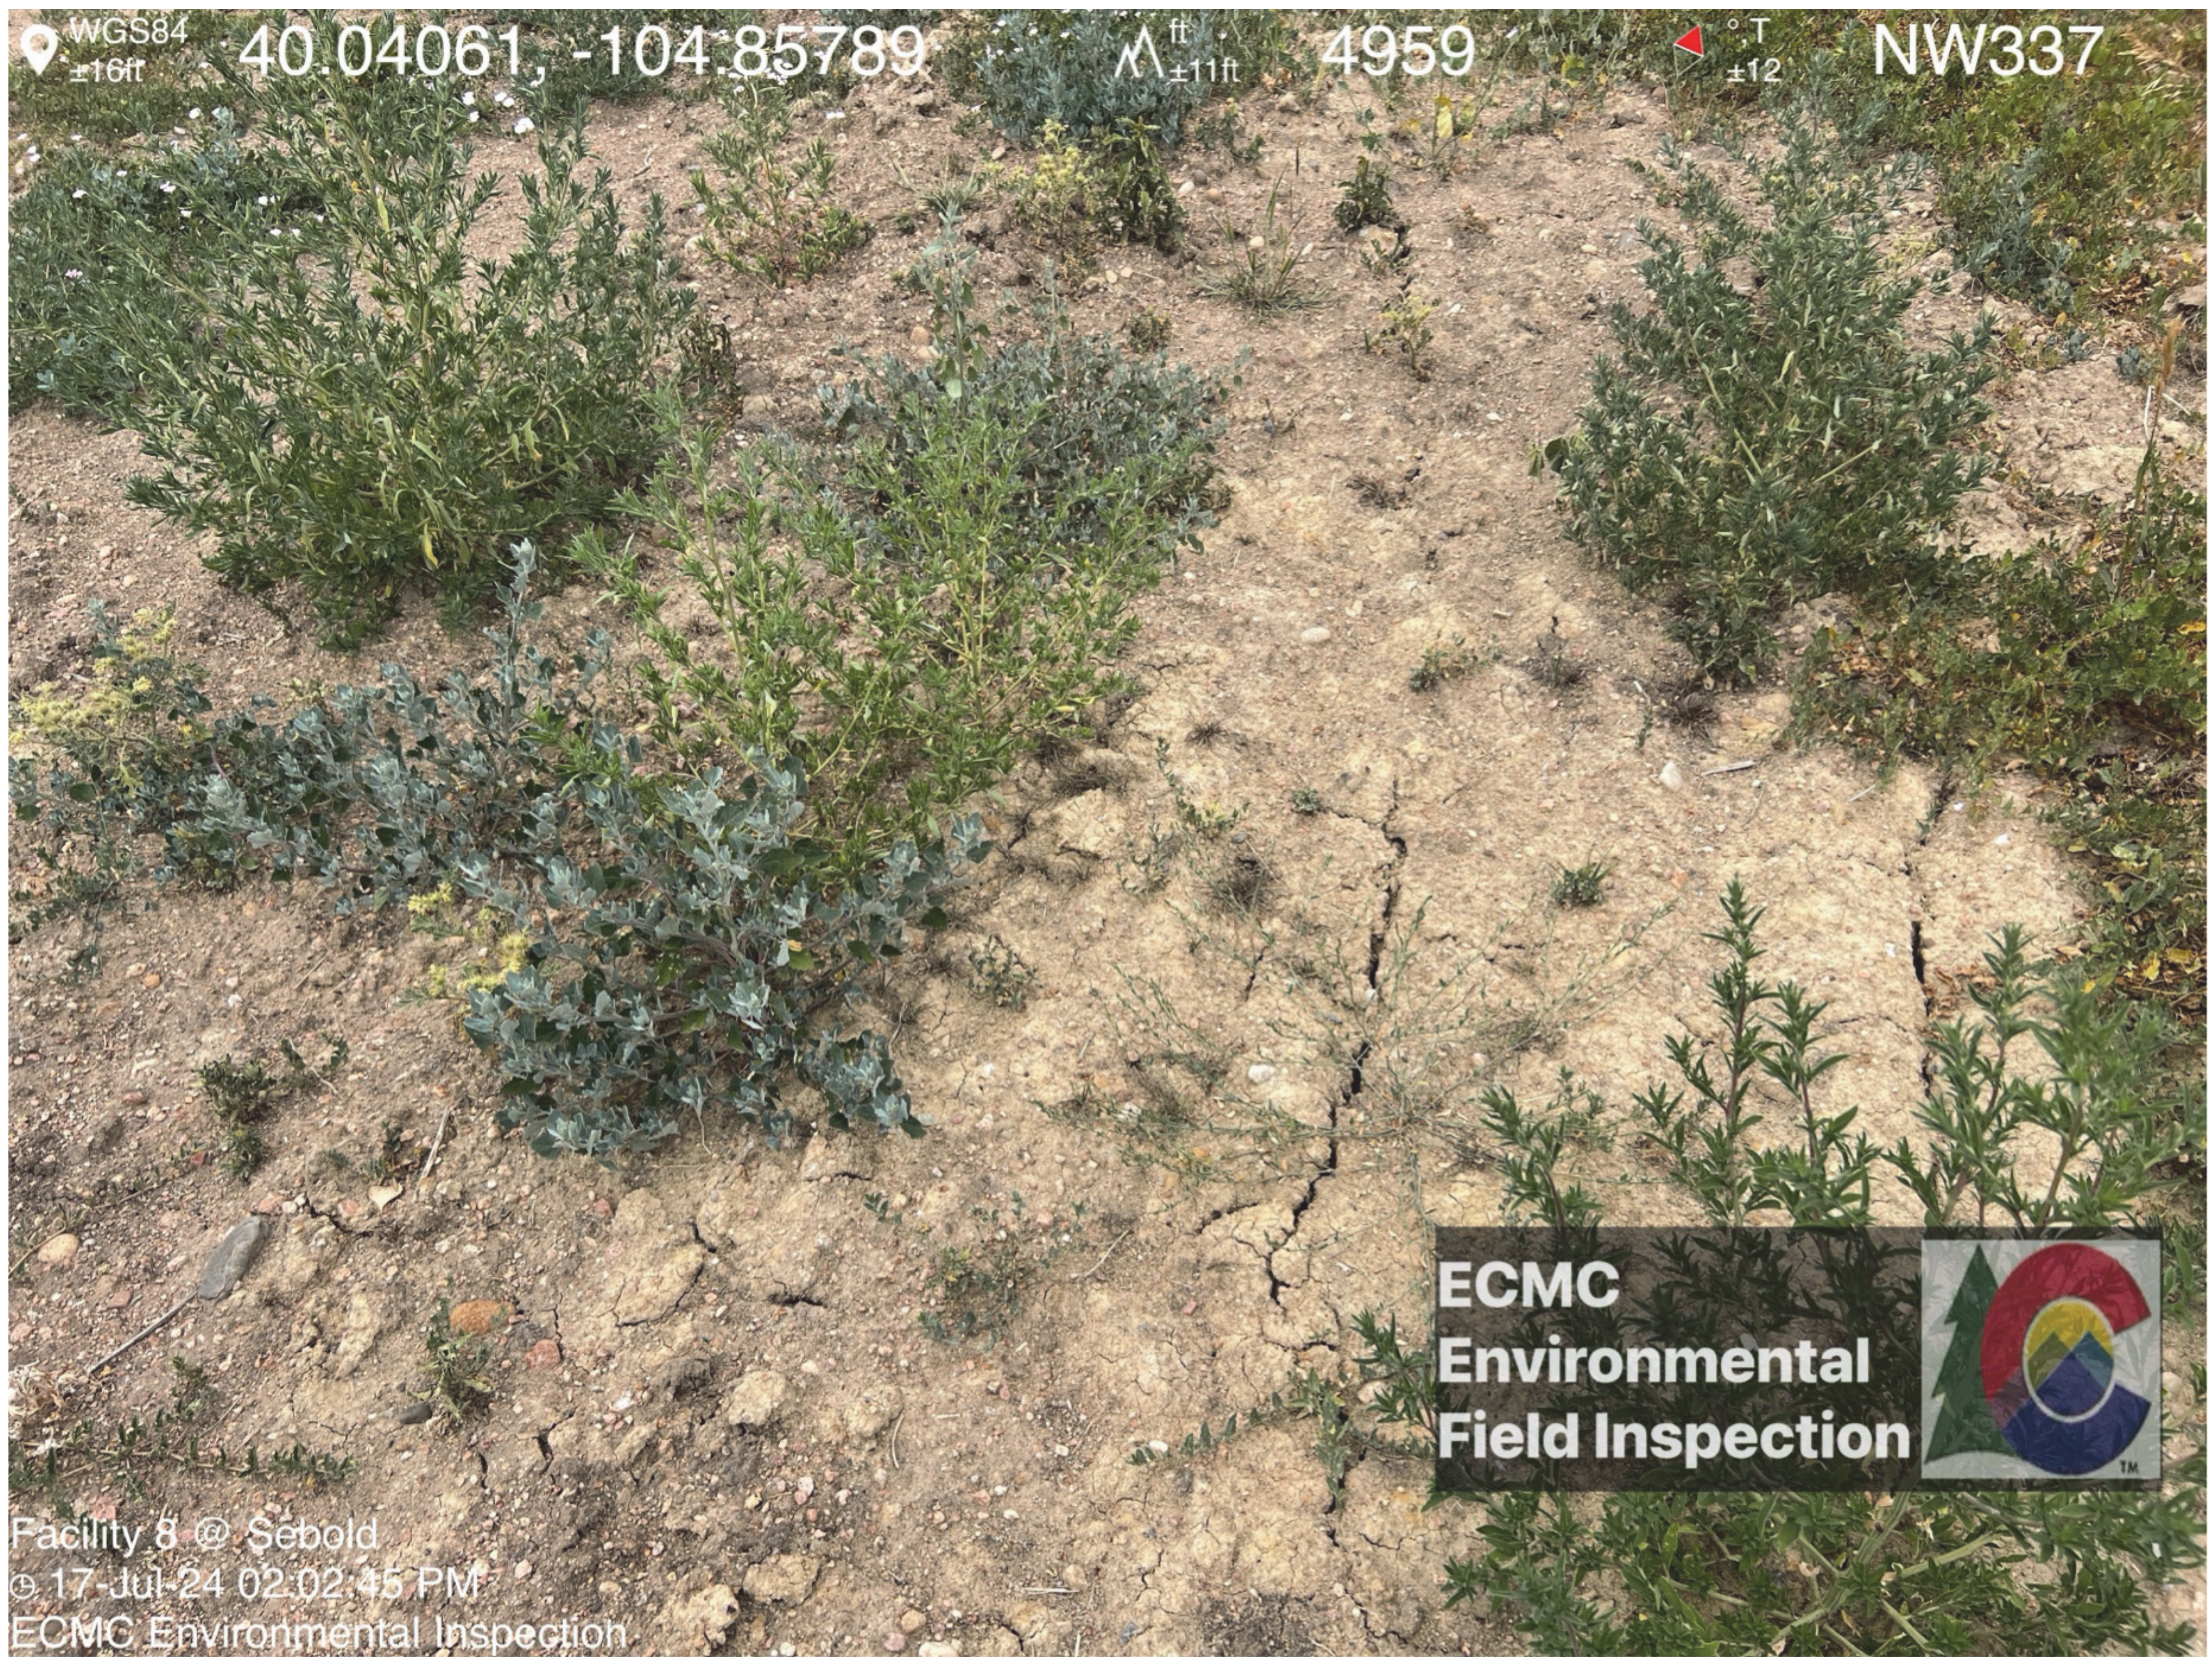
Weeds. Footprint of work area.

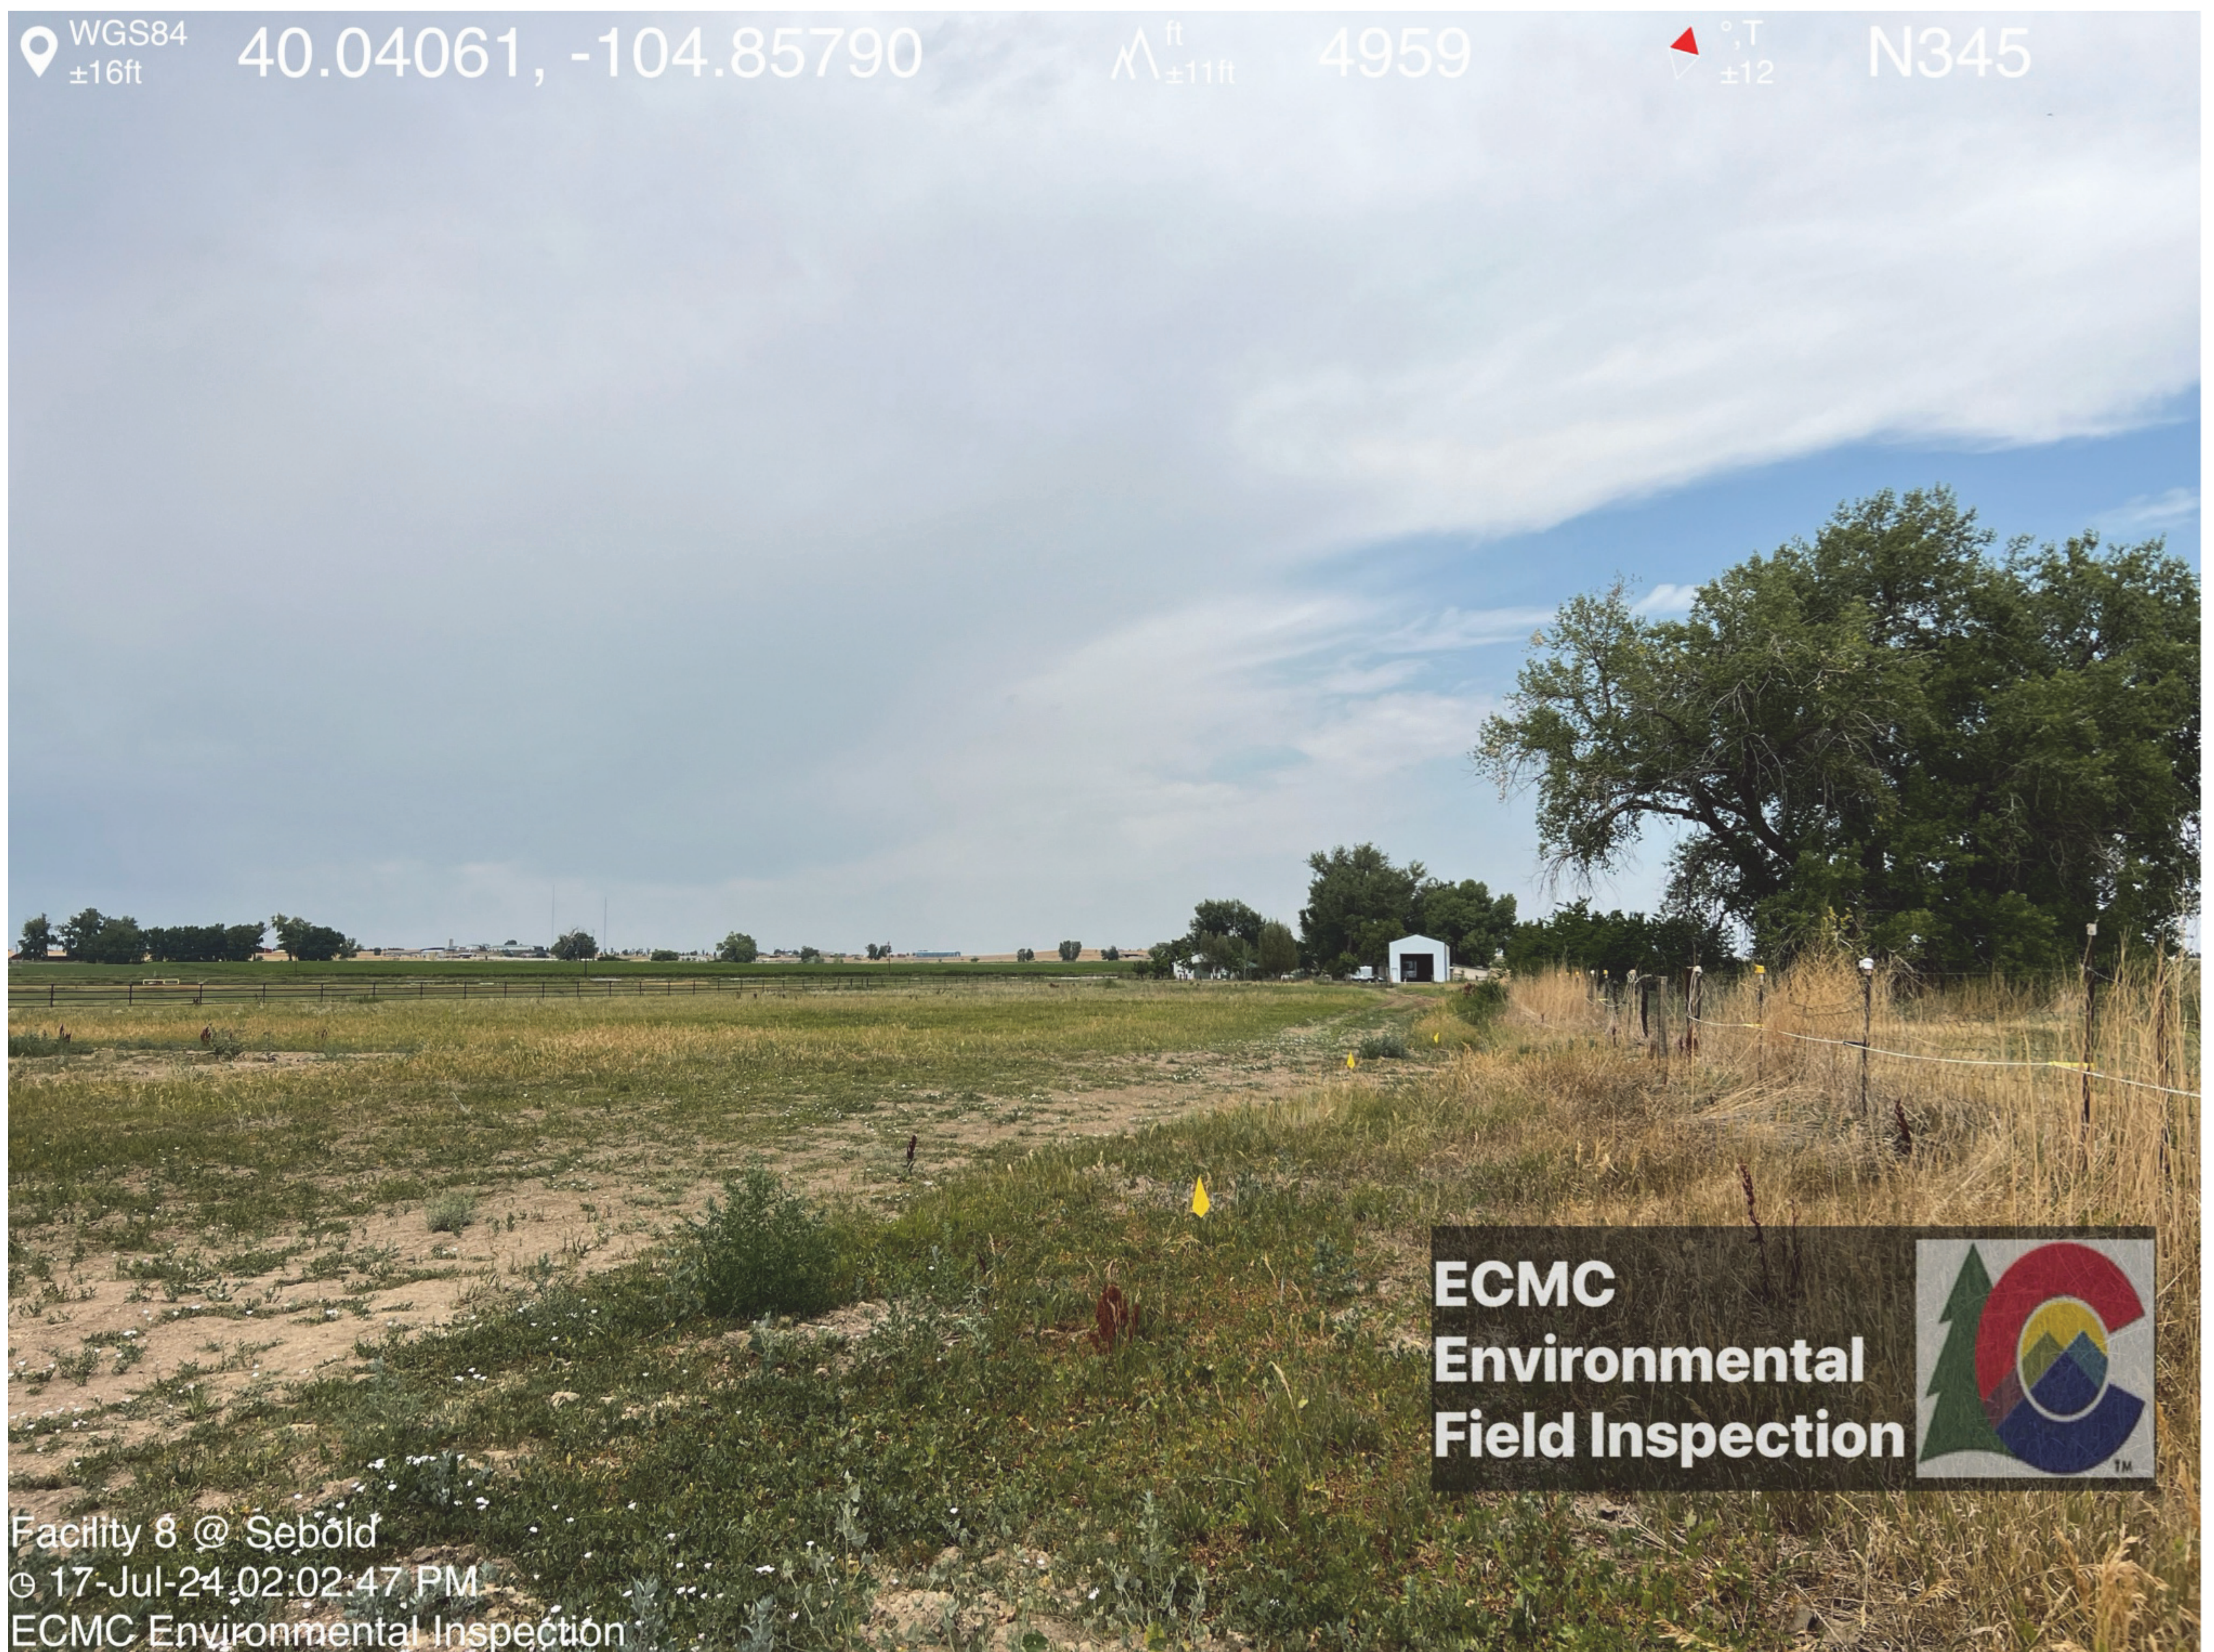
Weeds. Footprint of work area.

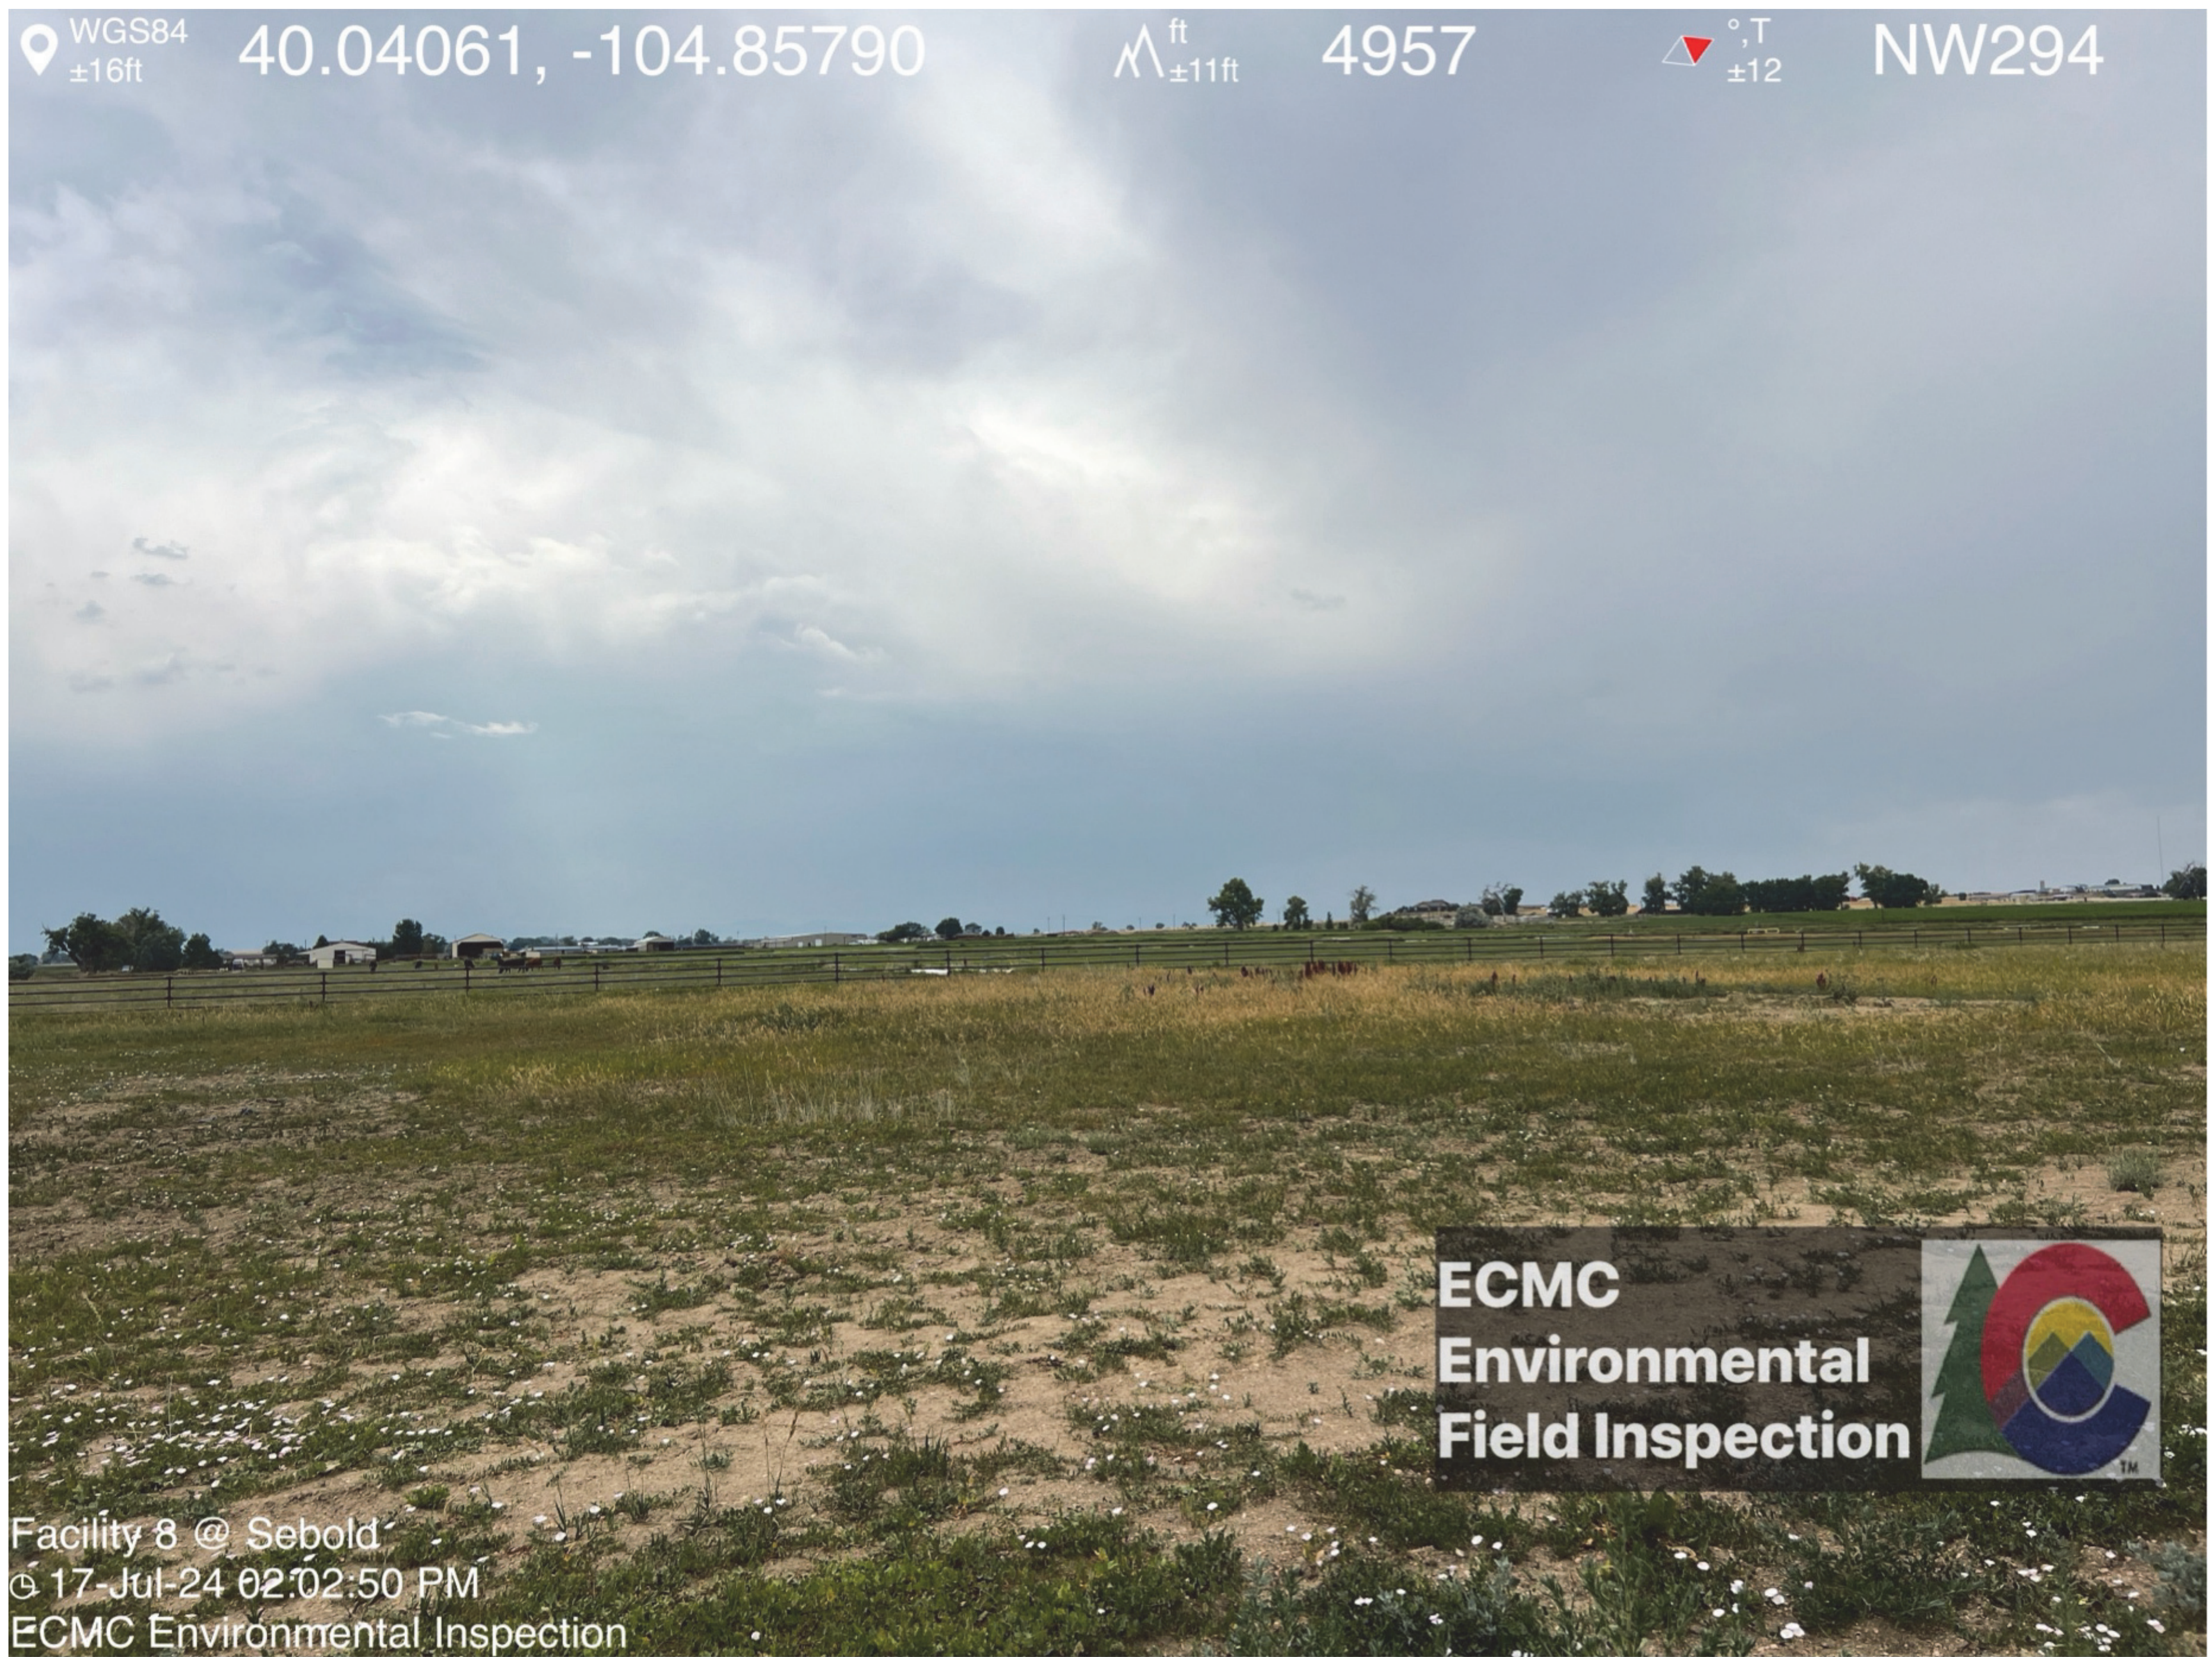
Weeds. Footprint of former work area (staging area/access/excavations/stockpiles).
