**ECMC
Environmental
Field Inspection**

Facility 8 @ Sebold
© 17-Jul-24 02:00:47 PM
ECMC Environmental Inspection
Weeds/Debris/Trash

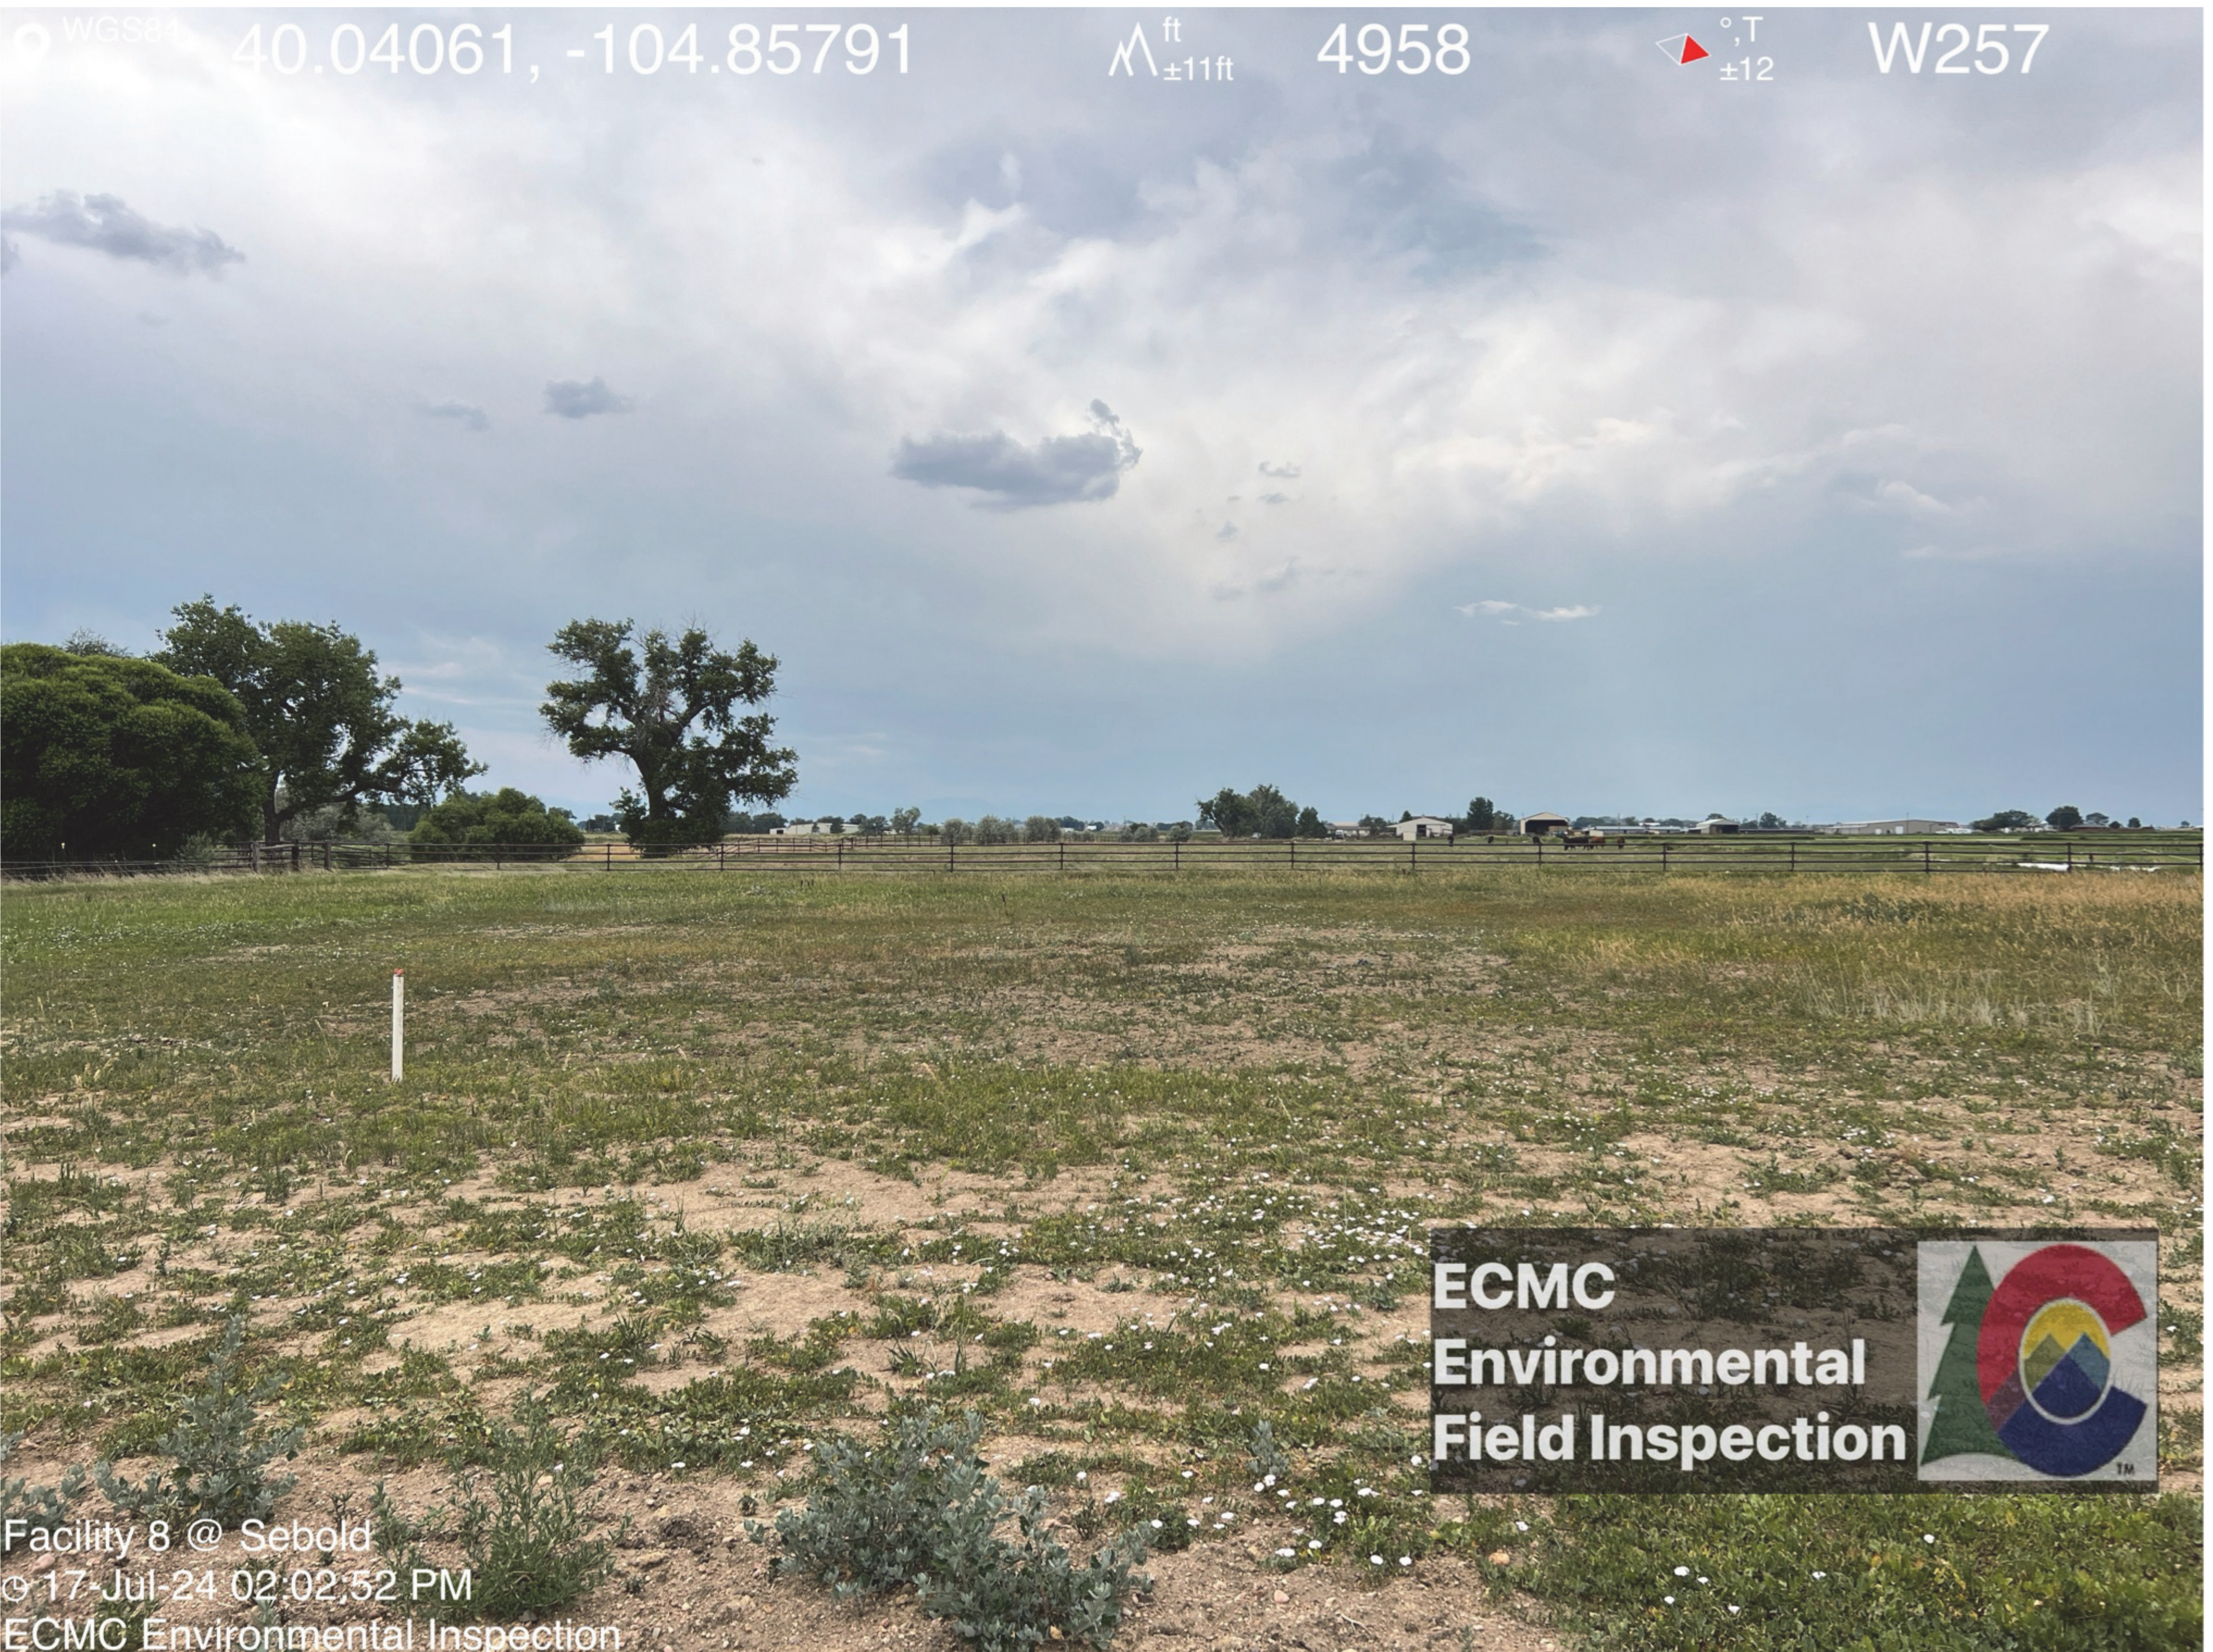
Weeds. Footprint of former work area (staging area/access/excavations/stockpiles).

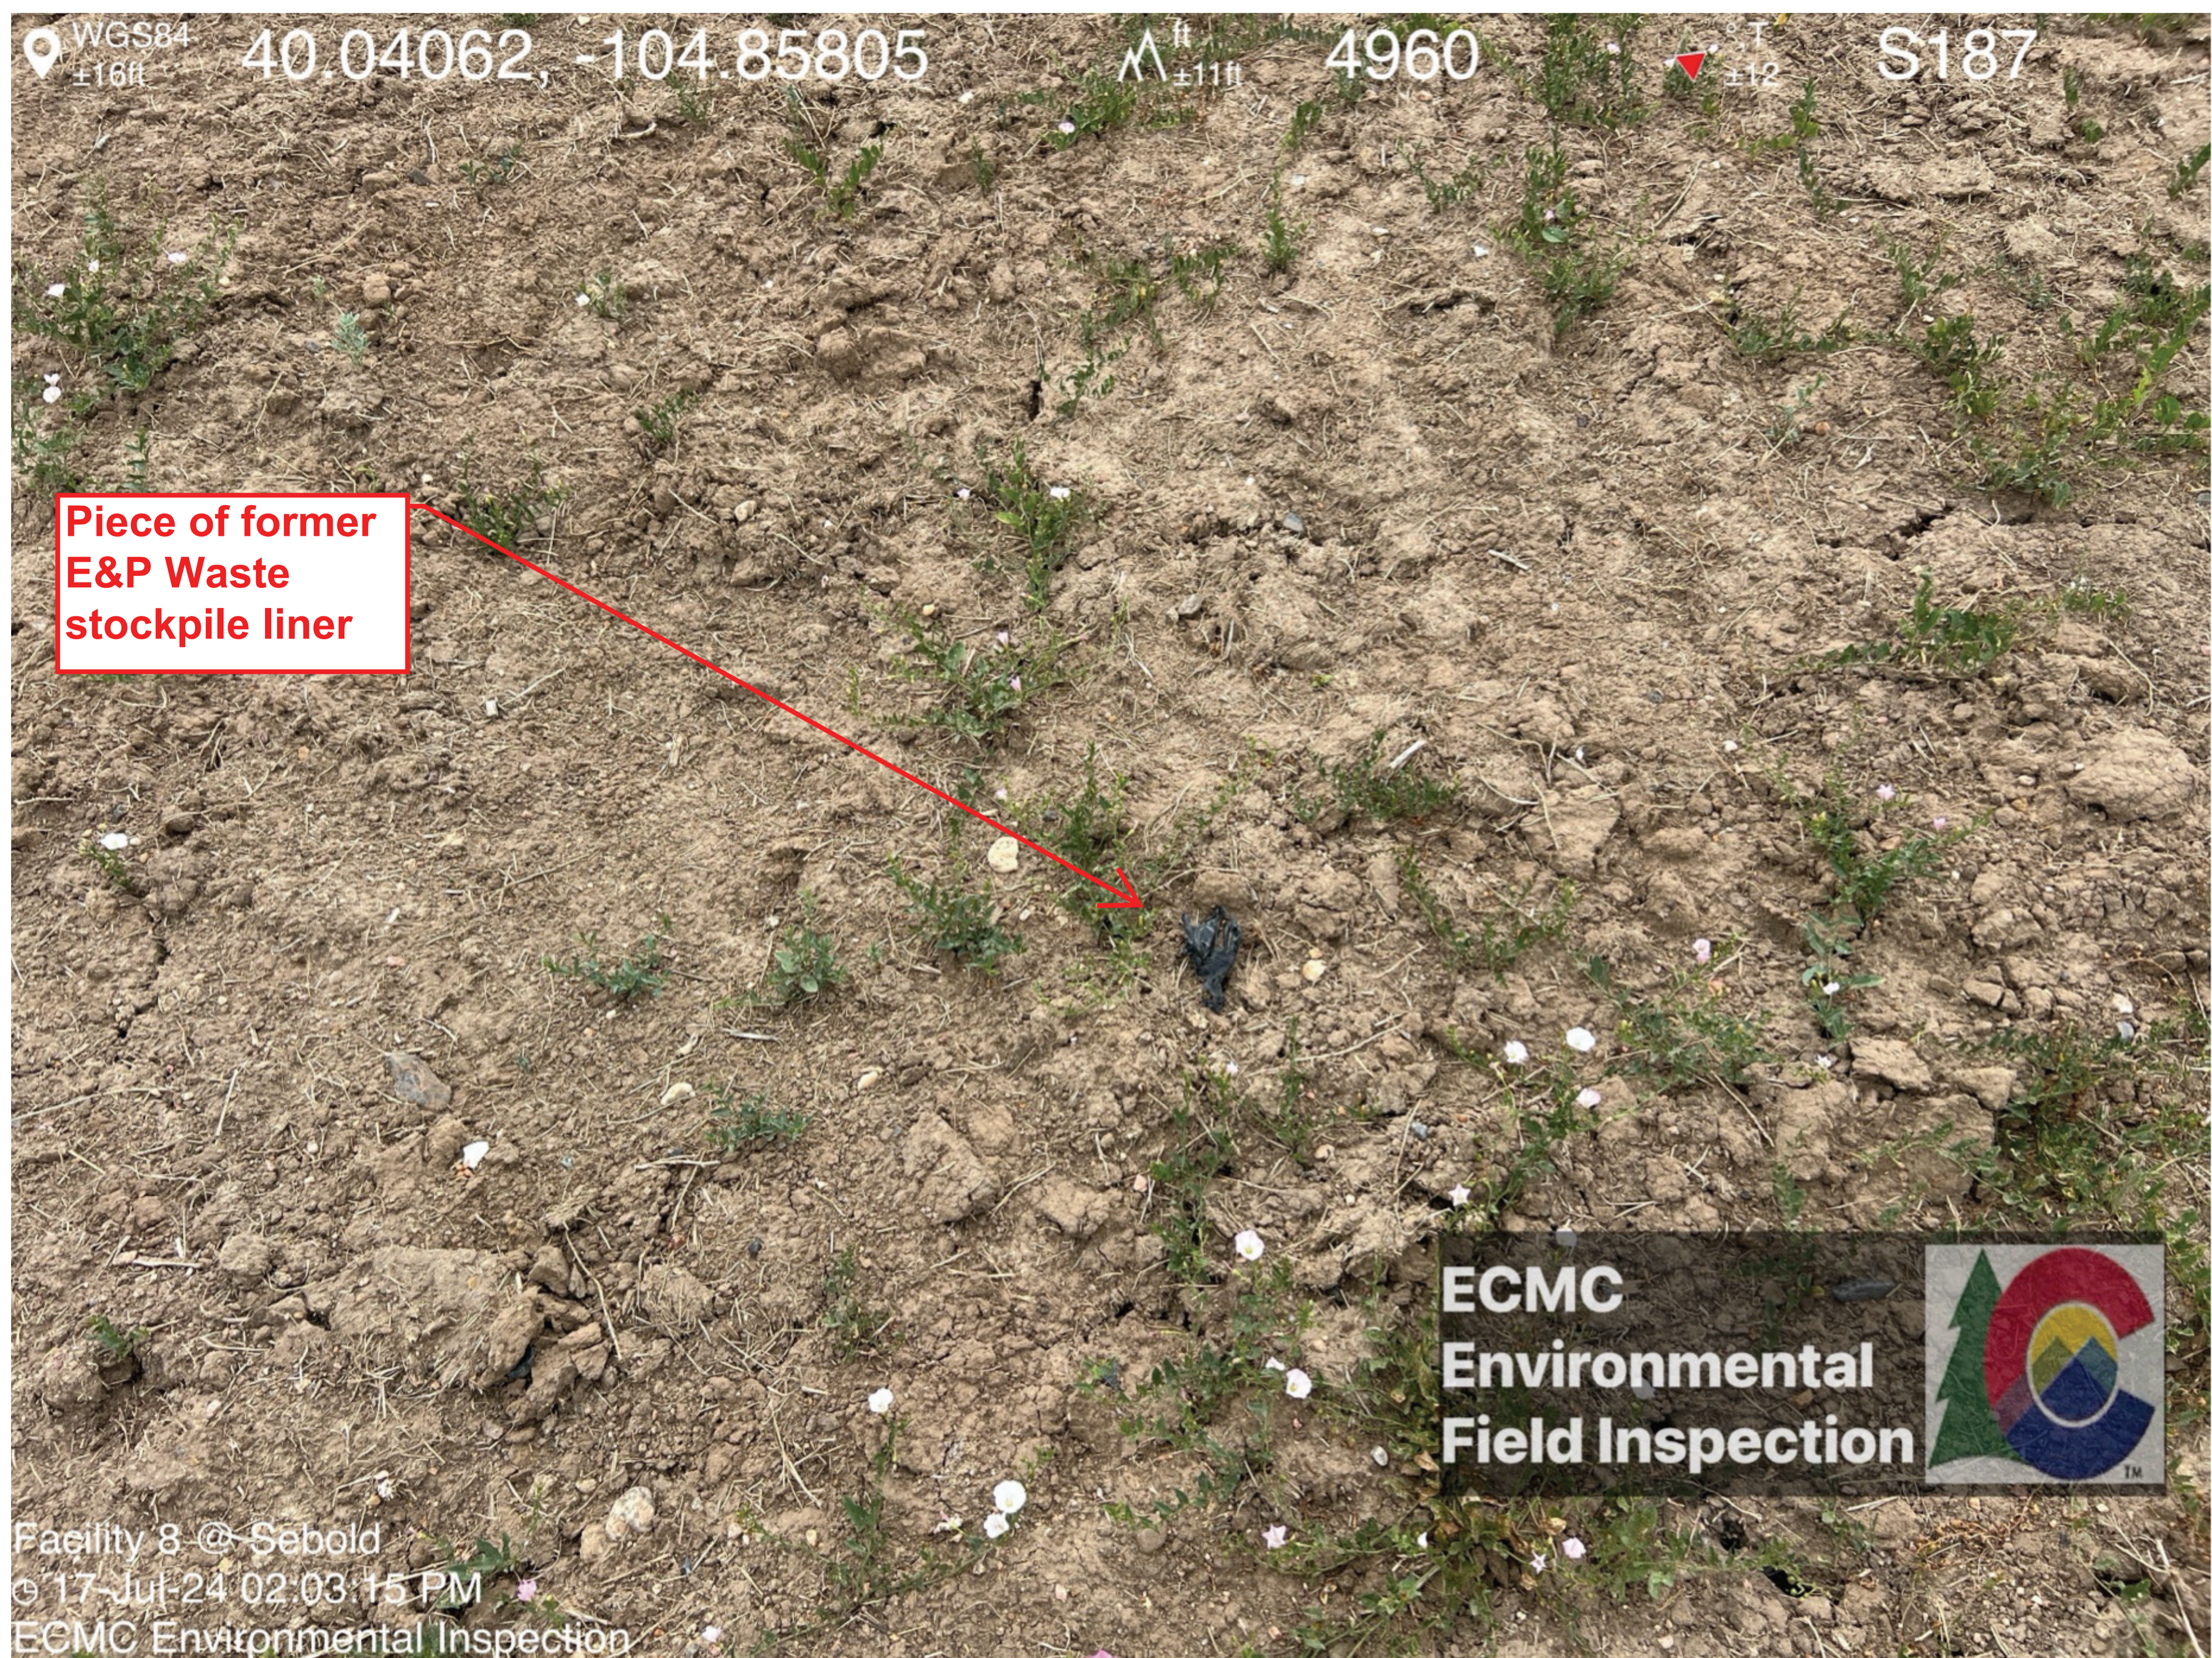
Weeds/Debris/Trash. Footprint of work area/former stockpile. **Pieces of former E&P Waste Stockpile liner** and trash observed throughout work area.

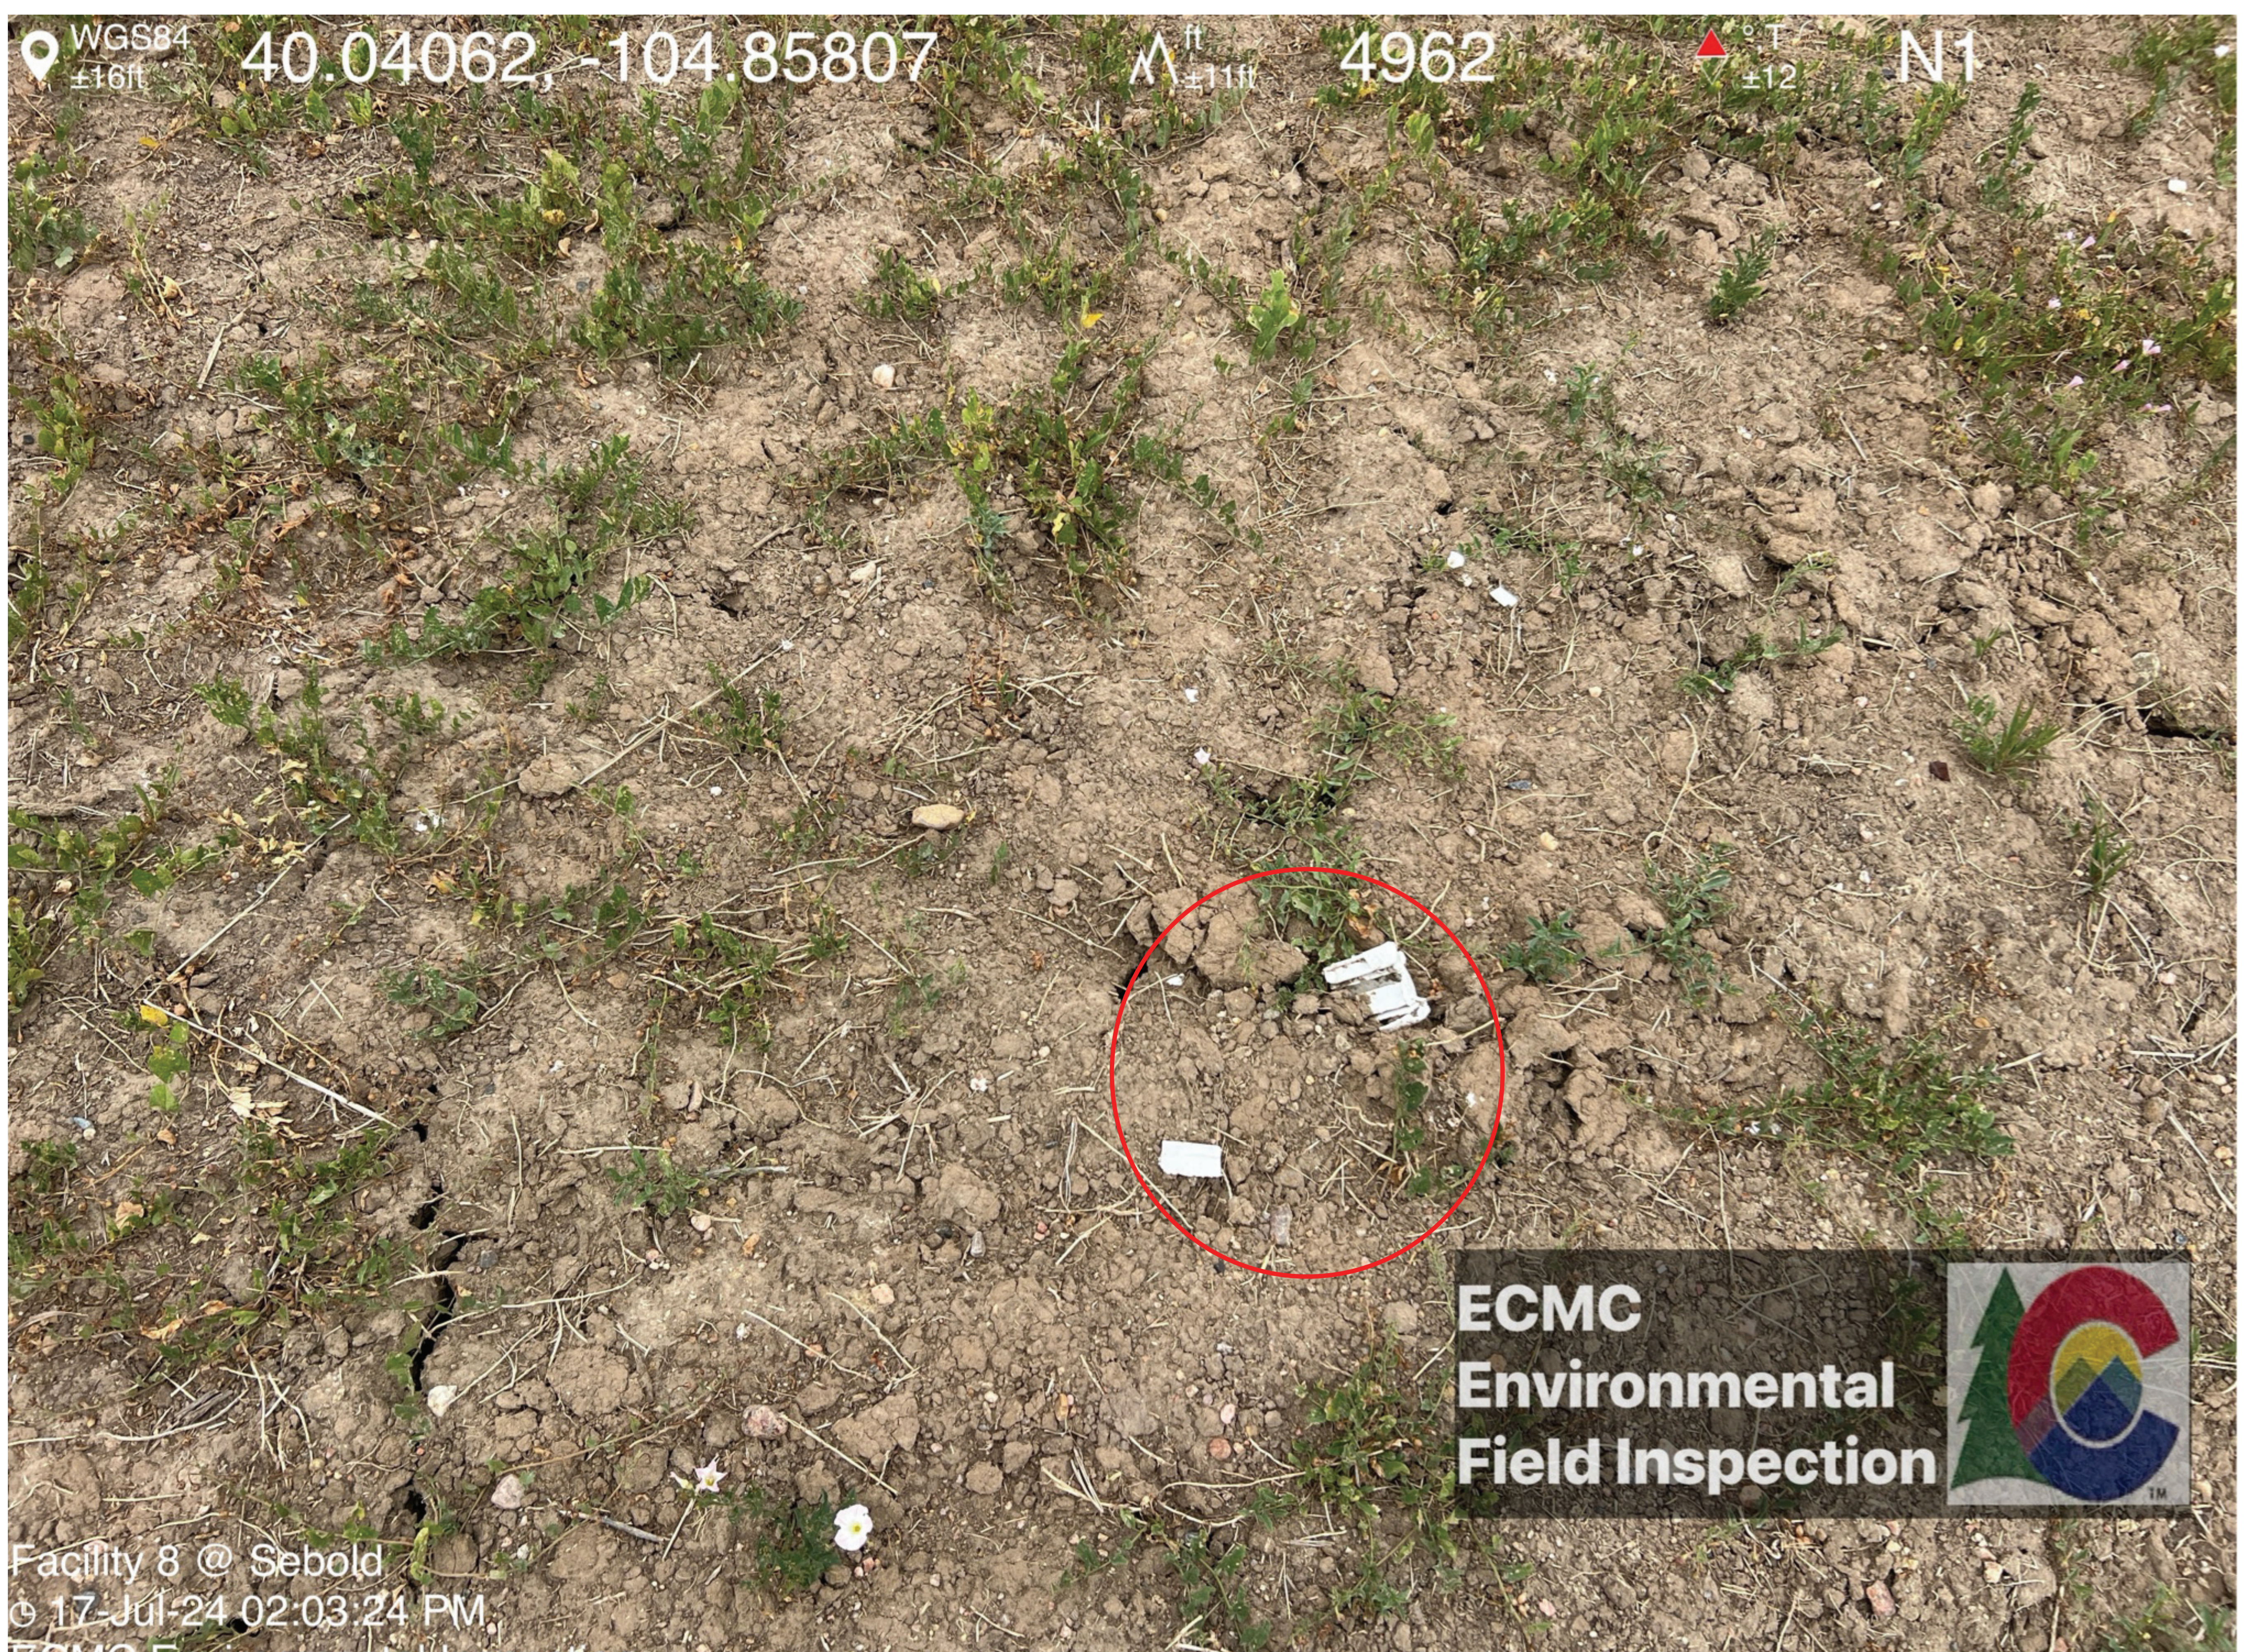
Weeds/Debris/Trash. Footprint of work area/former stockpile. **Trash** observed in work area.

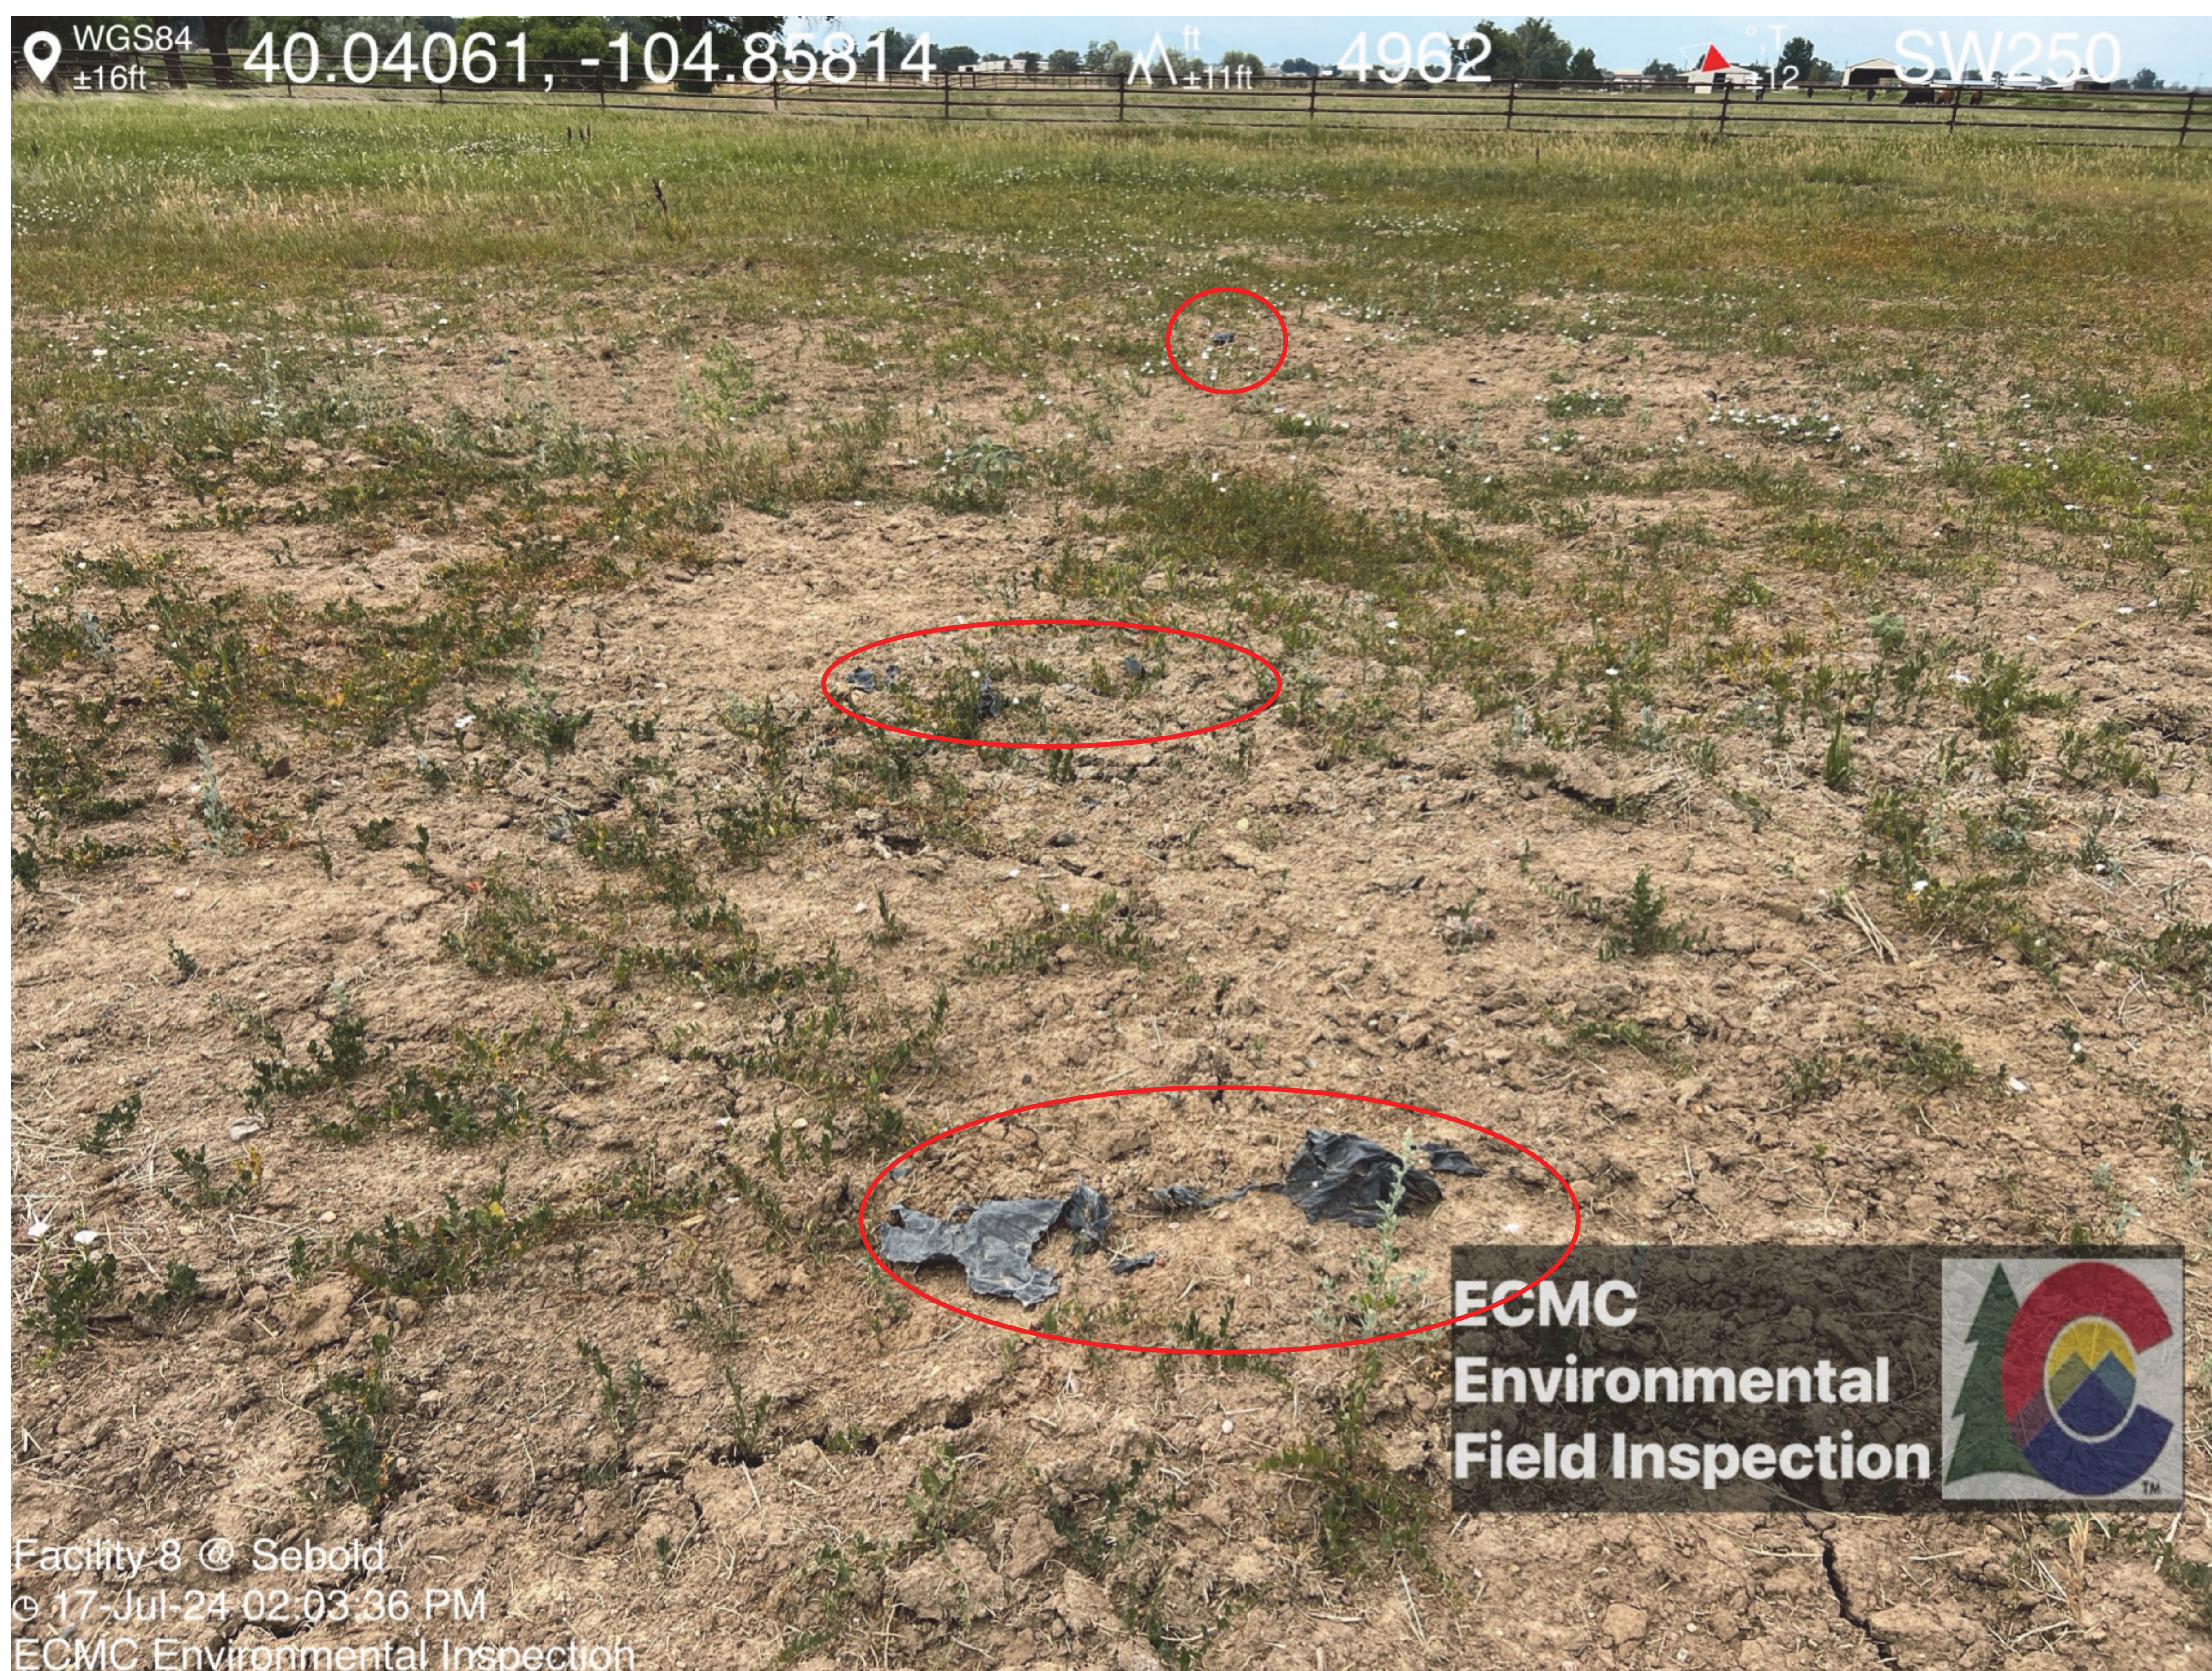
Weeds/Debris/Trash. Footprint of work area/former stockpile. Pieces of former E&P Waste Stockpile liner and trash observed throughout work area.

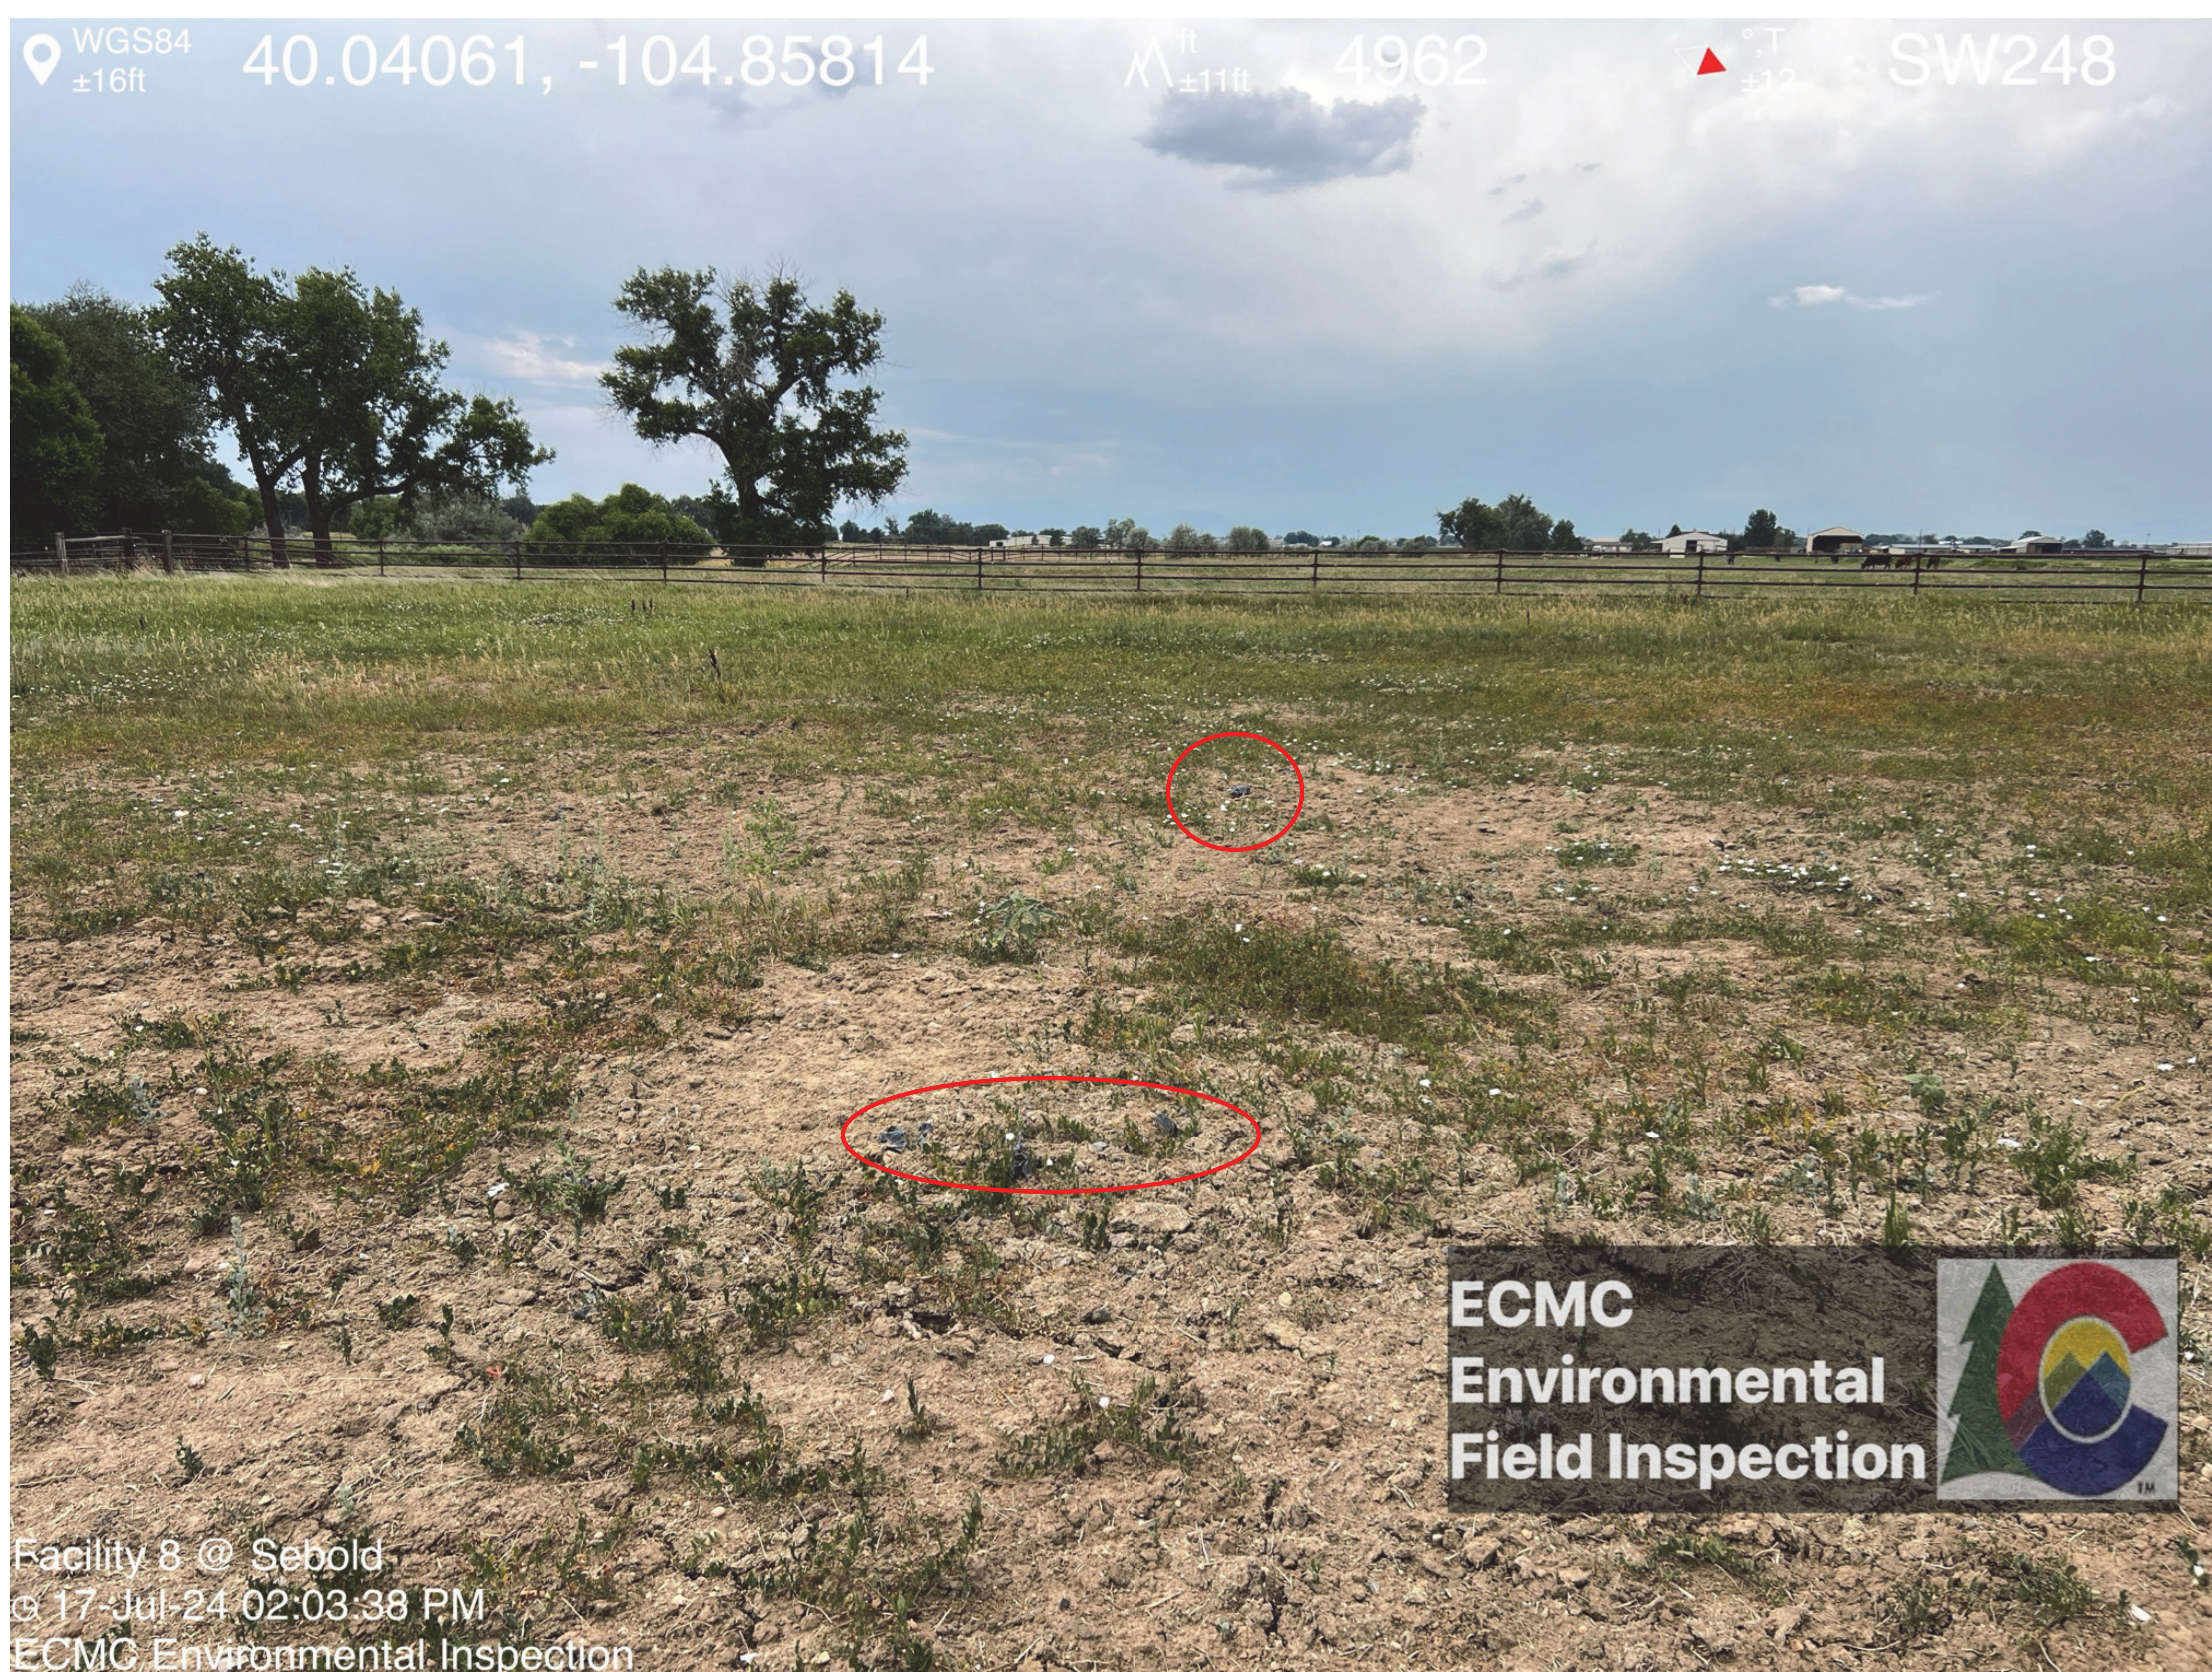
Weeds/Debris/Trash. Footprint of work area/former stockpile. Pieces of former E&P Waste Stockpile liner.

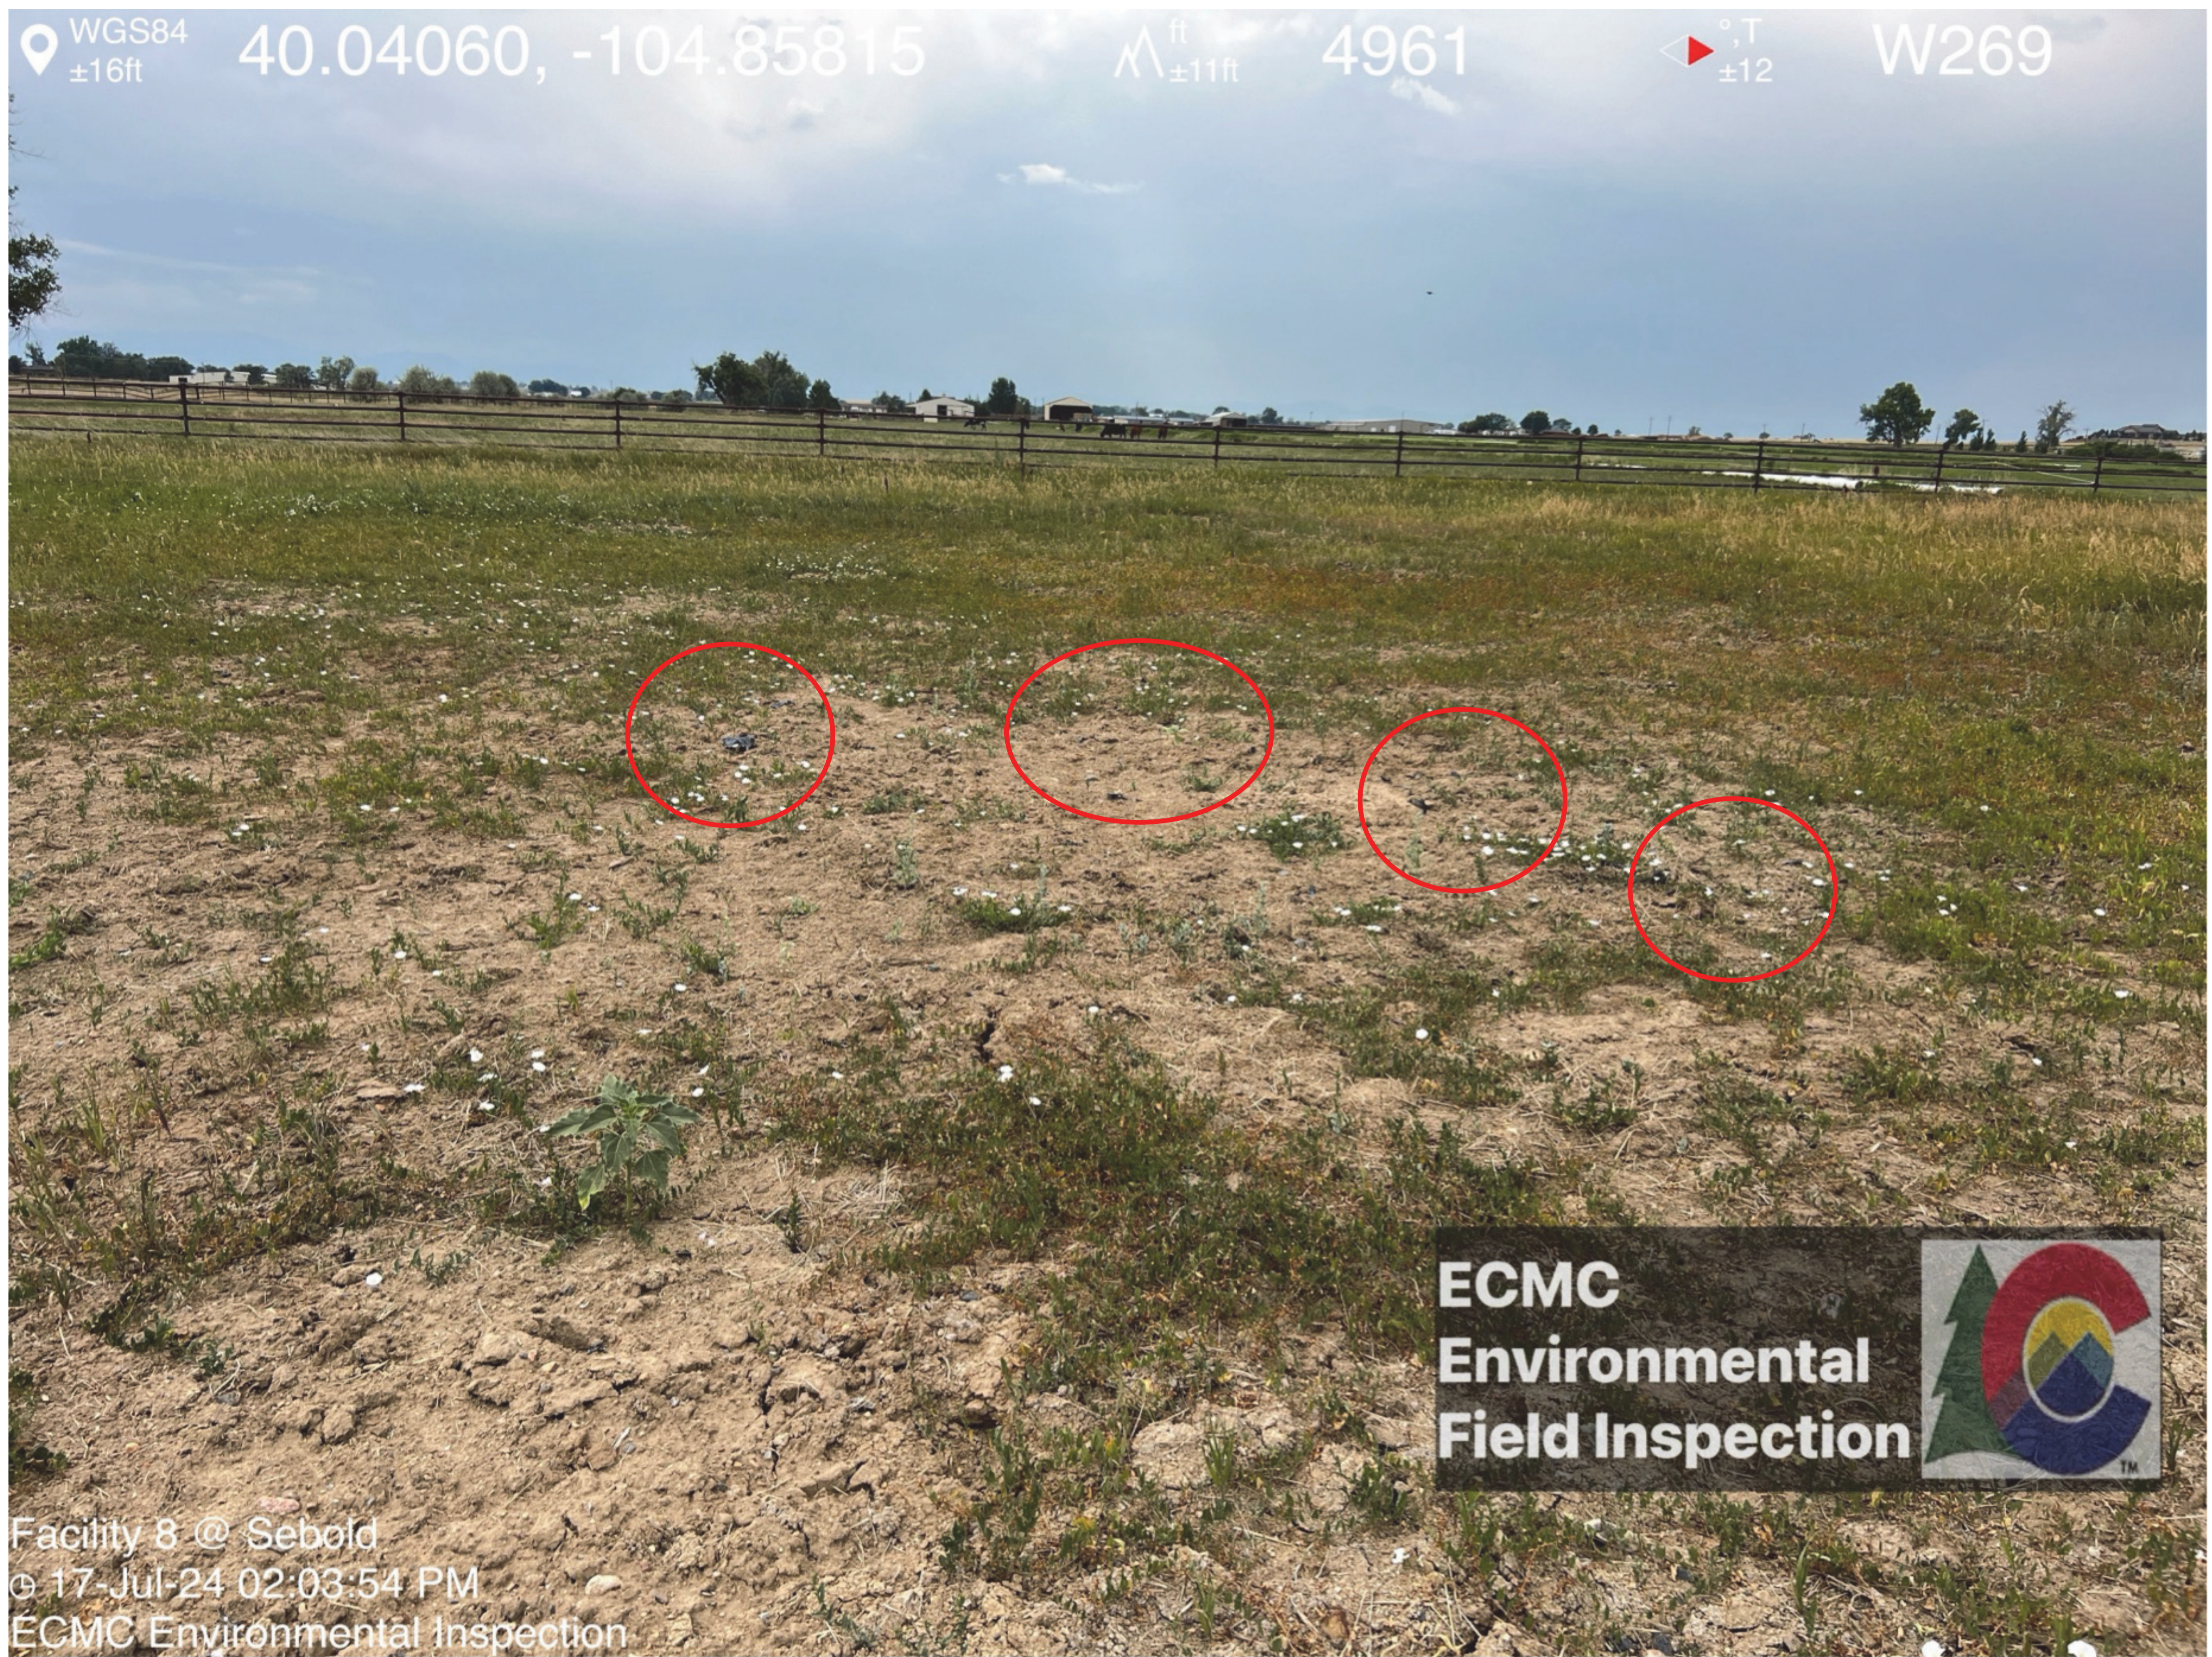
Weeds/Debris/Trash. Footprint of work area/former stockpile. Pieces of former E&P Waste Stockpile liner and trash observed throughout work area.
