**ECMC
Environmental
Field Inspection**

Facility 8 @ Sebold
© 17-Jul-24 02:00:47 PM
ECMC Environmental Inspection
Weeds/Debris/Trash

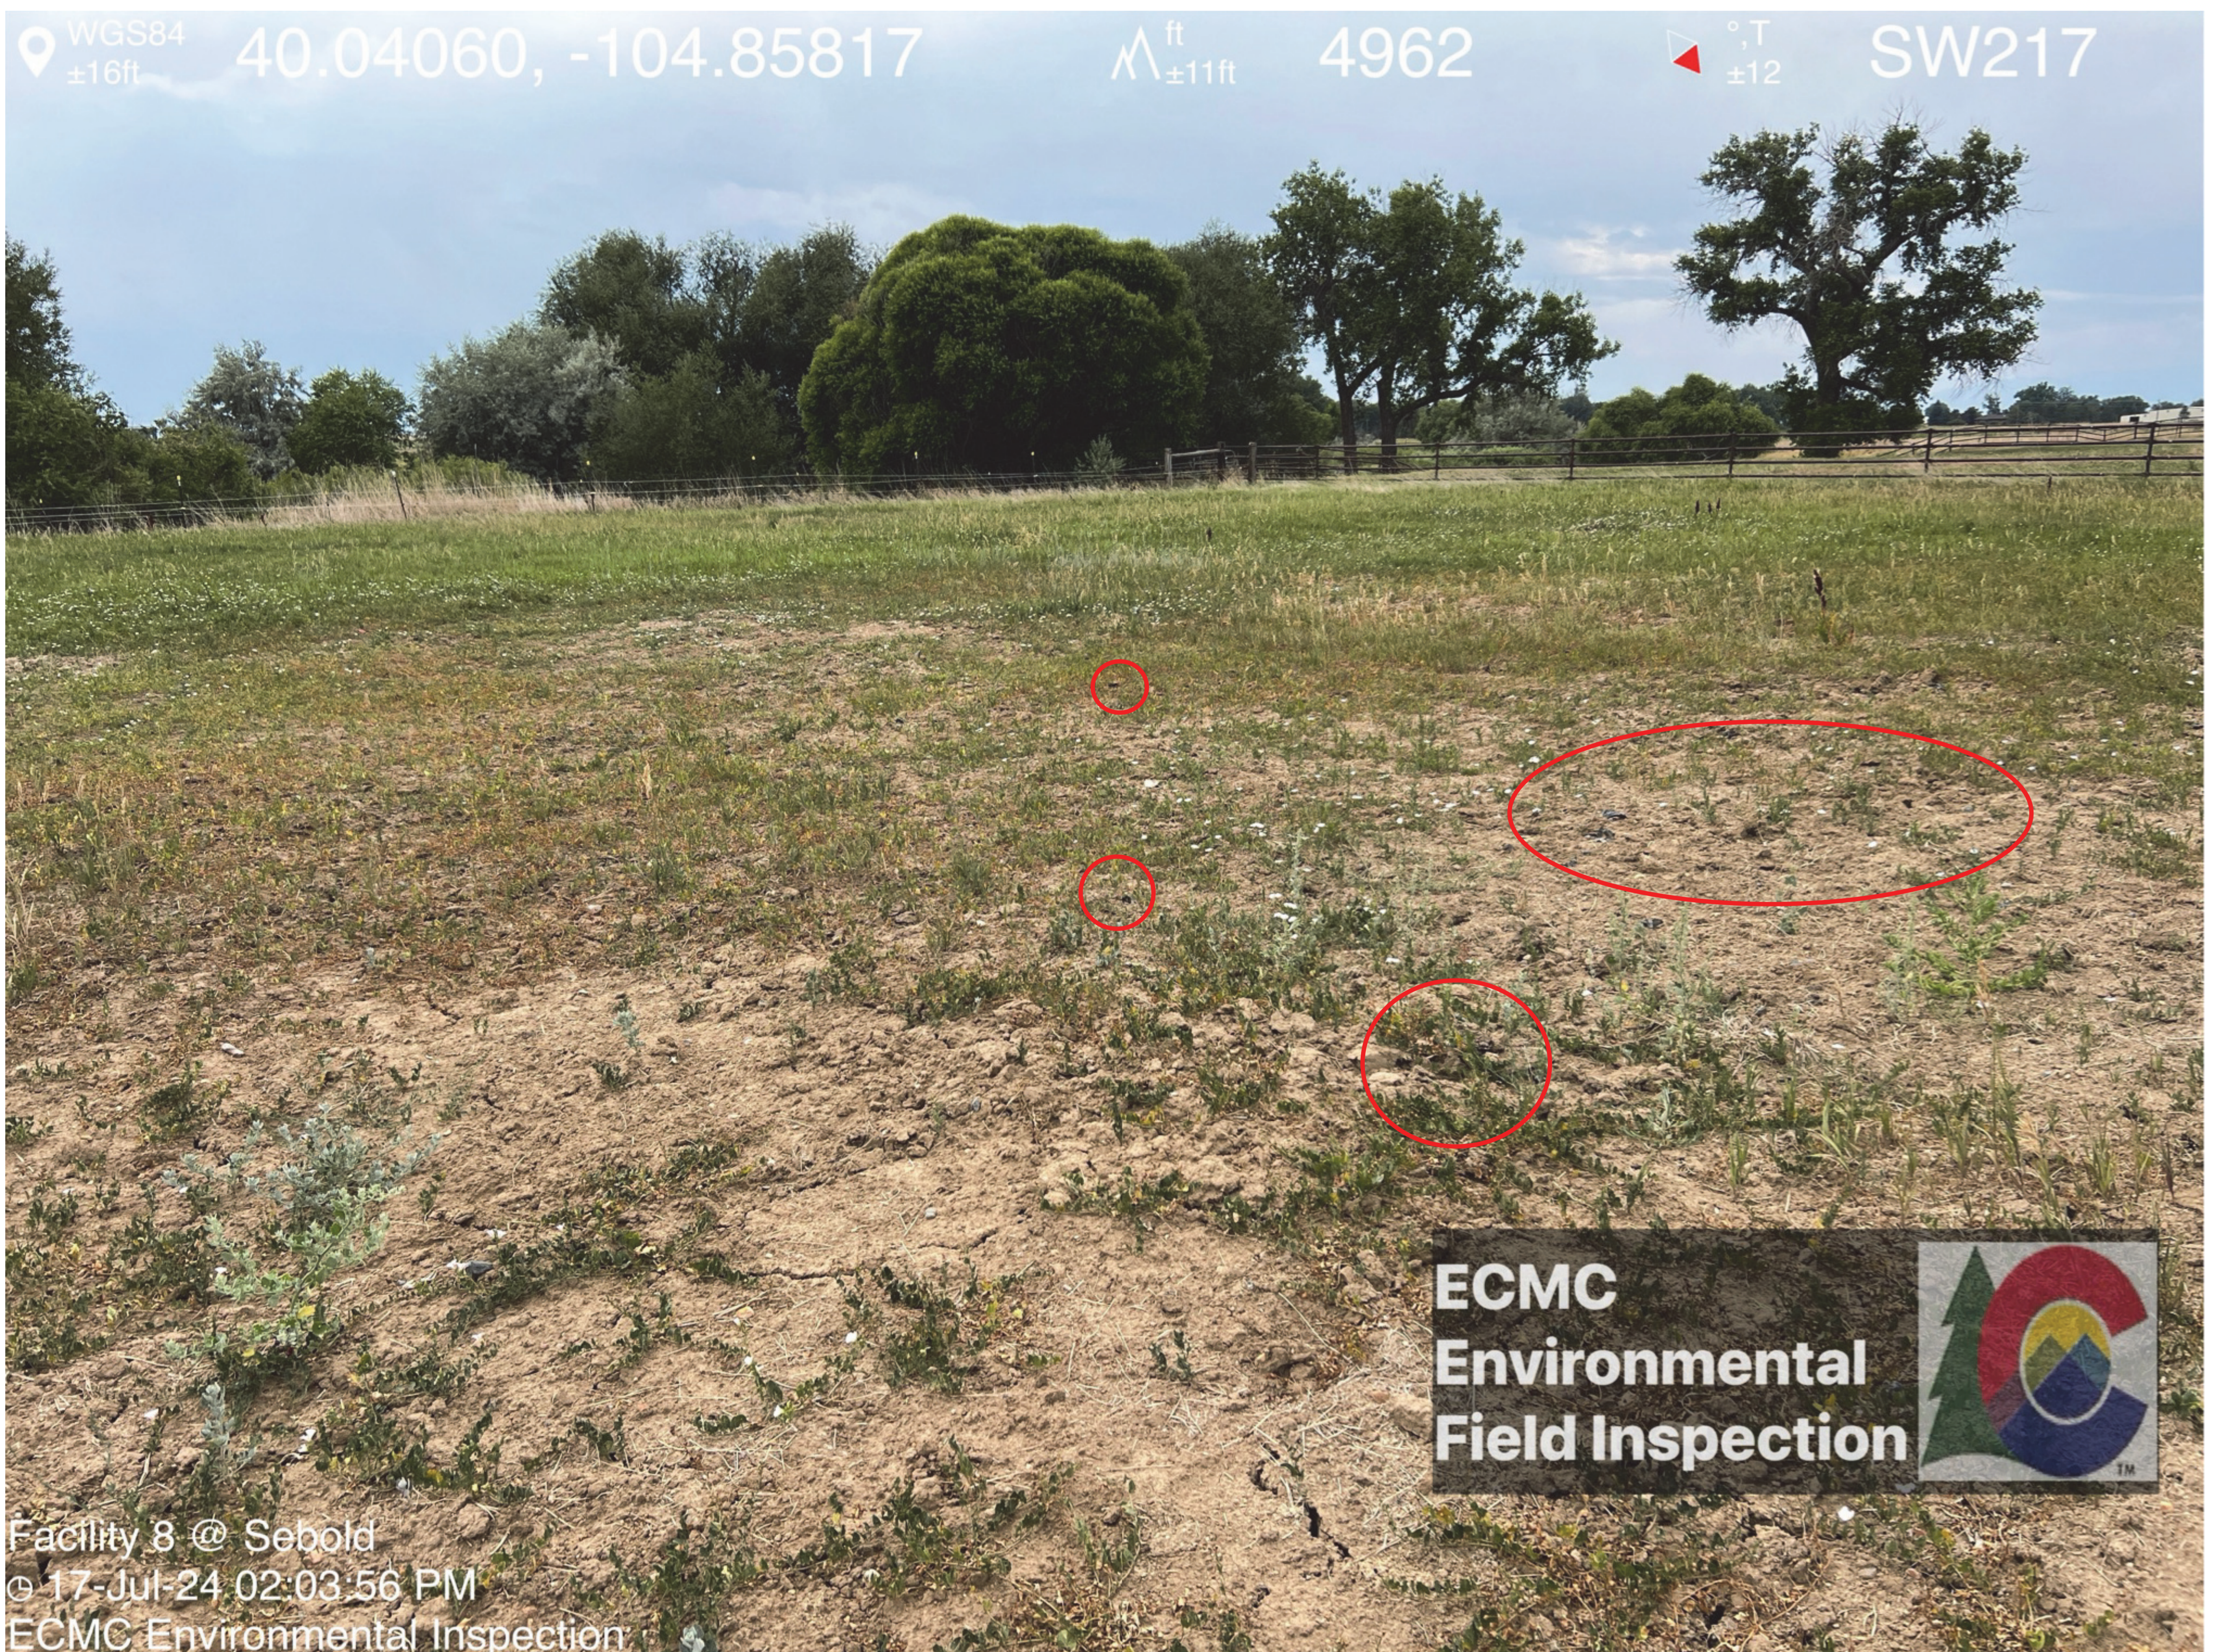
Weeds/Debris/Trash. Footprint of work area/former stockpile. Pieces of former E&P Waste Stockpile liner.

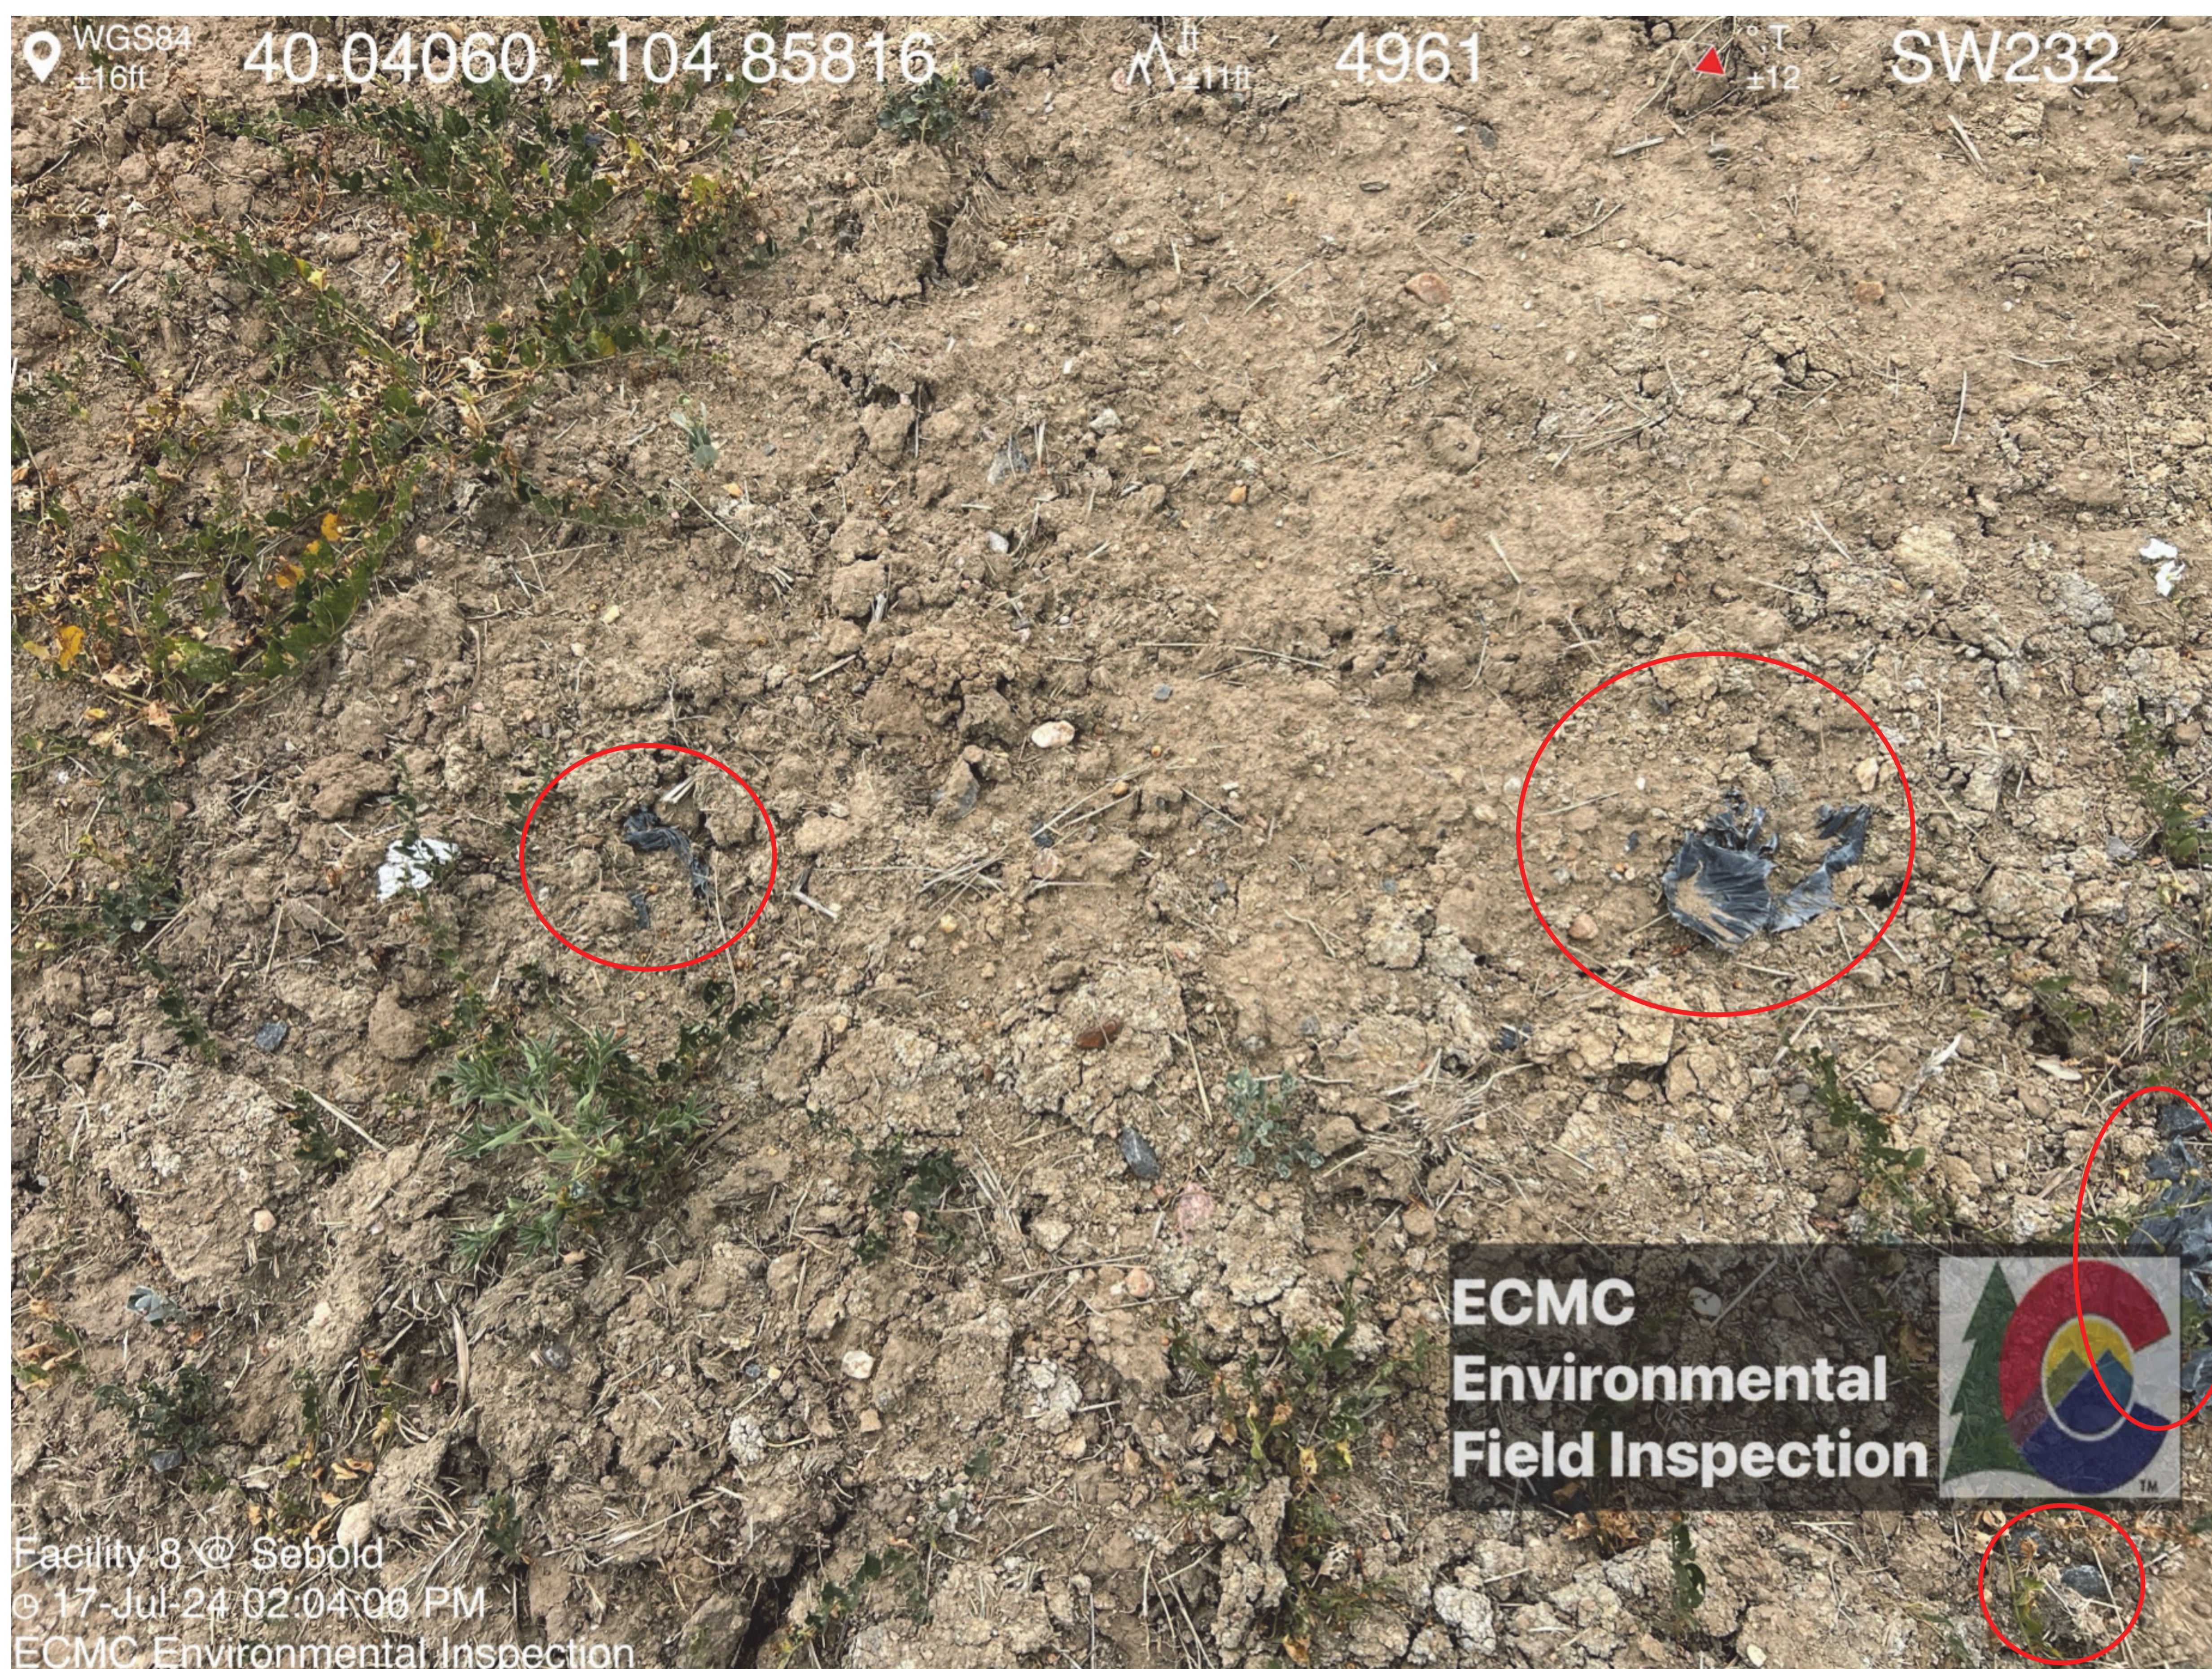
Weeds/Debris/Trash. Footprint of work area/former stockpile. Pieces of former E&P Waste Stockpile liner and trash observed throughout work area.

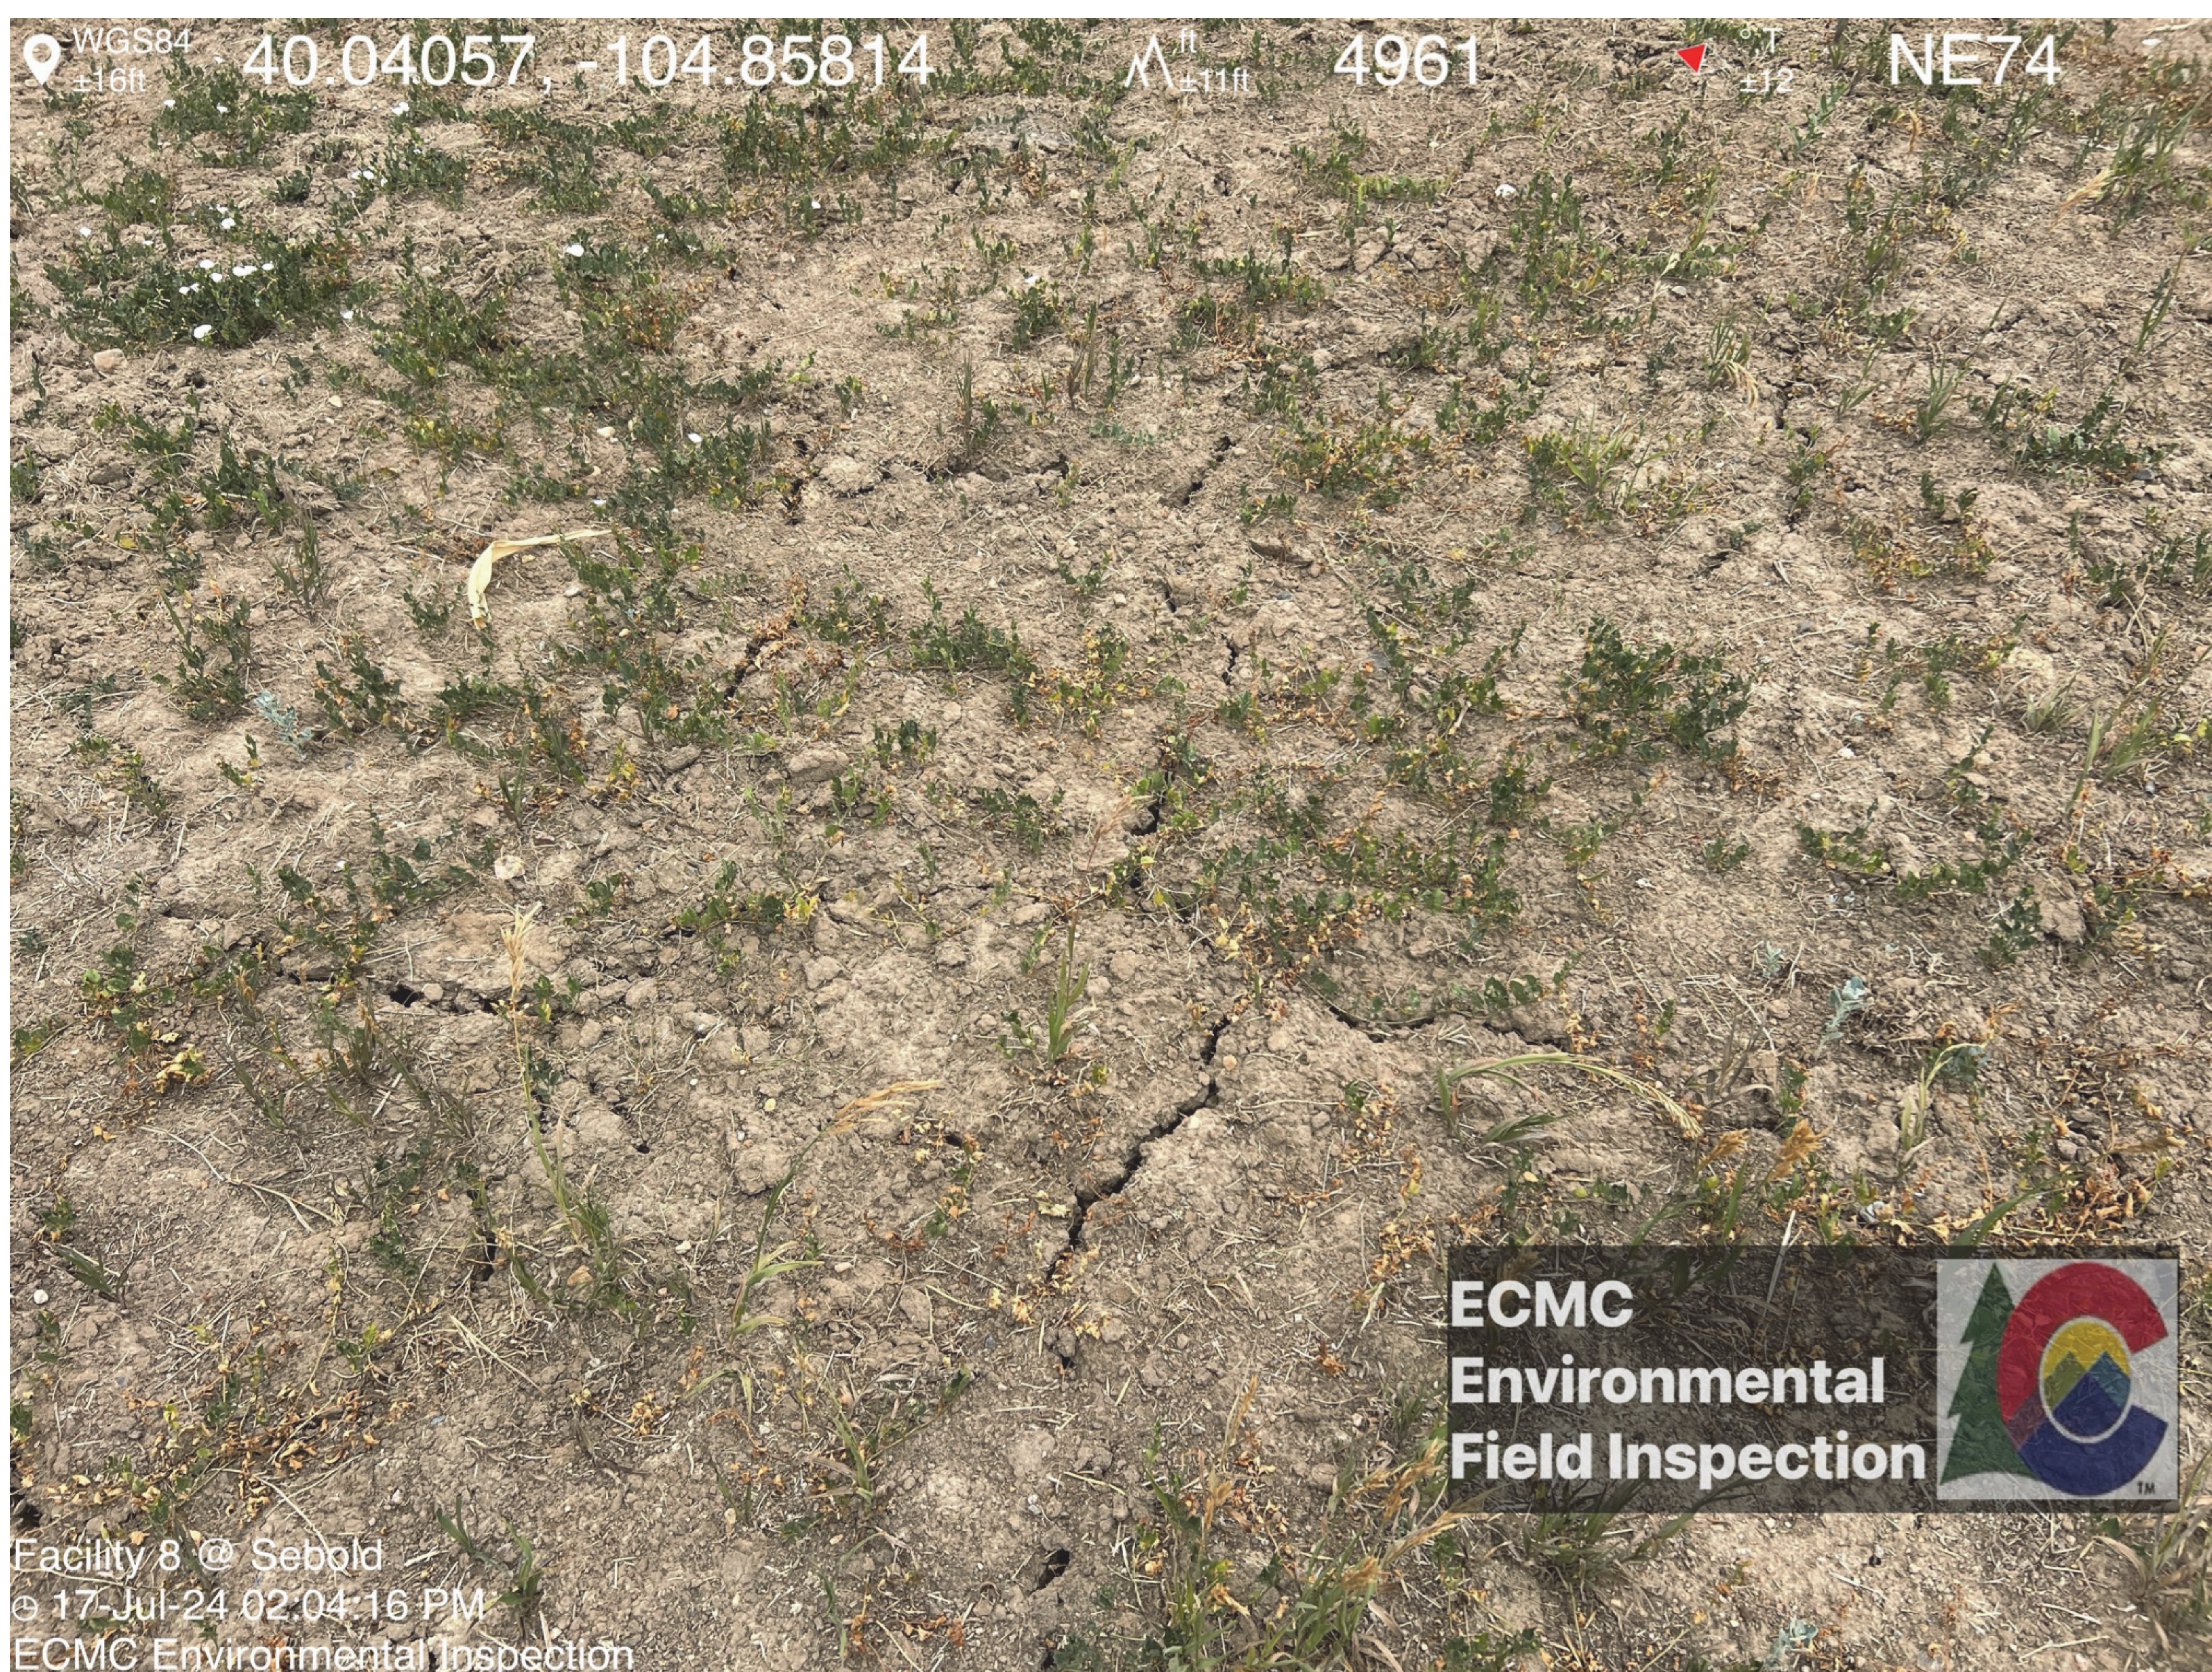
Weeds. Footprint of former work area (staging area/access/excavations/stockpiles).

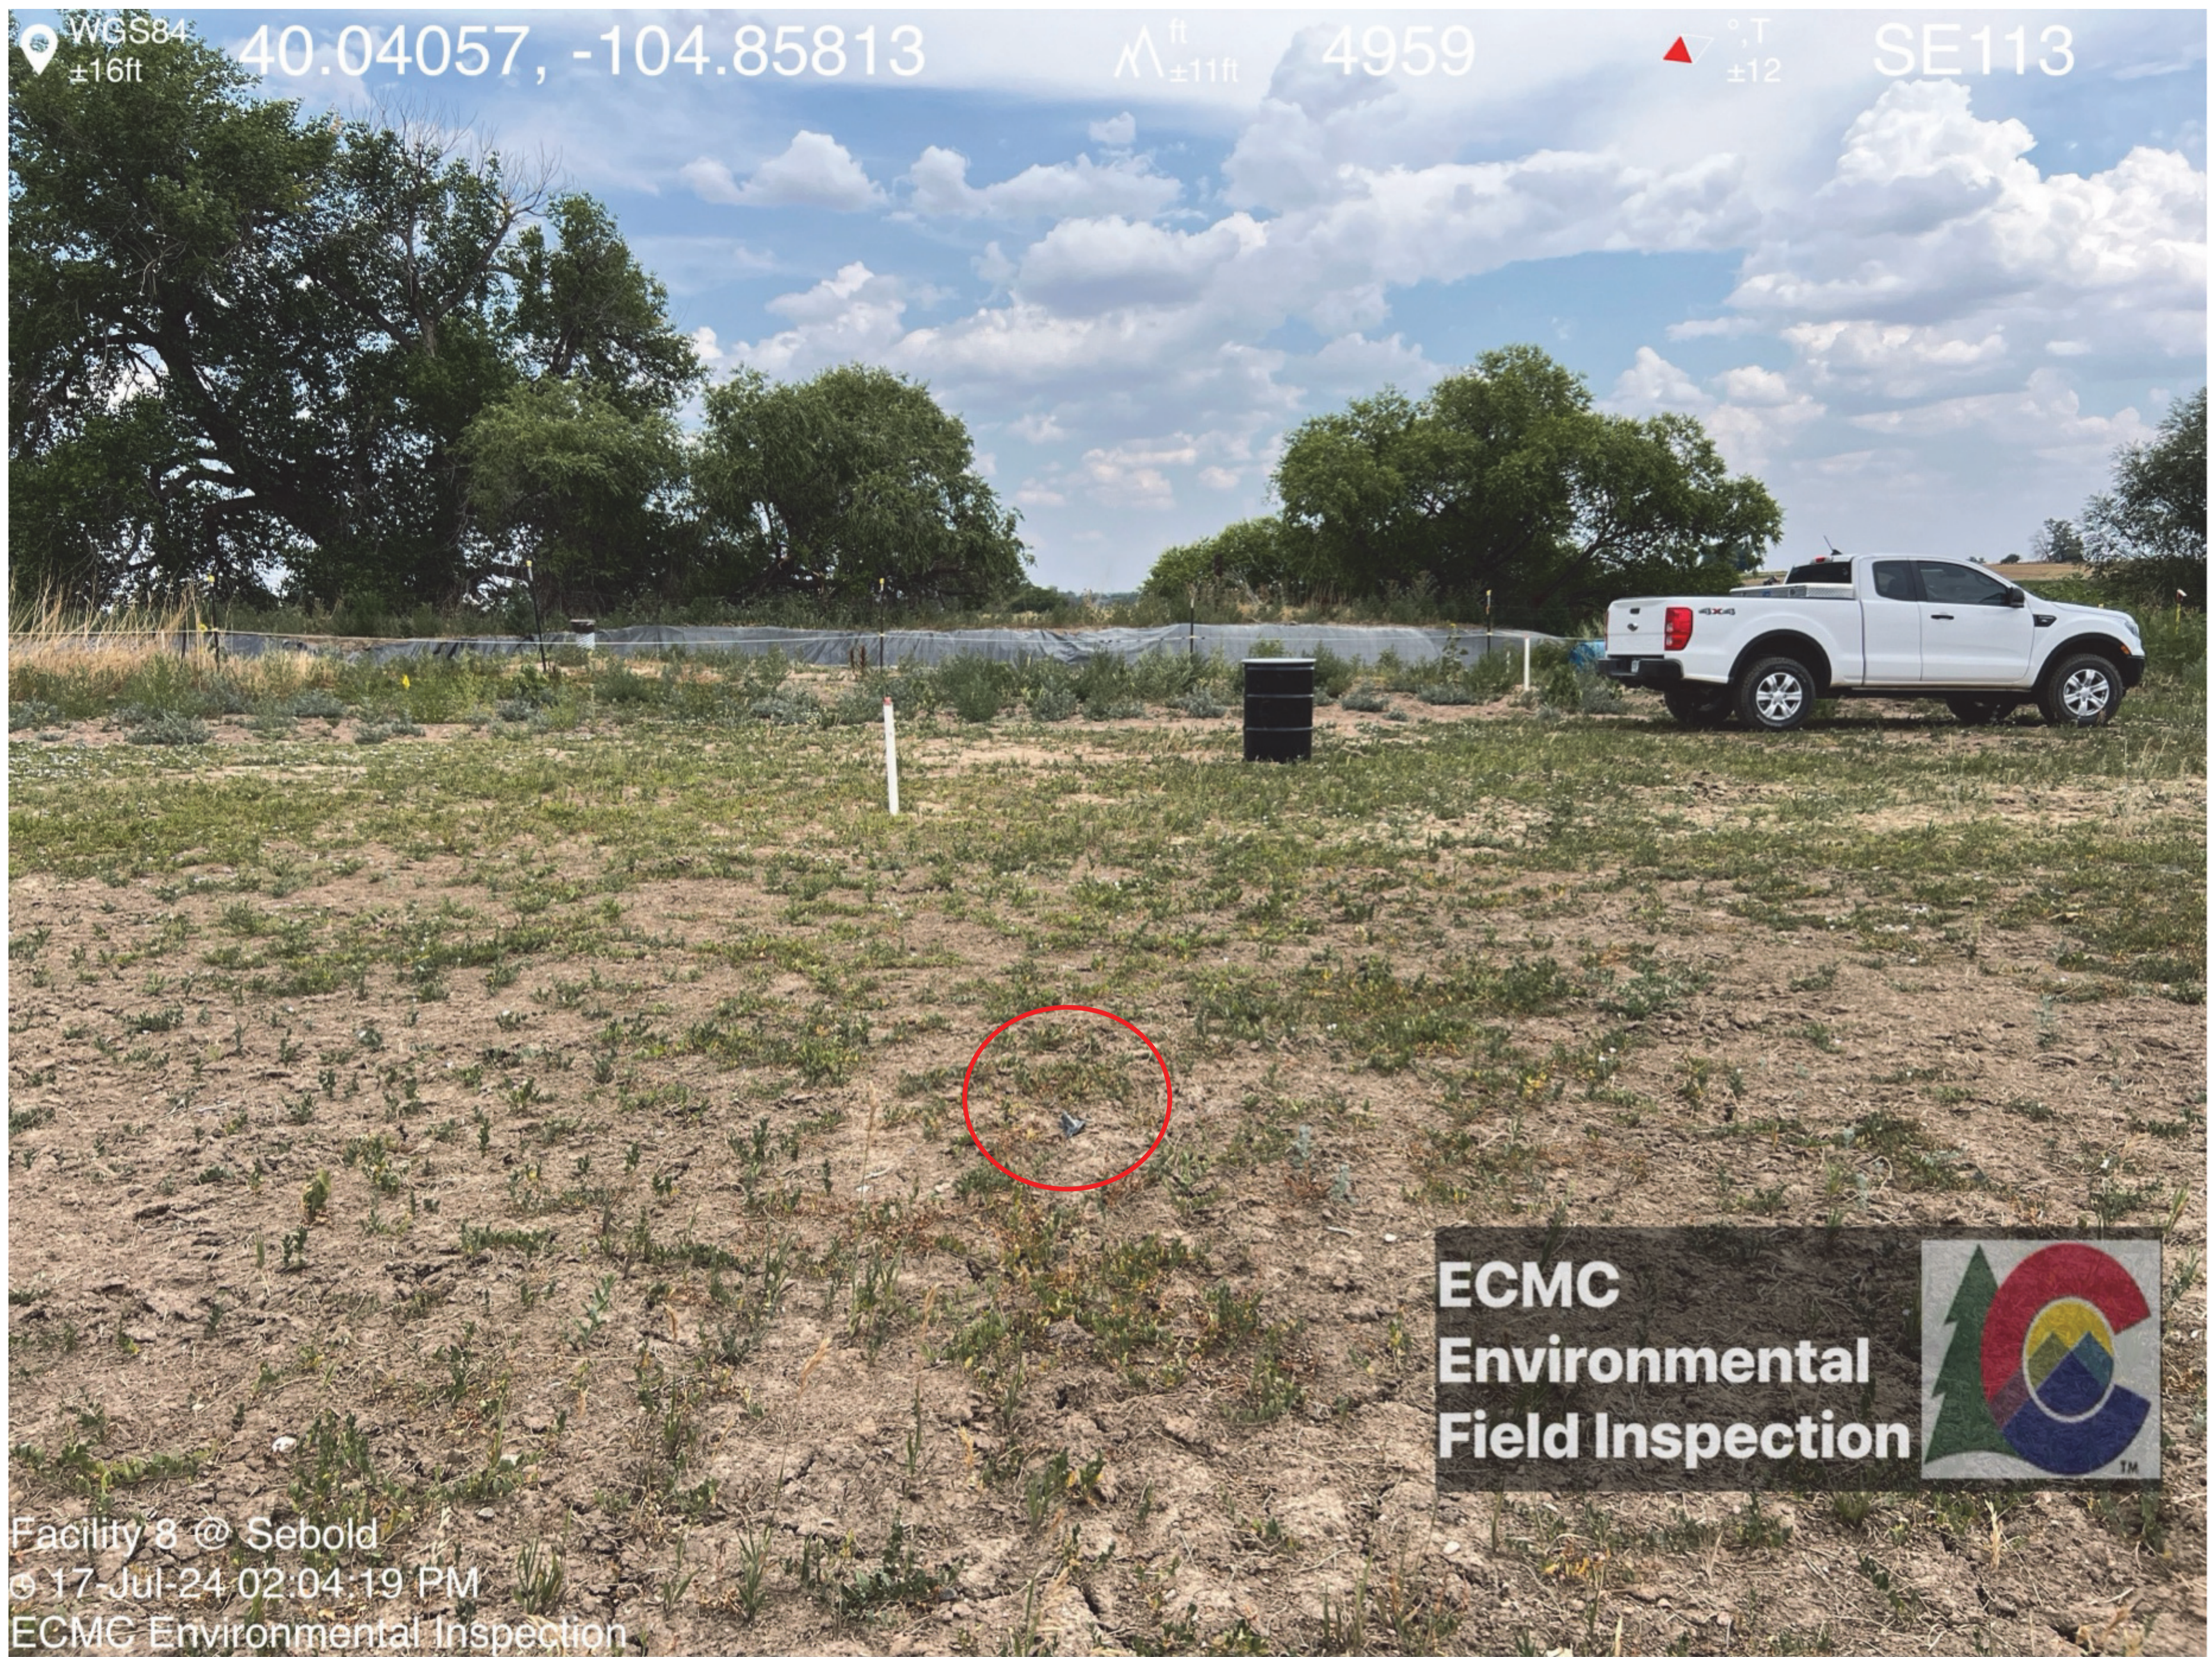
Weeds/Debris/Trash. Footprint of work area/former stockpile. Pieces of former E&P Waste Stockpile liner and trash observed throughout work area.

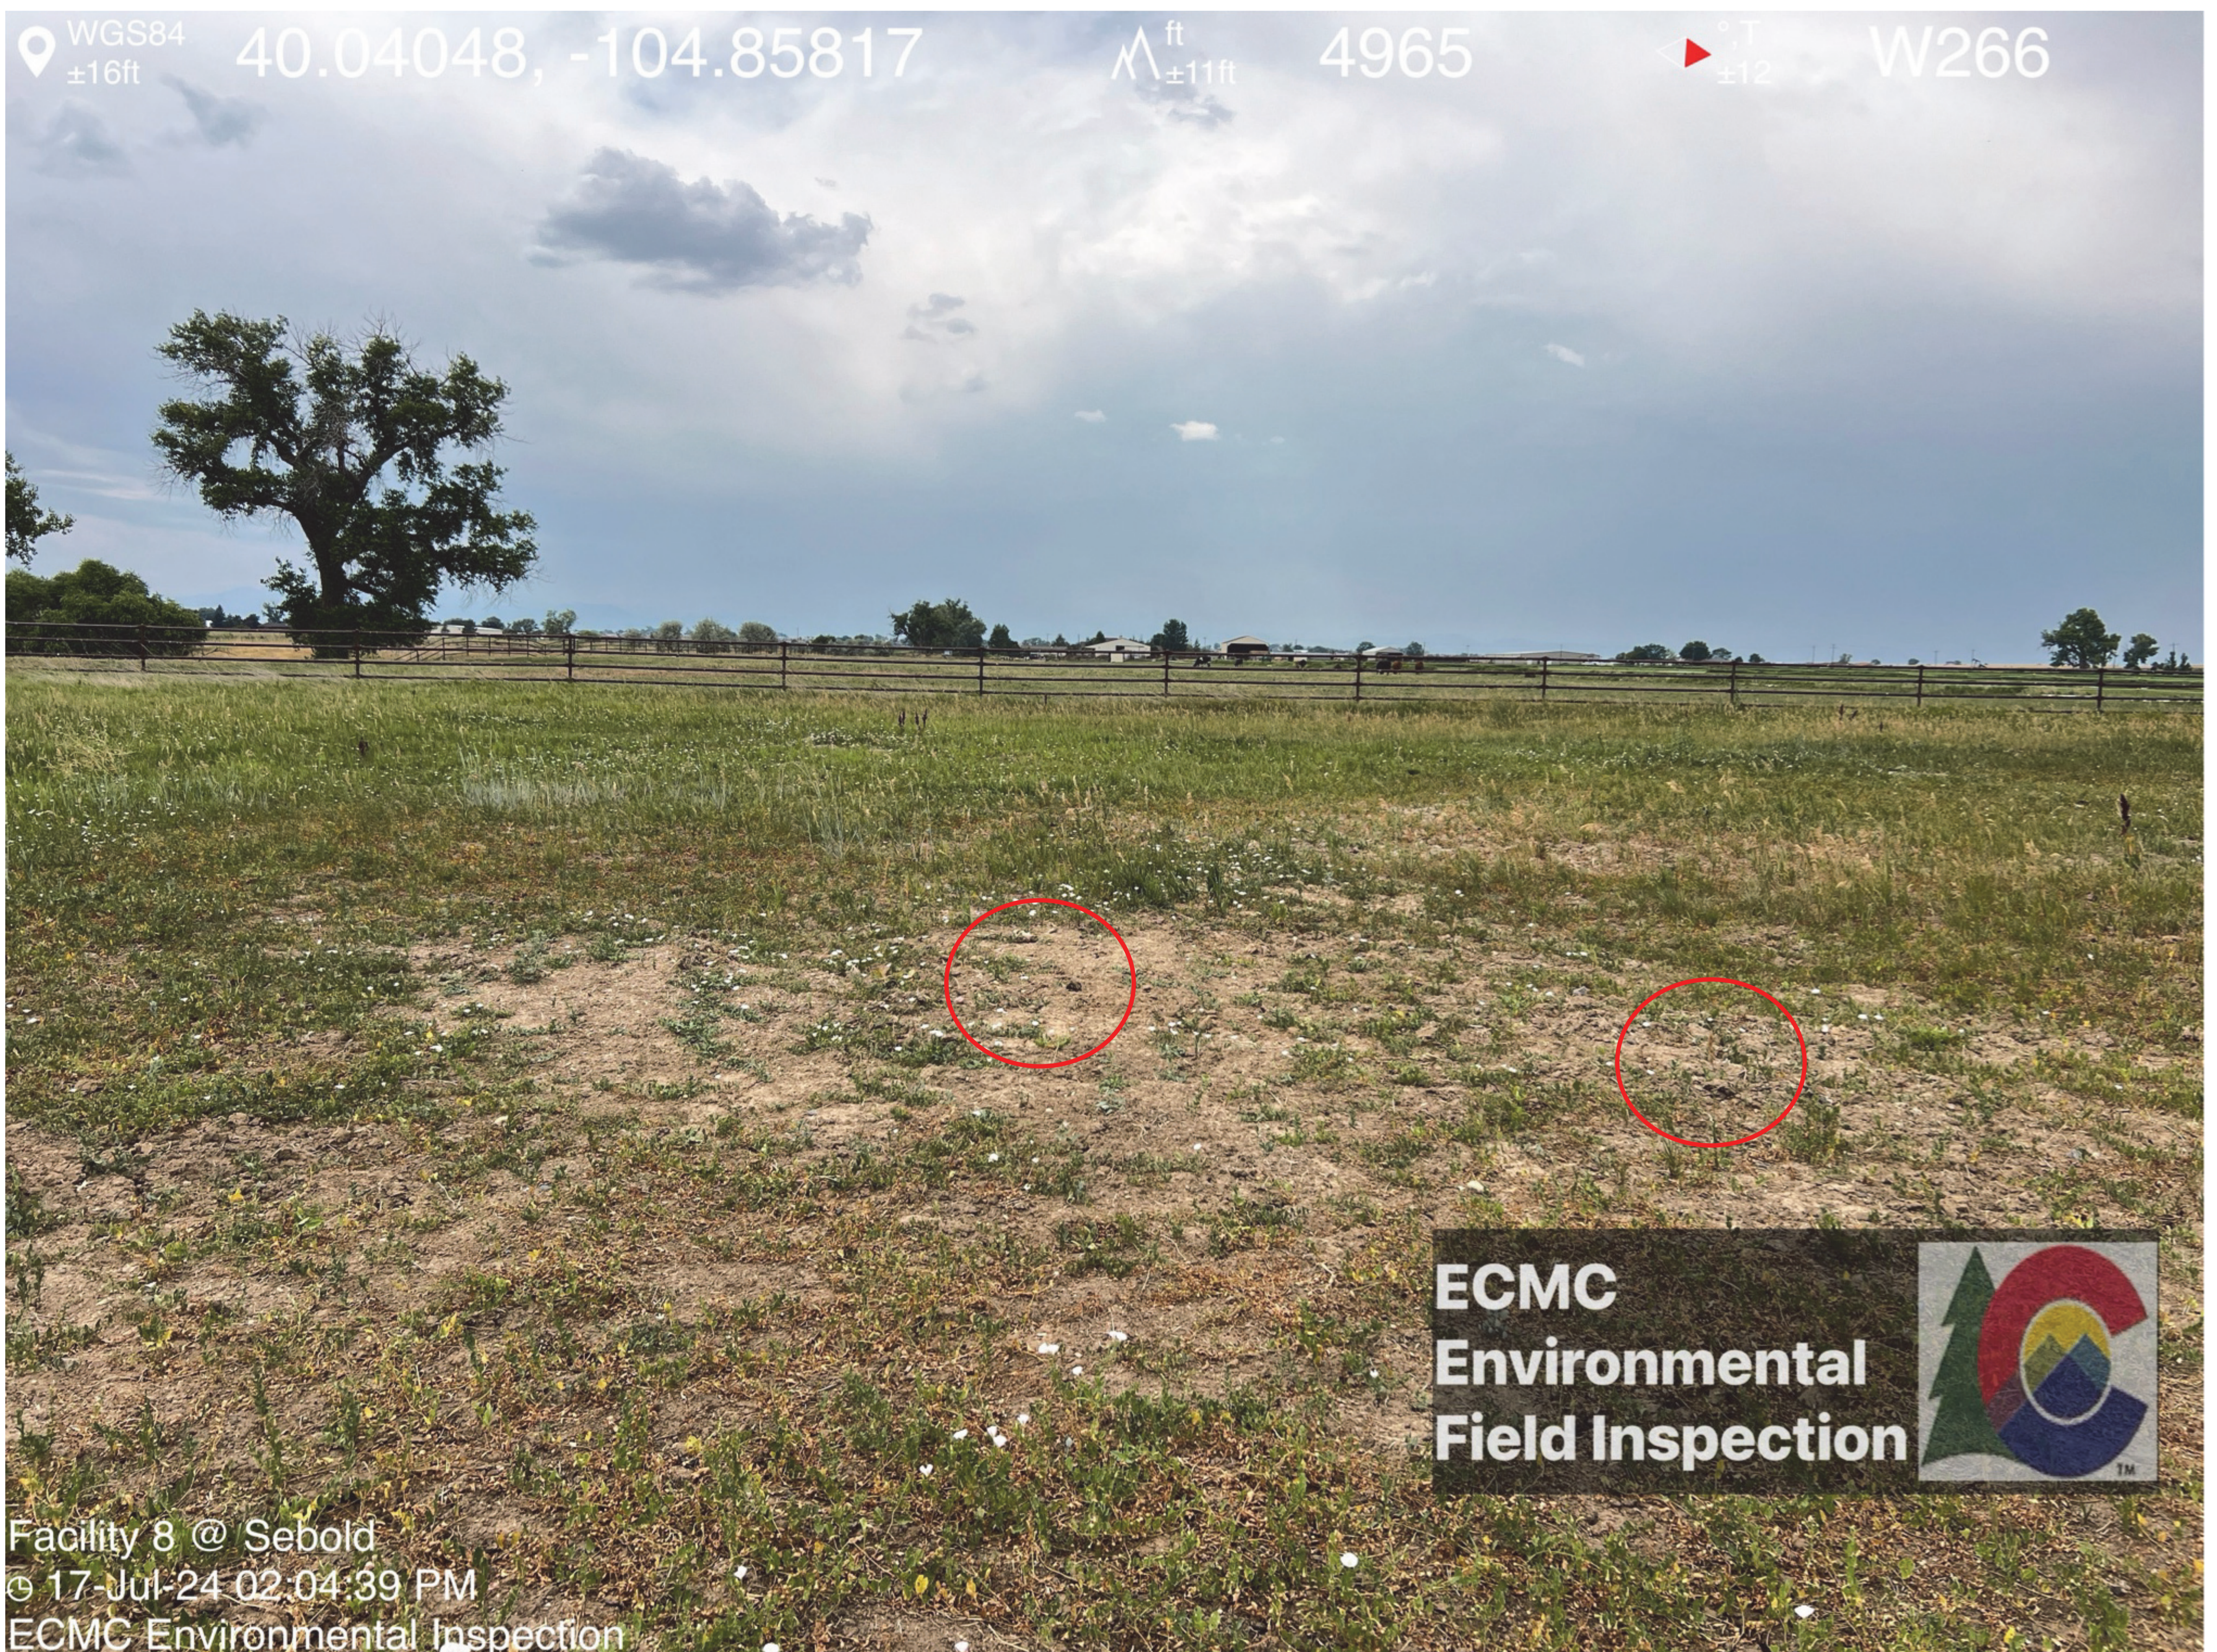
Weeds/Debris/Trash. Pieces of former E&P Waste Stockpile liner and trash observed throughout work area.

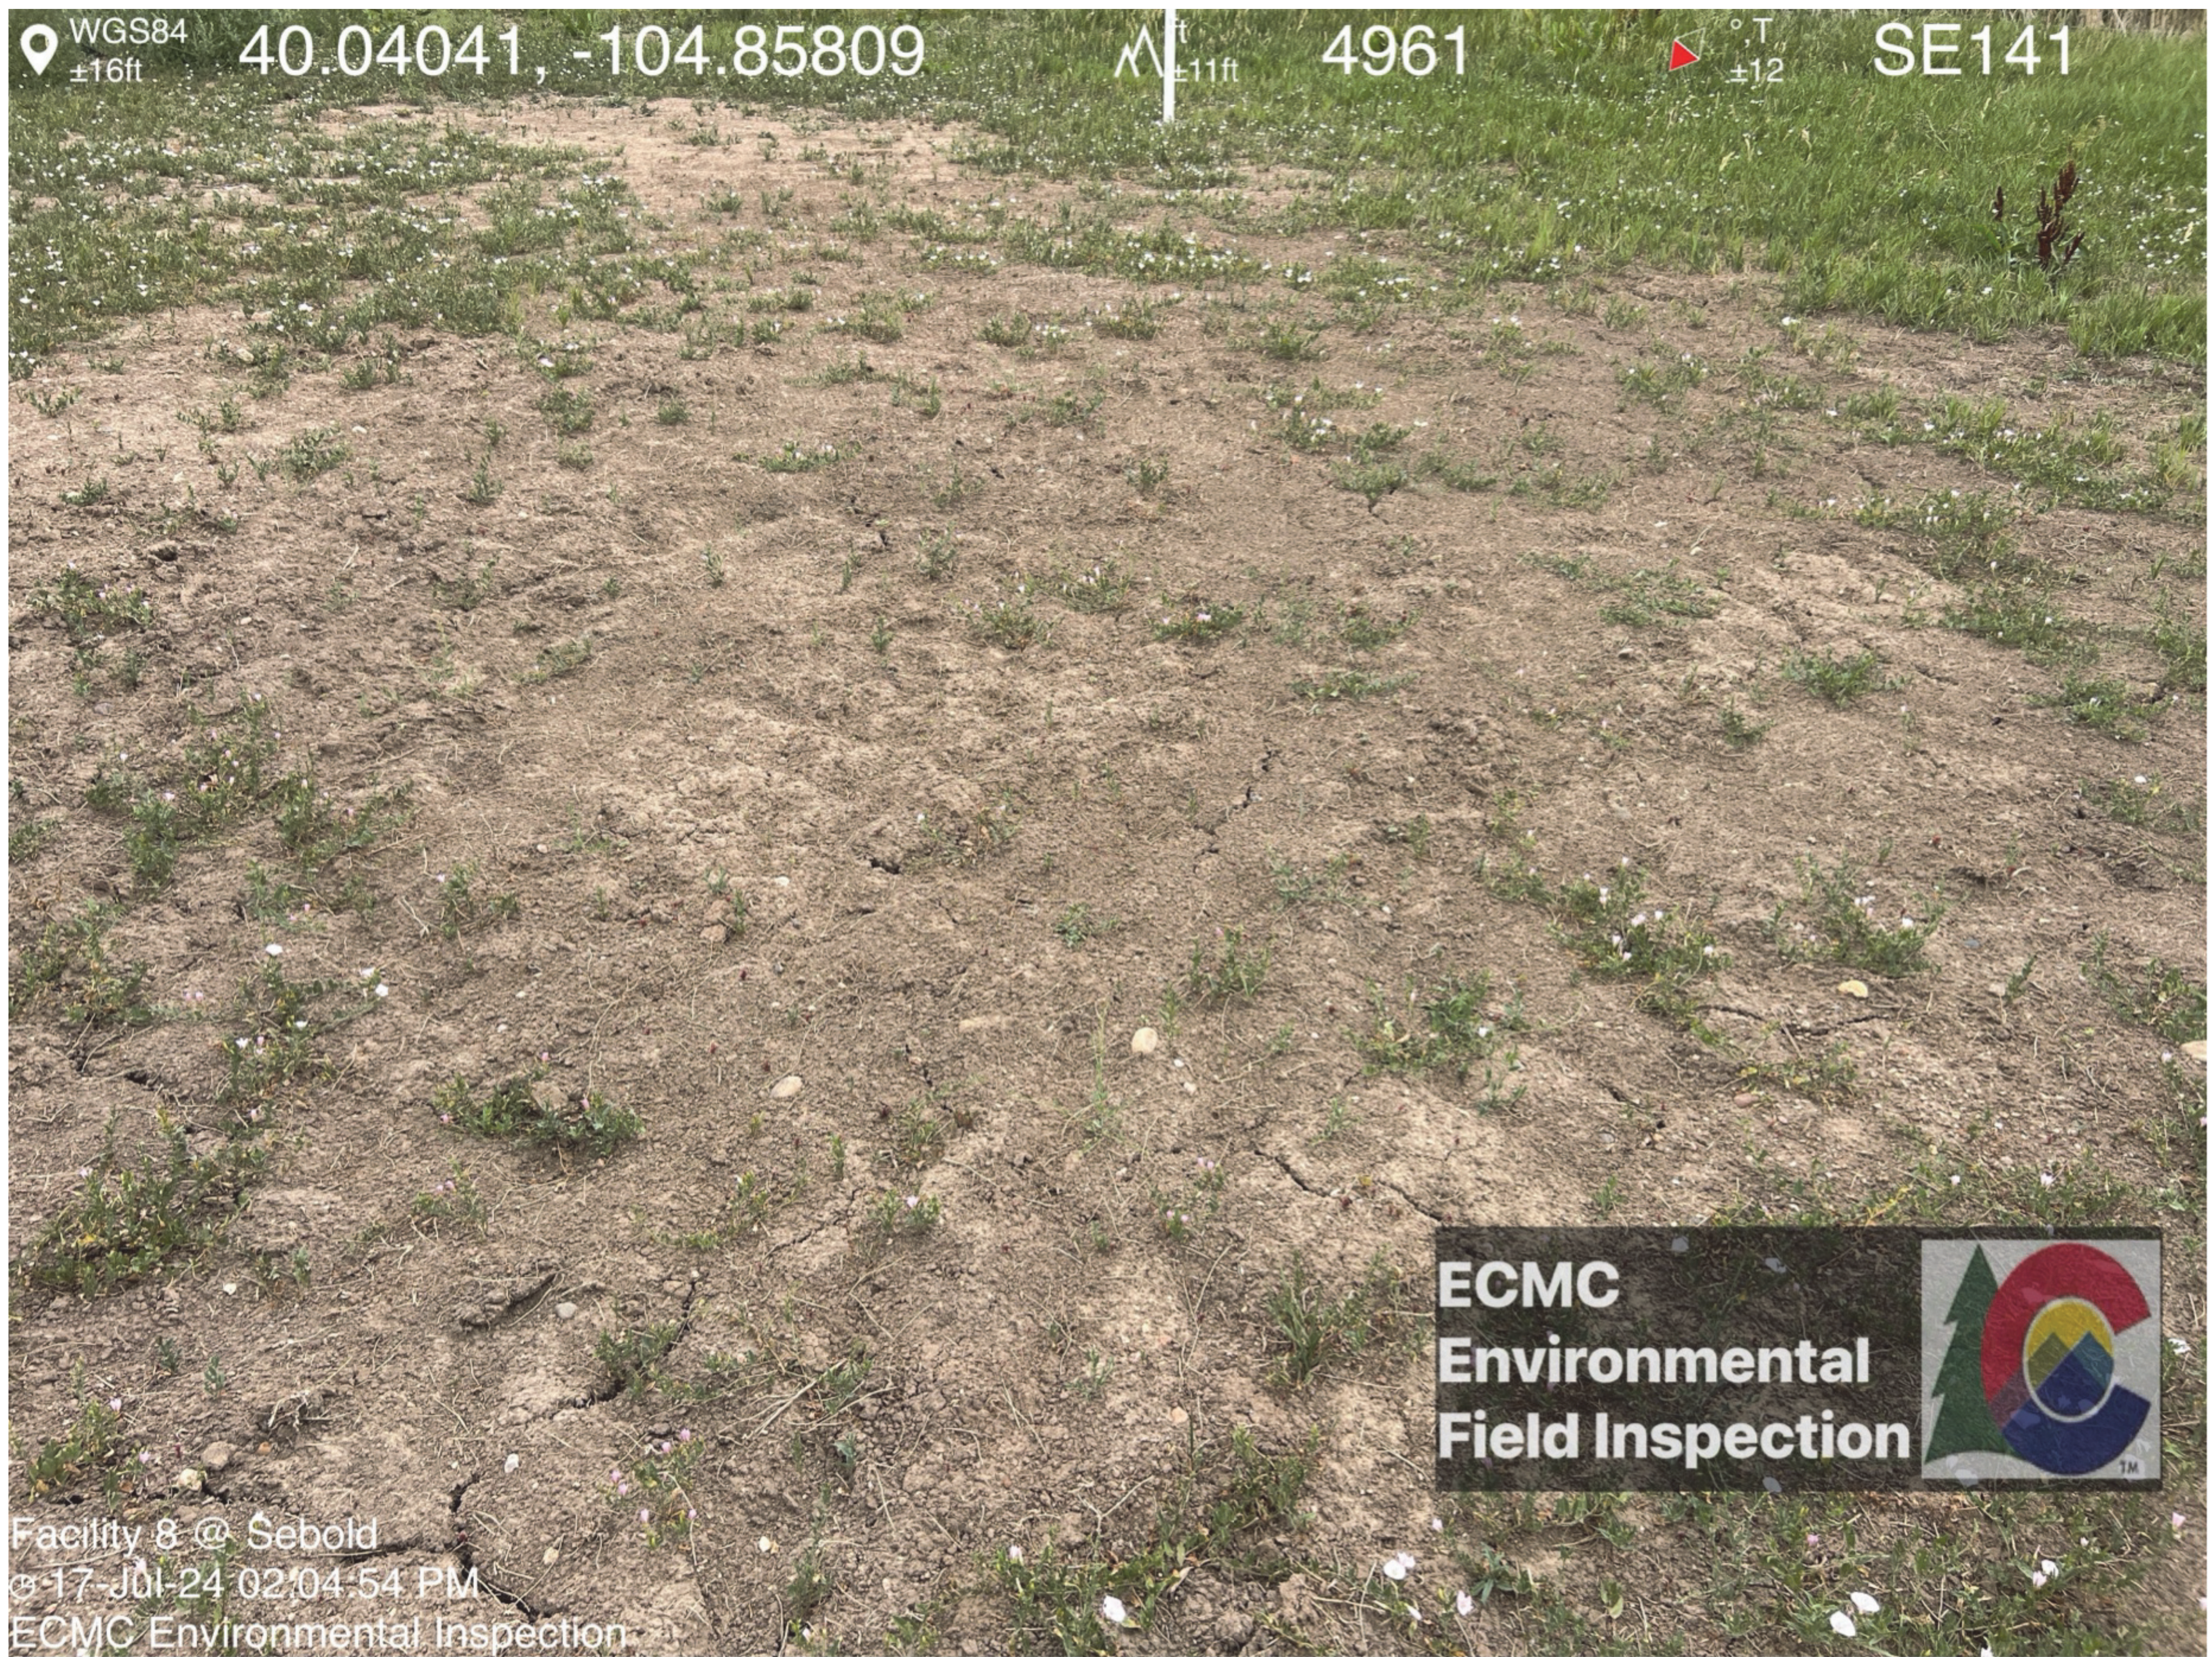
Weeds. Footprint of former work area (staging area/access/excavations/stockpiles).
