**ECMC
Environmental
Field Inspection**

Facility 8 @ Sebold
© 17-Jul-24 02:00:47 PM
ECMC Environmental Inspection
Weeds/Debris/Trash

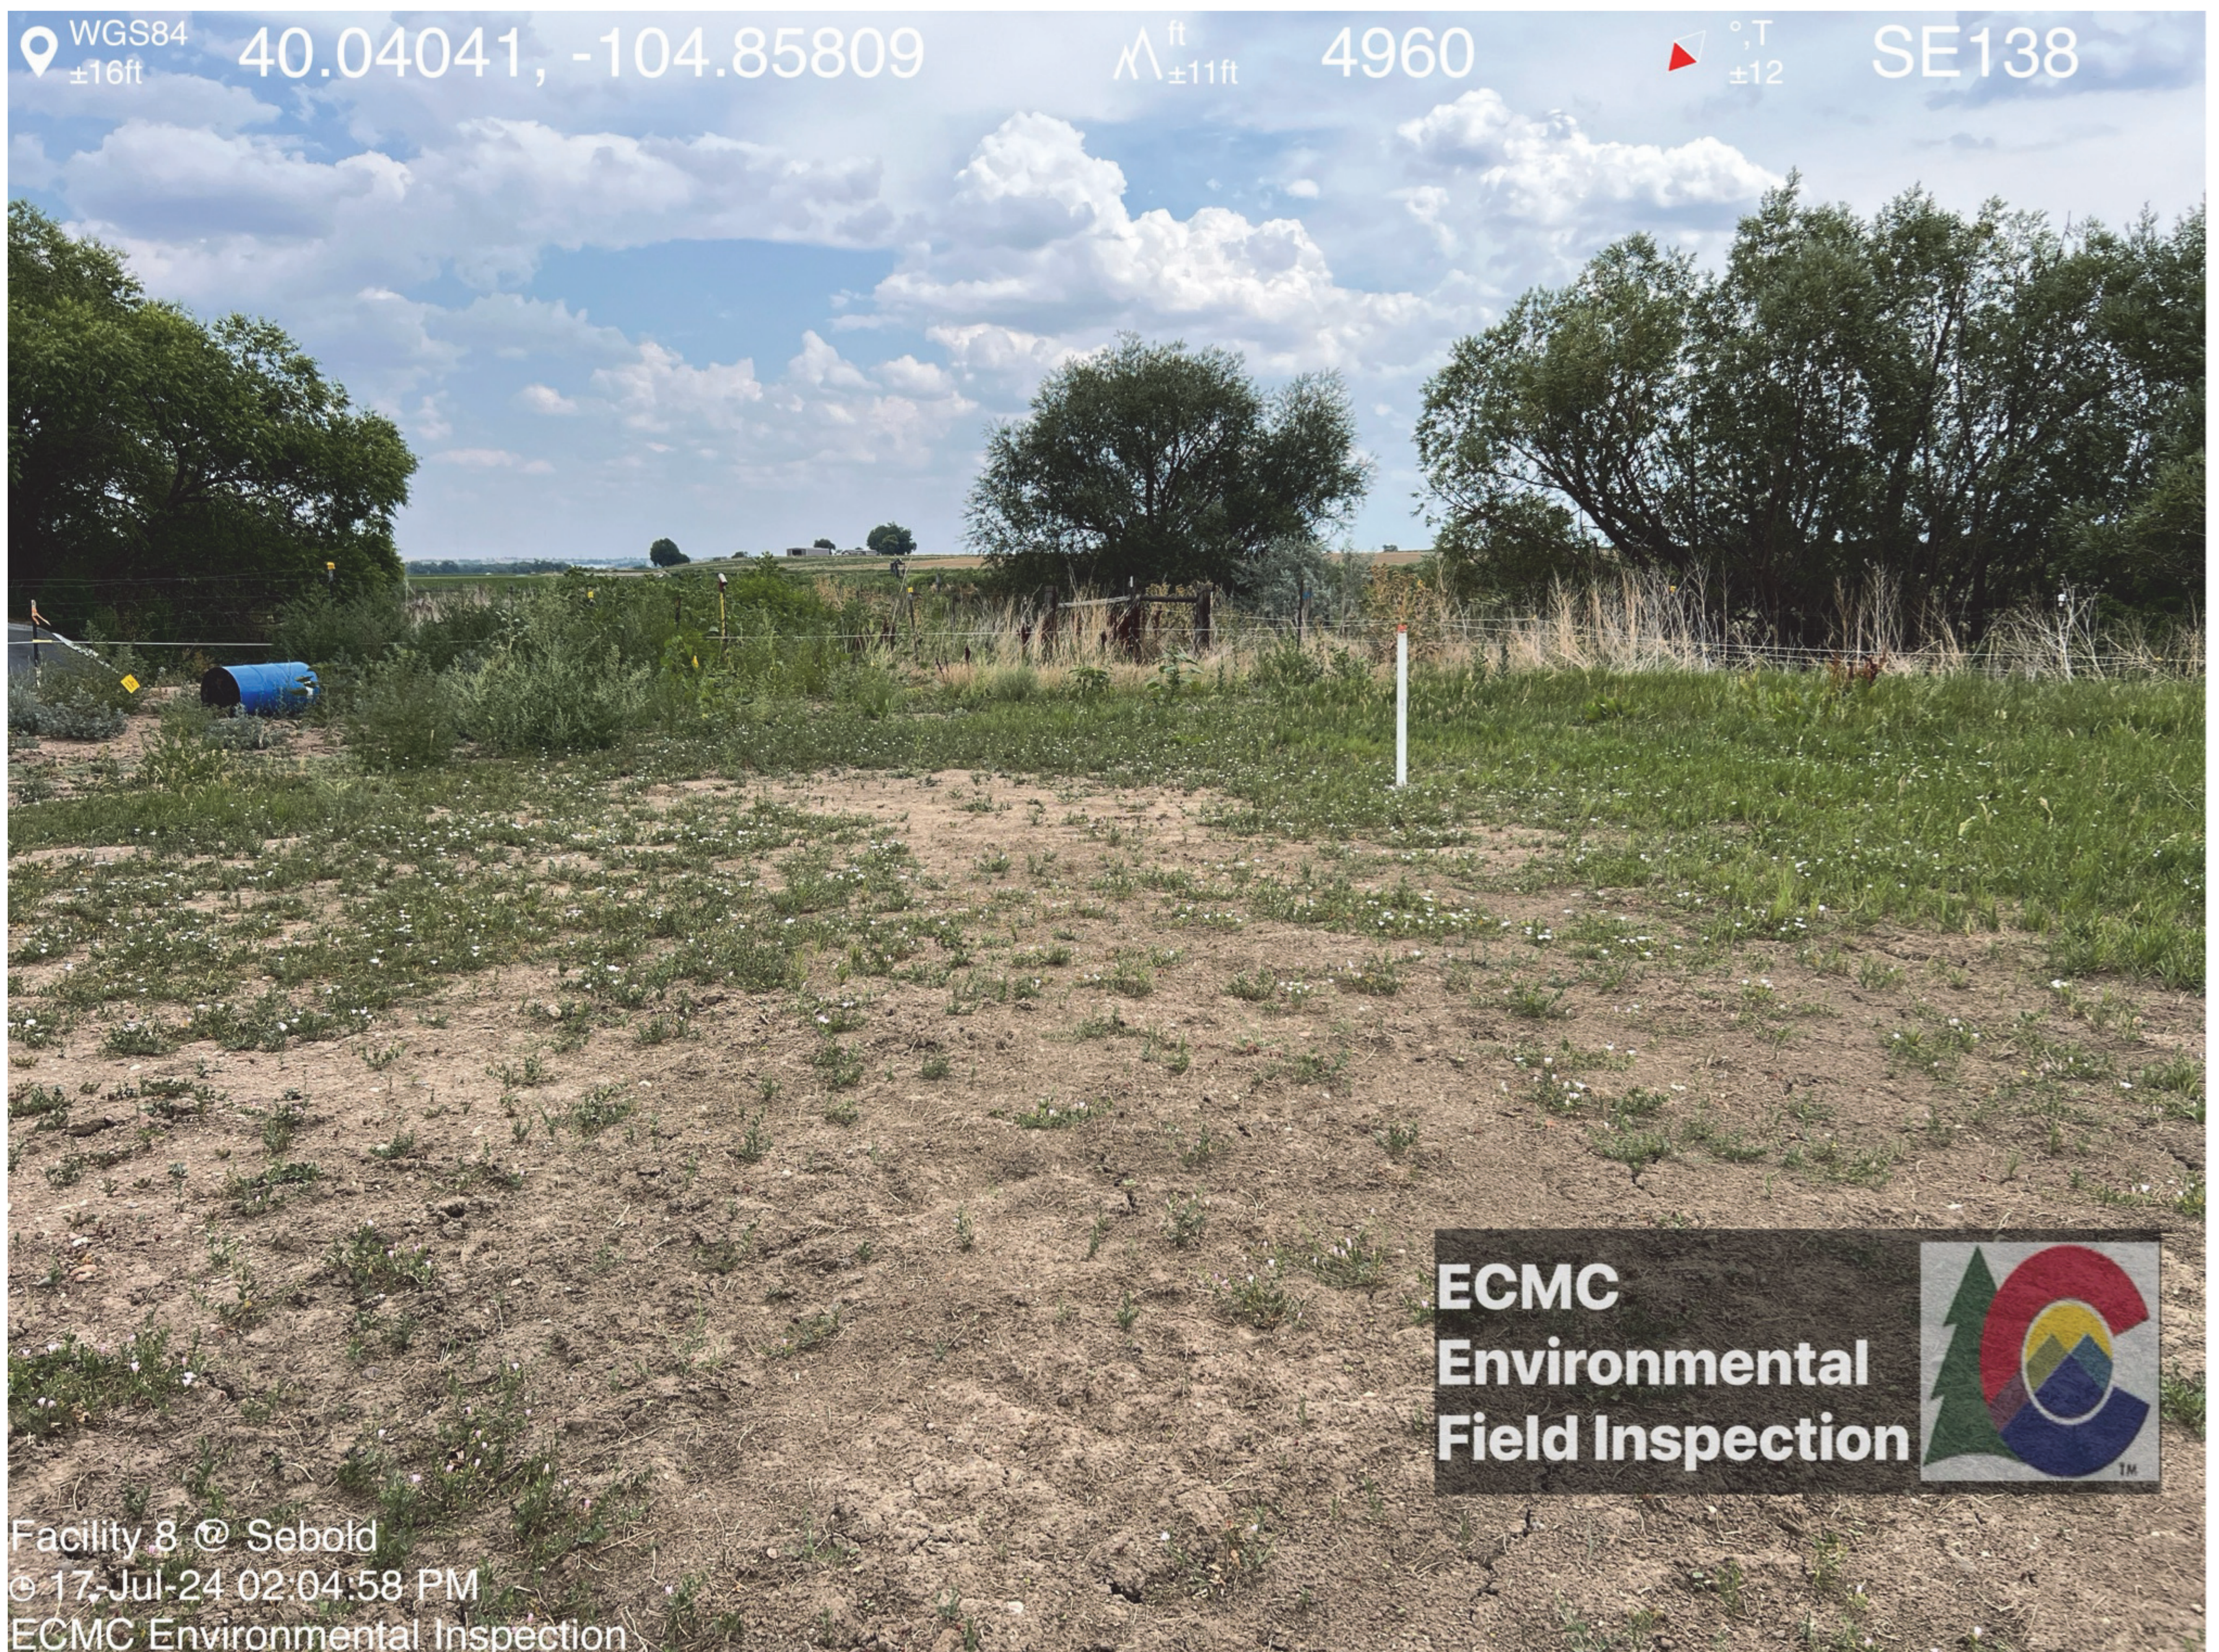
Weeds/debris/trash. Footprint of former work area (staging area/access/excavations/stockpiles).

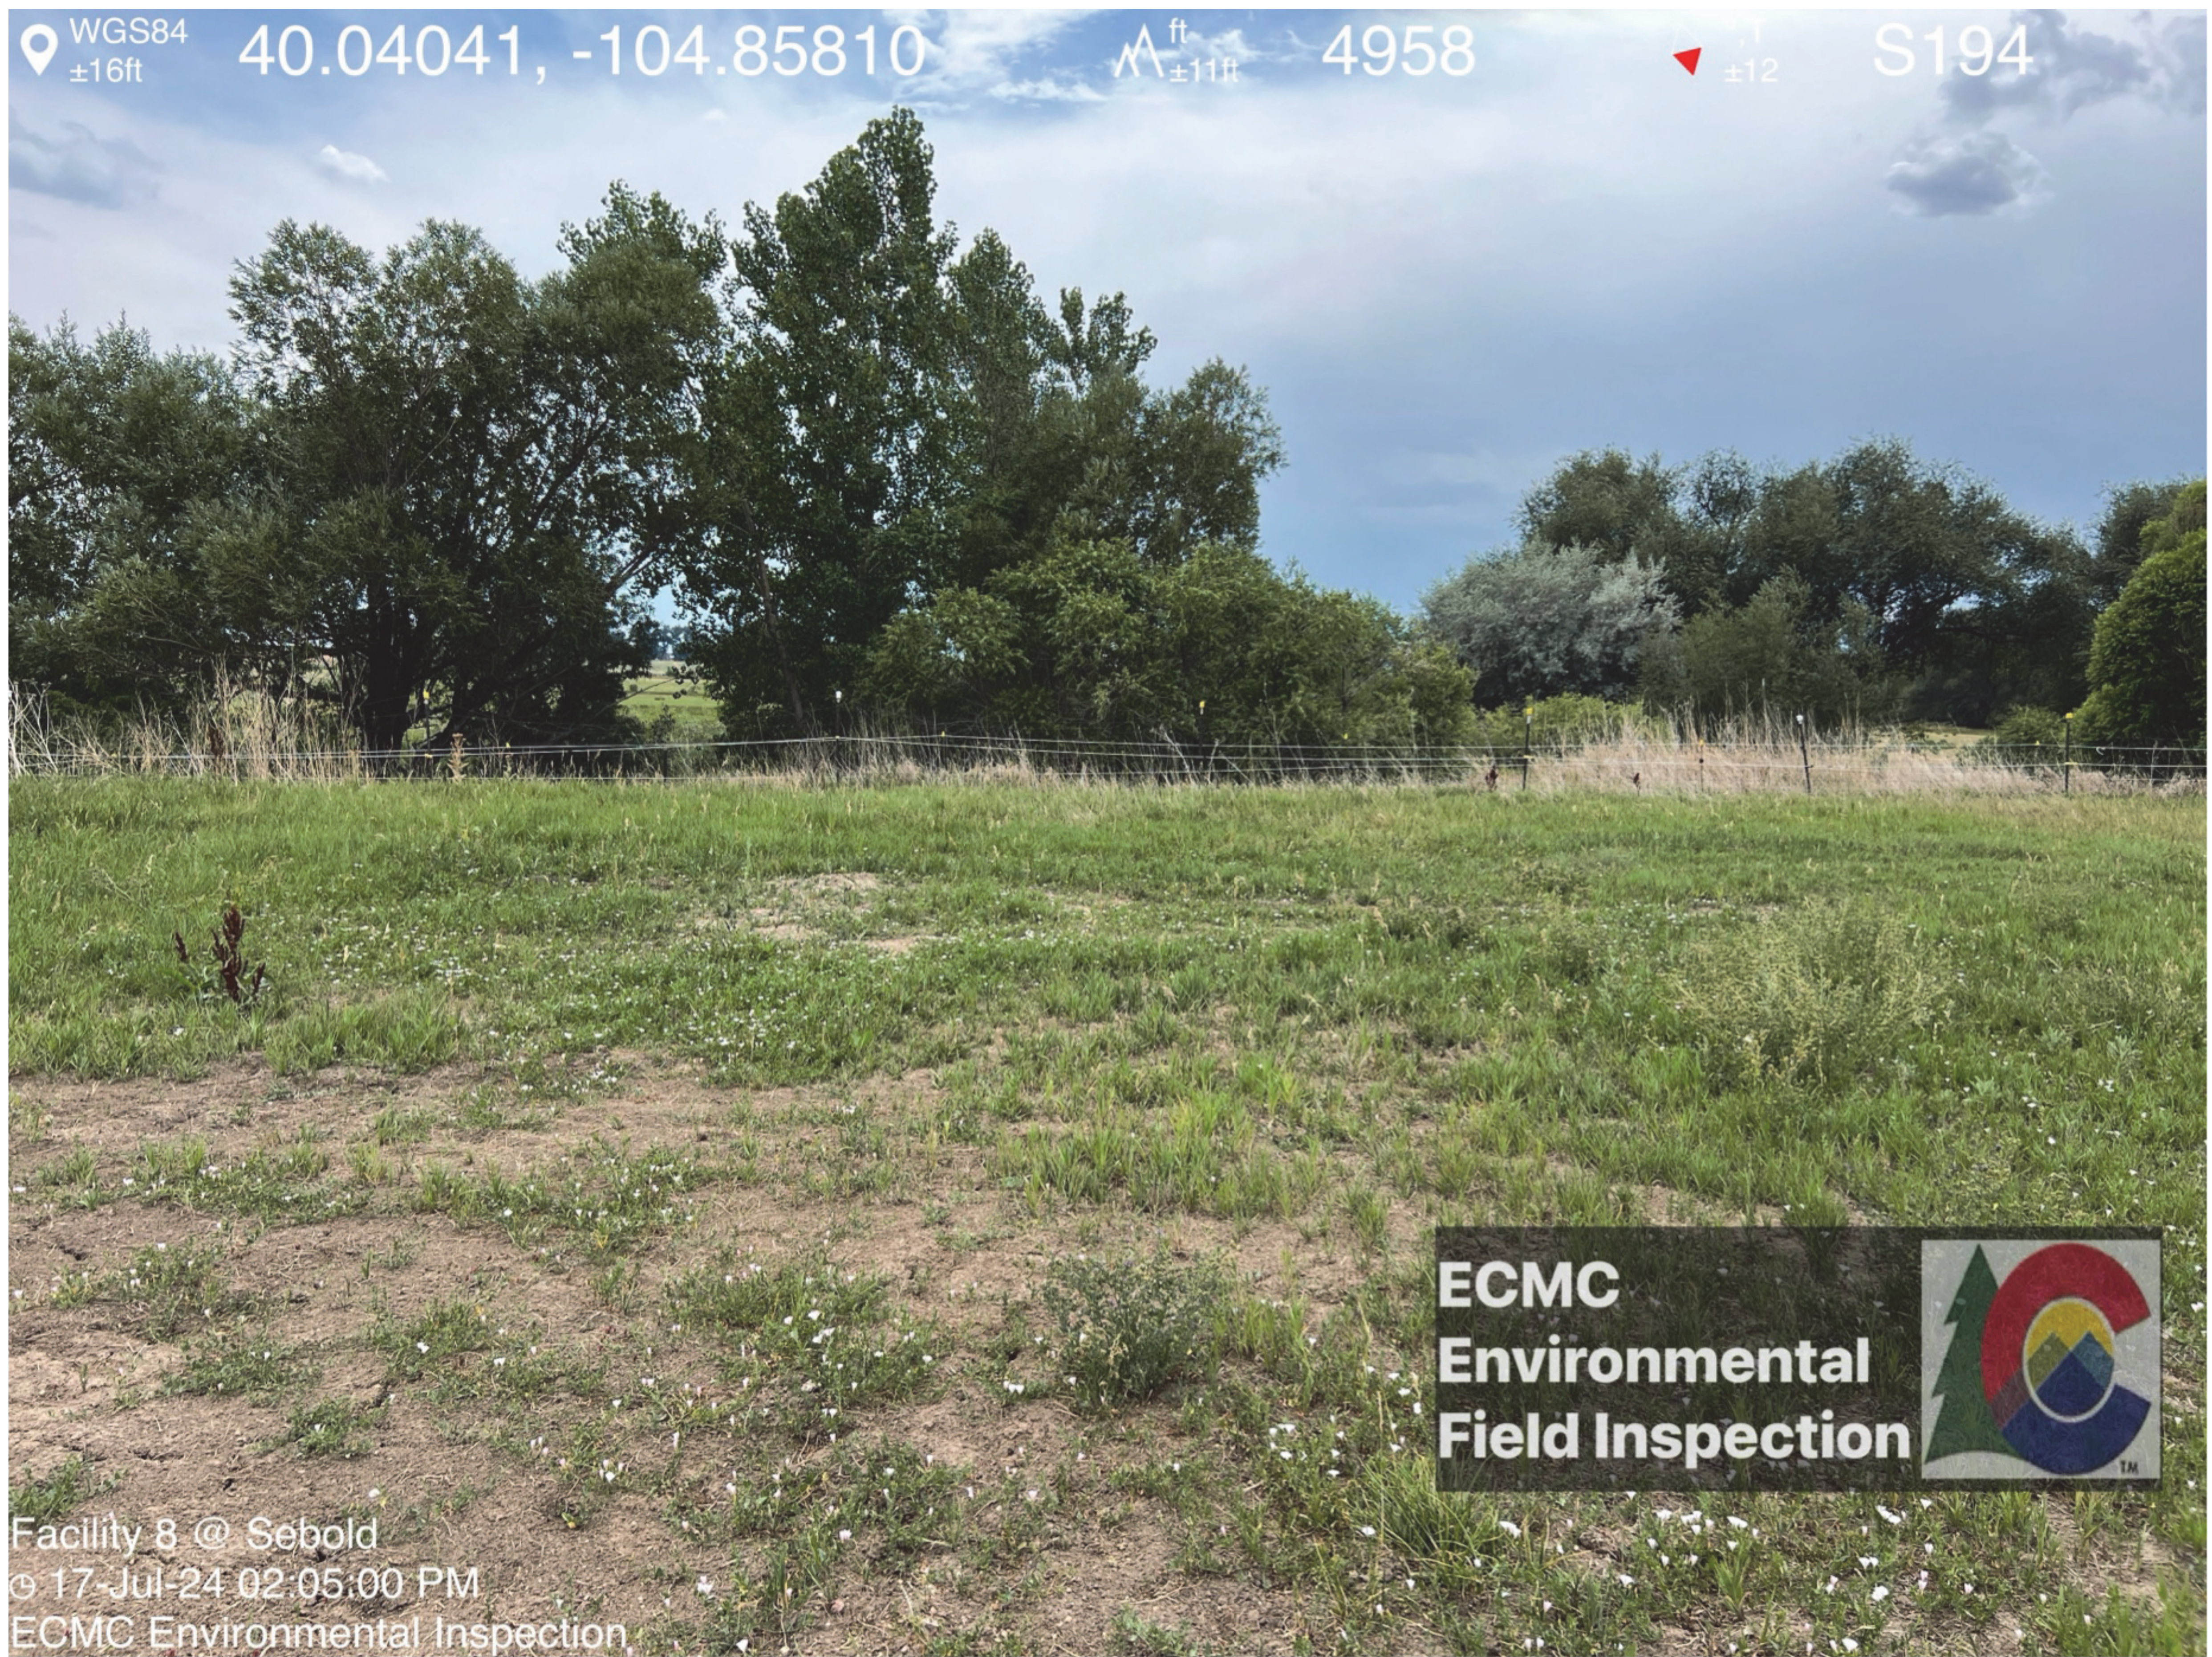
Weeds. Footprint of former work area (staging area/access/excavations/stockpiles).

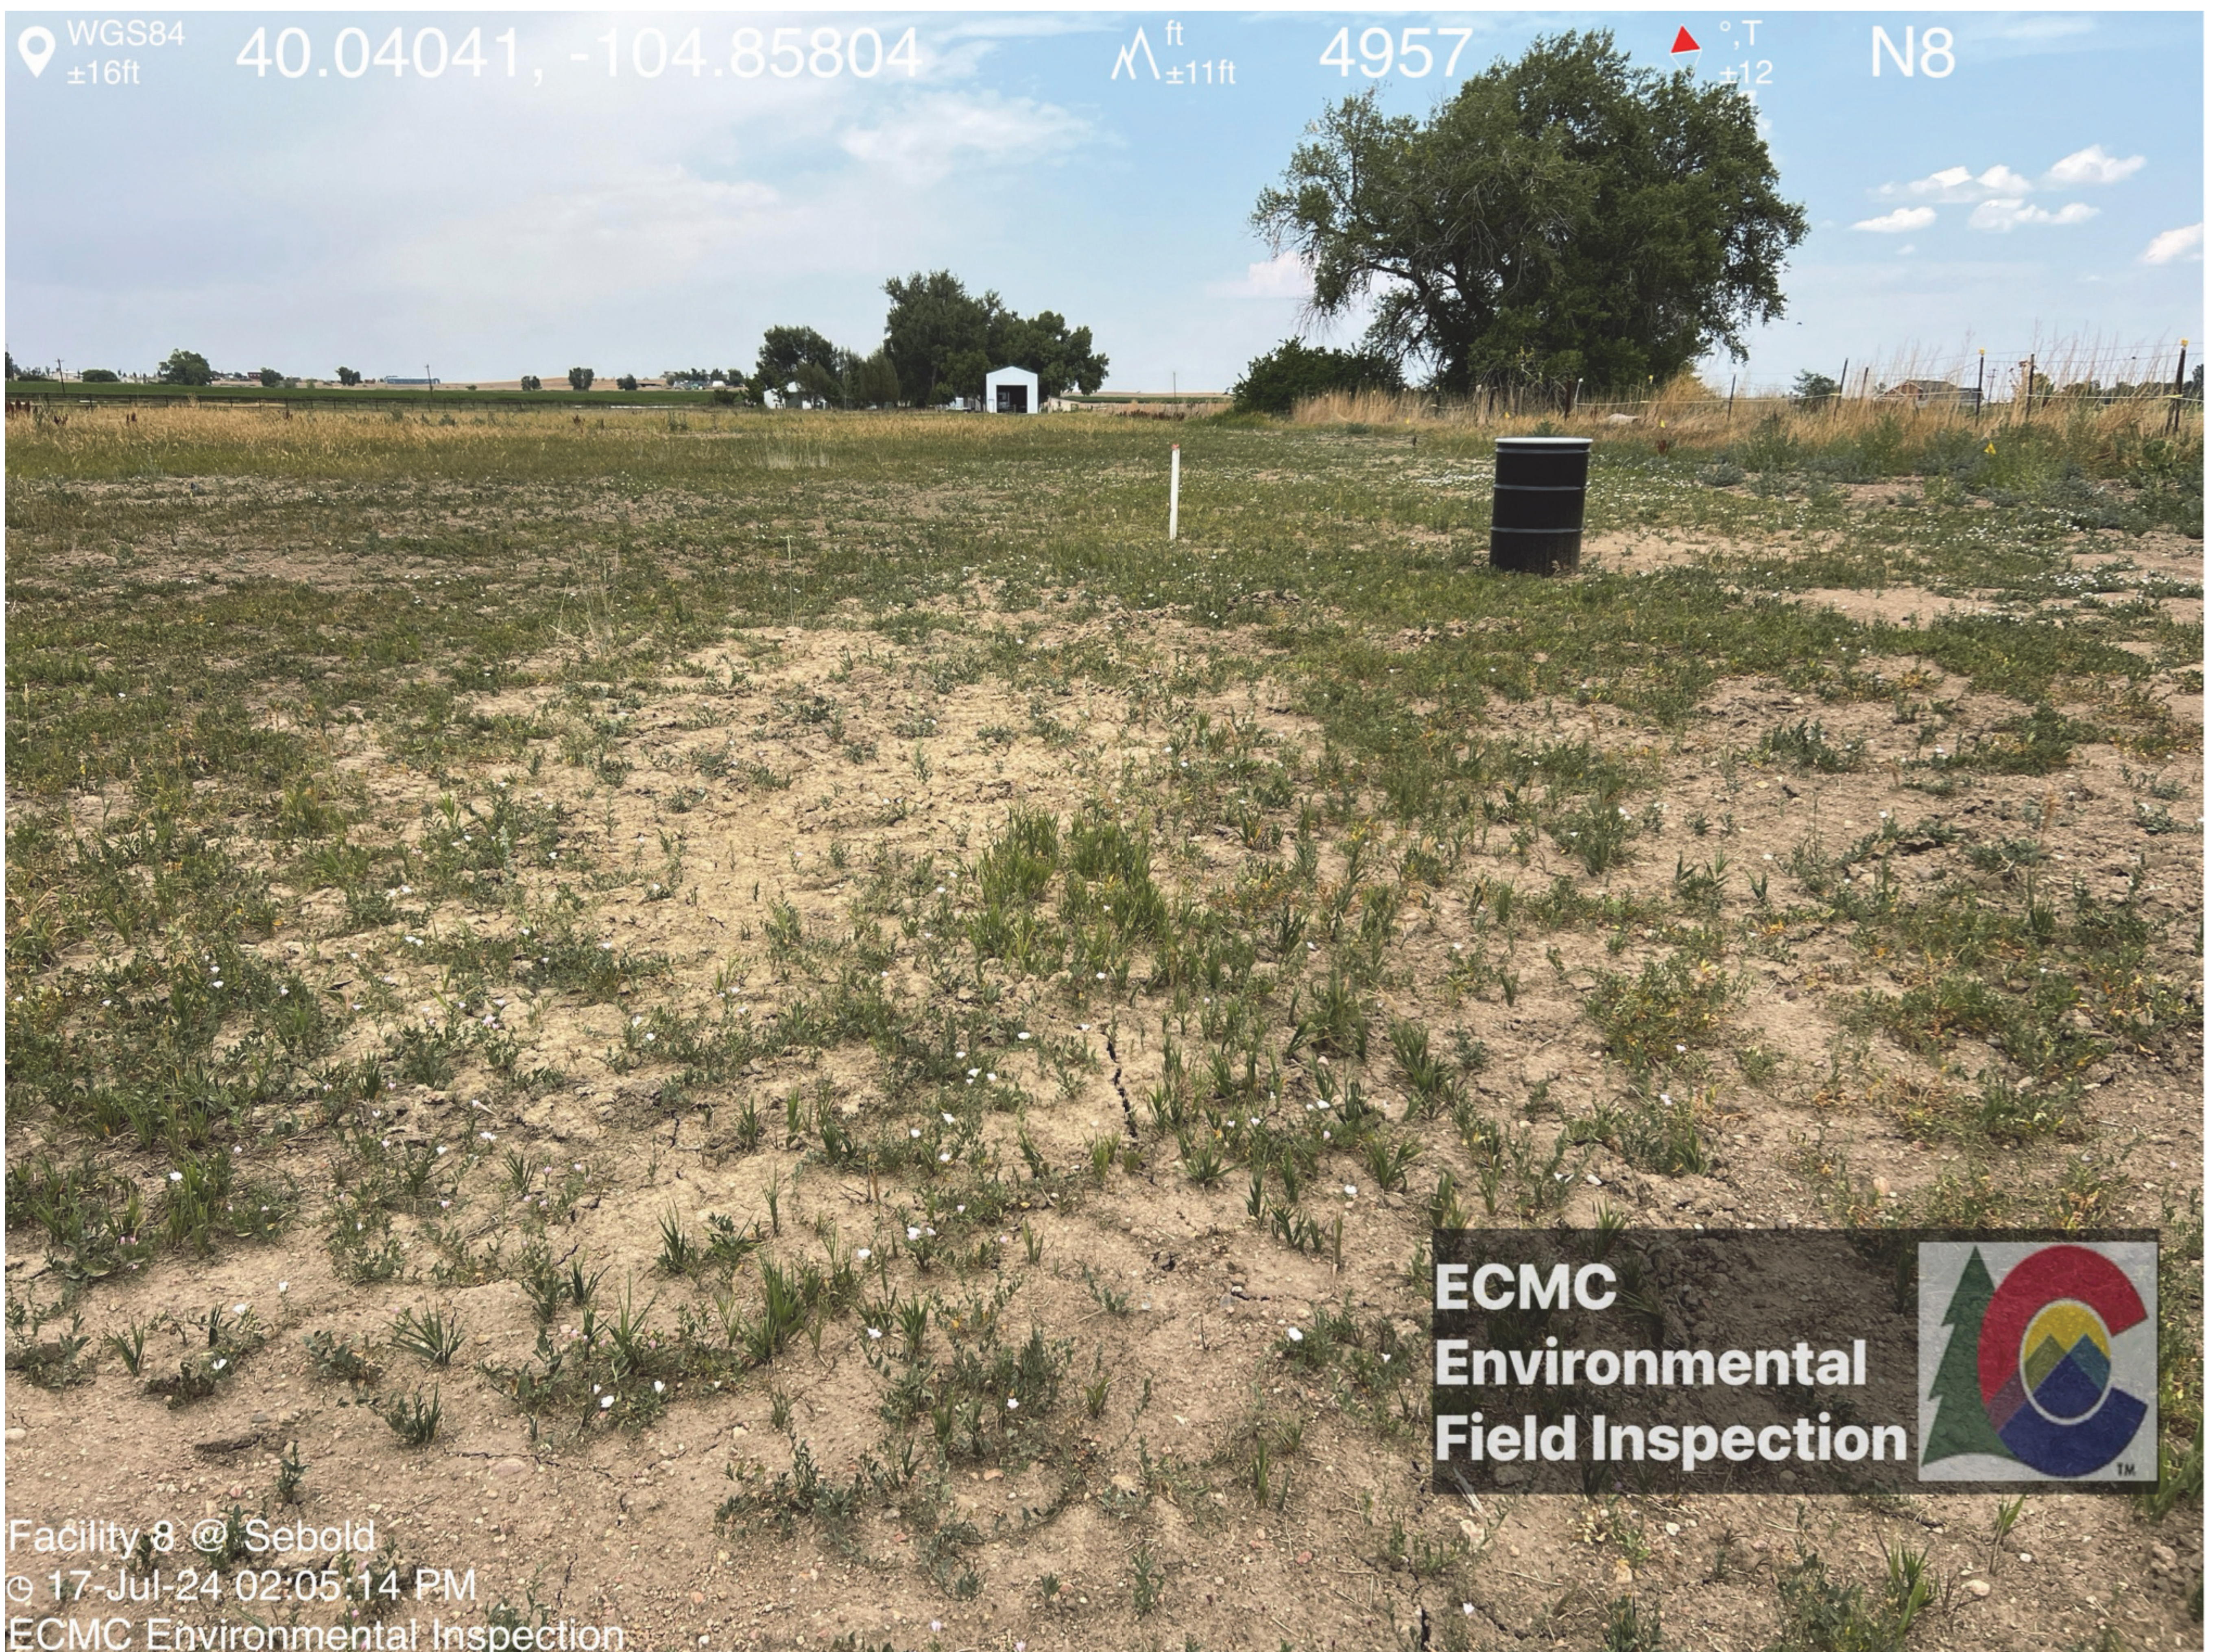
Weeds/debris/trash. Footprint of former work area (staging area/access/excavations/stockpiles).

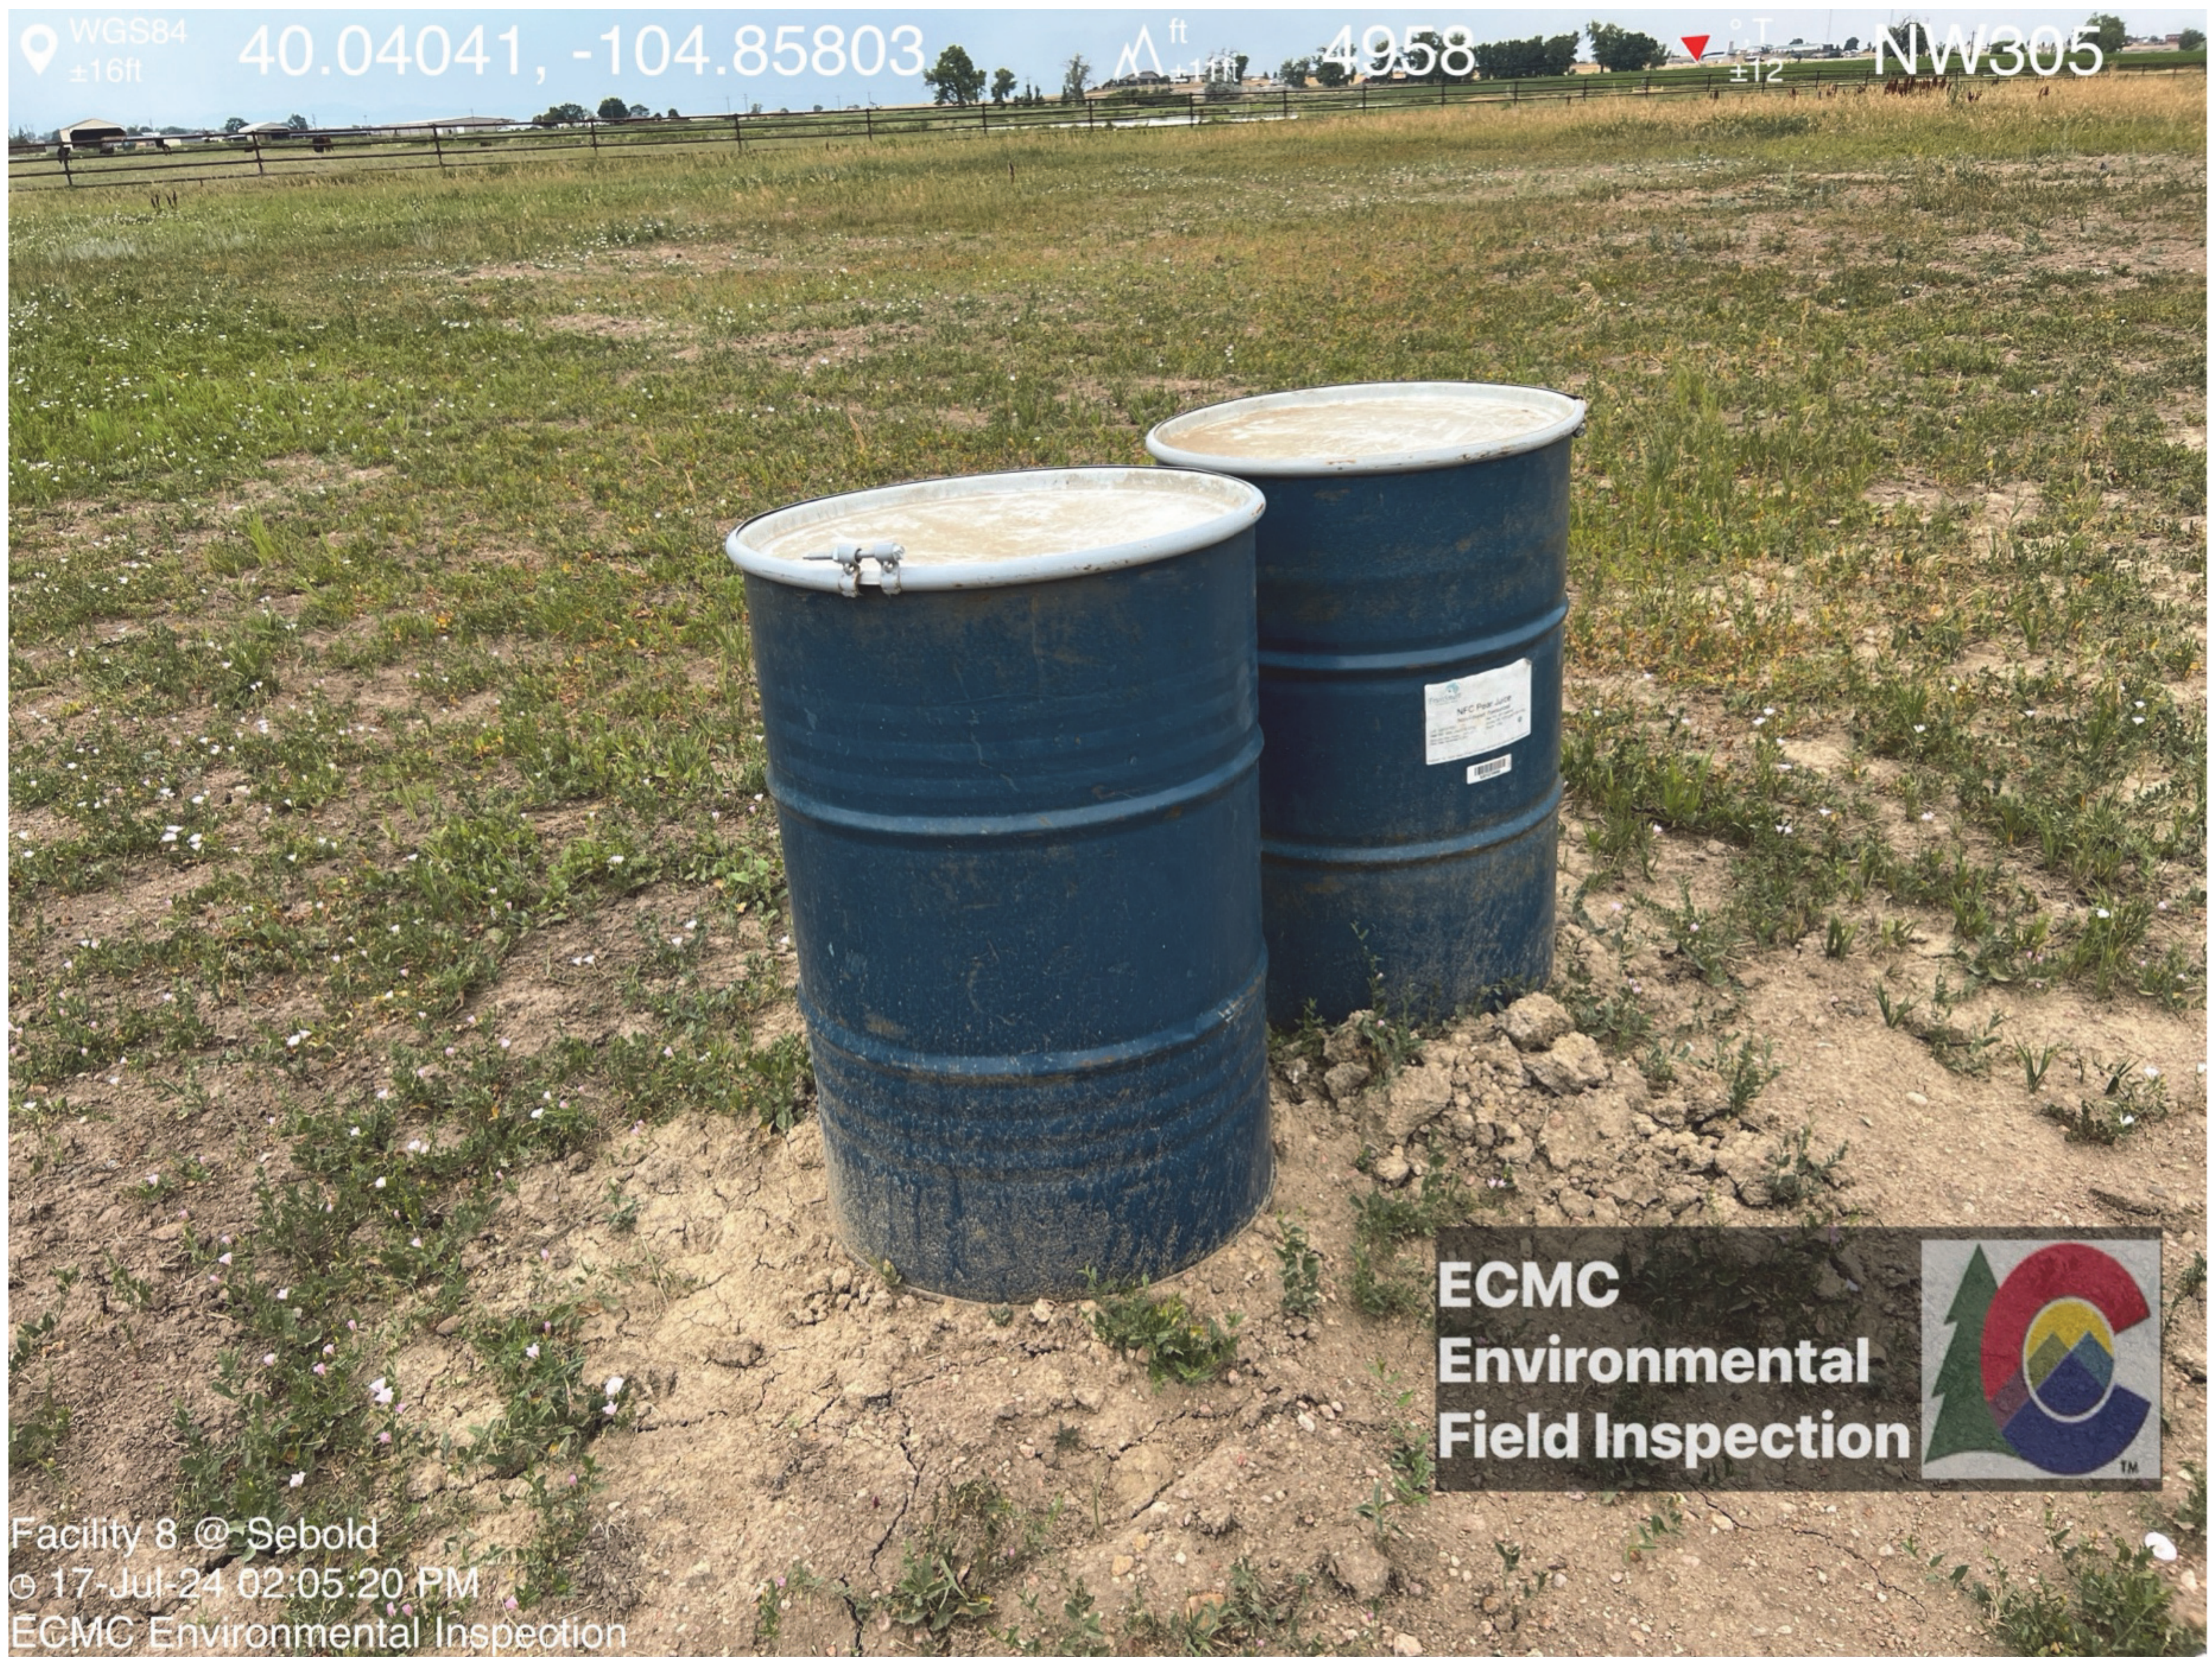
Weeds/debris/trash. Footprint of former work area (staging area/access/excavations/stockpiles).
