Work Completion Report

Contractor: Peerless

Job Name	Month/Season	Completed By	Completion Date
RICE 6-3I7 TANK BATTERY	July	Armando Munoz	7/18/2024

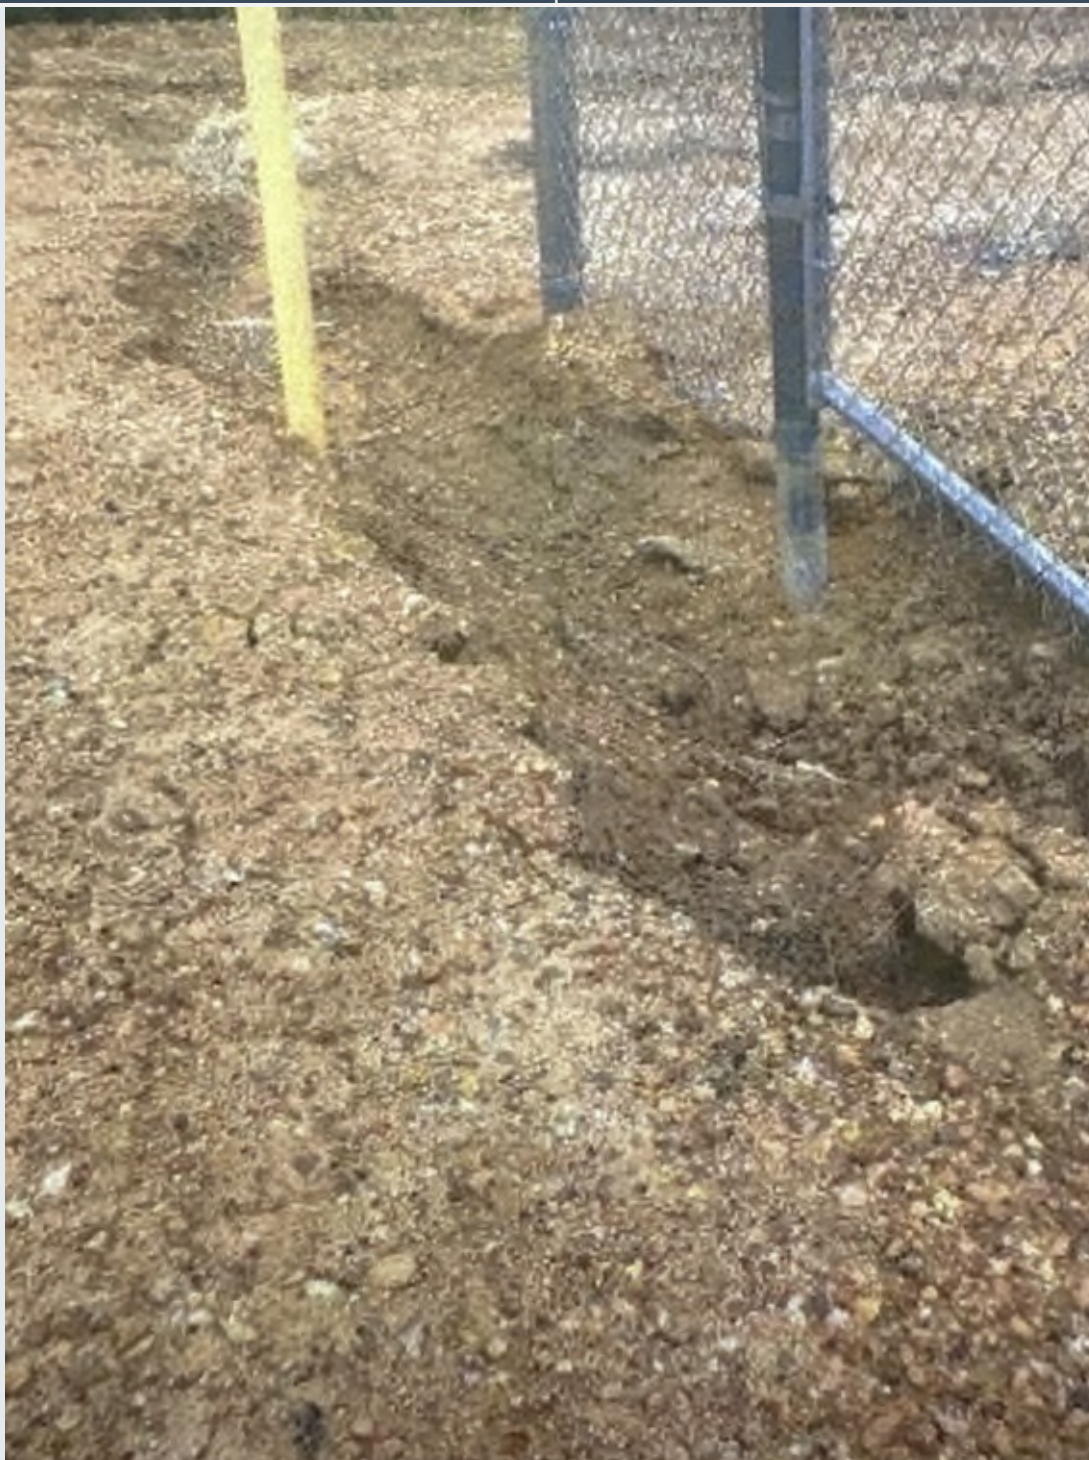
Photo Name: Pre-Completion

Work Summary	Reclamation Type	Land Use
Repaired and stabilized erosion found on the NW corner of the tank containment and the NE corner of the flare backfilled and surfaced roughened. Installed rip rap chem dams.	Stormwater	Crop
