Hill 9-31

Pipeline Leak

API# 05-103-08021

Facility ID# 230359

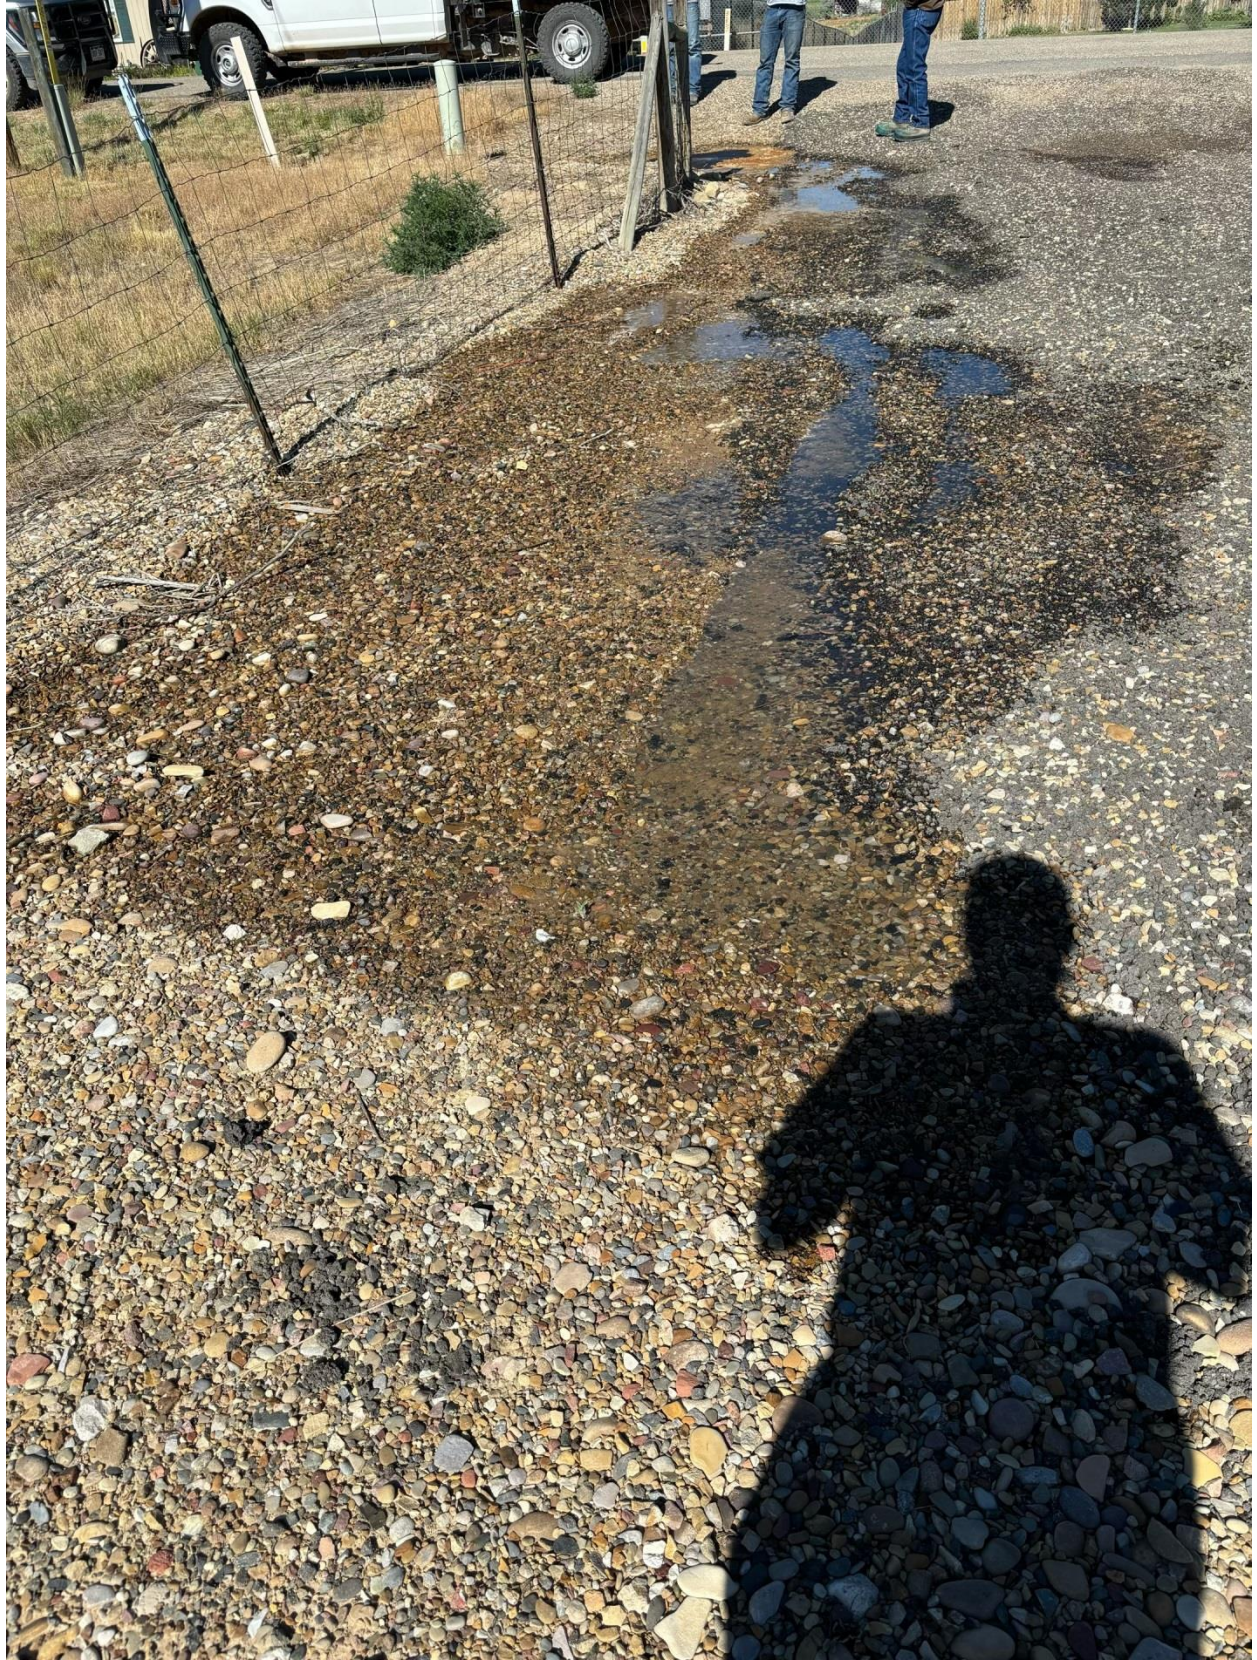
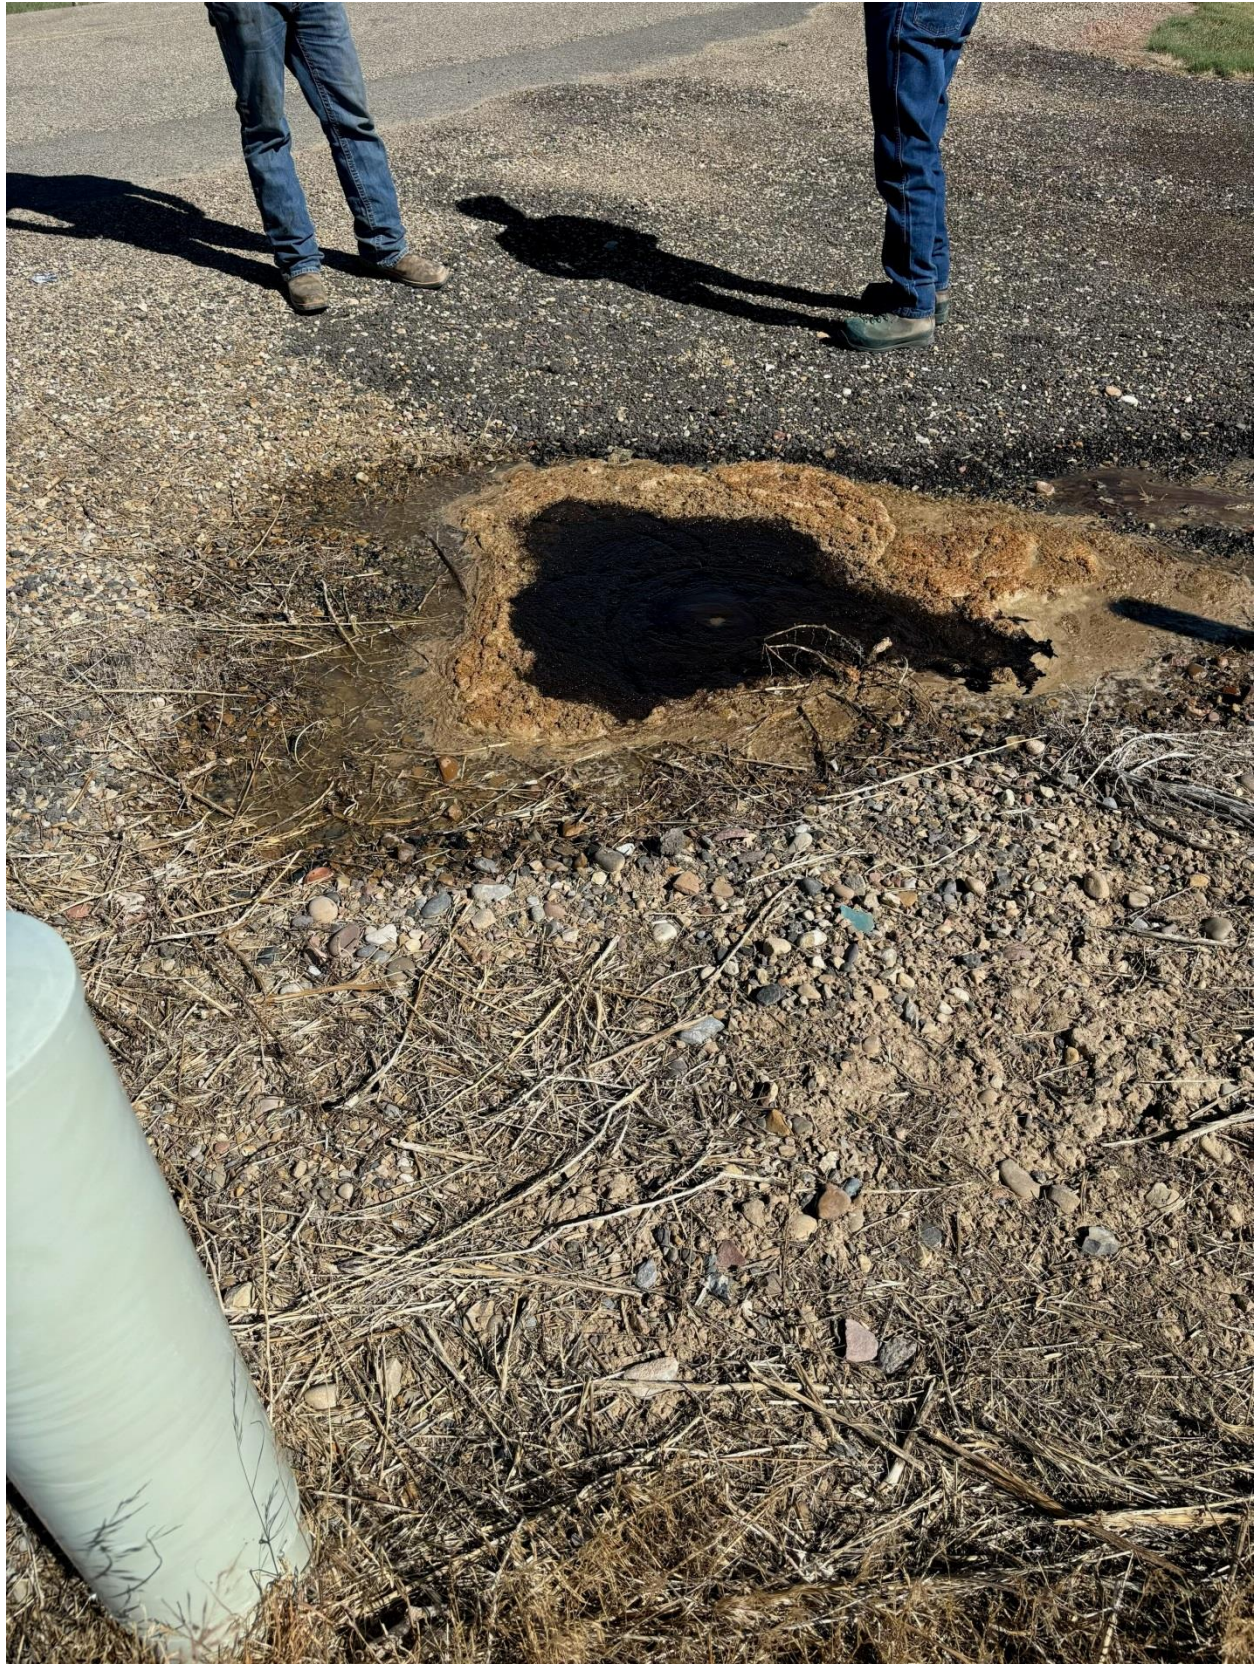
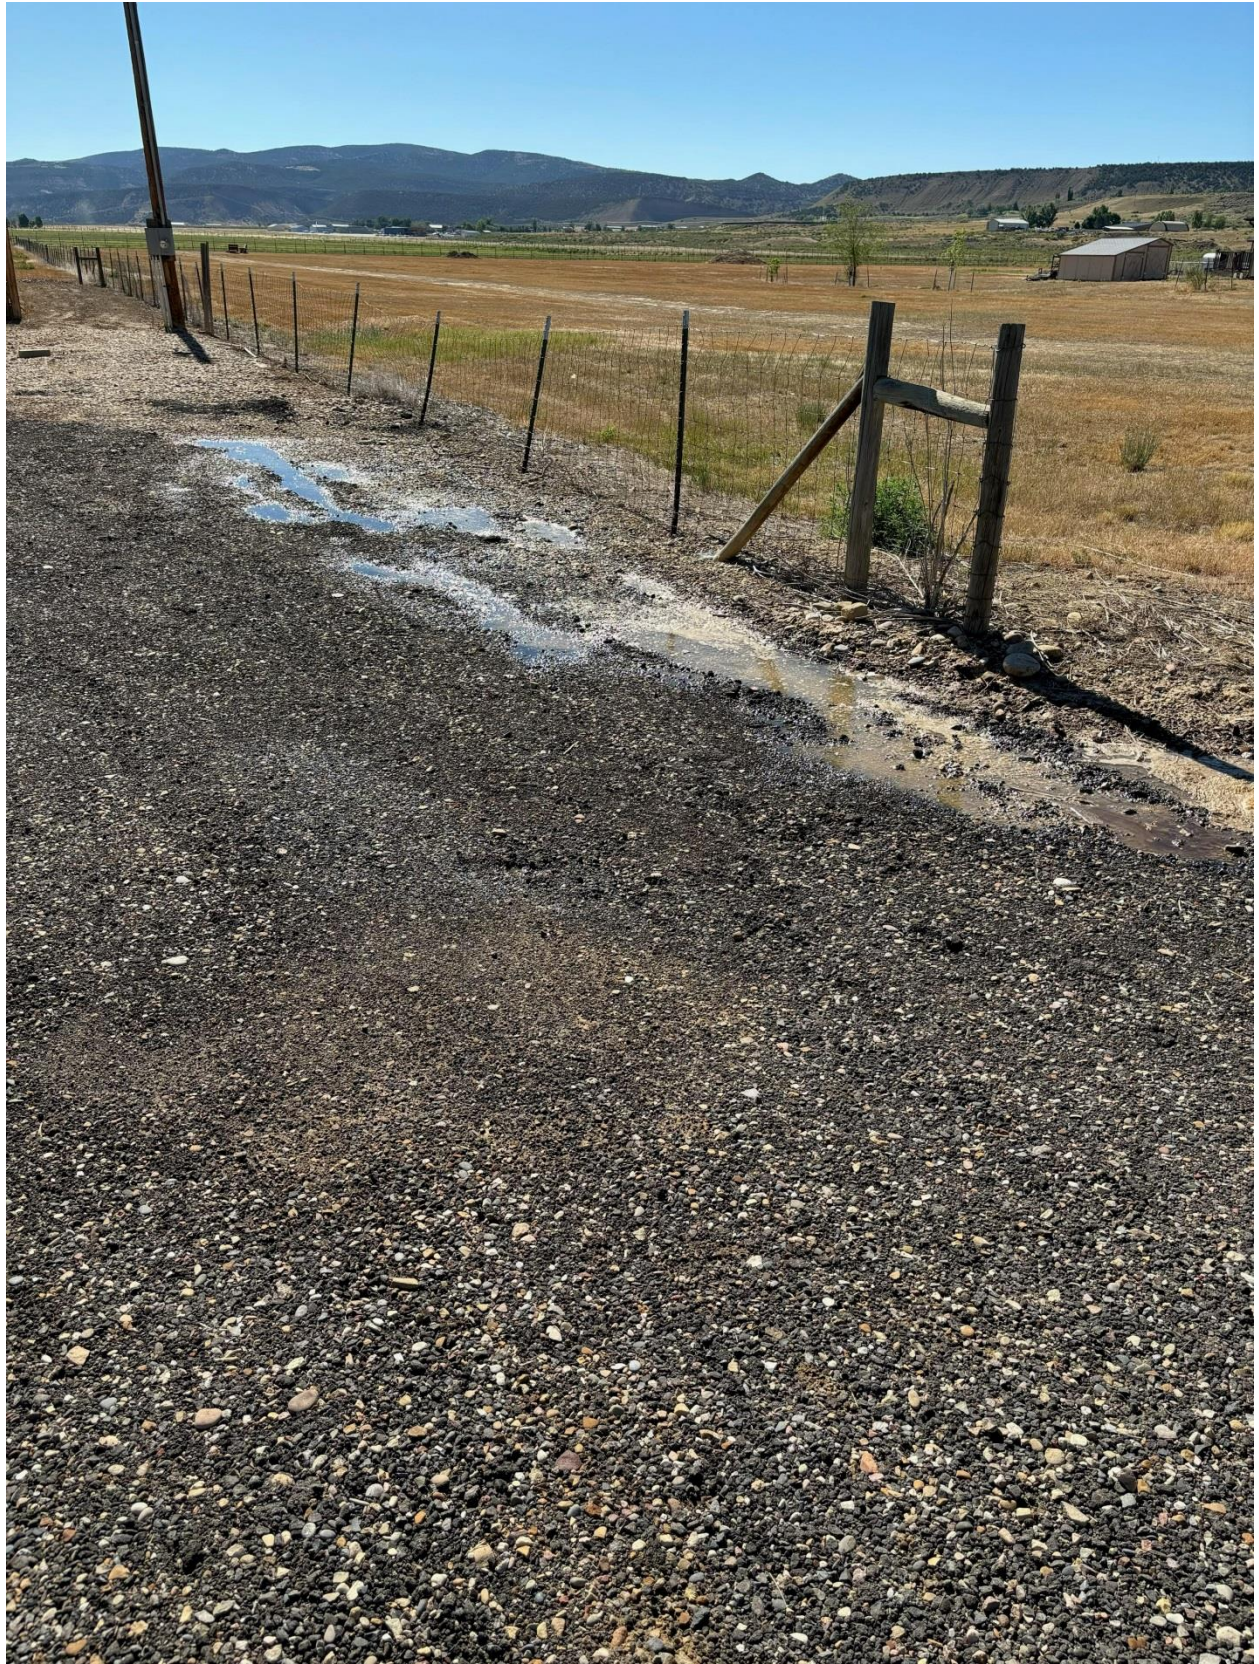
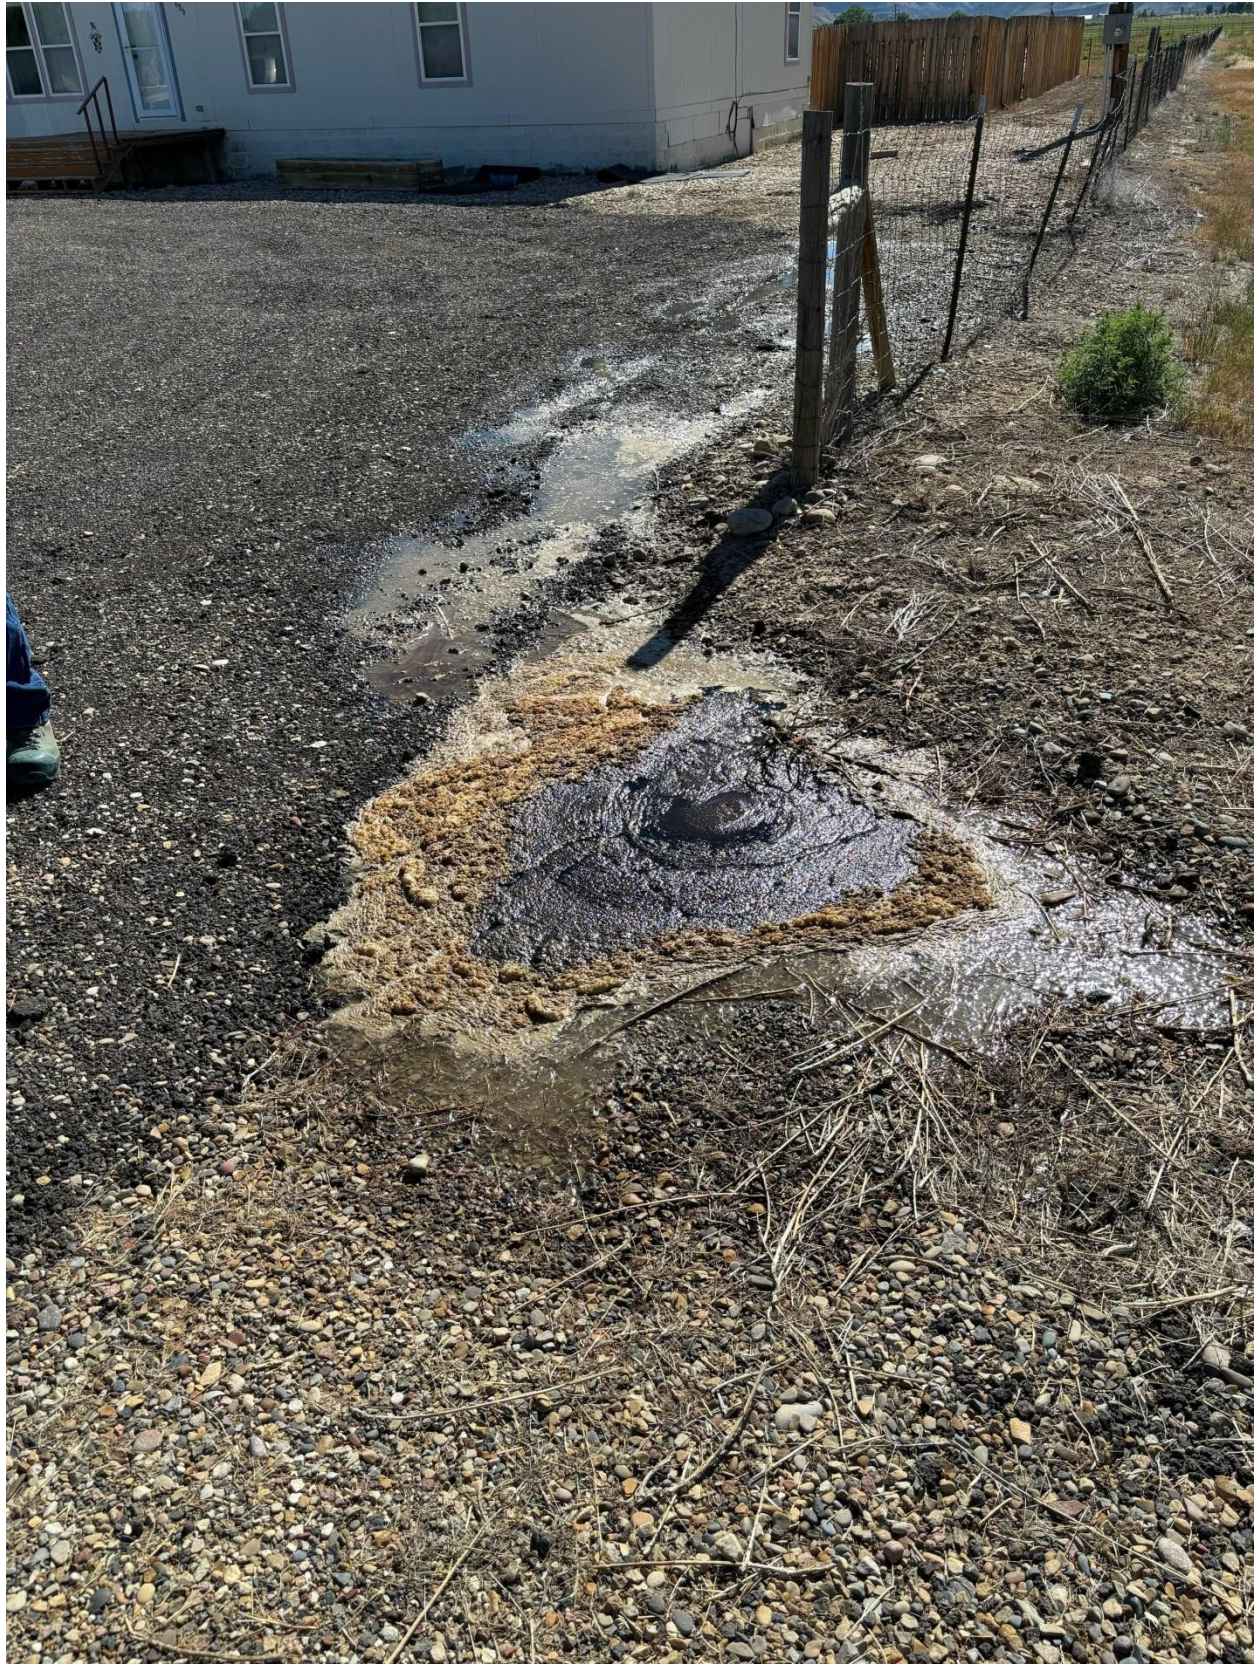
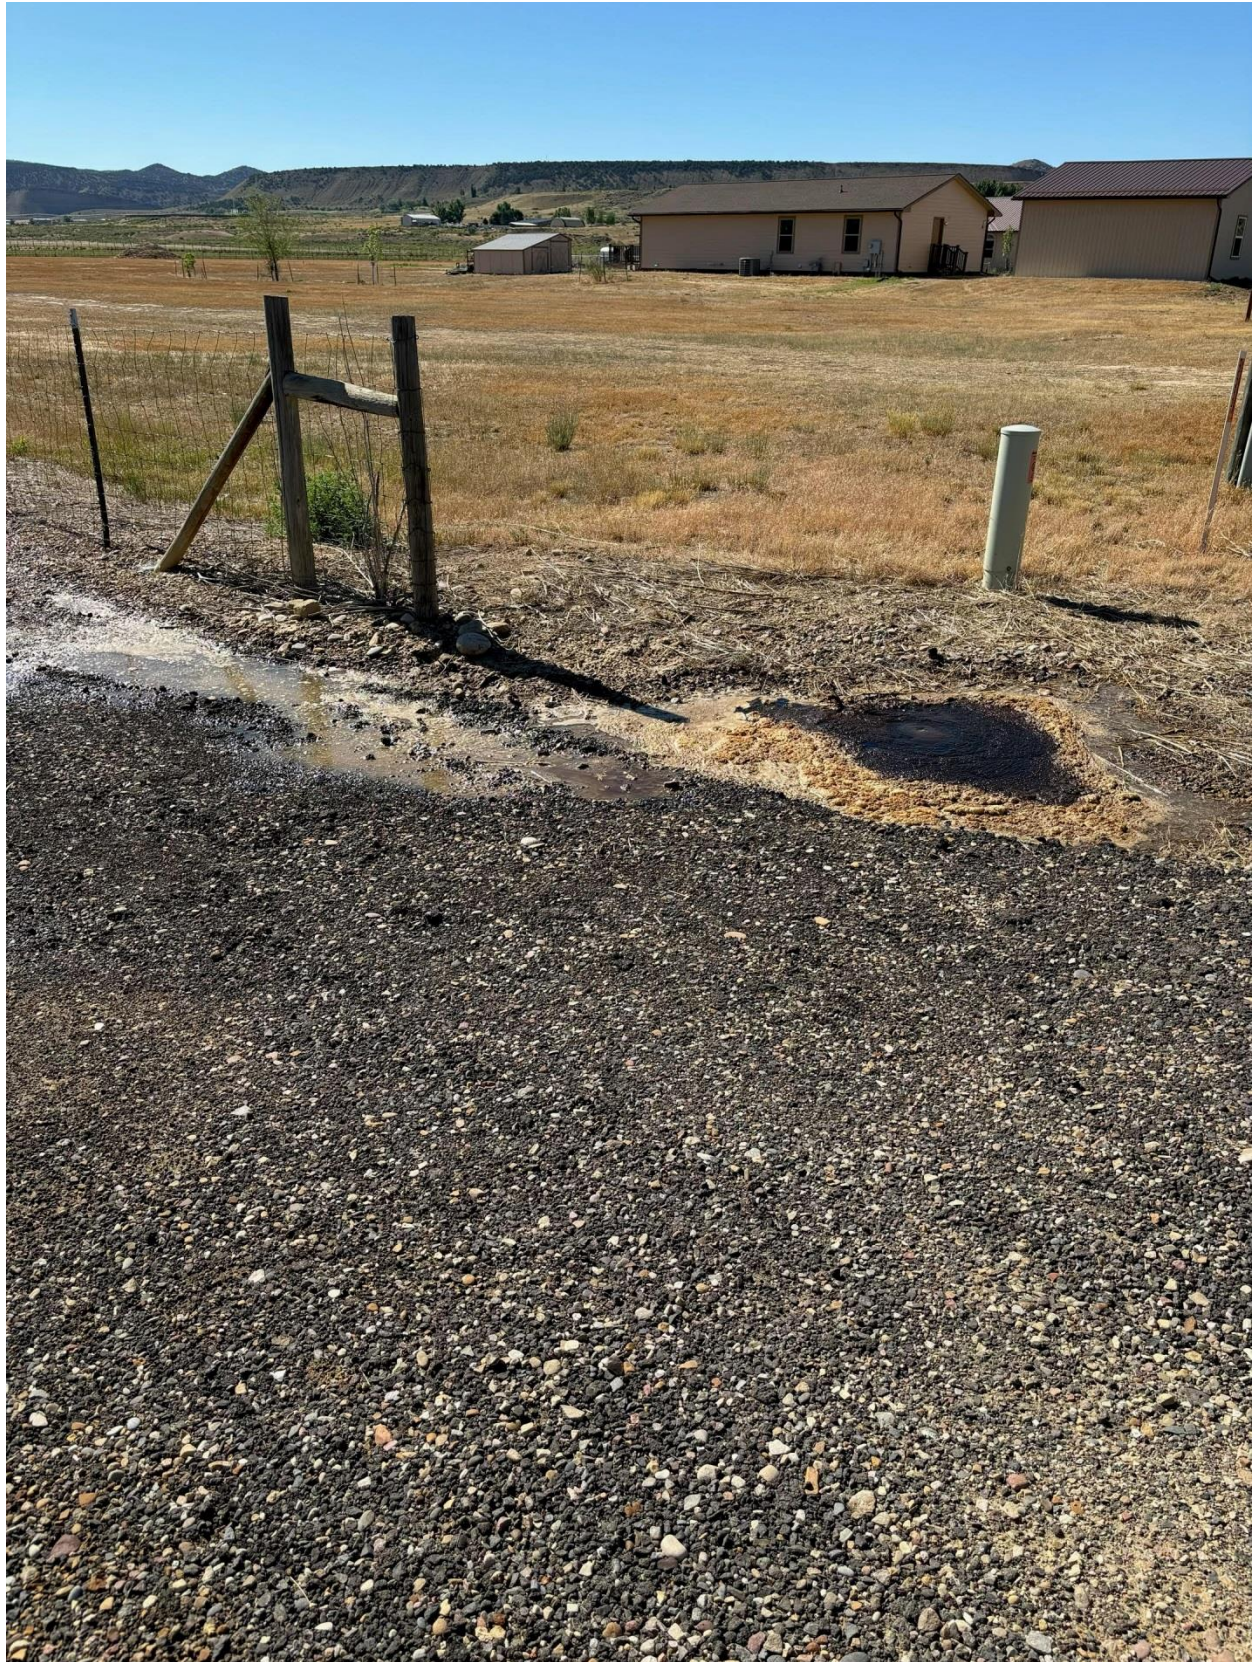
The pipeline leak was reported by the landowner at 886 County Road 101 at approximately 9:30am on 7/6/2024. The leak consisted of produced water/oil mixture, and daylighted from the subsurface. UGC field personnel responded to the spill and contacted local hydrovac company Badger Daylighting, to remove the spill from the surface. The producing well associated with this leak is the Hill 9-31 (API# 05-103-08021 Facility ID# 230359), which was shut-in immediately following leak notification from the landowner. The leak occurred on the gathering line between the well head and associated tank facility at approximately LAT/LONG: 40.096434/-108.772215. Approximately 1-2 barrels of fluid (oil/produced water) daylighted from the subsurface.

The following photos were taken at 9:45am on 7/6/2024 by the UGC personnel that responded to the spill/release.

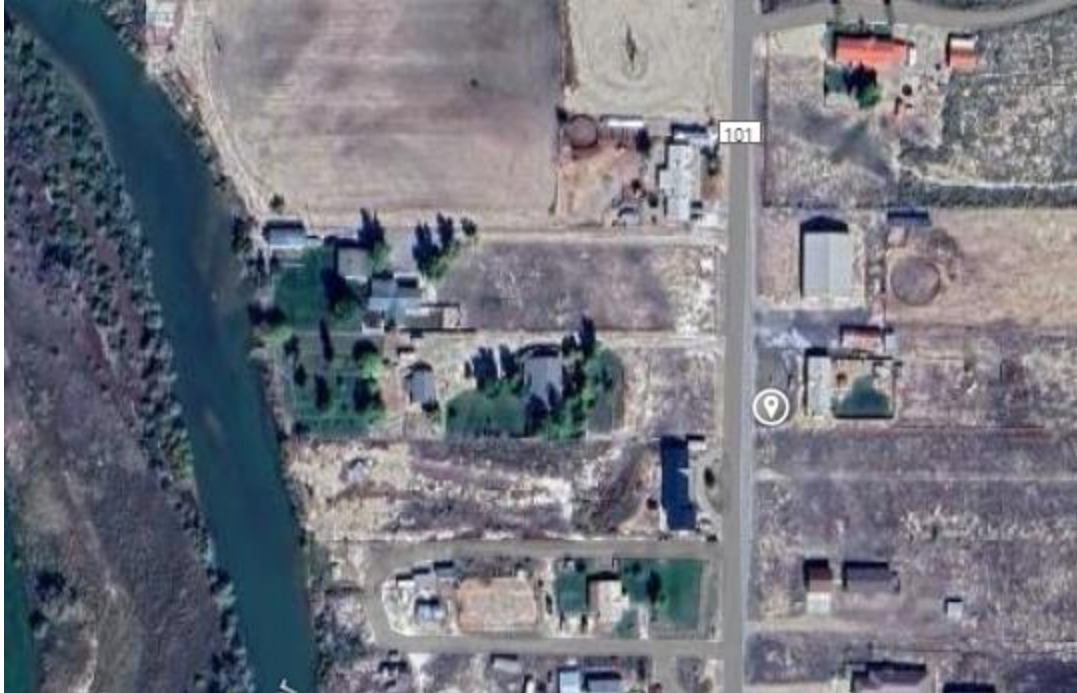
Location of the spill/release in comparison to the White River.

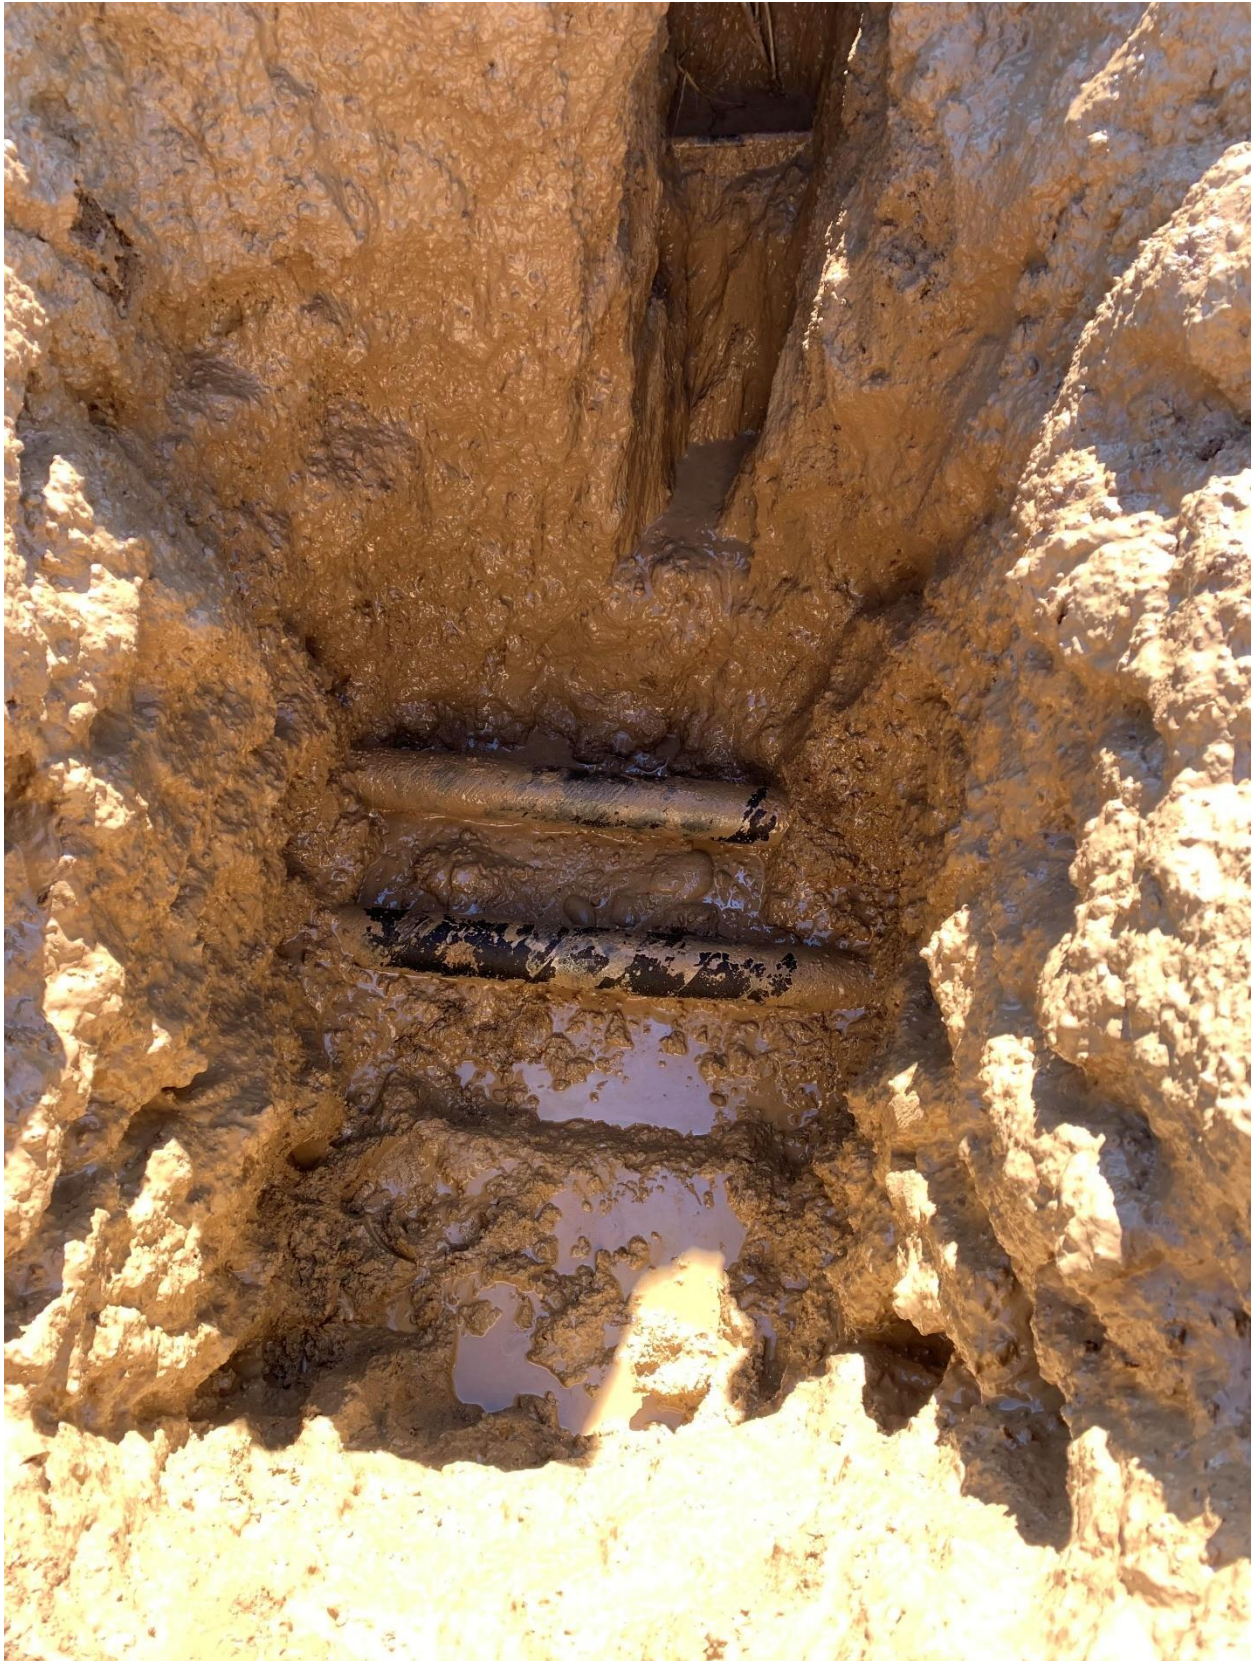
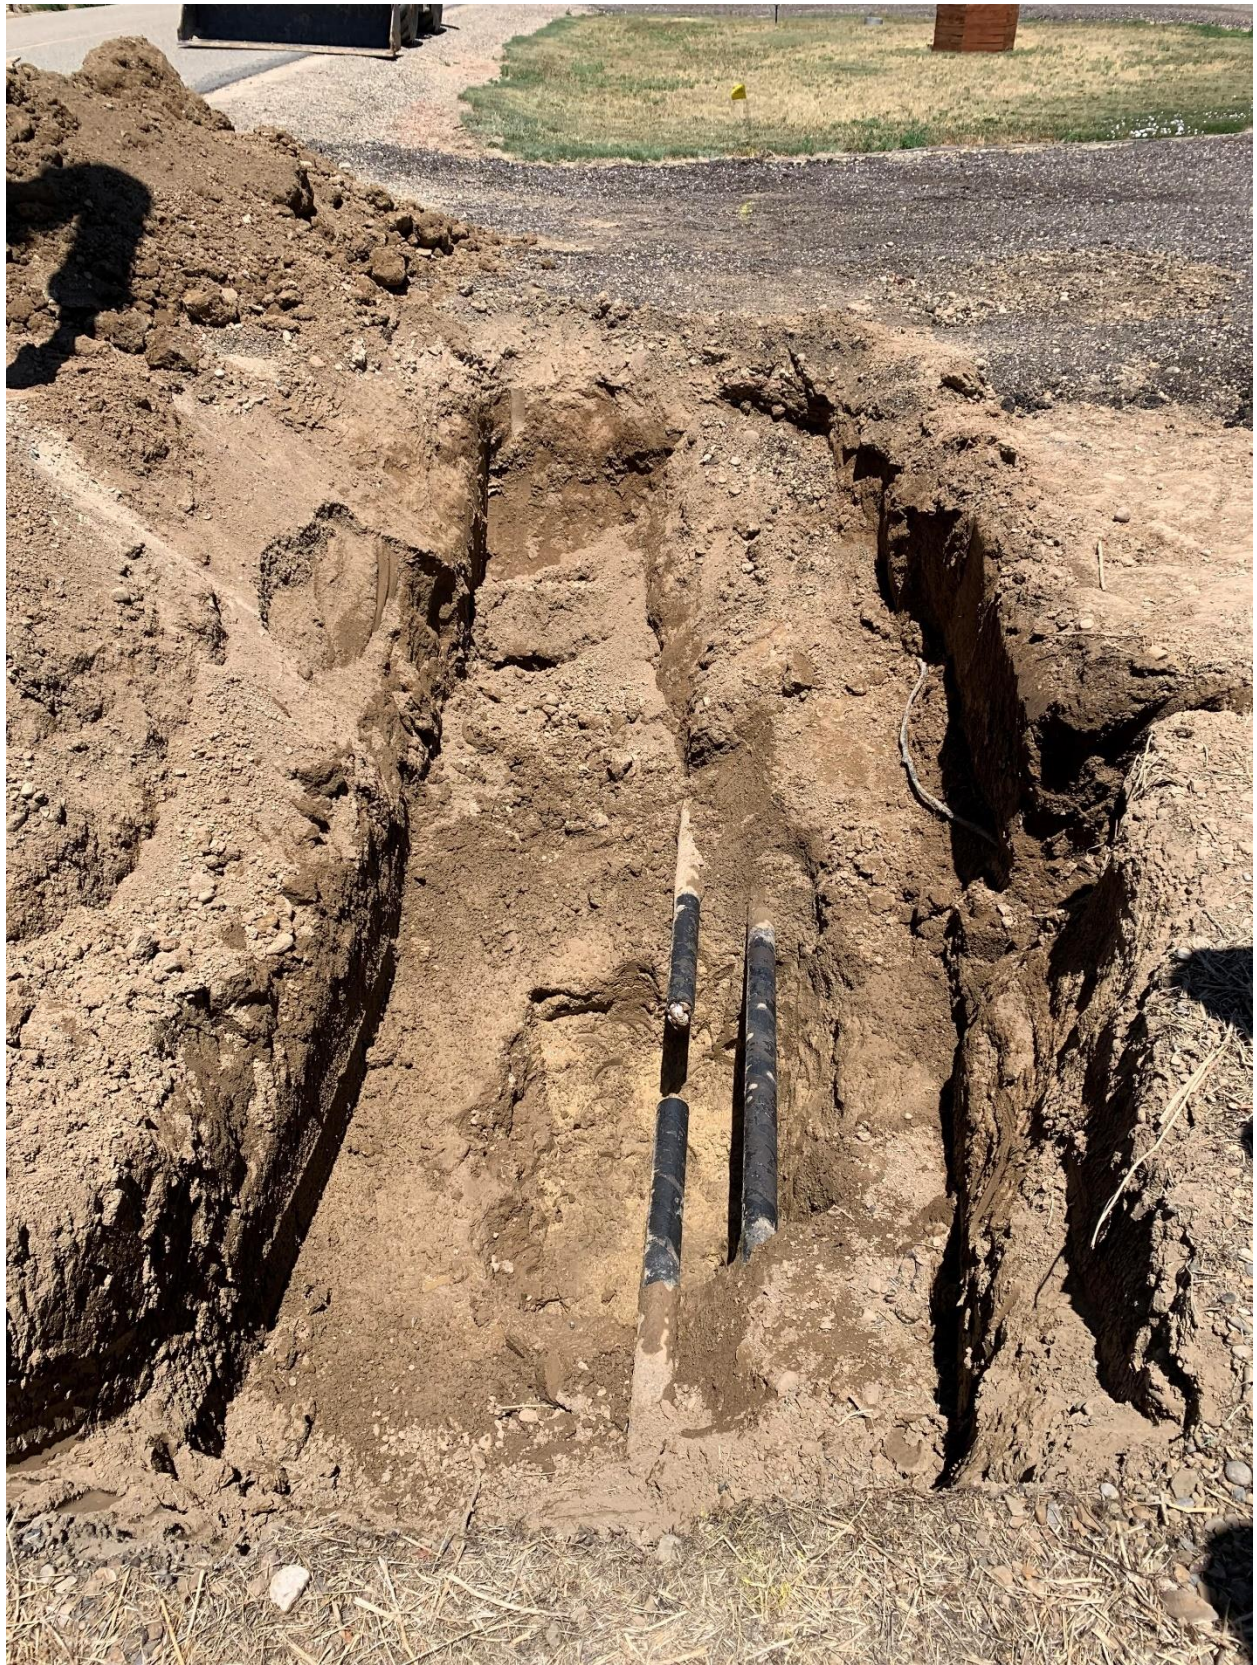
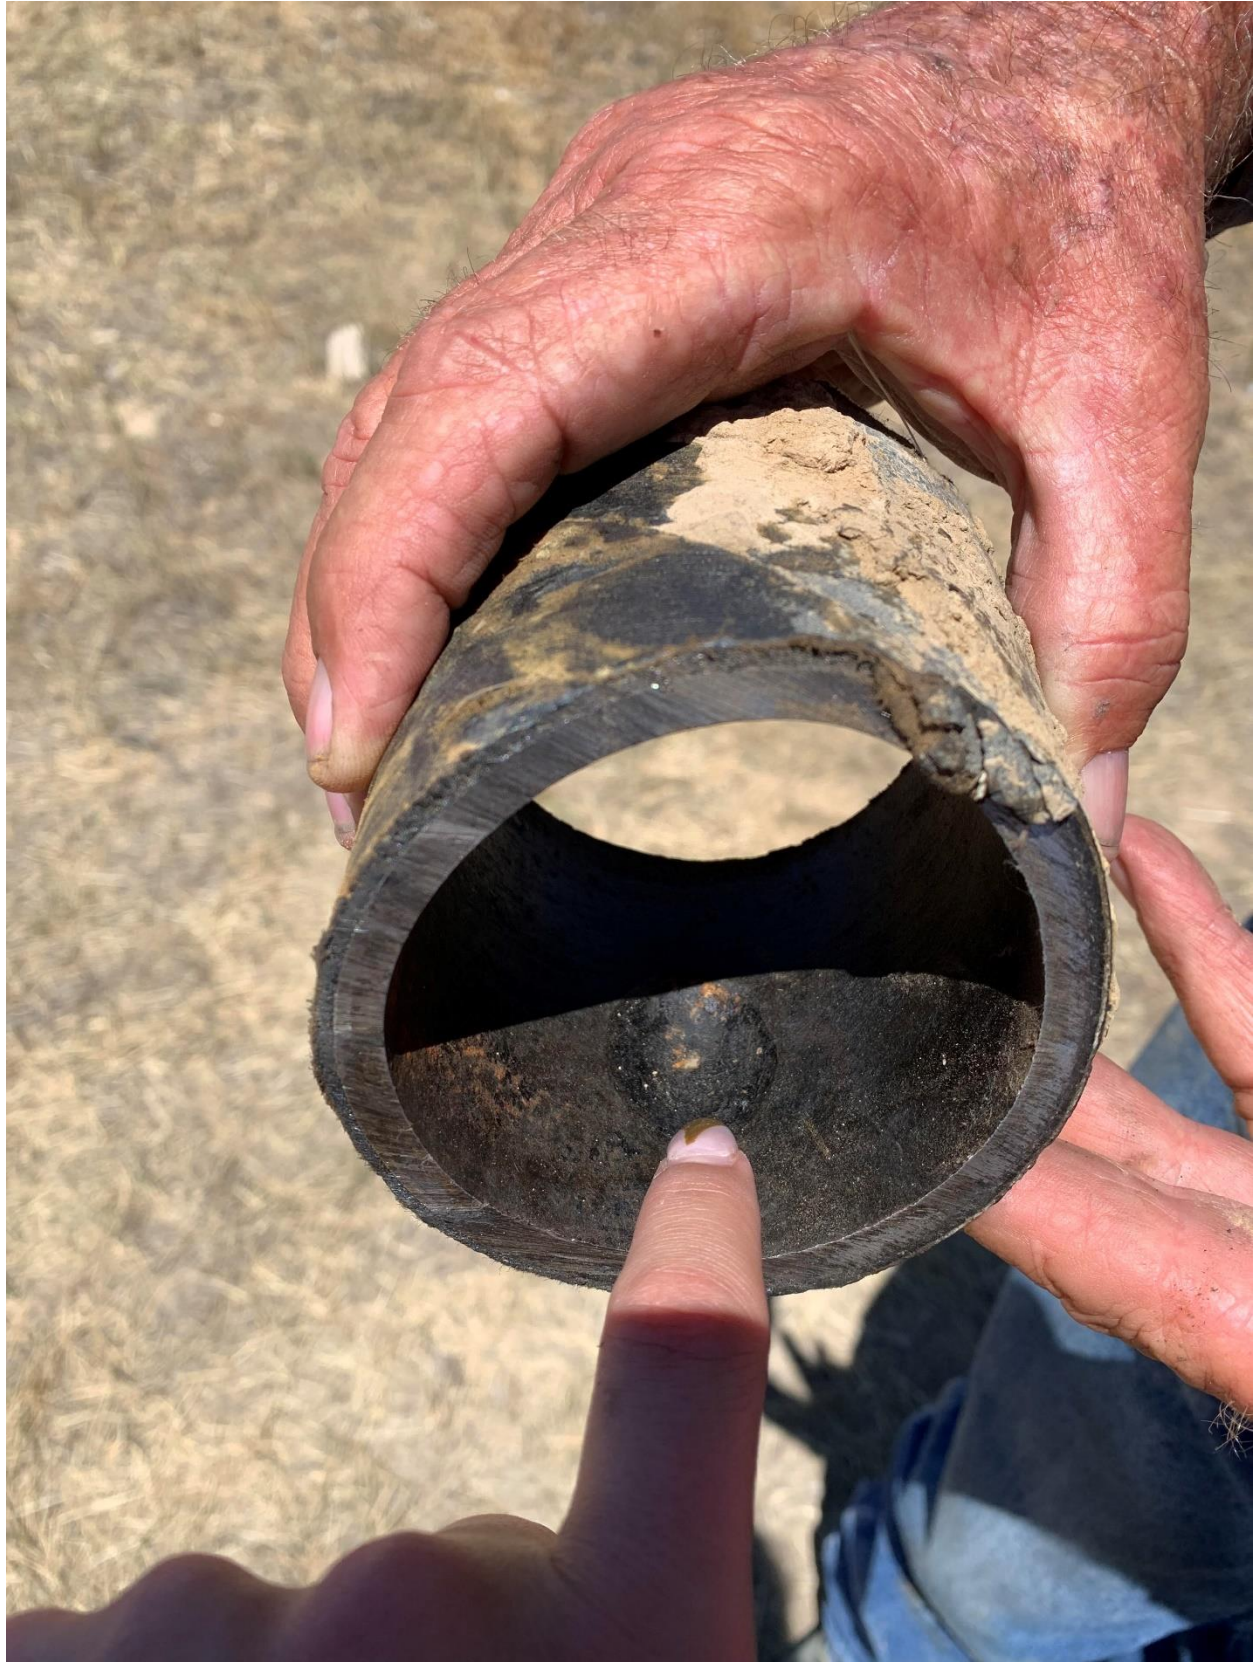
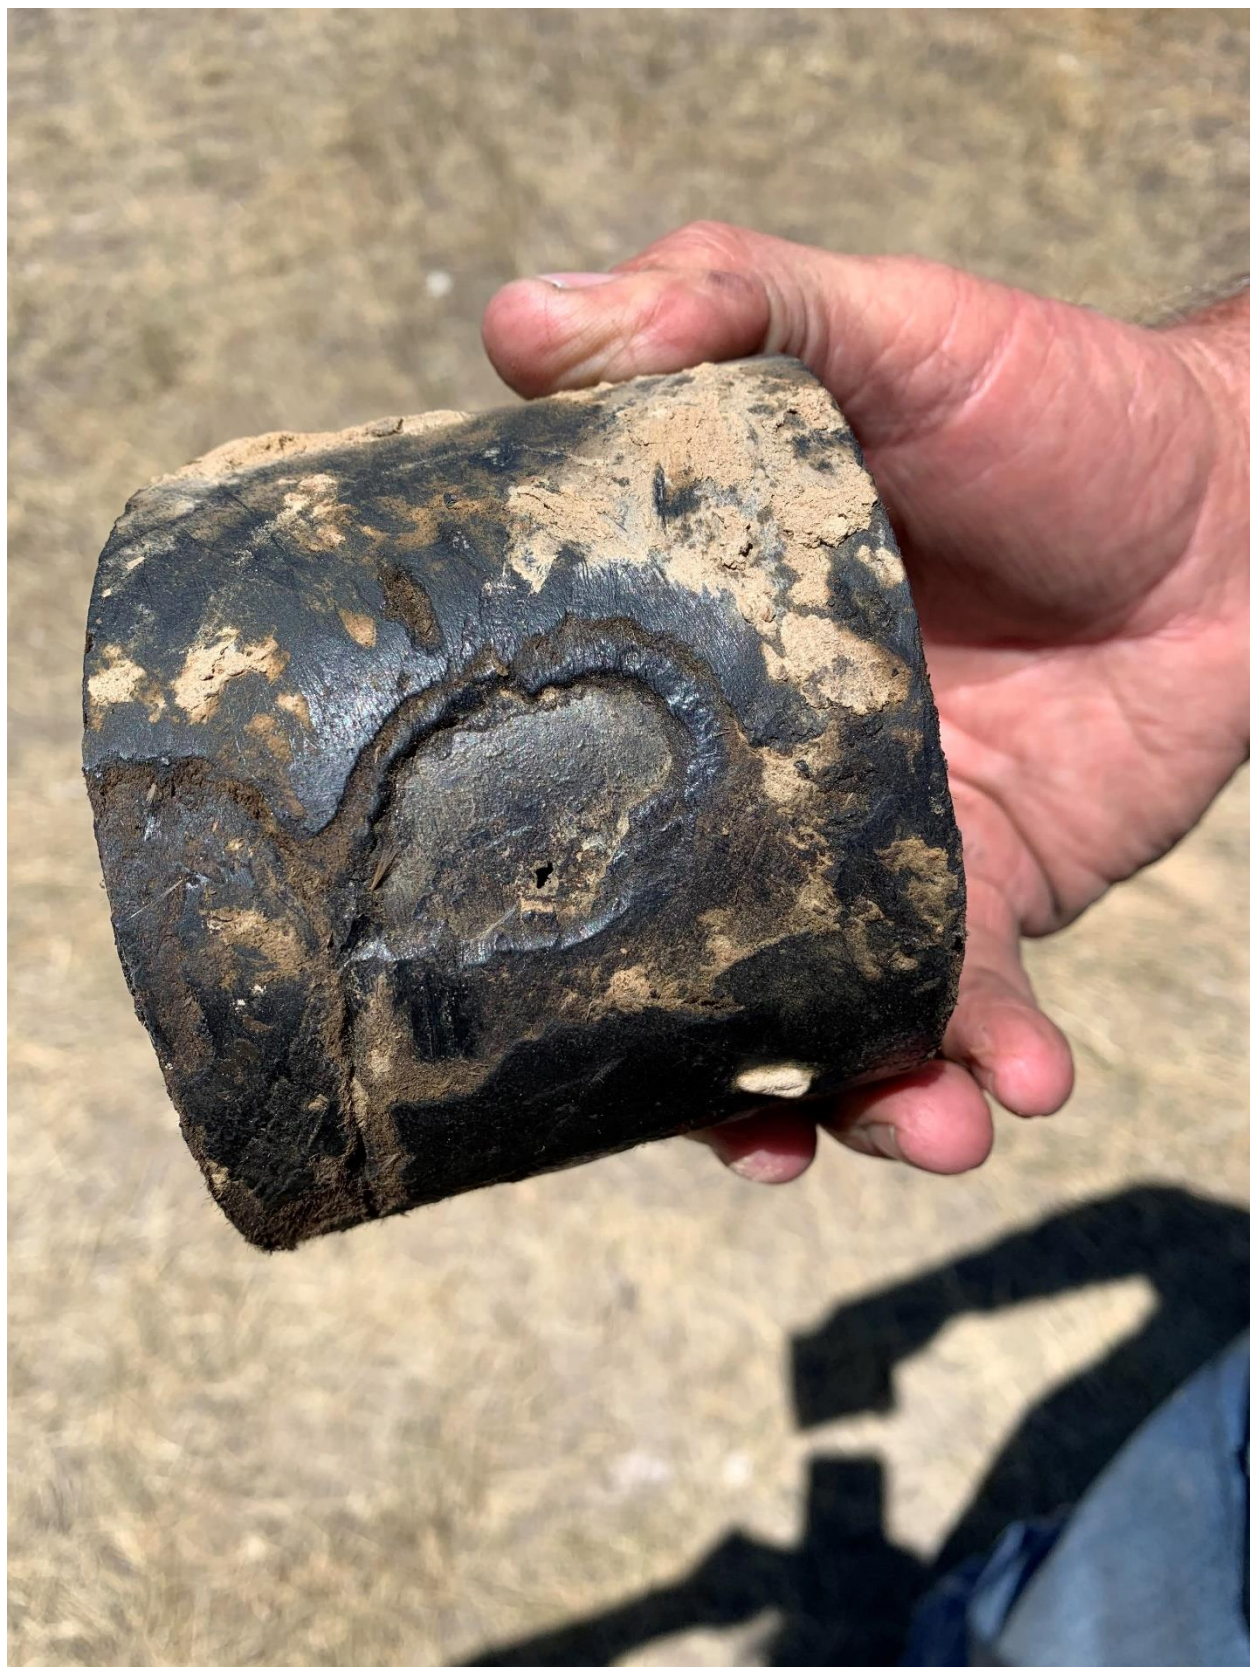
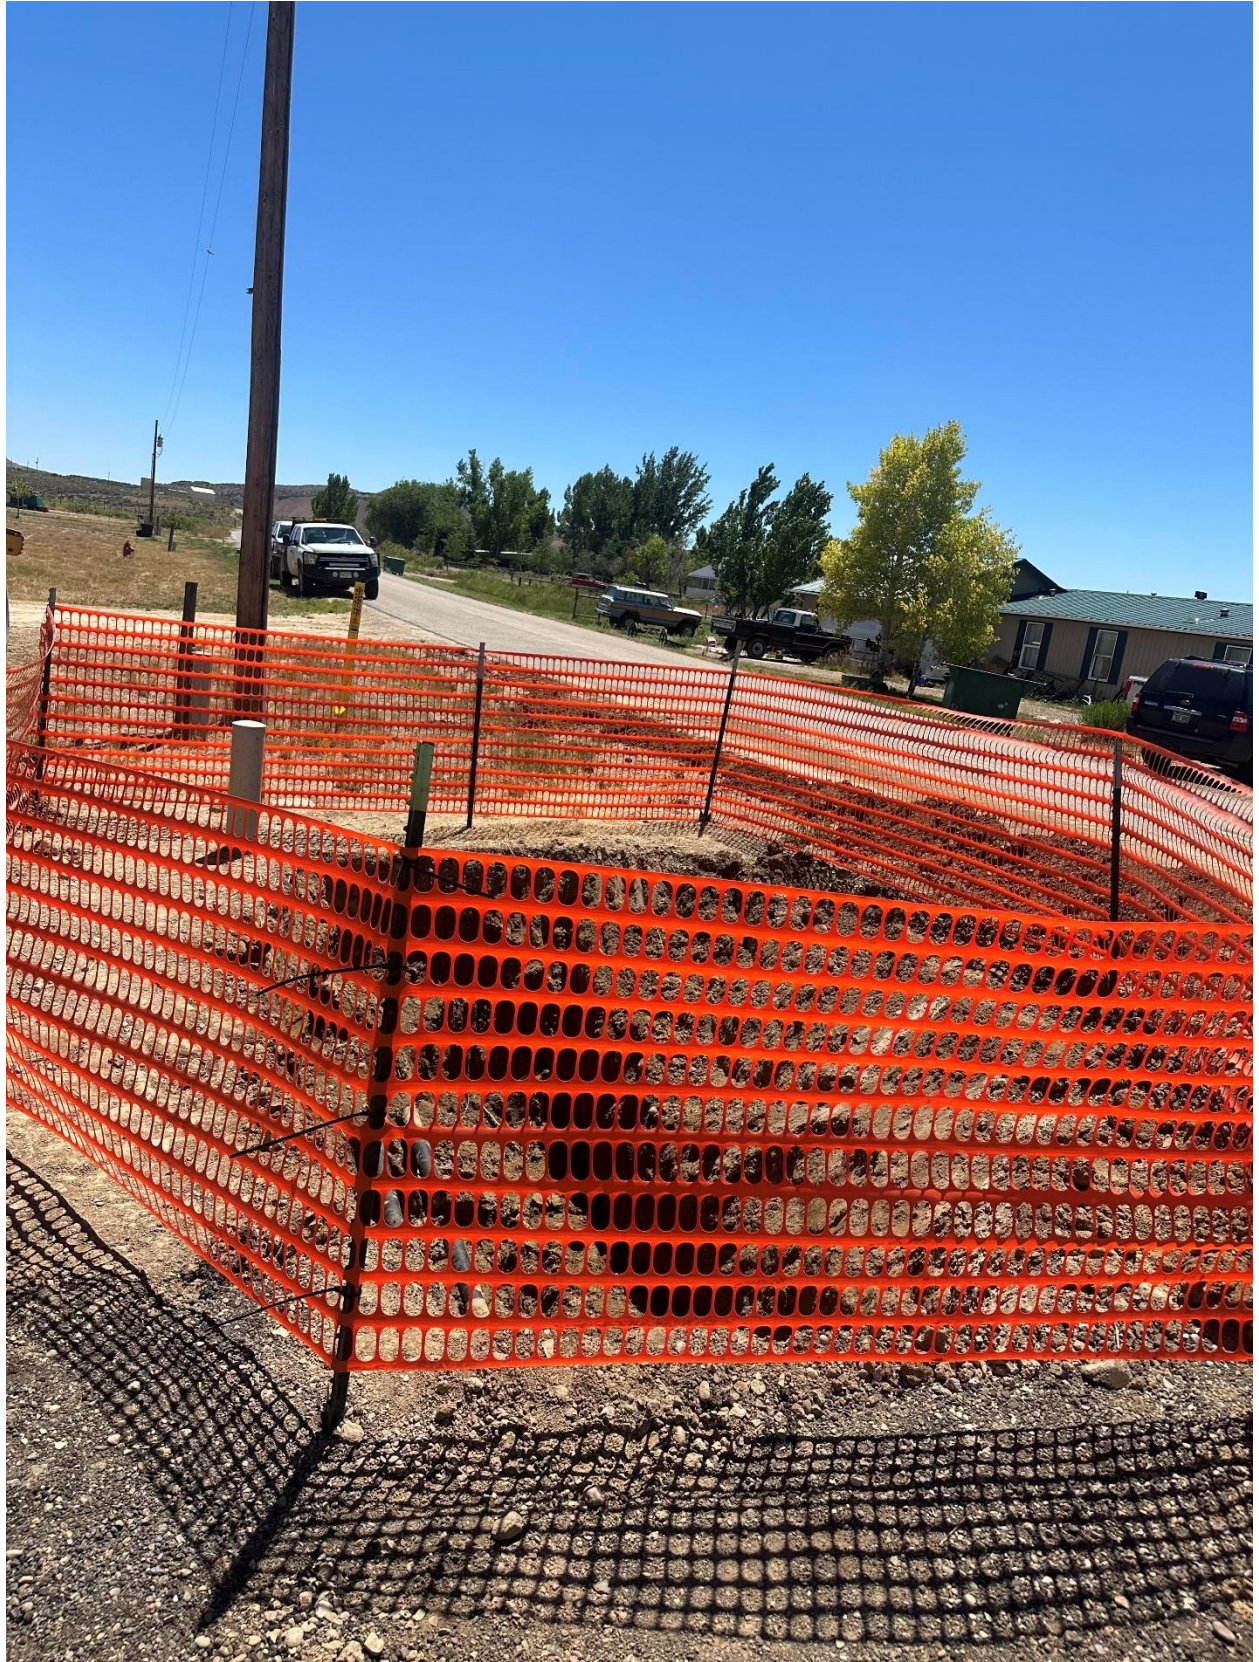
Photos From 7/8/2024

On 7/8/2024, UGC personnel arrive at the location of the pipeline leak with Badger Daylighting to further excavate the impacted area. Badger Daylighting (hydrovac) was used to carefully excavate the affected pipeline, as other lines were in the area. Once the affected line was opened, UGC utilized a backhoe to trench the line to find the hole in the pipeline. The hole was found in the east side of the pipe in the three o'clock orientation. The hole in the pipeline is about the size of a pen tip. During site excavation, dense clay was found at approximately 4-7ft depth. The excavation was opened to a total of 17ft in the north/south direction, 10ft in the east-west direction, and to a depth of 7ft. All material removed from the excavation and stockpiled nearby. The impacted section of pipeline was cut and removed, and a new segment of pipeline was welded into place.

5 soil samples were collected from the excavation walls (north, south, east, west, and bottom). No background samples were collected, as UGC has two other remediation projects within a 0.50mile radius. UGC is requesting the consideration of the nearby background samples for this project. No groundwater was encountered during site excavation, if groundwater is encountered, it will be sampled as part of this remediation project.

The excavation was fenced off and left open while UGC awaits soil sample results to determine if further excavation and delineation is required.
