Hill 9-31

Pipeline Leak

API# 05-103-08021

Facility ID# 230359

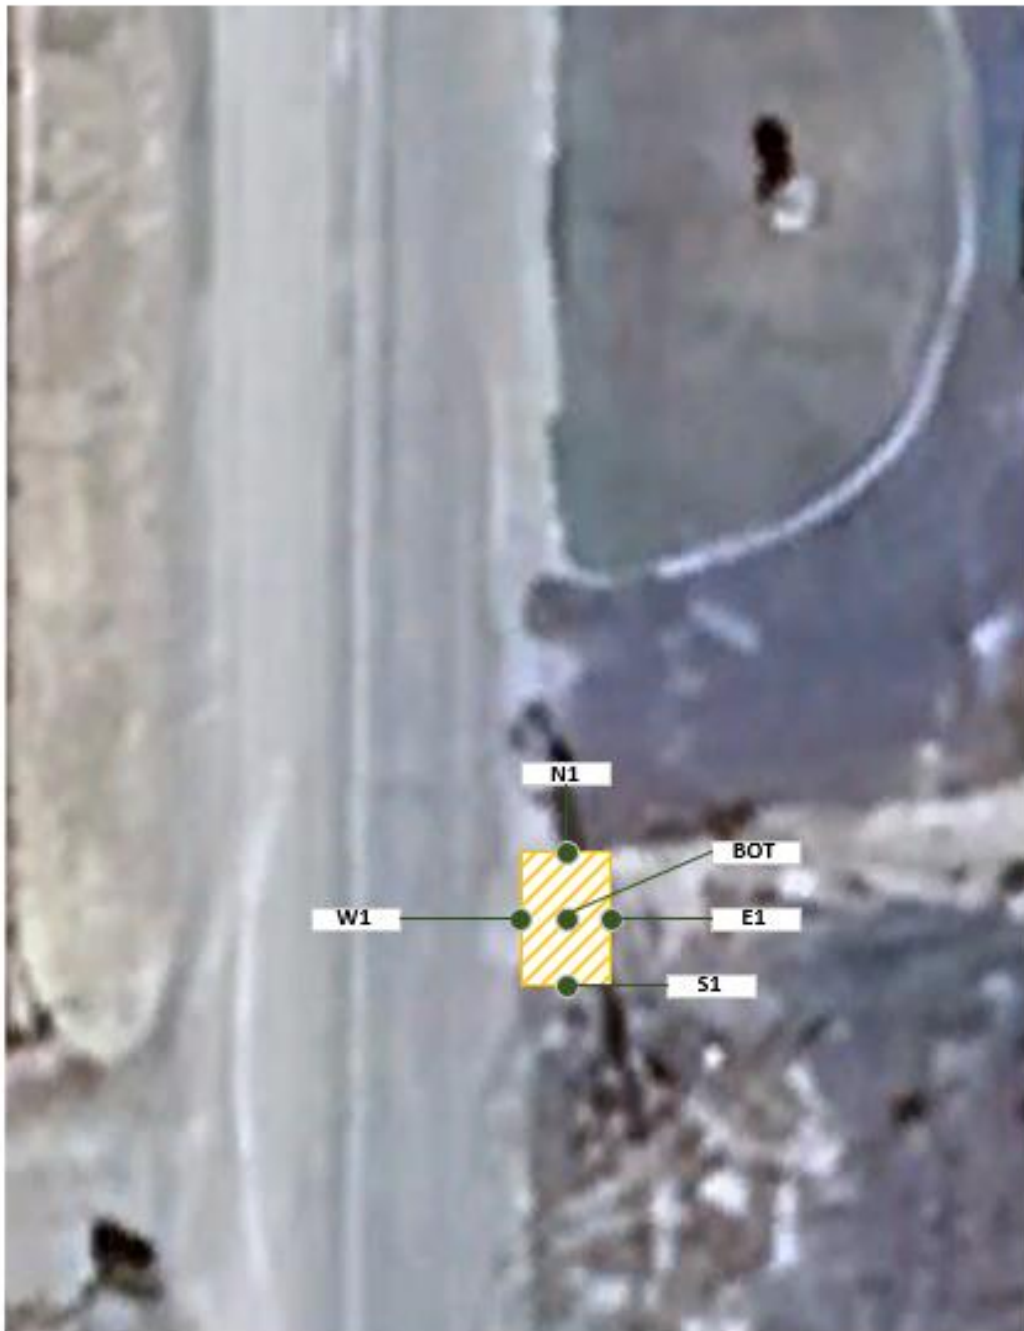
Hill 9-31 Pipeline Leak Diagram API# 05-103-08021	
Area: Rangely	
Legal: NESW 31 2N101W 6	
7/9/2024	Drawn By: Dana Pollack
Revision Date: NA	Scale: Not Applicable

Utah Gas Corp has received the initial soil sample results from the Hill 9-31 pipeline failure. Samples were collected from the points illustrated in the above diagram. The samples were returned with overages in TPH at the S1 and W1 locations. Overages in SAR and EC were also reported in varying locations. Utah Gas Corp is scheduling to excavate further and pull additional samples from the affected walls. All excavated material will be hauled to an offsite disposal facility. Once the site tests within ECMC 900 regulations, UGC will back-fill the area with clean fill dirt.

During initial site investigation, no background soil samples were collected as Utah Gas Corp has two other recent remediations within a 0.60-mile radius of the spill/release. UGC is requesting consideration of these adjacent background samples but will also collect additional background samples during the next round of sampling and excavation.
