Inspection Photos

Operator: CHEVRON USA INC #16700

Location ID: 324350

Inspection Doc: 696206065

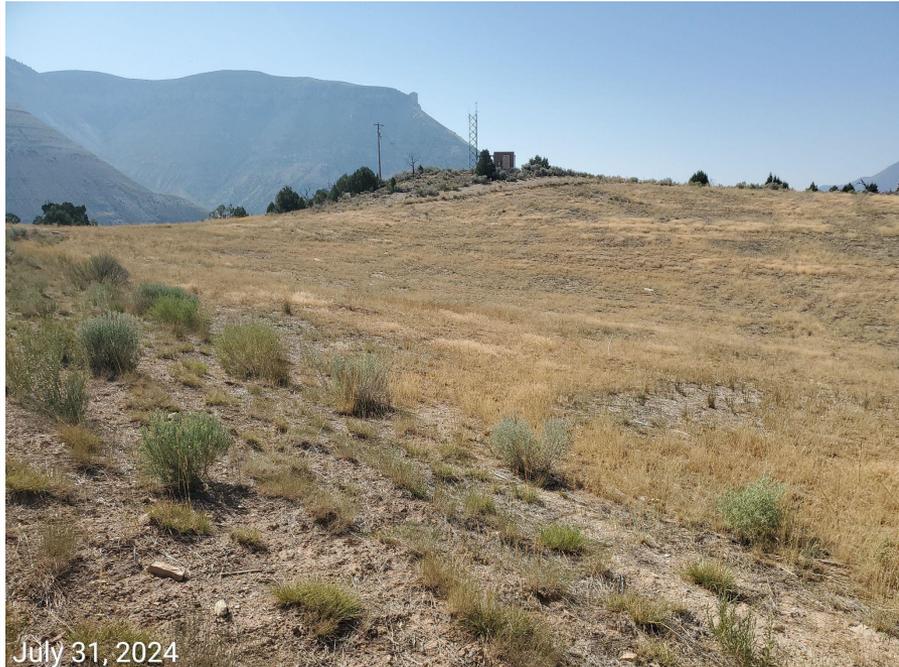
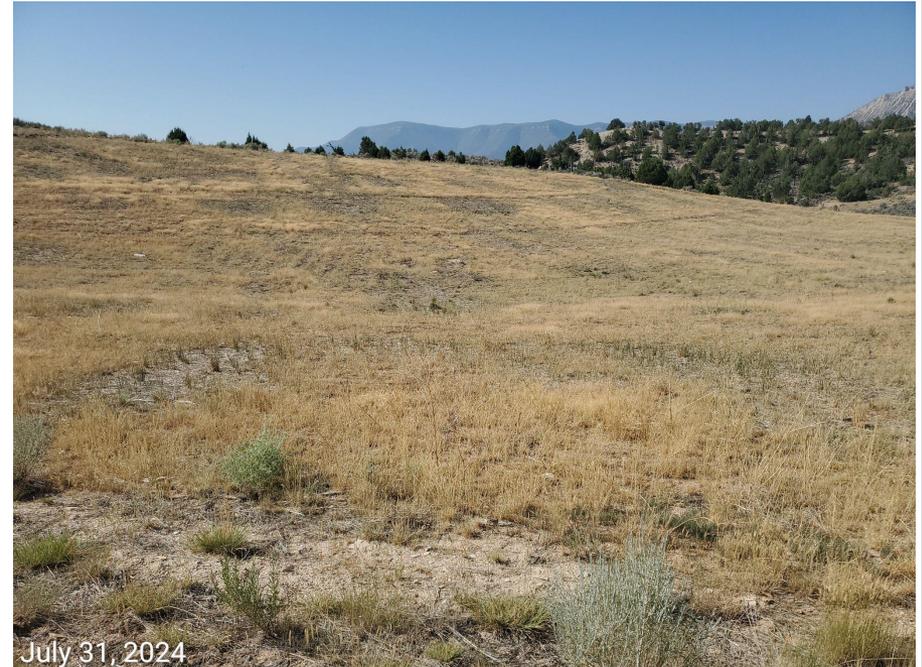
Photo 1: Photos 1-2 taken from the north end of the Location. Photos provide an overview of the Reclamation areas from east, southeast, southwest to west.

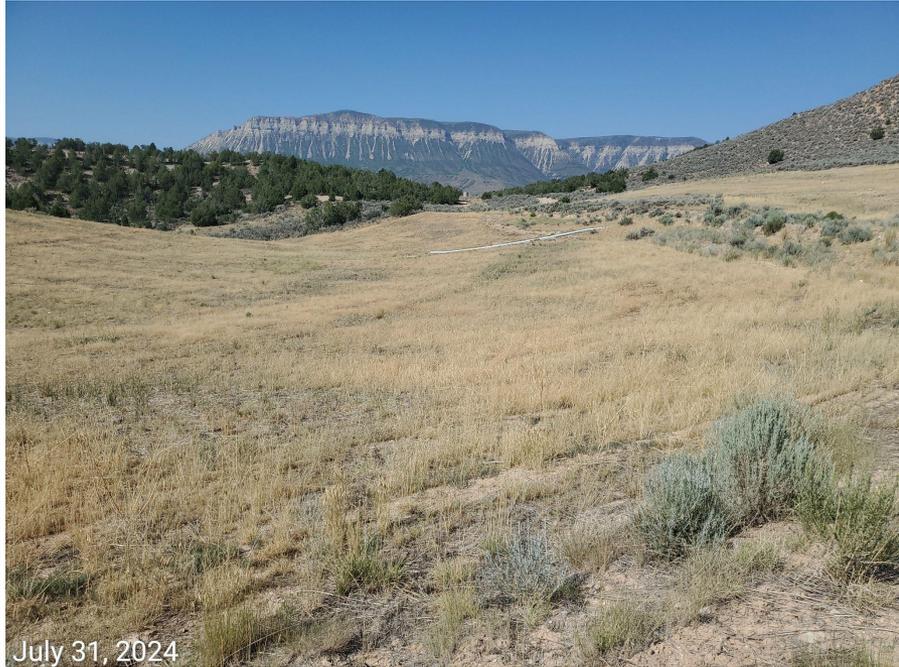
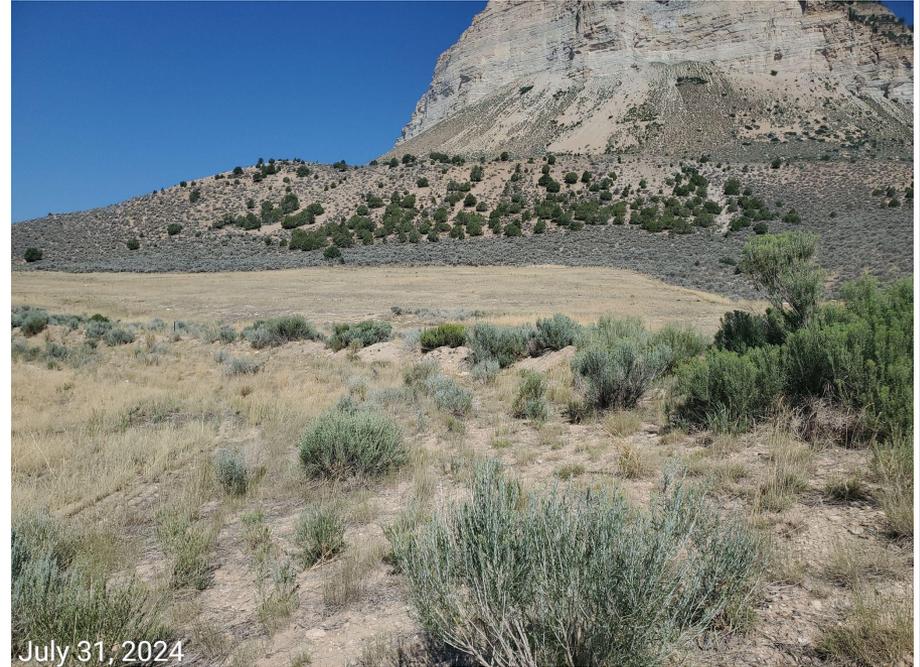
Photo 2: See comments under photo 1.

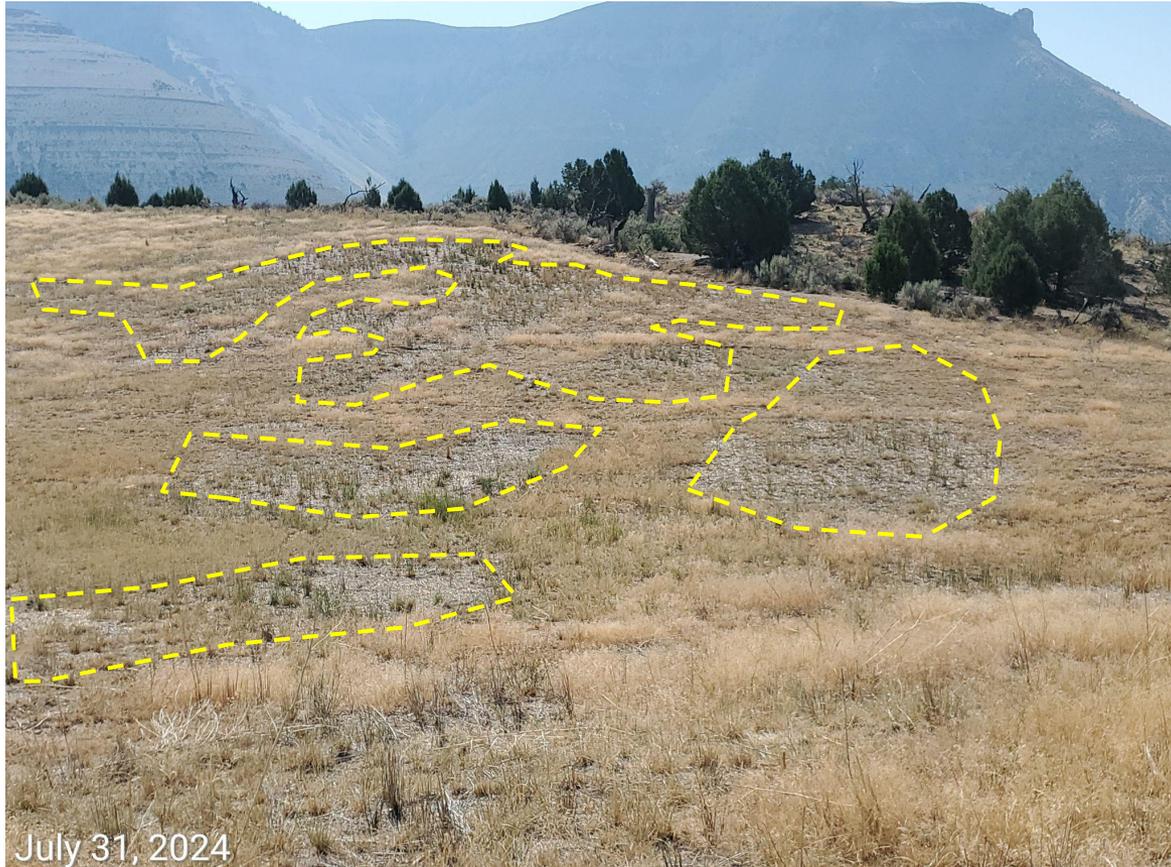
Photo 3: Photo example showing areas of the Location that do not appear to be progressing towards 1004 Standards; areas of concern observed on both eastern and western areas of the reclaim. Thick accumulation of straw mulch evident within these areas, and appears to be hindering reclamation.

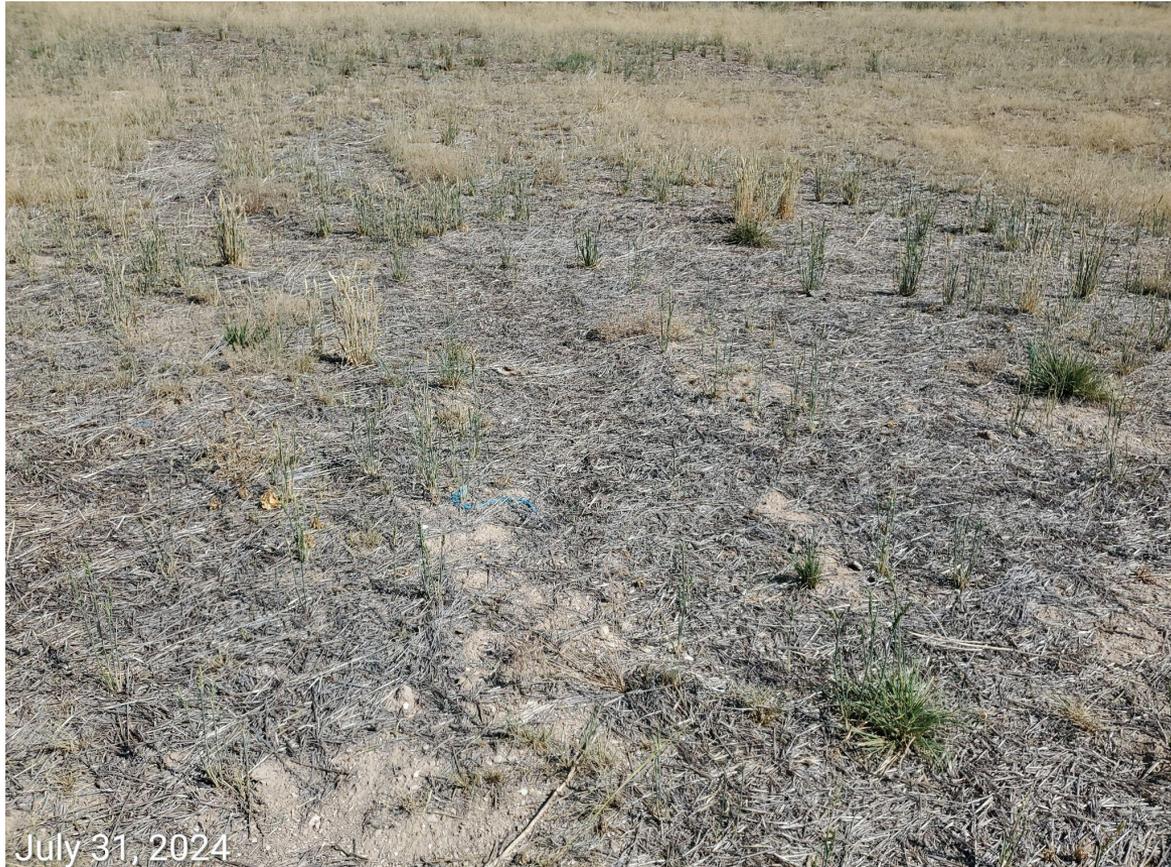
Photo 4: Continued from photo 3. Photo example areas of the Location that do not appear to be progressing towards 1004 Standards

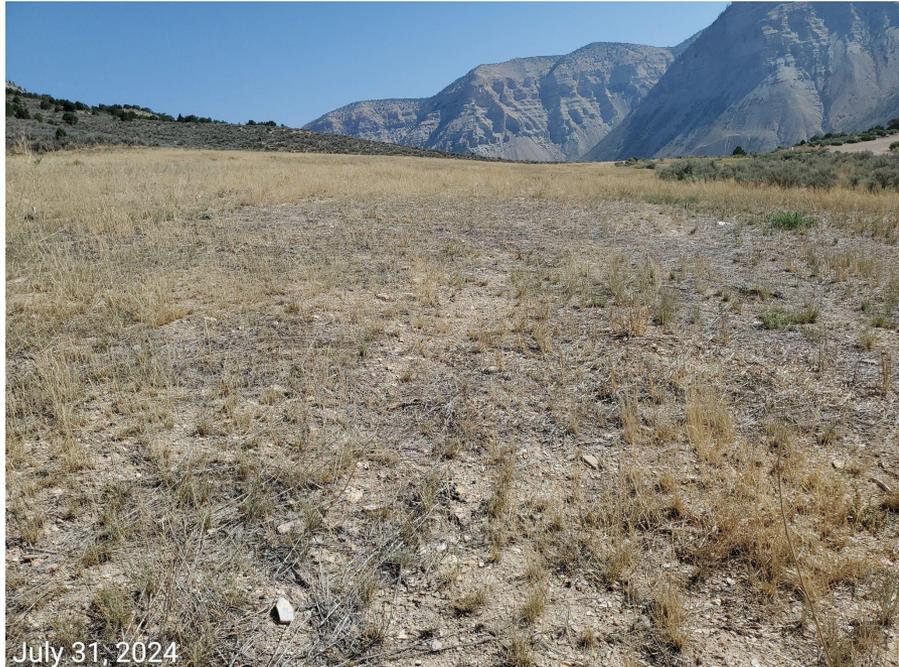
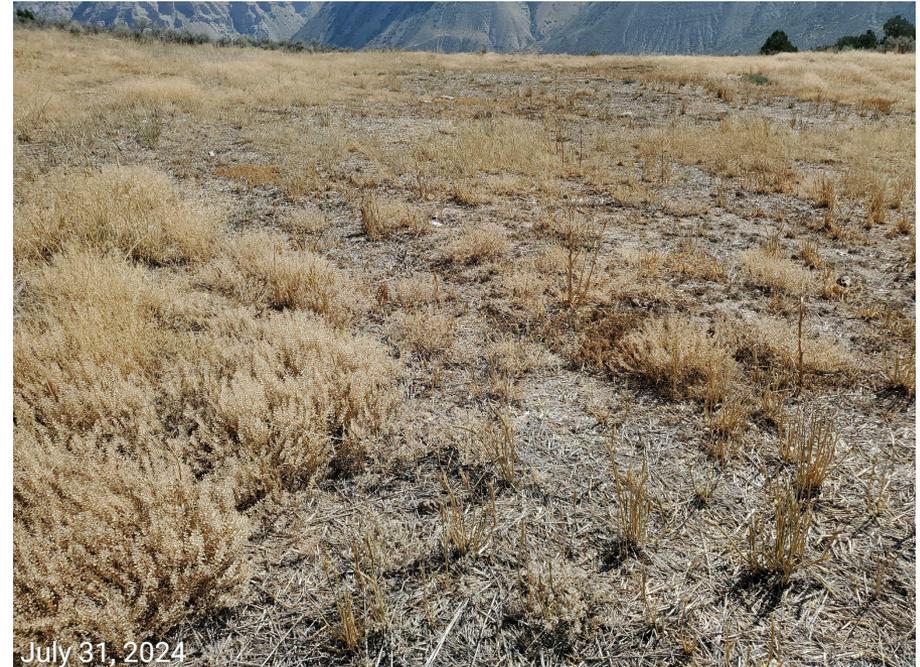
Photo 4: Continued from photo 3. Photo example areas on the west end of the Location that do not appear to be progressing towards 1004 Standards

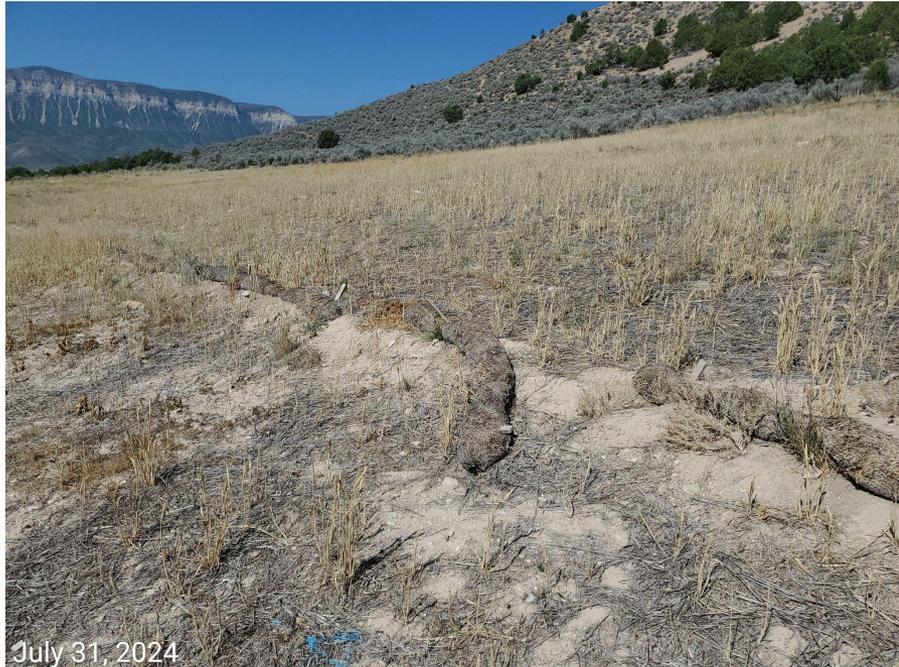
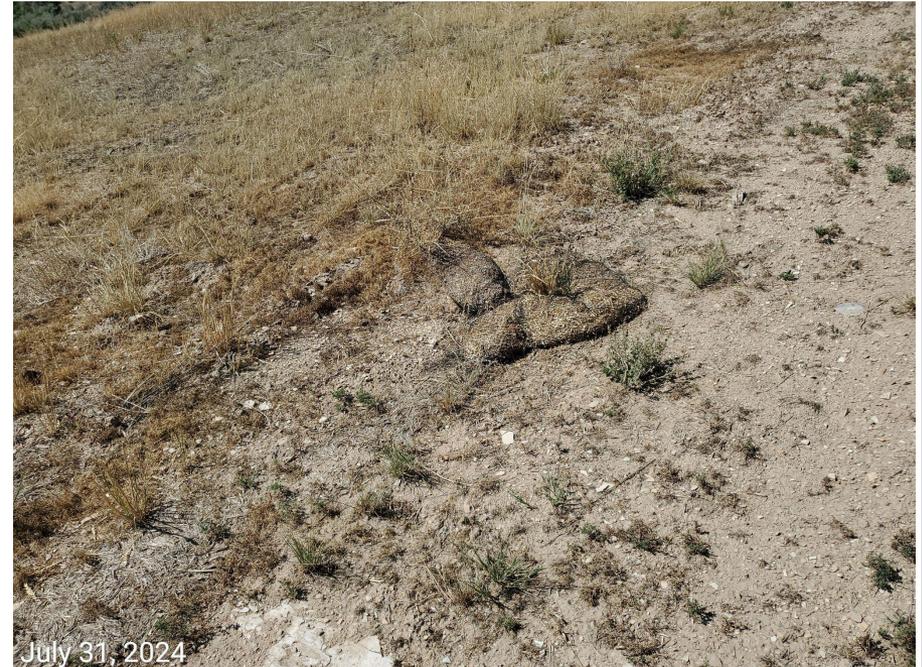
Photo 6: Photo examples showing sections of erosion logs observed throughout the Location in disrepair.

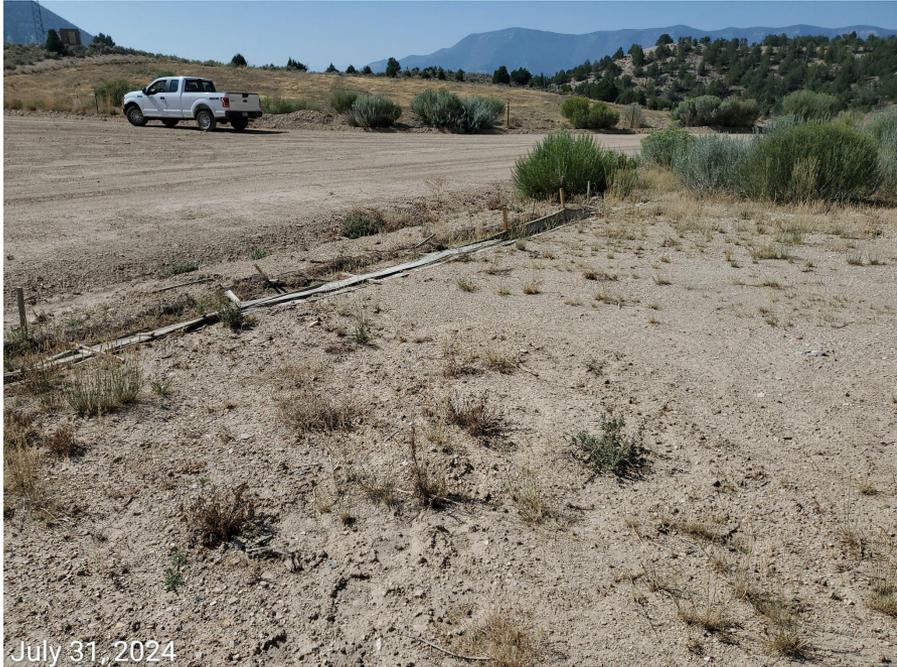
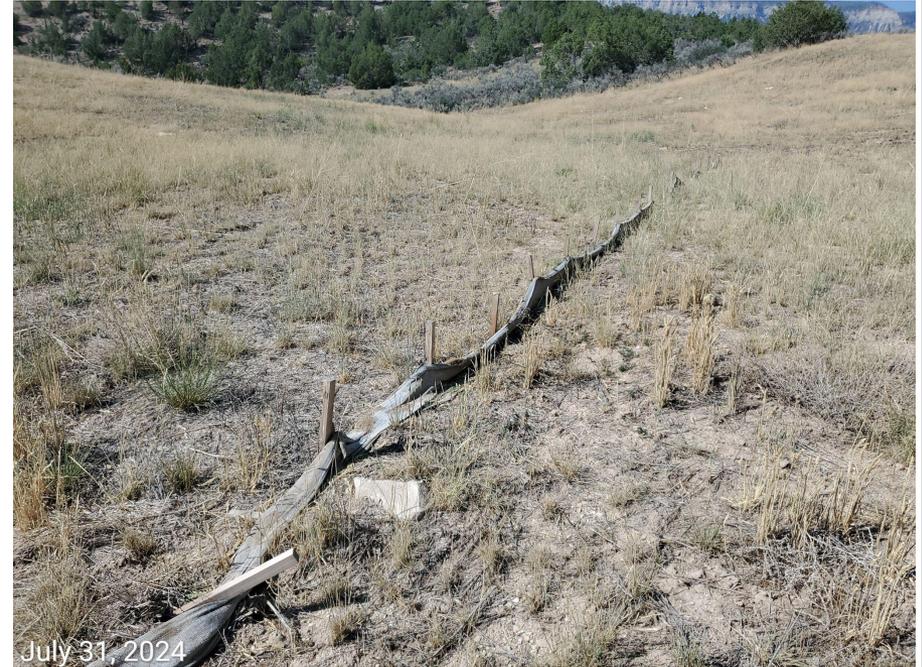
Photo 7: Photo examples showing silt fence observed throughout the Location in disrepair.

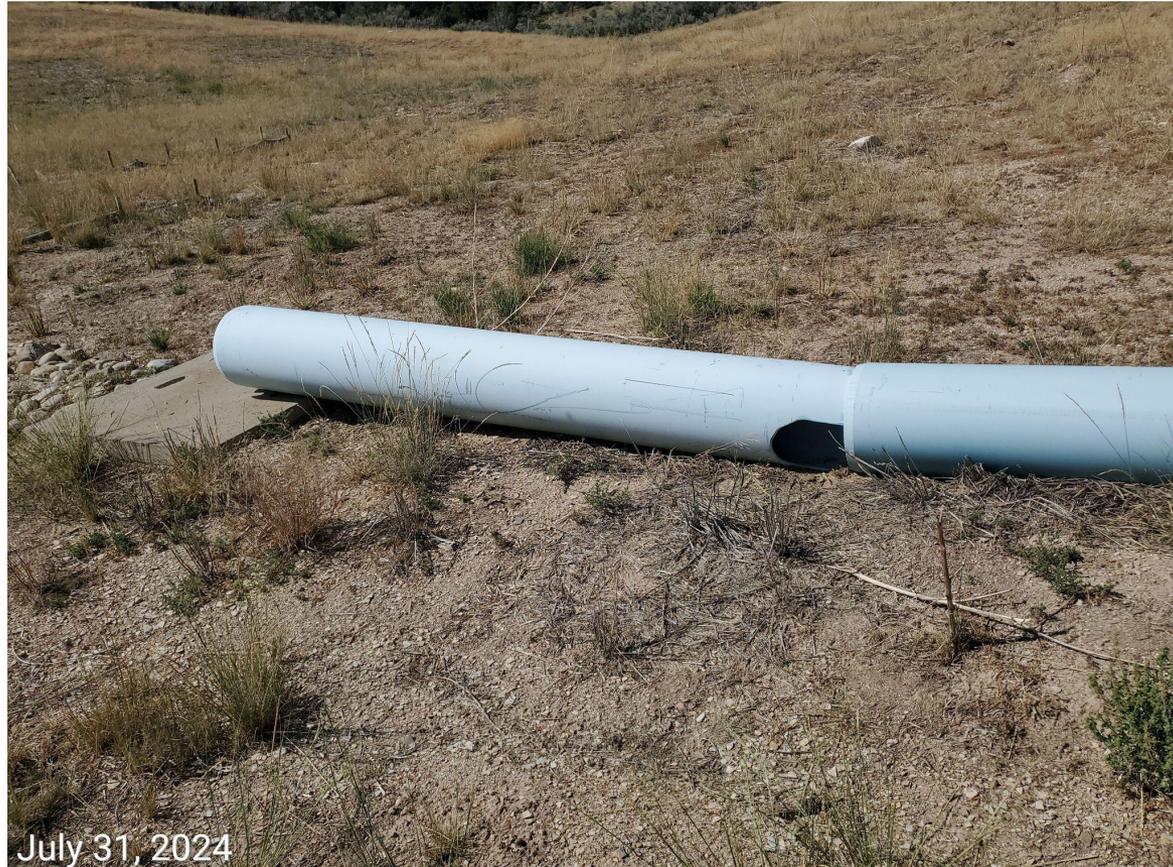
Photo 8: Photo shows slope drain in disrepair.

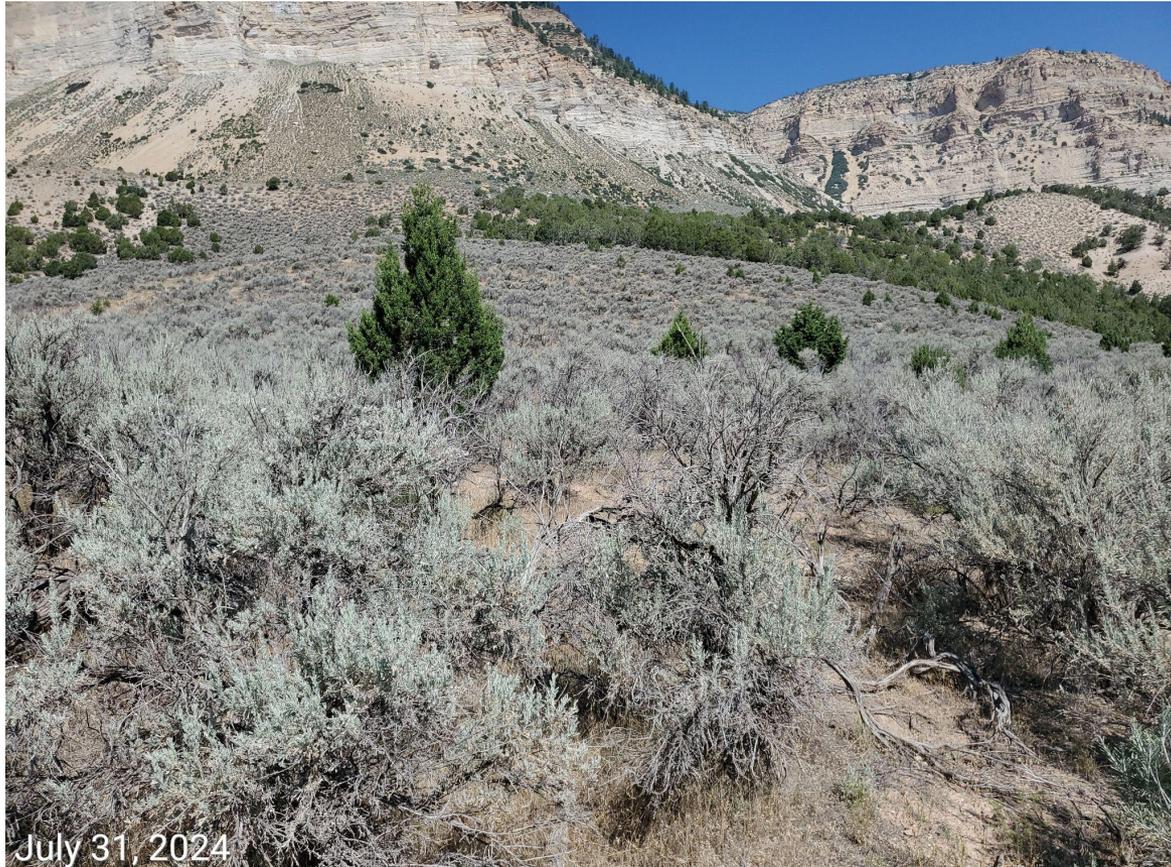
Photo 9: Photo example showing the vegetation within the adjacent reference area.
