Inspection Photos
Location Name: Focus Ranch Unit Federal #12-1
API: 05-107-06221

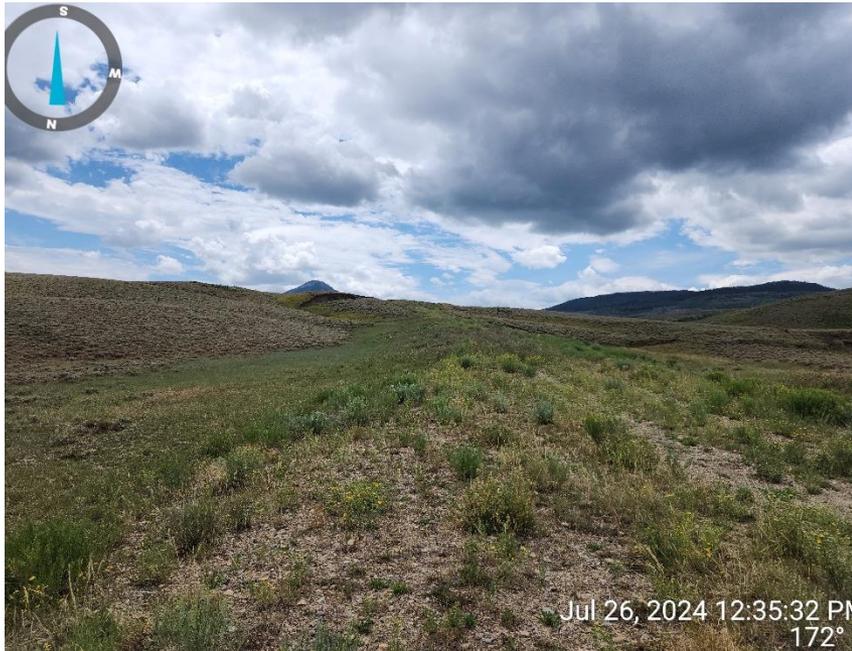
Adjacent hillside has slumped and made access road impassable.

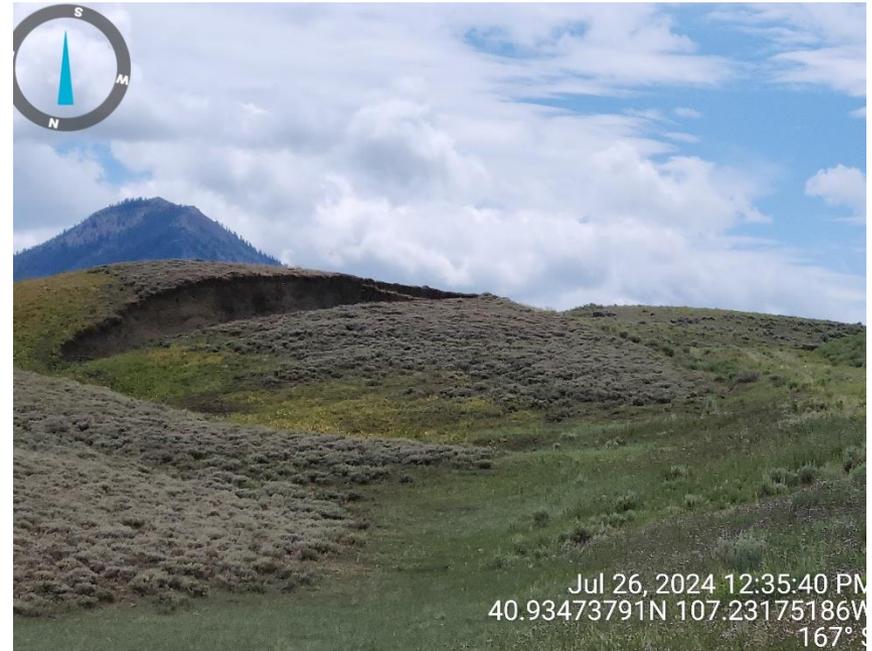
Access road is impassable where slump occurred.

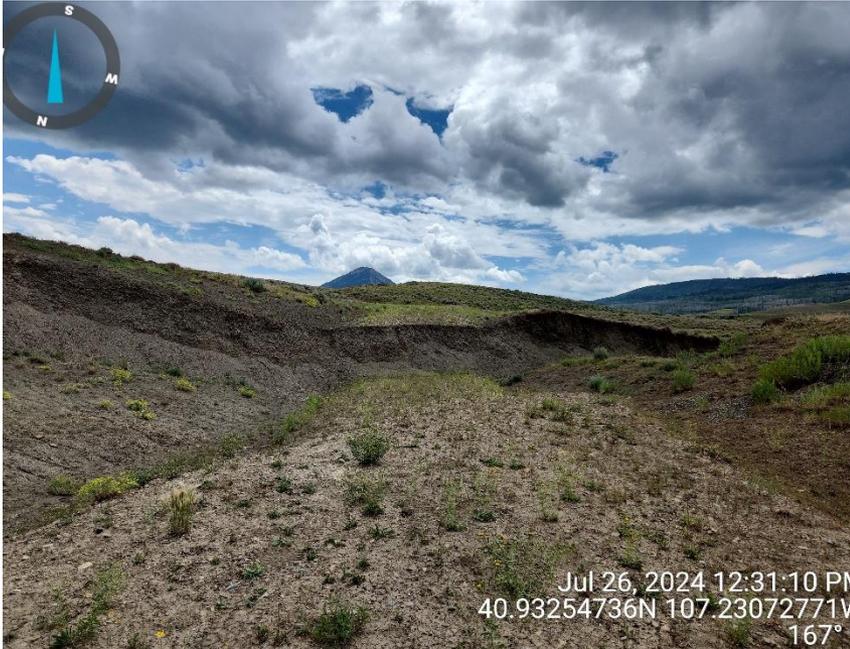
Approximately 1.5 miles from the location the access road has become impassable.

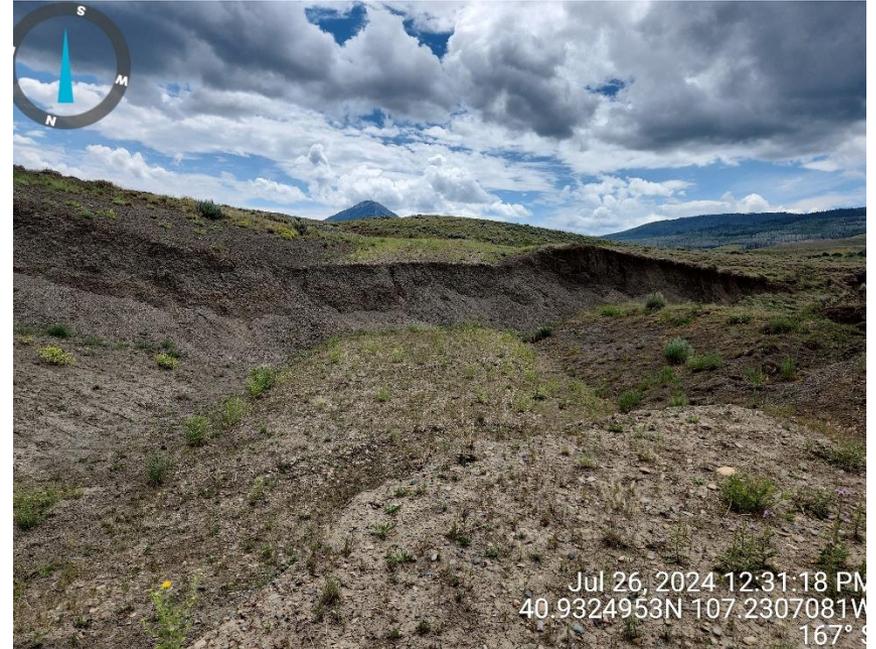
Access road bisected by hillside slump.
