Inspection Photos

Operator: Enduring Resources LLC - 10663

Location ID: 326208

Inspection Photos
Location Name: Indian Creek Wheeler 13-2
Location ID: 326208

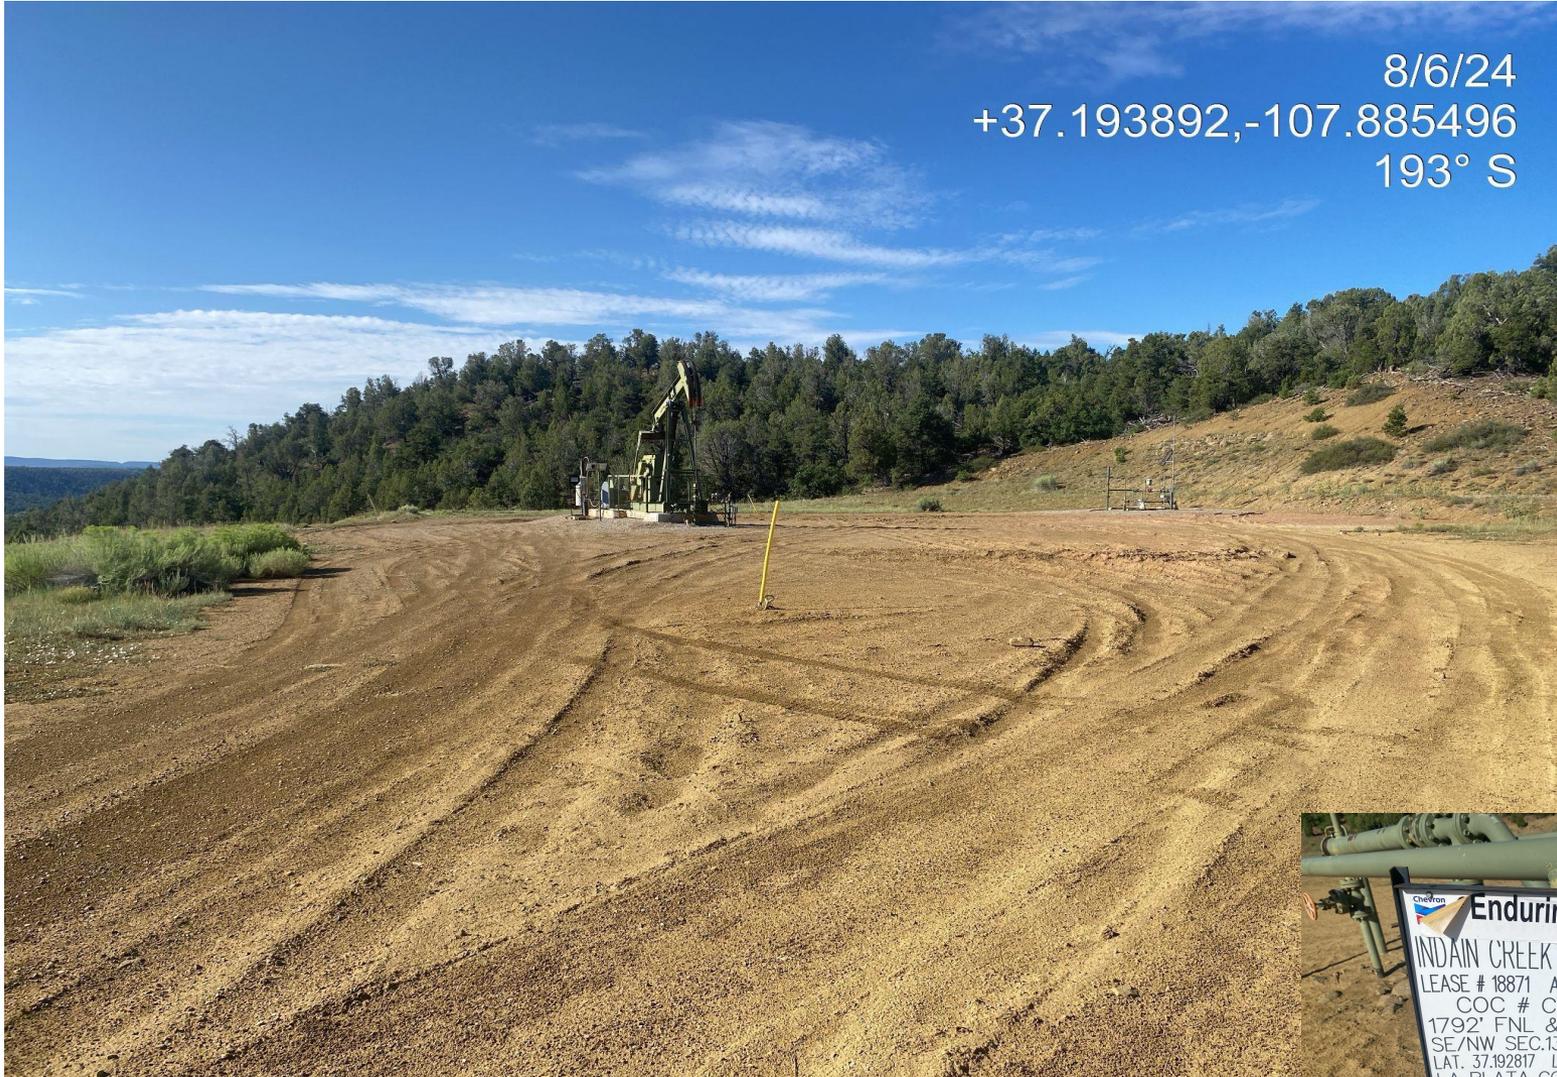
Photo 1. View of the location taken from the access point facing center.

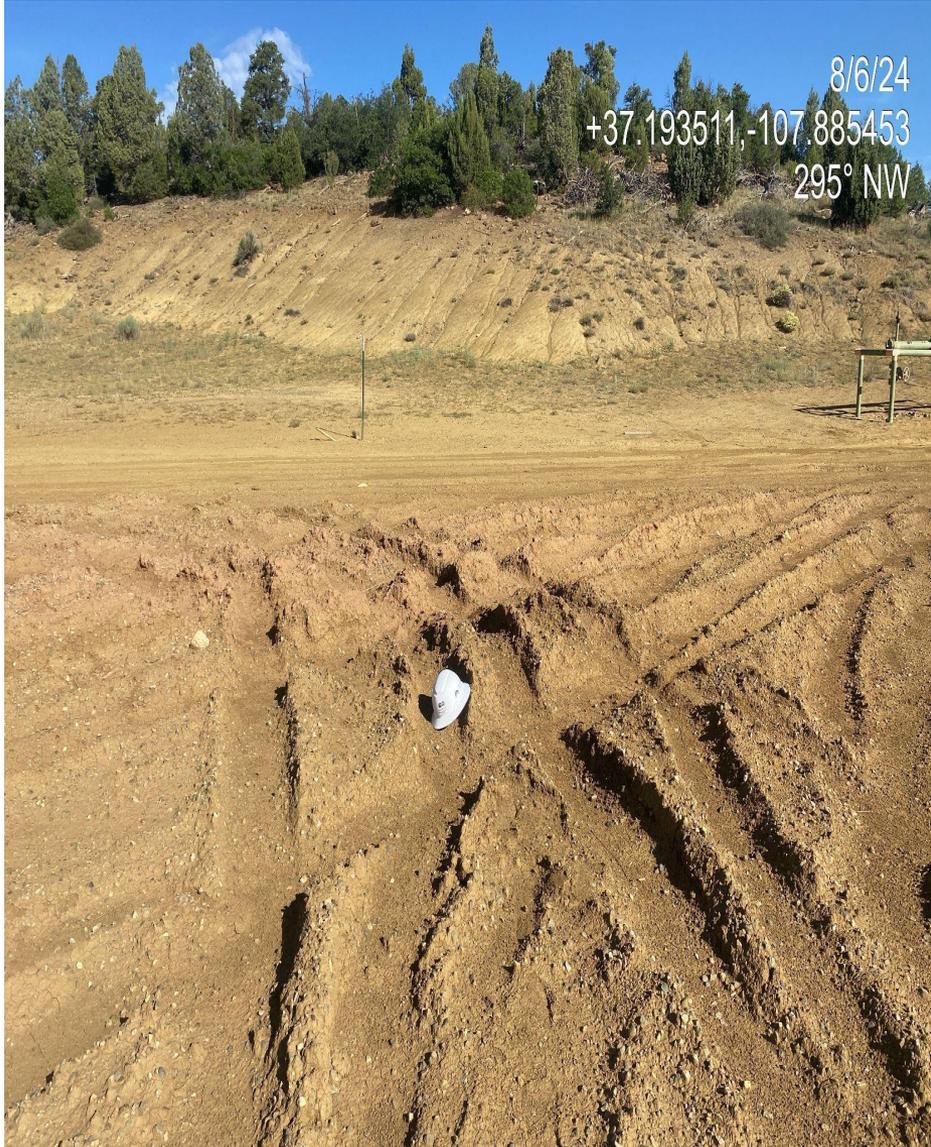
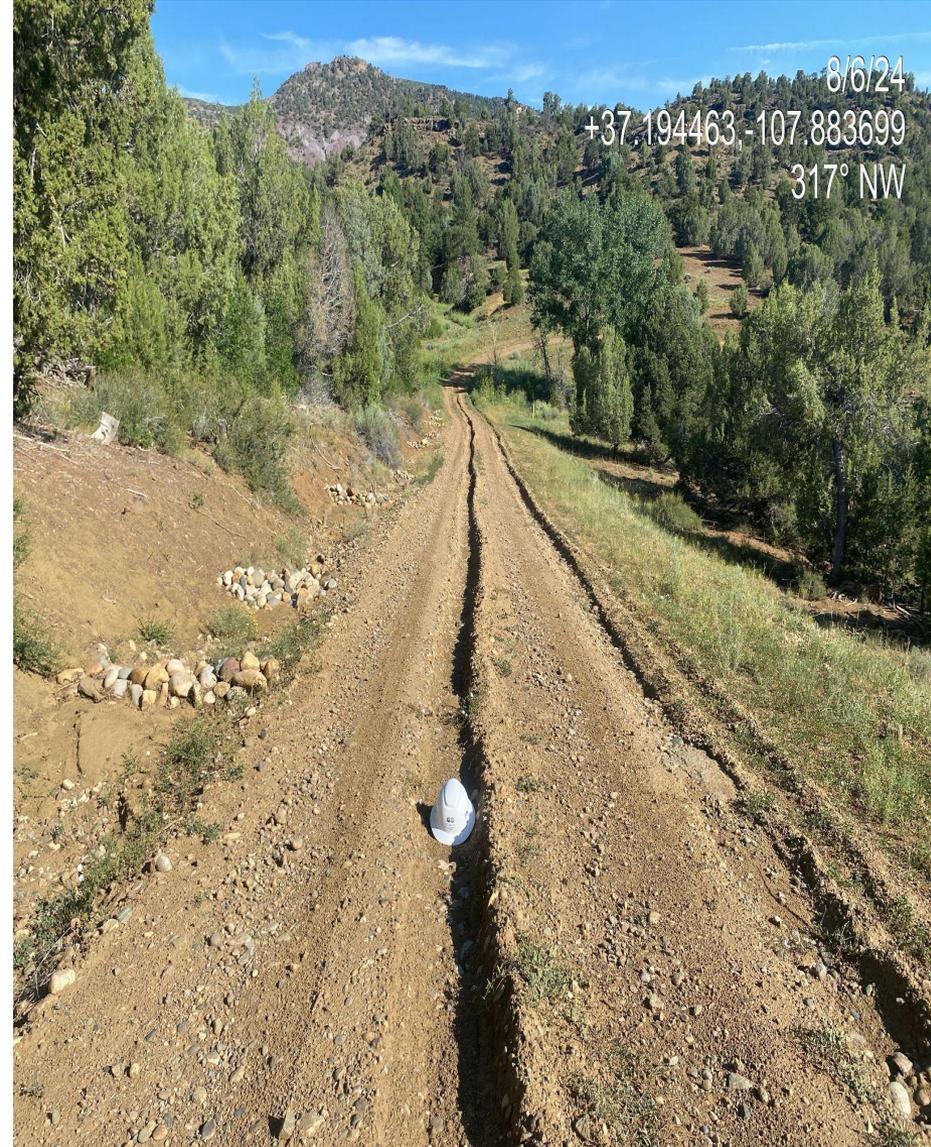
Photo 2. View of deep rutting occurring on the active pad and along the access road. Additional stabilization/grading is needed to minimize degradation to active pad/access road.

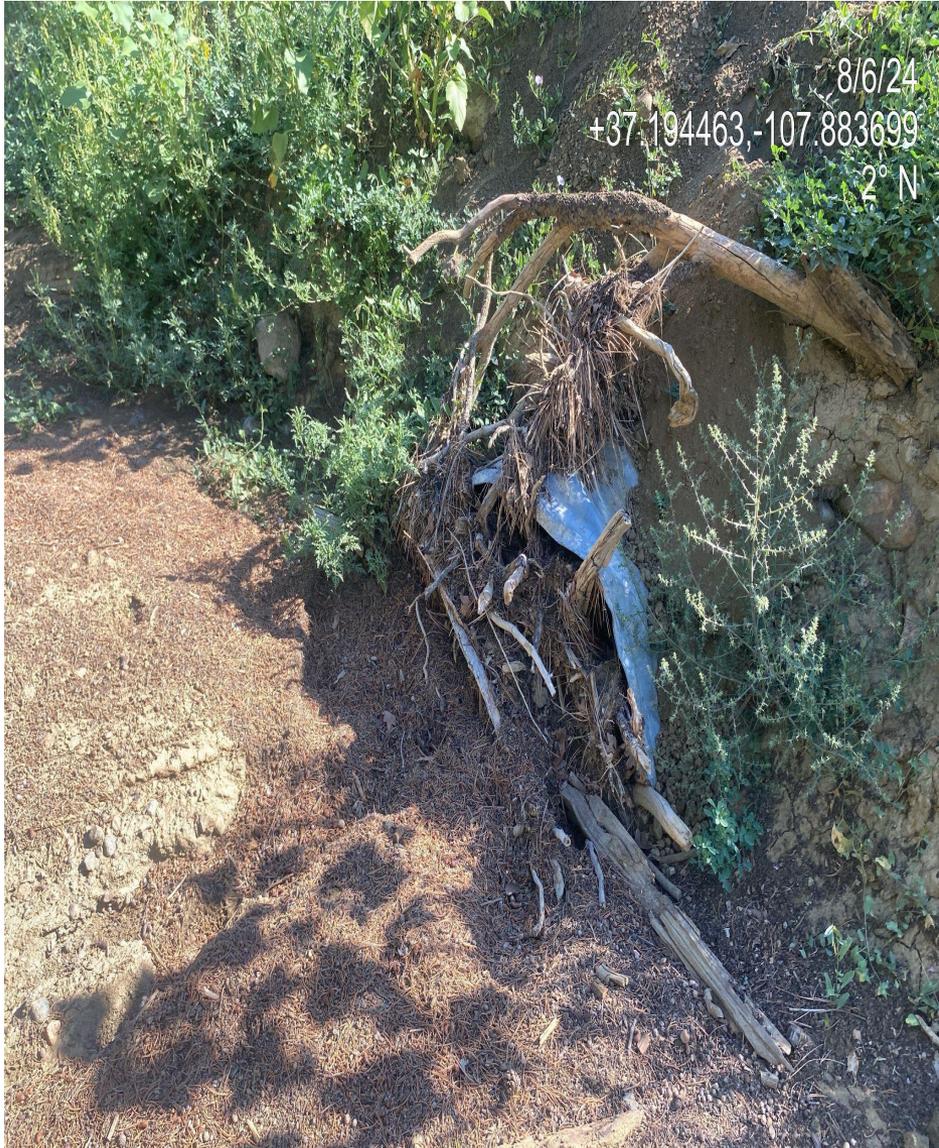
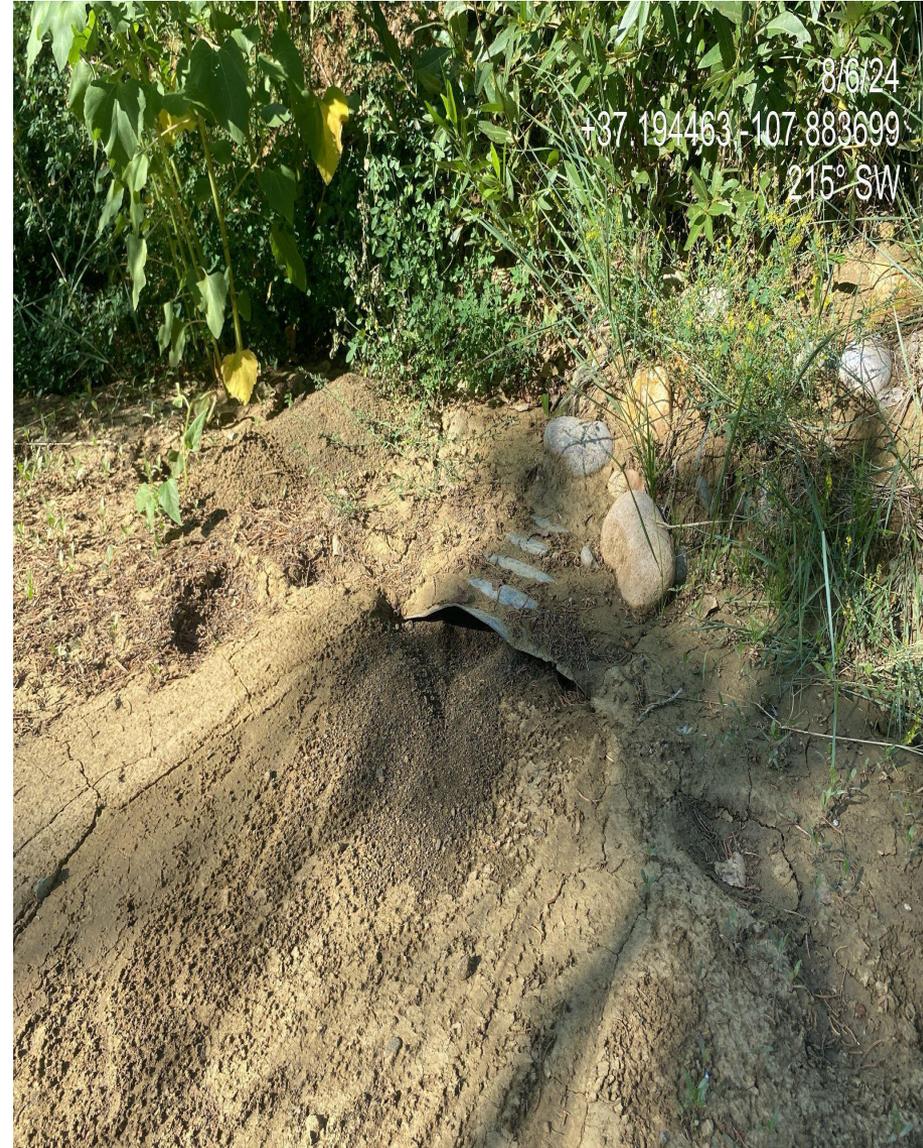
Photo 3. View of culvert crossing access road that is full of sediment/debris and is no longer functioning. Maintenance and storm water BMPs management is needed.

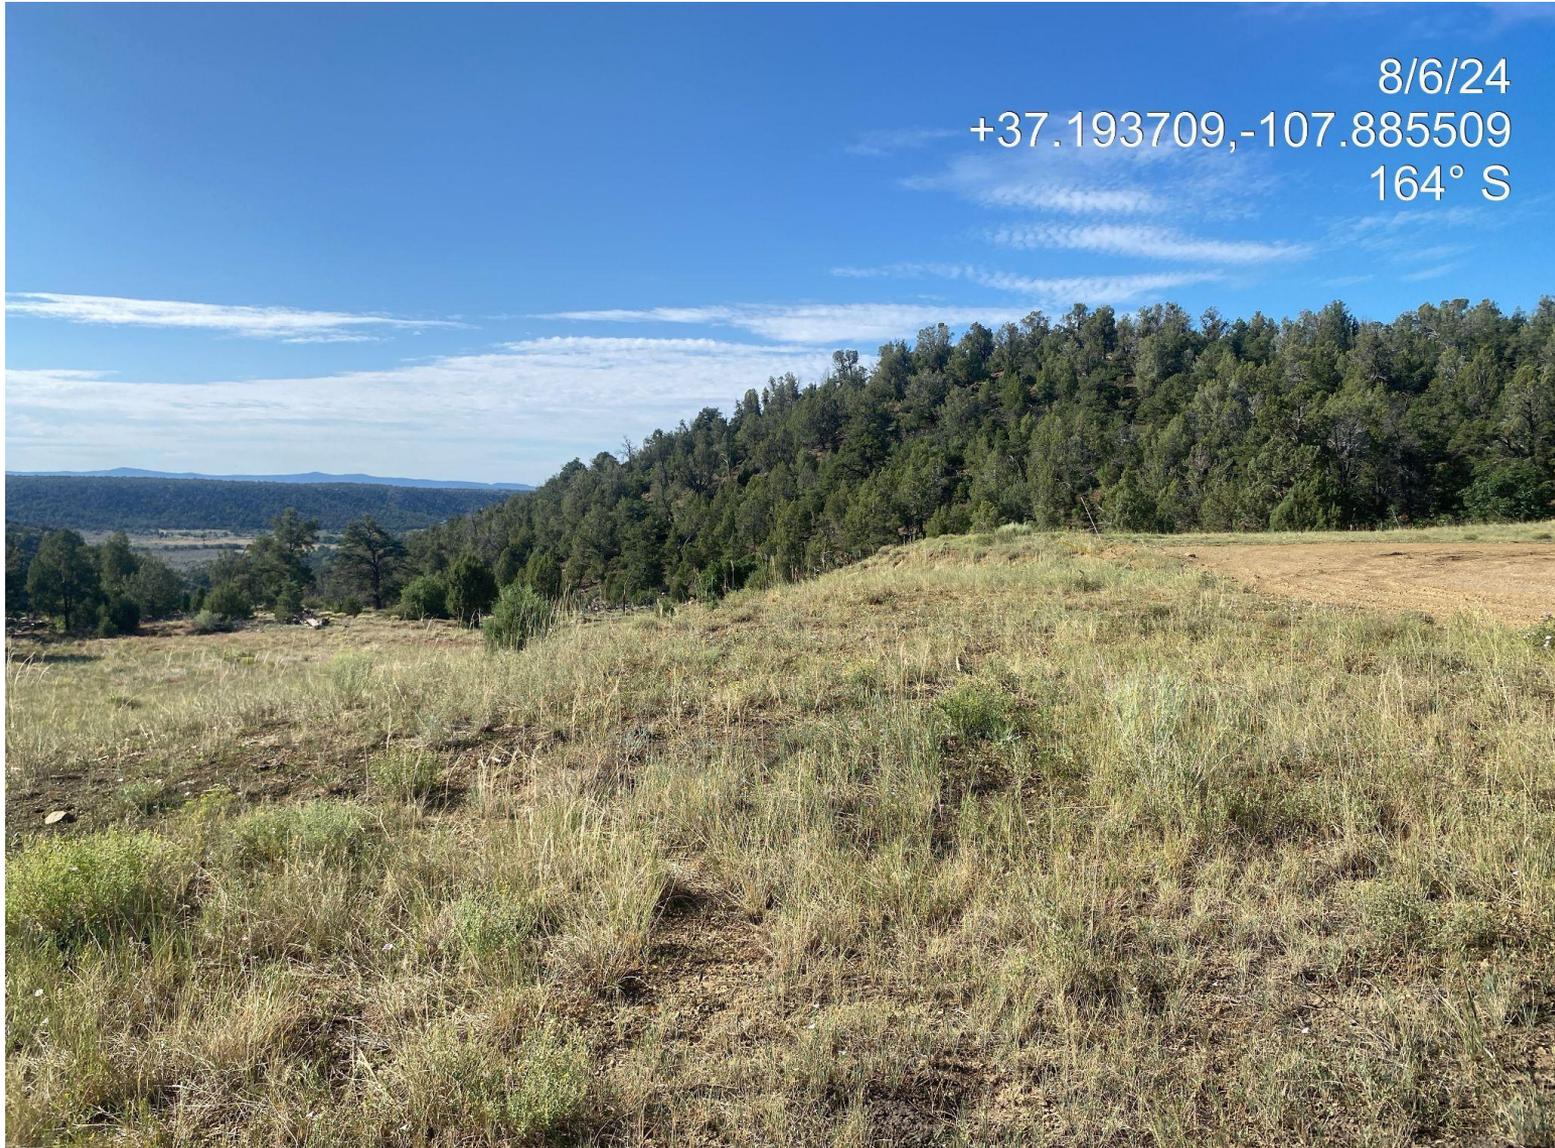
Photo 4. View of the western interim reclamation area facing south.

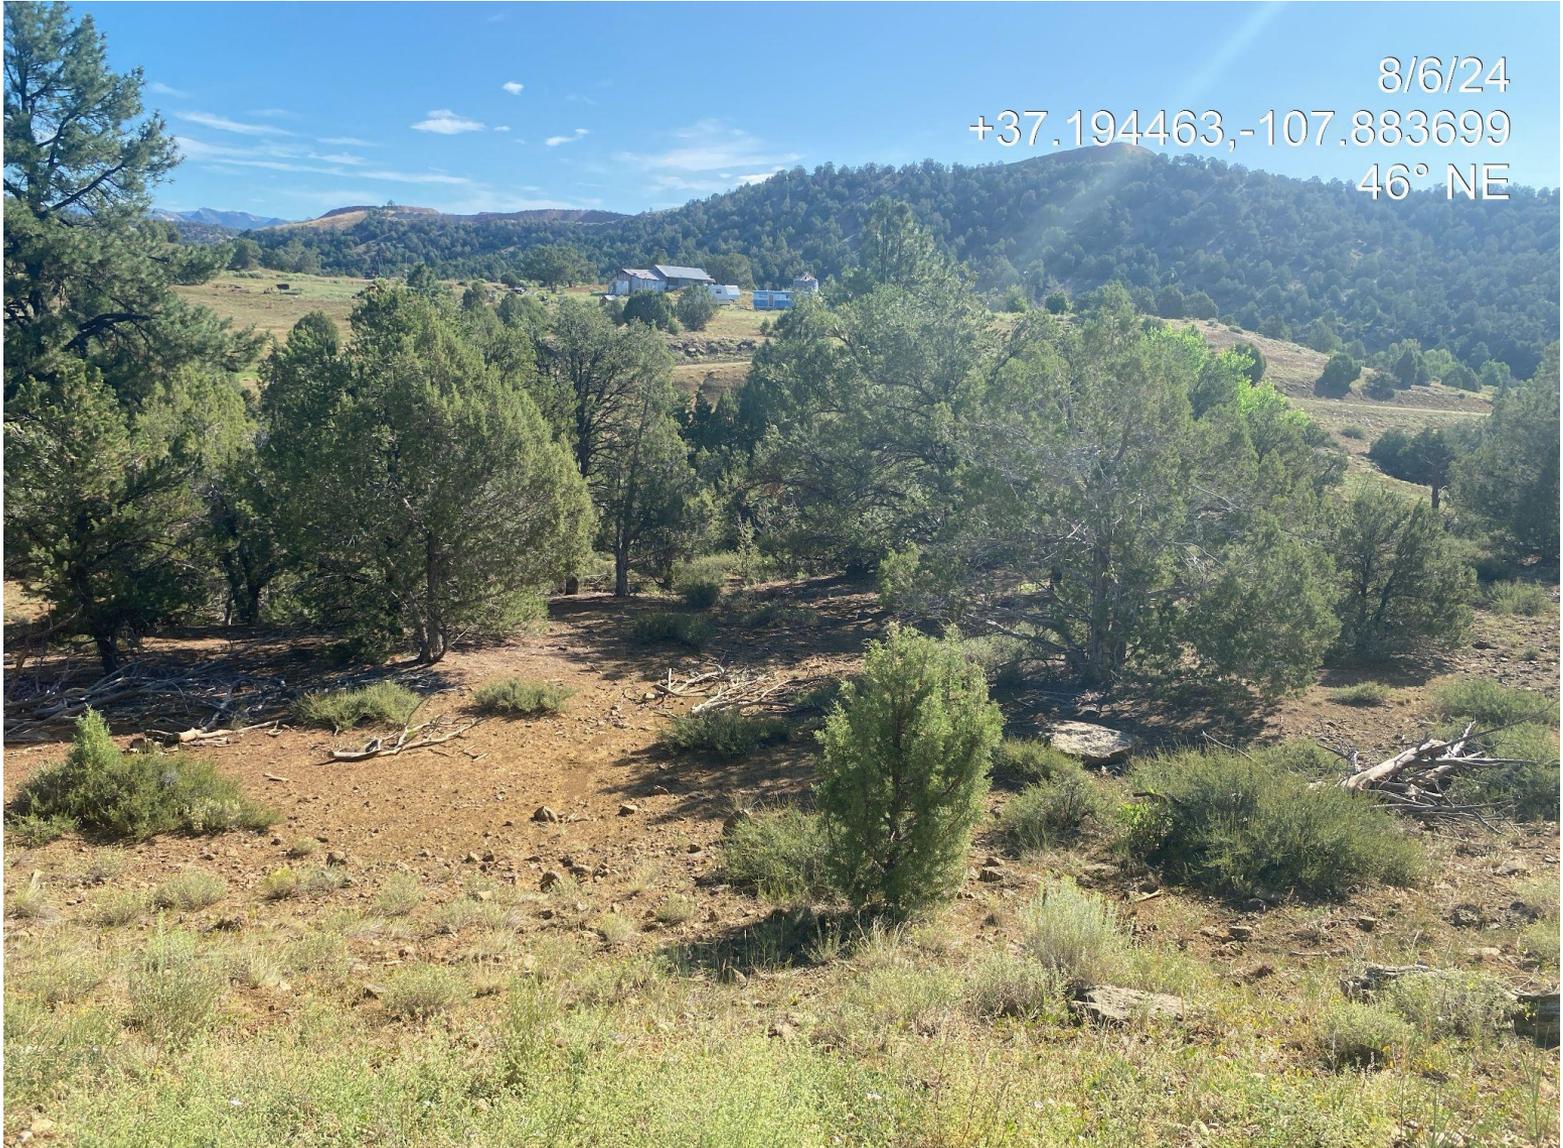
Photo 5. Reference area comprised of Juniper, Pine and Antelope bitterbrush.
