Inspection Photos

API: 043-40001

Operator: JAVERNICK OIL

Inspection Date: 8/5/2024

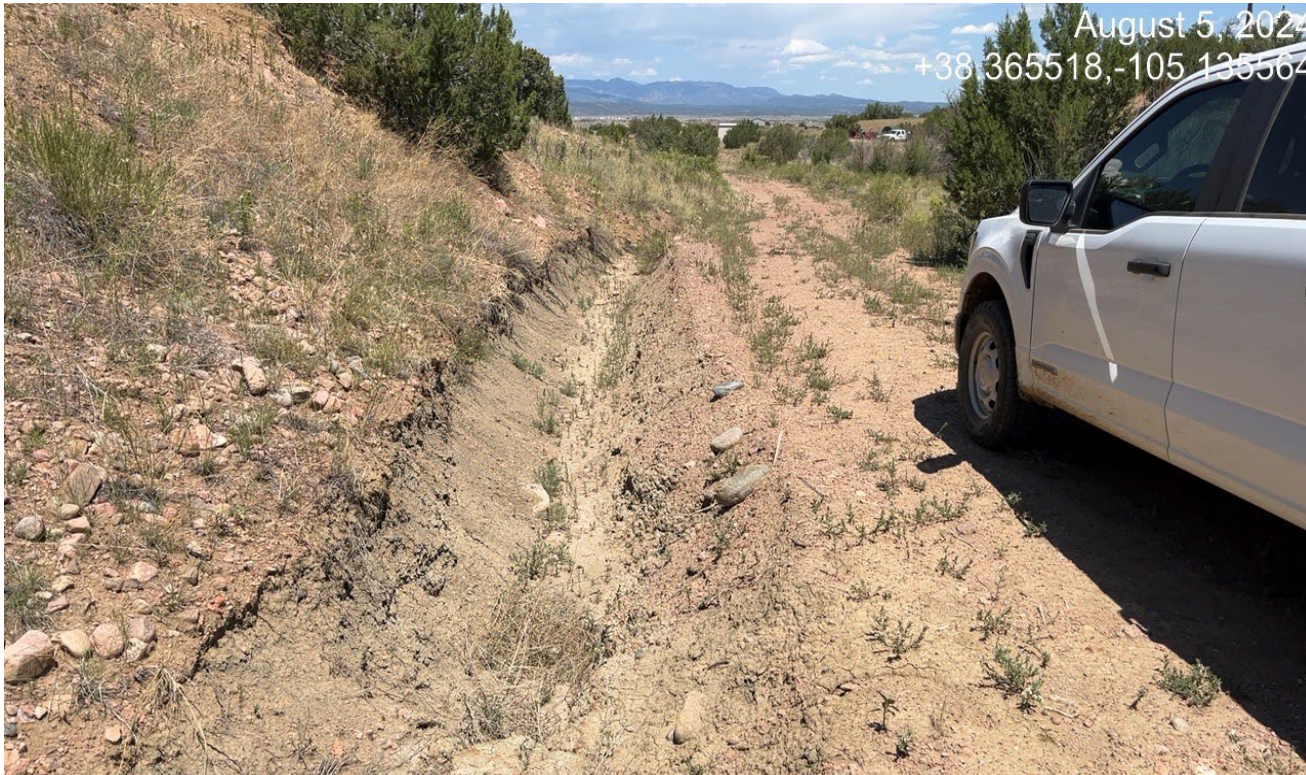
Photo 1. Facing north along the access road. There is an erosion gully along the roadside which needs to be repaired. Previous corrective action was not completed.

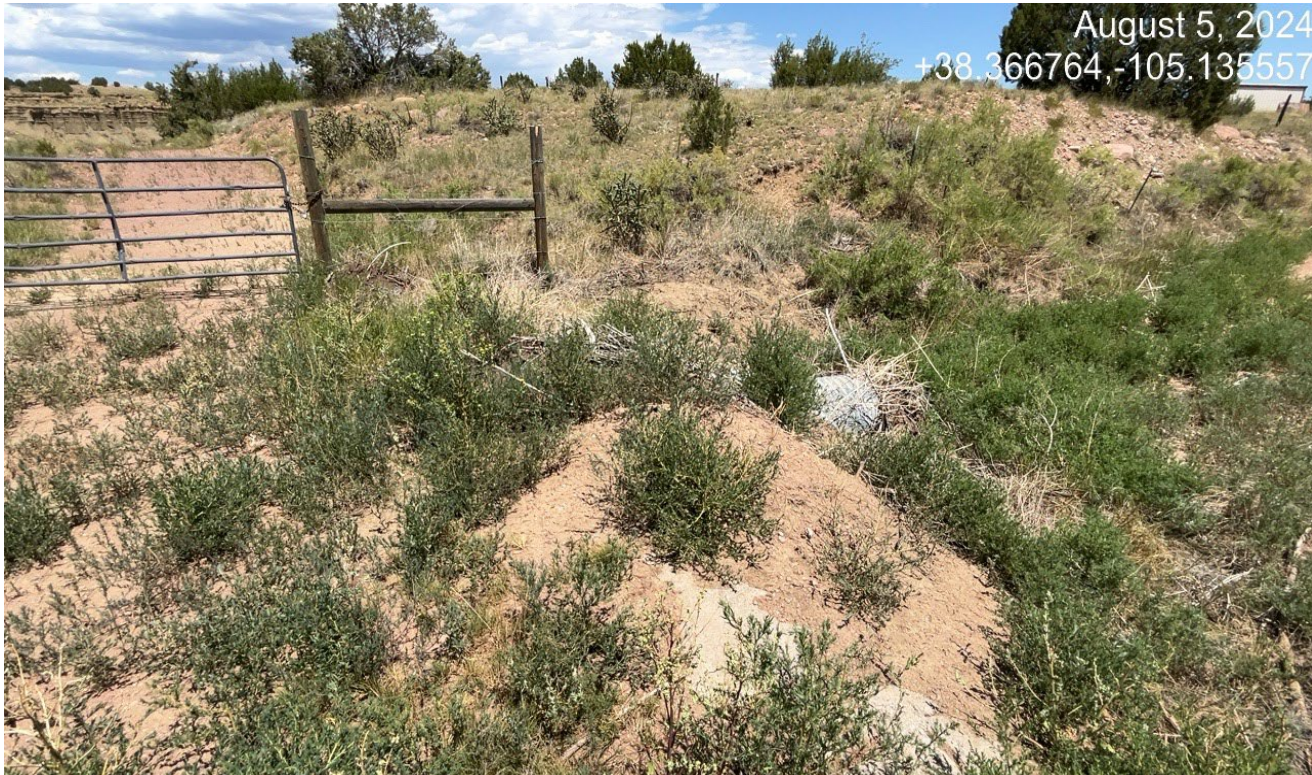
Photo 2. The culvert at this drainage crossing has filled in with sediment and debris and must be cleaned out. Previous corrective action was not completed.

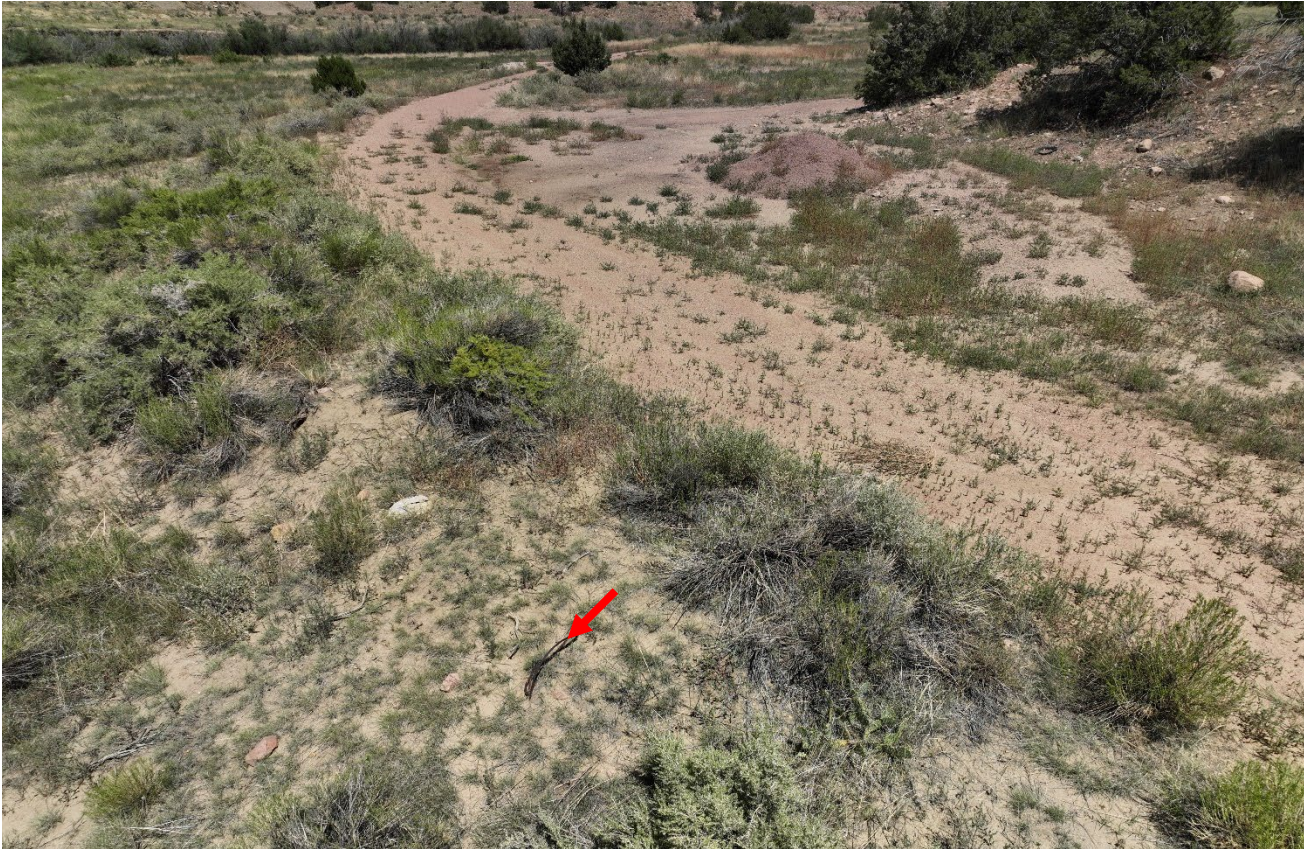
Photo 3. Drone aerial photo facing northeast toward the abandoned wellsite which was never reclaimed. Guyline anchor cable still remains at red arrow. Previous corrective action was not completed.

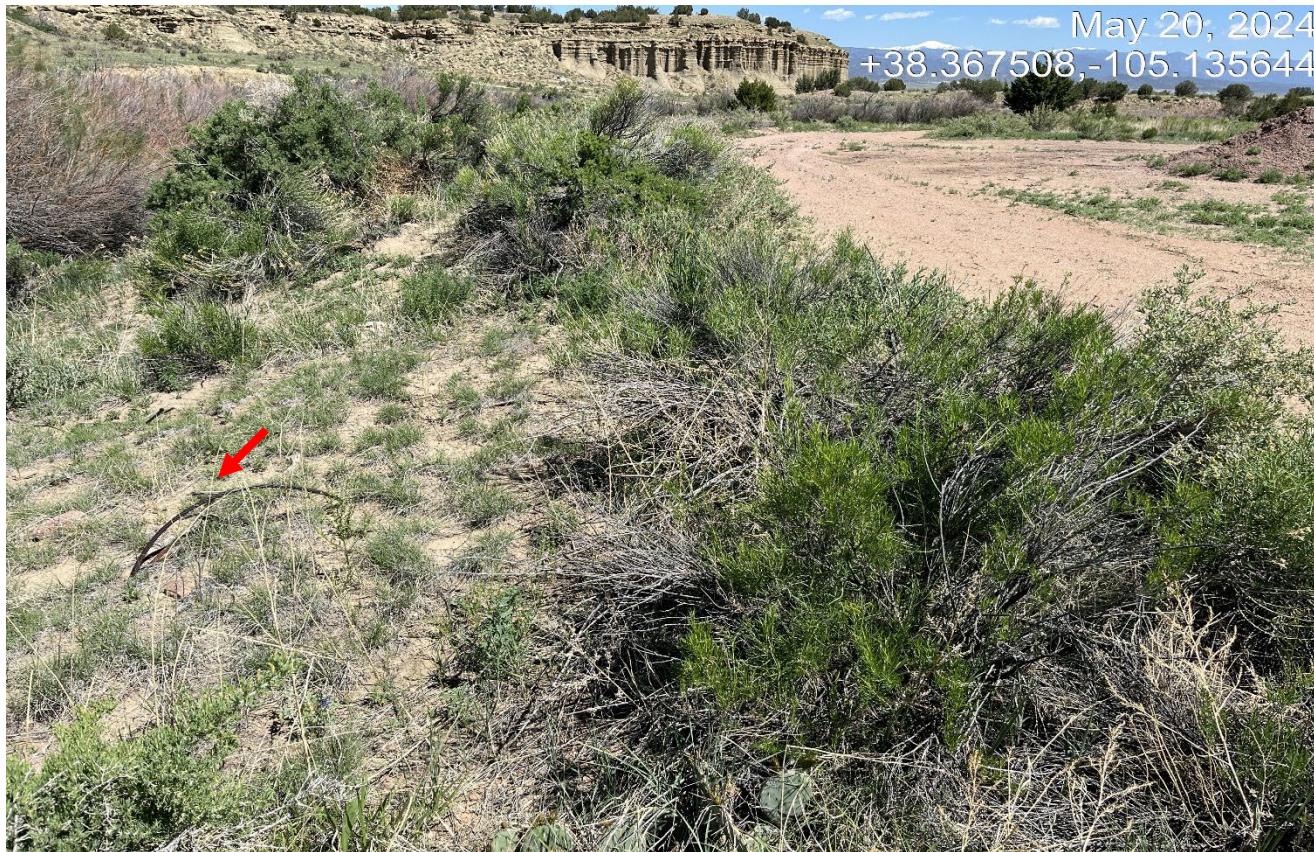
Photo 4. Facing northeast at the wellsite. There is a metal cable guyline anchor that remains at red arrow. Previous corrective action was not completed.

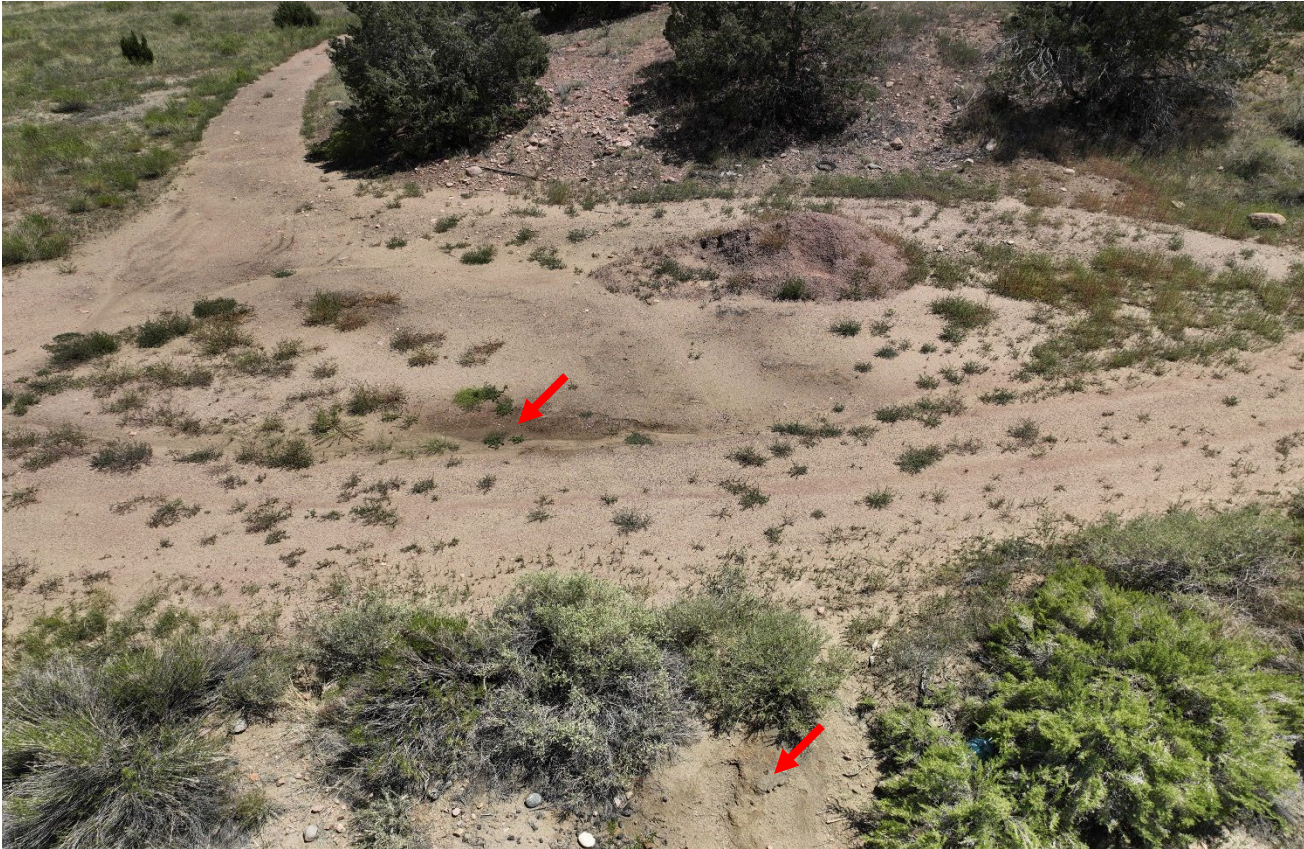
Photo 5. There are oil stained soils in this area at the abandoned well. Impacted soils need to be excavated and removed. Red arrows point to the areas where stained soil is evident.

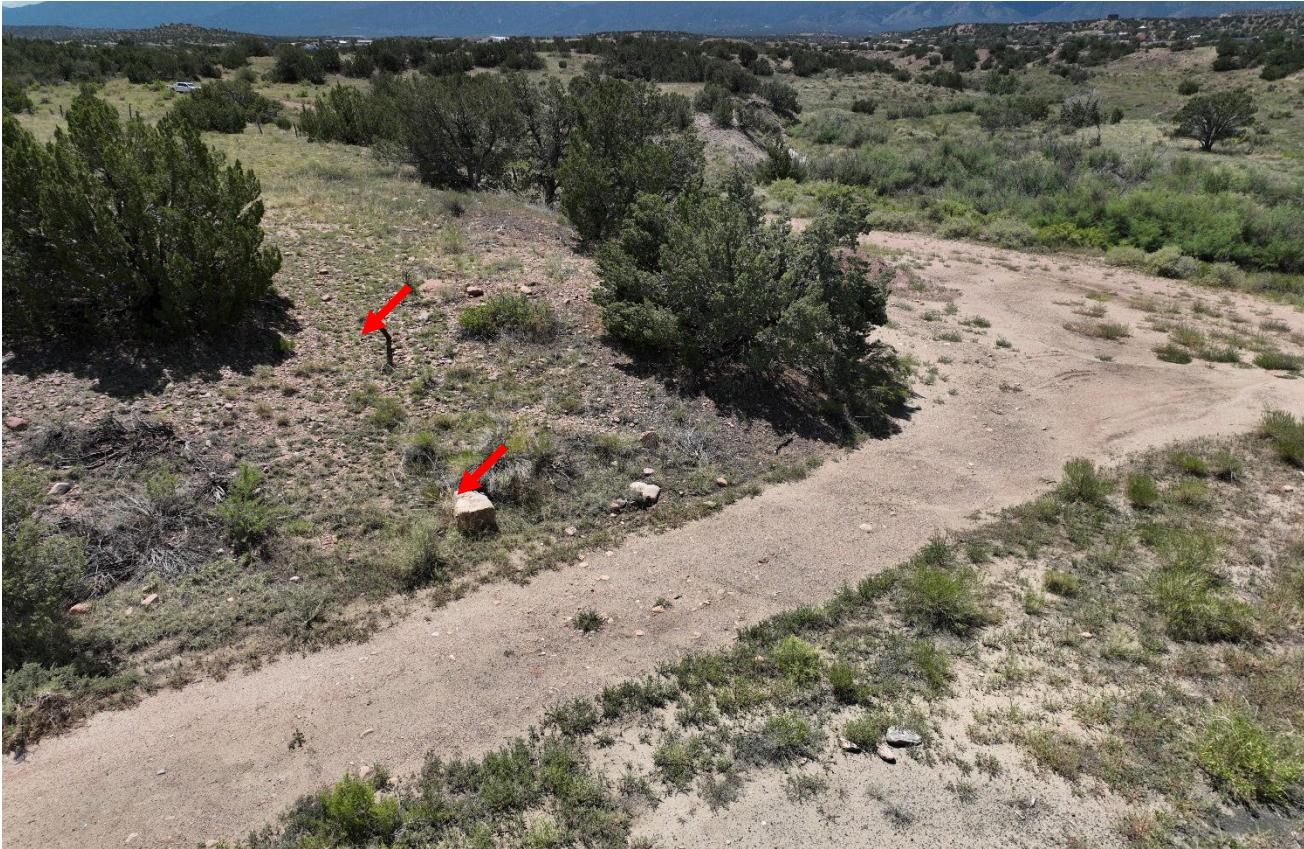
Photo 6. There is a cement block and guy line anchor that remains at the northeast side of the location which must be removed. Previous corrective action was not completed.
