Inspection Photos

API: 043-06182

Operator: INCREMENTAL OIL & GAS
(FLORENCE) LLC

Inspection Date: 8/5/2024

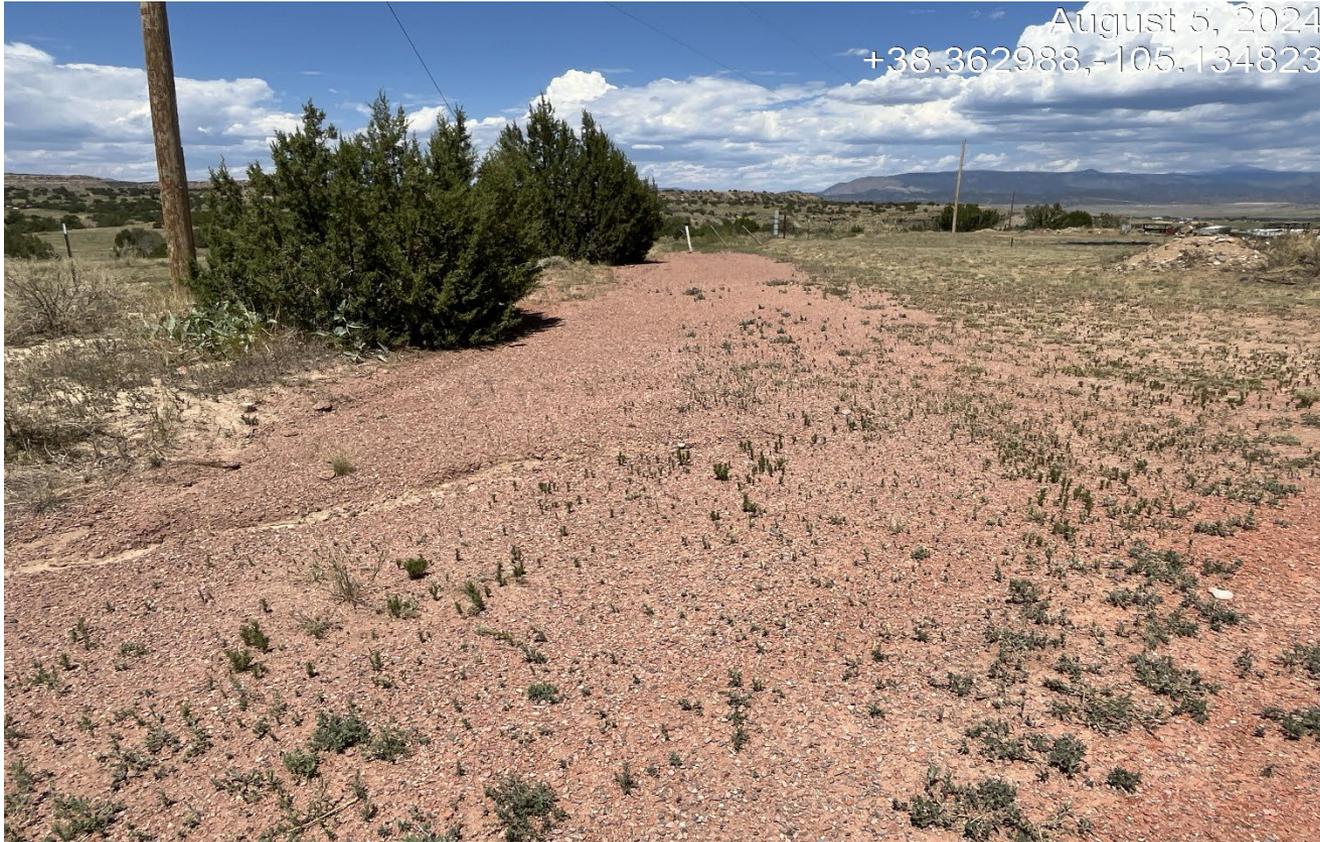
Photo 1. Facing northwest along the former access road. The red gravel was brought in by the Operator. This section of the road is now blocked by the fence and needs to be reclaimed.

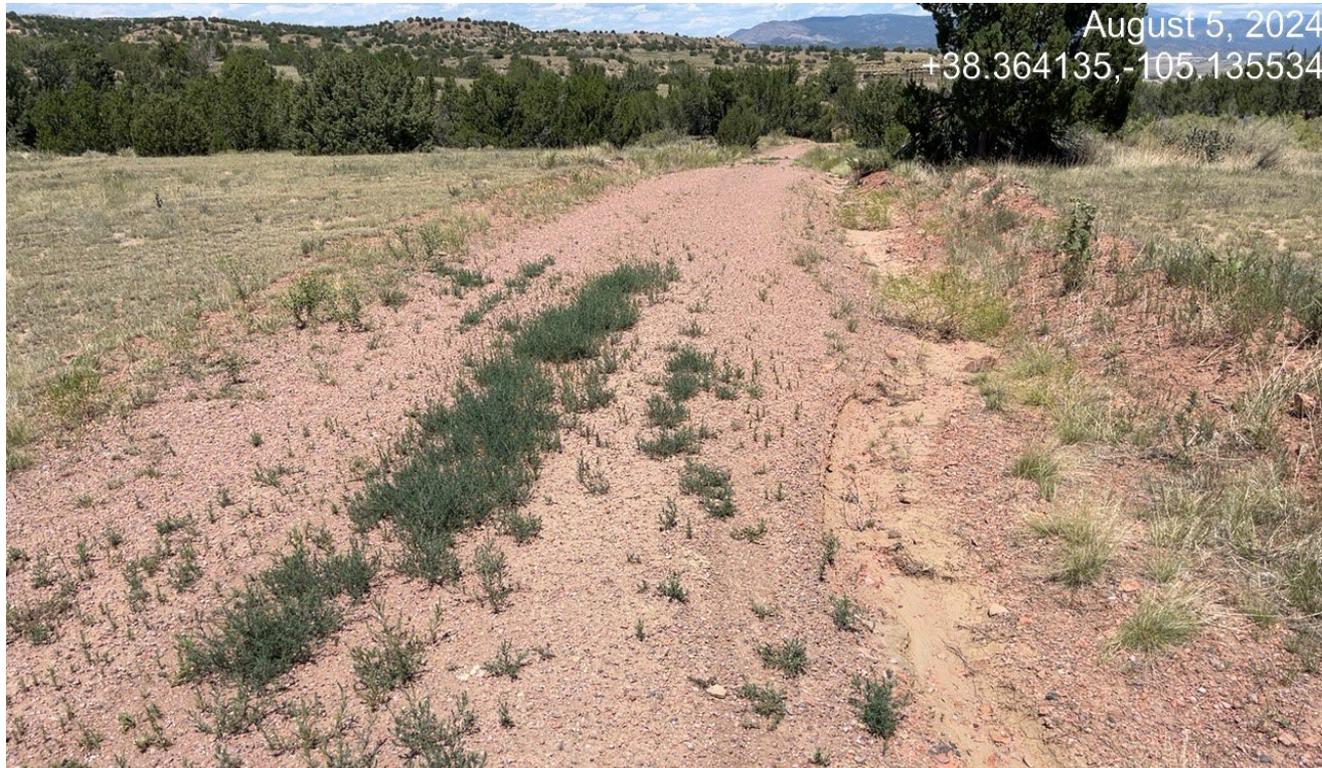
Photo 2. Facing northwest further along the access road. There is an erosion channel down the road which needs to be repaired.

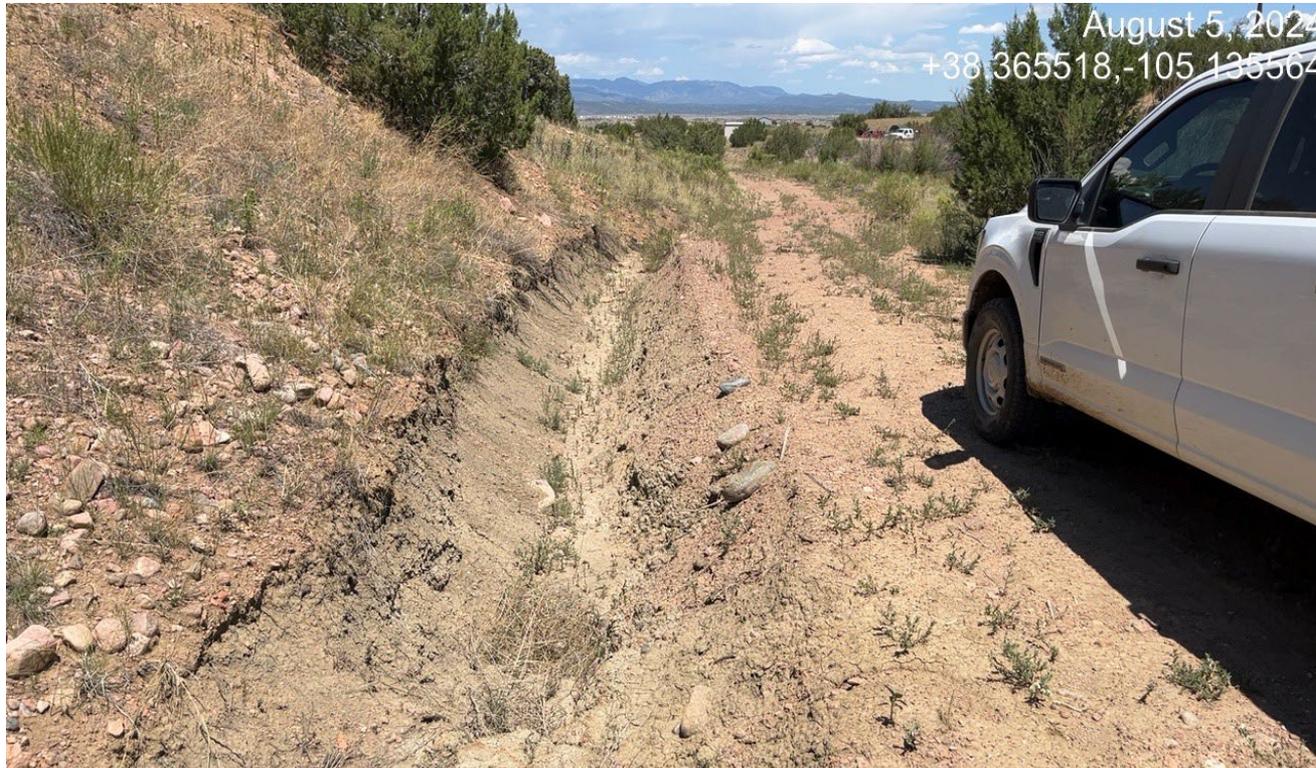
Photo 3. Facing north along the access road. There is an erosion gully along the roadside which needs to be repaired. Previous corrective action was not completed.

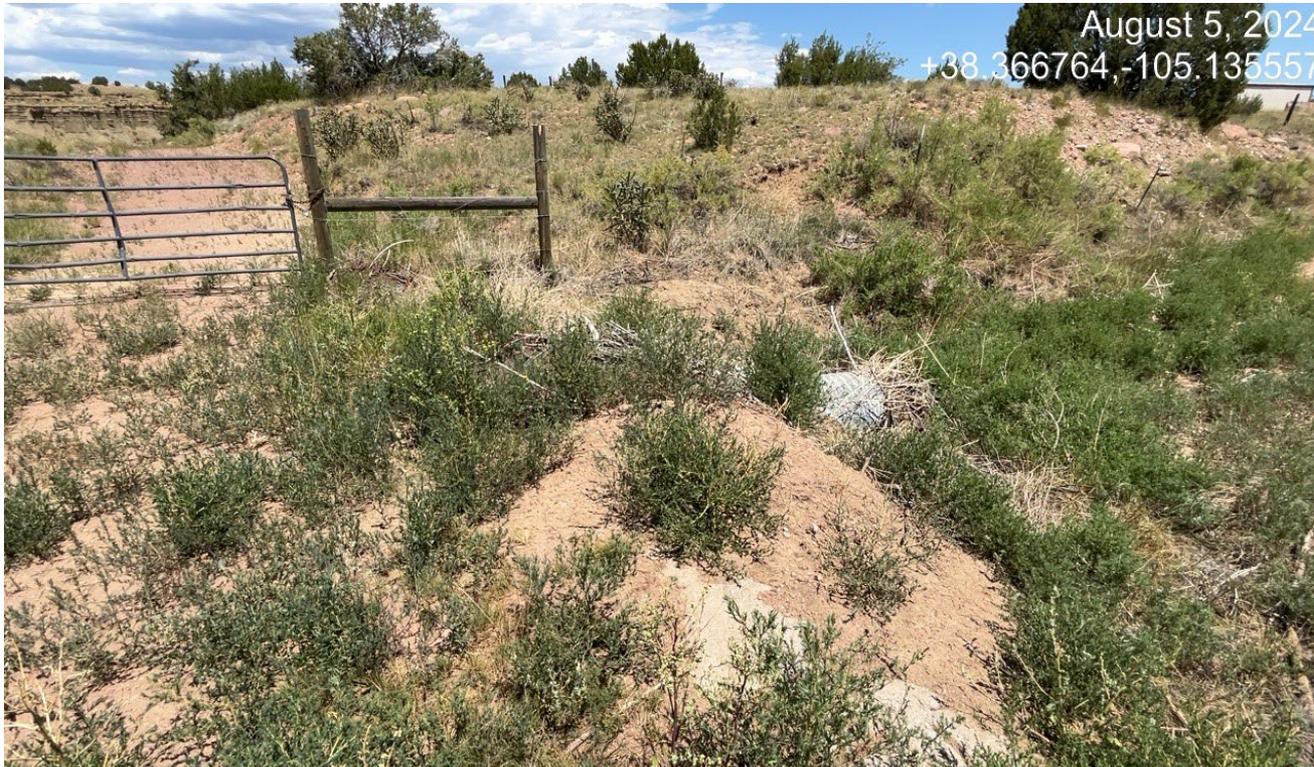
Photo 4. The culvert at this drainage crossing has filled in with sediment and debris and has not been cleaned out. Previous corrective action was not completed.

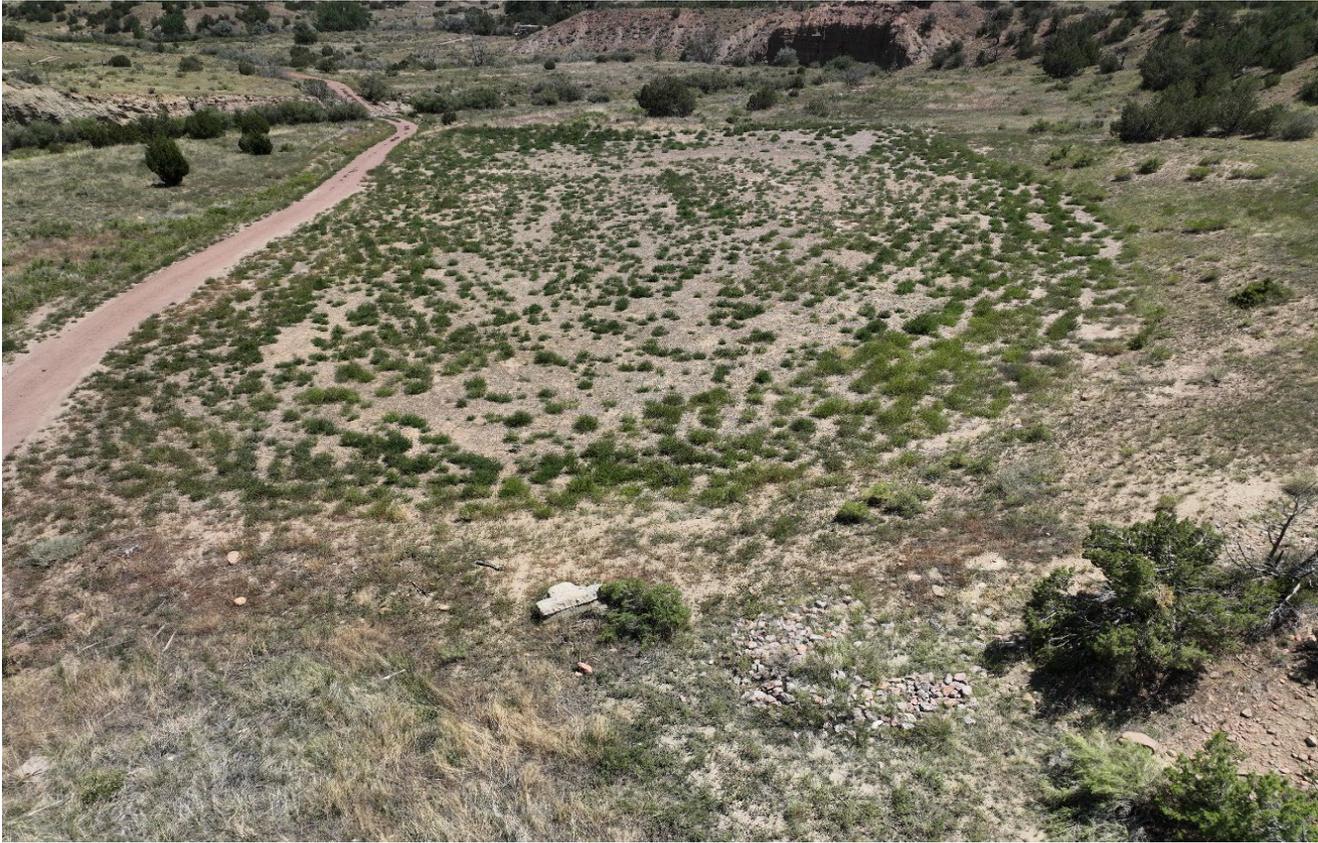
Photo 5. Drone aerial photo facing northeast toward the location.

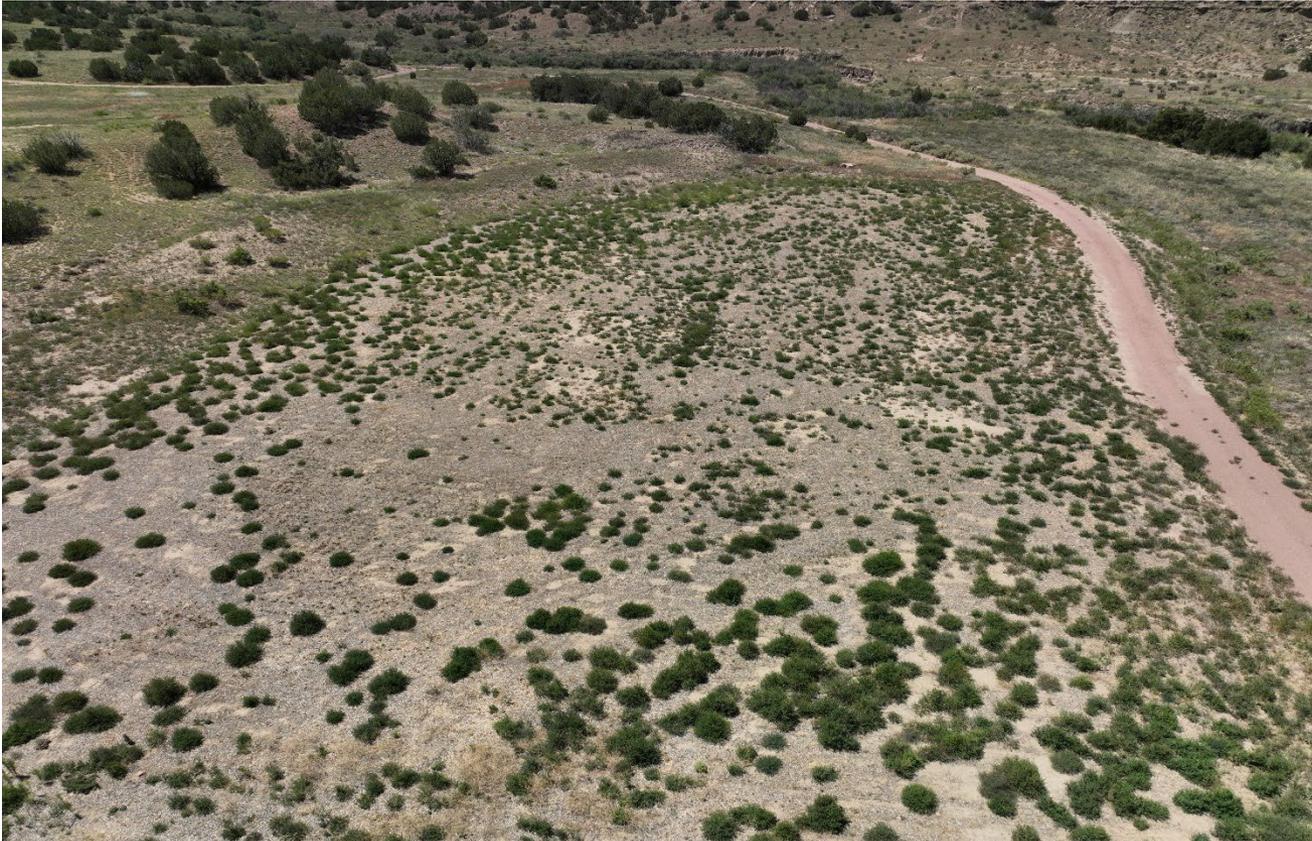
Photo 6. Facing southwest at the location. There are areas that are not vegetation and there are also undesirable weeds that need to be controlled.

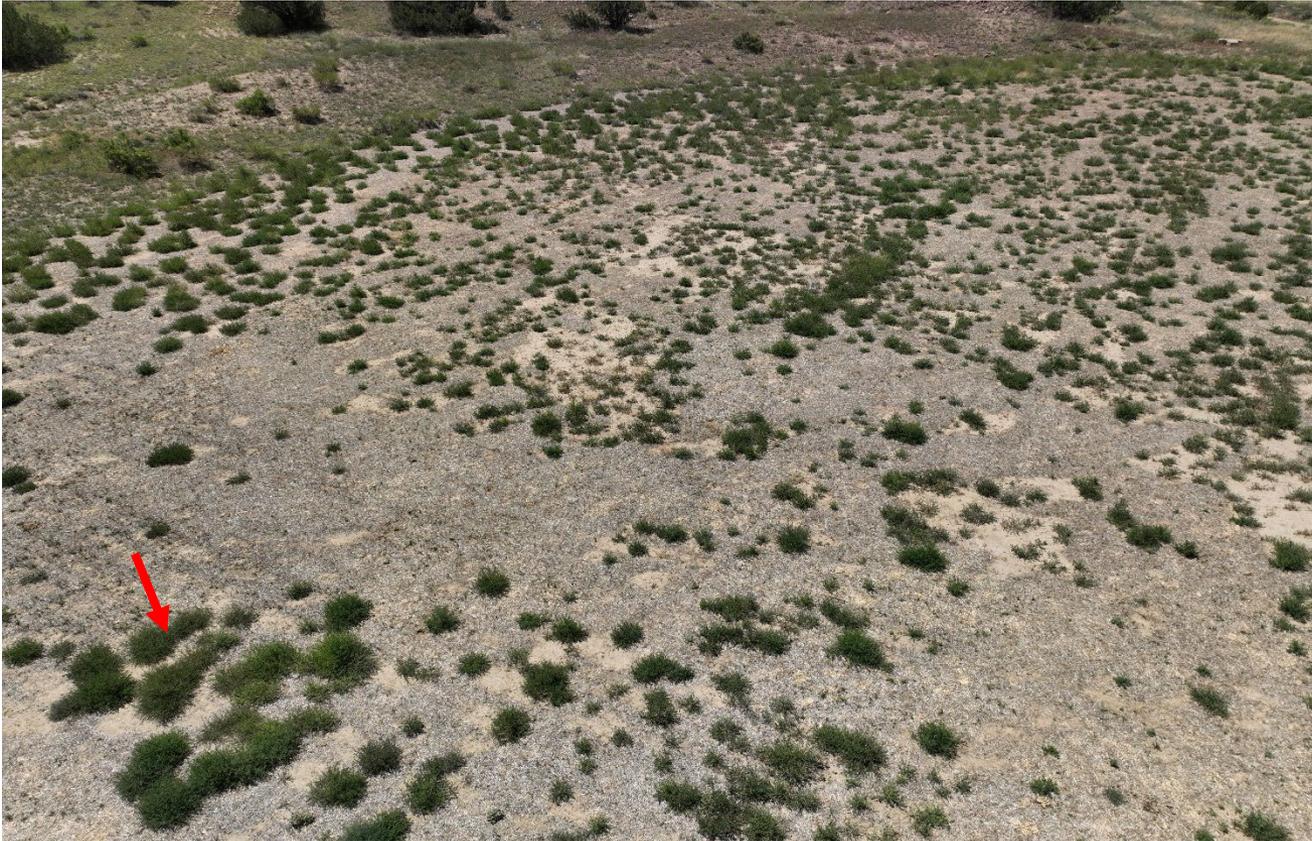
Photo 7. Facing southwest down toward the location. There are areas that are not vegetation and there are also undesirable weeds that need to be controlled. Red arrow points to Russian thistle.
