Inspection Photos

API: 011-05055

Loc: 321208

Operator: RENEGADE OIL & GAS COMPANY LLC

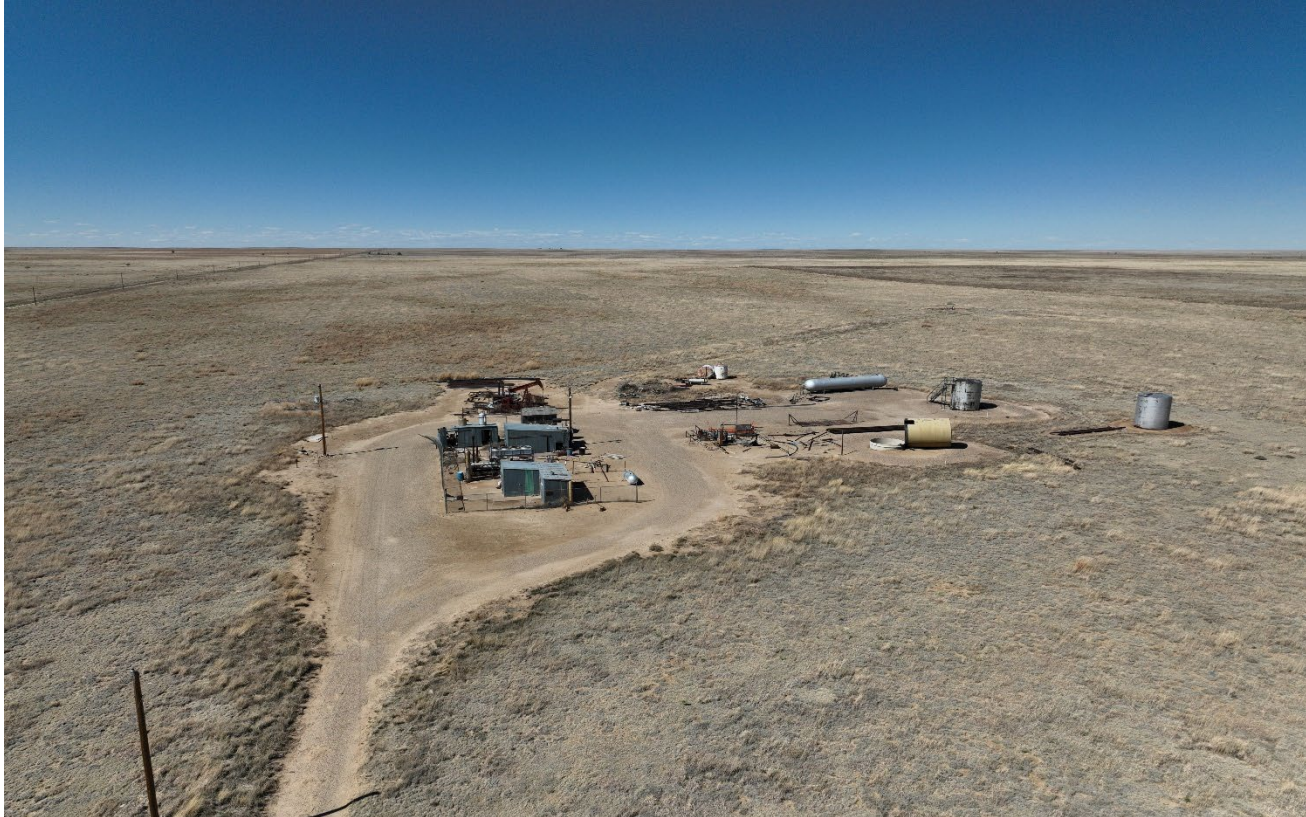
Photo 1. Drone aerial photo taken on 5/8/2024. Facing northeast toward the GAS PROCESSING PLANT and Wellsite.

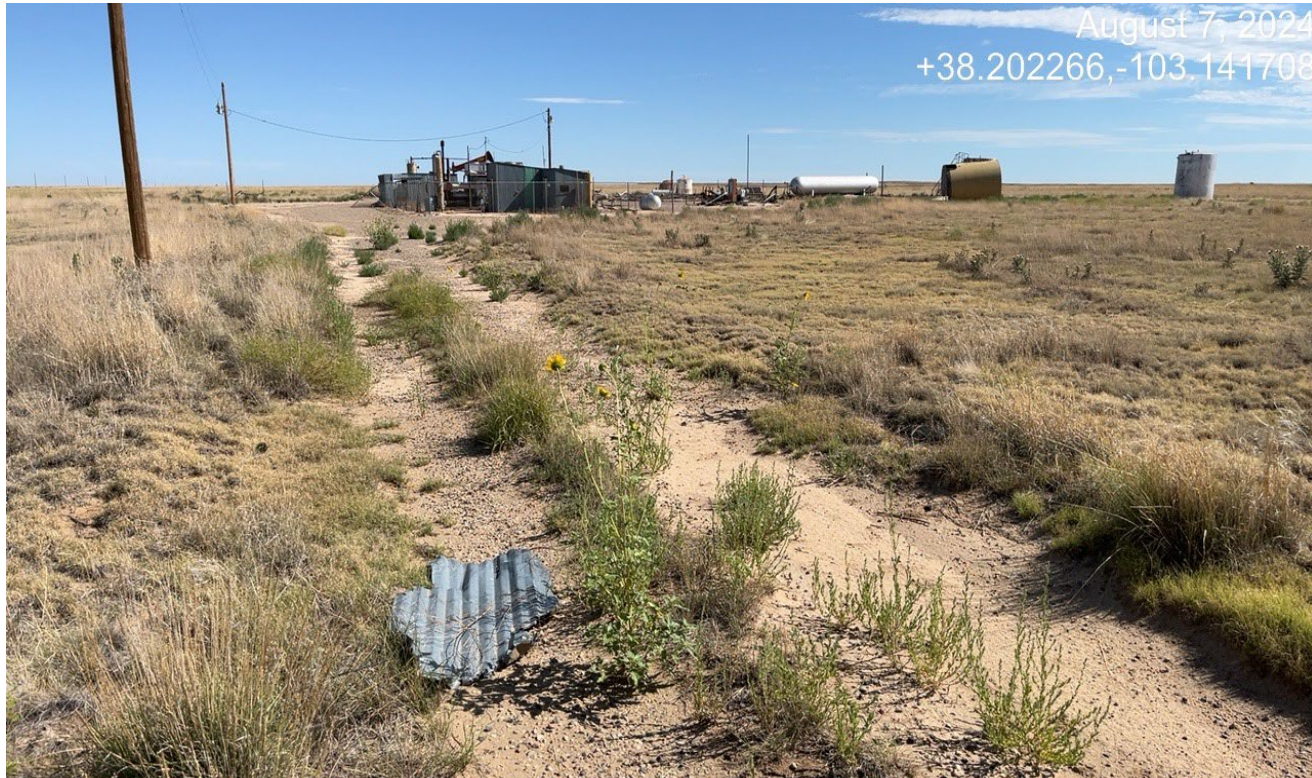
Photo 2. Facing northeast toward the GAS PROCESSING PLANT and Wellsite.

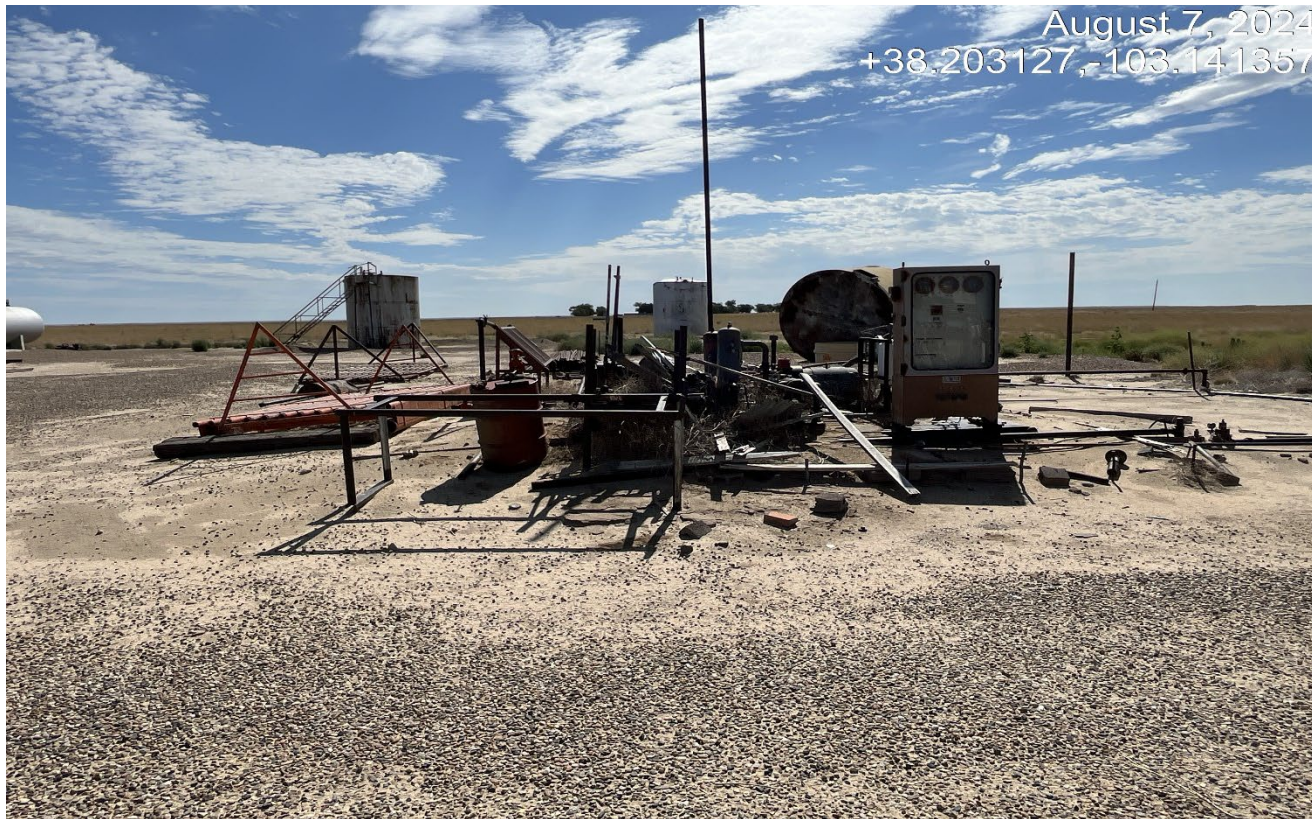
Photo 3. Facing northeast at the location. There is various unused equipment, supplies and tanks stored at the location that will need to be removed.

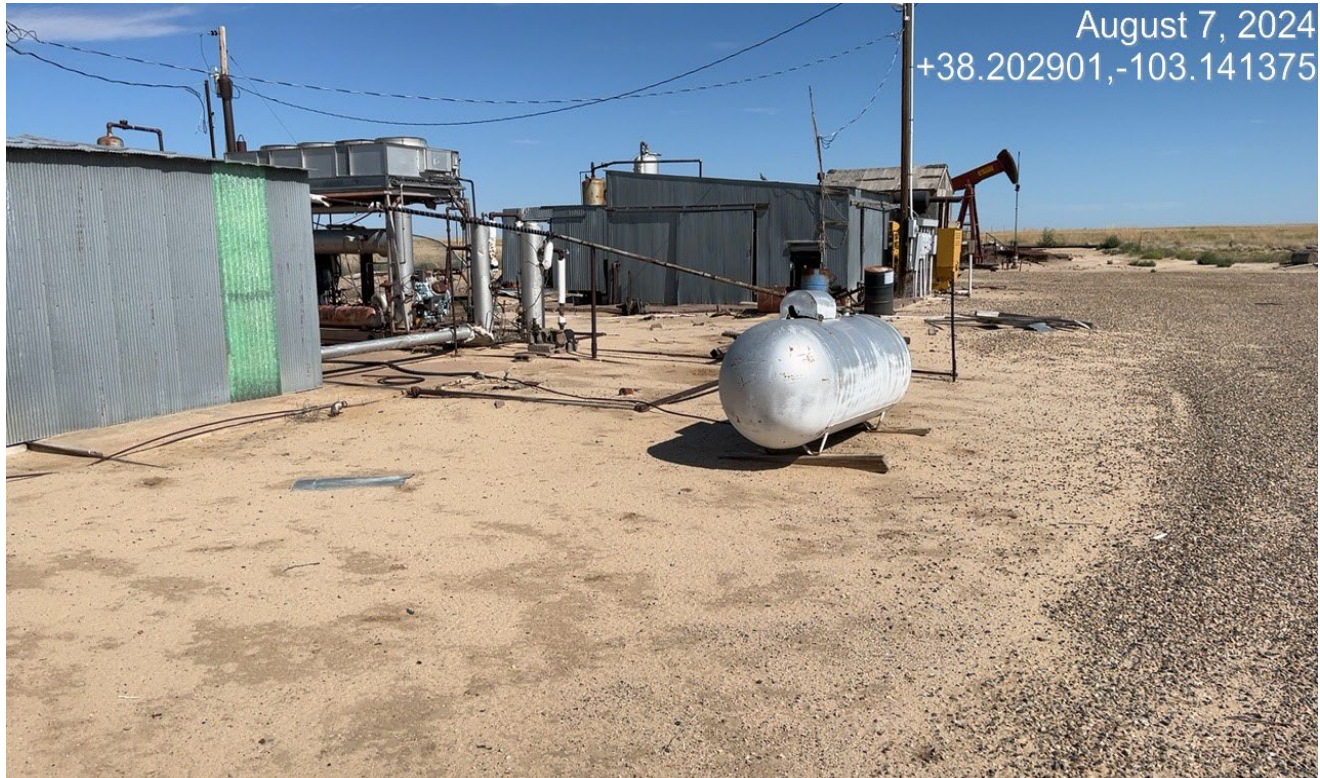
Photo 4. Facing northwest toward the GAS PROCESSING PLANT and Wellsite.

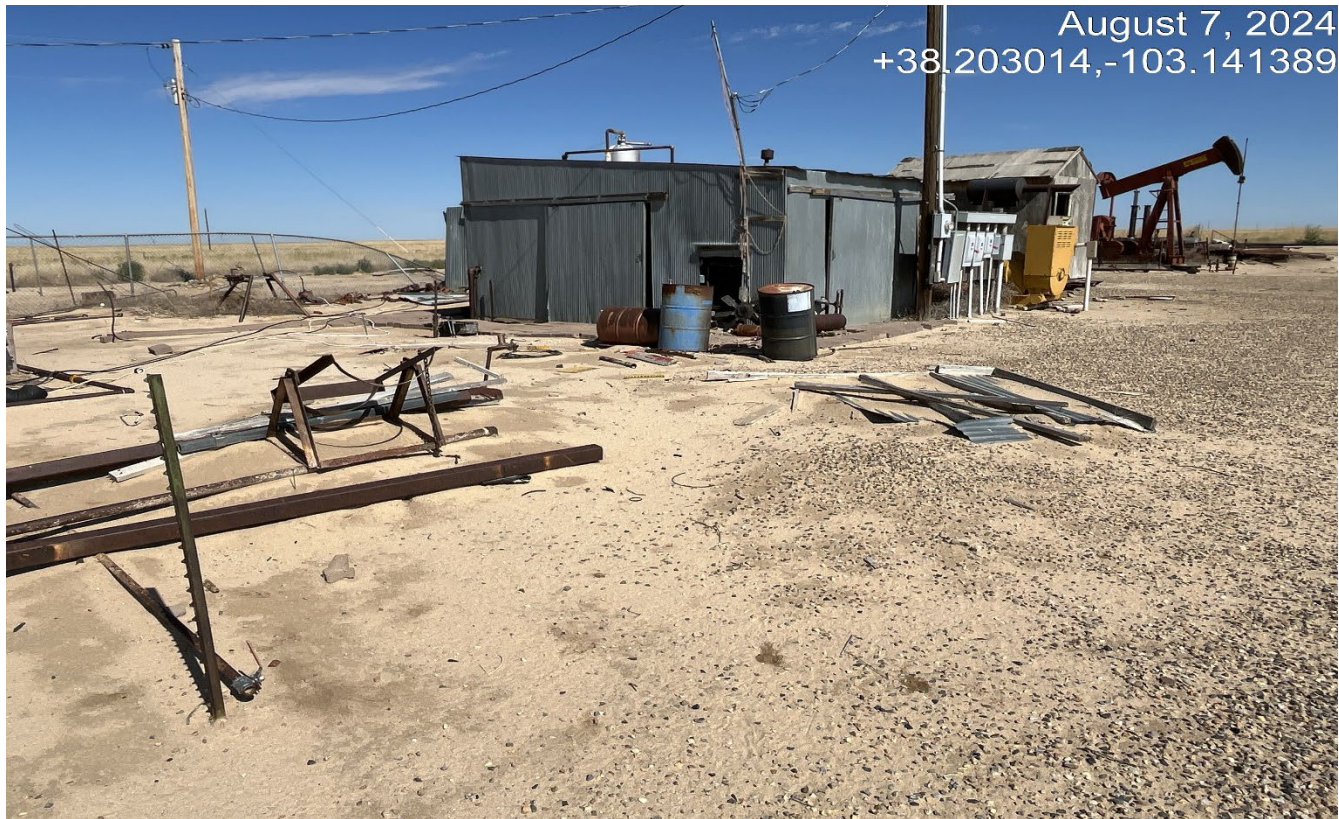
Photo 5. Facing northwest at the sheds and various equipment which are in disrepair. There is chemical barrels with no containment and various debris laying on the ground.

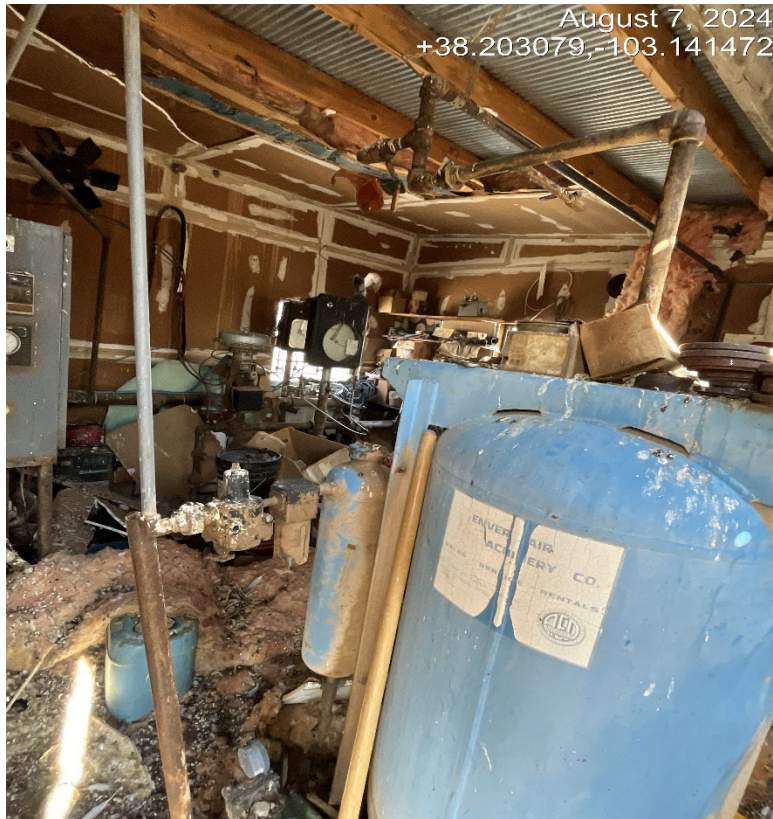
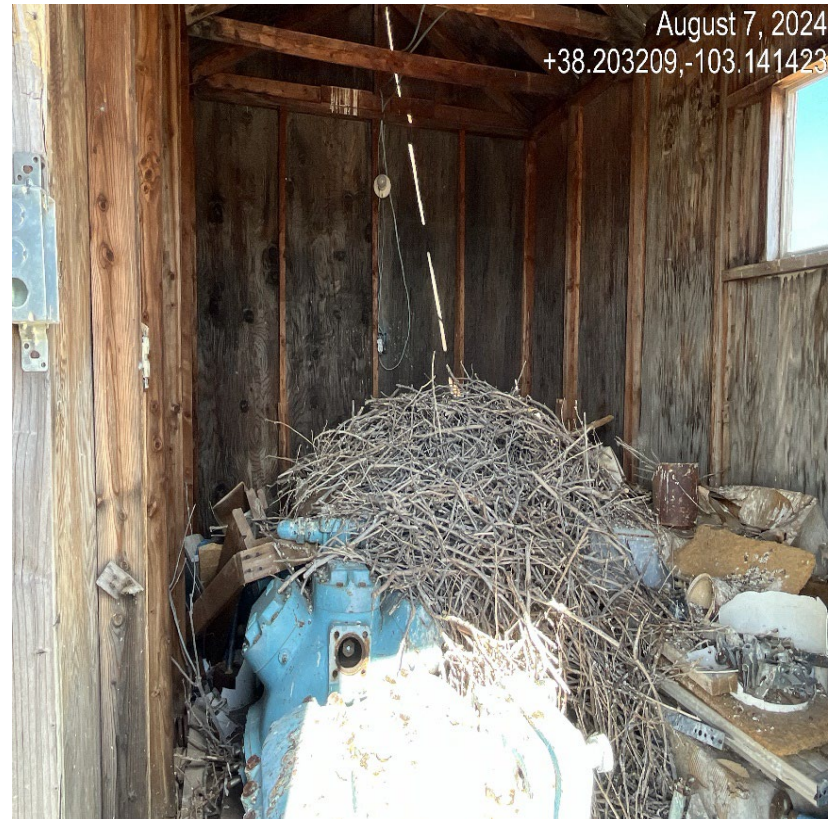
Photo 6&7. There are other sheds with large bird nests. Operator will need to consult with USFS and CPW regarding time restrictions and relocation.

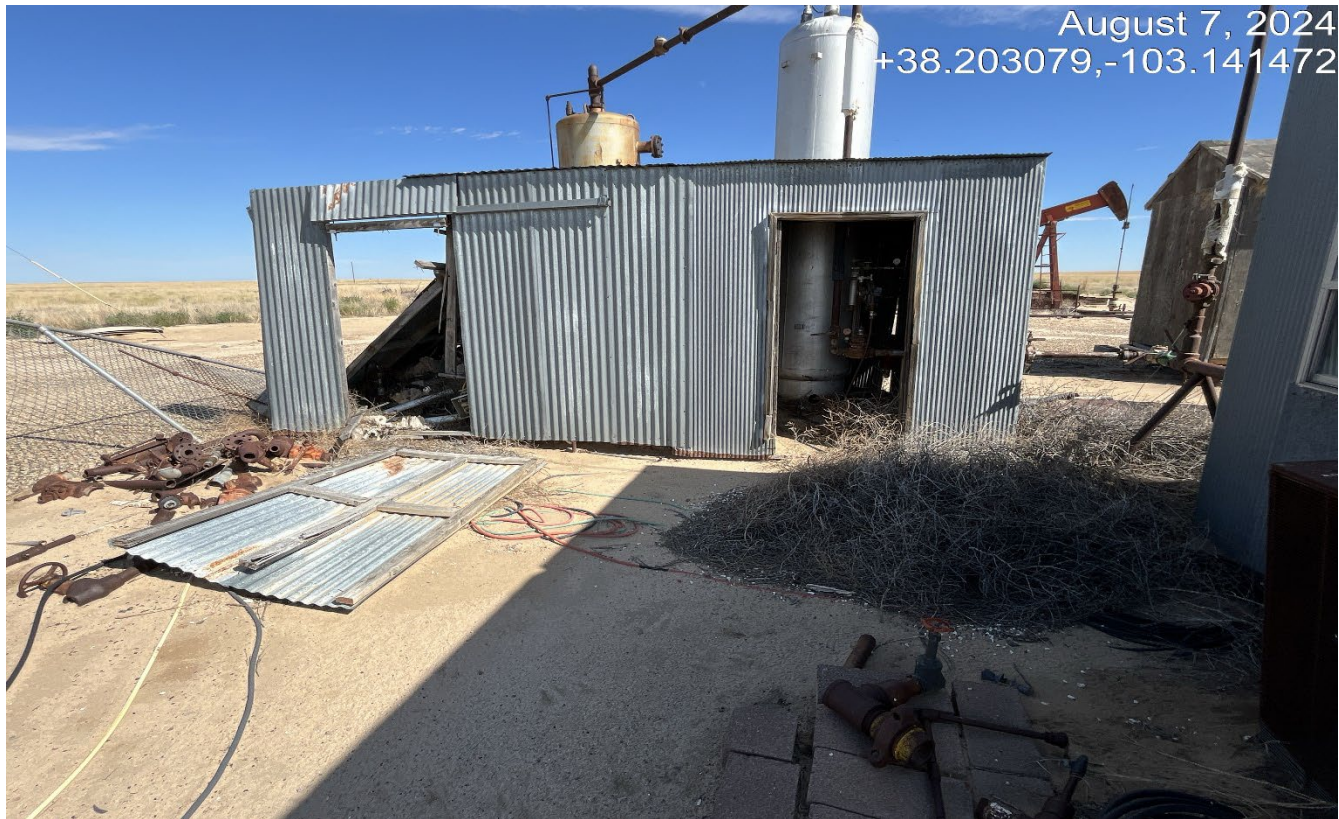
Photo 8. Facing northwest at the sheds and equipment which are in disrepair.

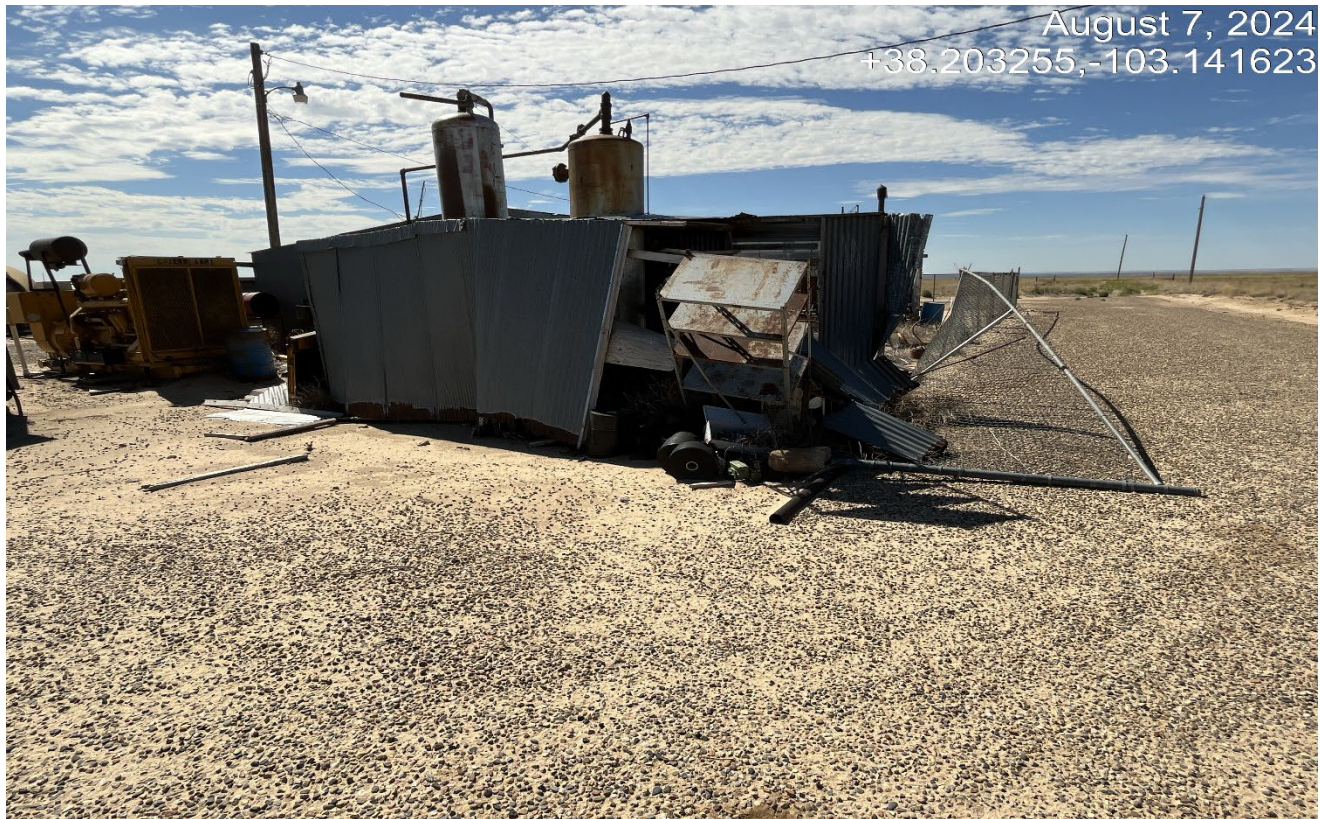
Photo 9. Facing southeast at the west side of the location. This shed and fence are in disrepair with various unused unneeded supplies.

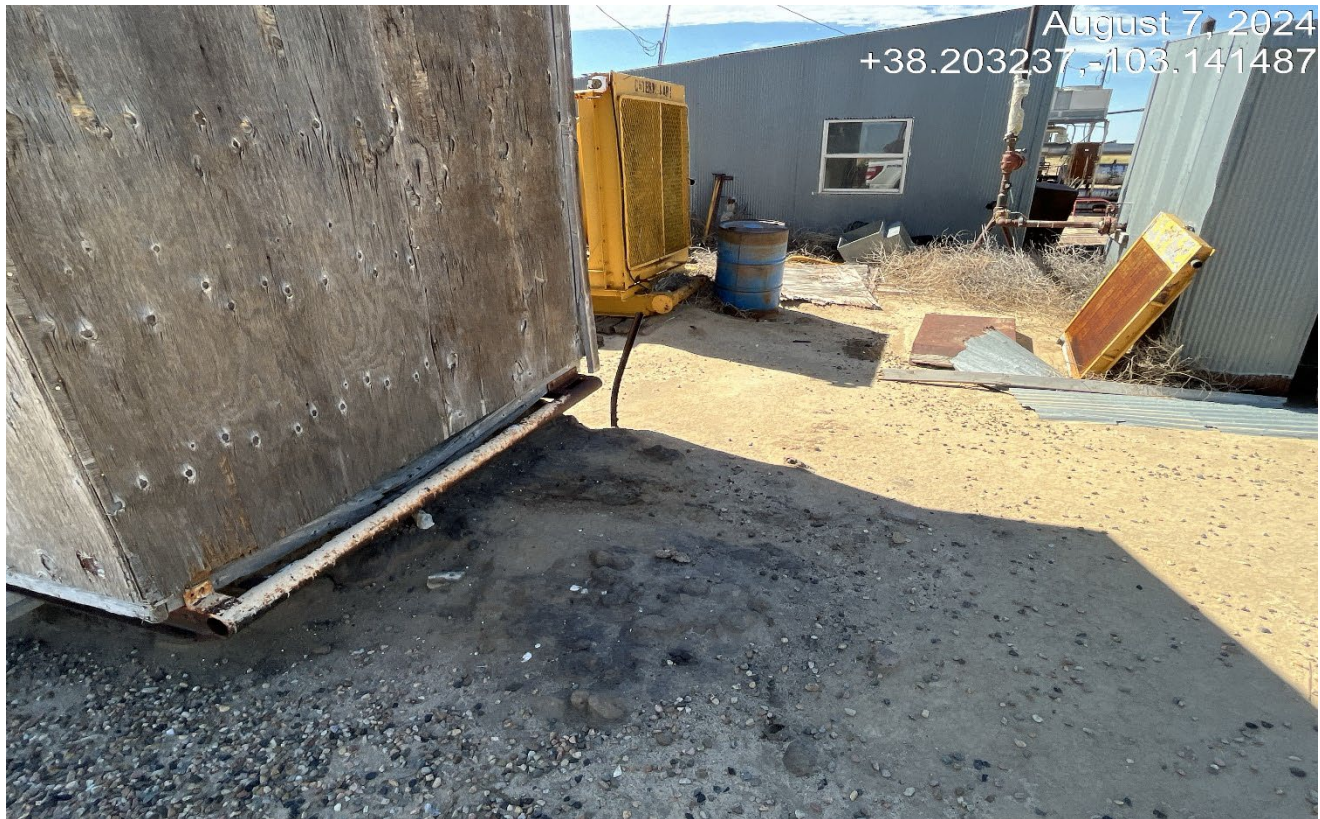
Photo 10. There are stained soils near this shed and engine compressor. There is chemical barrels with no containment and various debris laying on the ground.

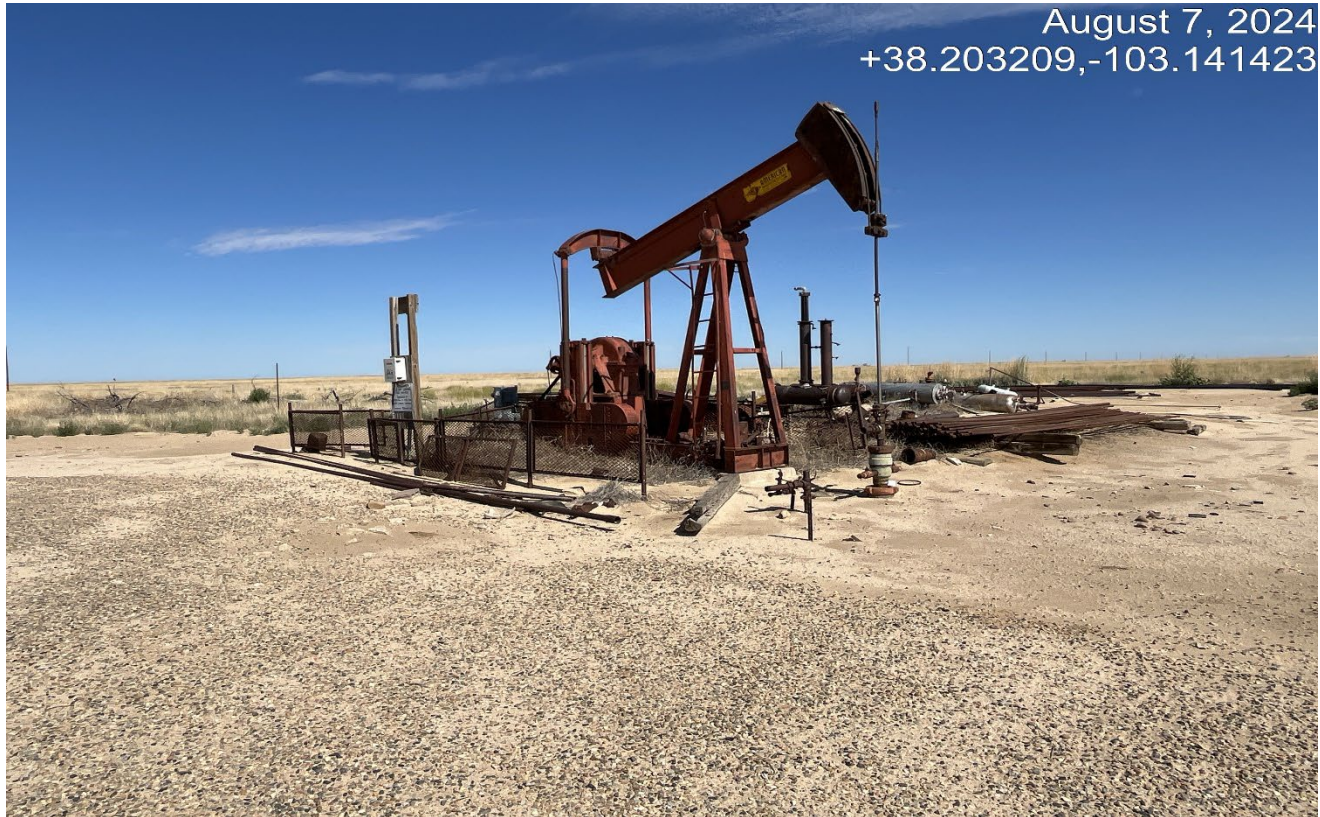
Photo 11. Facing northwest toward the well. The fence around the pumpjack is in disrepair and there is unused equipment stored near the well.

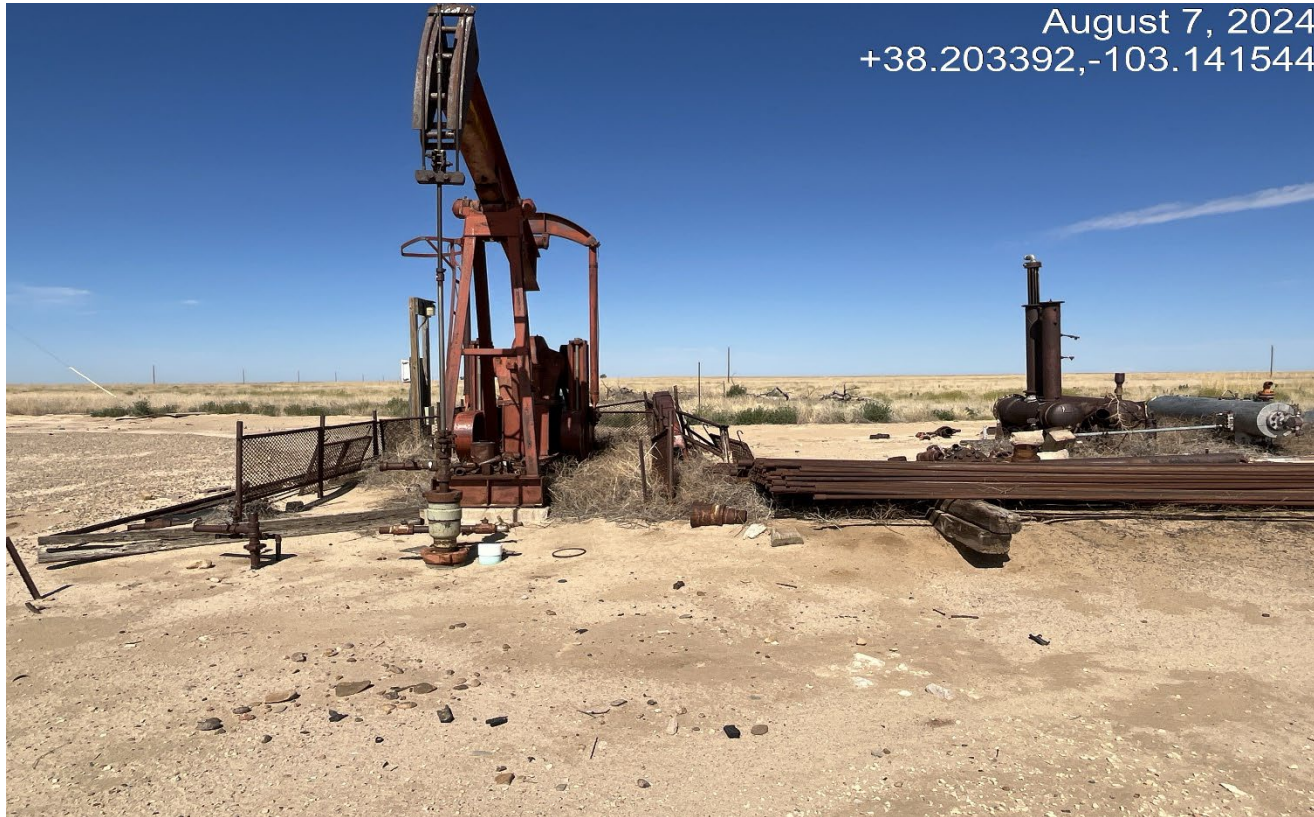
Photo 12. North side of the location facing west. There is unused pipe stored on location that needs to be removed.

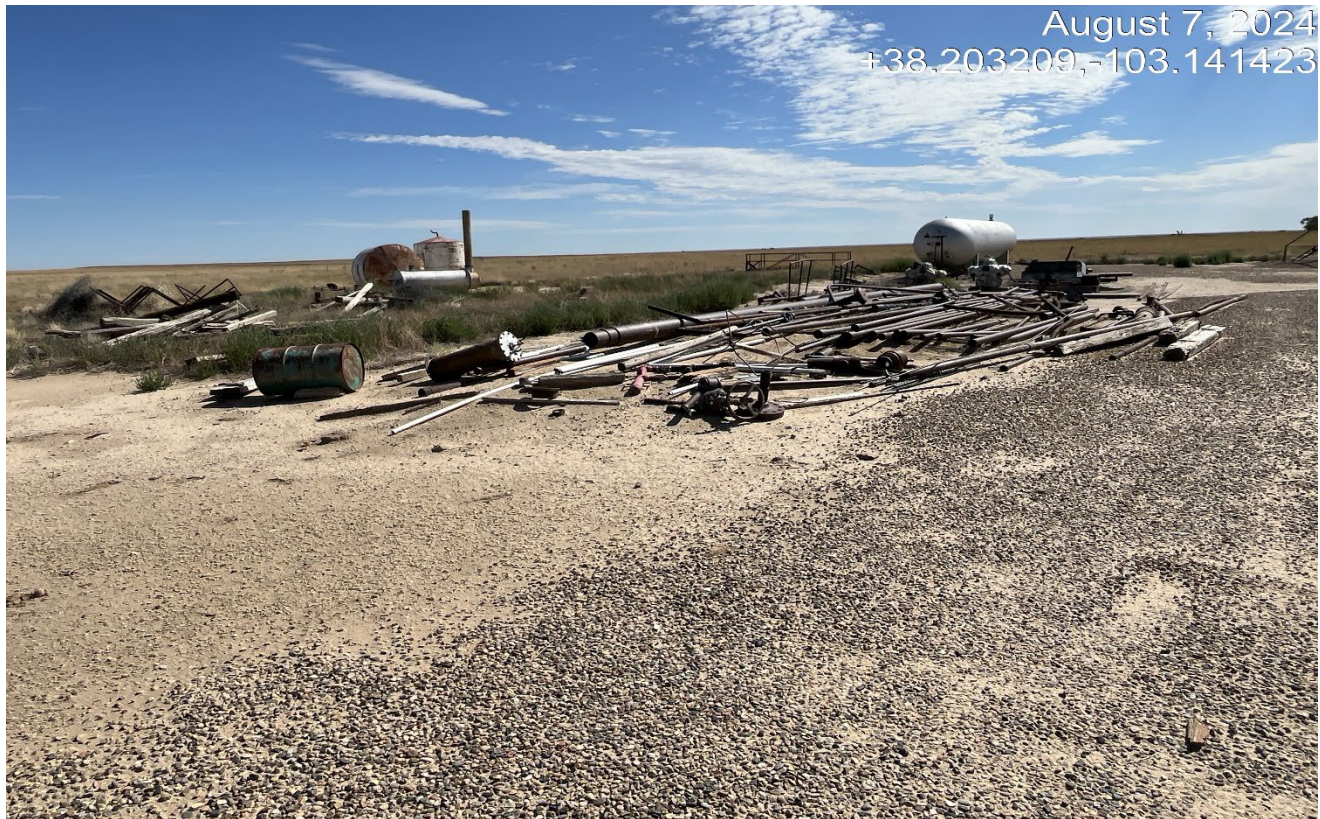
Photo 13. Facing northeast. There are various unused equipment and supplies stored on location that needs to be removed.

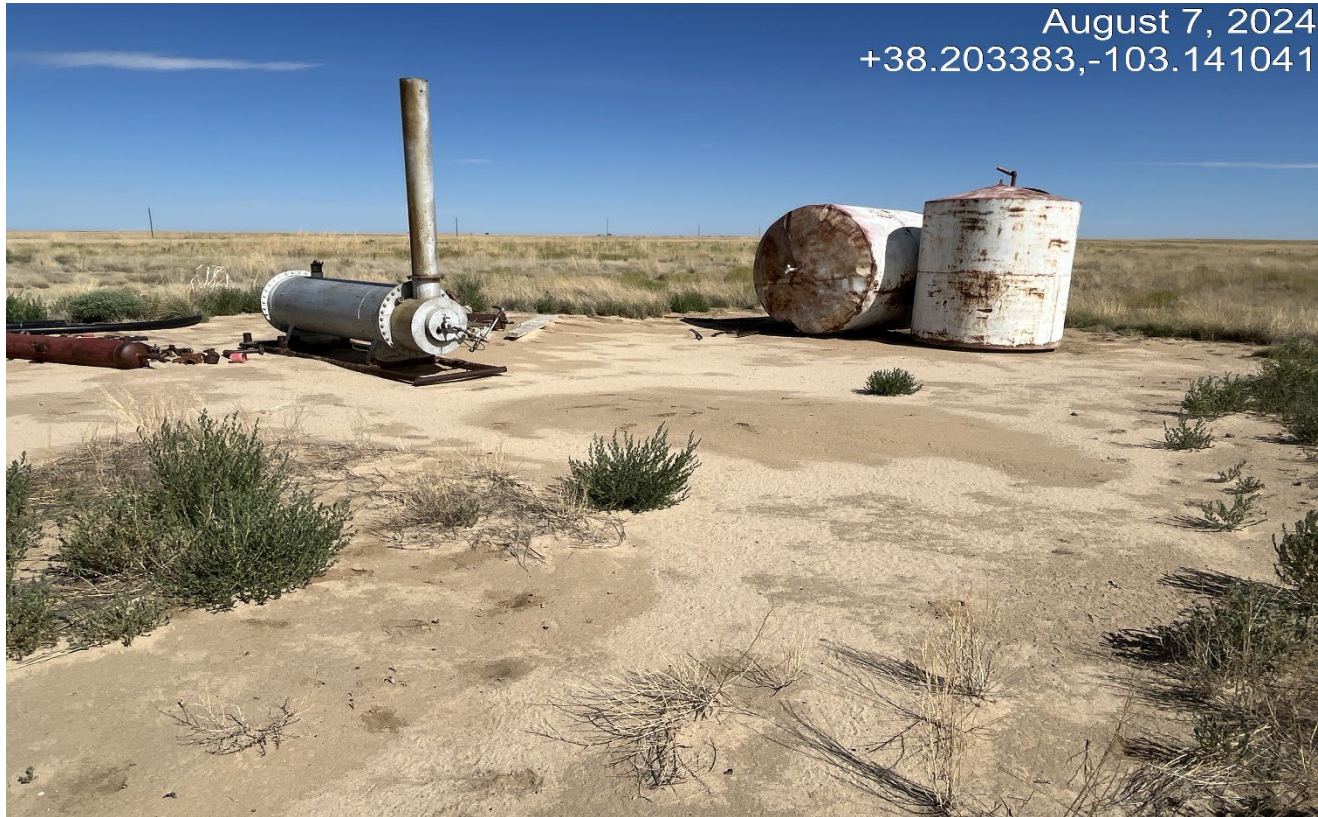
Photo 14. North side of the location facing northwest. There are unused tanks stored on location which is impacting vegetation in this area.

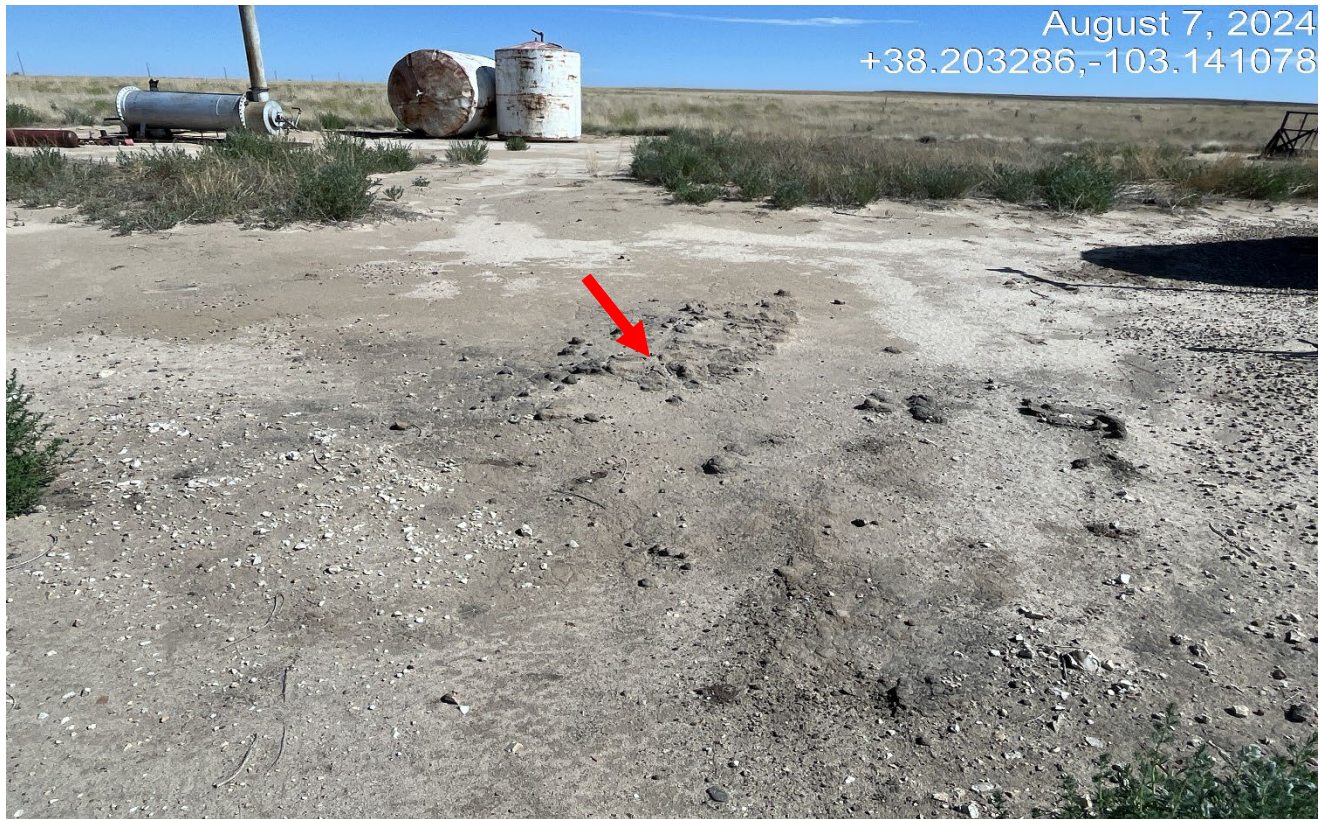
Photo 15. Facing north at the location. There appears to be impacted stained soil shown at red arrow.

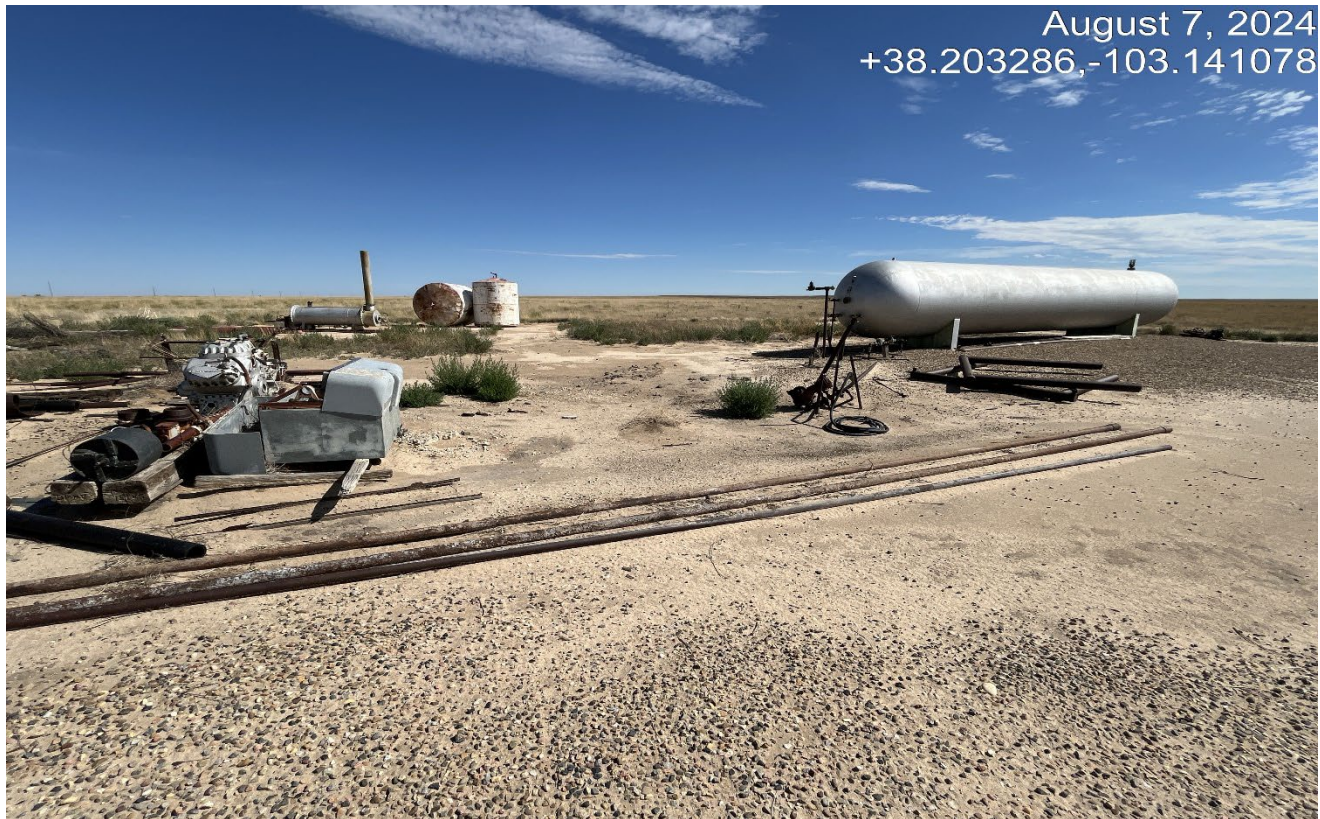
Photo 16. Facing toward the west side of the location There is a large volume tank with no labeling and appear to be unused.

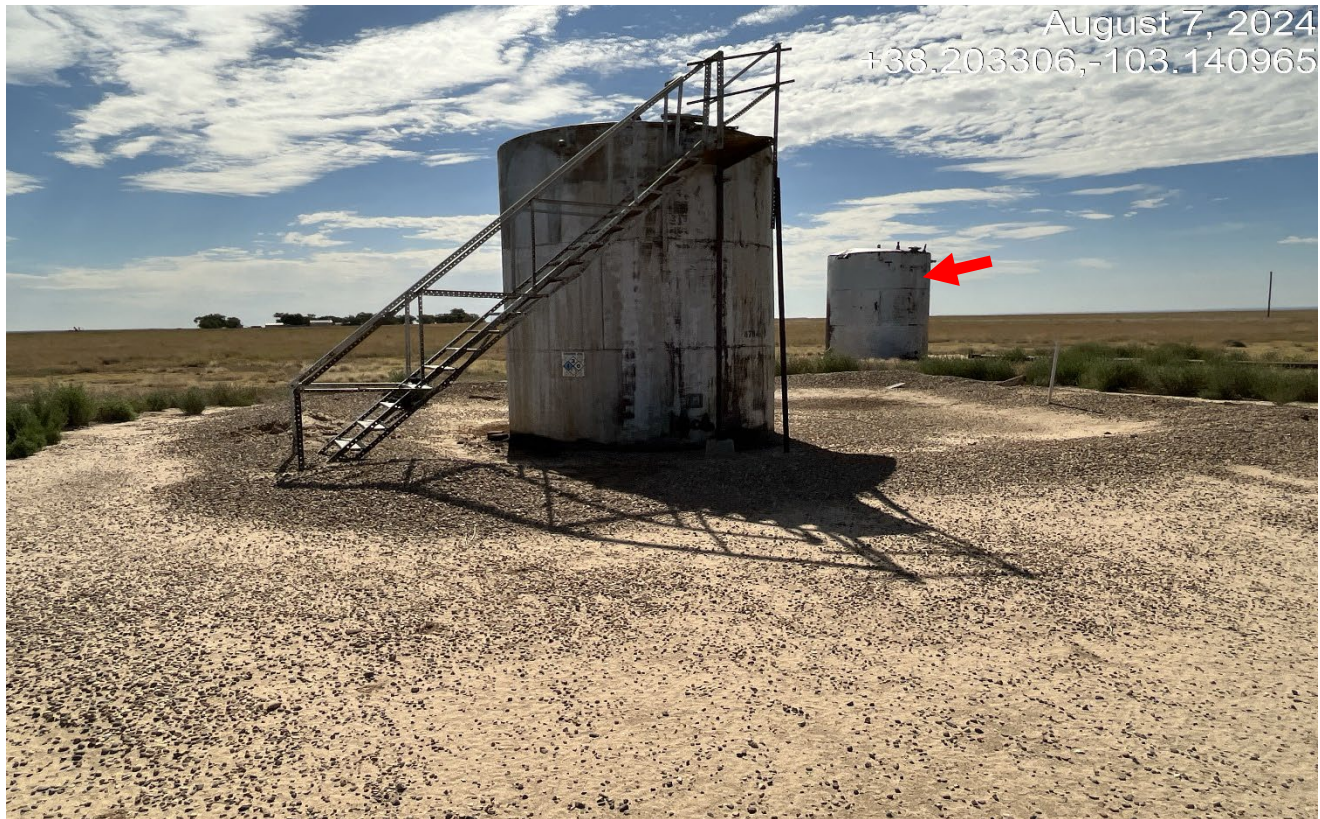
Photo 17. Facing toward the east side of the location. There is an tank with berm installed around the tank. The tank at red arrow is unused equipment.

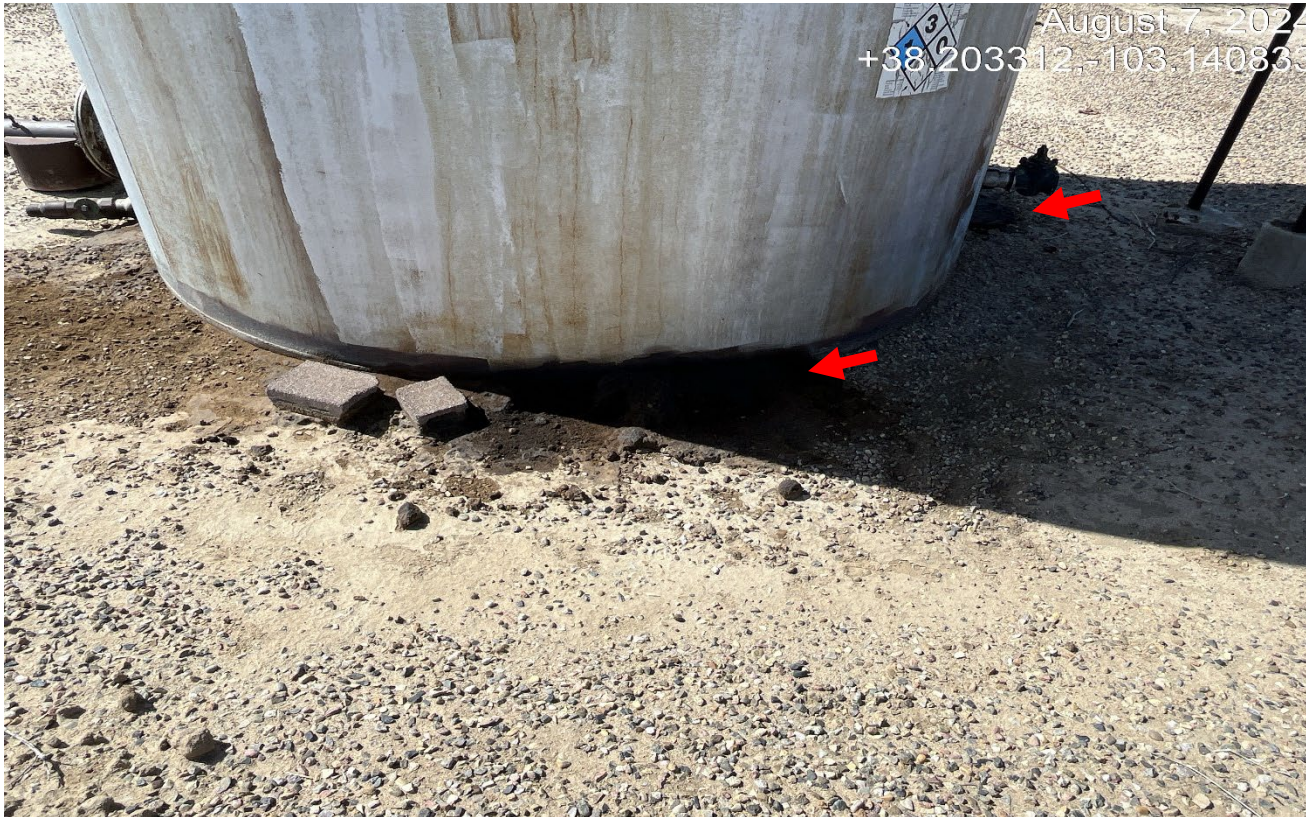
Photo 18. There is oily sludge at the base of the tank that needs to be cleaned up and properly disposed.

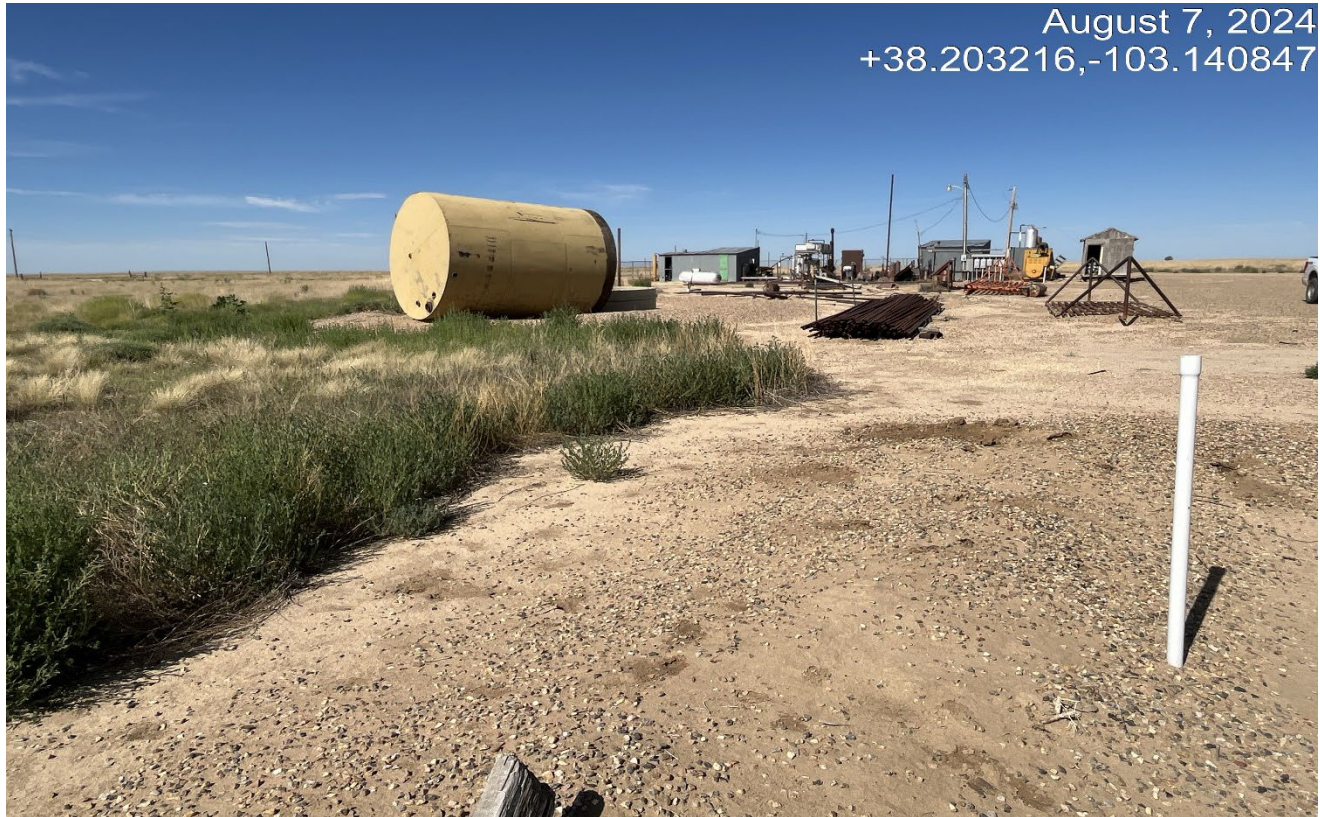
Photo 19. East side of the location facing west. There is unused pipe stored on location and a tank that is tipped over.
