Inspection Photos

Operator: CAERUS PICEANCE LLC - 10456

Location ID: 418660

Inspection Doc: 696206094

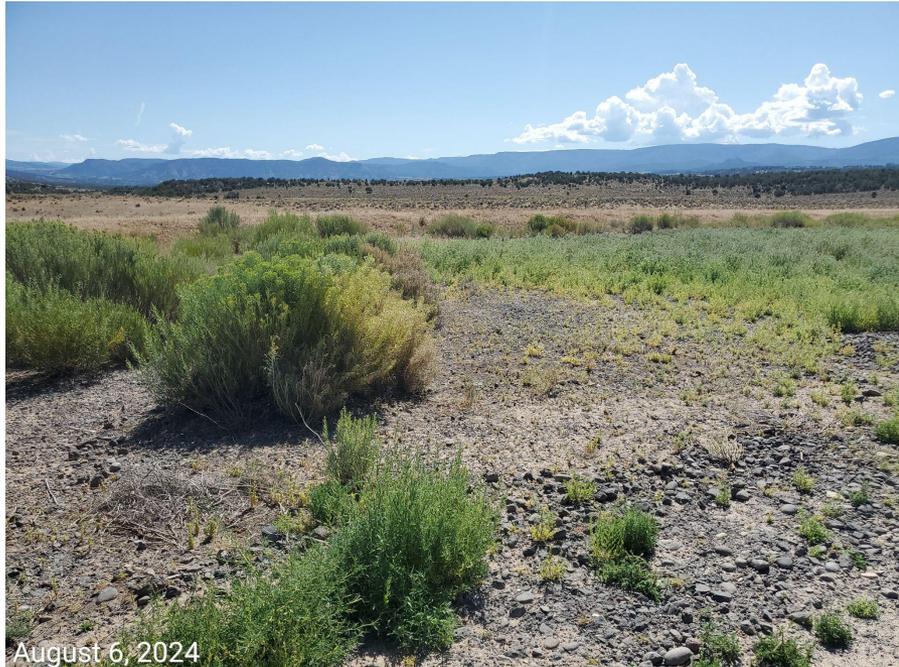
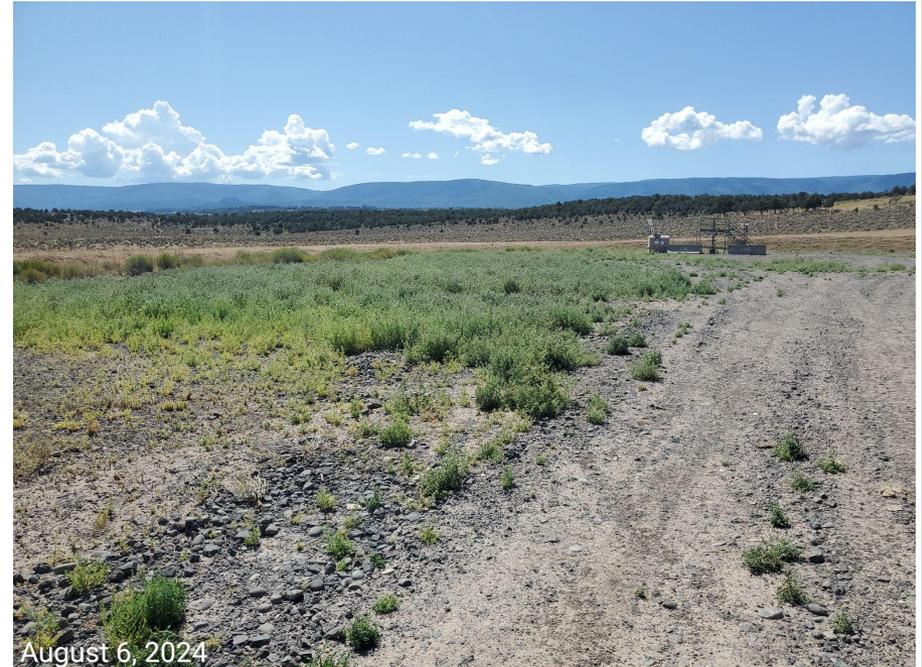
Photo 1: Photos 1-2 taken from the north end of the Location. Photos provide an overview of the Location from east, southeast, southwest to west. Photos show areas of the current working pad that are not necessary for production, and require reclamation. Photos also show weeds have established throughout the current working pad surface of the Location.

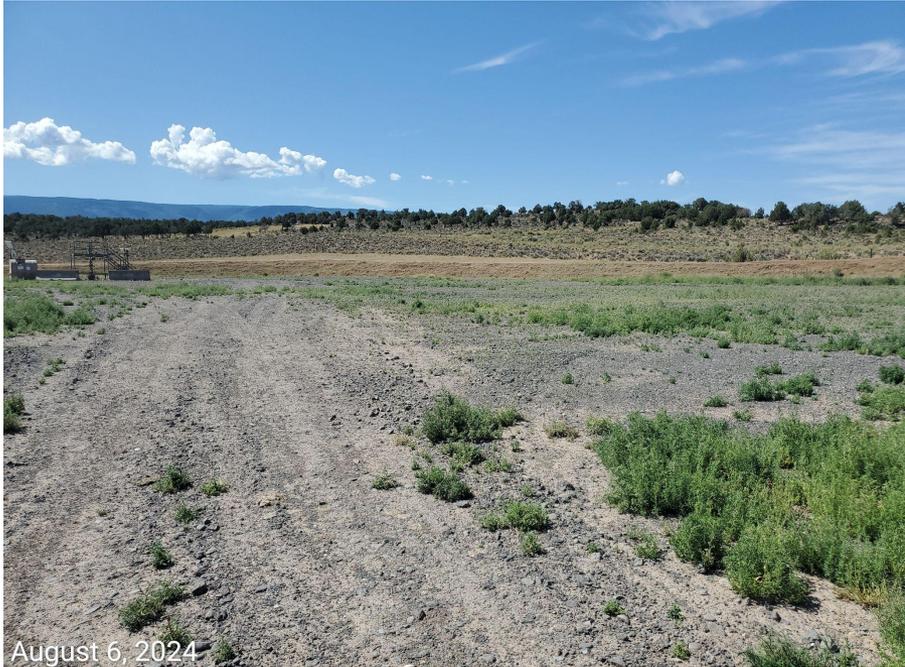
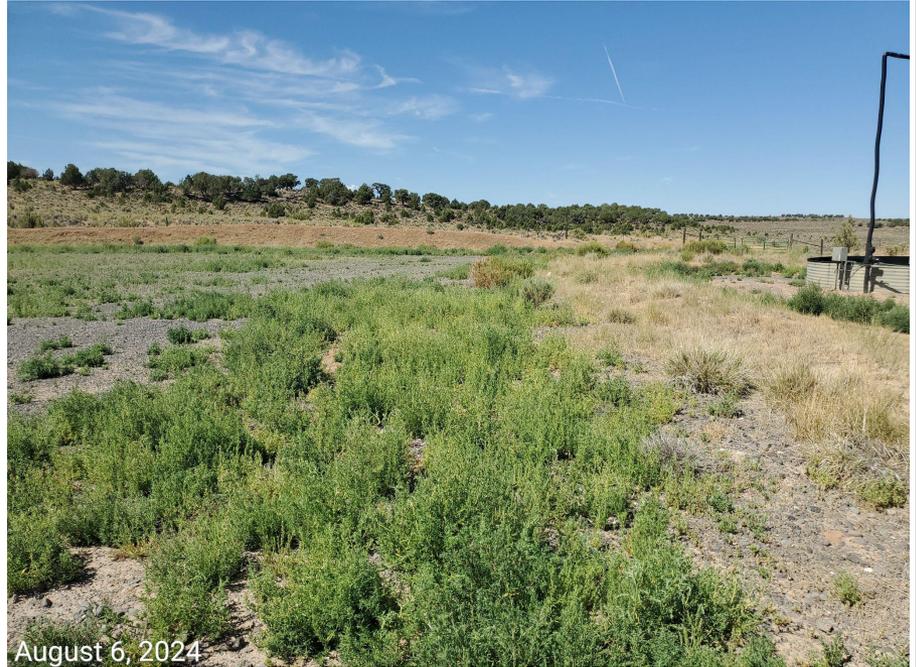
Photo 2: See comments under photo 1.

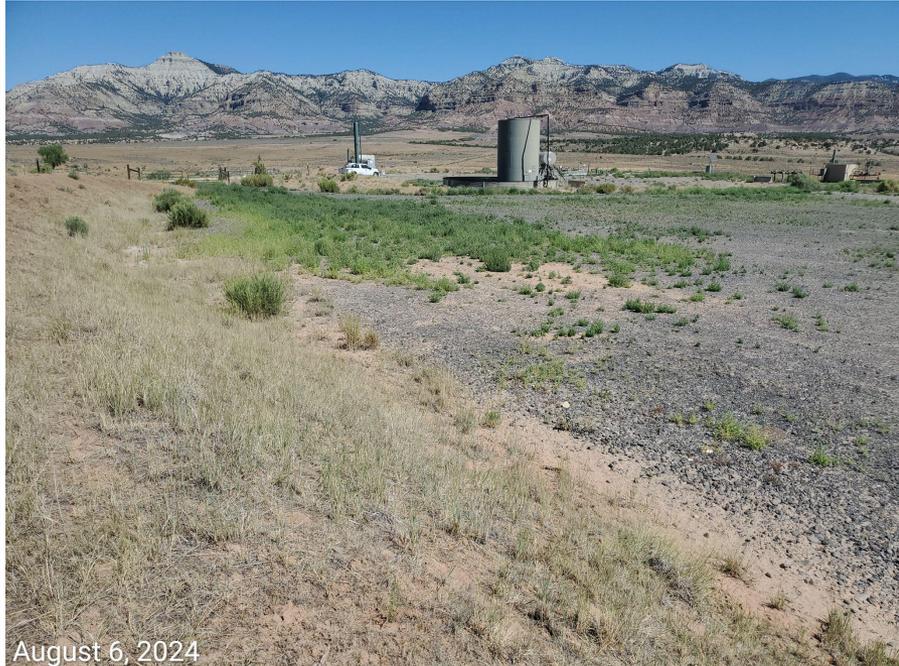
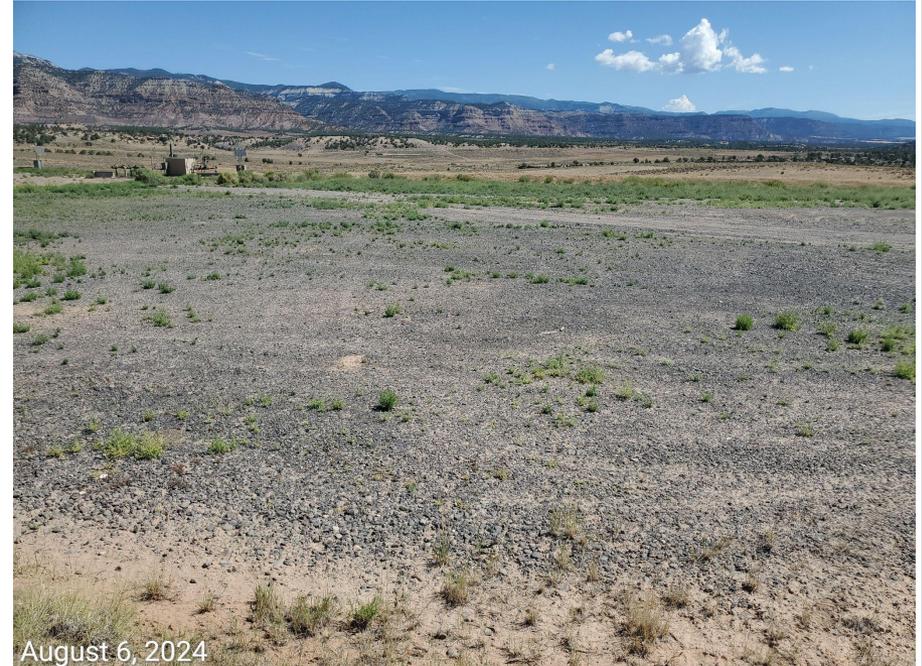
Photo 3: Photos 3-4 taken from the west end of the Location. Photos provide an overview of the Location from north, northeast, southeast to south. Photos show areas of the current working pad that are not necessary for production, and require reclamation.

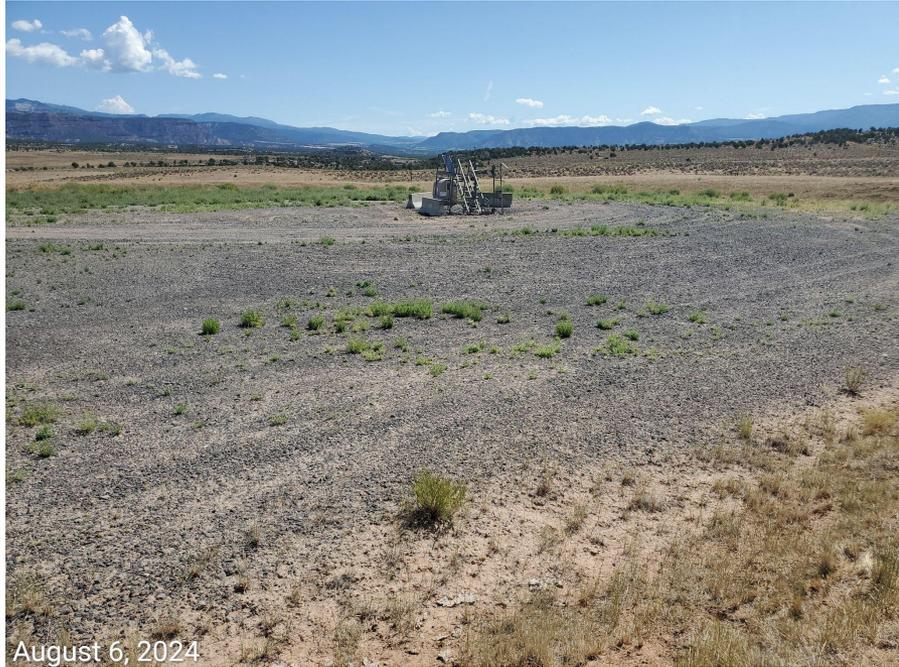
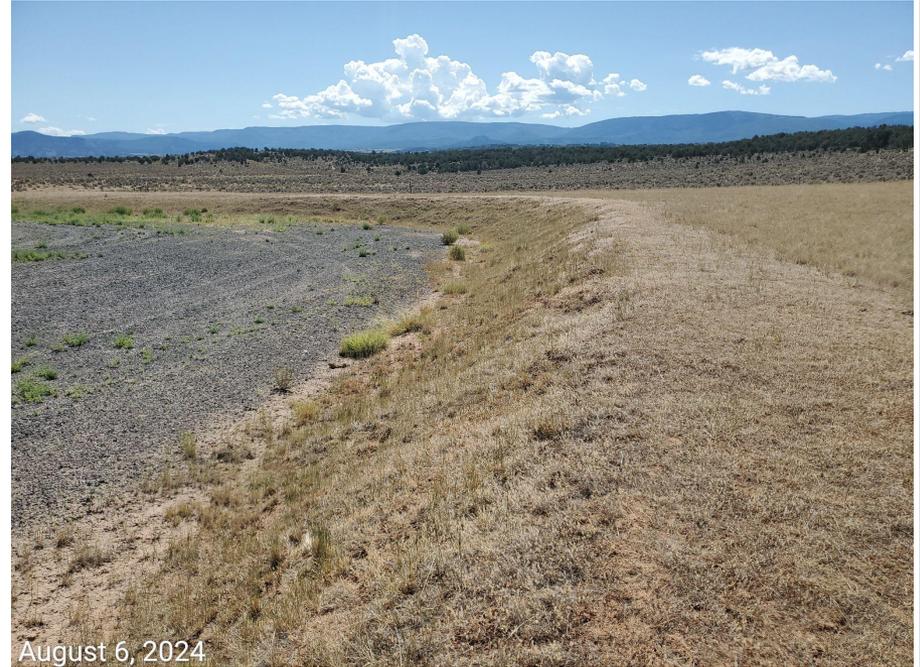
Photo 4: See comments under photo 3.

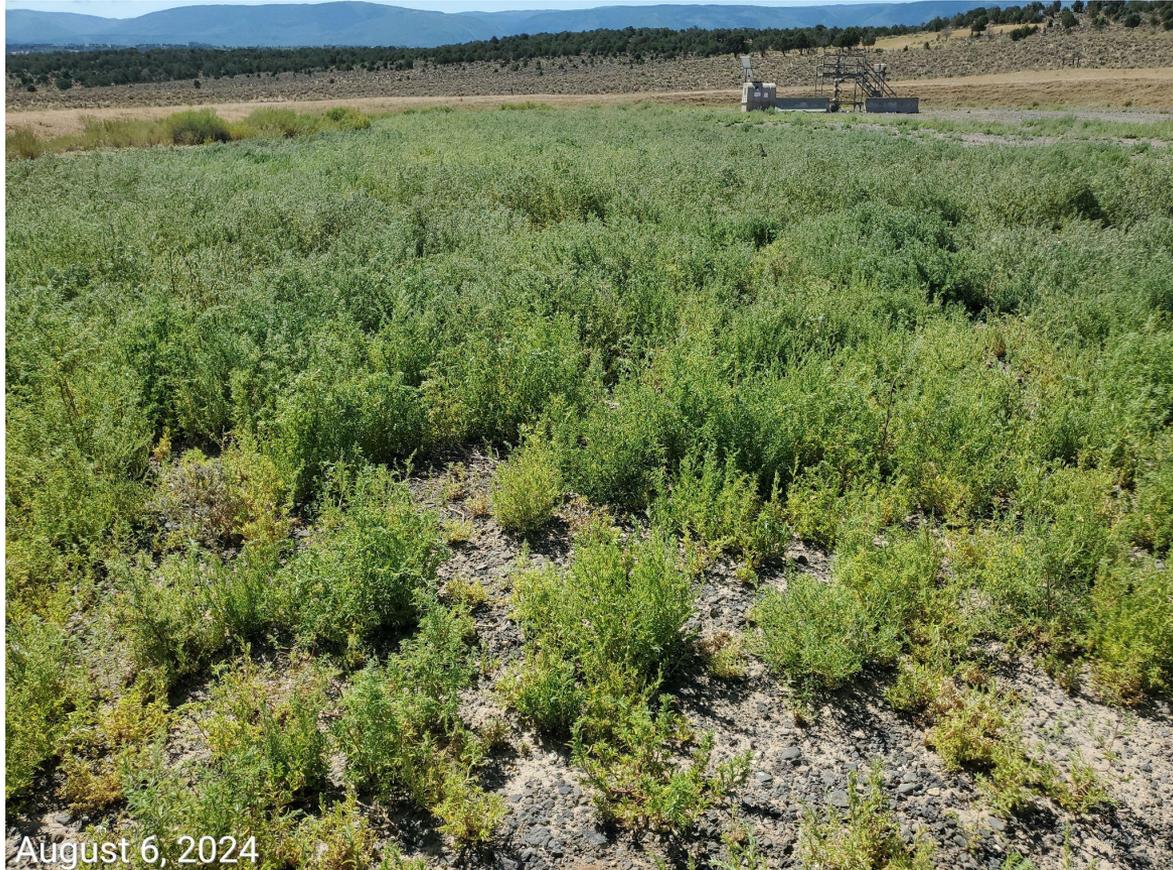
Photo 5: Photo example showing weeds have established throughout the current working pad surface of the Location.

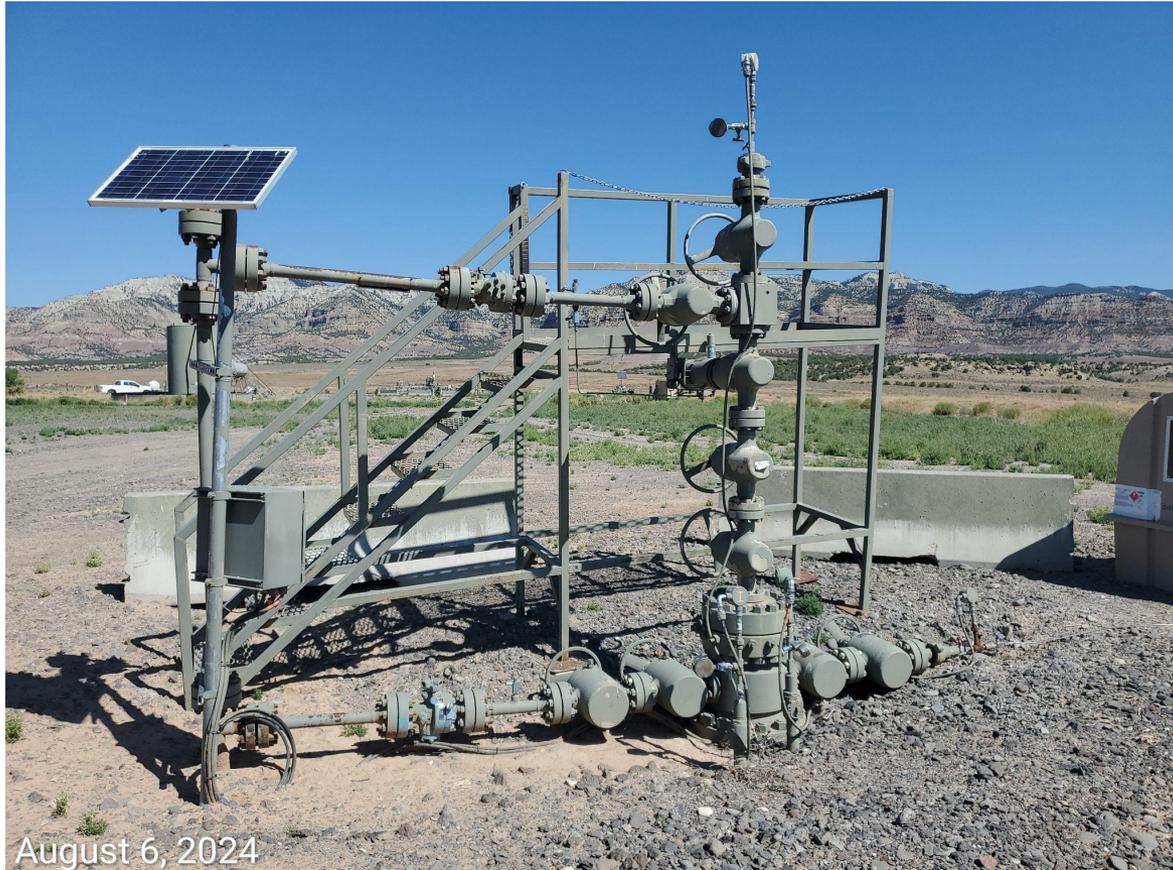
Photo 6: Photo shows well on Location. Signage does not comport with Rule 605 Requirements.

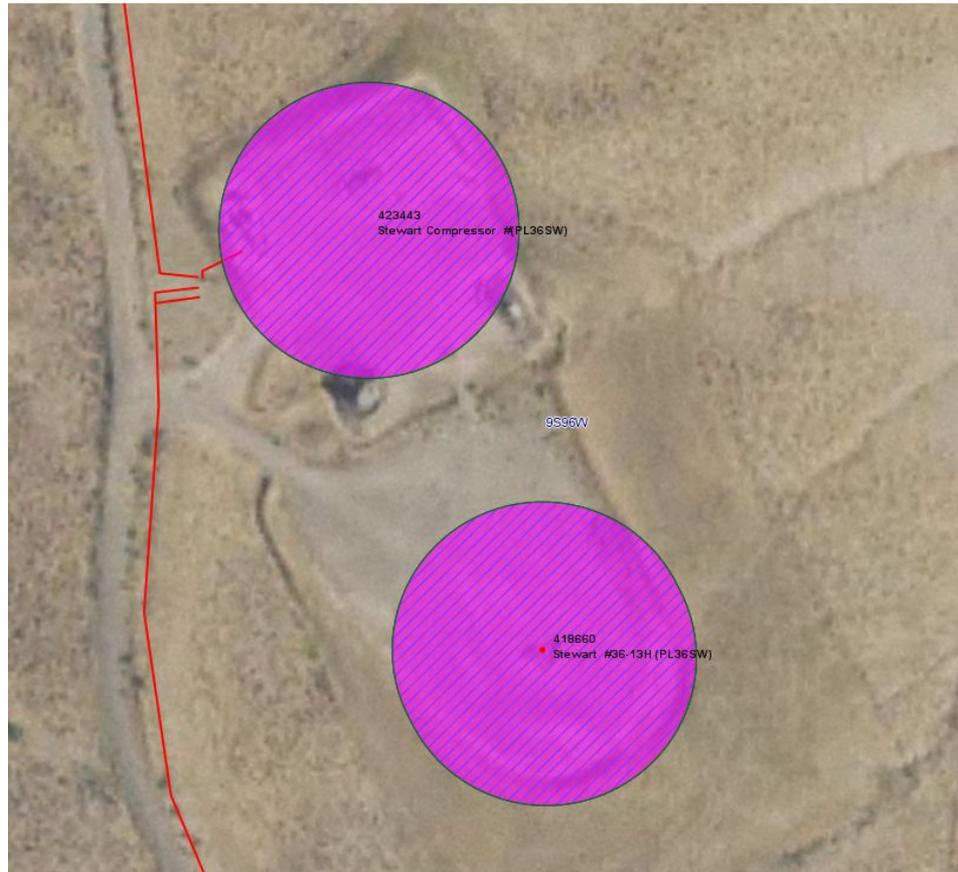
Photo 7: ECMC COGIS imagery. Photo shows flowline systems registered in the area. Photo also shows no Off-location flowline has been registered at the Stewart #36-13H; no other facilities exist on the Location; flowlines from the well likely travel off-location to the tank facility on the Stewart Compressor Location (#423443), to the North of the Stewart Location (#418660).

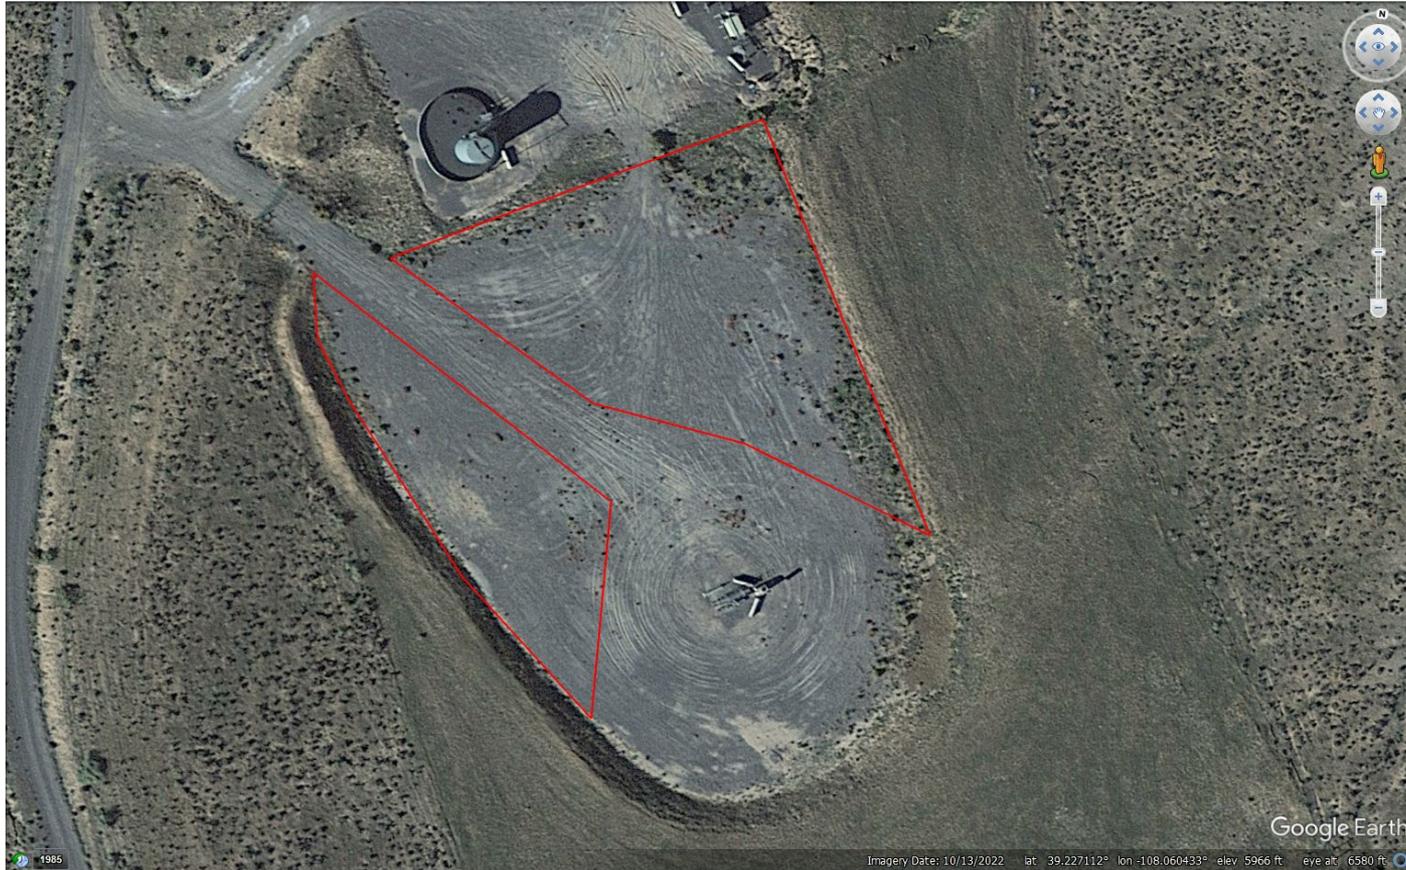
Photo 8: 2022 Google Earth aerial imagery. Photo provides an overview of the Stewart #36-13H Location (#418660). Production facilities (not including the well) have either not been installed on the Location, or have since been removed. Red polygons represent approximate areas of the Location that are not necessary for production, and are subject to 1003.b reclamation requirements.
