Inspection Photos
Location Name: Christensen 4-9
Location ID: 335580

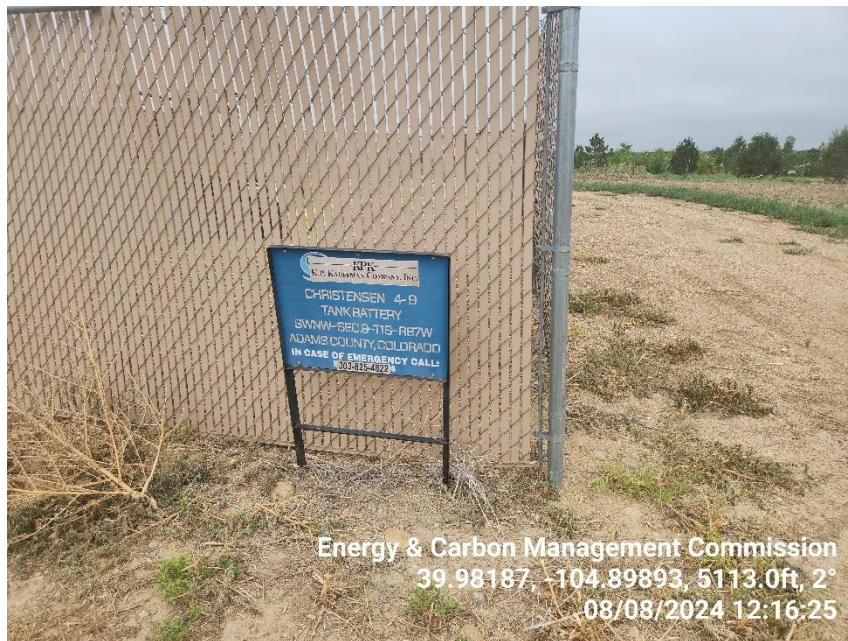
Photo 3 Tank Battery sign.

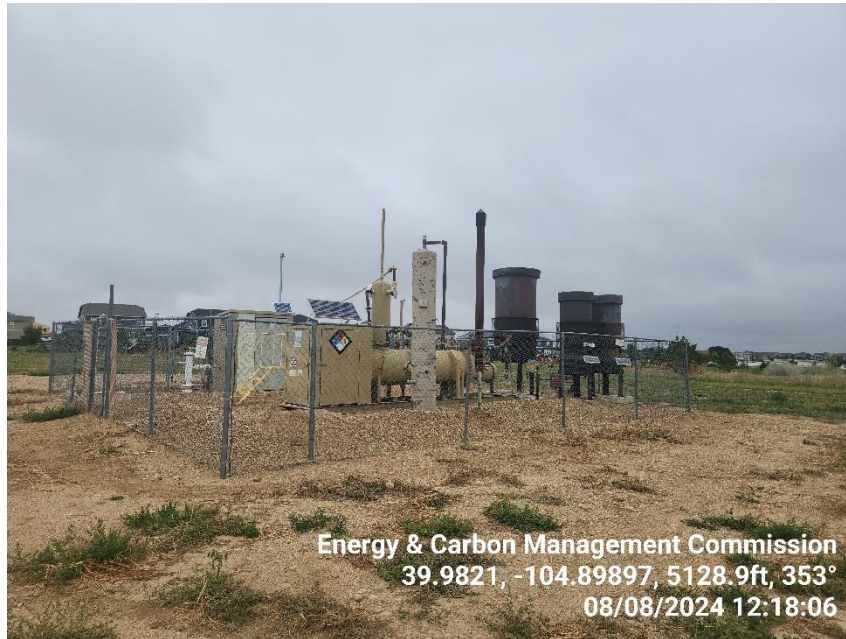
Photo 7 Gas Meter Run, ECDs & Horizontal Heated Separator.

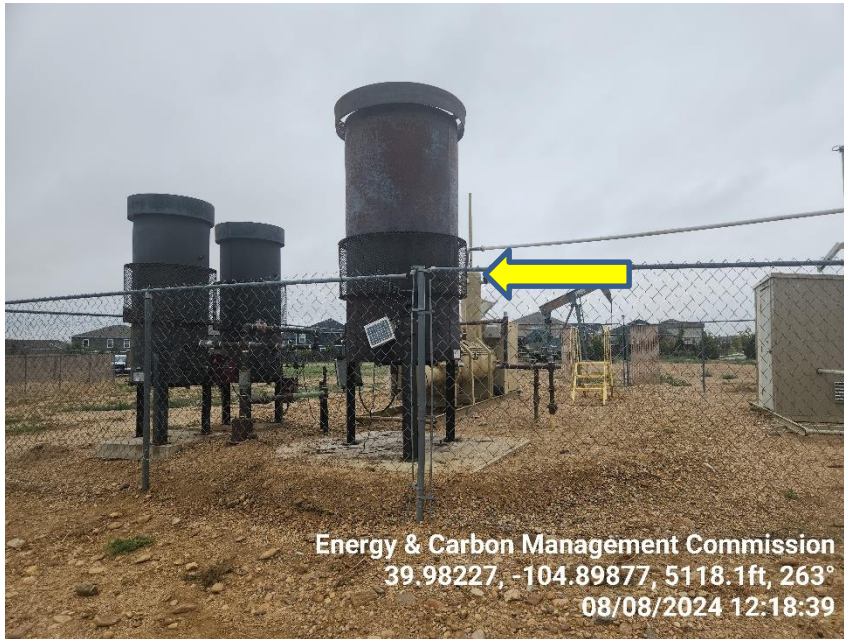
Photo 9 ECDs, The closest has fire damage.

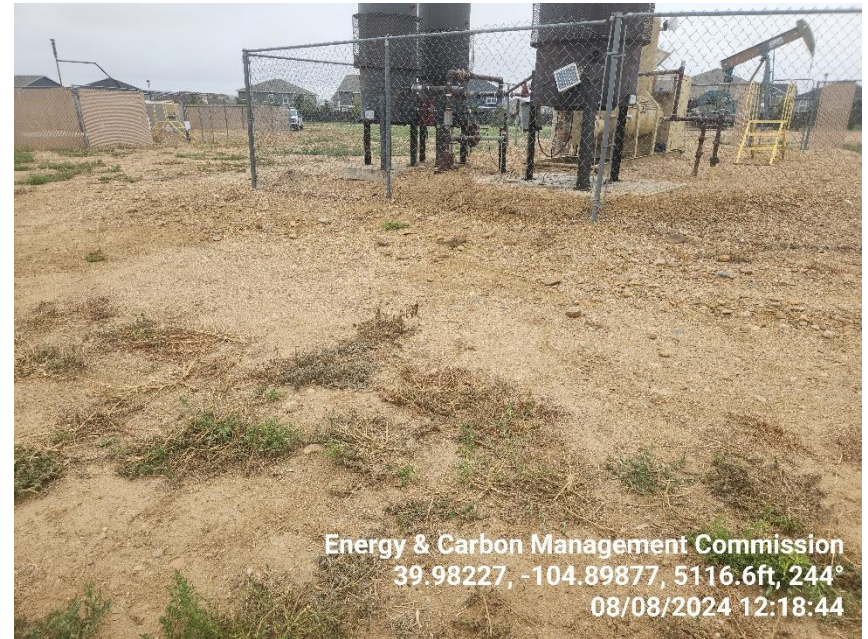
Photo 10 The ground out of the ECD berm appears dry.

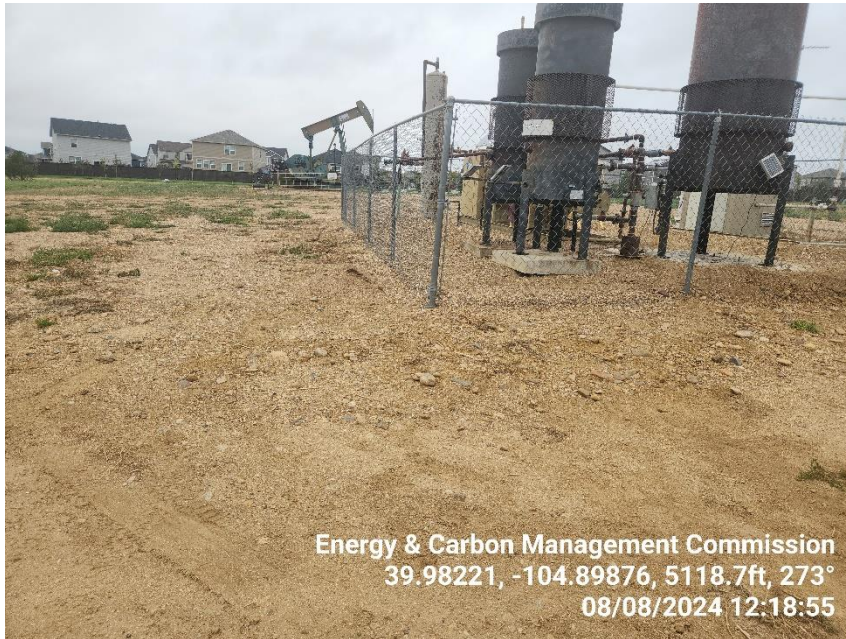
Photo 11 The ground out of the ECD berm appears dry.

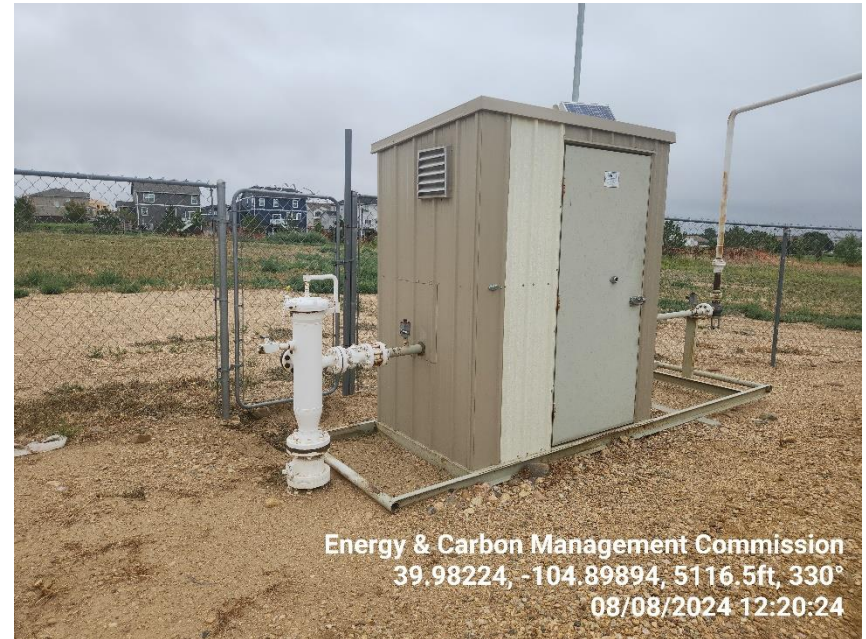
Photo 12 Gas Meter Run.

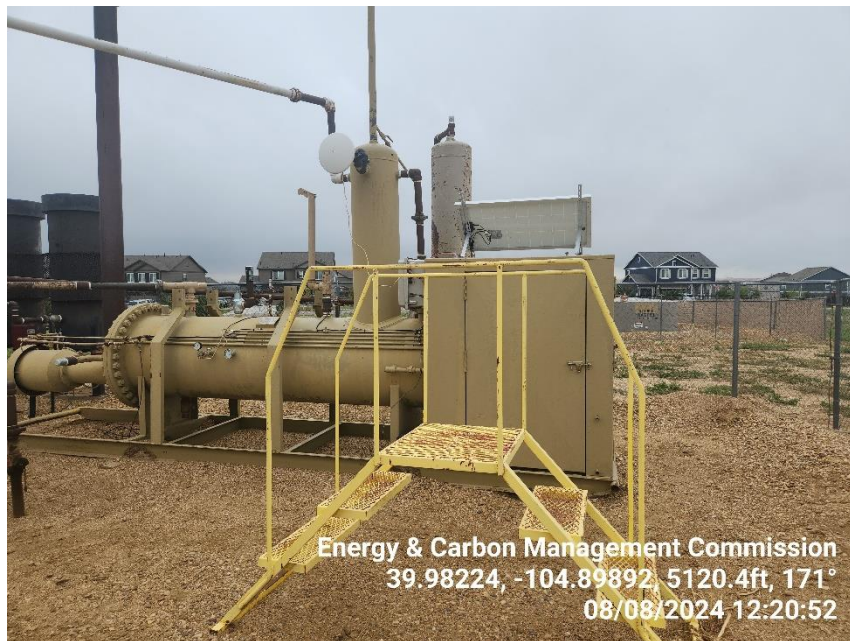
Photo 13 Horizontal Heated Separator.

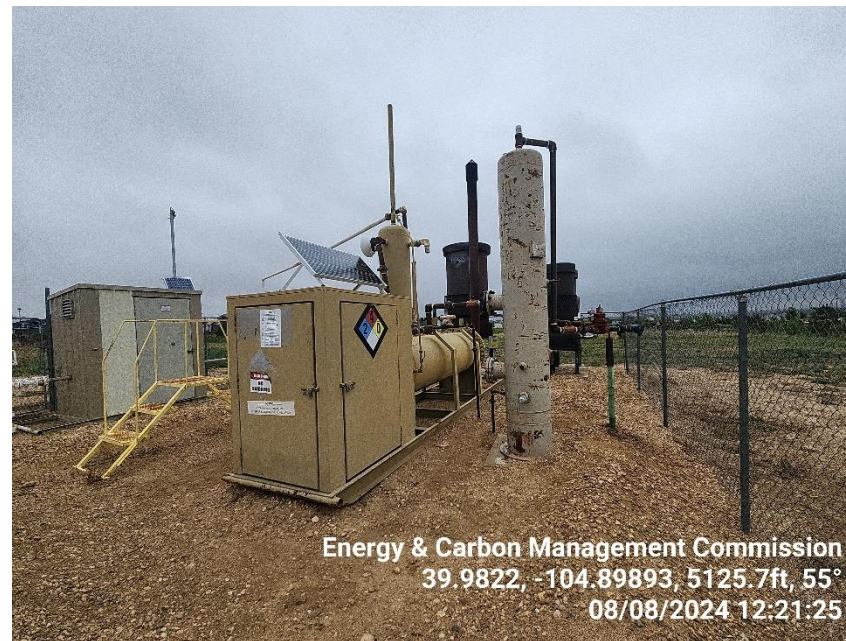
Photo 14 HHS & Vertical Sep..

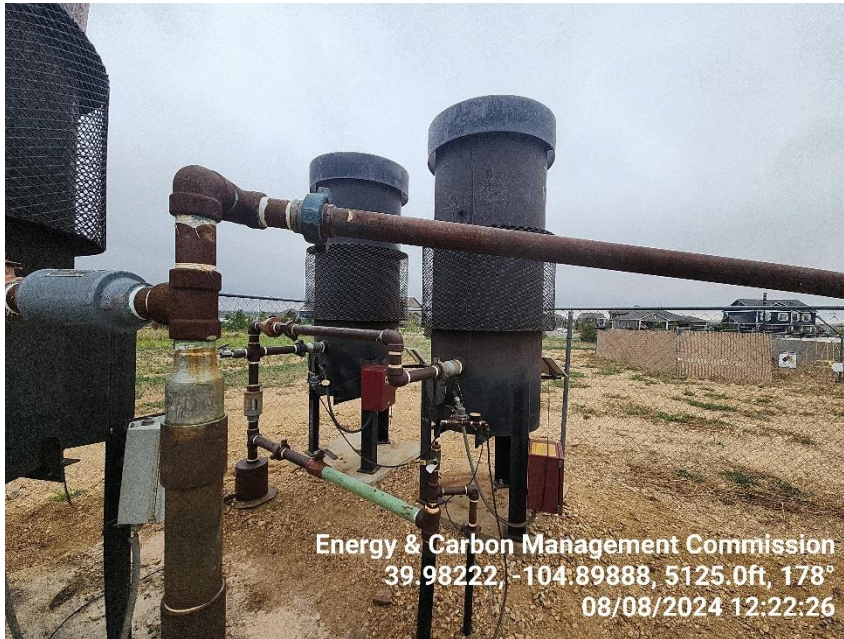
Photo 15 ECDs sight glass on pressure gages are melted.

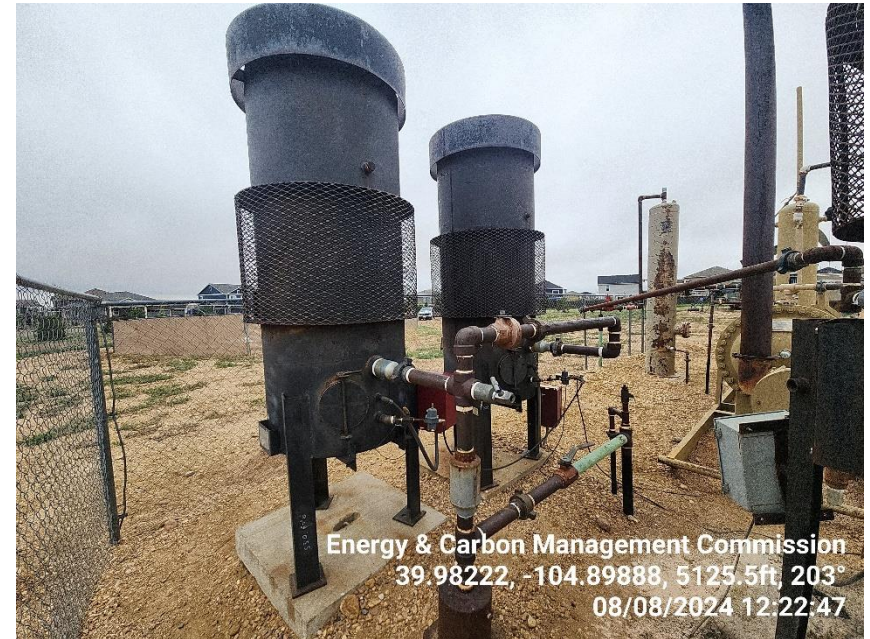
Photo 16 ECDs sight glass on pressure gages are melted.

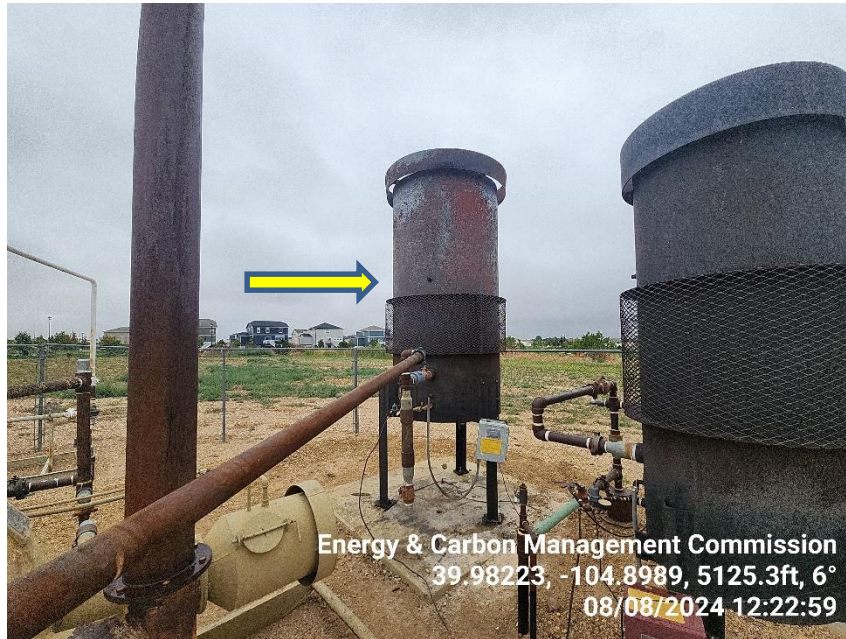
Photo 17 Damaged ECD melted wire, gauges.

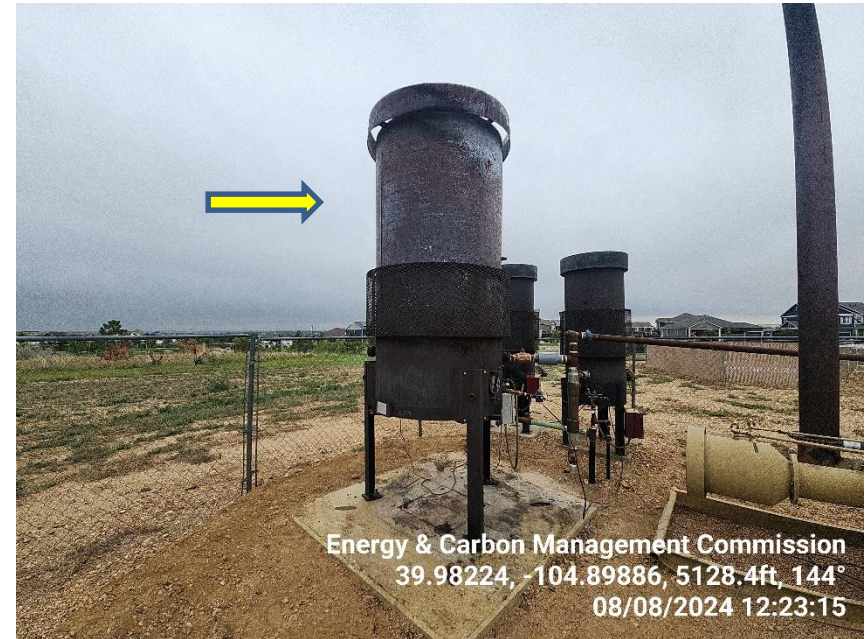
Photo 18 Damaged ECD.

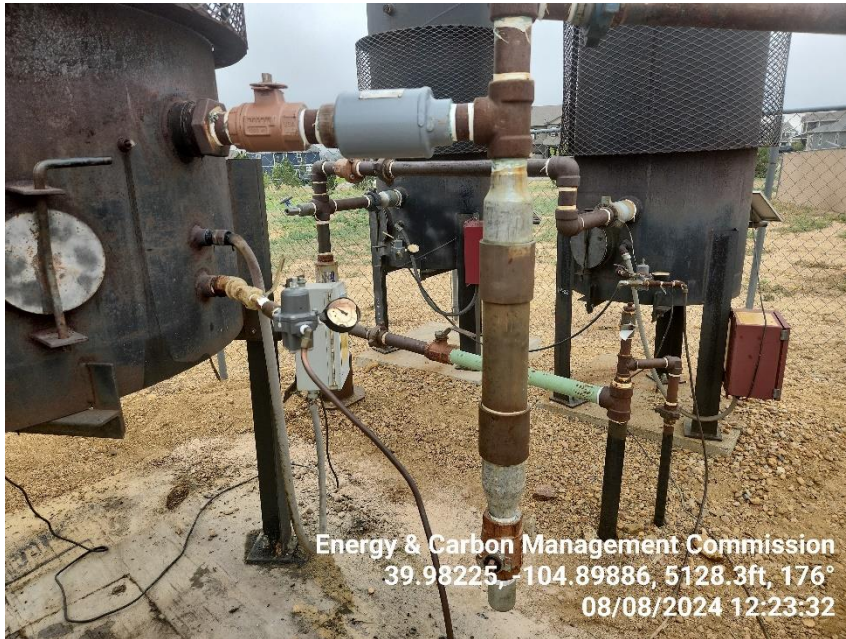
Photo 19 Damaged ECD melted wire, gauges.

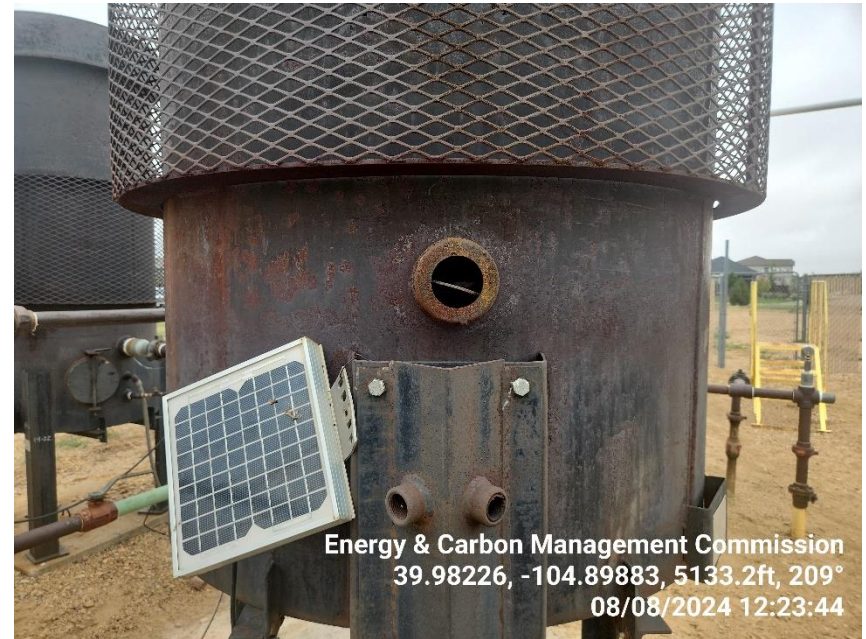
Photo 20 Damaged ECD sight glass.

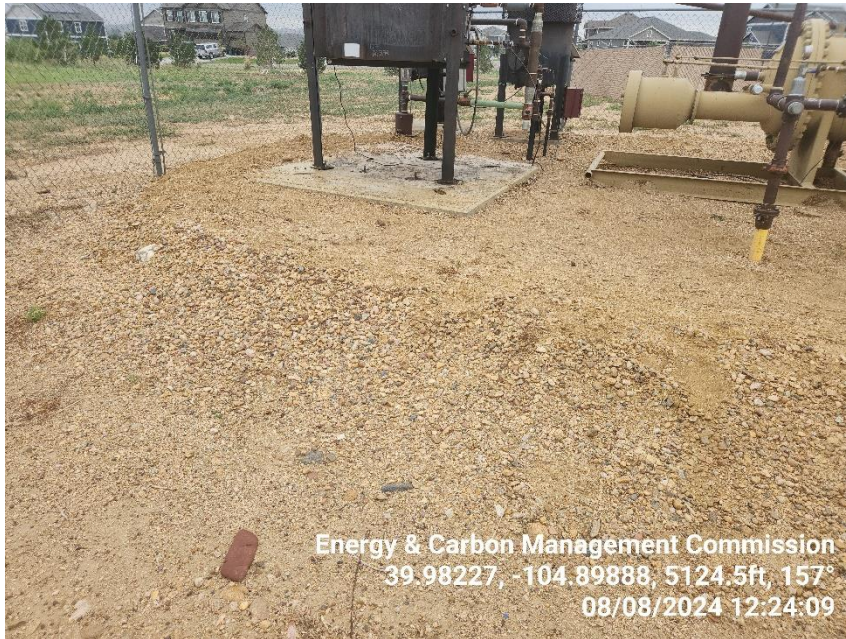
Photo 21 The ground around the ECD appears dry.

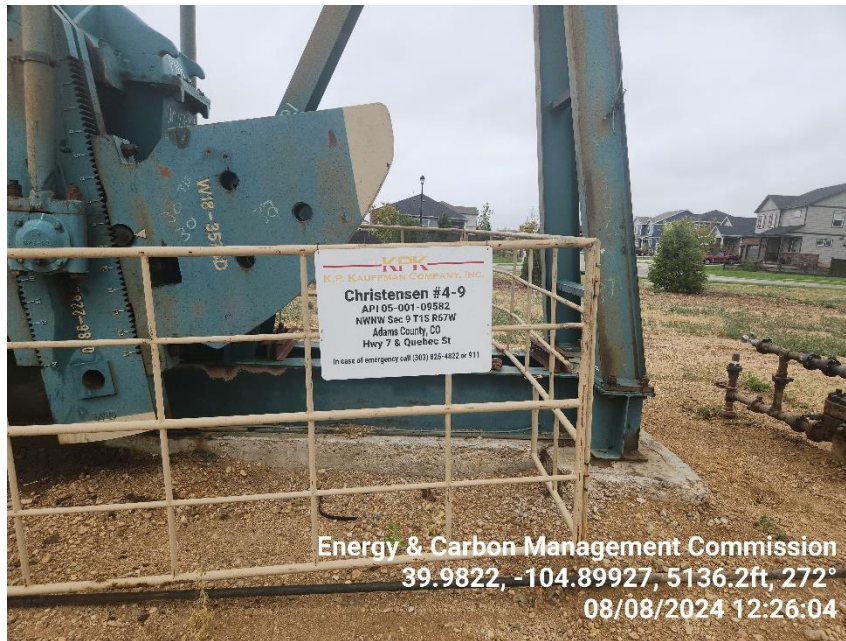
Photo 23 WH sign.

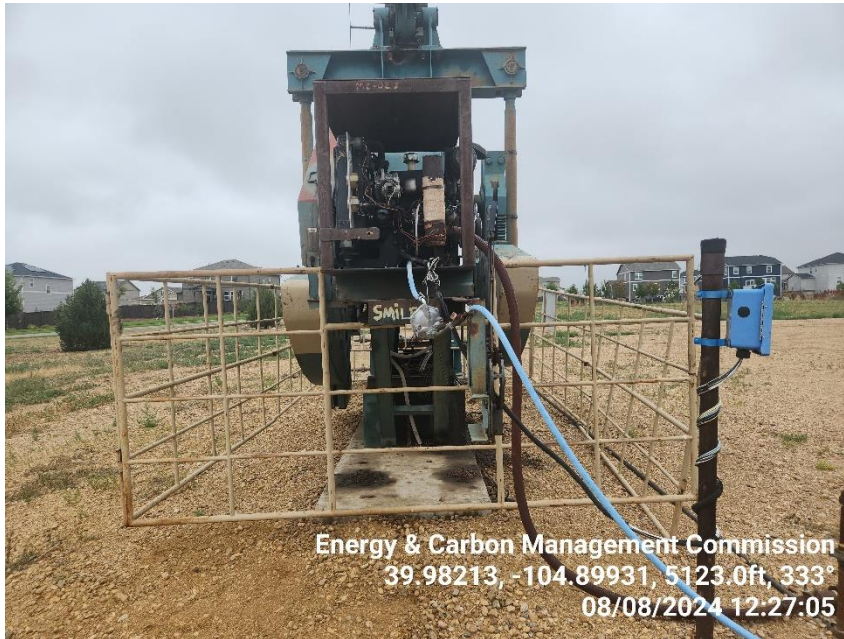
Photo 25 Prime mover.

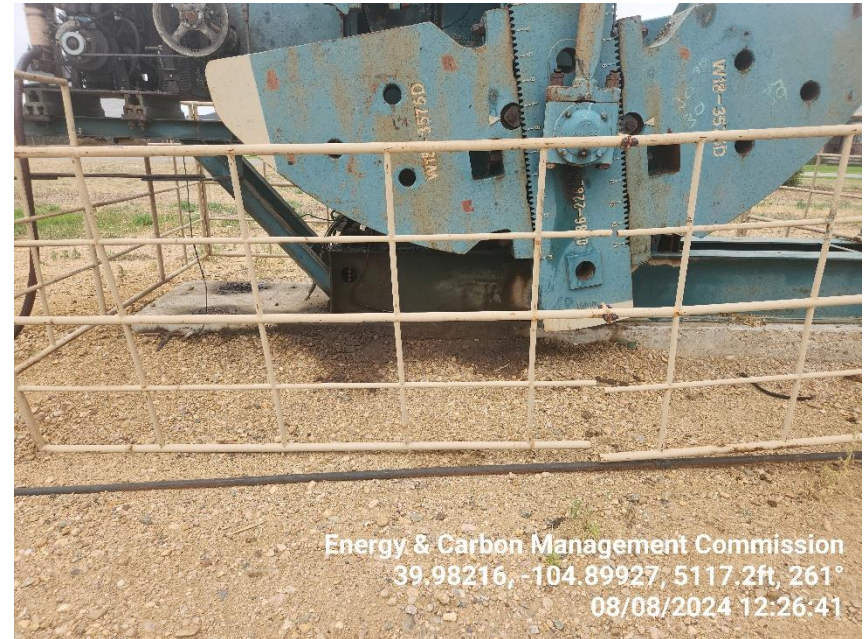
Photo 26 Stained soil on & at the Pump Jack base.

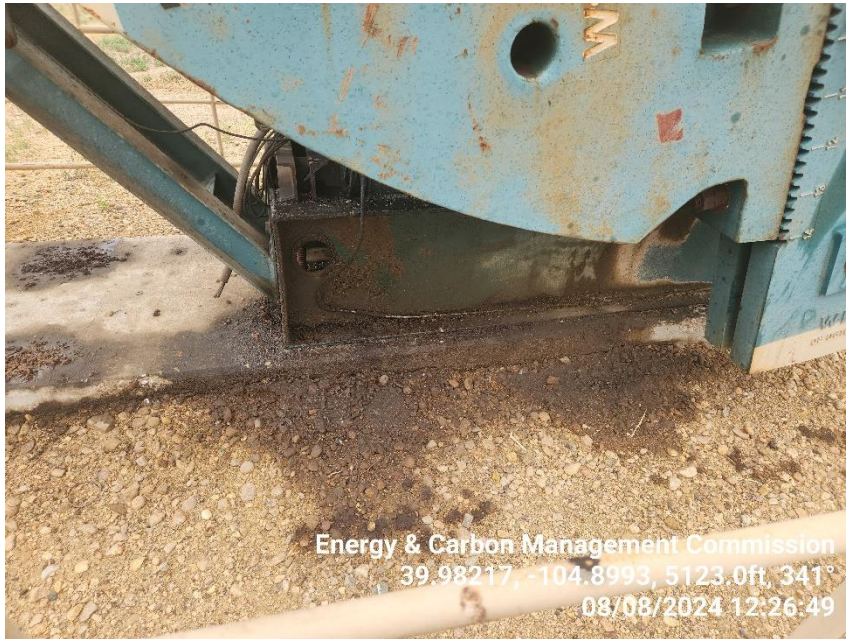
Photo 27 Stained soil on & at the Pump Jack base.

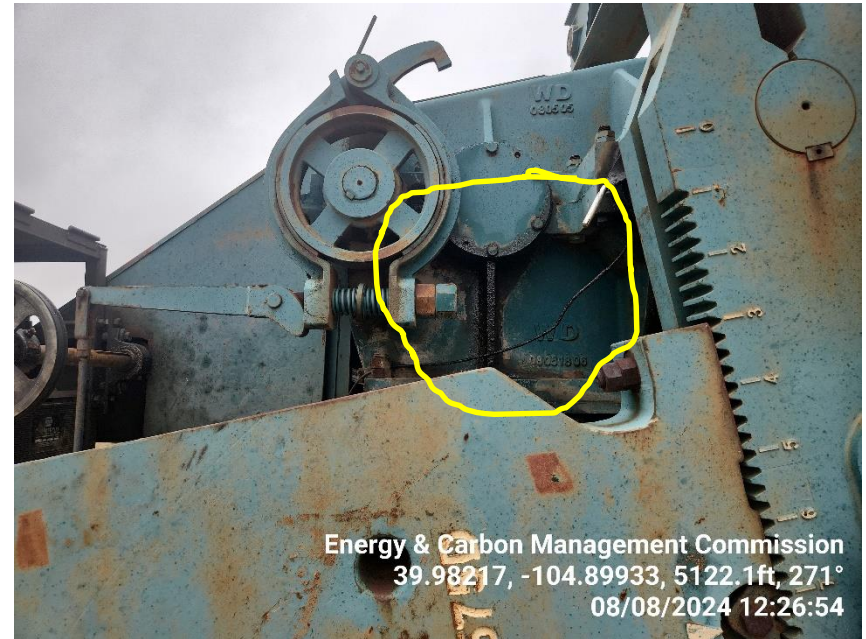
Photo 28 Pump Jack seal leaking oil onto the PJ base & ground.
