## Inspection Photos

Location: Caerus Piceance LLC Chevron/Texaco-66S97W/12SWSE

Location ID: 335774

Date: 8/1/2024

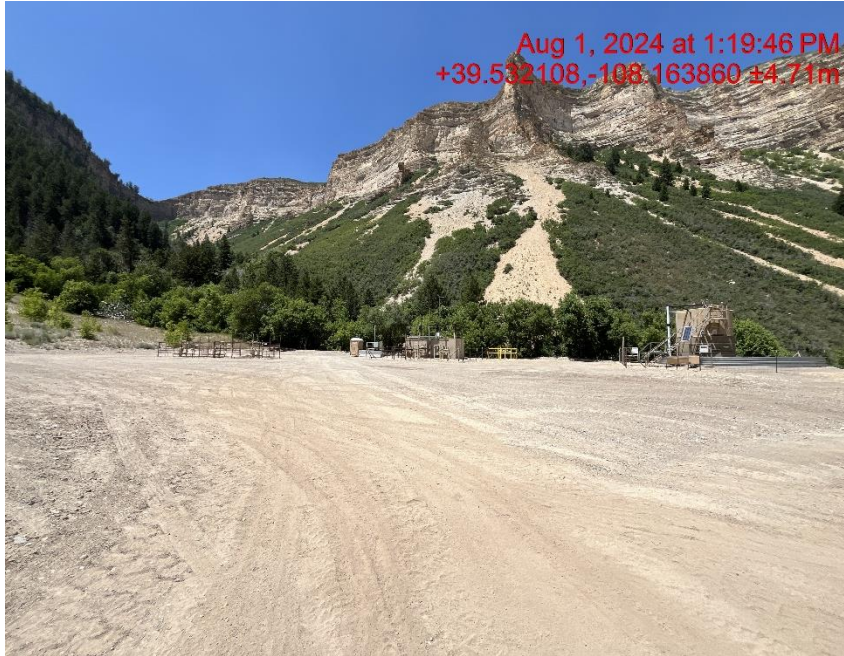
Entrance to location - Photo #03910

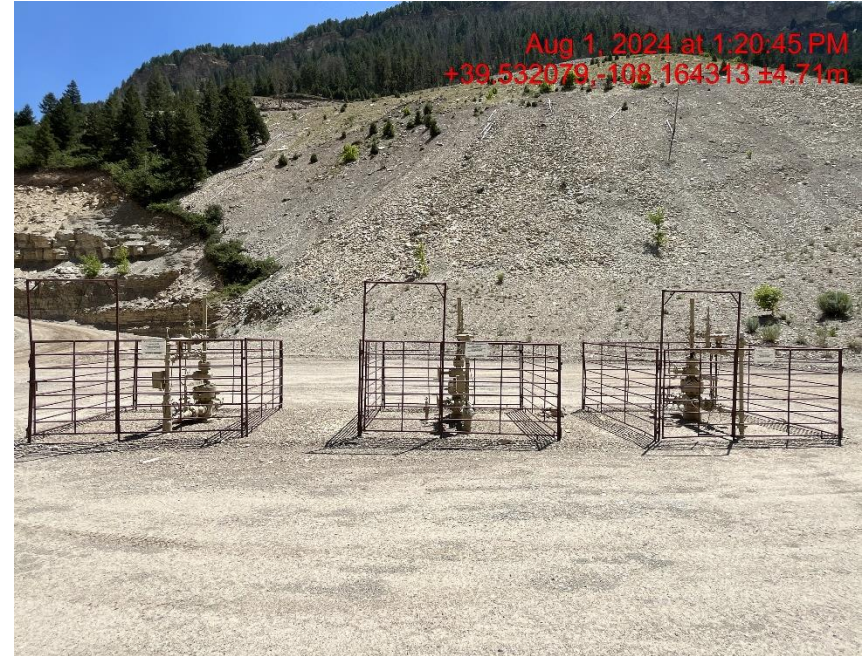
Wellheads - Photo #03911

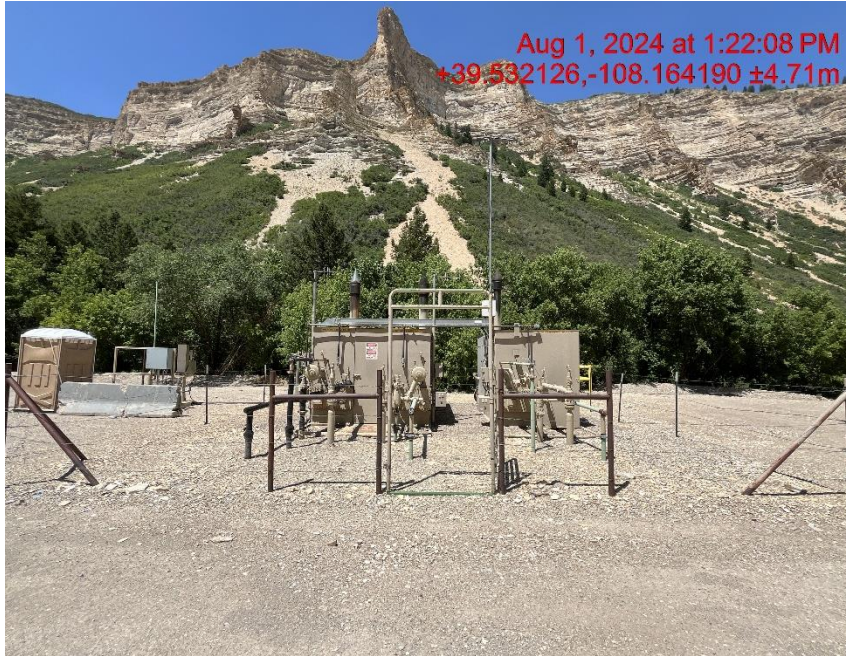
Separators - Photo #03916

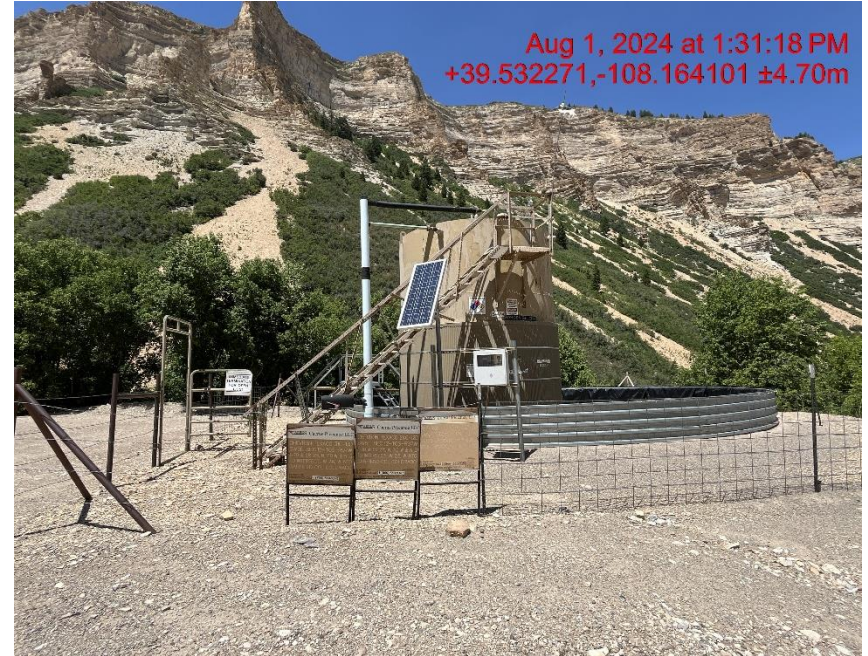
Tank battery/No tank battery sign - Photo #03929

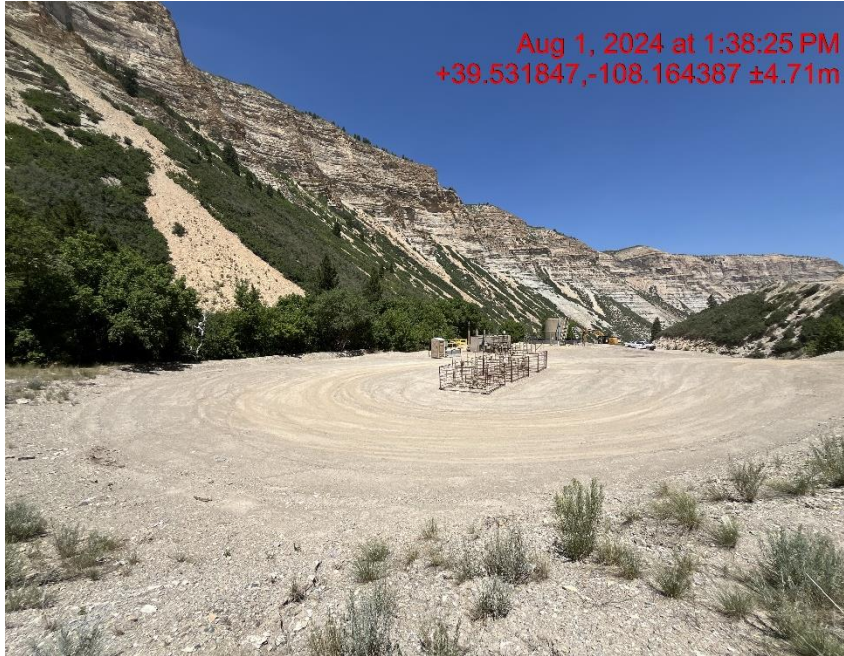
Southwest corner of location - Photo #03940

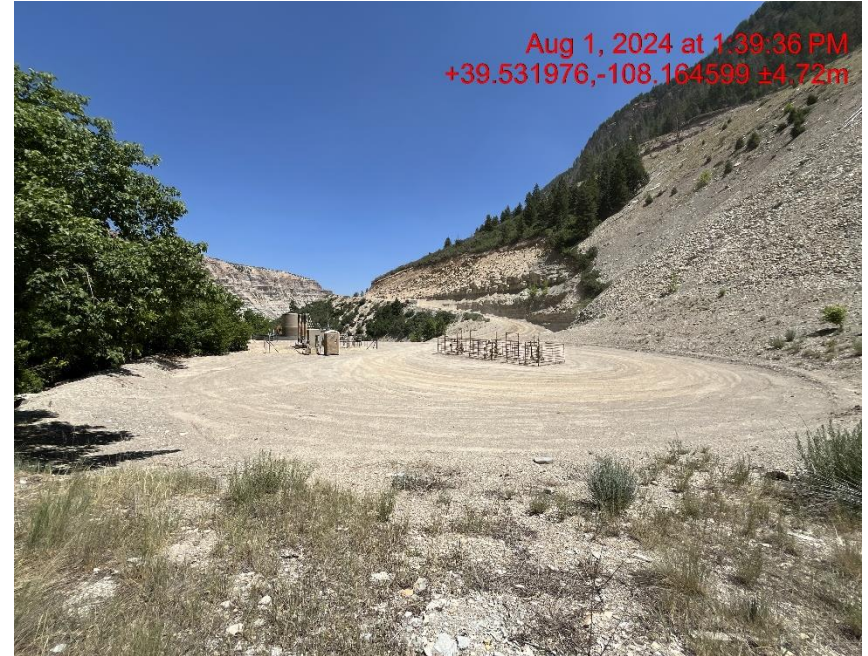
Northwest corner of location - Photo #03941

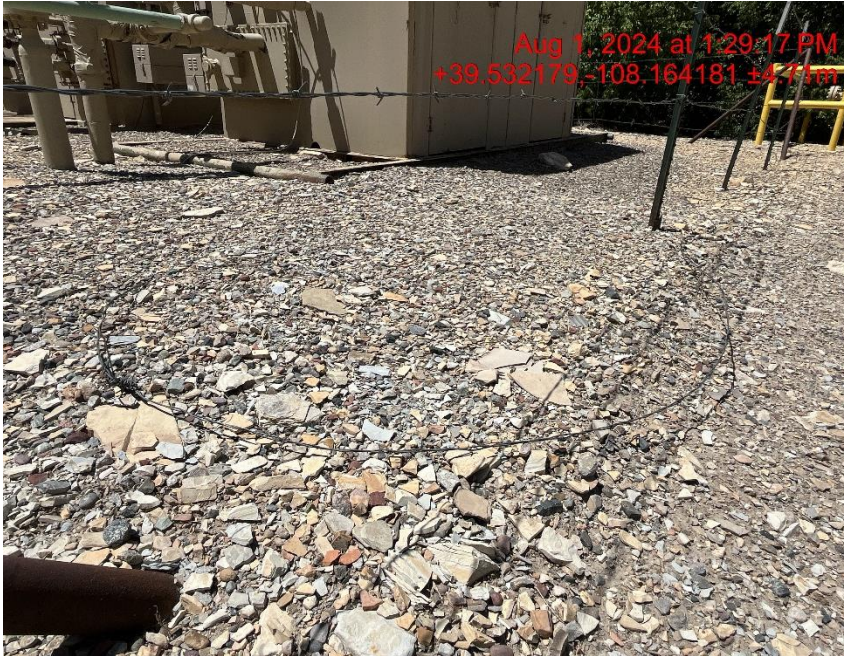
Loose Barbed wire/wildlife hazard - Photo #03923

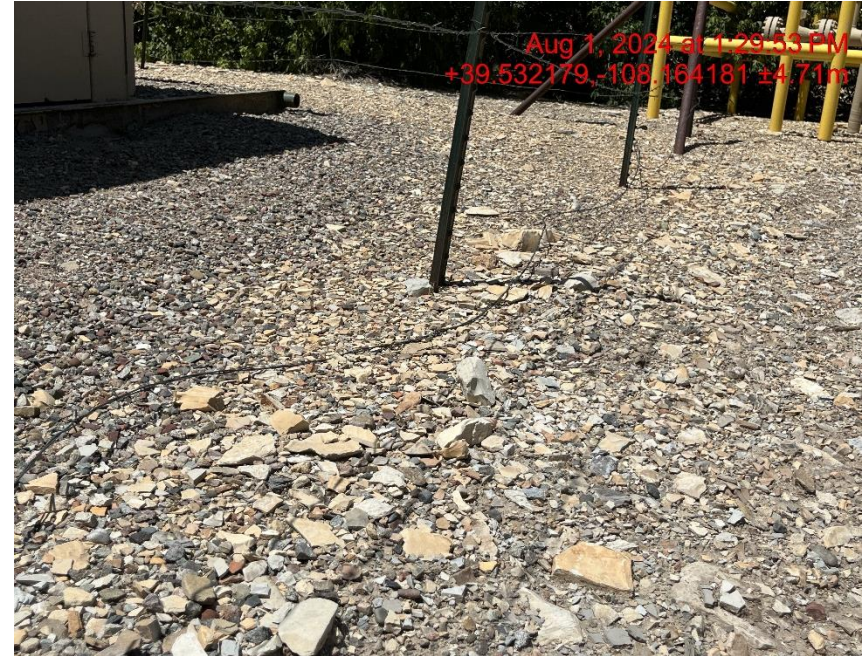
Loose Barbed wire/wildlife hazard - Photo #03926

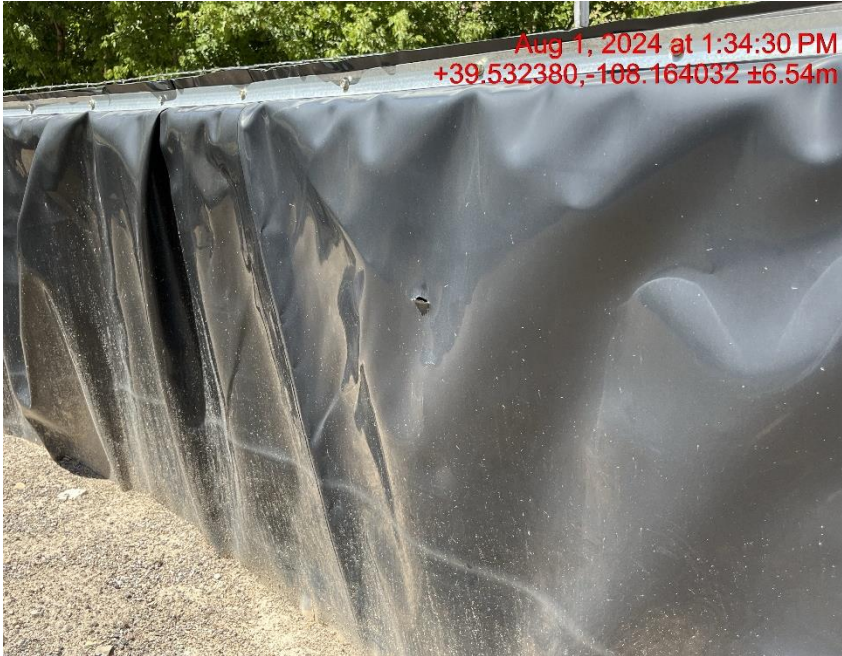
Holes in containment liner - Photo #03933

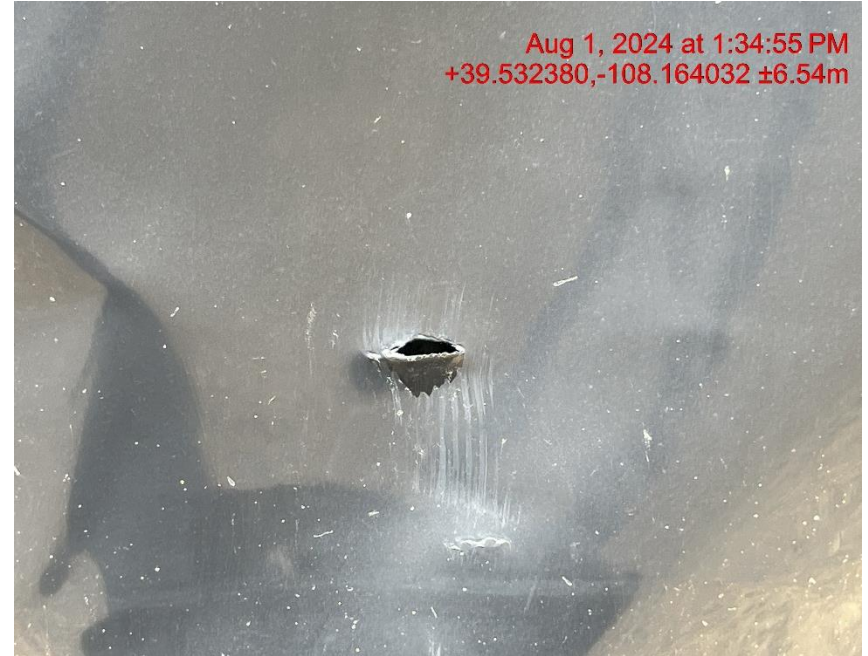
Holes in containment liner - Photo #03934

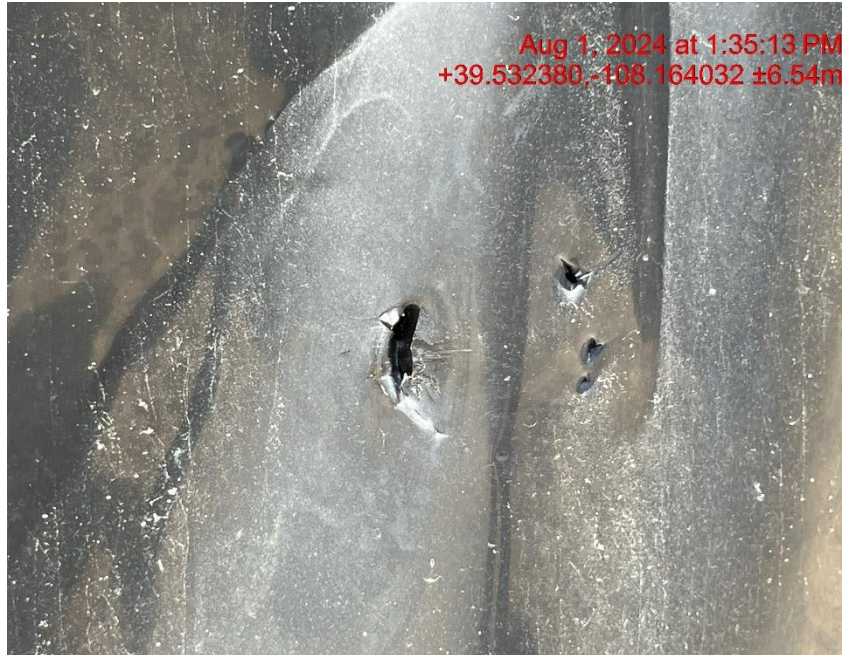
Holes in containment liner - Photo #03935
