Operator: 8 NORTH

Location Name: HALEY-RAY-611N61W 21SWSW

Loc ID: 305413

Inspection: 691200008

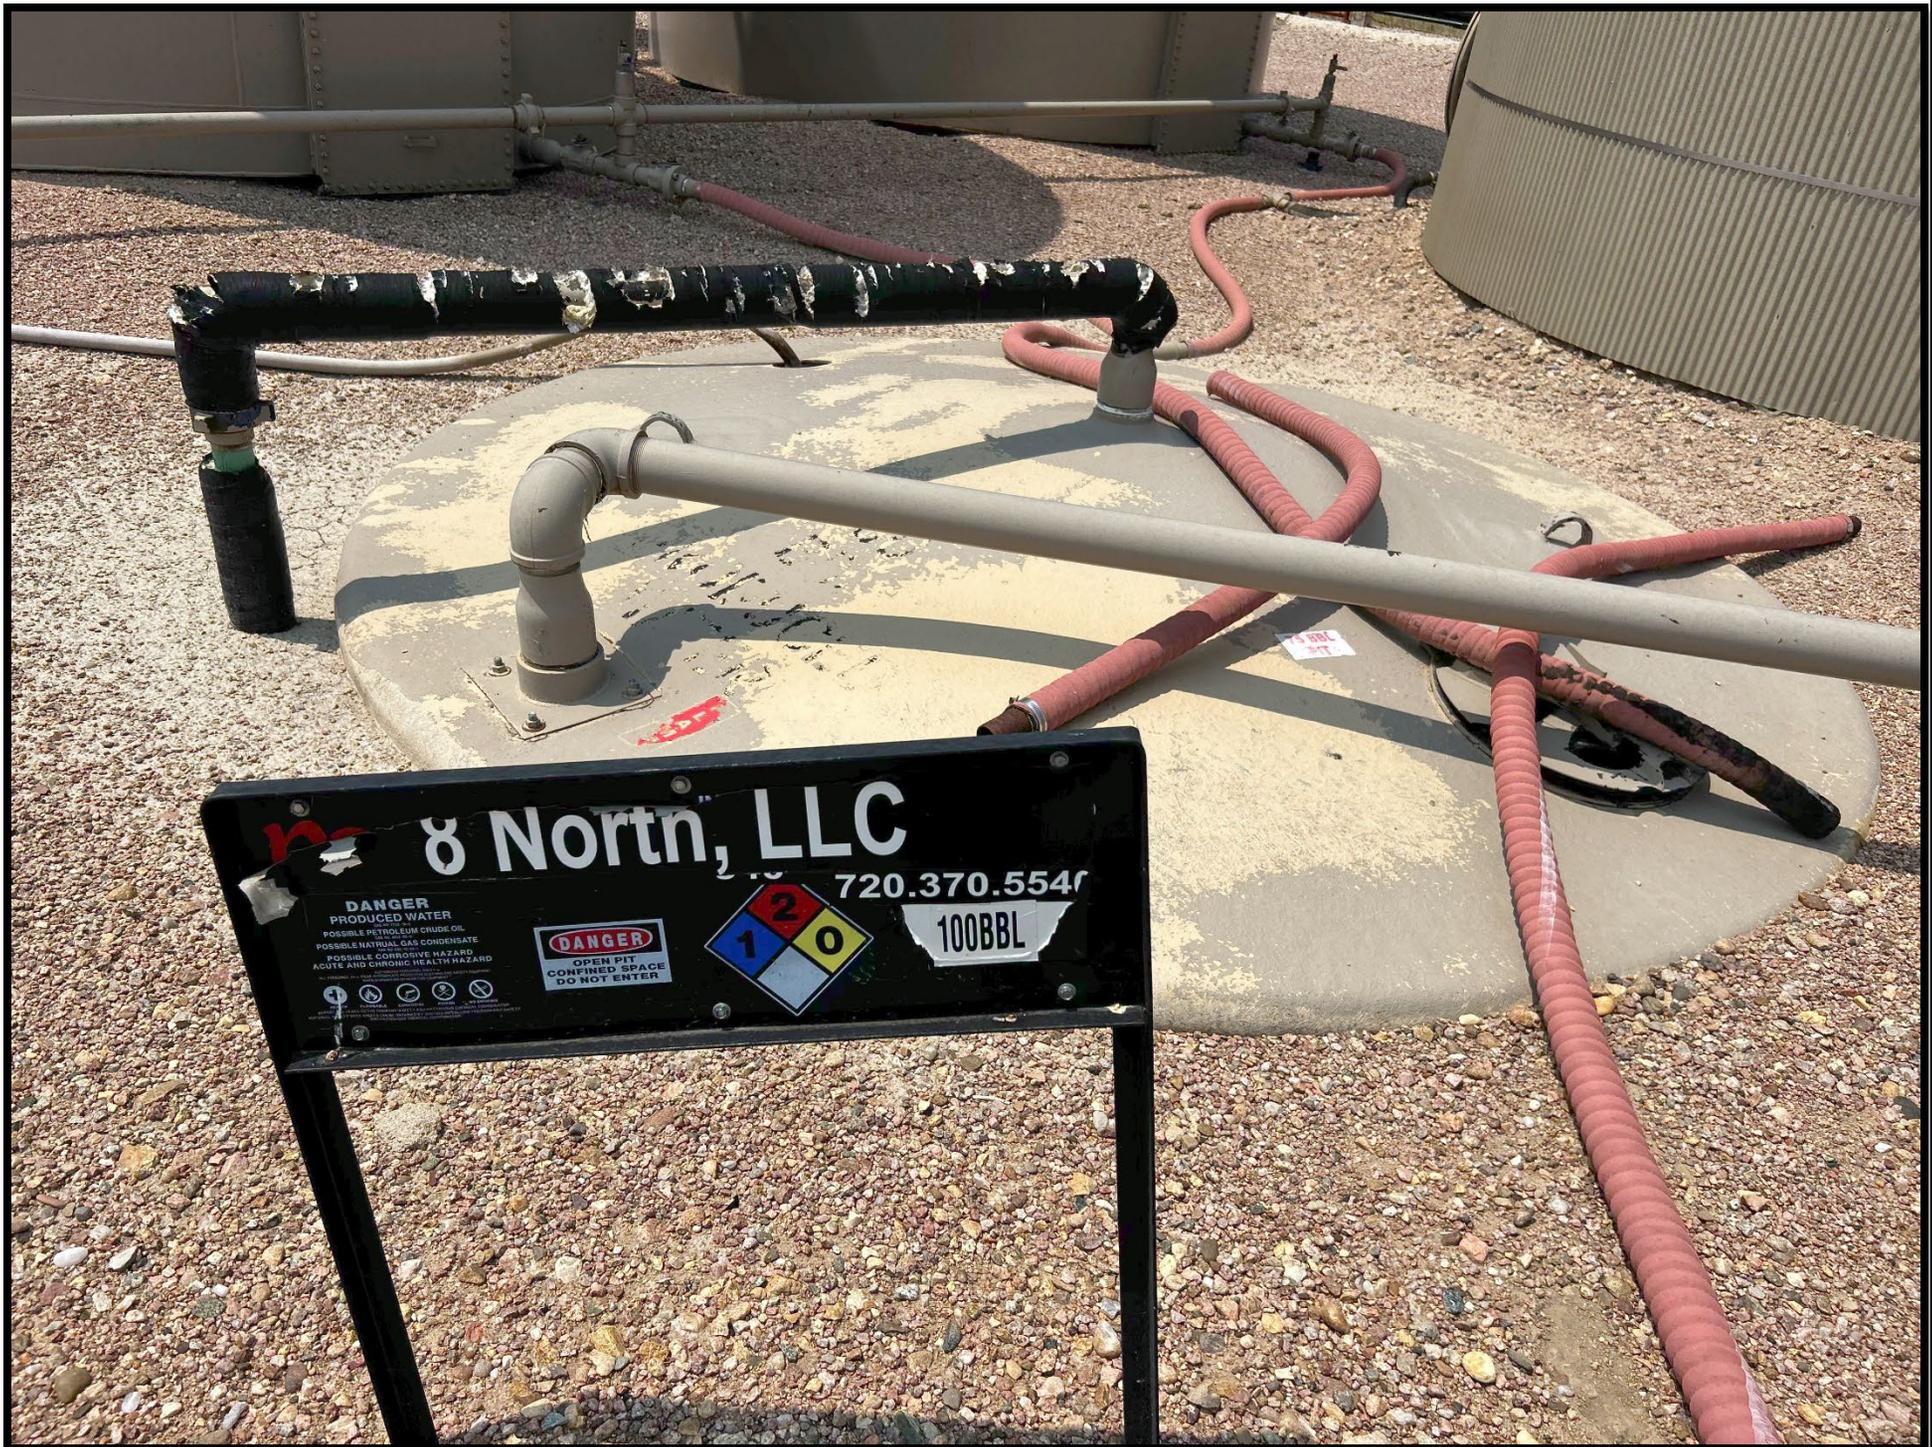
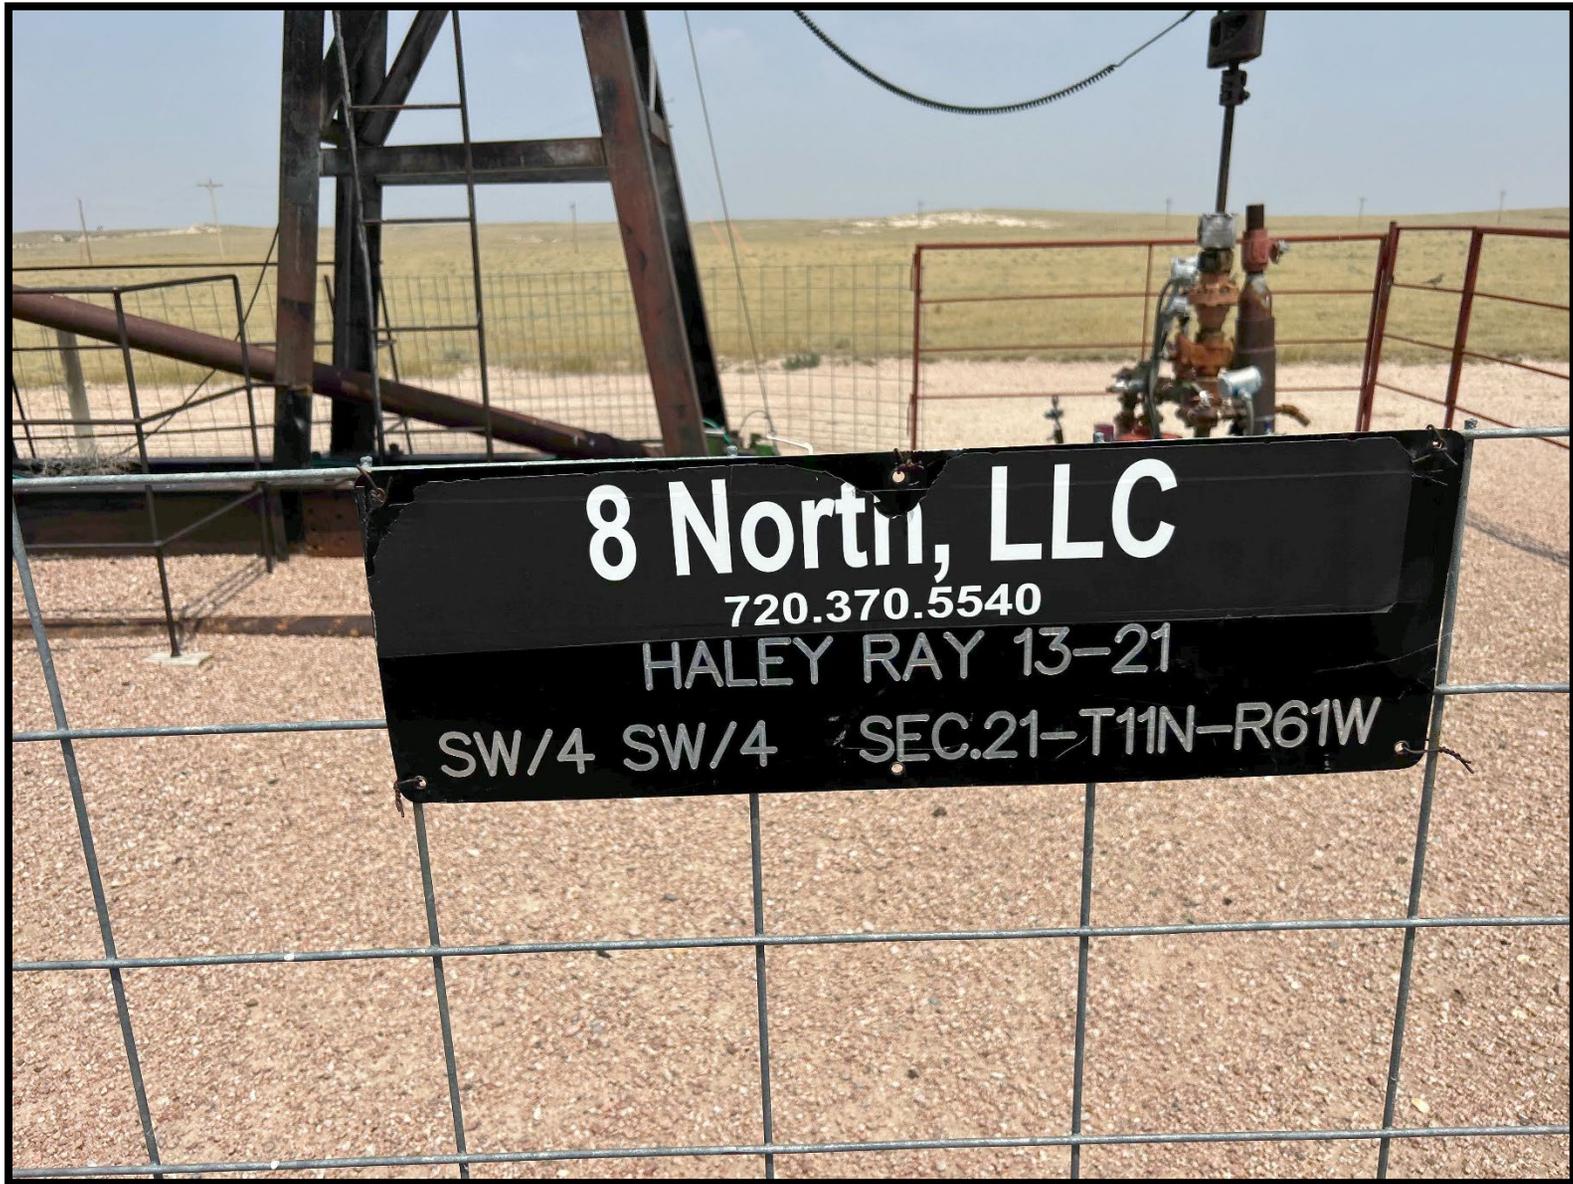
CA: No capacity shown on produced water vault. Install sign to comply with Rule 210.d.

CA Resolution: Operator has installed capacity label to comply with Rule 210.d.

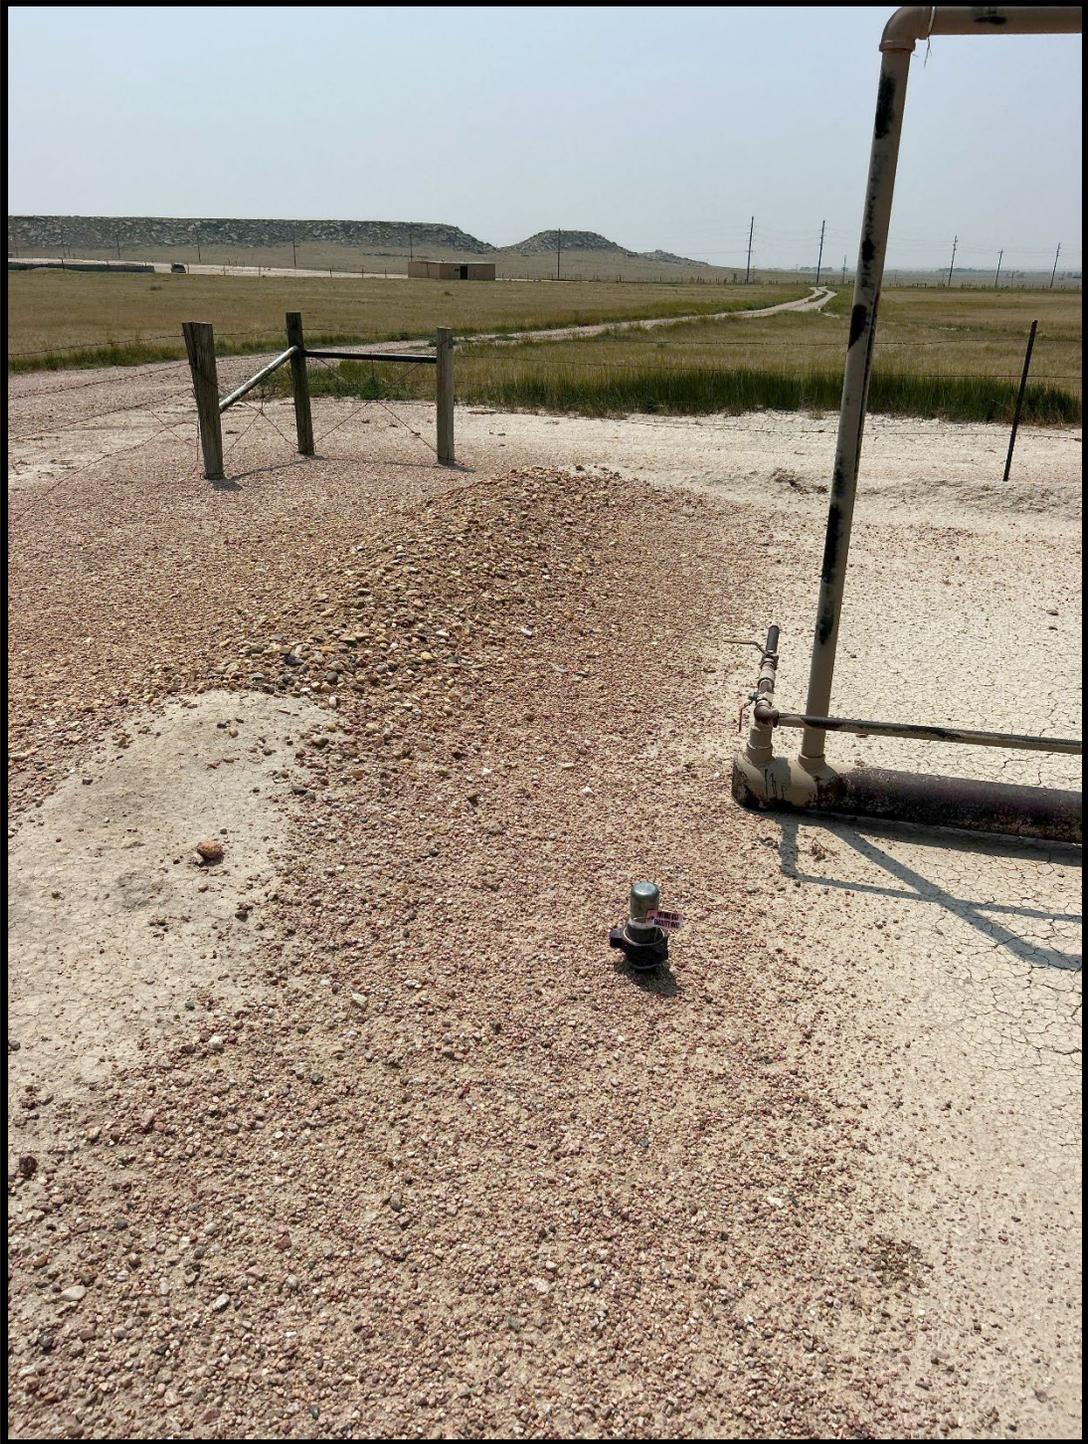
CA: Unused fittings around produced water tank. Comply with Rule 603.f.

CA Resolution: Unused equipment has been removed to comply with 600 series.

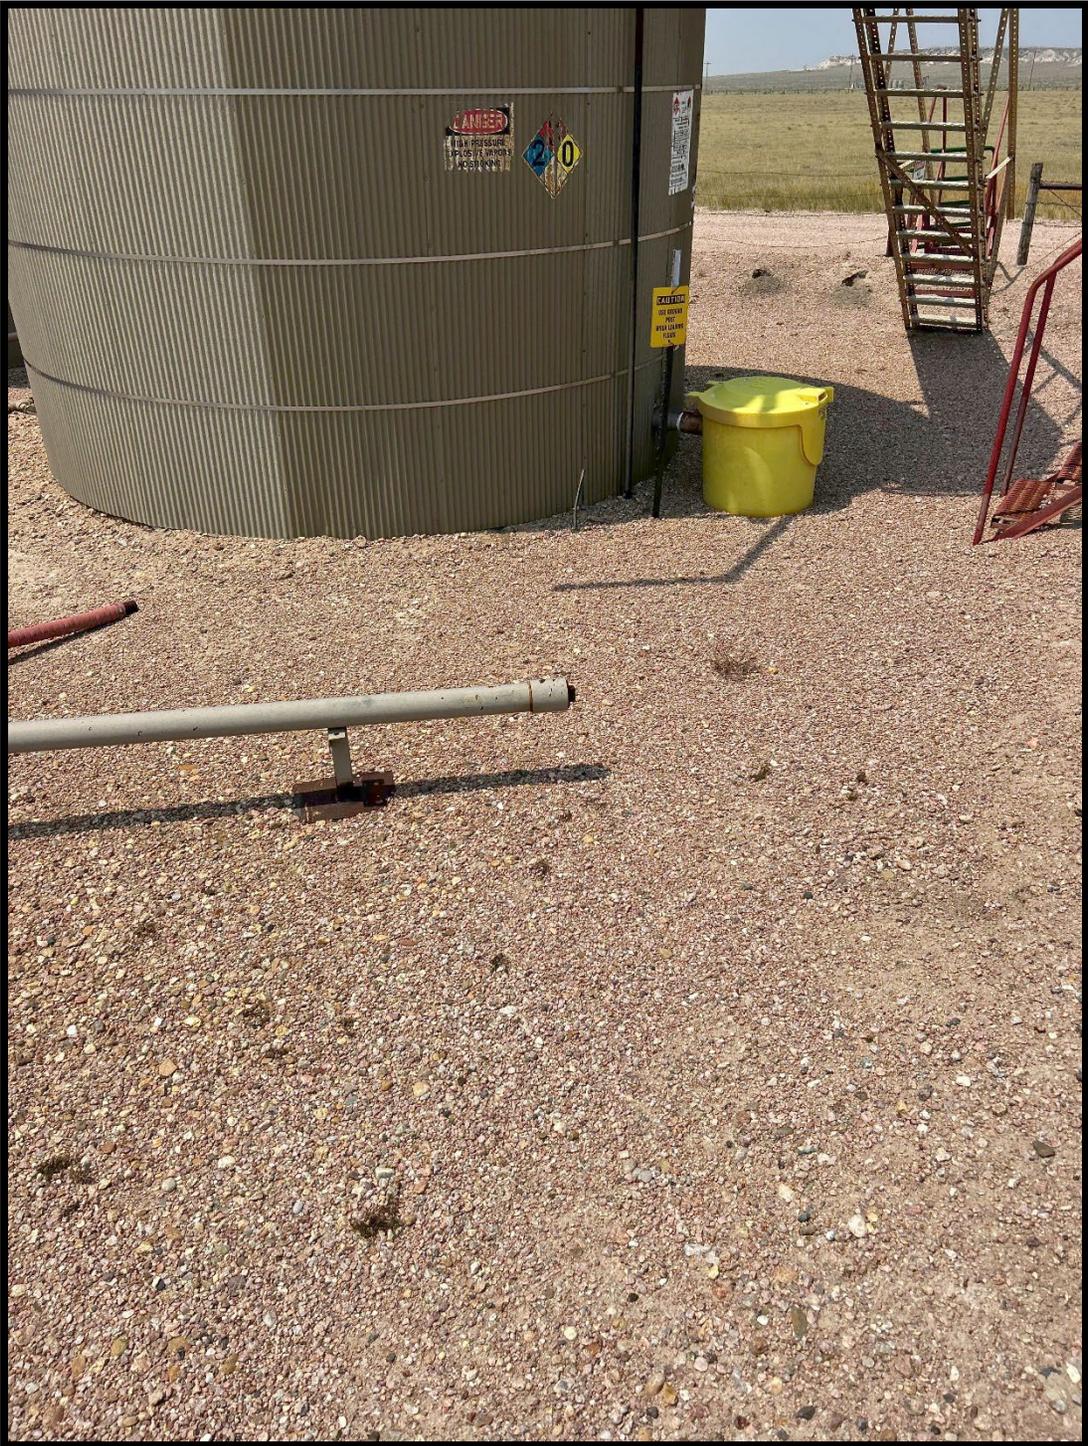
CA: Burrows in berms. Repair or install berms or other secondary containment devices per Rule 605.a.(4).

CA Resolution: Operator has completed actions to repair berm.
