**Inspection Photos**  
**Location Name: Macroni 1-1H**  
**Location ID: 423680**

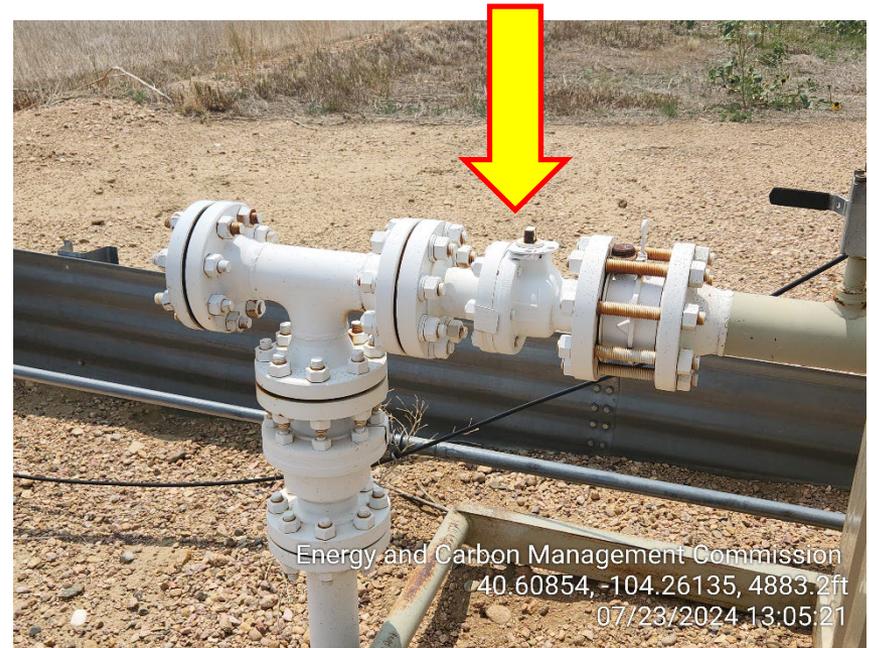
**Photo 8 – Sales Line Valve closed**

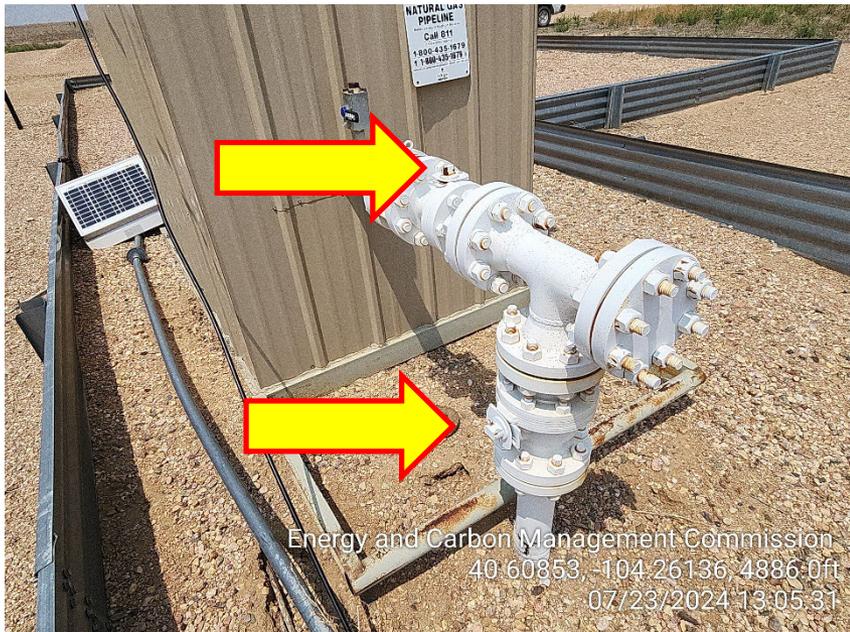
Photo 9 – Sales Line Valves closed

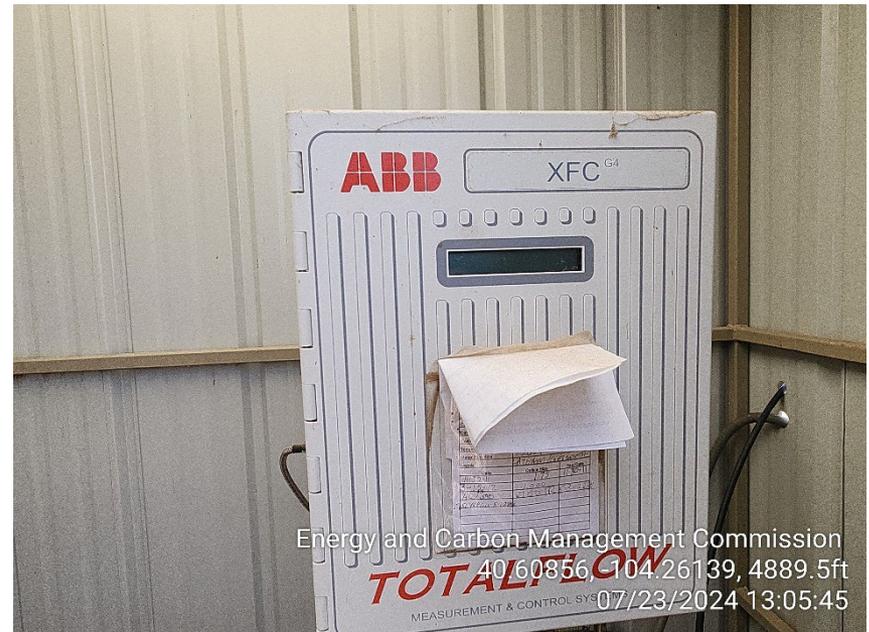
Photo 10 – Sales Meter appears to be Powered Off

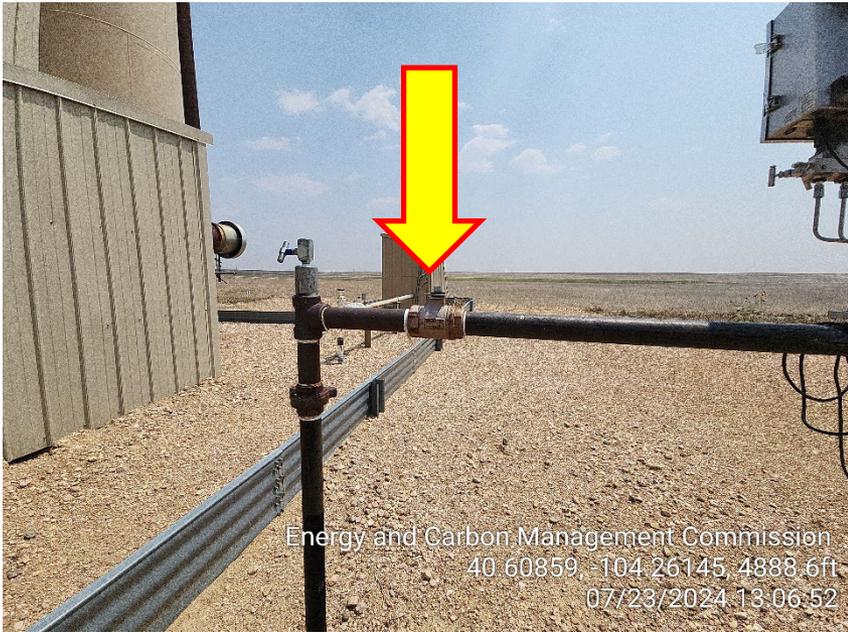
**Photo 13 – Valve Open on Flare Line**

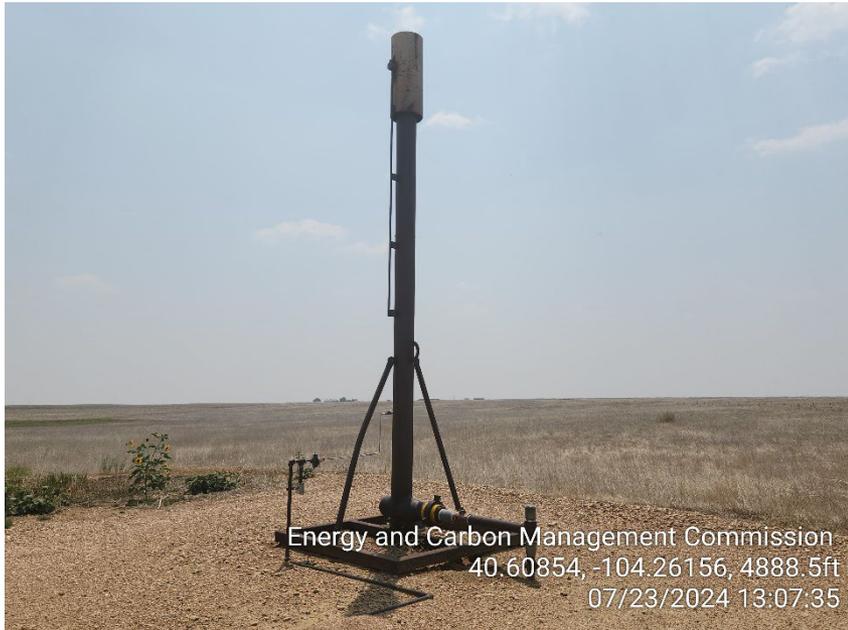
**Photo 15 – Flare Valve Open on Flare Line**

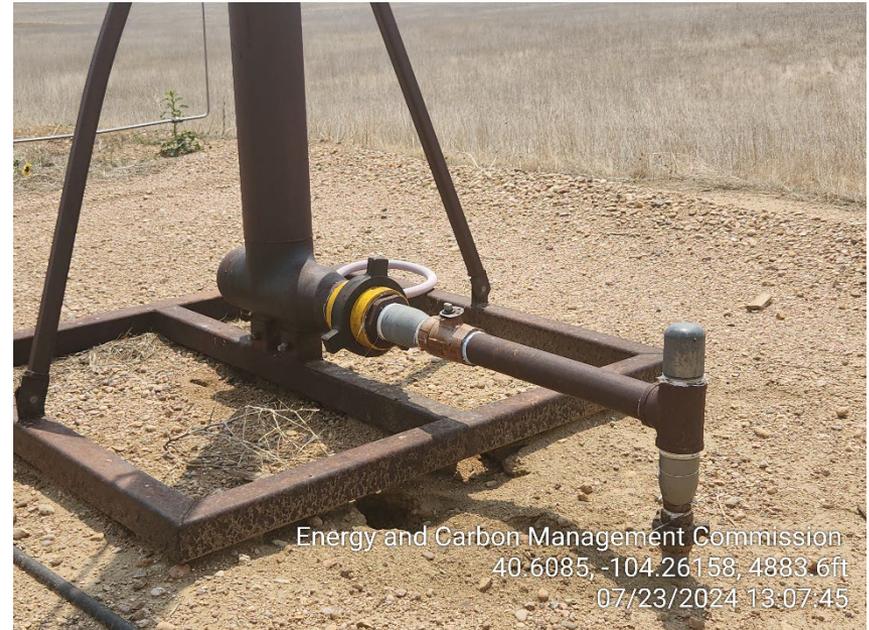
**Photo 16 – Valve Open on Flare Line**

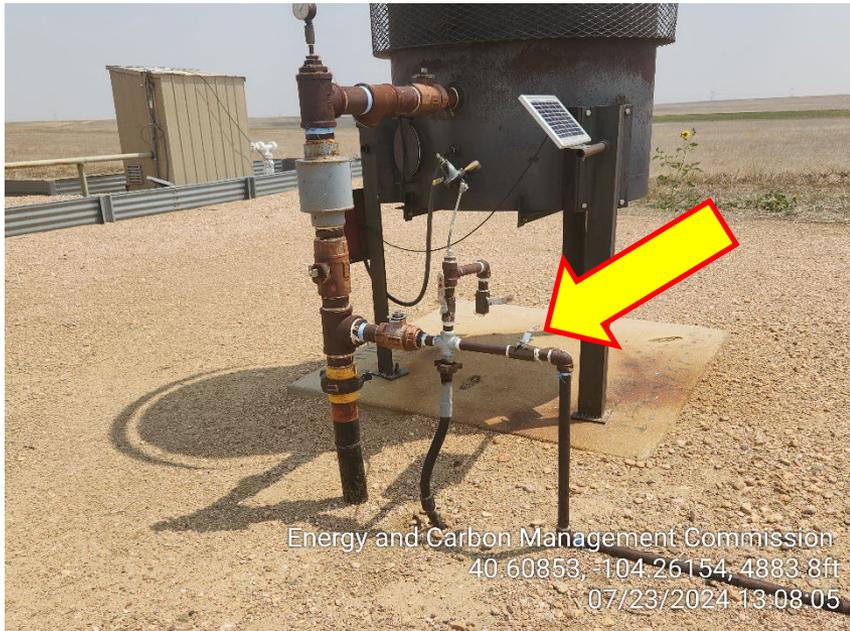
**Photo 17 – ECD – 1" Supply line to Flare in Closed position**

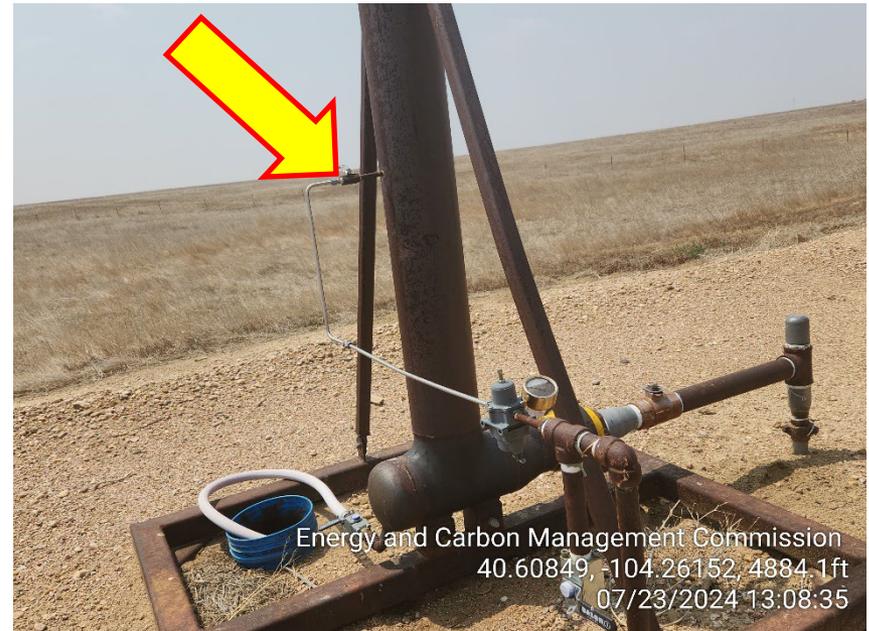
**Photo 18 – Supply line to Flare in Closed position**
