Inspection Photos
Location Name: Dunn 1-13H
Location ID: 426457

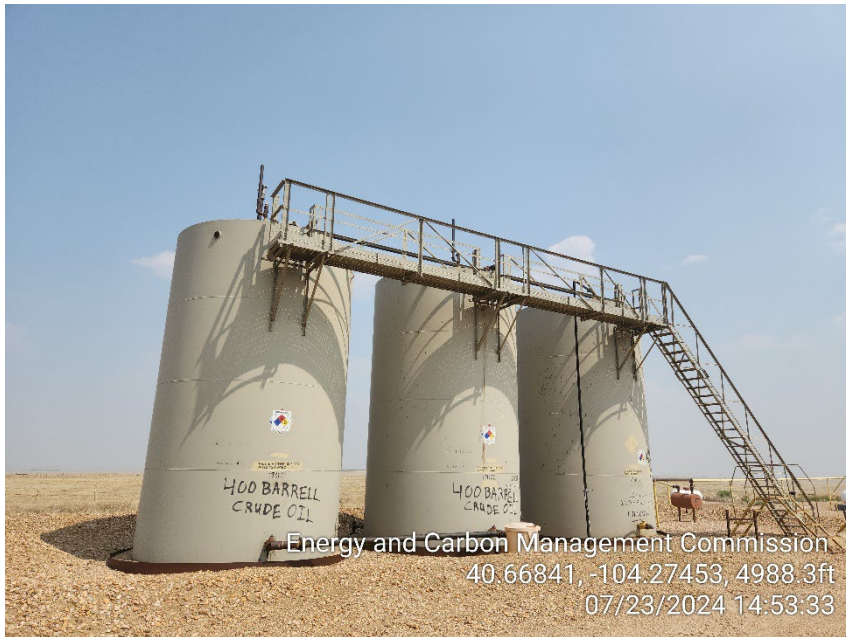
Photo 1 – Tank Battery

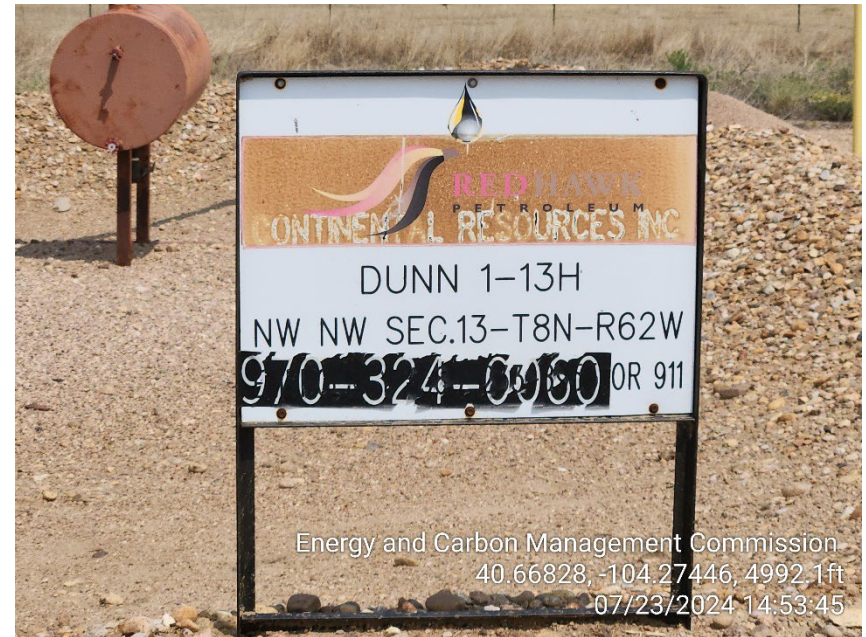
Photo 2 – Tank Battery Sign

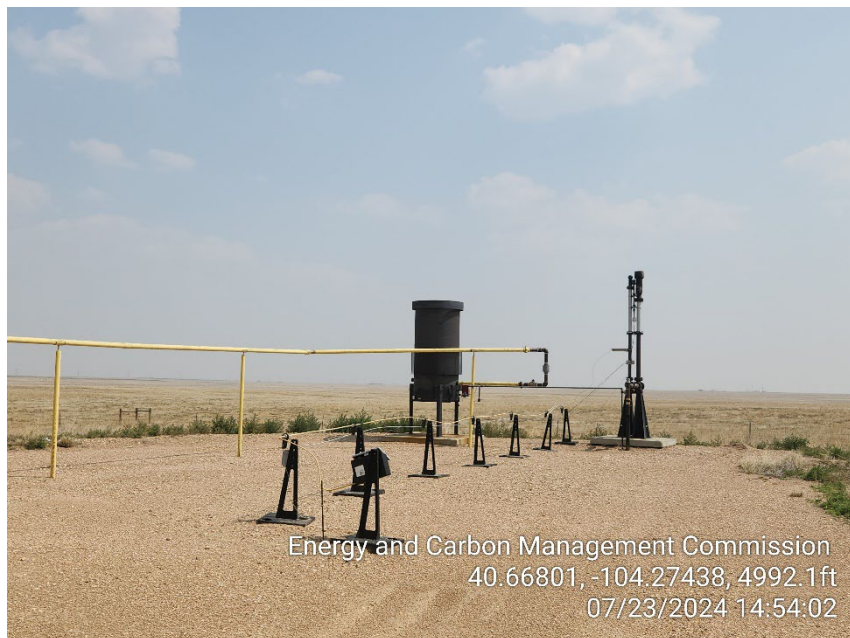
Photo 3 – ECD and Flare

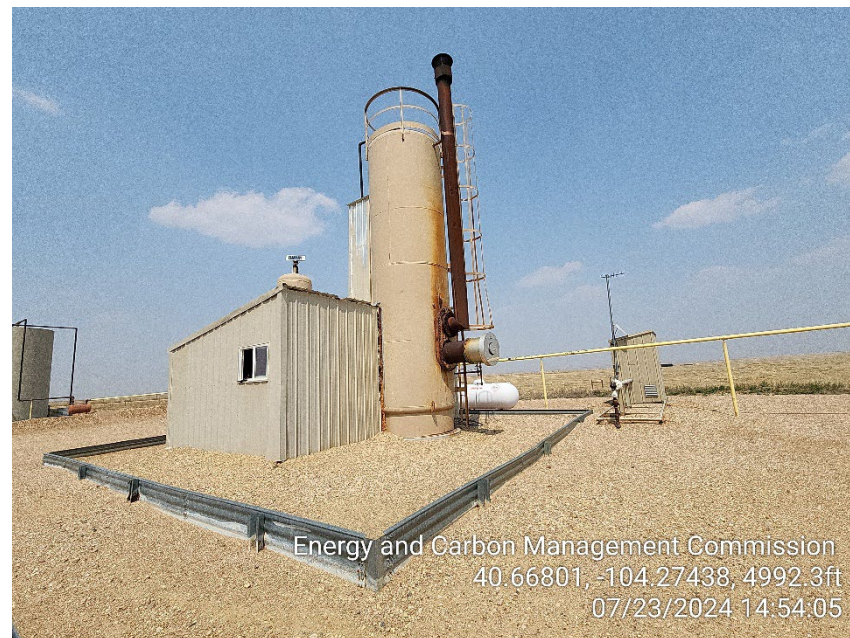
Photo 4 – Heater Treater and Gas Meter

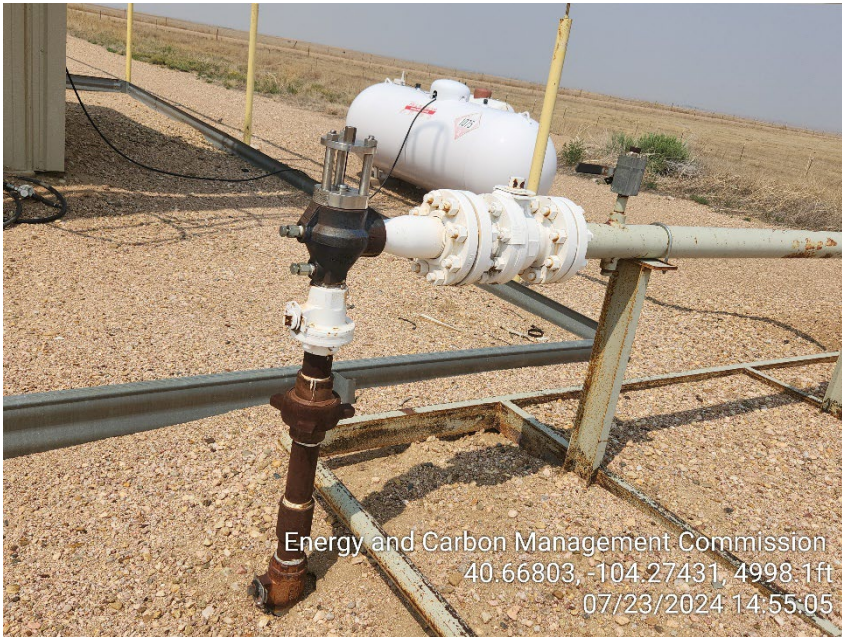
Photo 5 – Sales Line Valves in open position

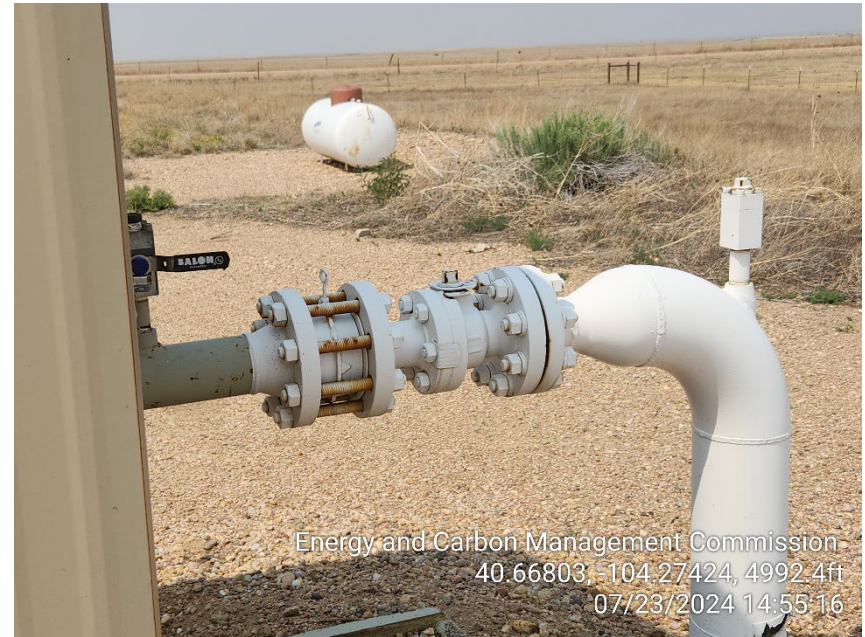
Photo 6 – Sales Line Valves in open position

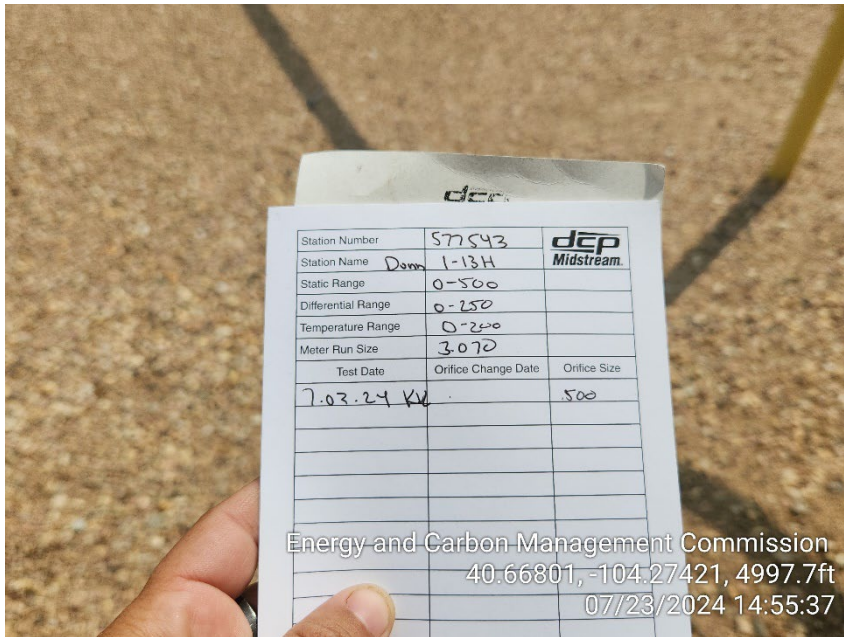
Photo 7 – Sales Meter Calibration Card

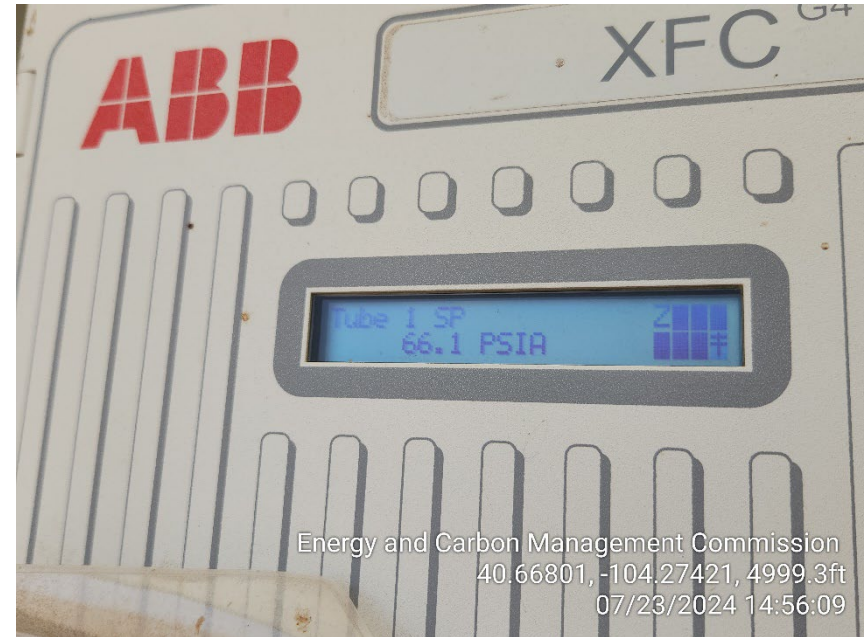
Photo 8 – Static Pressure

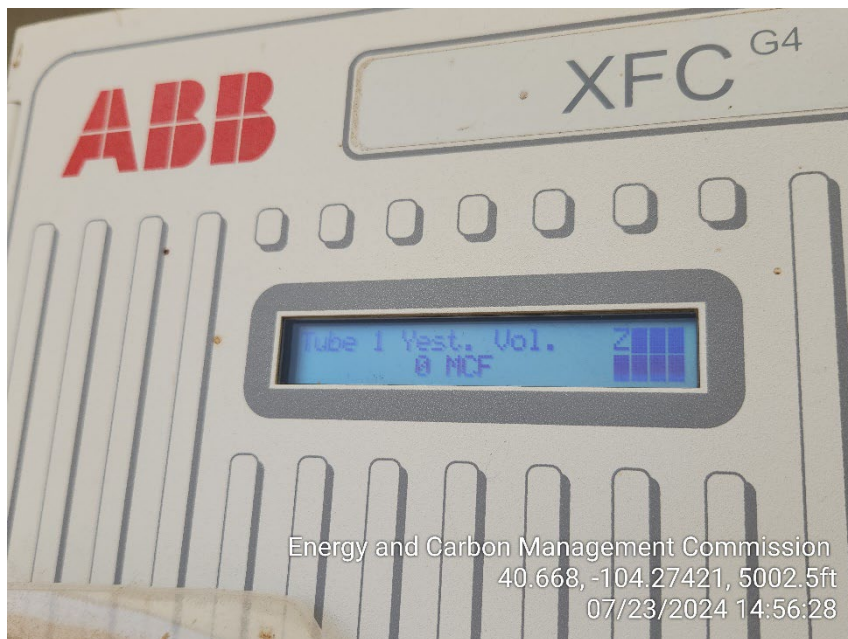
Photo 9 – Yesterday Volume

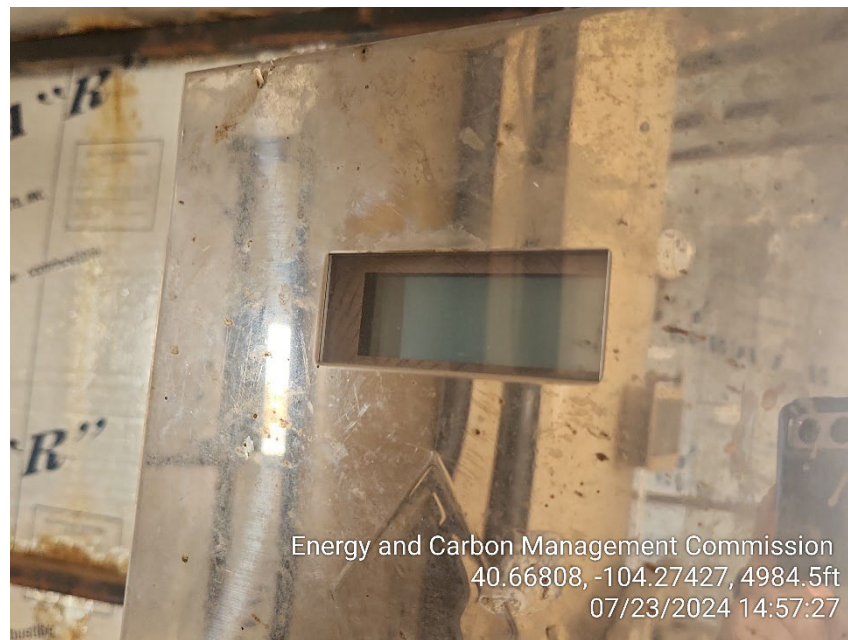
Photo 10 – Flare Gas Meter – Appears to be powered off

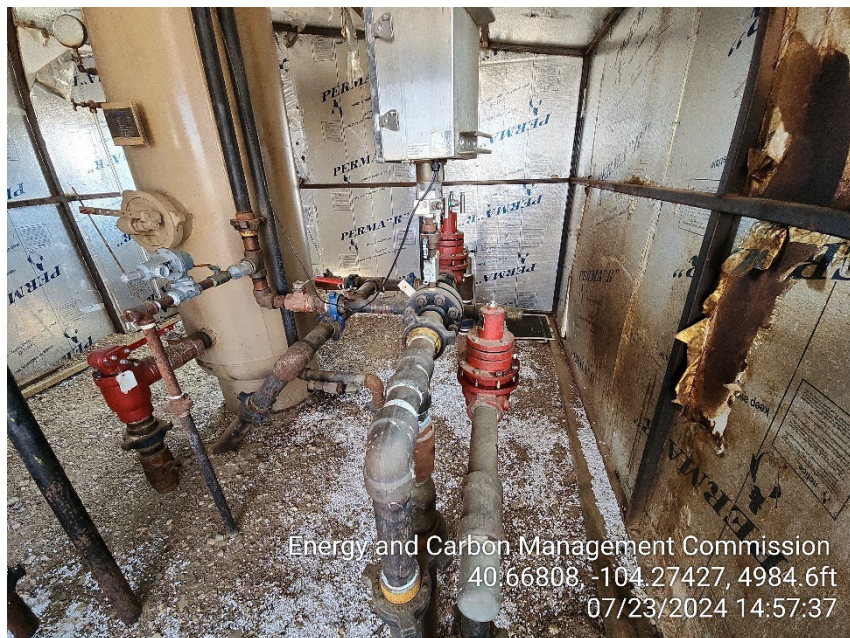
Photo 11 – Flare Gas Meter

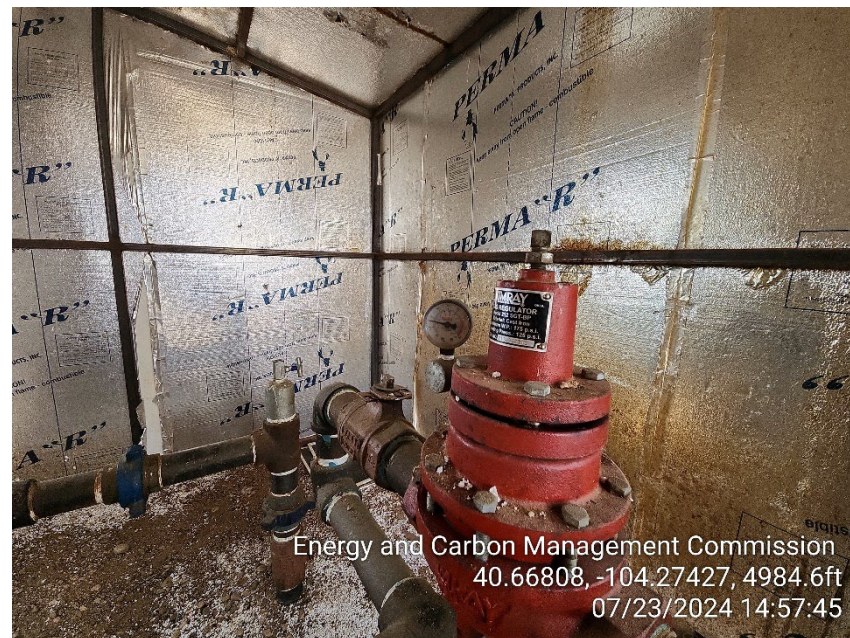
Photo 12 – Valves in Open position to Flare Line

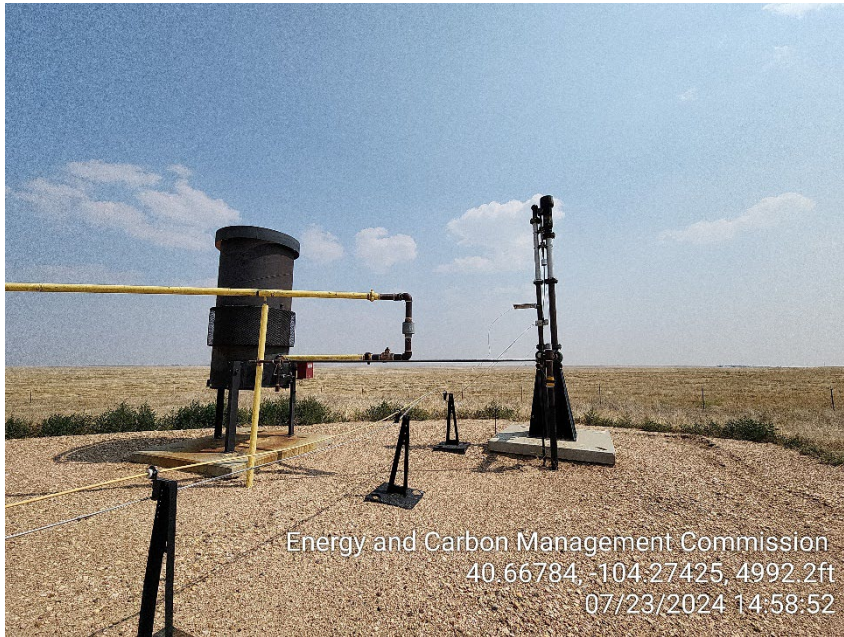
Photo 13 – Flare and ECD

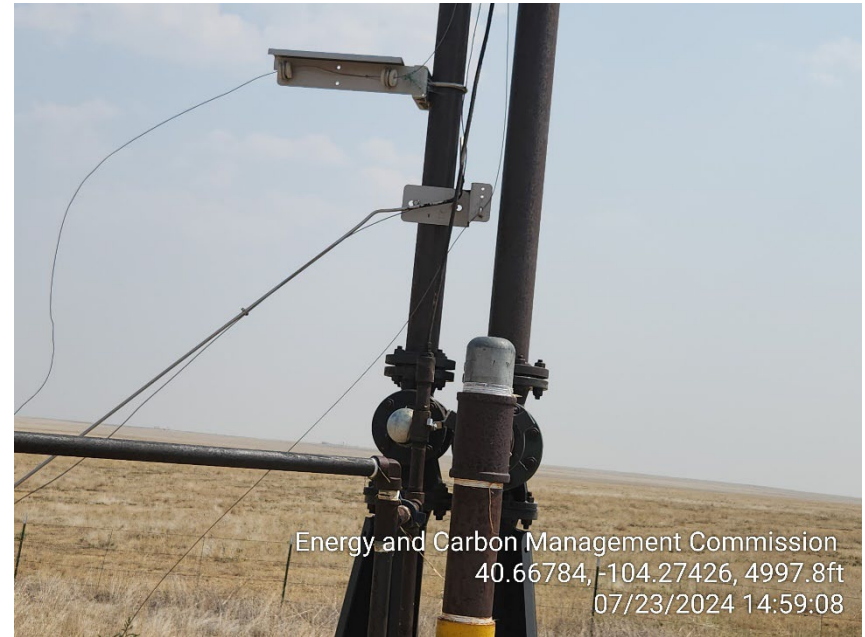
Photo 14 – Flare – Pilot supply valve open

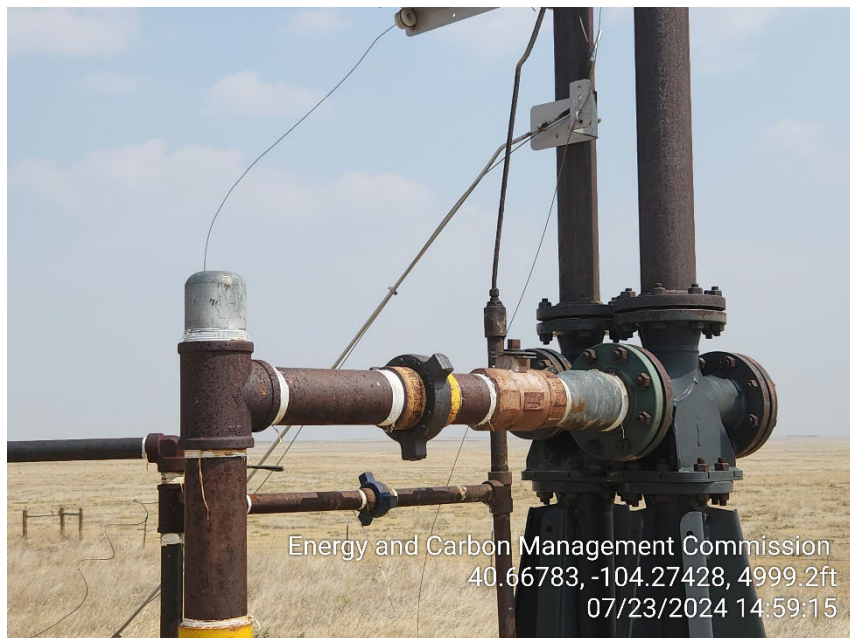
Photo 15 – Valves open to Flare

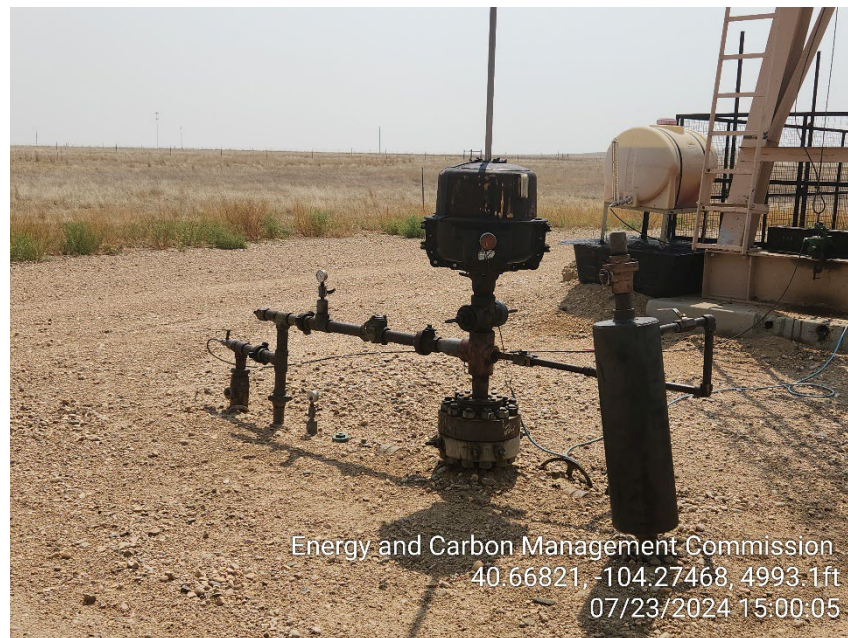
Photo 16 – Wellhead

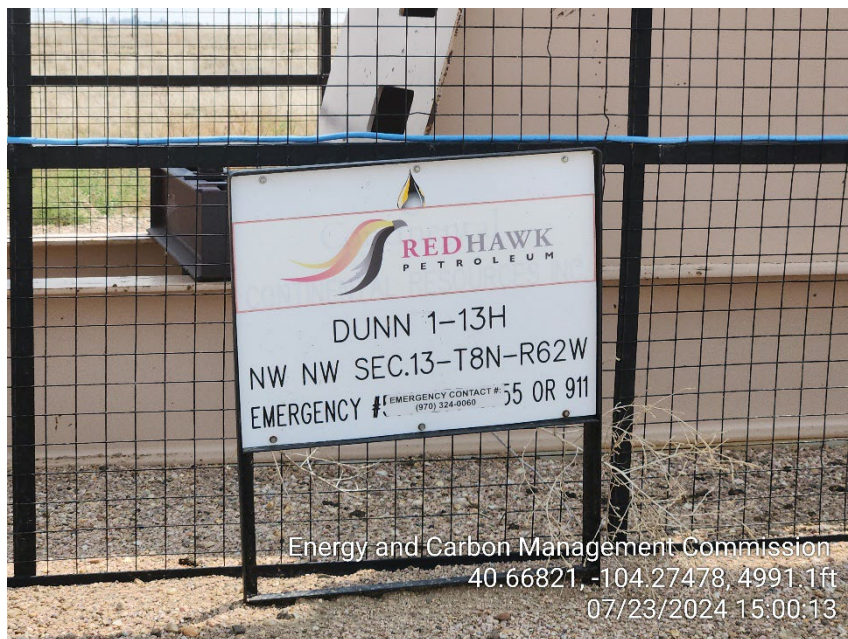
Photo 17 – Well Sign

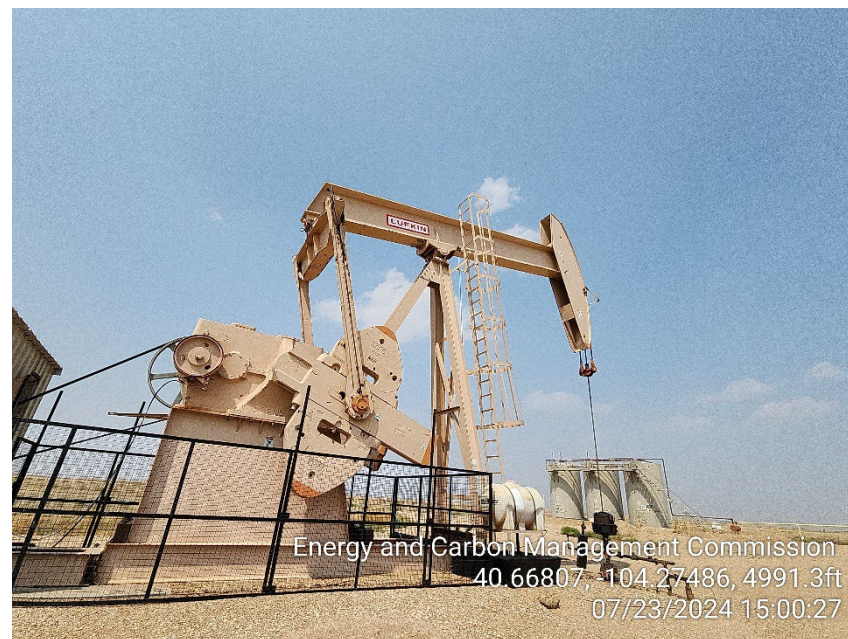
Photo 18 – Pumping Unit
