Inspection Photos
Location Name: Logan 2H
Location ID: 430811

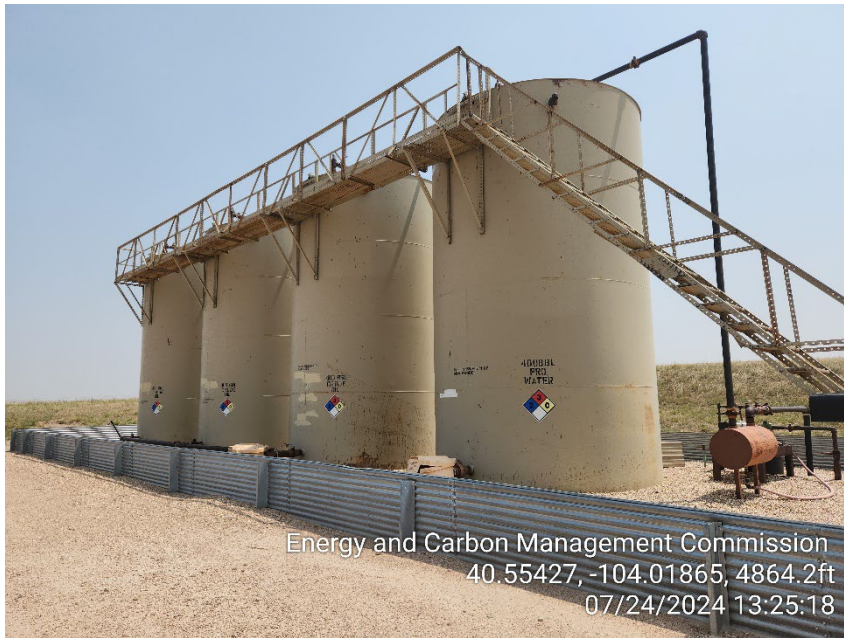
Photo 1 – Tank Battery

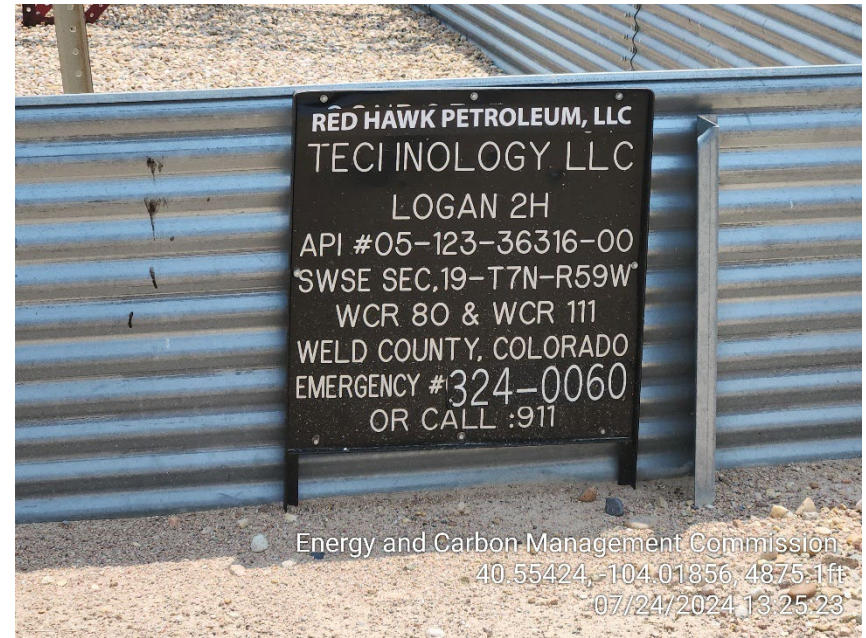
Photo 2 – Tank Battery Sign

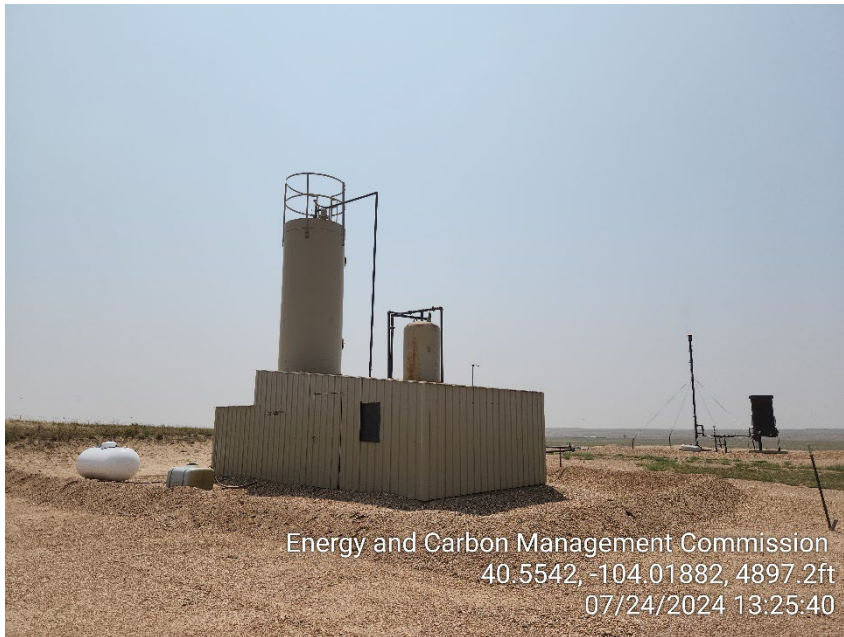
Photo 3 – Heater Treater

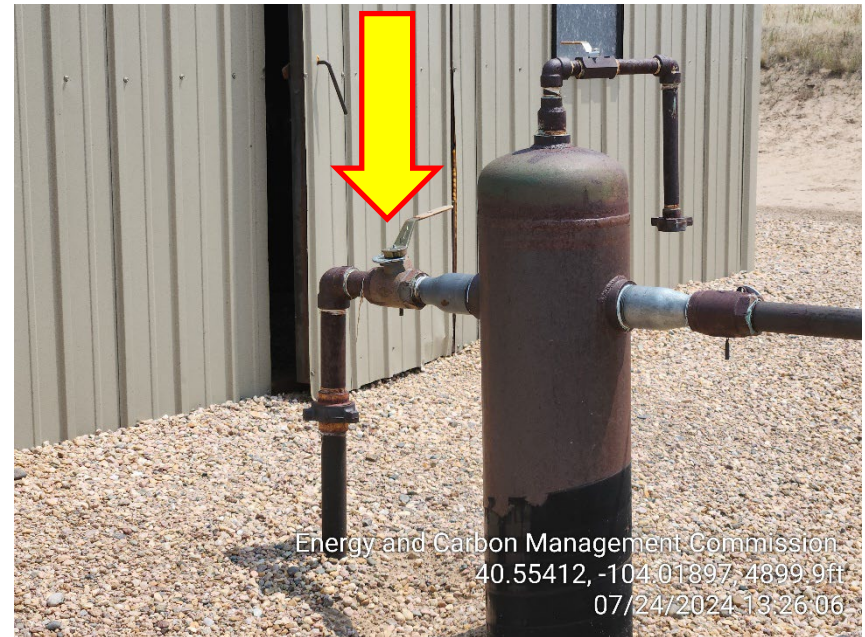
Photo 4 – Sales Line appears to be in the closed position Upstream of the Sales Meter

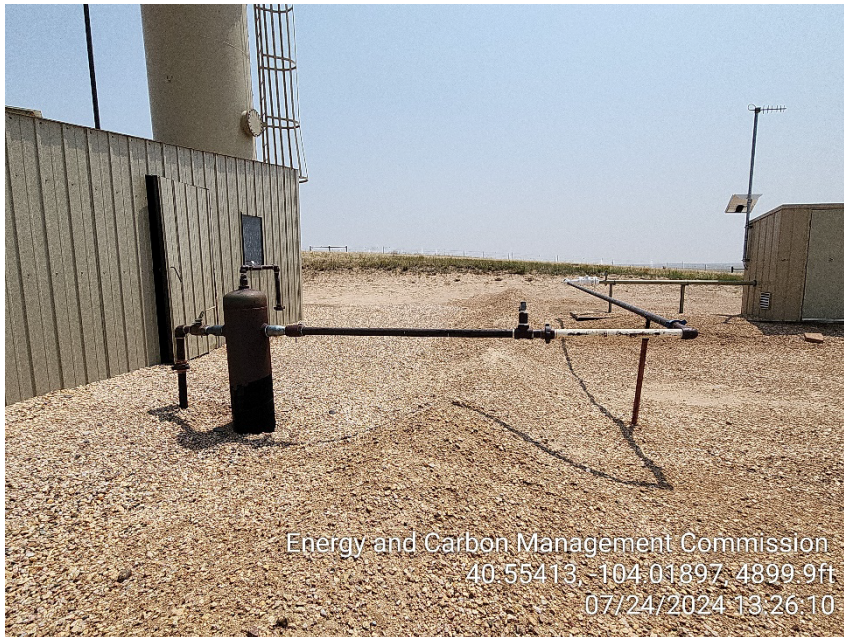
Photo 5 – Sales Line

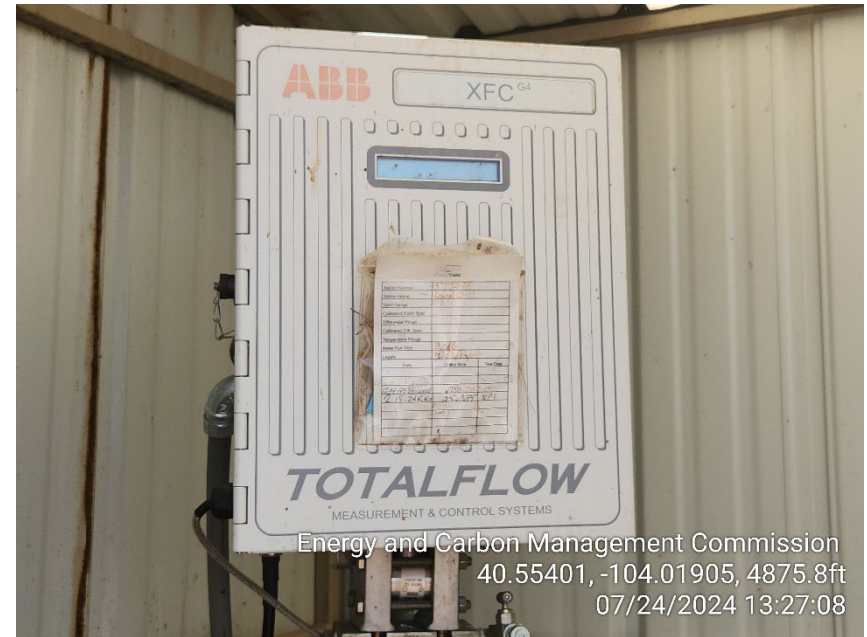
Photo 6 – Sales Meter appears to be powered off

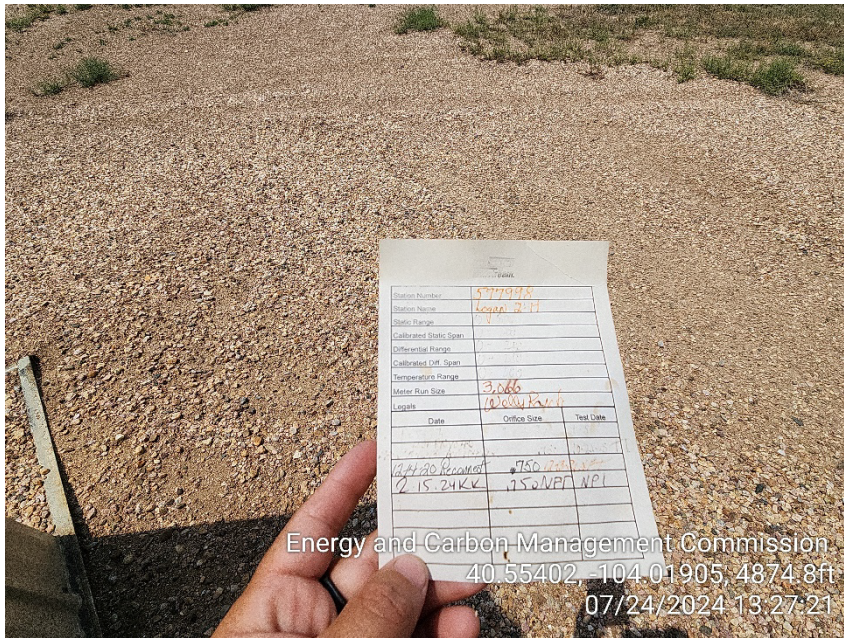
Photo 7 – Gas Sales Meter Calibration Card

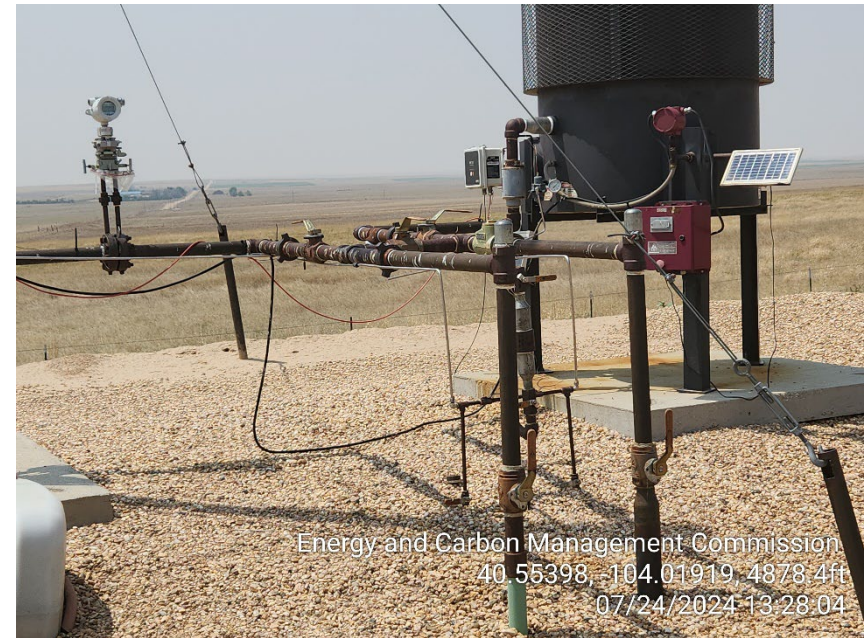
Photo 8 – ECD and Flare Gas Meter

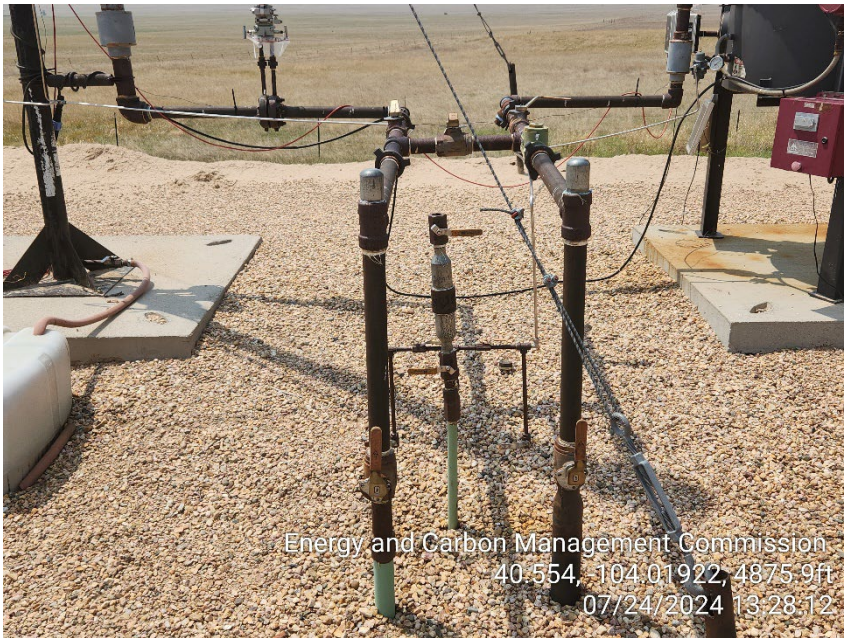
Photo 9 – Flare inlet Valves appear to be in open position

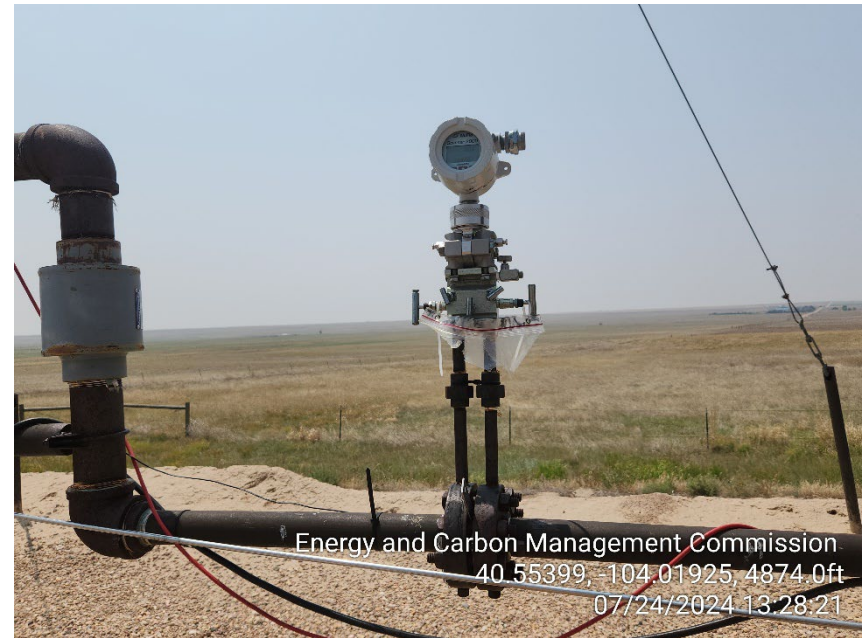
Photo 10 – Flare Gas Meter

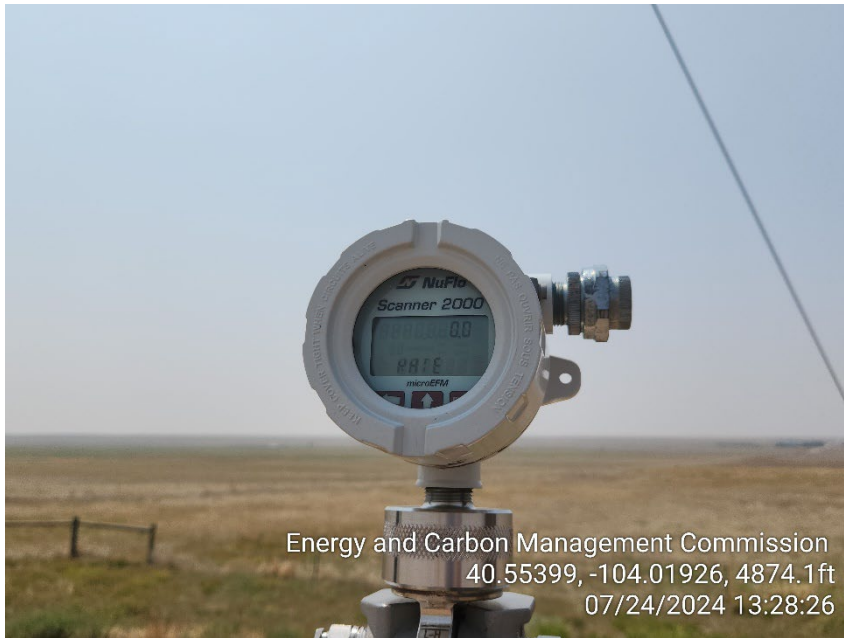
Photo 11 – Flare Gas Meter – Flow Rate

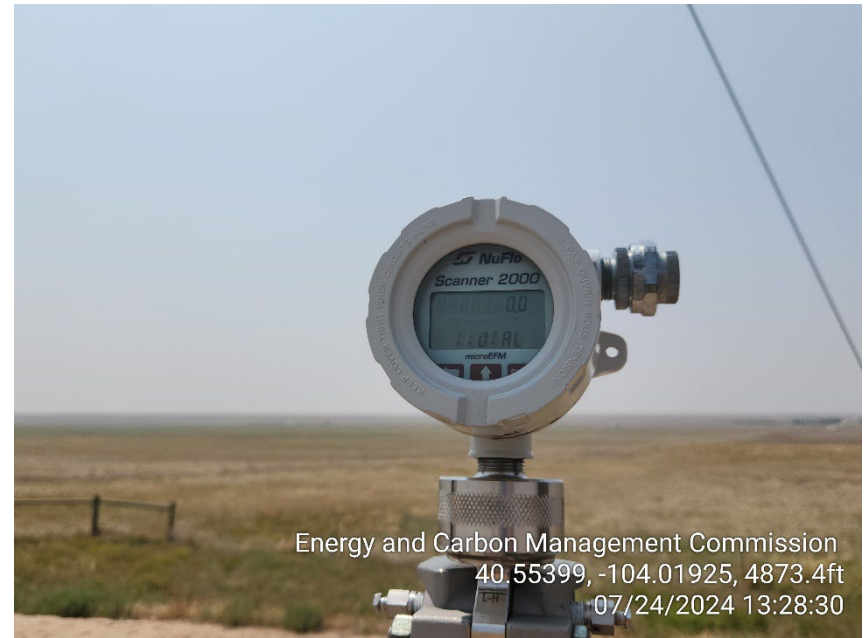
Photo 12 – Flare Gas Meter – Today Total

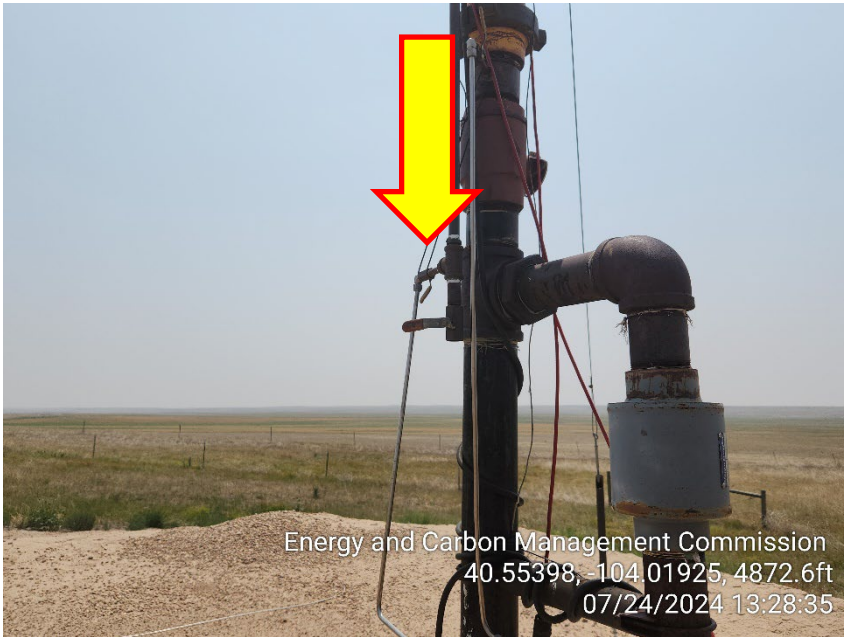
Photo 13 – Pilot Line appears to be in open position

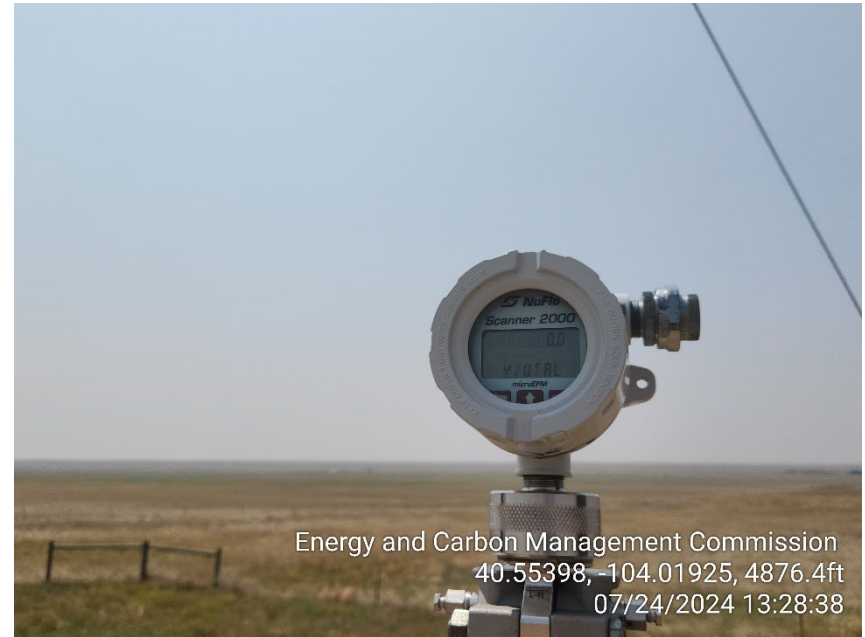
Photo 14 – Flare Gas Meter – Yesterday Total

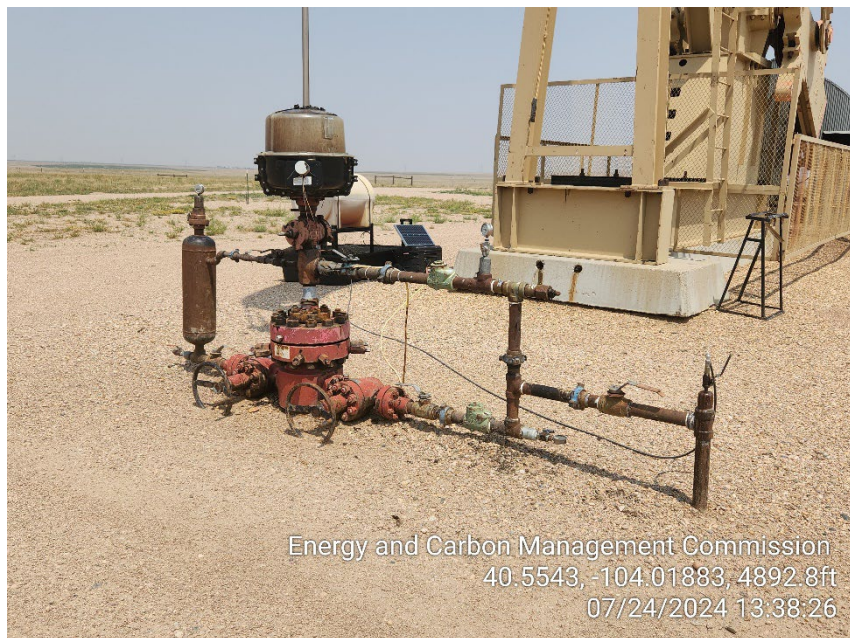
Photo 15 – Wellhead

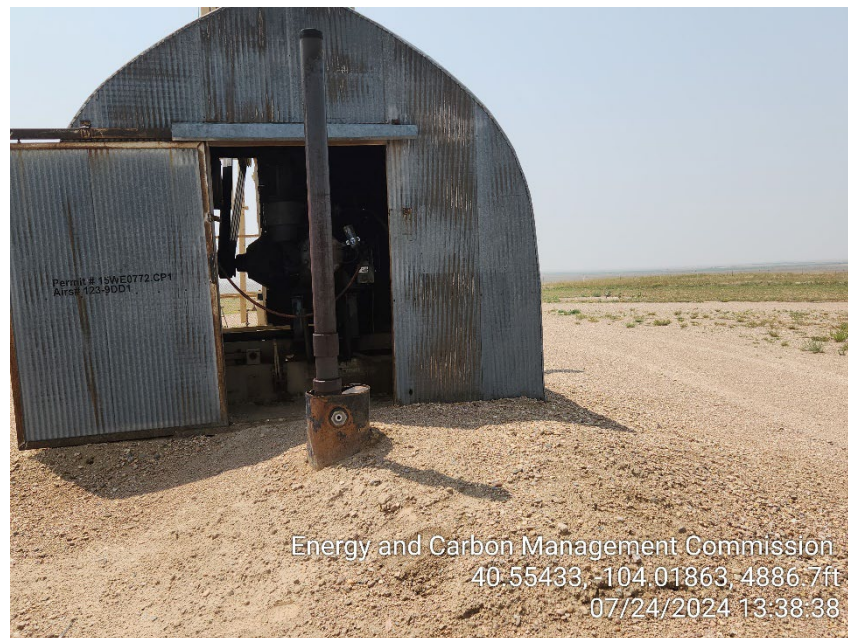
Photo 16 – Gas Engine

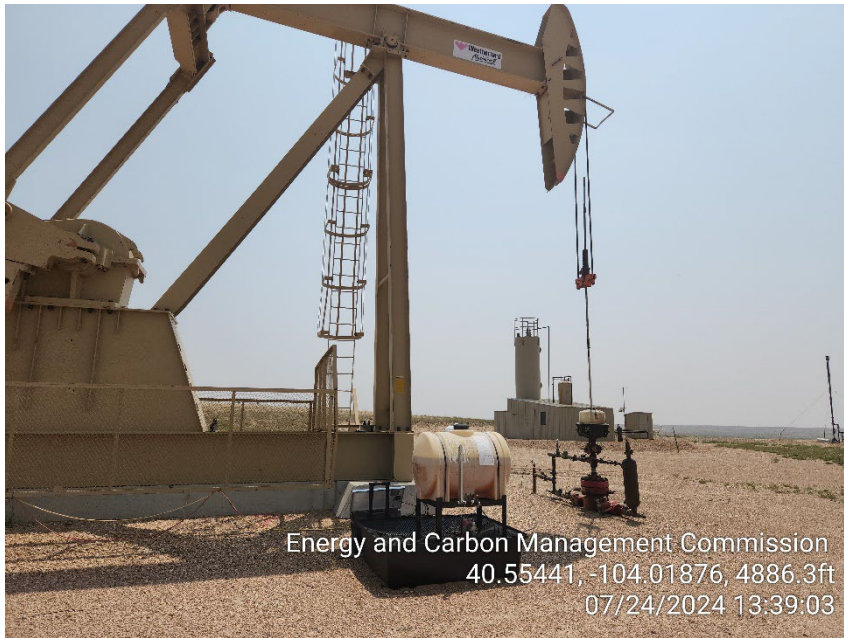
Photo 17 – Pumping Unit
