Inspection Photos
Location Name: Buchner 2-2
Location ID: 431634

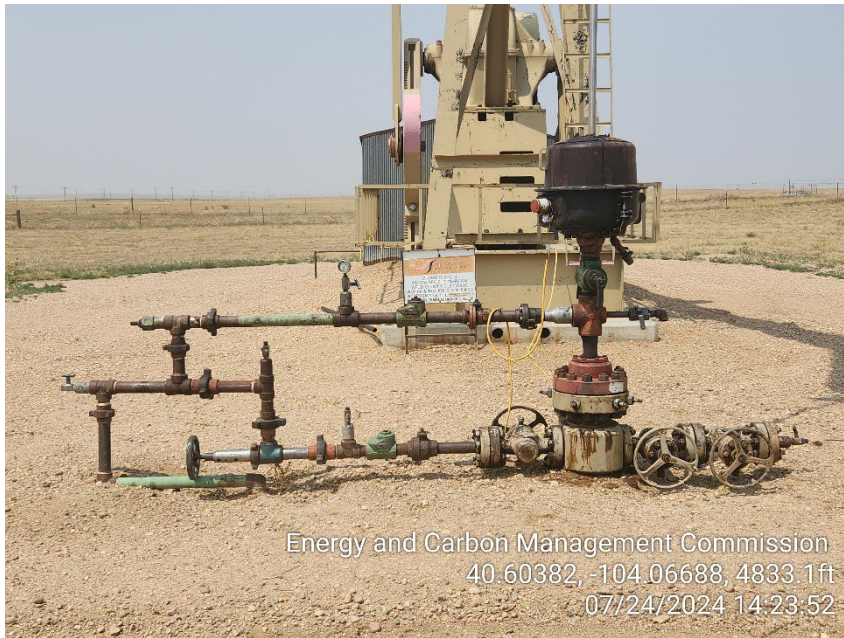
Photo 1 – Wellhead

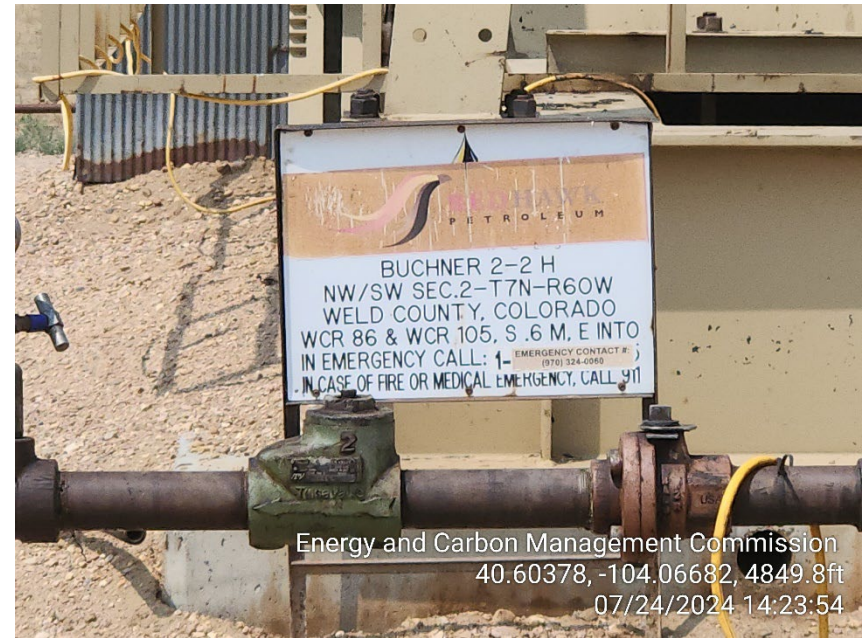
Photo 2 – Well Sign

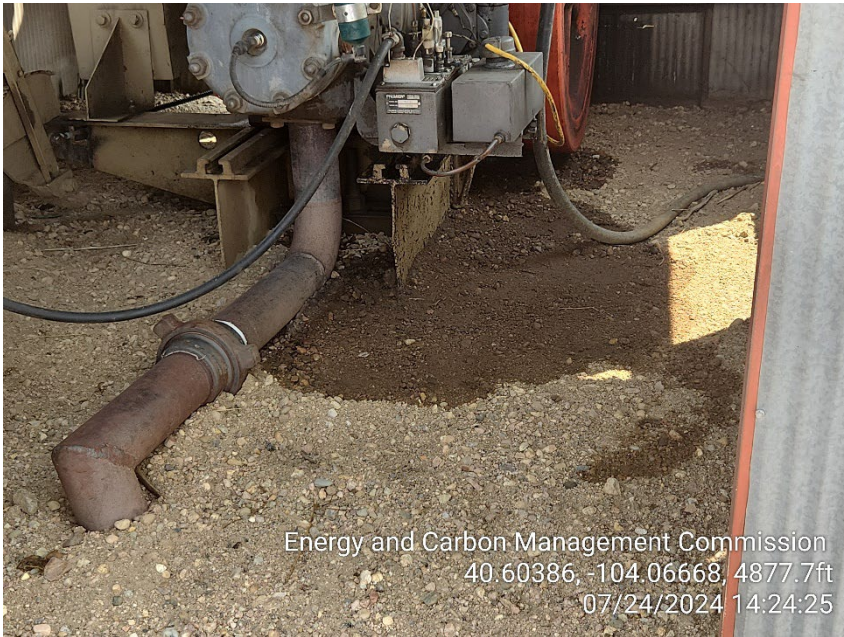
Photo 3 – Stained Soil at Gas Engine

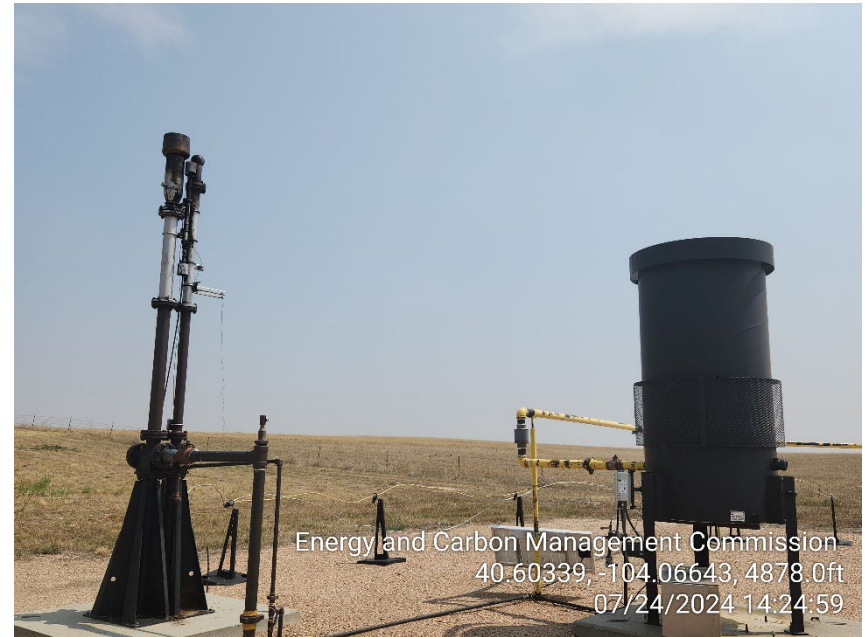
Photo 4 – Flare and ECD

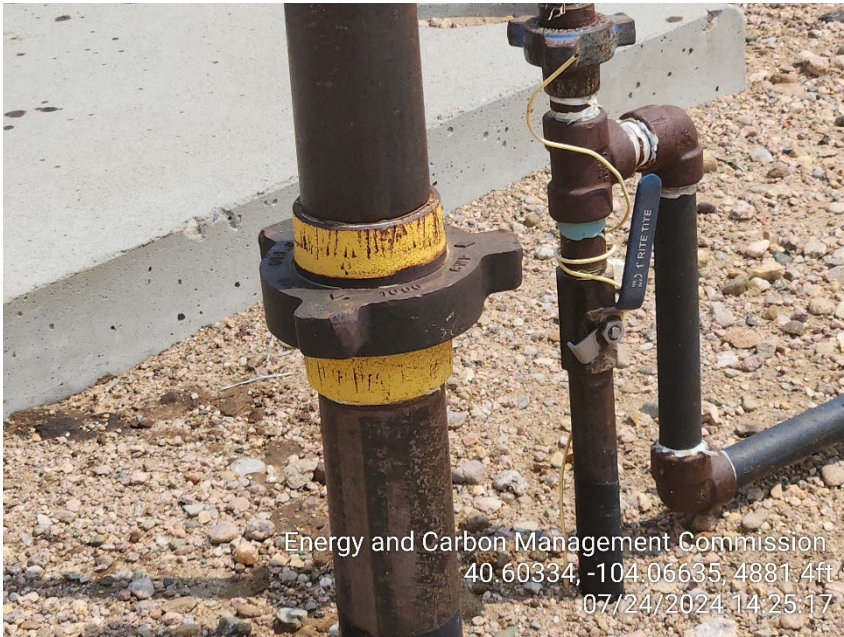
Photo 5 – Pilot Supply Valve appears to be in open position

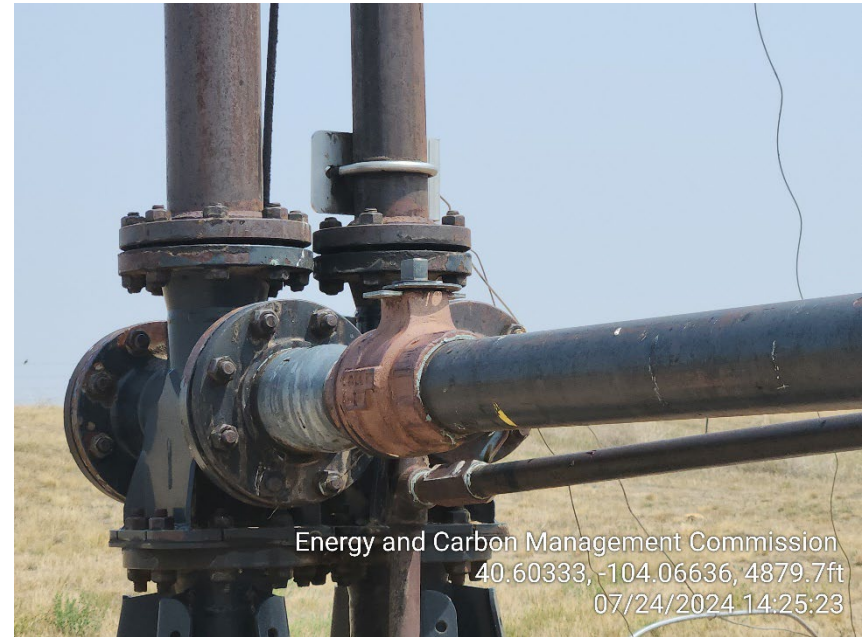
Photo 6 – Inlet Valve to Flare appears to be in open position

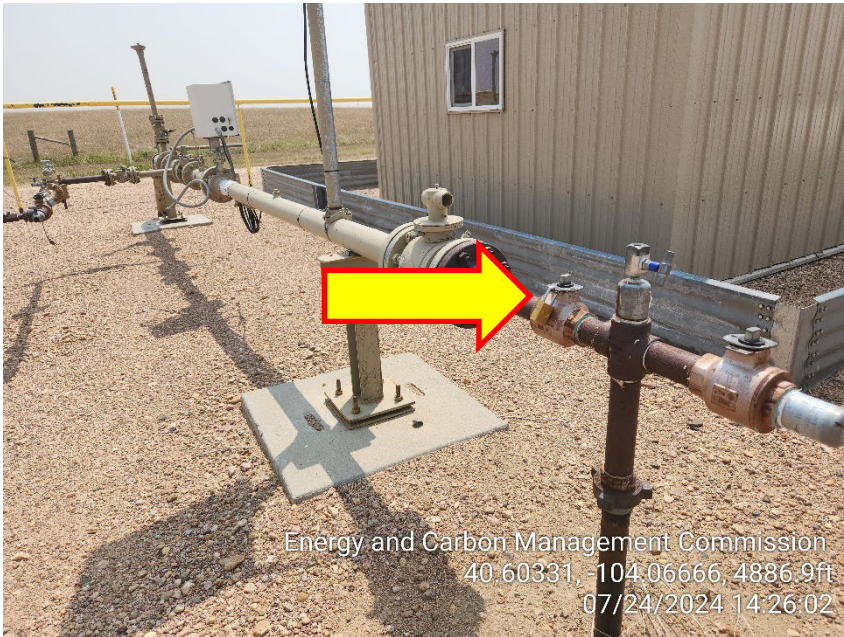
Photo 7 – Gas Sales Line and Meter – Locked Out

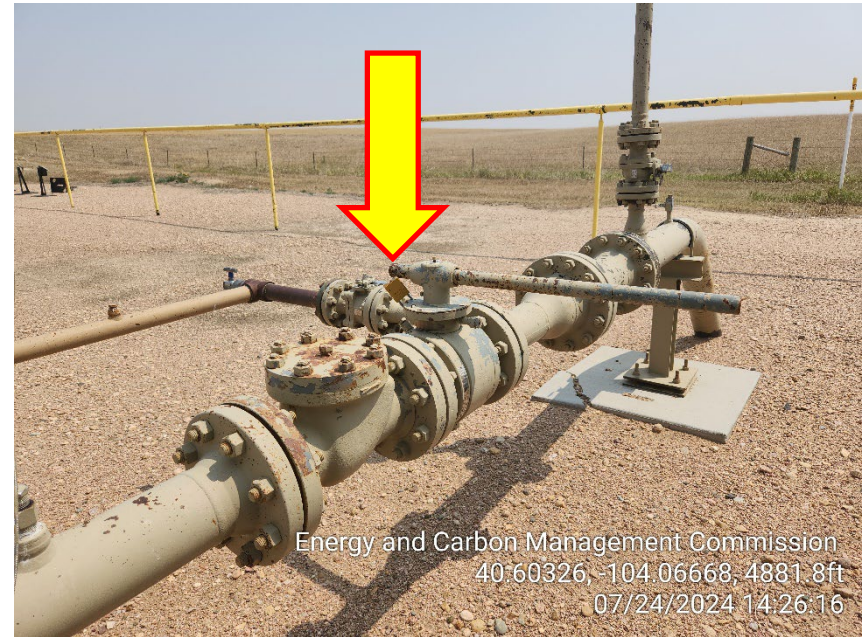
Photo 8 – Sales Line – Locked Out

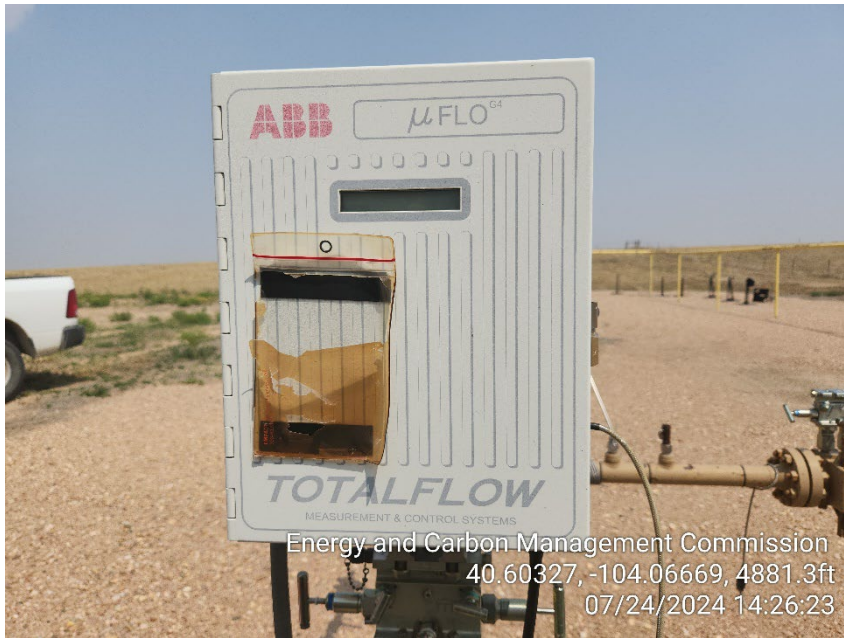
Photo 9 – Gas Sales Meter appears to be powered off

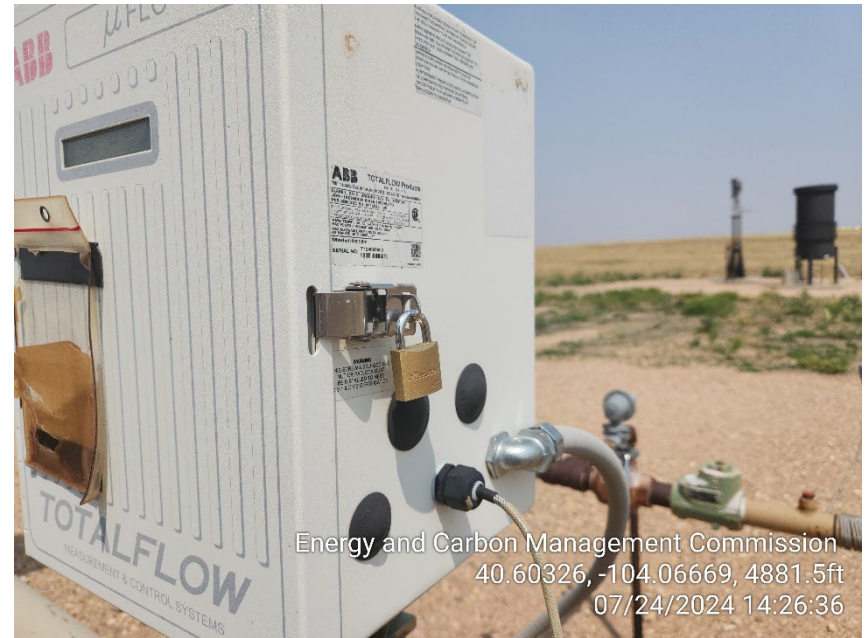
Photo 10 – Gas Sales Meter – Locked Out

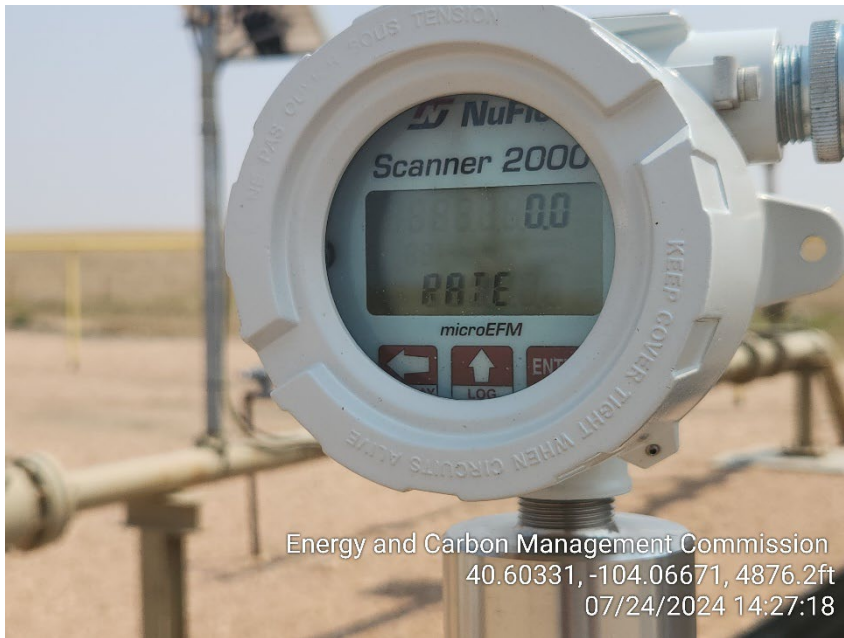
Photo 13 – Rate – Flare Gas Meter

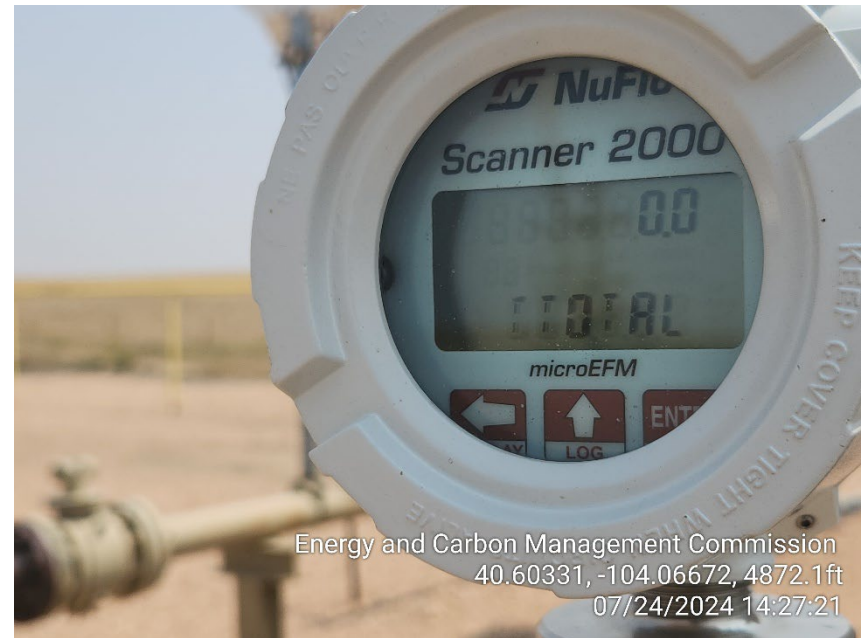
Photo 14 – Today Total – Flare Gas Meter

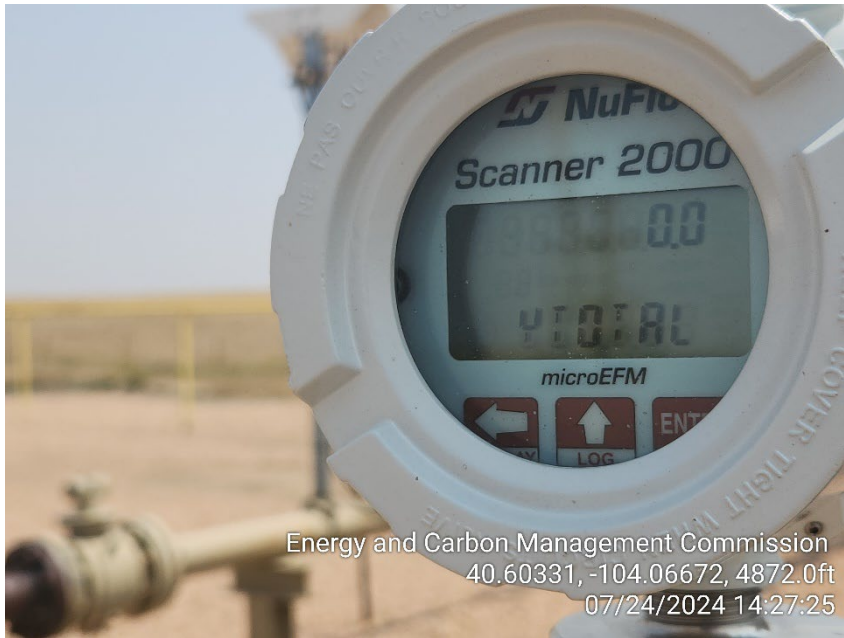
Photo 15 – Yesterday Total – Flare Gas Meter

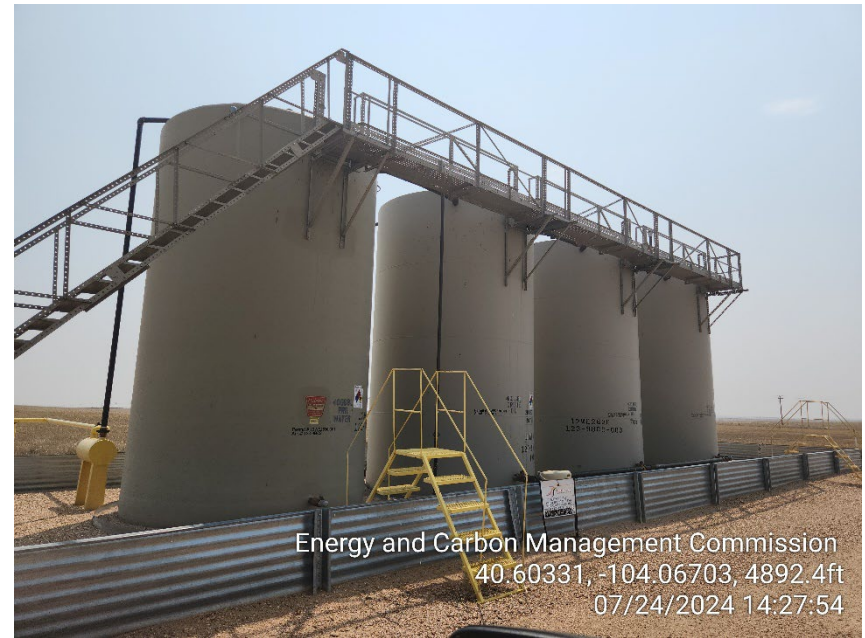
Photo 16 – Tank Battery

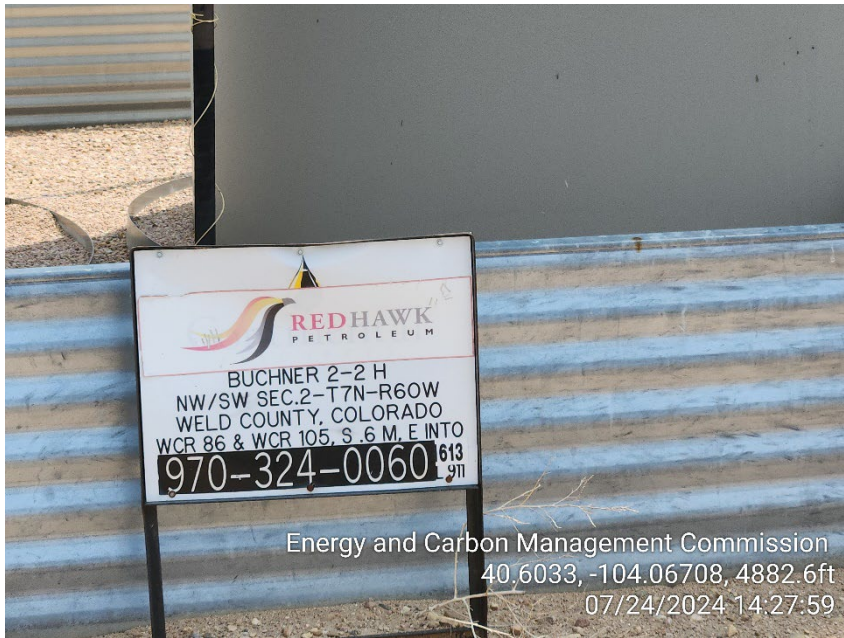
Photo 17 – Tank Battery Sign
