Inspection Photos
Location Name: Buchner 1-2H
Location ID: 427041

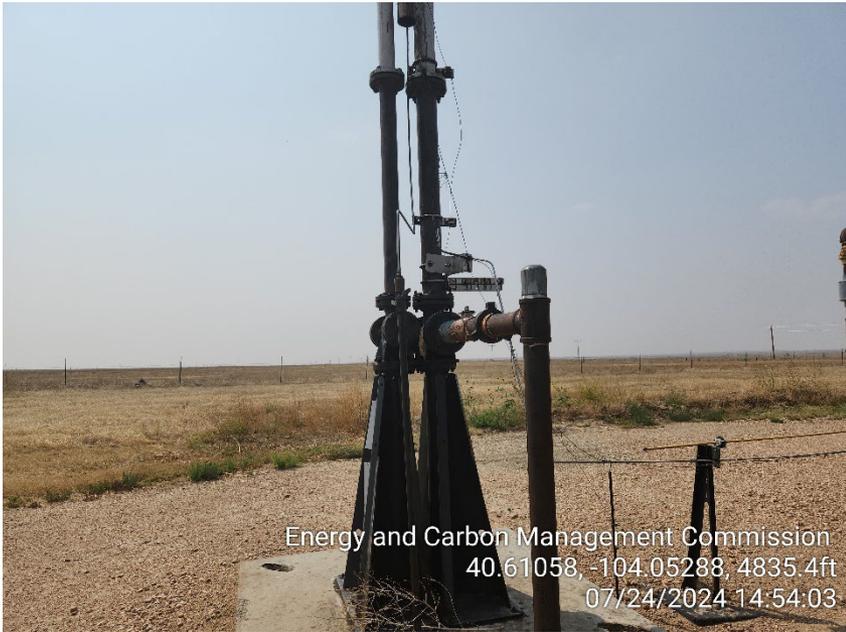
Photo 5 – Pilot Supply Valve appears to be in open position

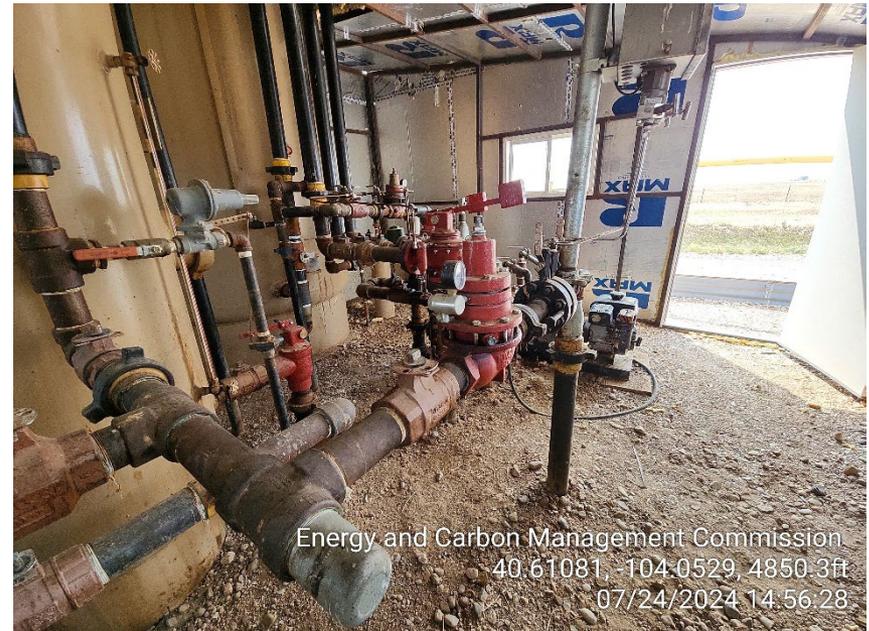
Photo 10 – Gas Sales Meter Line open
