Inspection Photos
Location Name: Reines 1-1H
Location ID: 427144

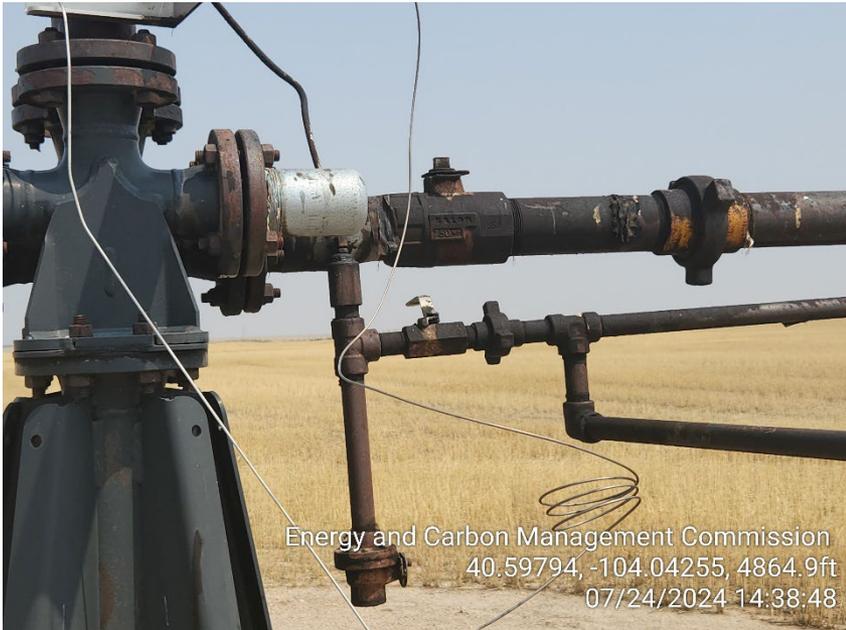
Photo 5 – Pilot Supply Valve appears to be in closed position. Inlet Valve appears to be in the open position

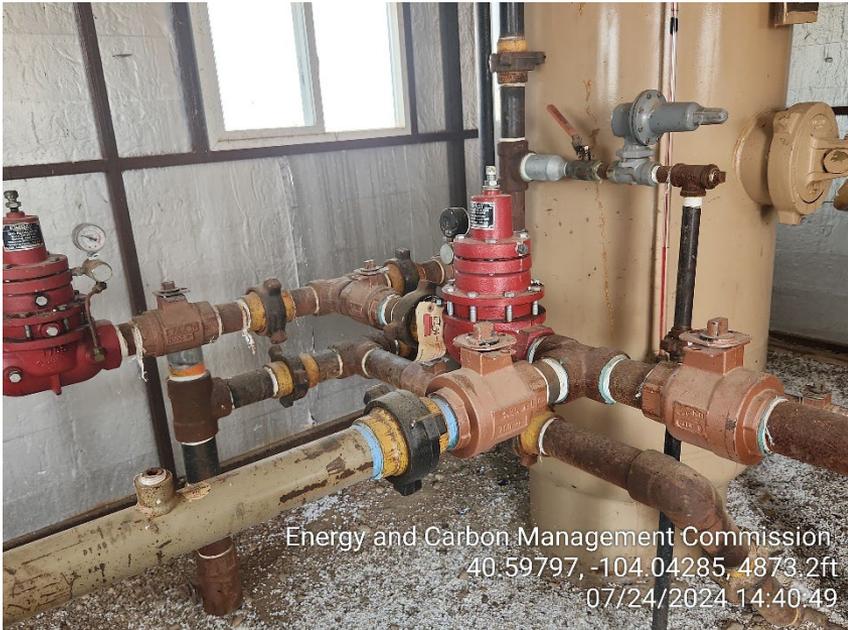
Photo 11 – Sales Line Valve and Flare Line Valves appear to be in the open position

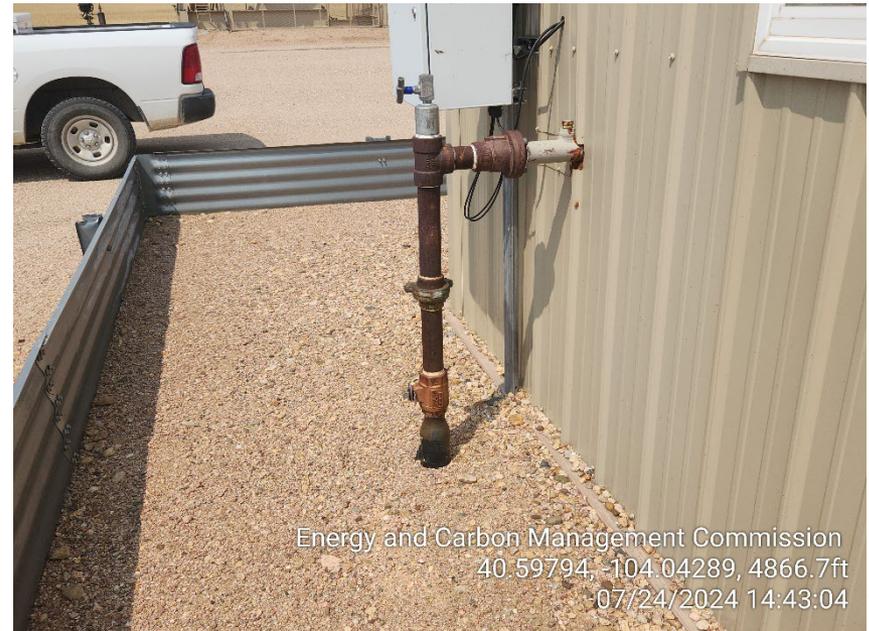
Photo 16 – Sales Line Valve appears to be in the open position
