## Inspection Photos

Location Name: TEP Rocky Mountain LLC Mead RWF 43-23 Pad

Location # 419862

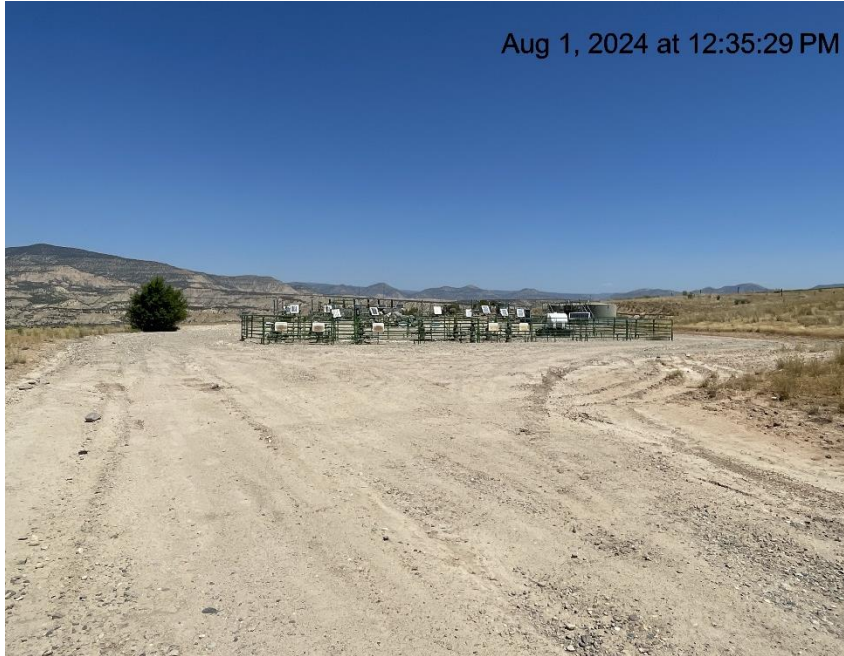
Photo # 4425 From entrance to location

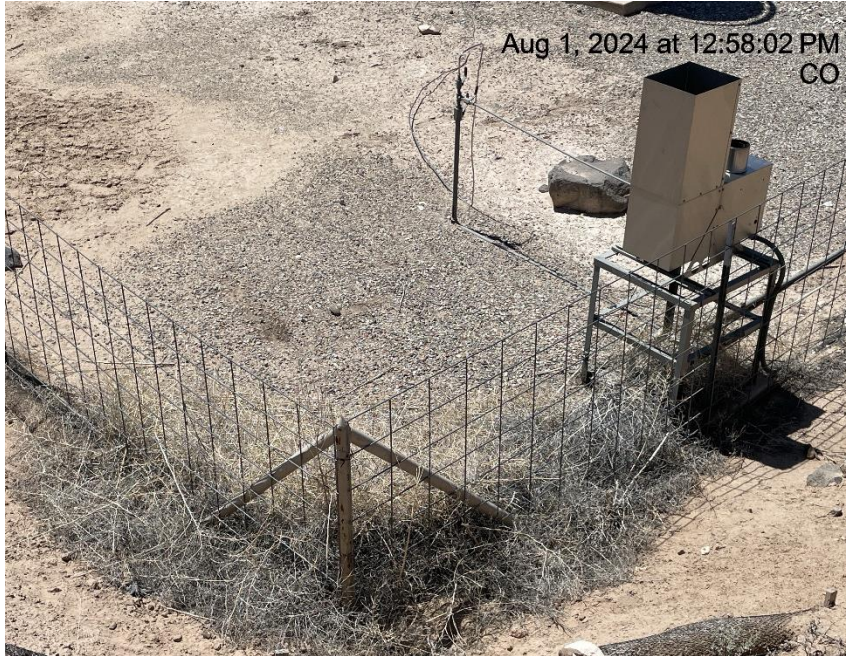
**Photo # 4433 Dead weeds/debris near thermogen**

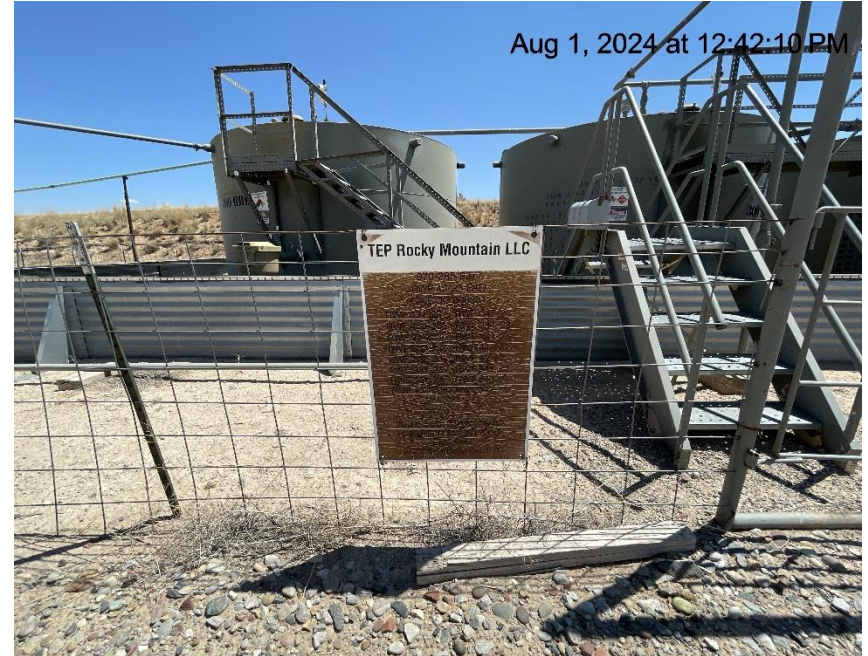
**Photo # 4434 Battery sign weathered & cracking/becoming illegible/does not comply with CECMC rules**

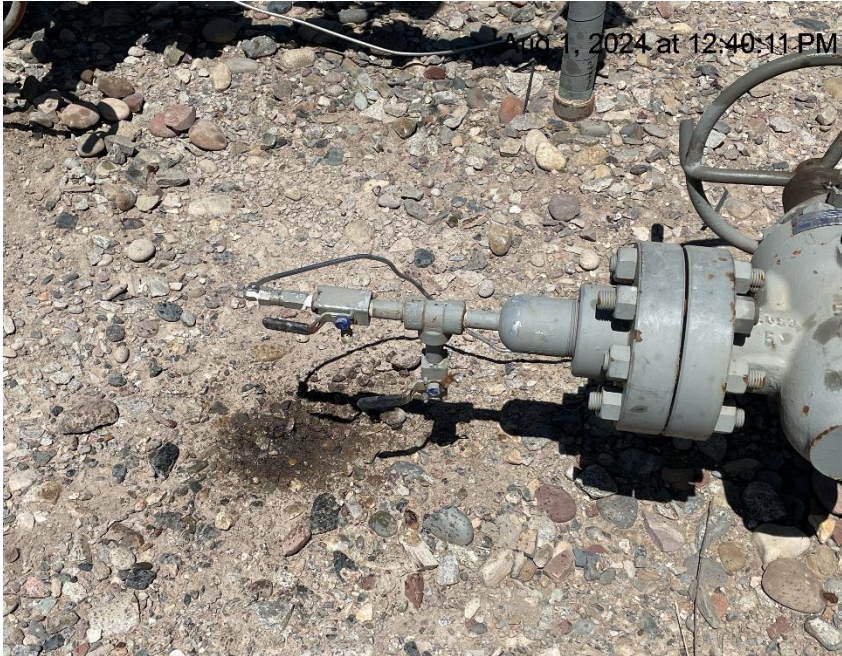
Photo # 4435 Staining near wellhead

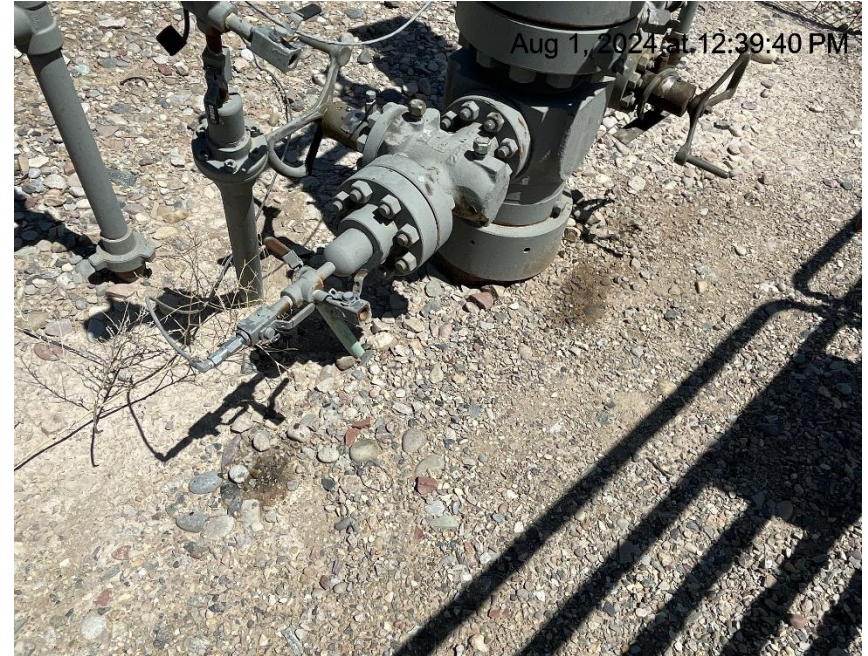
Photo # 4436 Staining near wellhead

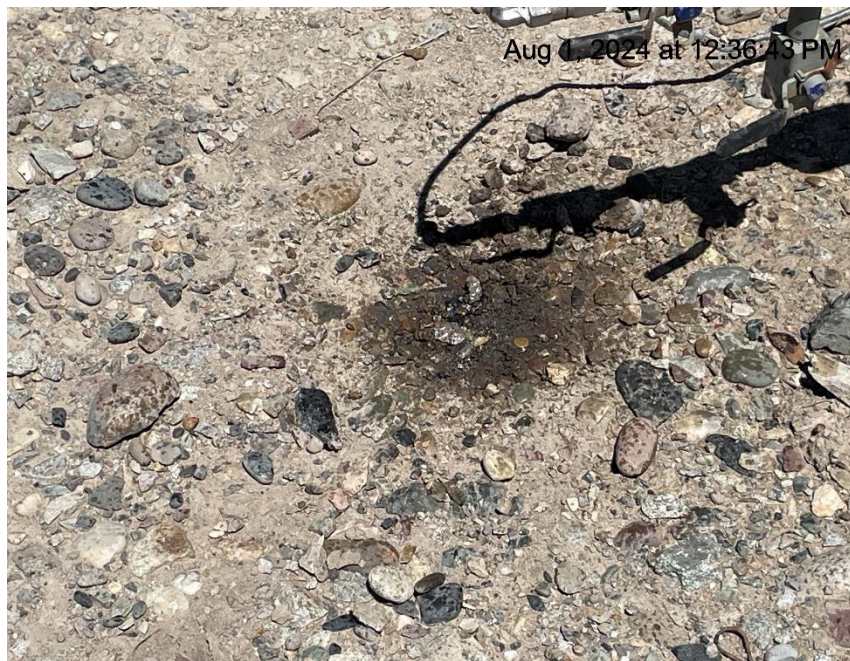
Photo # 4437 Staining near wellhead

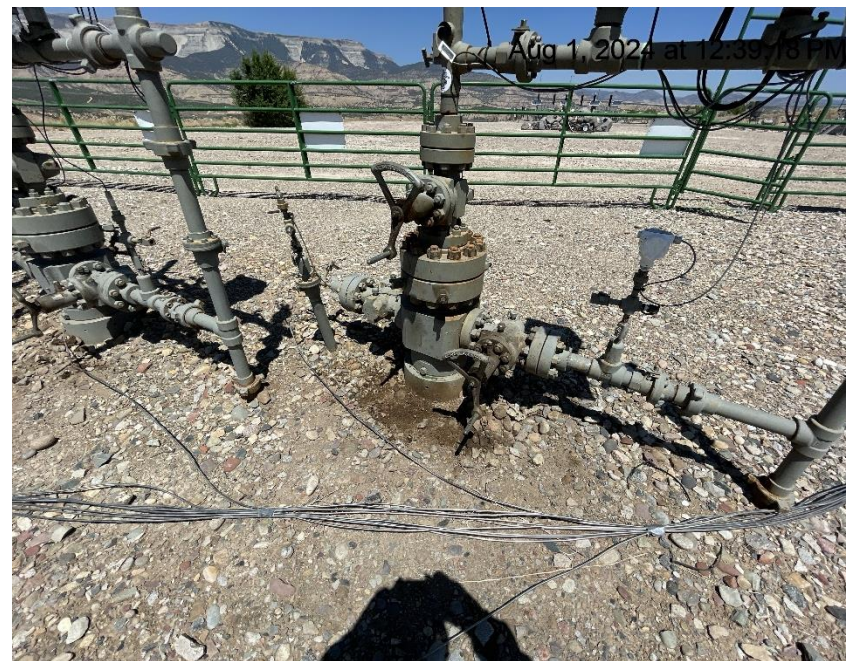
Photo # 4438 Staining near wellhead

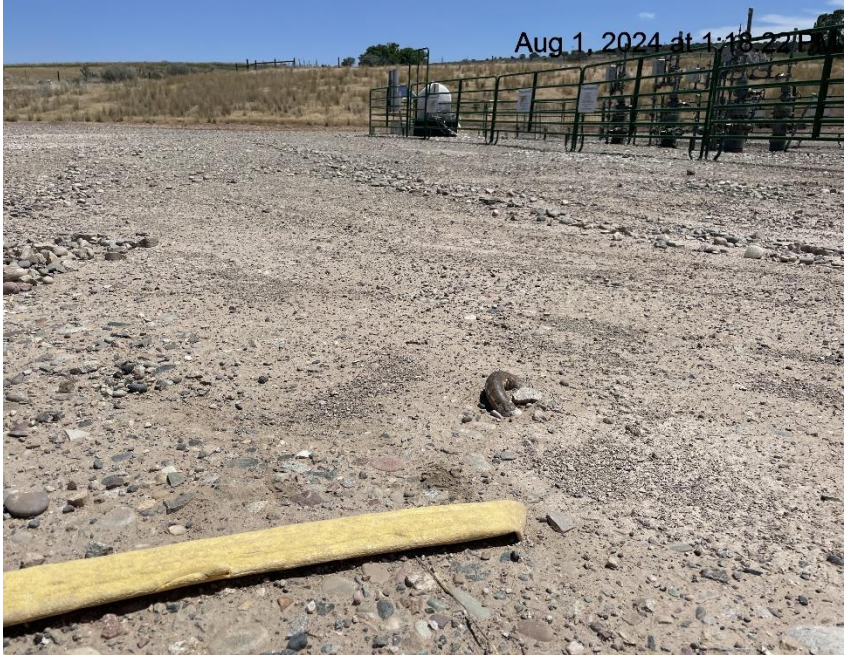
Photo # 4439 Improperly marked deadman

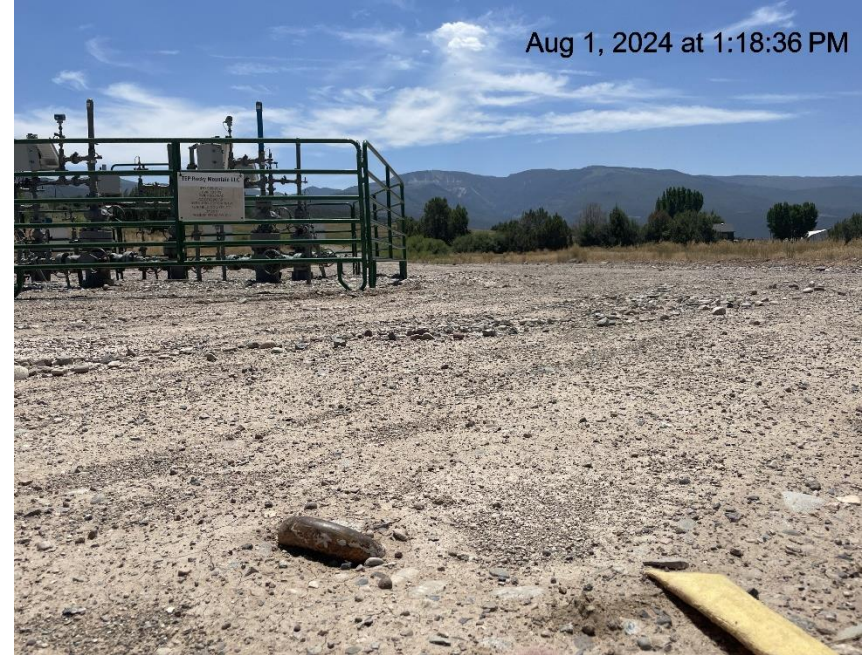
Photo # 4440 Same improperly marked deadman from a different angle
