**Operator:** 8 North

**Location Name:** DF RANCH-611N61W 15SESE

**Loc ID:** 410138

**Inspection:** 696300877

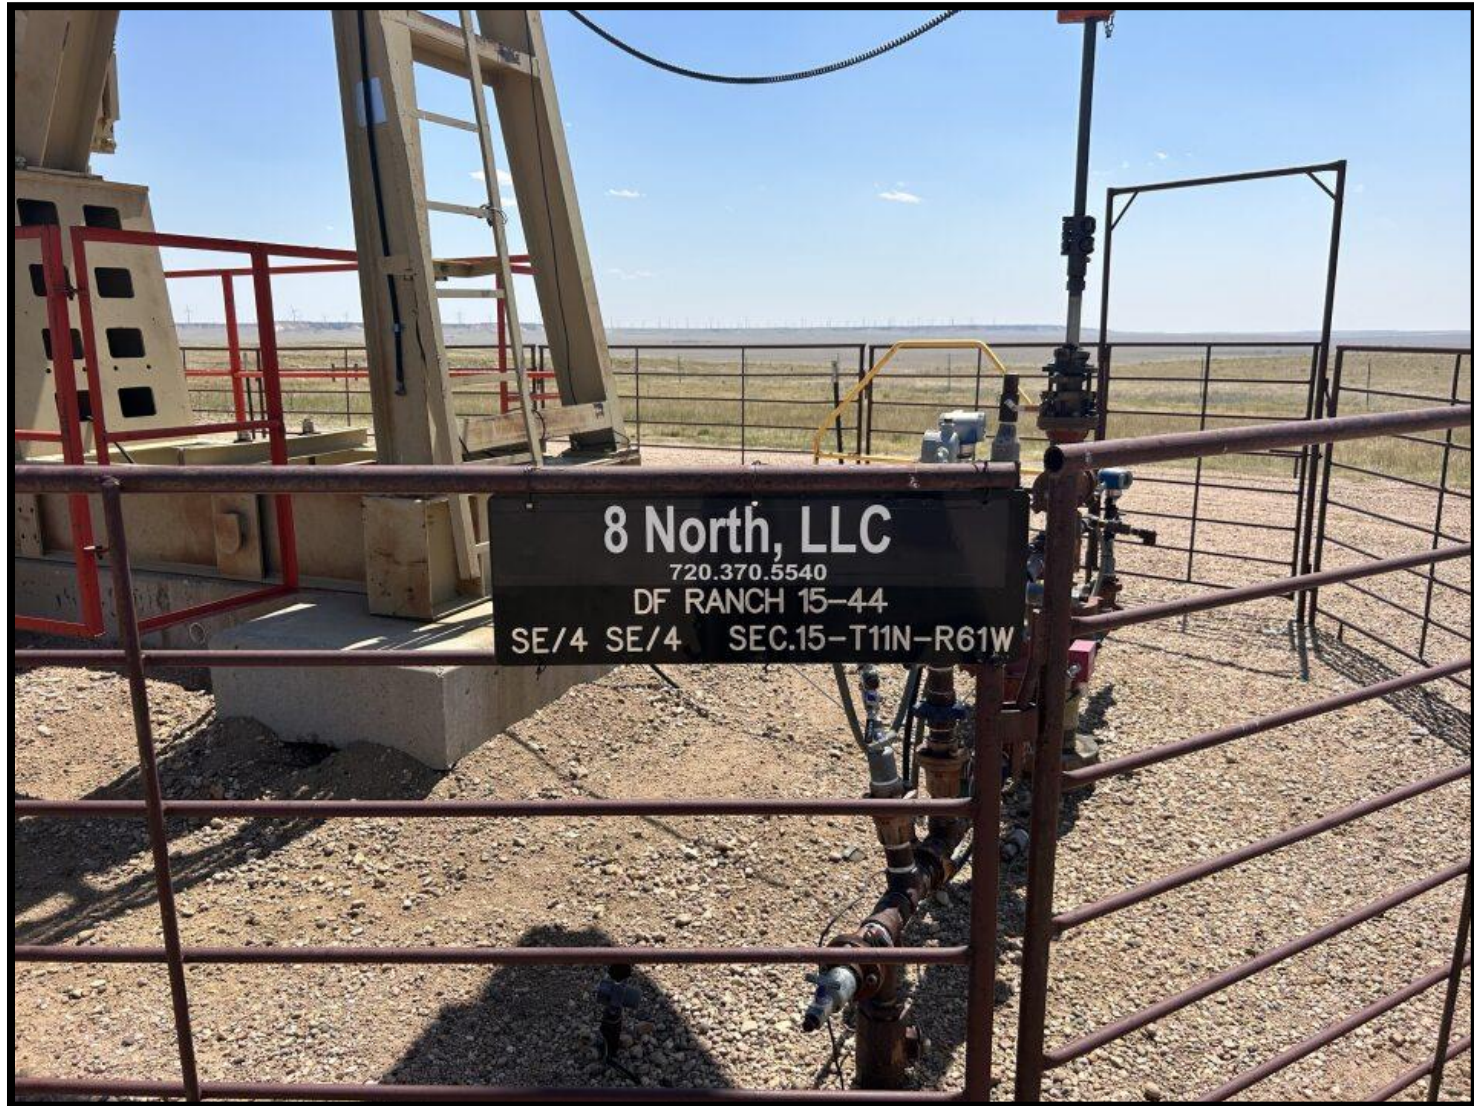
Exhibit A

**CA:** Stained Soil at Exhaust and Gas Engine Corrective Action: Properly treat or dispose of oily waste in accordance with 907.e

**CA Resolution:** Operator has provided photo evidence that the stained soil in the exhaust and gas engine area has been addressed in accordance with rule 907.e.
