# Construction and Stormwater Inspection

Operator: KERR MCGEE OIL & GAS ONSHORE LP -  
47120

Location ID: 485056

Inspection Photos  
Location Name: Schmerge 9-4HZ  
Location ID: 485056

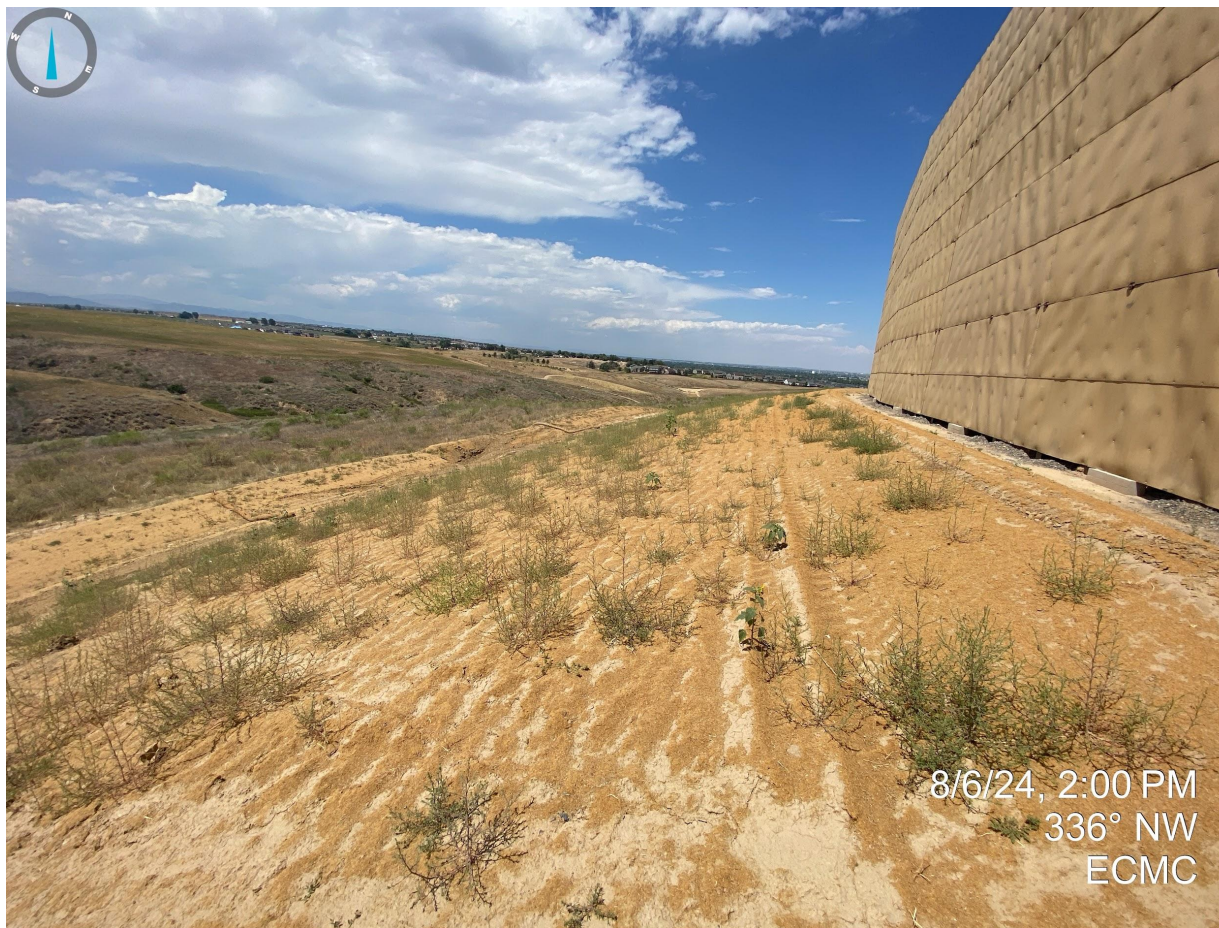
**Photo 1.** Western portion of the location. Undesirable vegetation (russian thistle and kochia) was observed to be growing throughout. No germination observed throughout the hydroseeded portions.

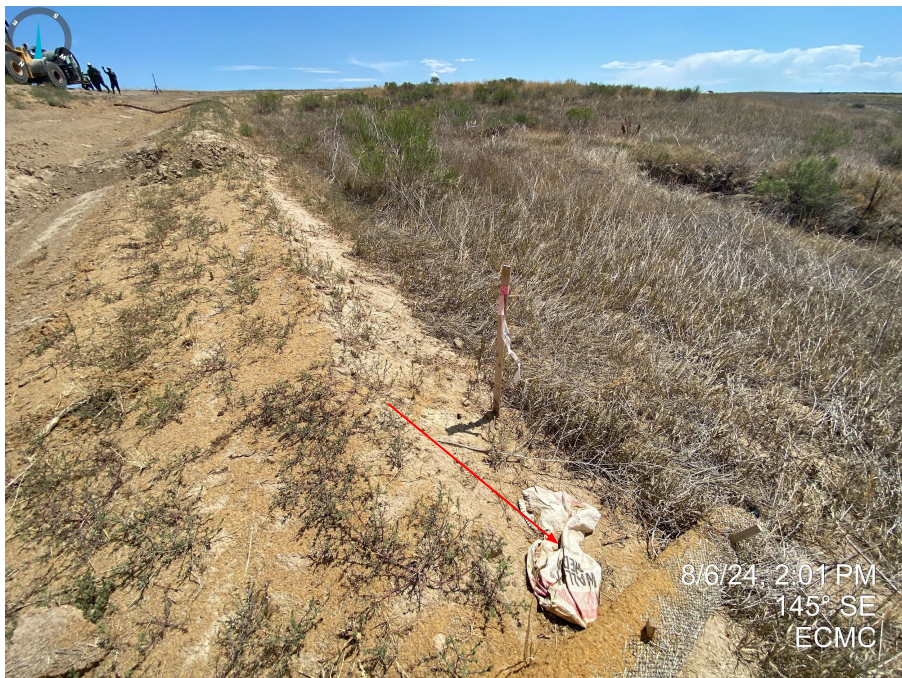
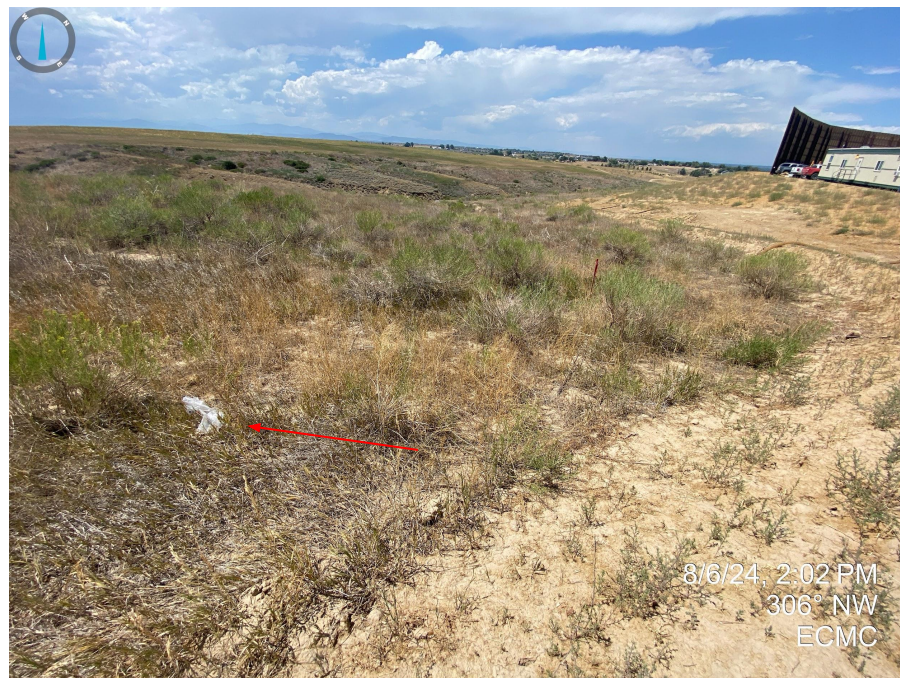
**Photo 2.** Examples of trash observed on the west side of the location.

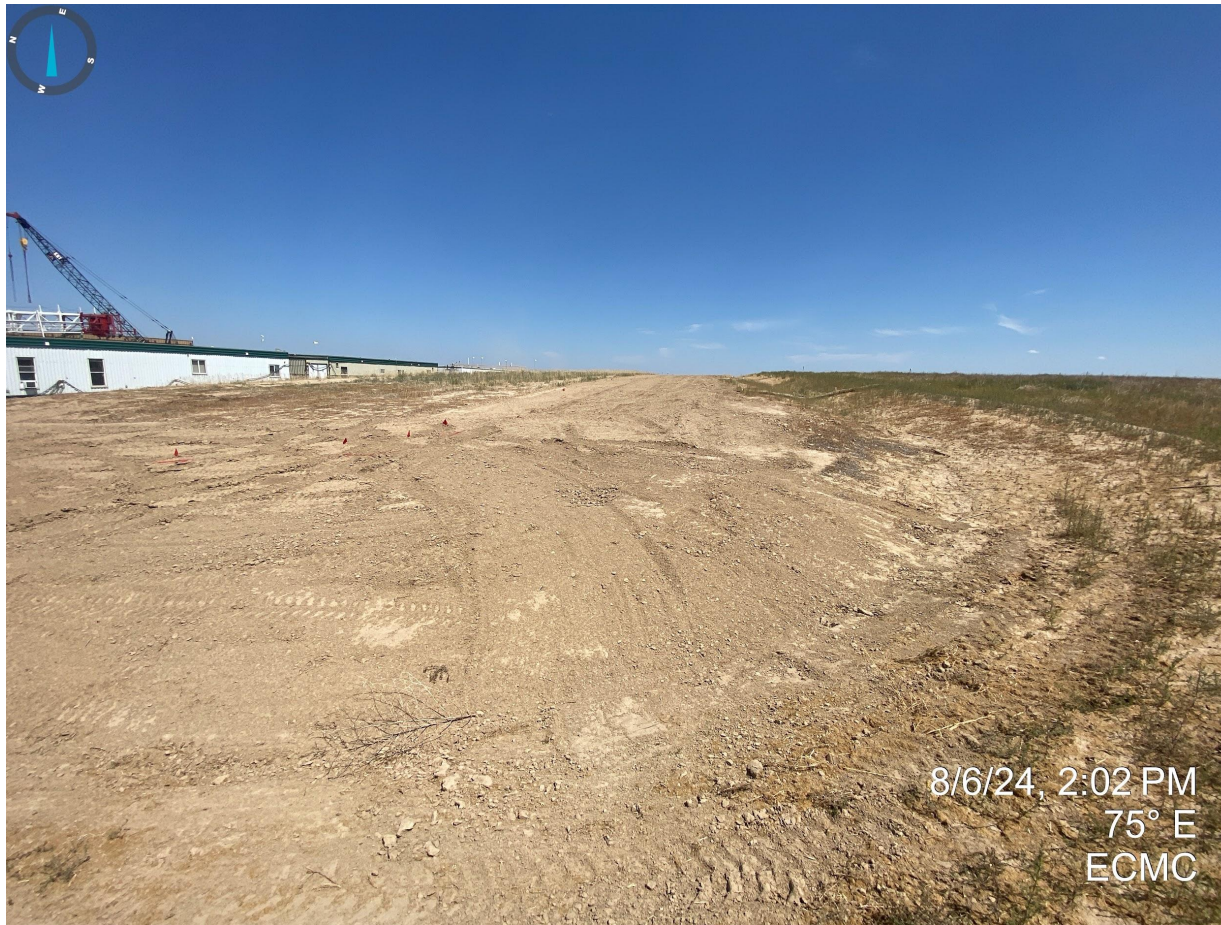
**Photo 3.** Southwestern portion of the location. It appears that recent dirt work is associated with pipeline/flowline installation. All soils shall be stabilized in order to comply with Rule 1002.c.

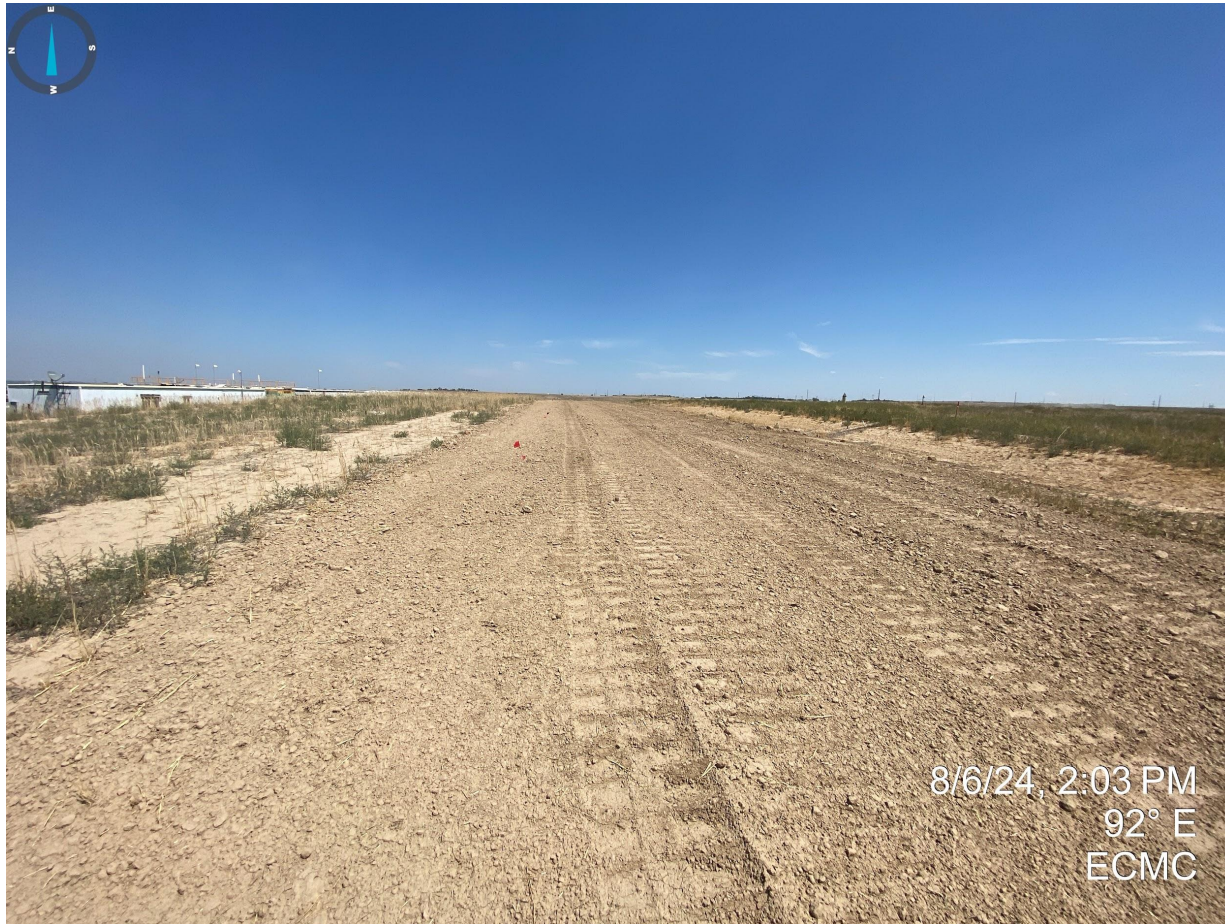
**Photo 4.** Continued from Photo 3; facing east from the center/southern portion of the location.

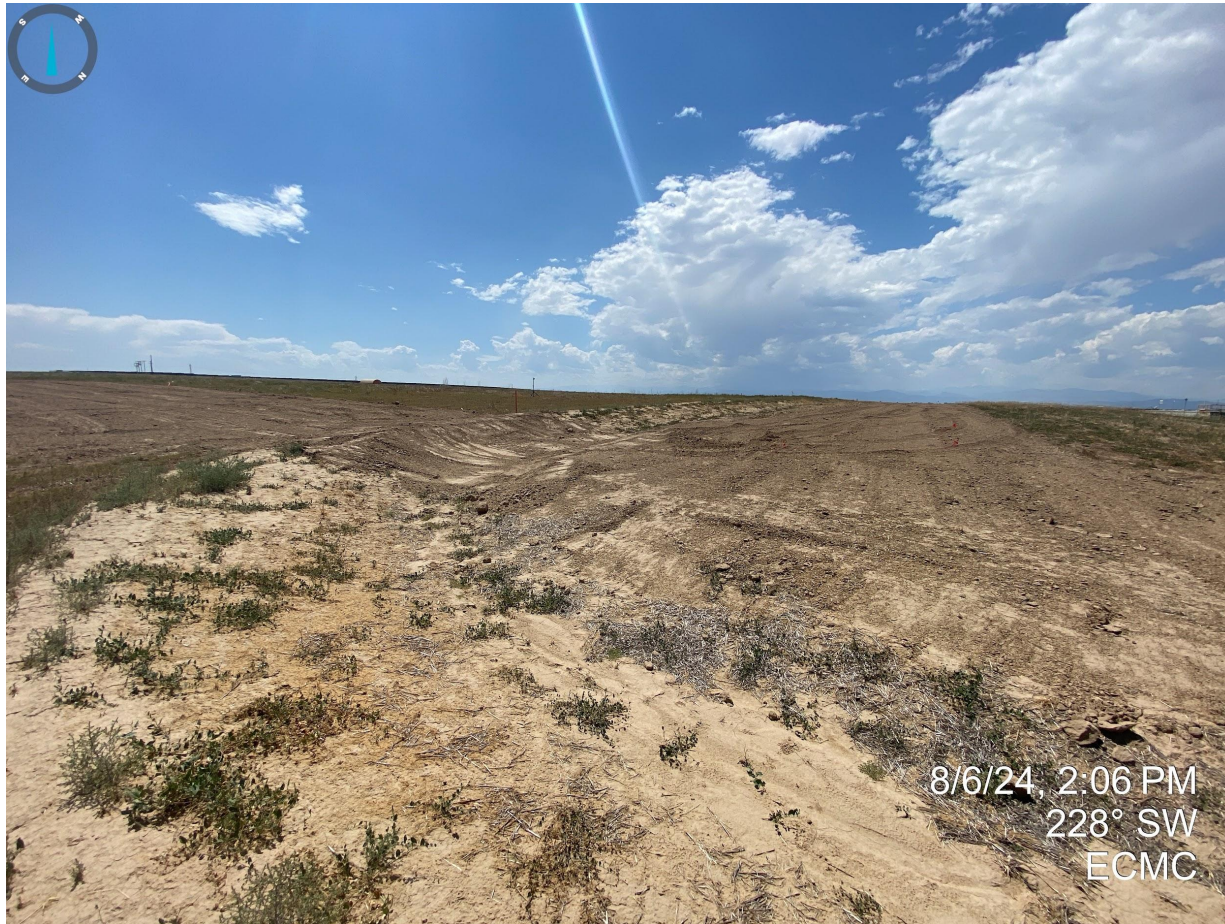
**Photo 5.** Continued from Photo 3; facing southwest from the southeast end of the location.

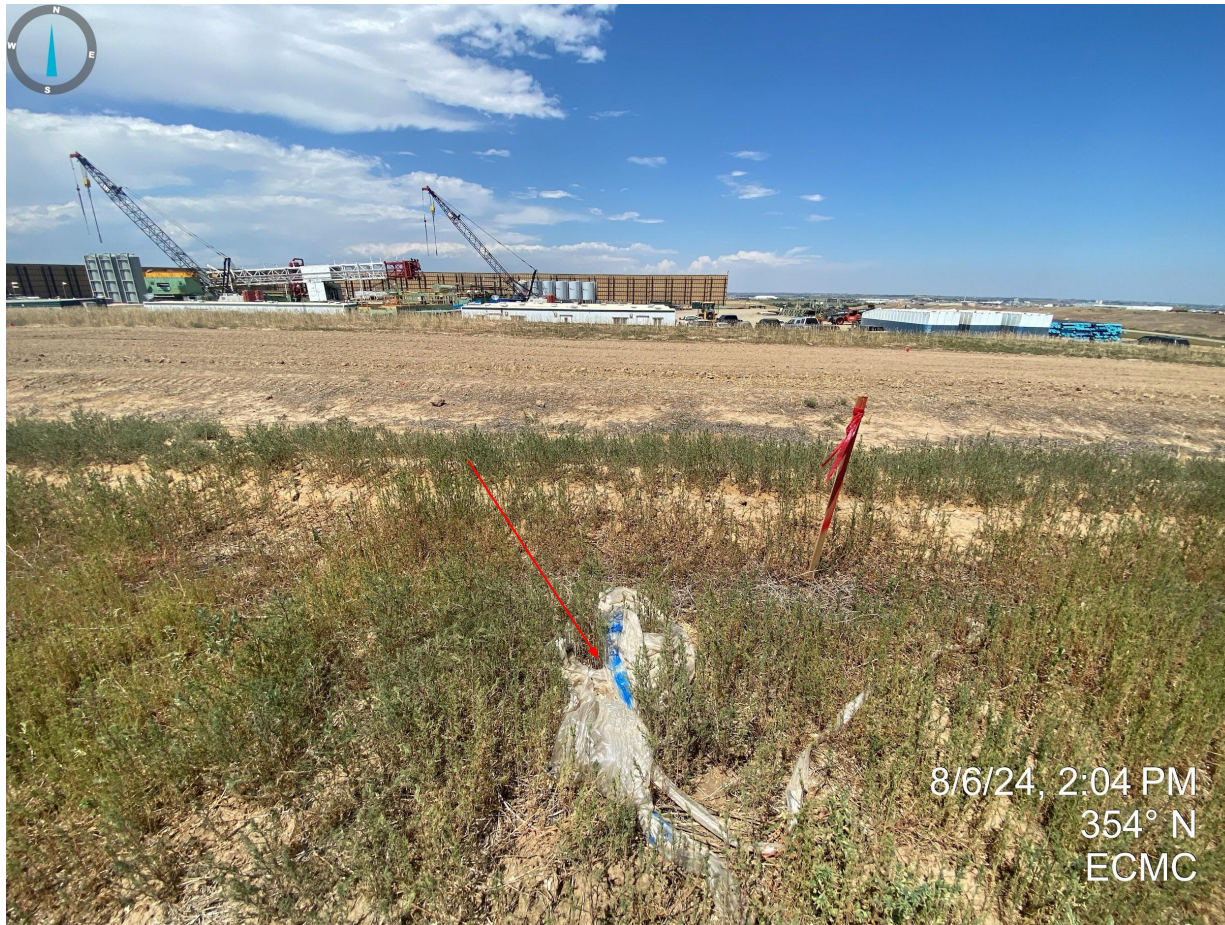
**Photo 6.** Examples of trash observed on the south side of the location.

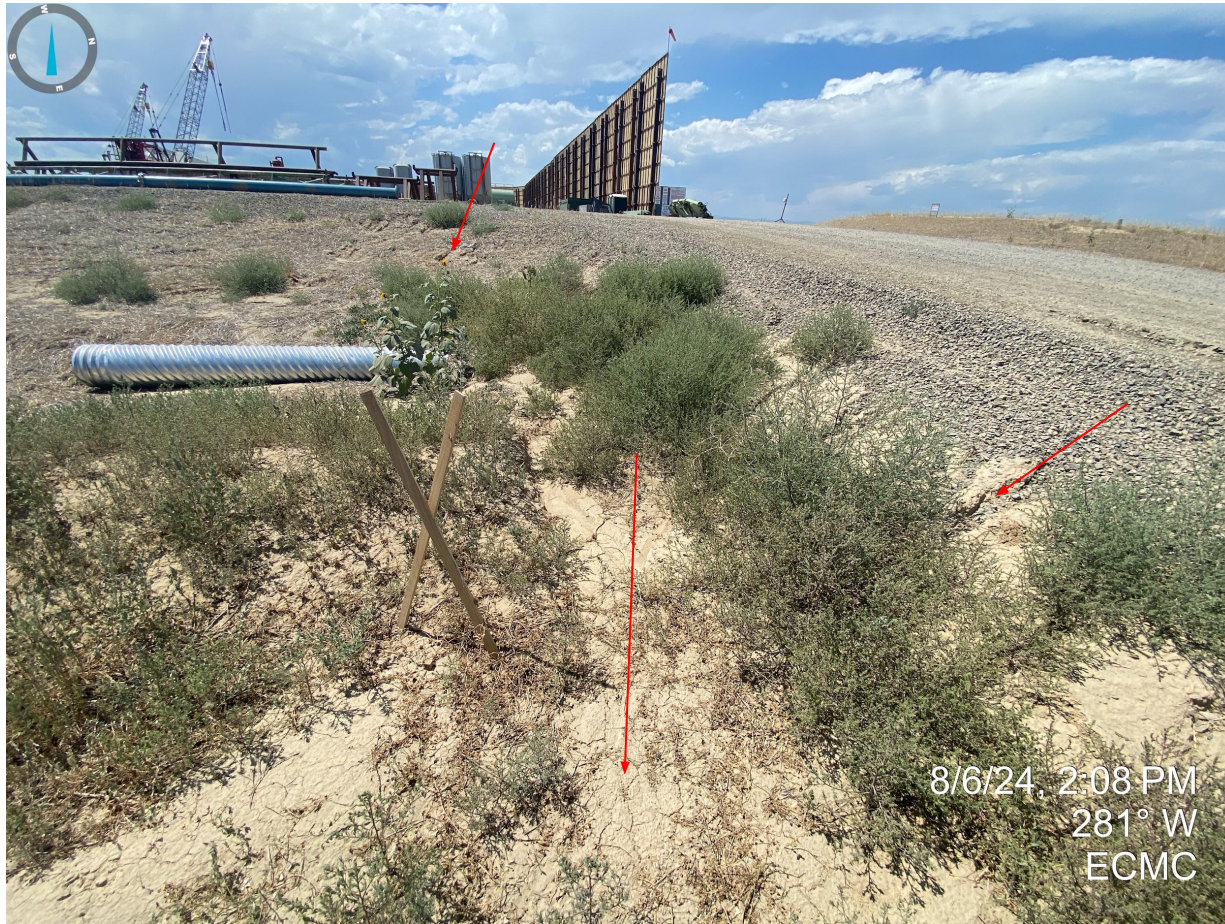
**Photo 7.** Taken near the location entrance. Photo illustrates undesirable vegetation and sediment discharge and erosion degradation (riling) near the culvert crossing.

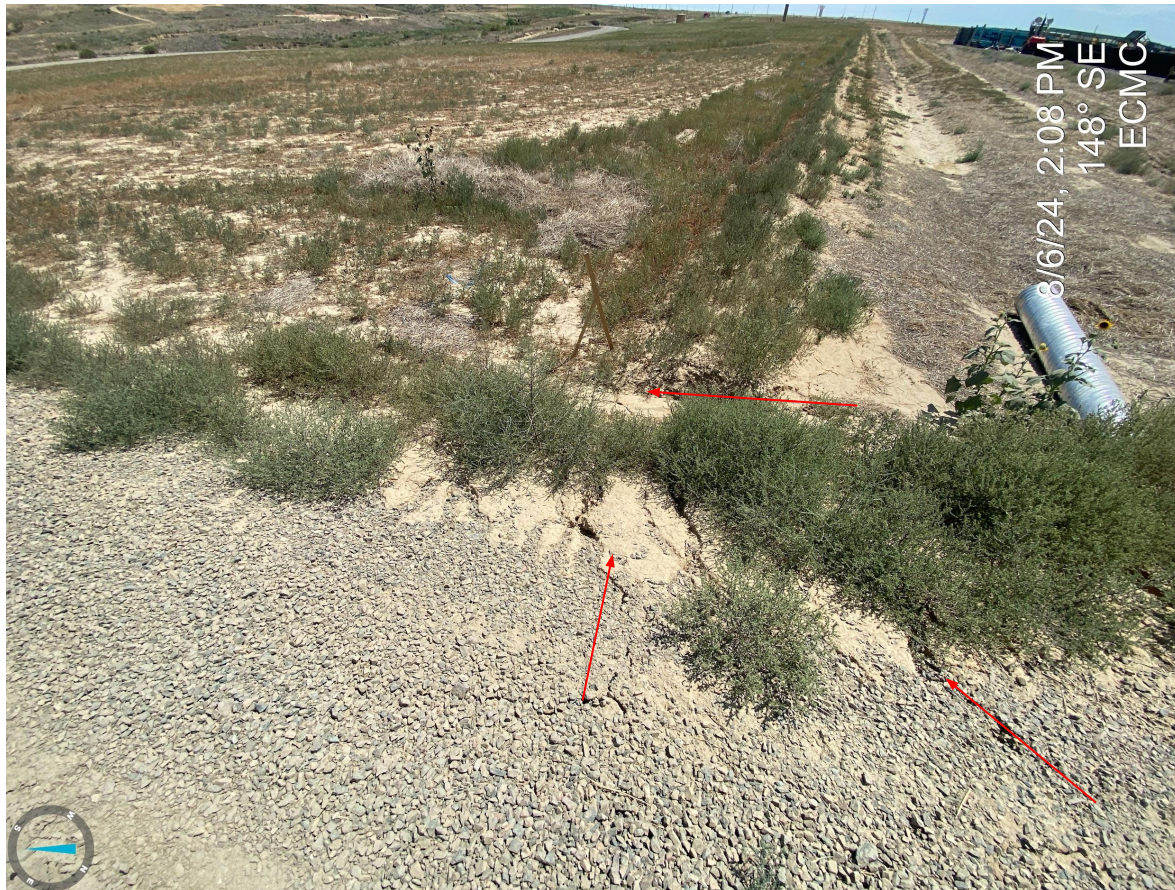
**Photo 8.** Continued from Photo 7; facing southeast.

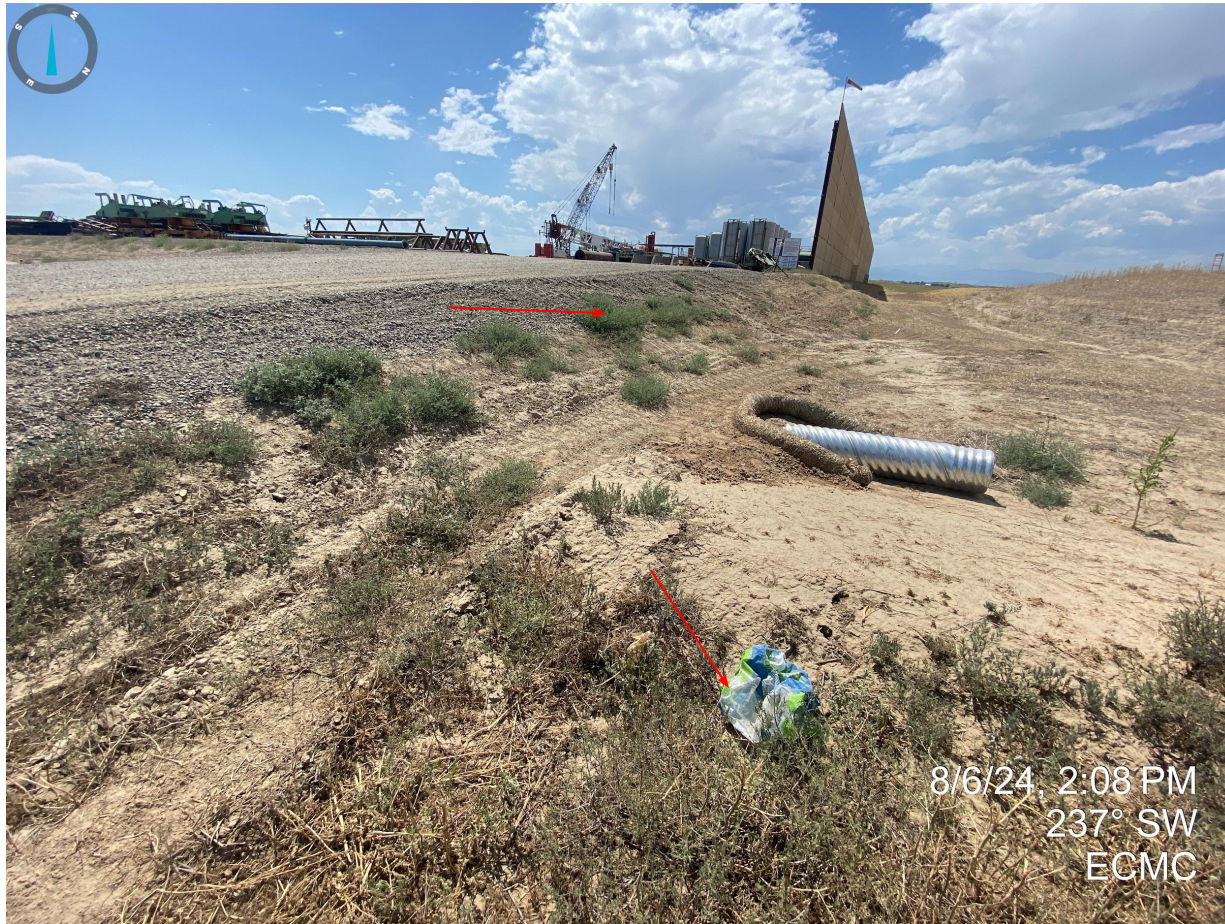
**Photo 9.** Example of trash and undesirable vegetation observed near the location entrance.

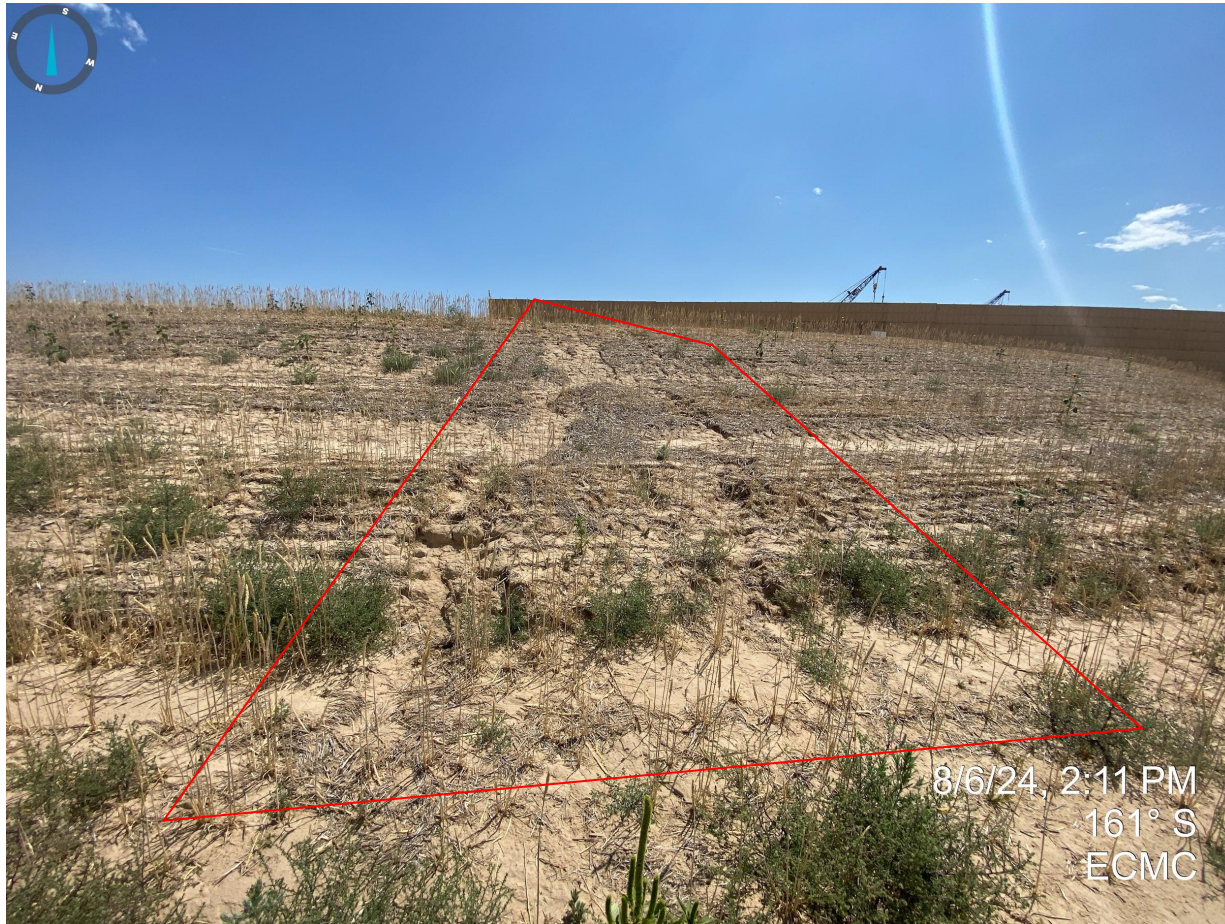
**Photo 10.** Erosion degradation and undesirable vegetation observed at the topsoil stockpile.

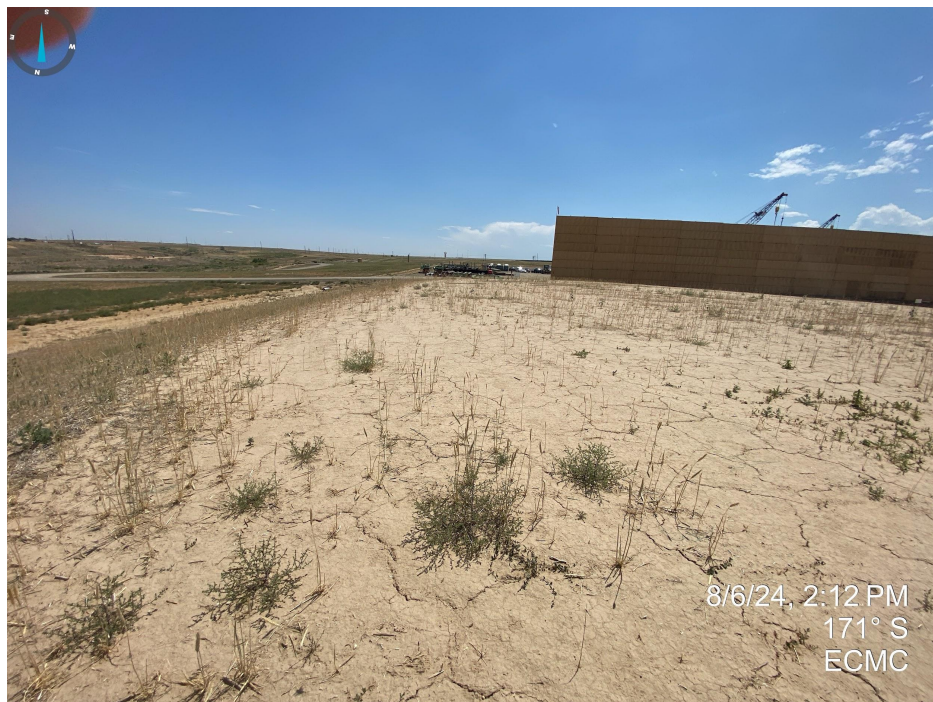
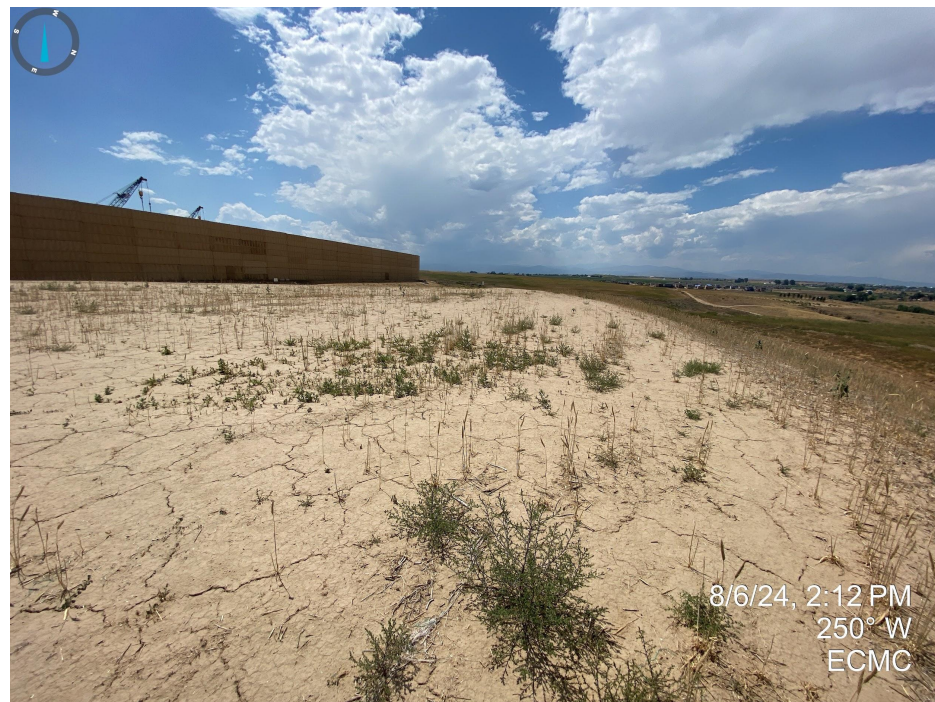
**Photos 11 & 12.** Taken from the northeast corner of the topsoil stockpile. Additional stabilization BMPs are required as the stockpile is predominantly exposed/bare soil.

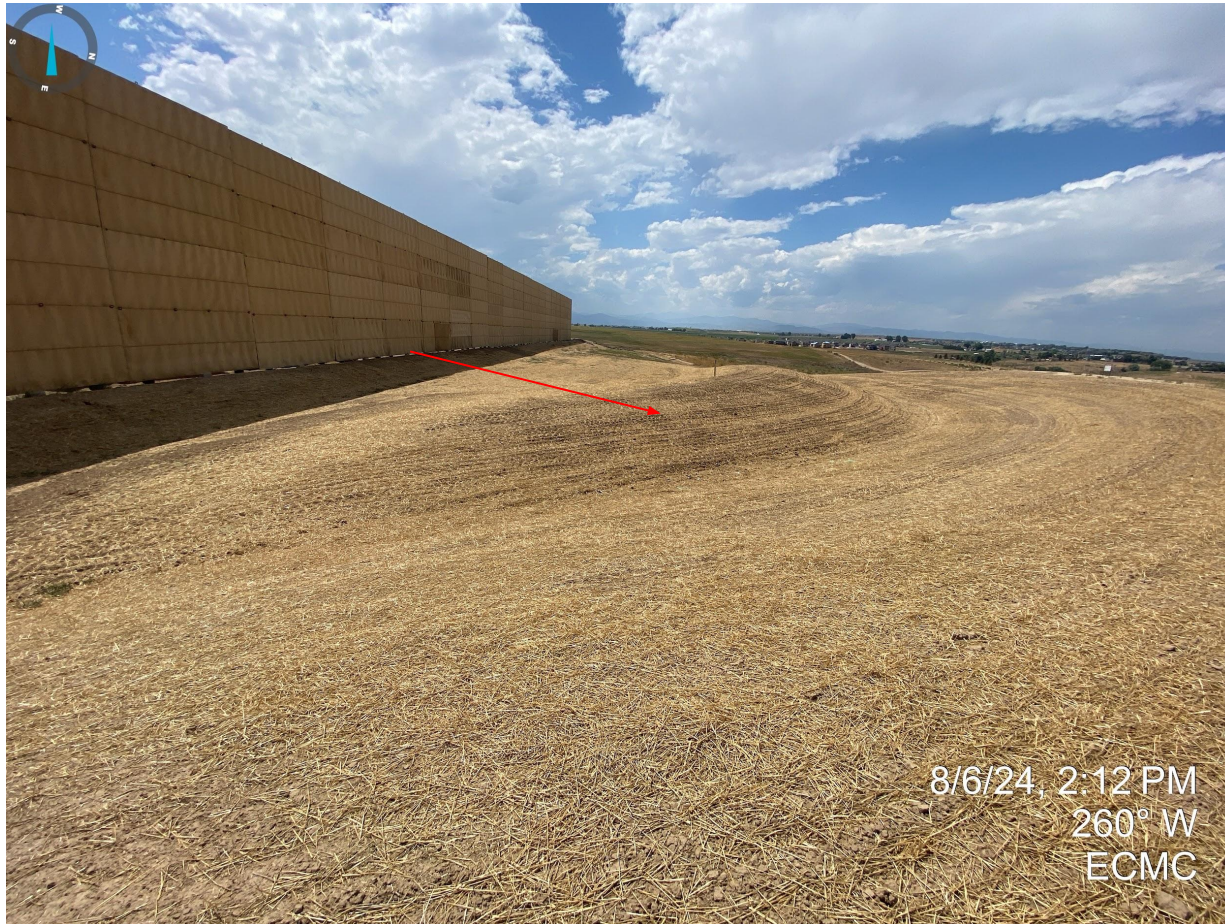
**Photo 13.** Imported topsoil stockpile appears to have been seeded with straw crimped mulch for stabilization.

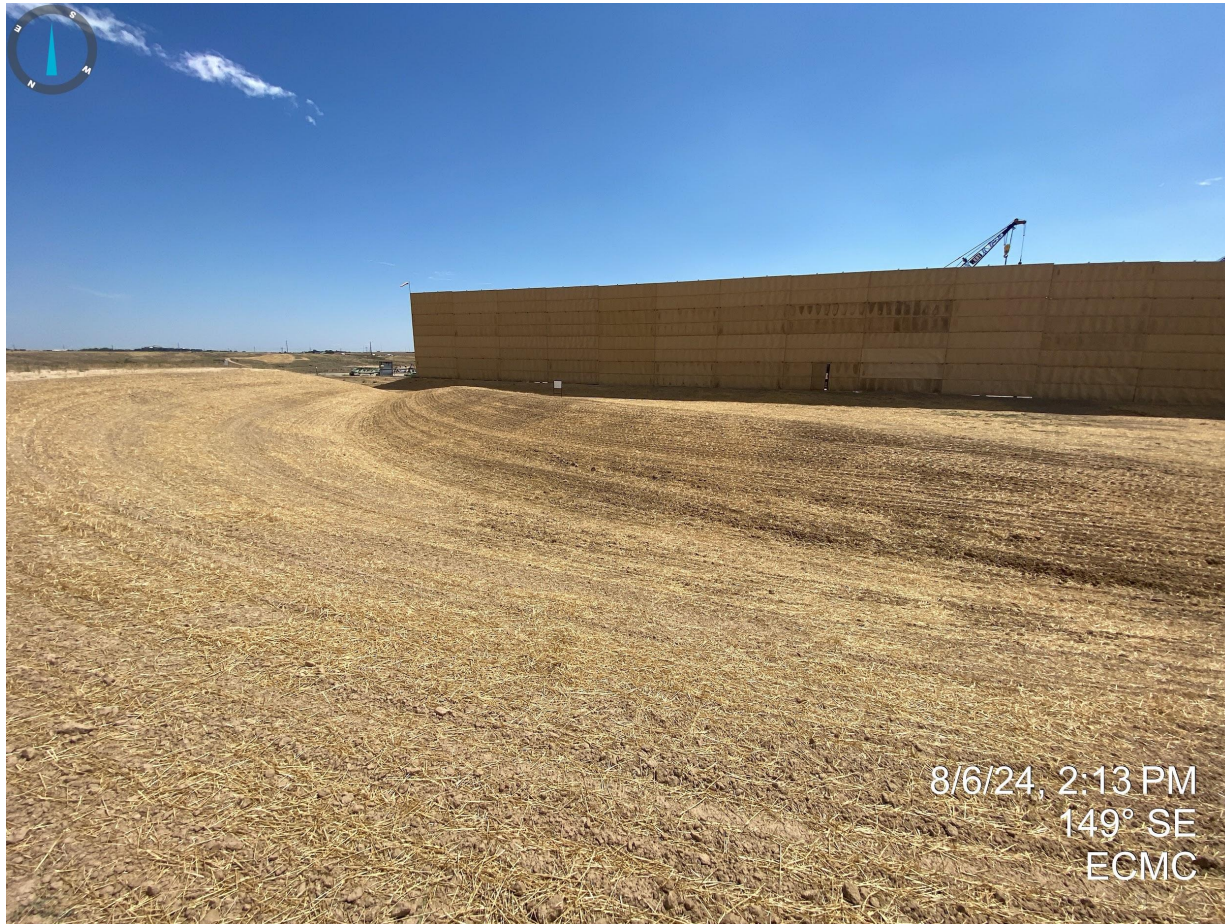
**Photo 14.** Continued from Photo 13; facing southeast.

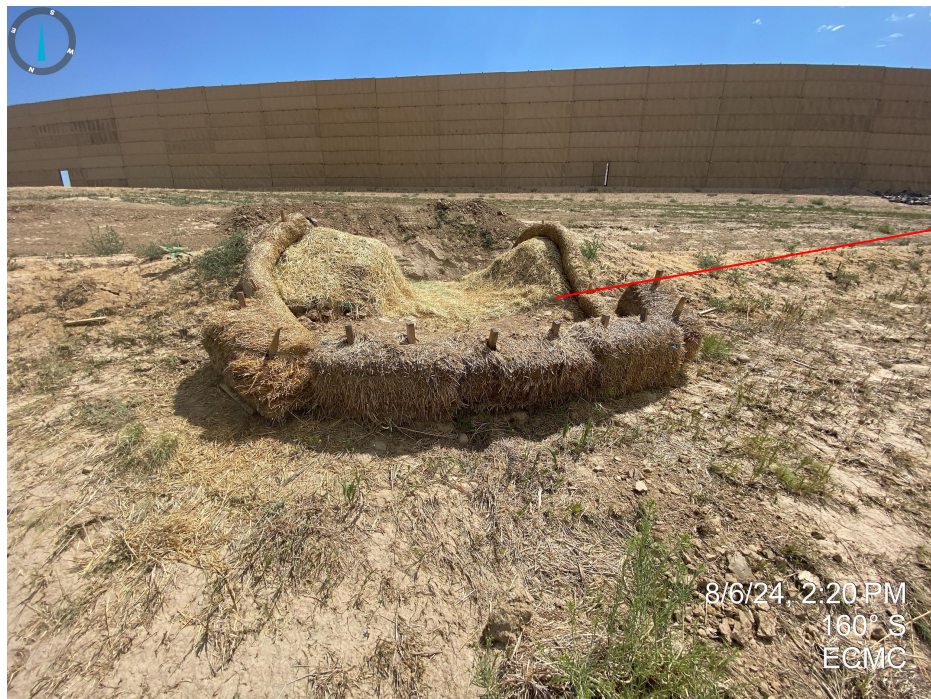
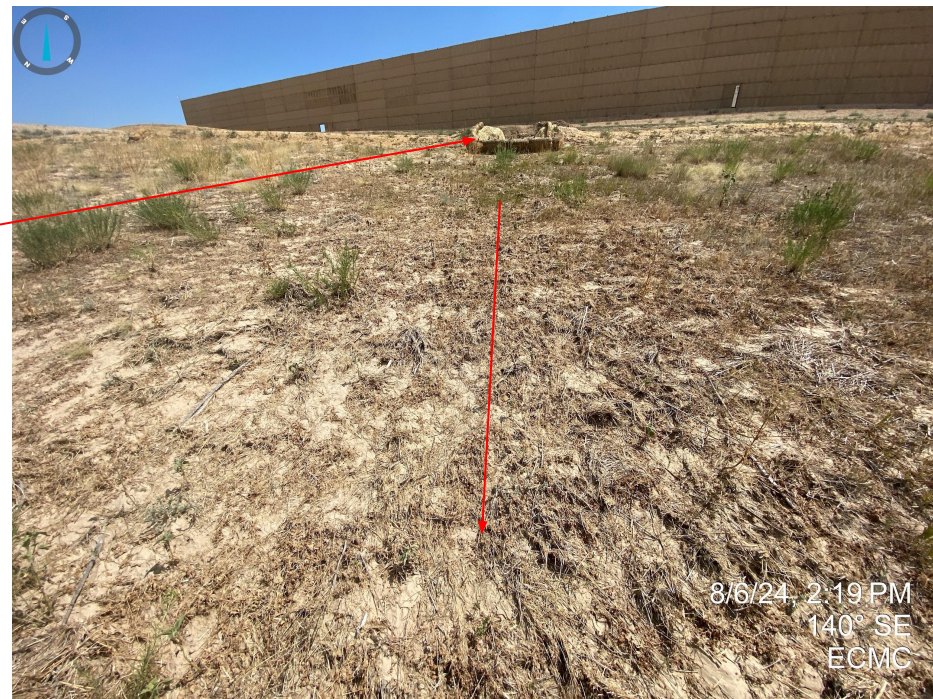
**Photo 15 & 16.** Taken near the northern portion of the construction area. Evidence of off location sediment transport observed near one of the sediment traps.

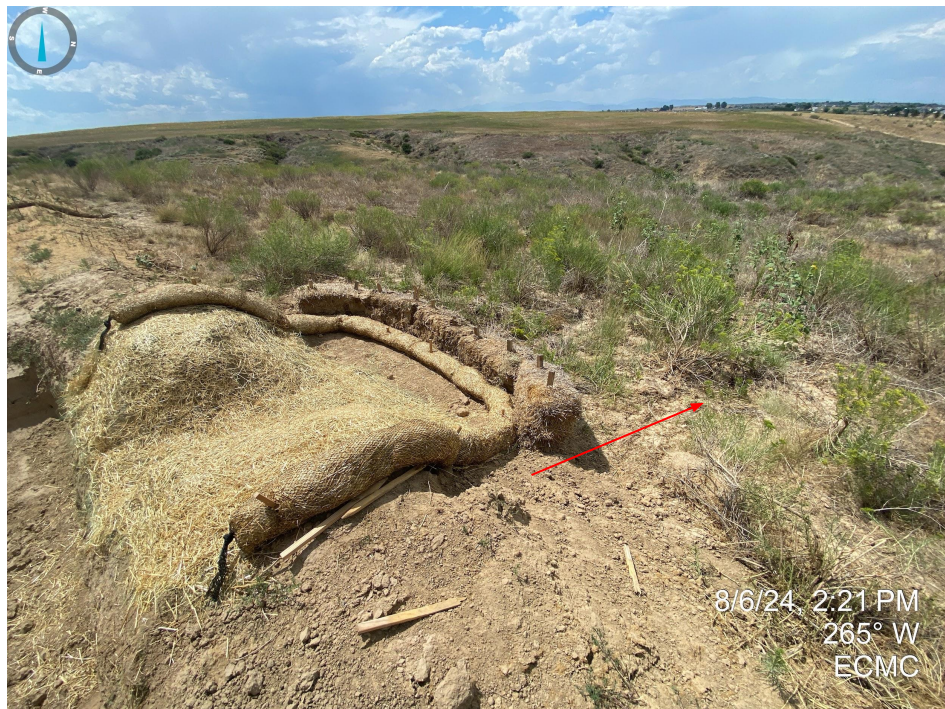
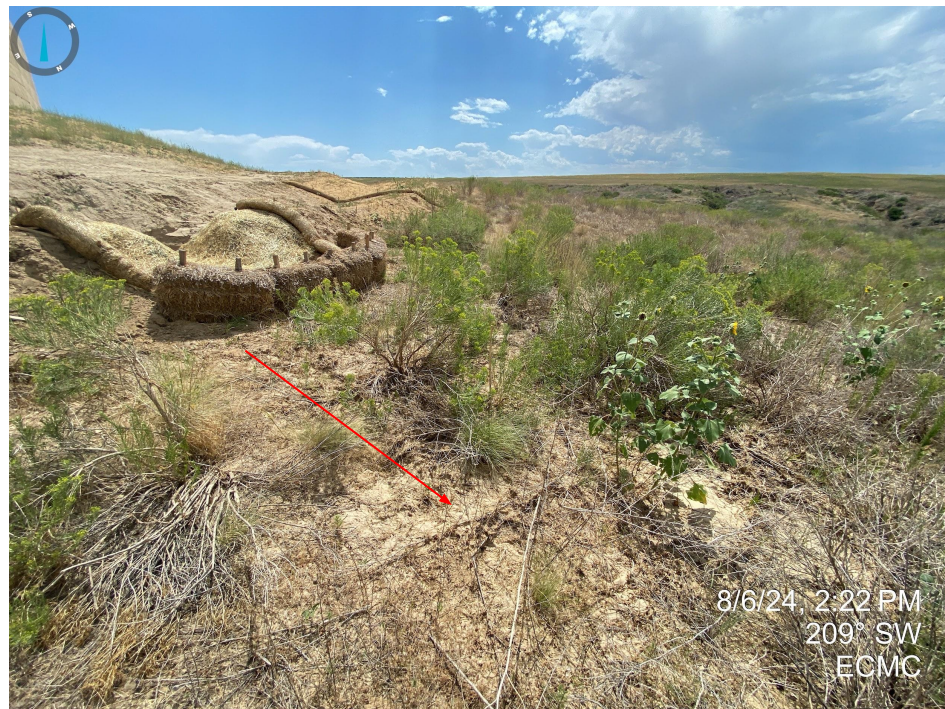
**Photos 17 & 18.** Taken near the northern portion of the construction area. Evidence of off location sediment transport observed near one of the sediment traps.

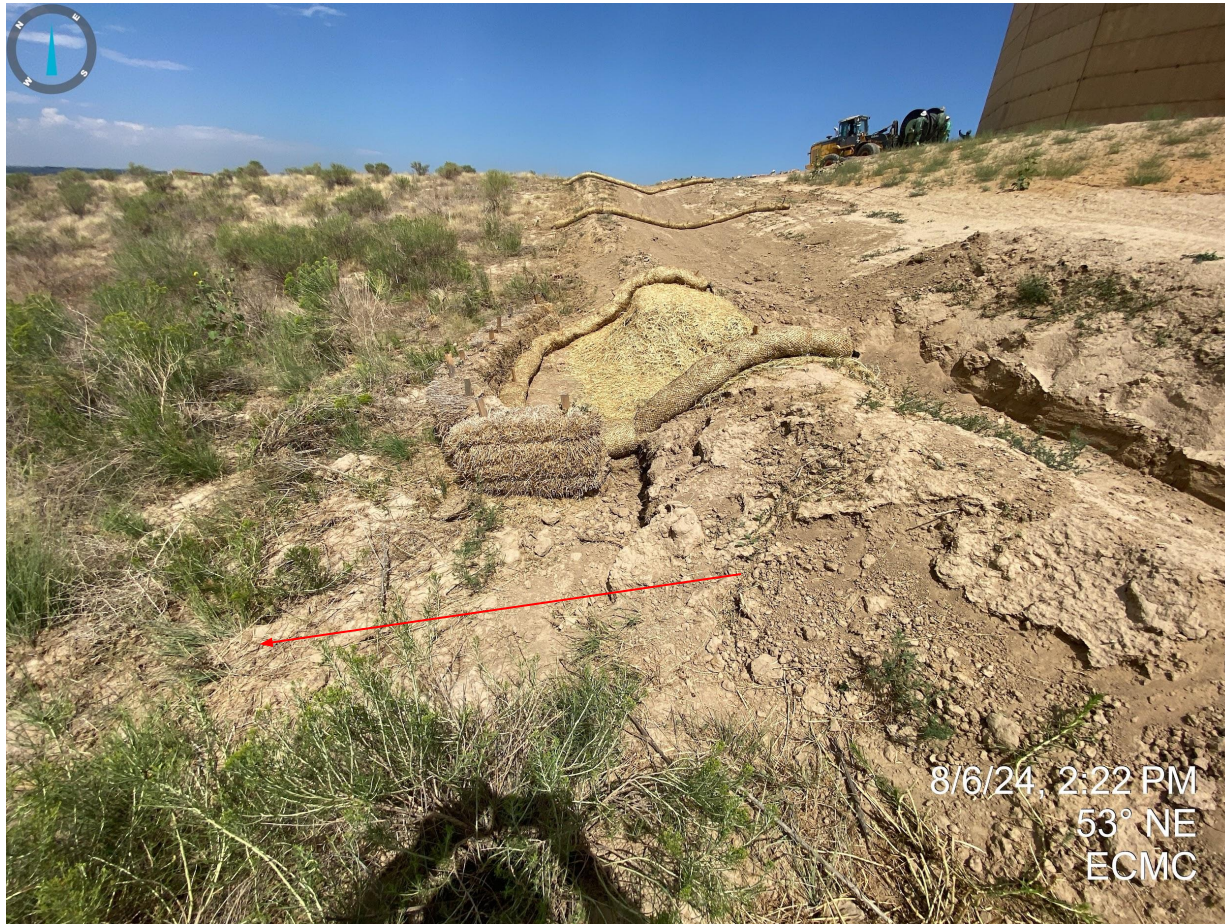
**Photo 19.** Continued from Photos 17 & 18; facing northeast.

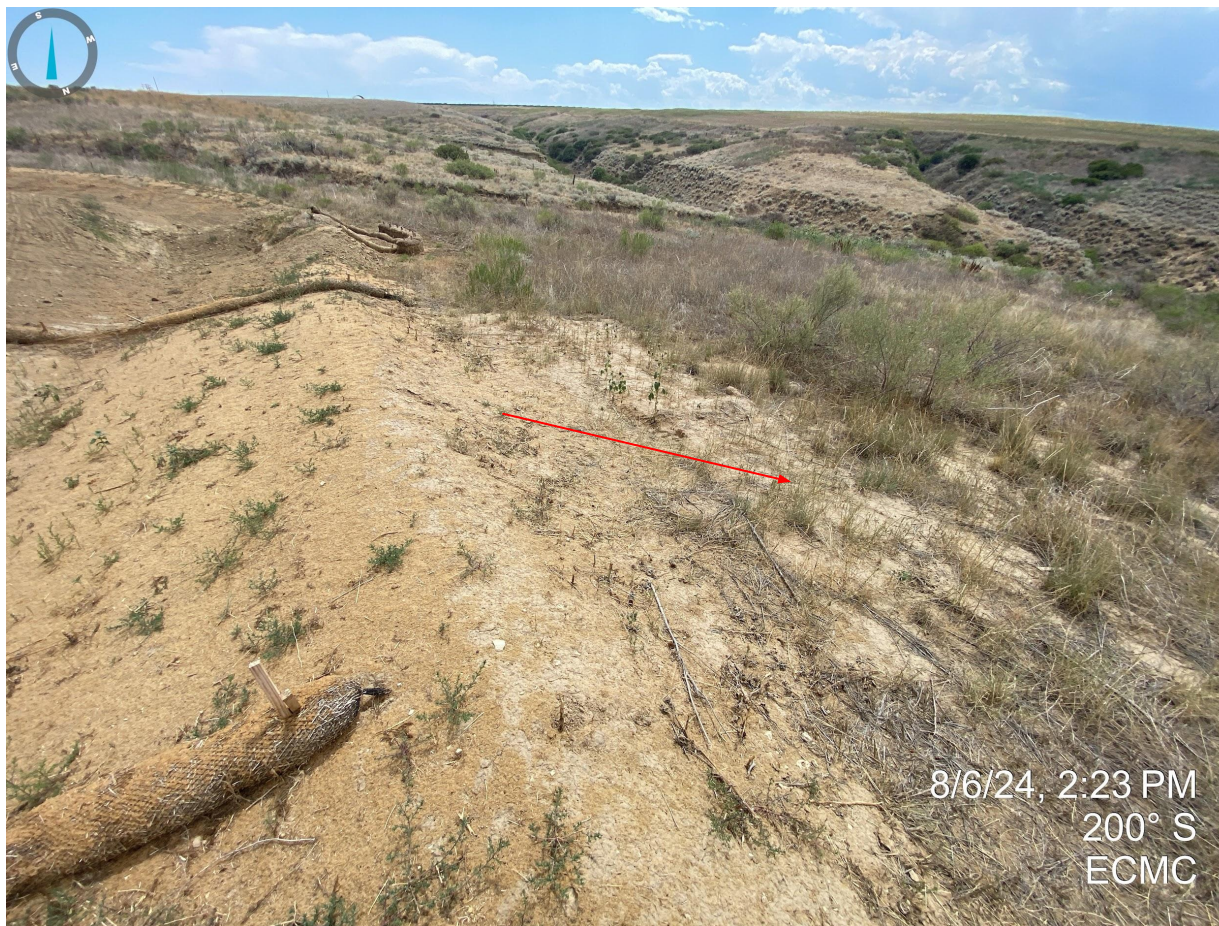
**Photo 20.** Taken near the northwestern portion of the construction area. Evidence of off location sediment transport observed along the exterior of the perimeter ditch and berm.

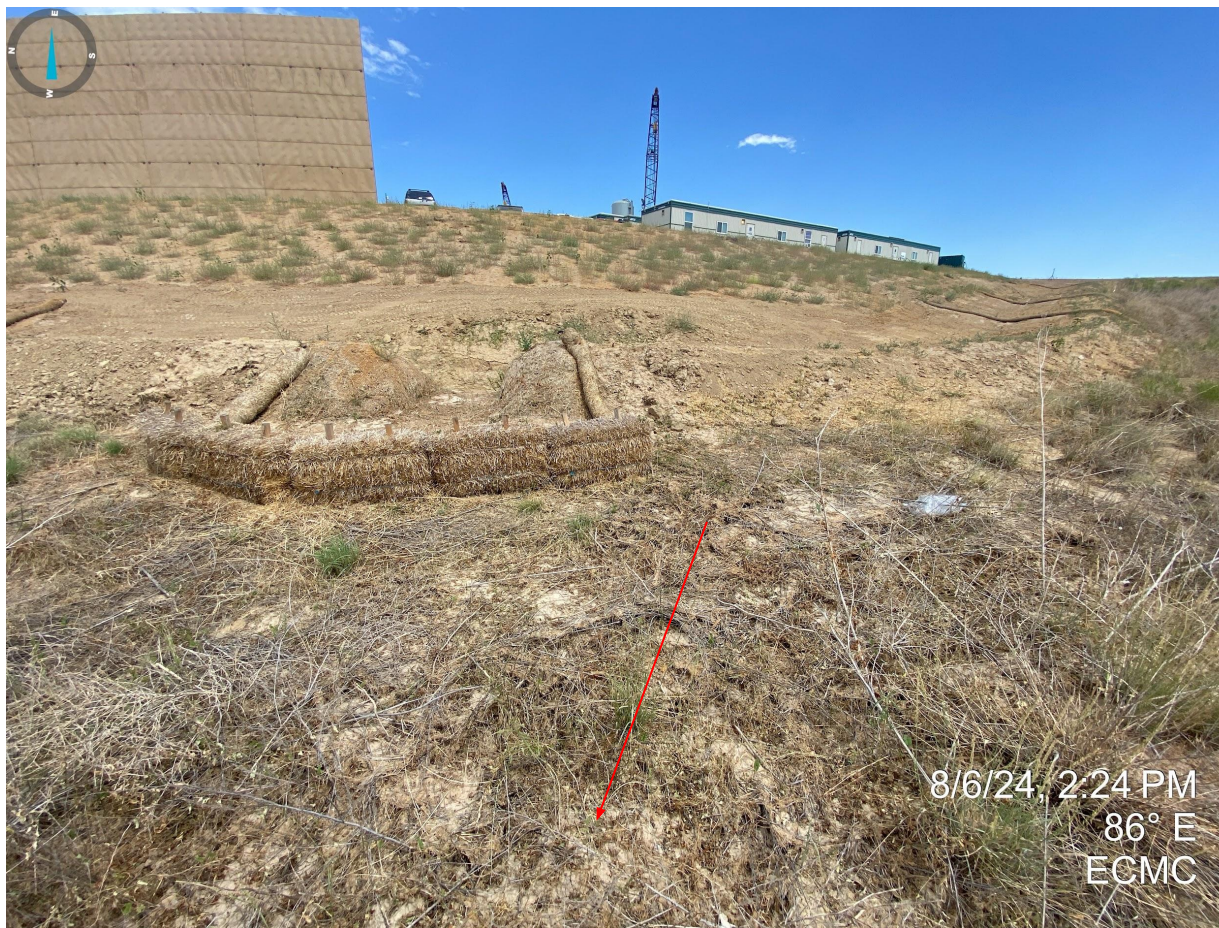
**Photo 21.** Taken near the northwestern portion of the construction area. Evidence of off location sediment transport observed near one of the sediment traps.

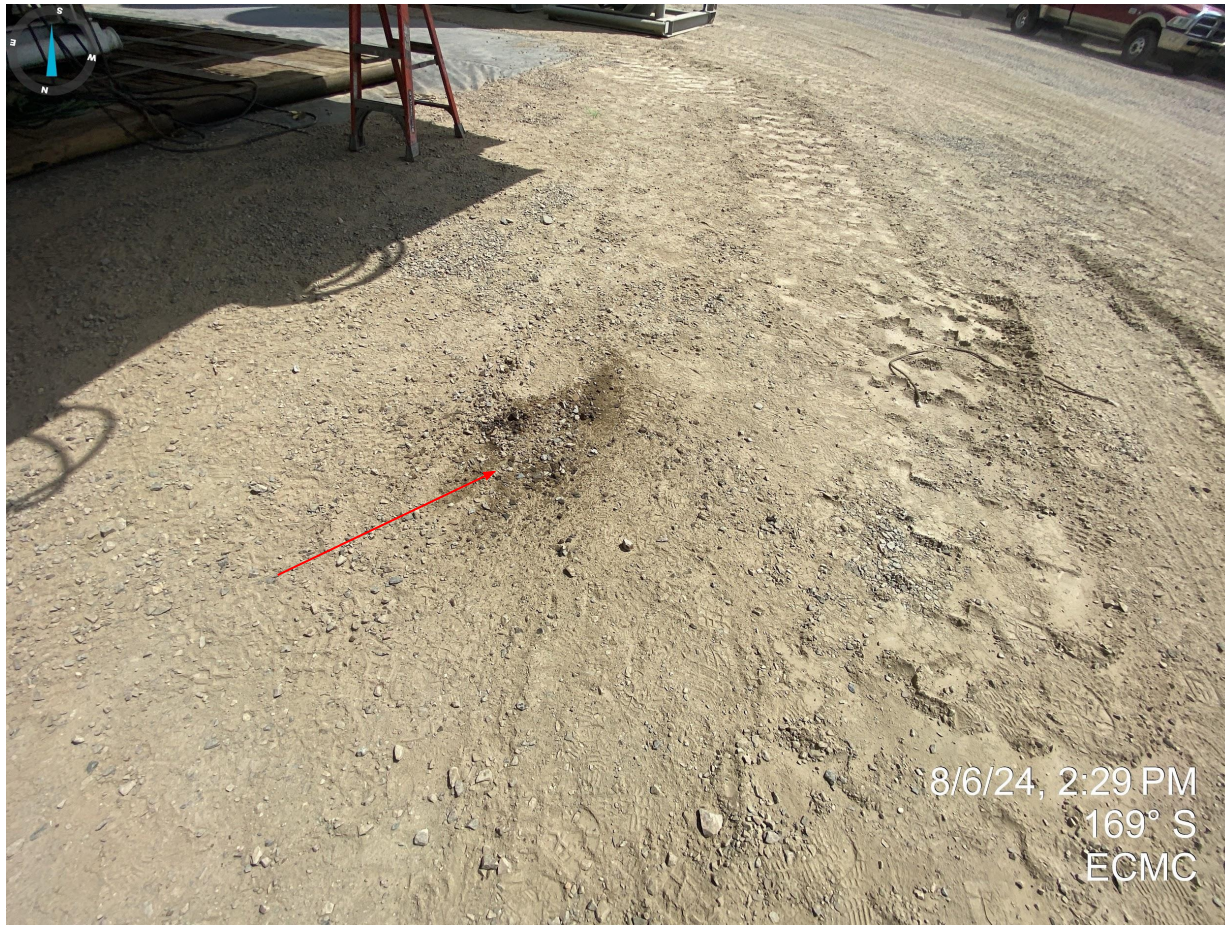
**Photo 22.** Stained soil observed near drilling rig.
