## Inspection Photos

Location Name: TEP ROCKY MOUNTAIN LLC CLOUGH 2-27 RMV

Location ID: 311537

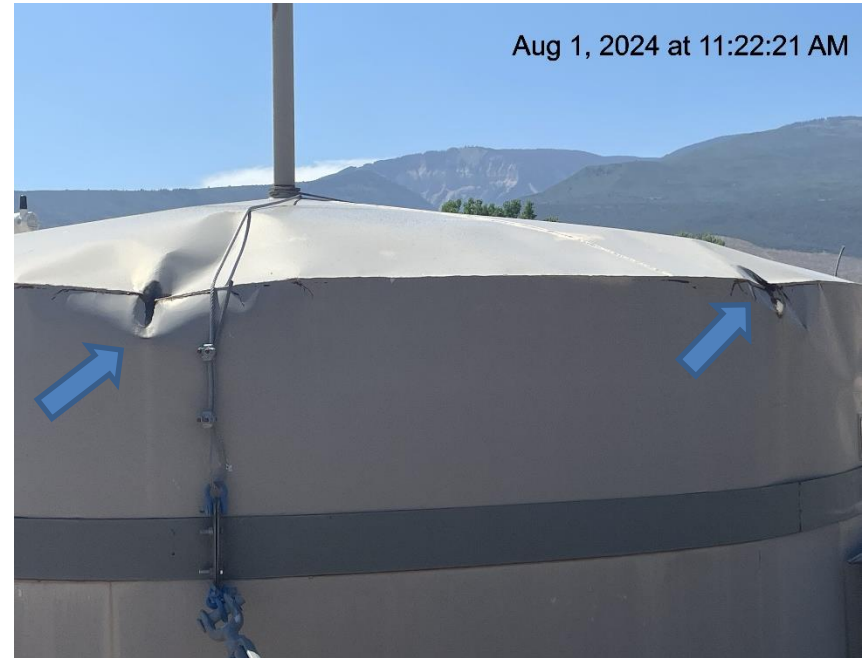
Photo # 4354 Production tank damaged

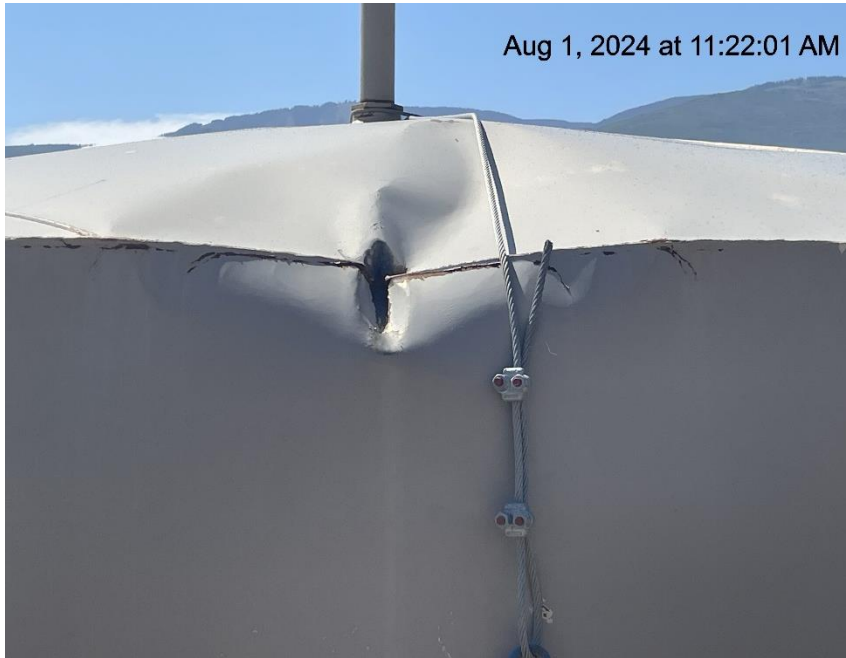
Photo # 4355 Production tank damaged

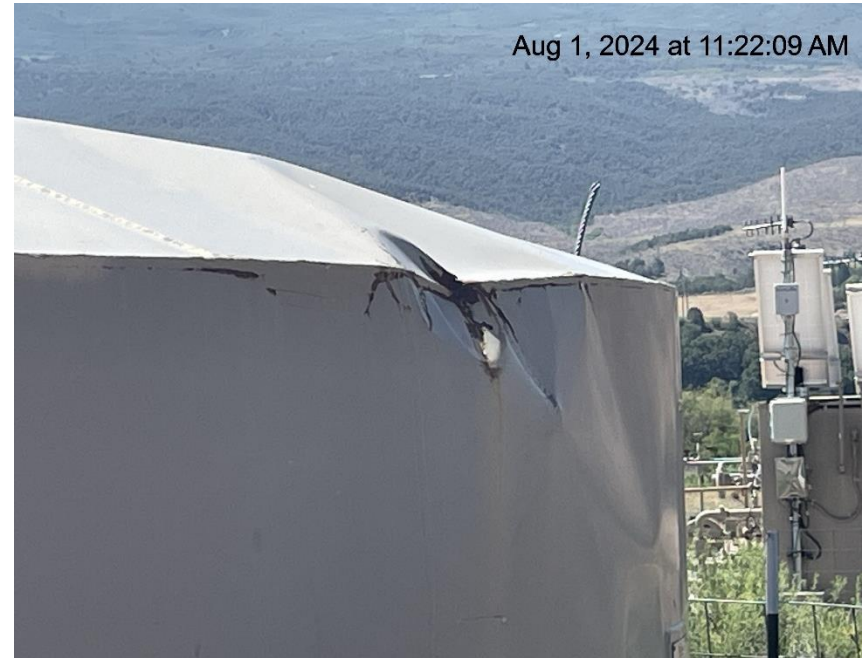
Photo # 4356 Production tank damaged
