# Inspection Photos

Operator: Hilcorp Energy Company - 10133

Location ID: 326093

Inspection Photos  
Location Name: Carter Ute 107  
Location ID: 326093

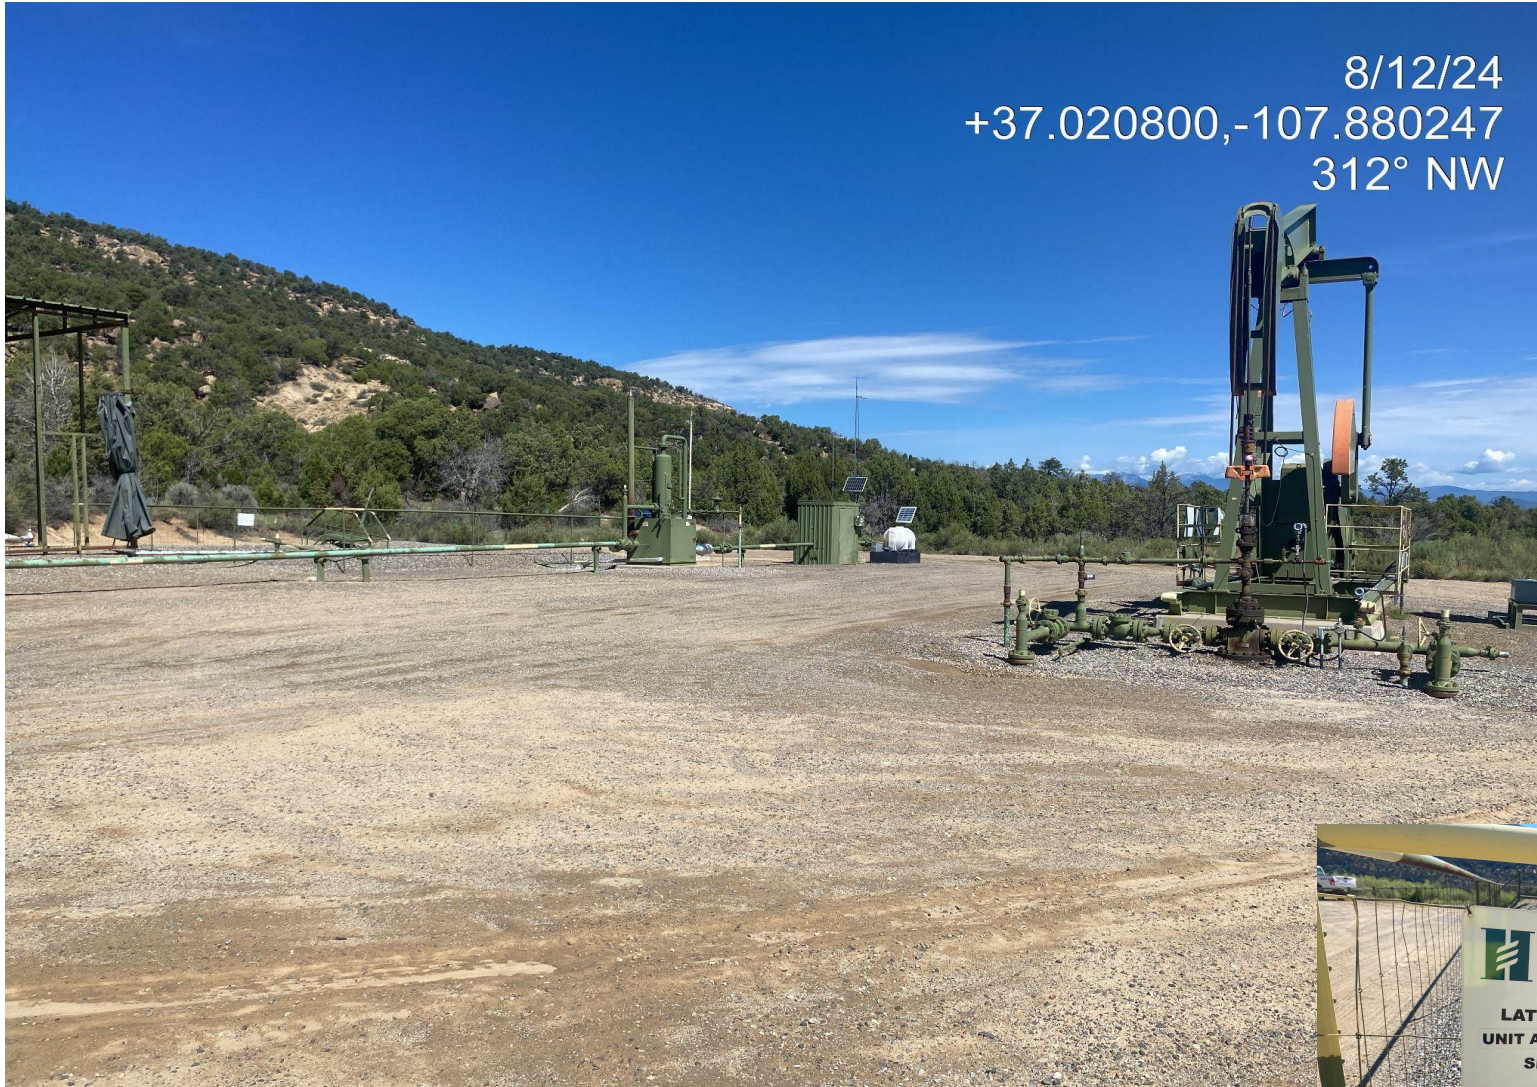
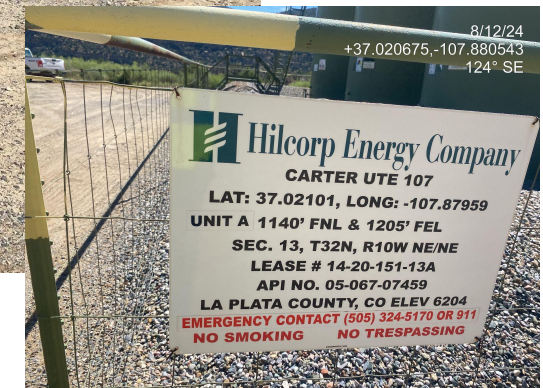
Photo 1. View of the location taken from the access point facing center.

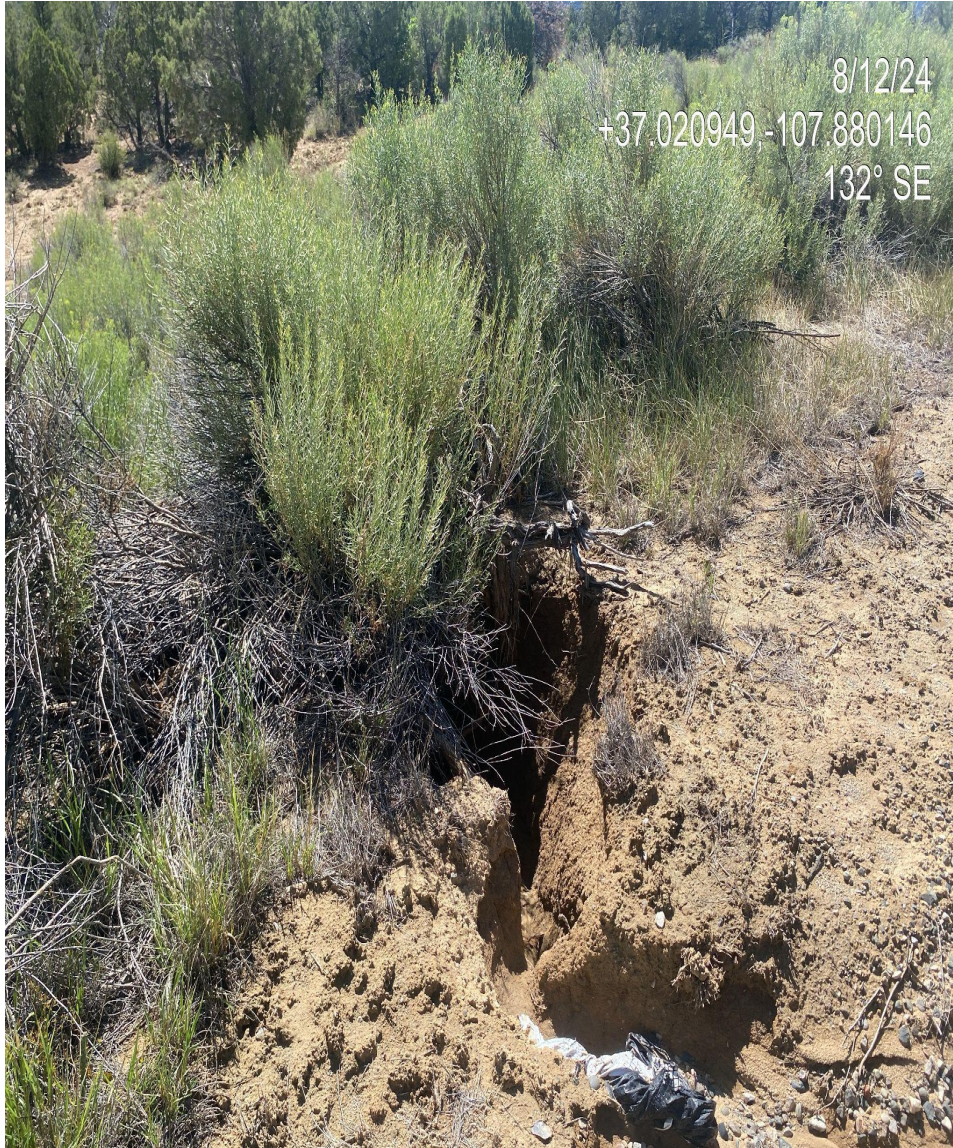
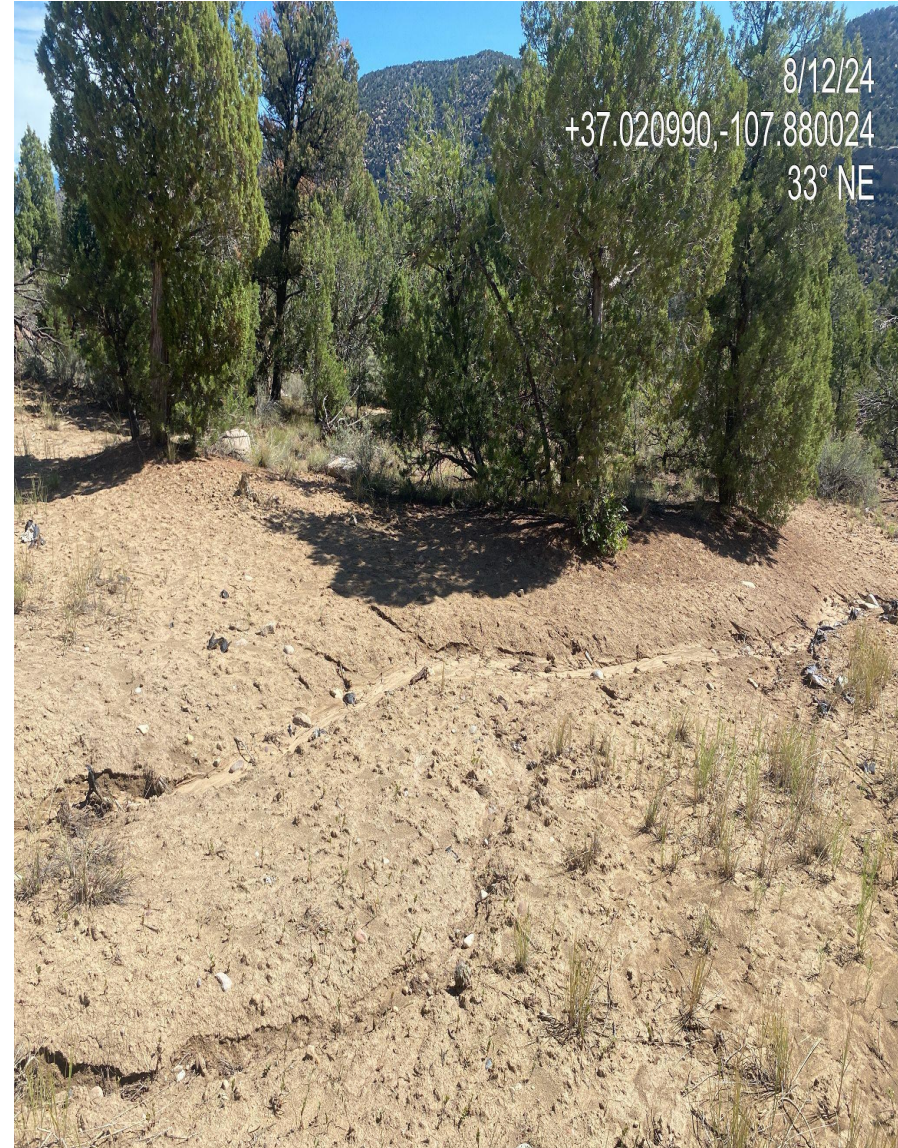
**Photo 2.** View of gully erosion head forming on the southern edge of the disturbance, with channelized flows running through the southern interim reclamation area and evidence of sediment transport off of the location.

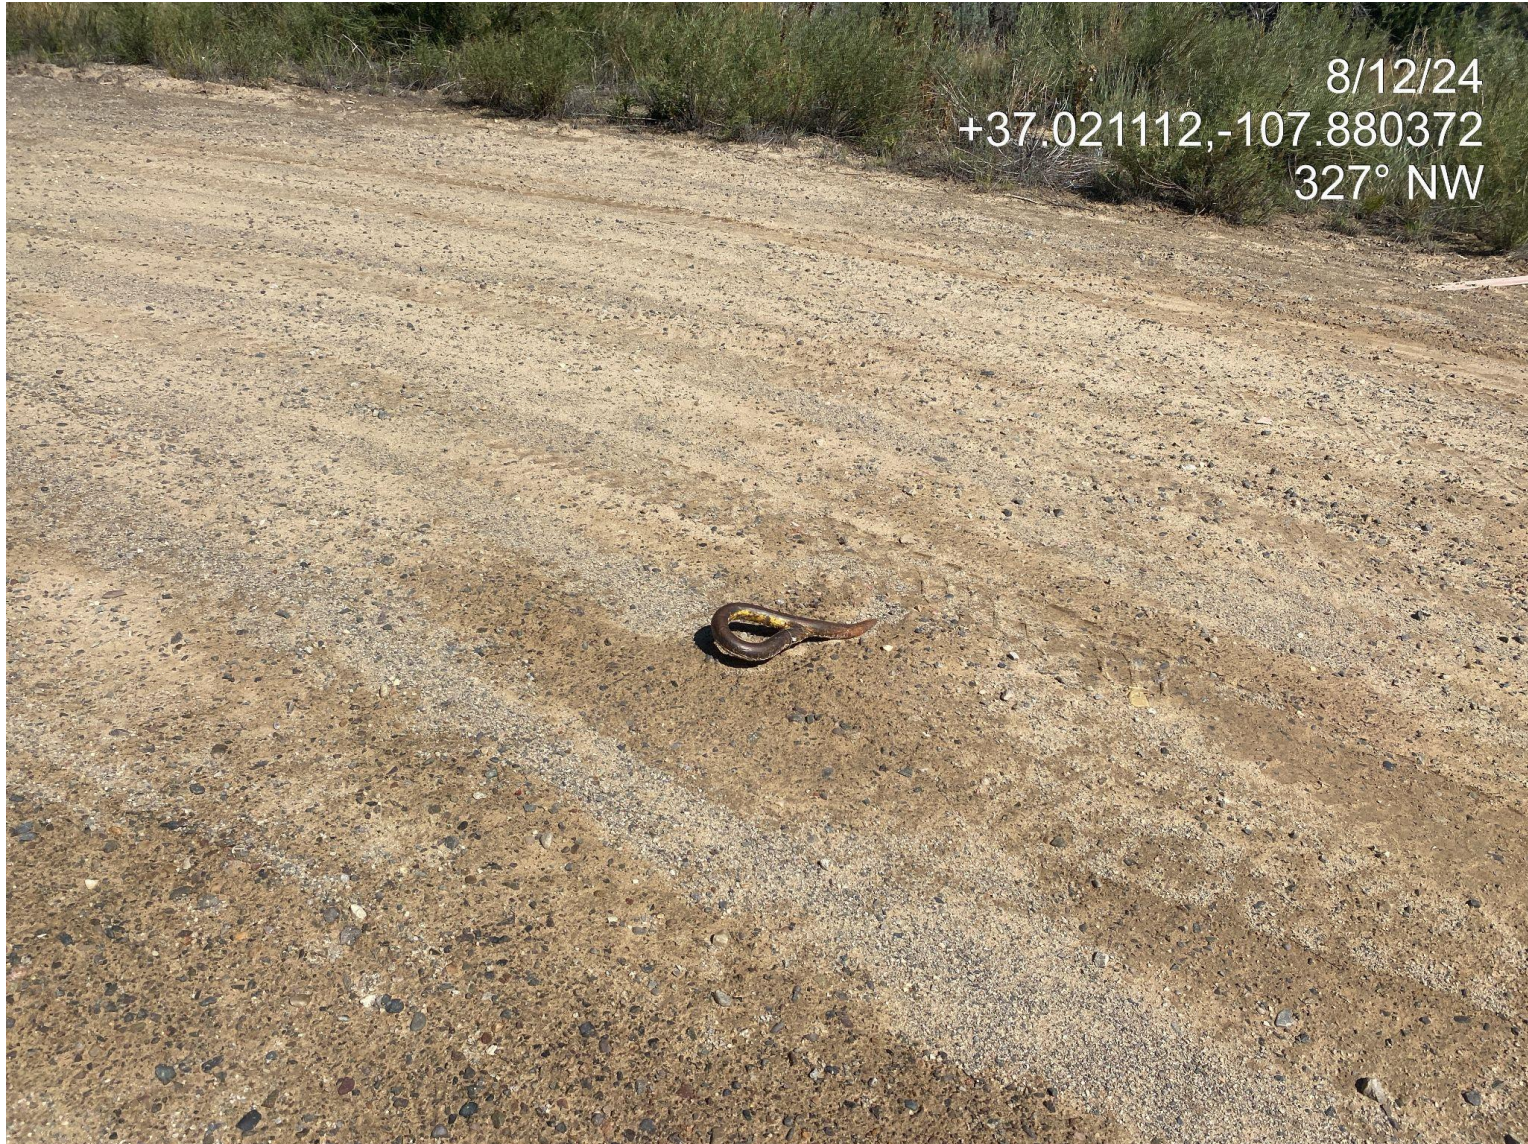
**Photo 3.** Unmarked guyline anchor on the active pad.

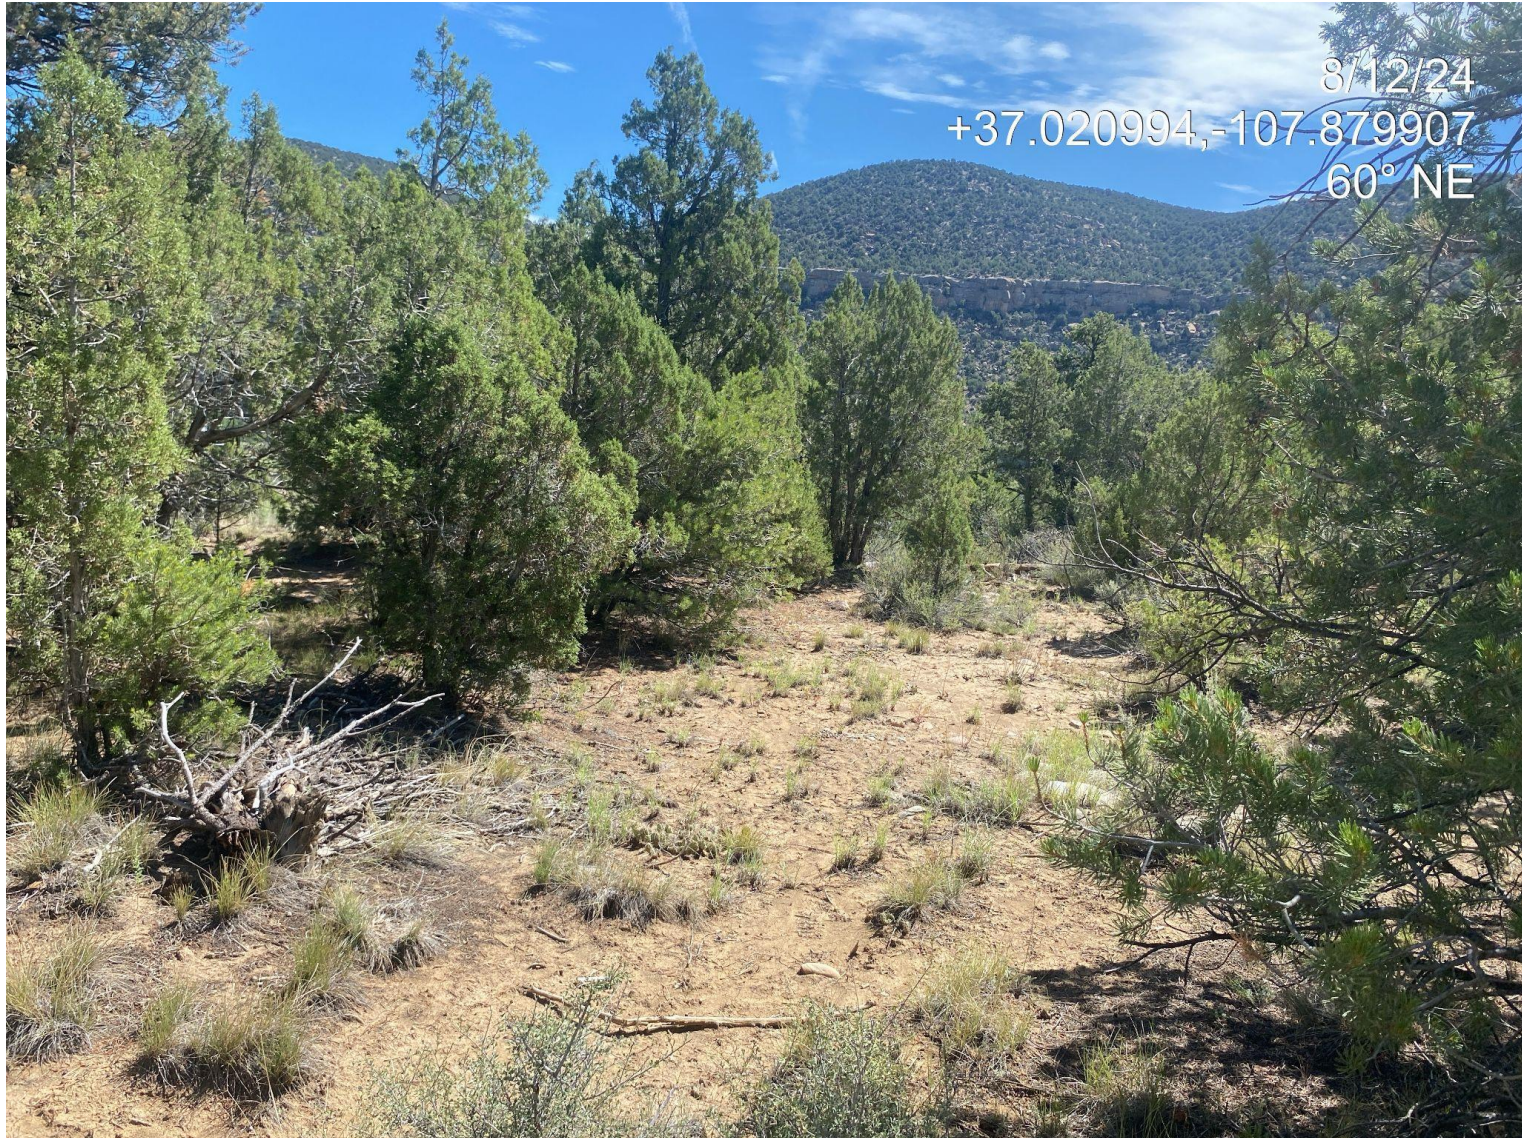
**Photo 4.** Reference area comprised of Juniper, Antelope bitterbrush and Indian ricegrass.
