# Inspection Photos

08/09/2024

**Operator:** TEP ROCKY MOUNTAIN LLC #96850

**Location ID:** 335467

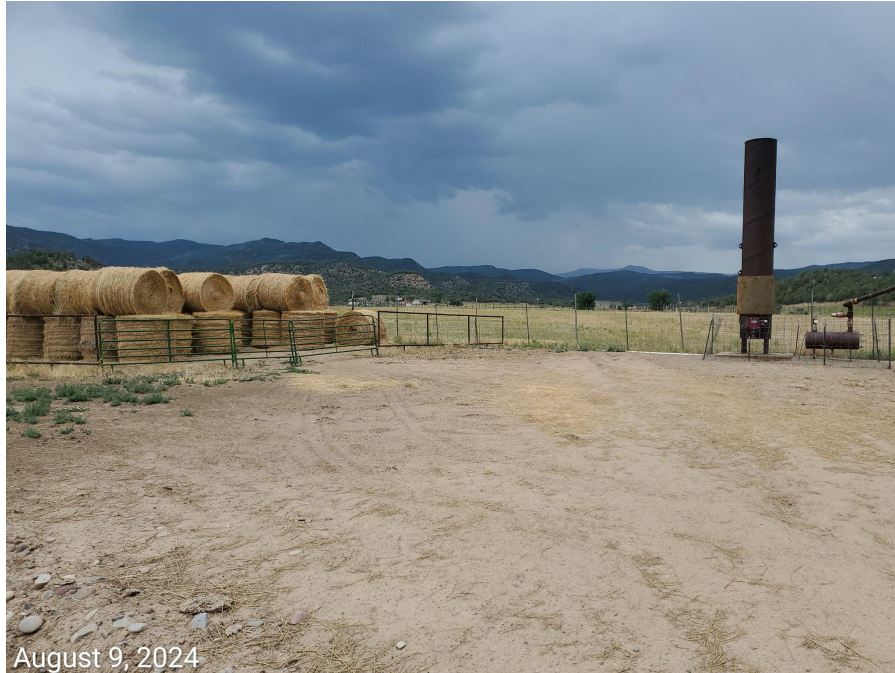
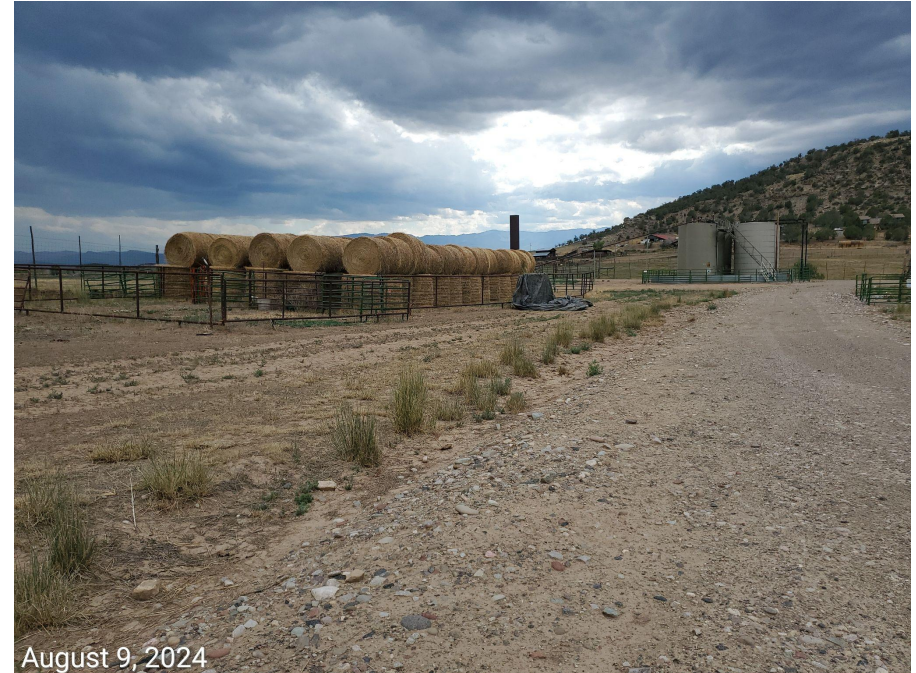
**Photo 1:** Photos show hay storage in close proximity of production equipment. Hay is currently being stored between two Locations: the GGU VAN ORDSTRAND-66S91W/30NESW Location (#335467) and the GIBSON GULCH UNIT-66S91W/30NESW Location (#335294)

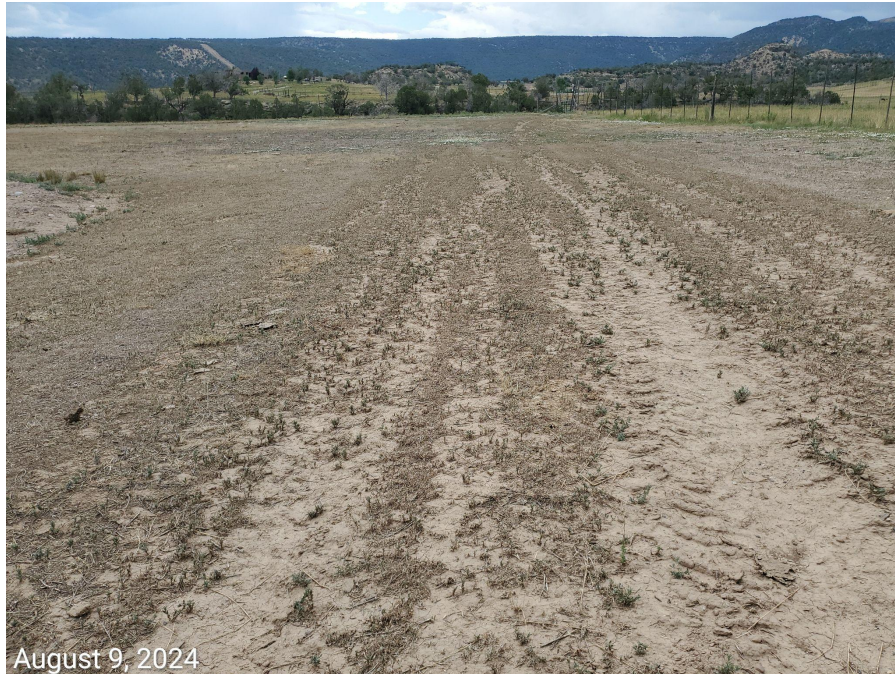
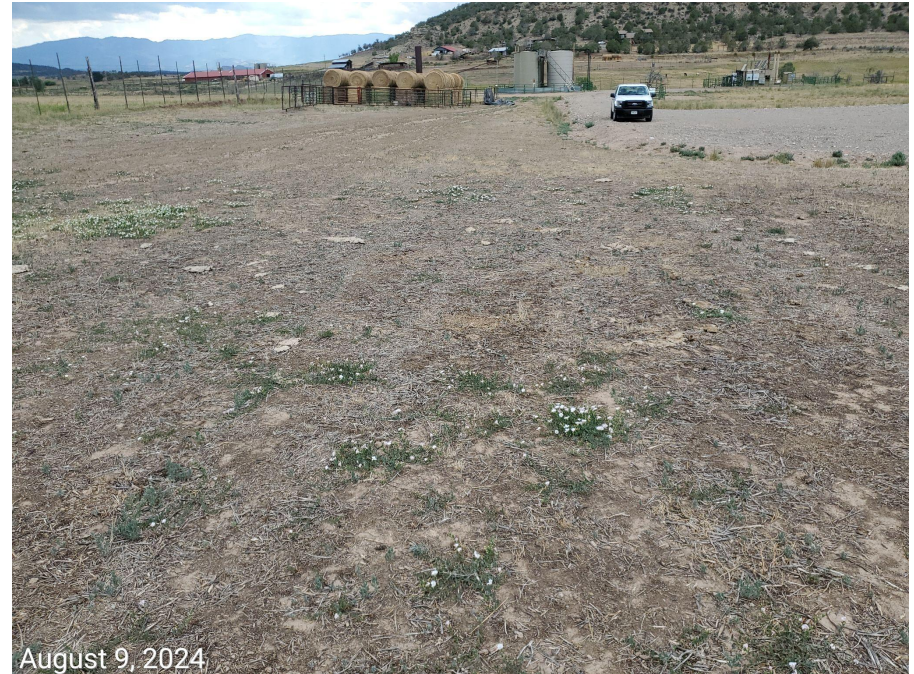
**Photo 2:** Photos 2-4 taken from the interim areas of the Location. Photos show that interim reclamation is not progressing towards ECMC 1003 Reclamation requirements; interim areas are predominantly bare, or vegetated by Undesirable Plant Species. Perennial establishment that was observed was sparse.

Noxious weed establishment, including Jointed Goatgrass and Field Bindweed observed throughout interim areas of the Location.

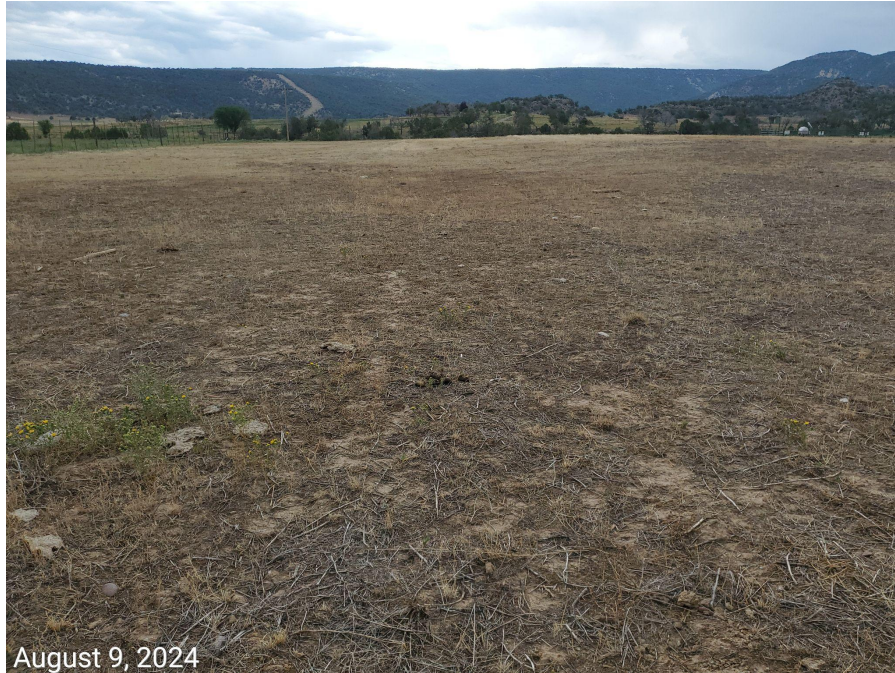
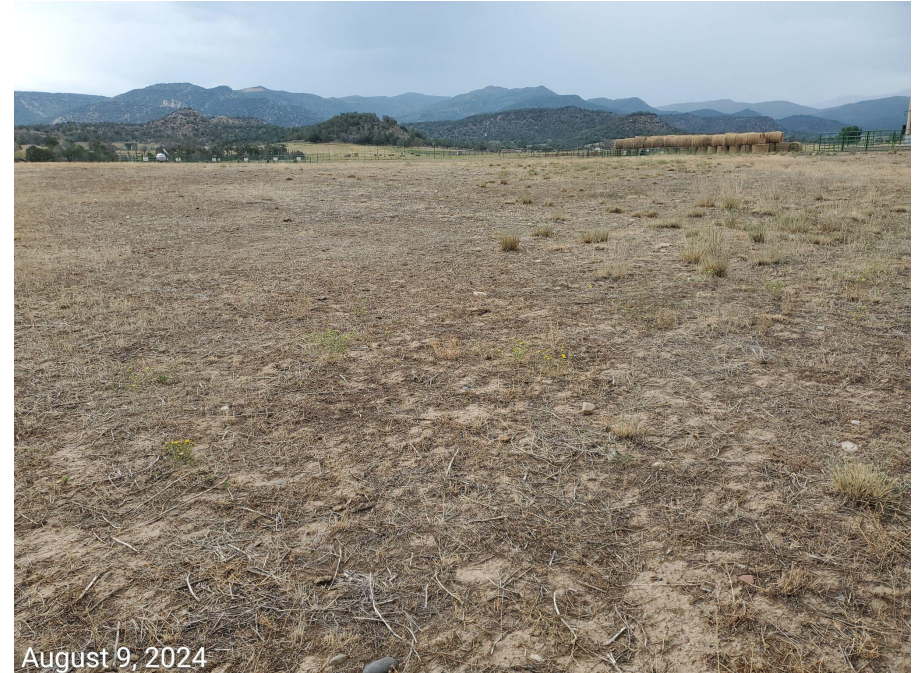
**Photo 3:** See comments under photo 2.

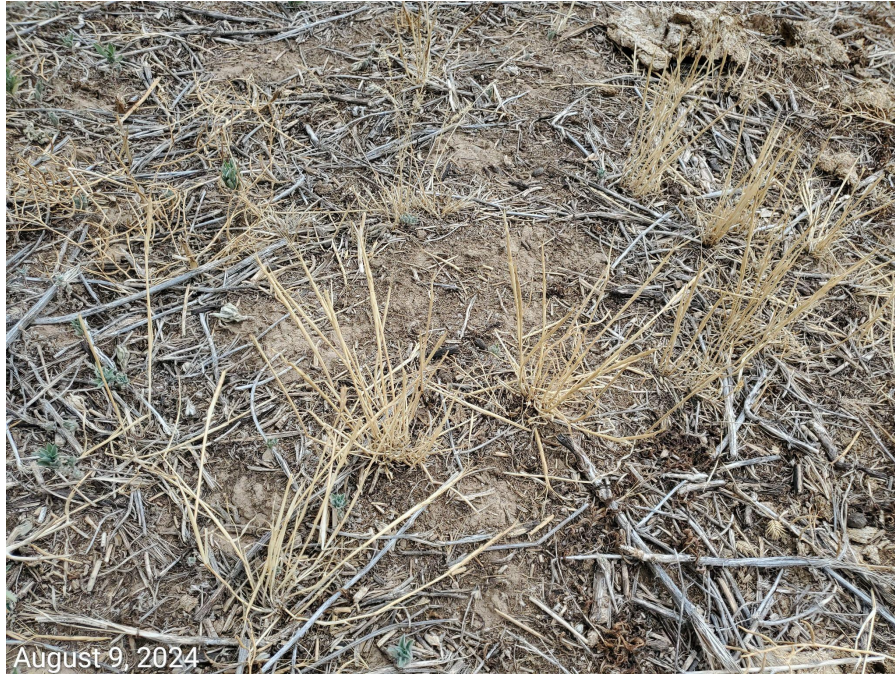
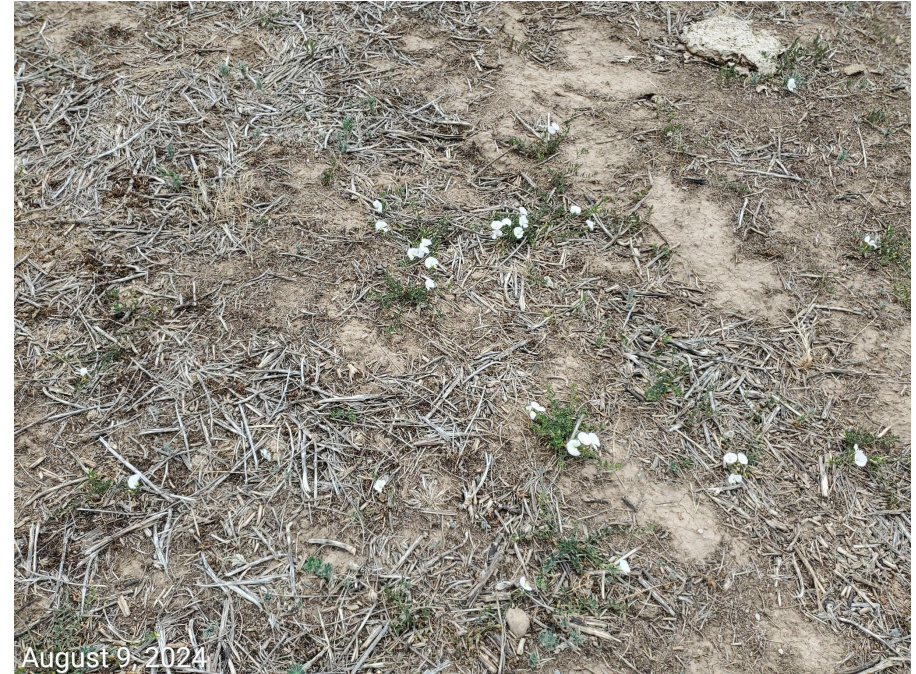
**Photo 4:** See comments under photo 2. Photo left example showing Jointed Goatgrass establishment on the interim areas; photo right example showing Field Bindweed.

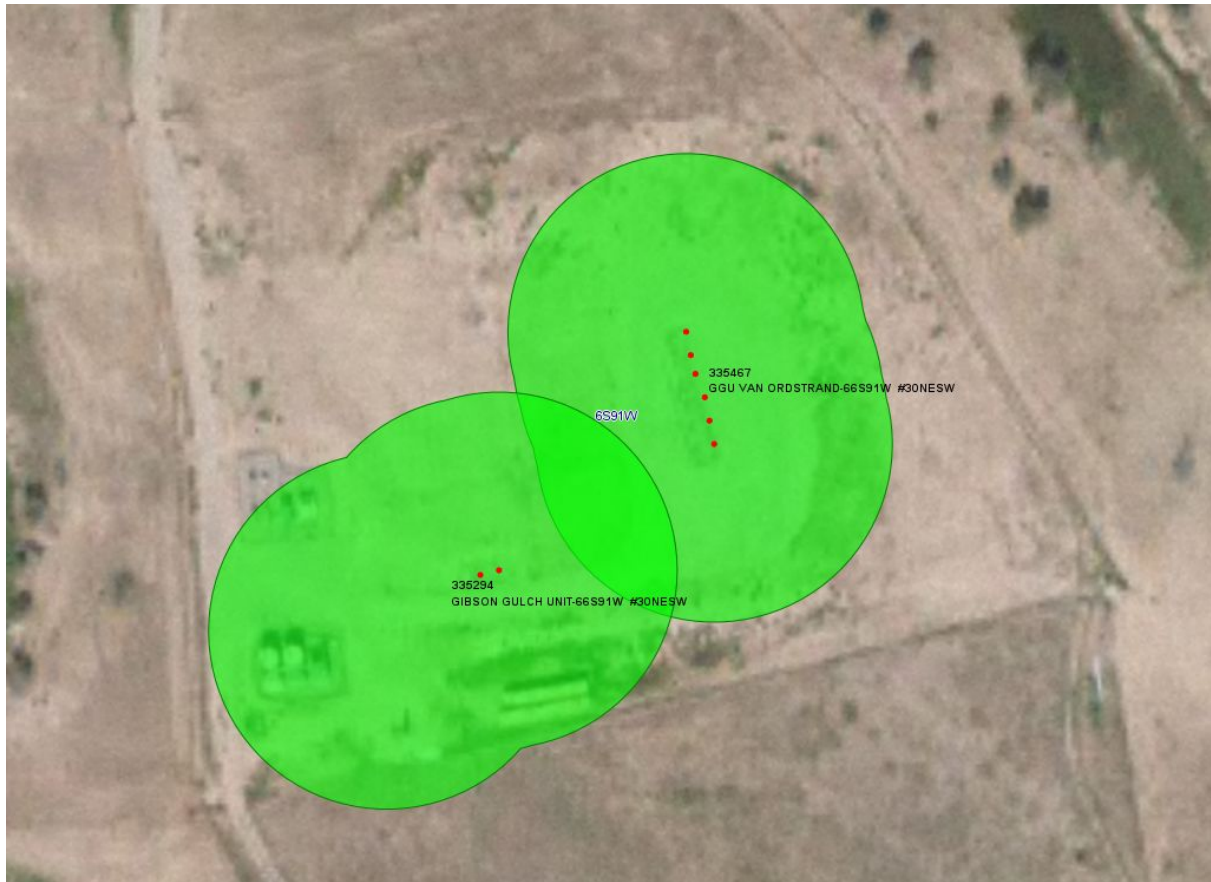
**Photo 5:** ECMC COGIS imagery. Photo shows flowline systems registered in the area; no Off-location flowlines have been registered at the VAN ORDSTRAND Location; no other facilities exist on the Location; flowlines from the wells likely travel off-location to the tank facility on the GIBSON GULCH UNIT-66S91W/30NESW (#335294), to the west of the Van Ordstrand Location (#335467).
