Inspection Photos

Operator: TEP ROCKY MOUNTAIN LLC #96850

Location ID: 335264

Inspection Doc: 696206112

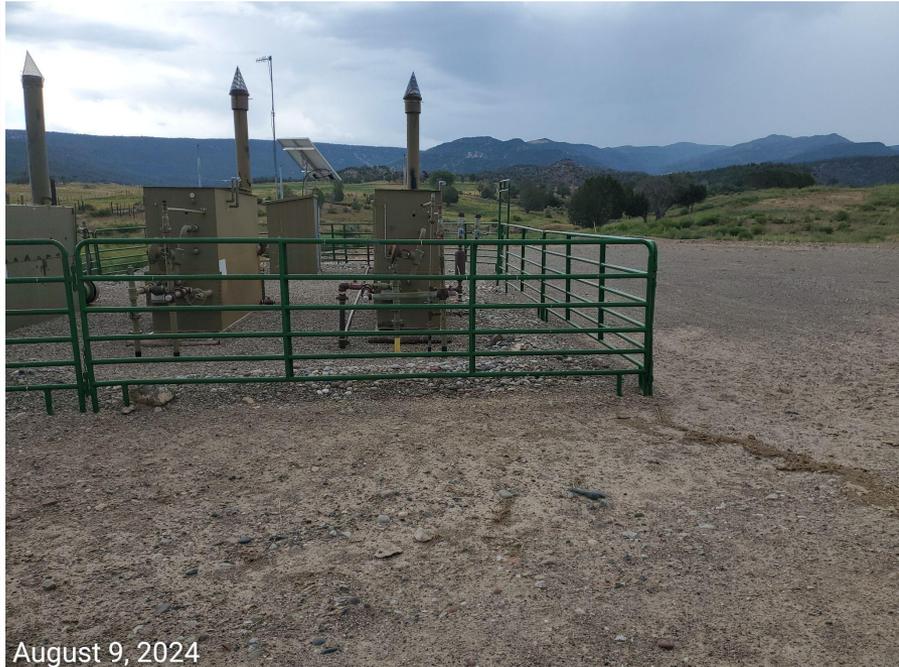
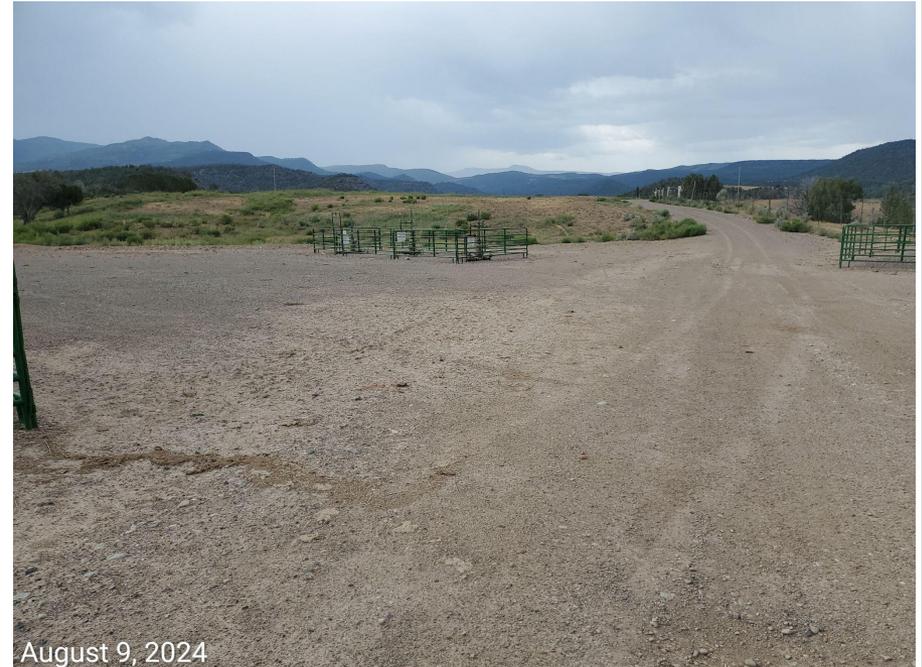
Photo 1: Photos 1-2 taken from the south end of the Location. Photos provide an overview from east, southeast, southwest to west.

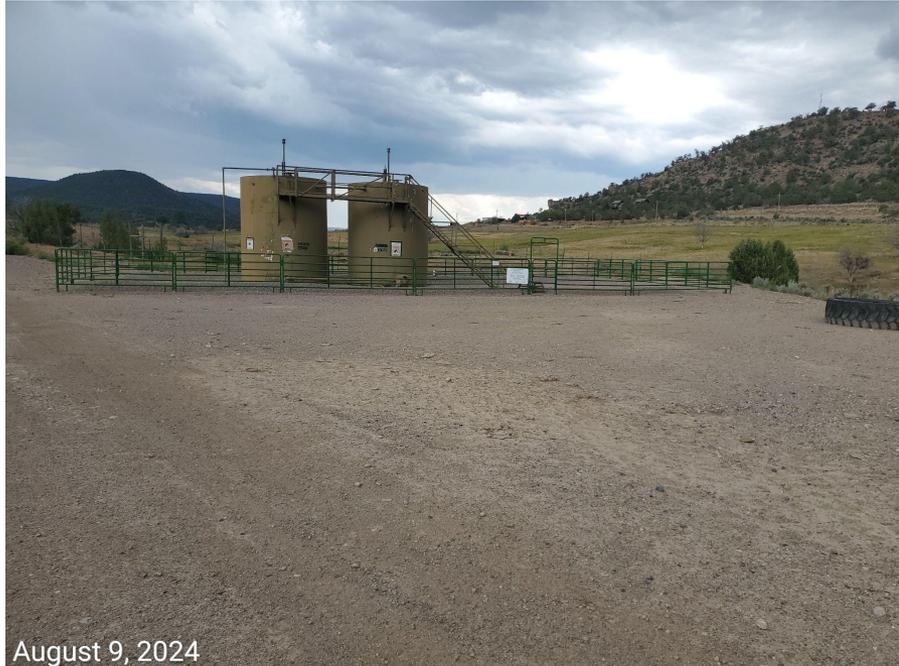
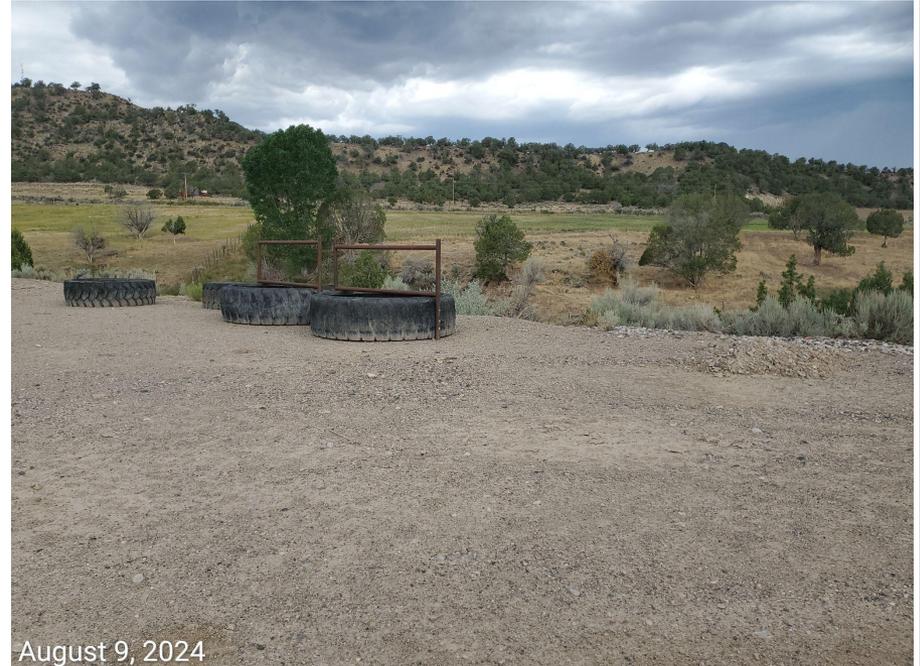
Photo 2: See comments under photo 1.

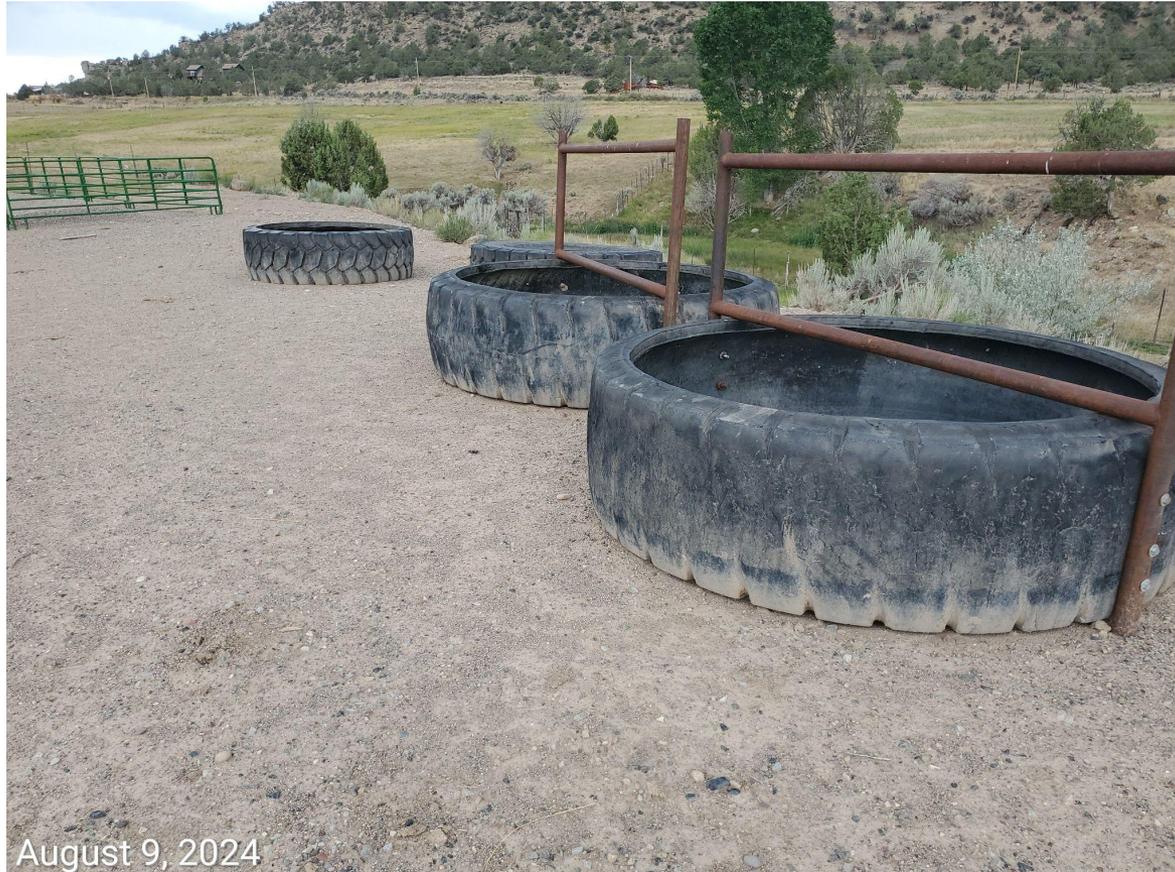
Photo 3: Photo taken from the west end of the Location. Photo shows 4 large tires, possibly placed by the surface owner for feeding livestock, stored on the Location. Tires are not necessary for use on the Location and require removal.

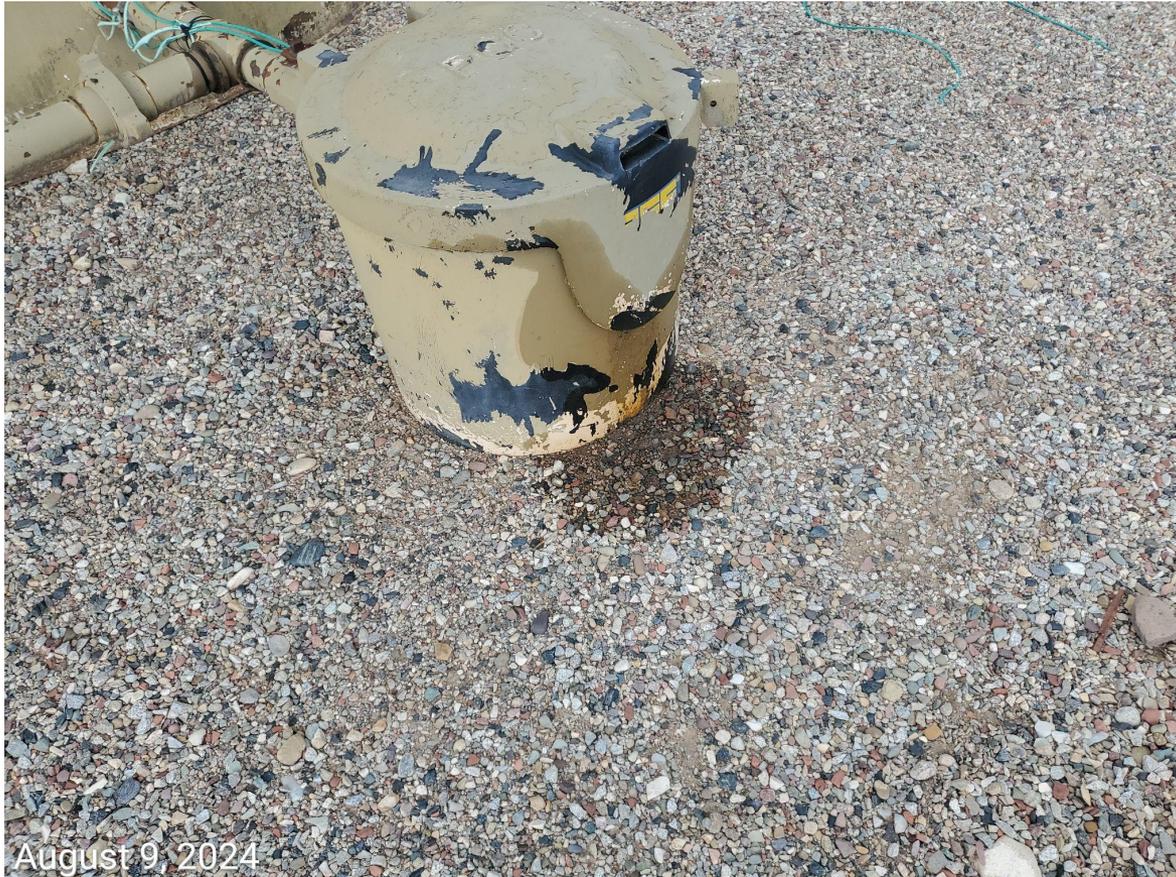
Photo 4: Stained soils at loadline.

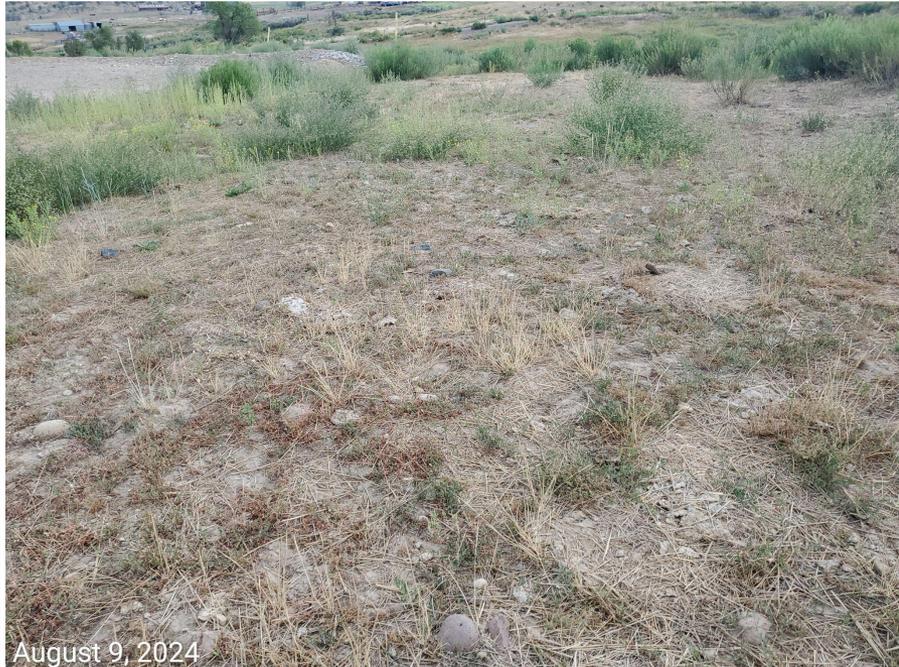
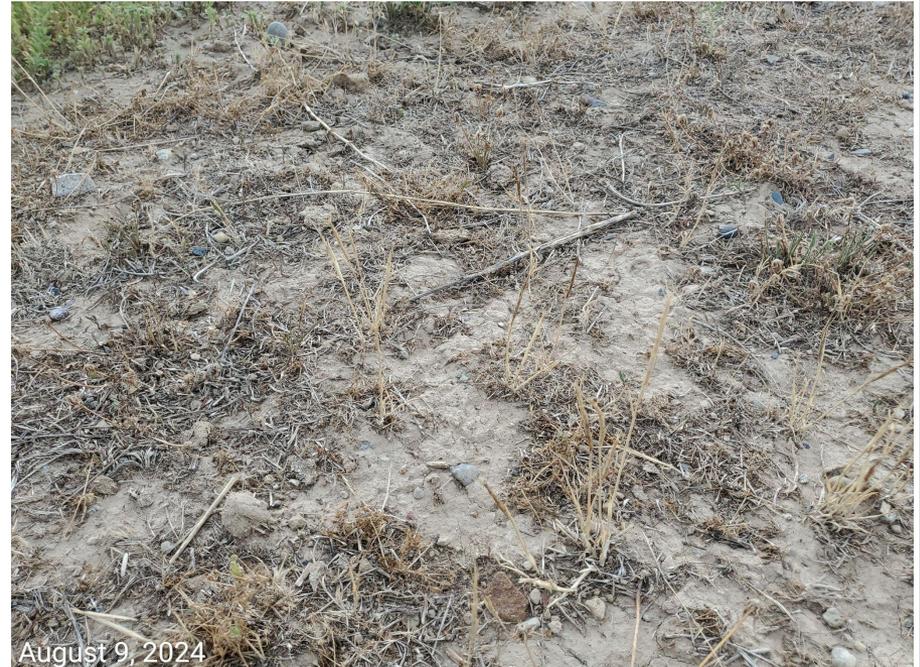
Photo 5: Photo taken from the interim areas on the southeast end of the Location. Photos show that interim reclamation is not progressing towards ECMC 1003 Reclamation requirements; interim areas are predominantly bare, or vegetated by Undesirable Plant Species. Grass observed in the photos is Jointed Goatgrass.

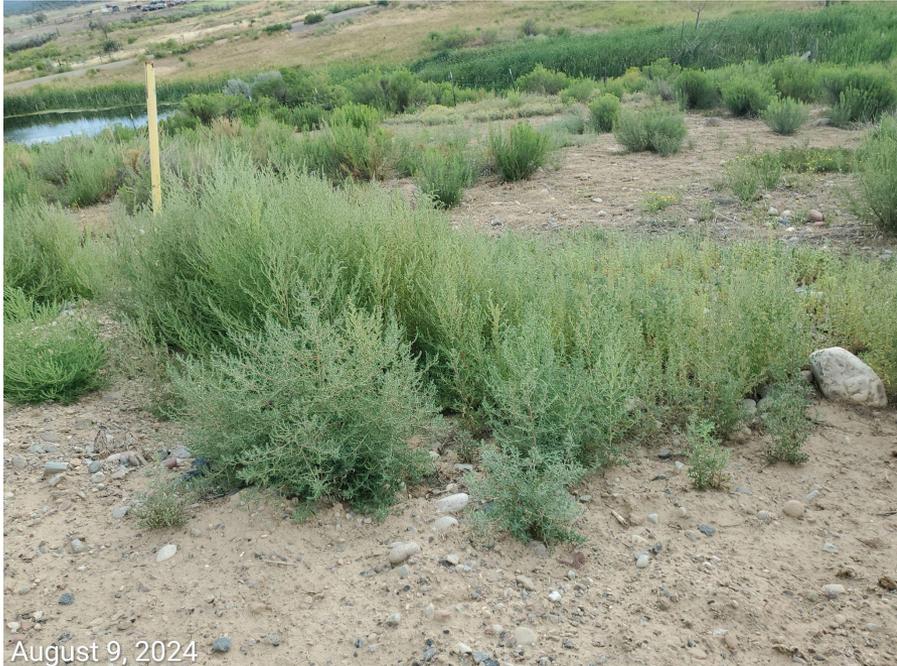
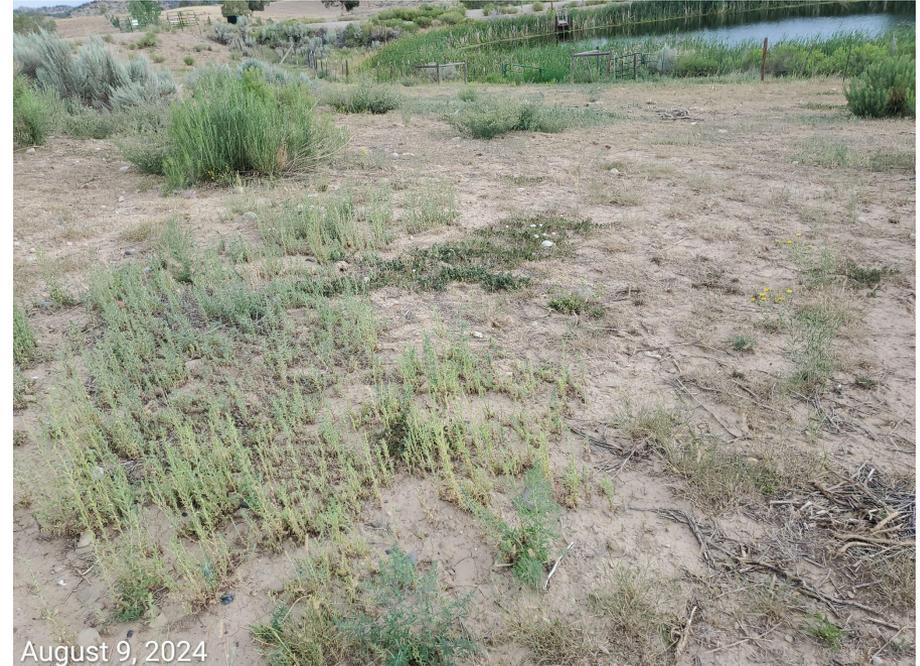
Photo 6: Photo taken from the interim areas on the north end of the Location. Photos show that interim reclamation is not progressing towards ECMC 1003 Reclamation requirements; interim areas are predominantly bare, or vegetated by Undesirable Plant Species; weeds observed in photo include Kochia, Field Bindweed and Jointed Goatgrass.
