Inspection Photos

Operator: TEP ROCKY MOUNTAIN LLC #96850

Location ID: 418828

Inspection Doc: 696206120

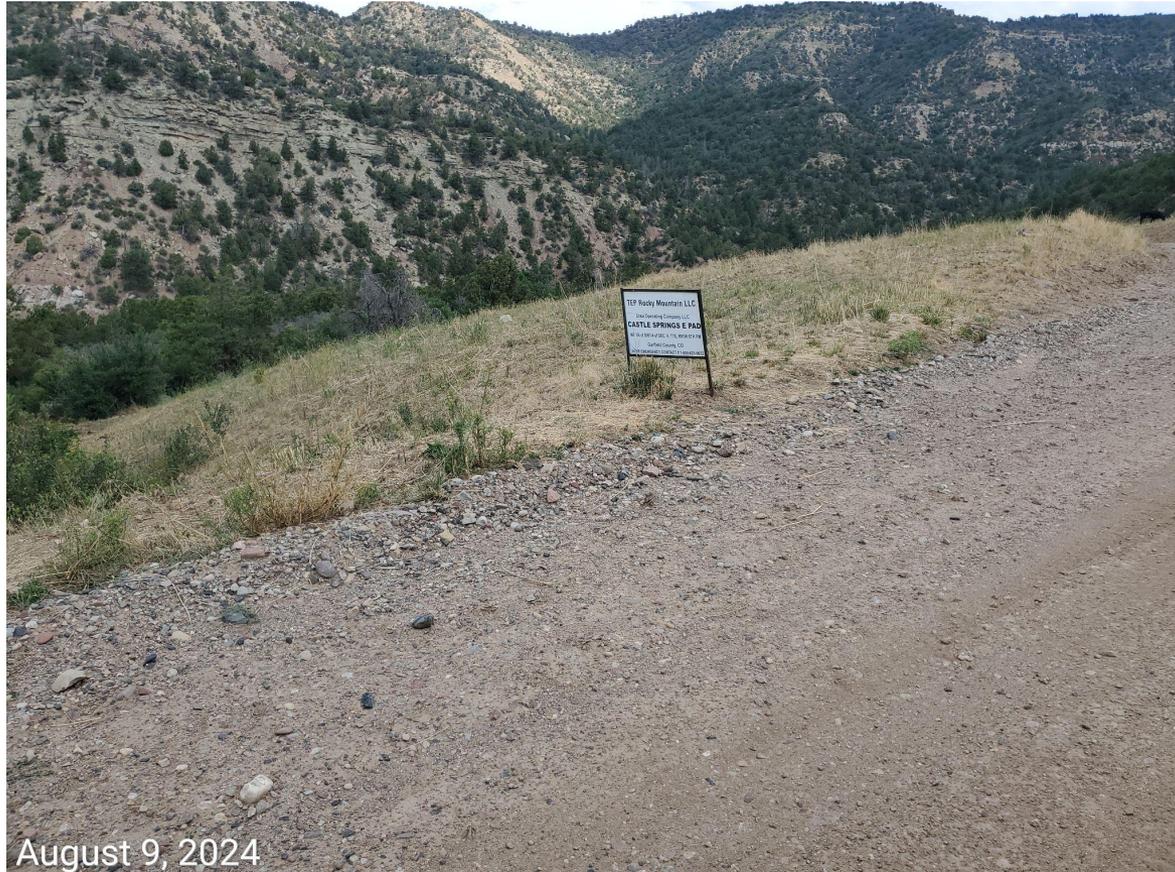
Photo 1: Photo shows signage at Location entrance. TEP and URSA are both identified as Operators for the Location. Emergency contact number posted no longer operational.

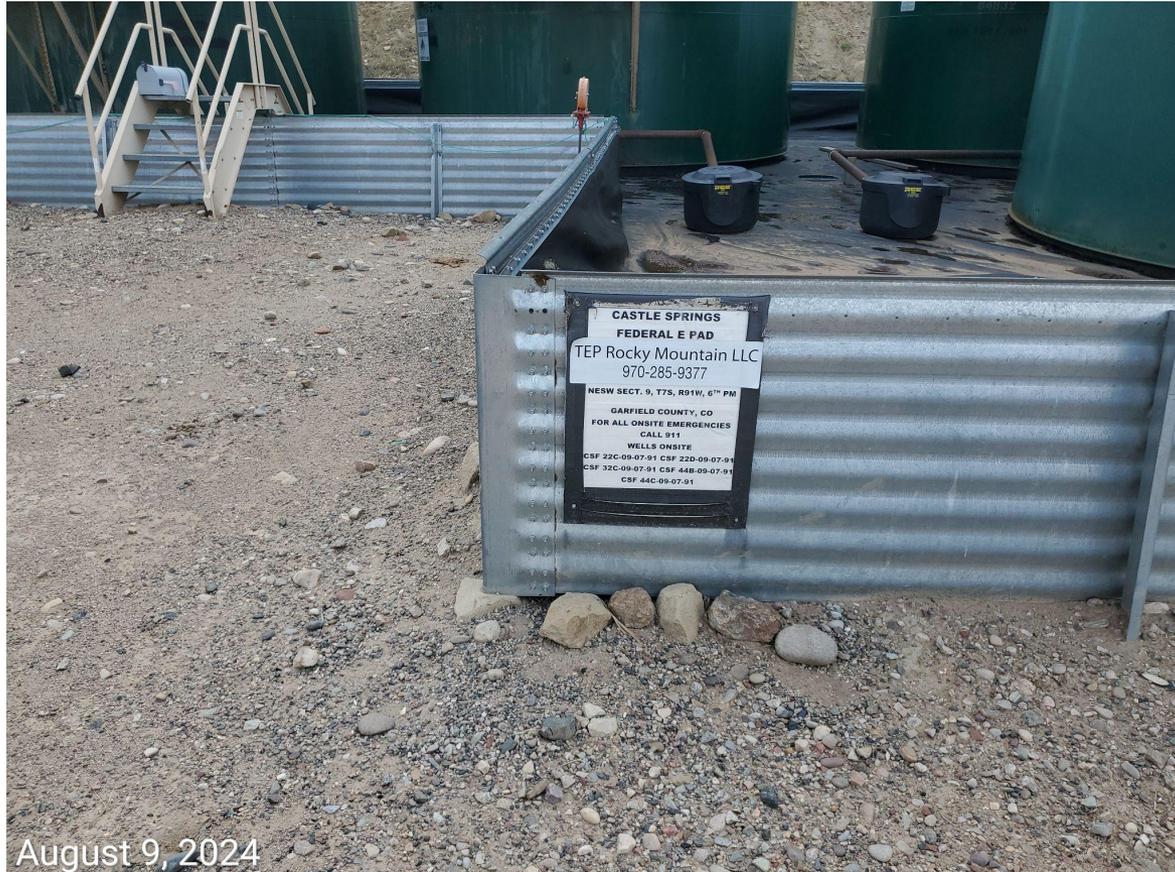
Photo 2: Tank battery signage has been updated.

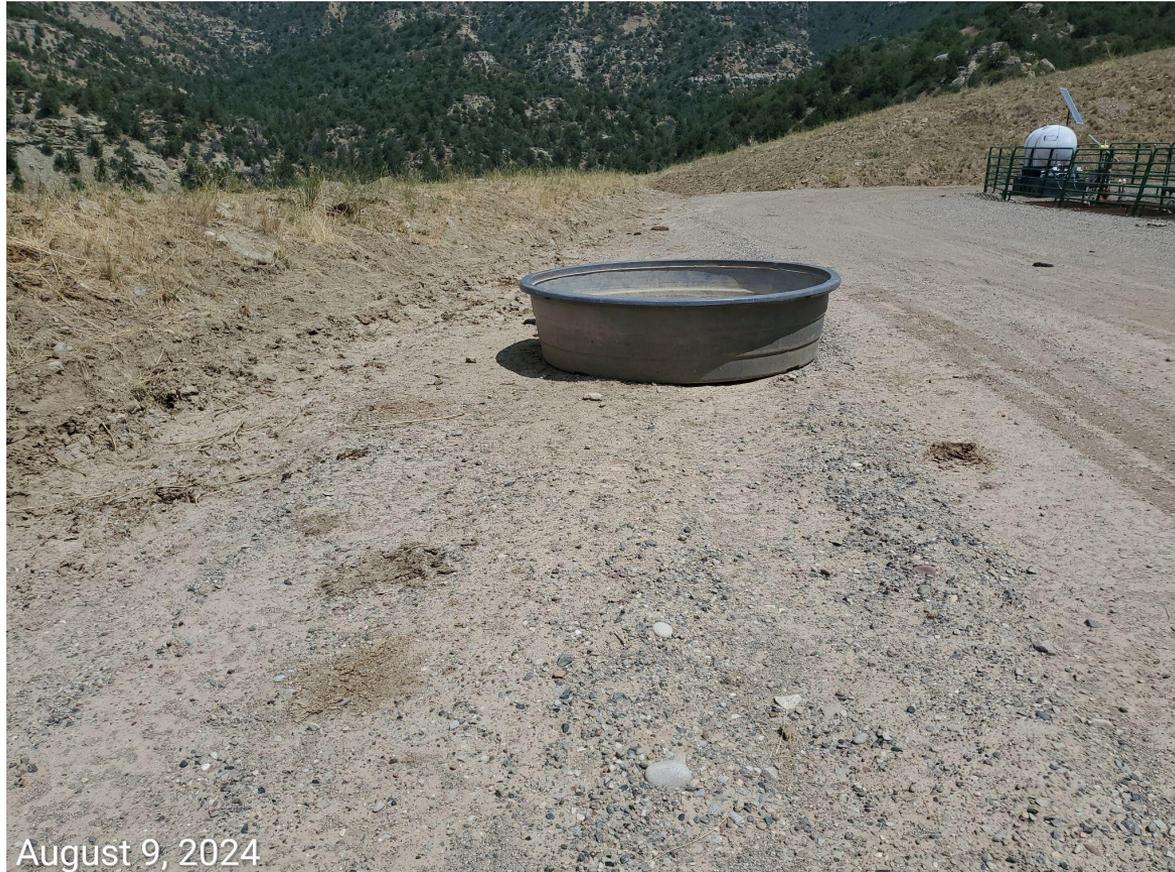
Photo 3: Unused stock tank stored on the Location. The storage, placement, or maintenance of equipment, vehicles, trailers, commercial products, Chemicals, drums, totes, Containers, materials, and all other supplies not necessary for use on an Oil and Gas Locations is prohibited.

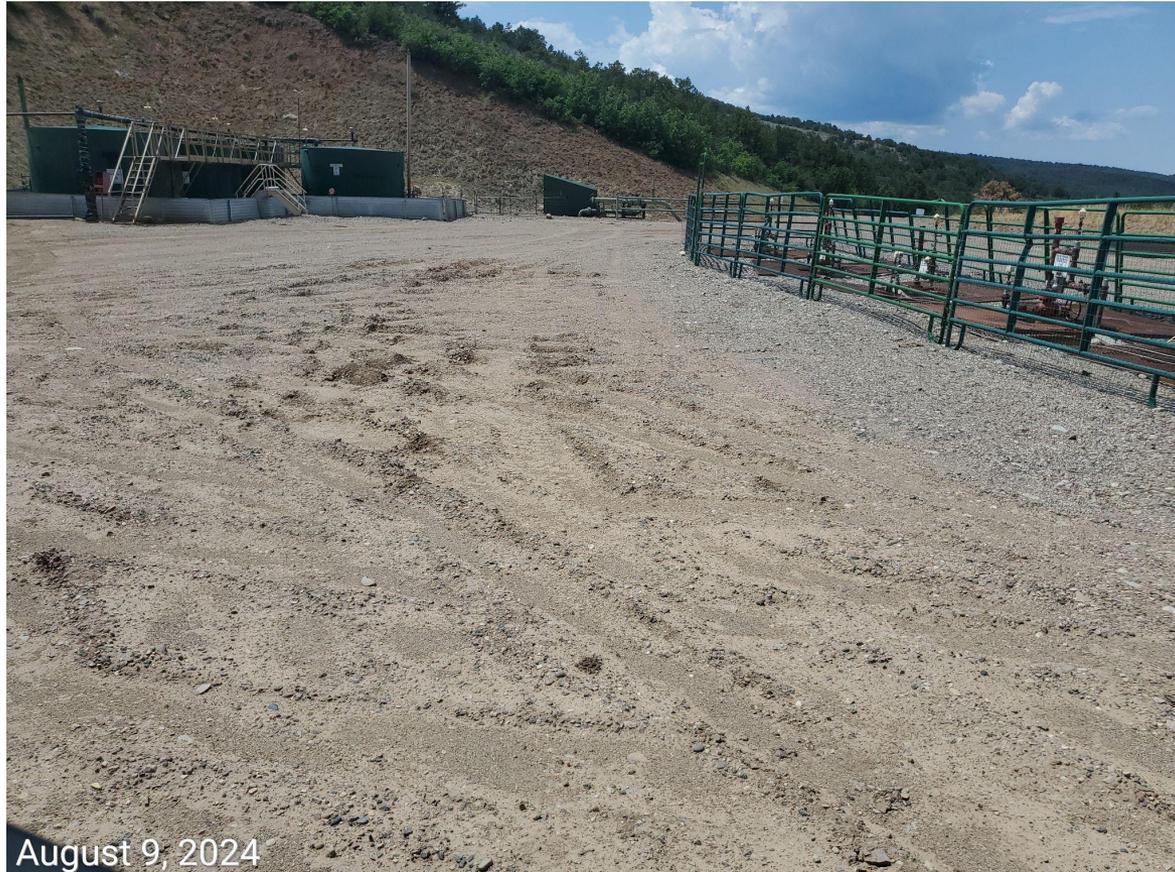
Photo 4: Photo taken from the eastern working pad surface, facing west. Inspection #696205757 observed BMPs to stabilize, as well as to minimize tracking and degradation during wet conditions are inadequate. Photo shows BMPs remain missing or insufficient.

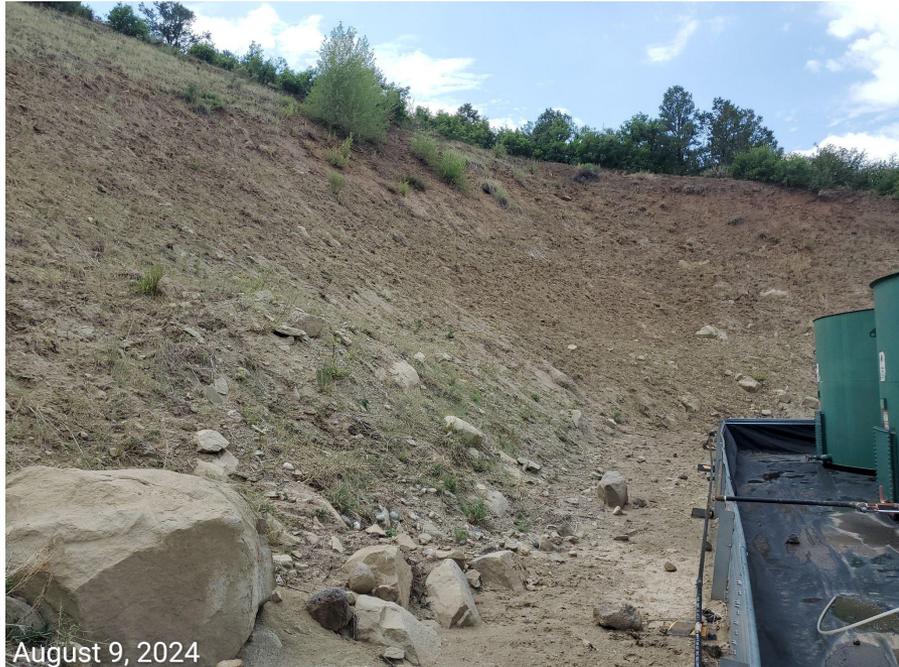
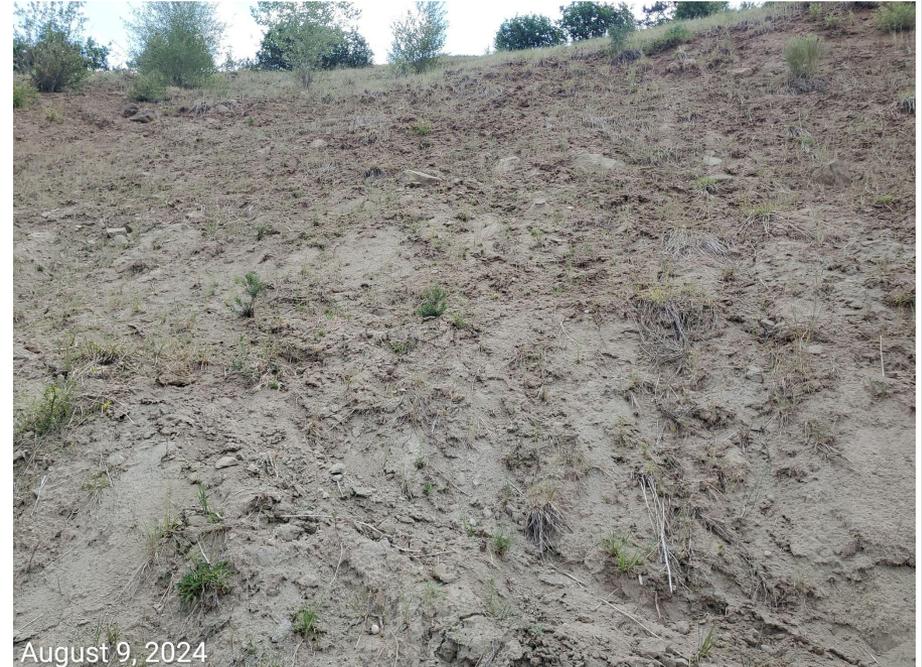
Photo 5: Photos taken from the south end of the Location. Southern areas of the Location are predominantly bare and unstabilized soils. Corrective actions to conduct additional reclamation and stabilization efforts have not been taken.

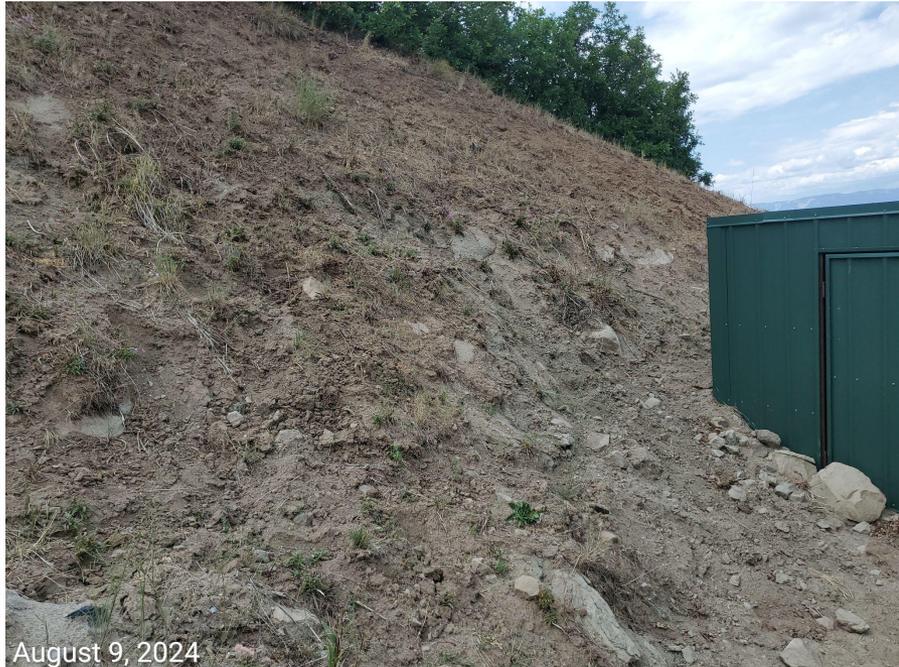
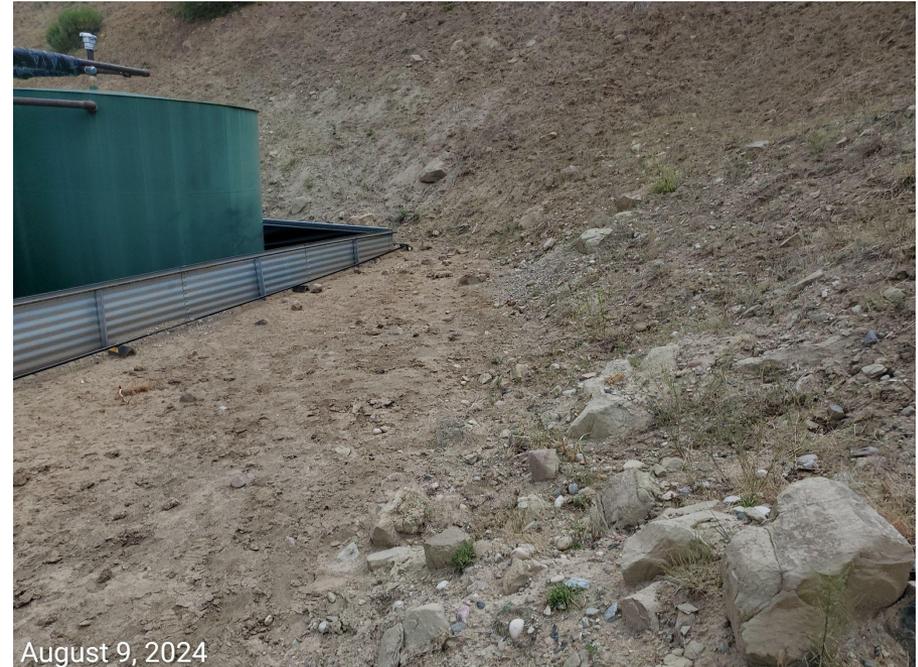
Photo 6: Photos taken from the south end of the Location. Southern areas of the Location are predominantly bare and unstabilized soils. Corrective actions to conduct additional reclamation and stabilization efforts have not been taken.

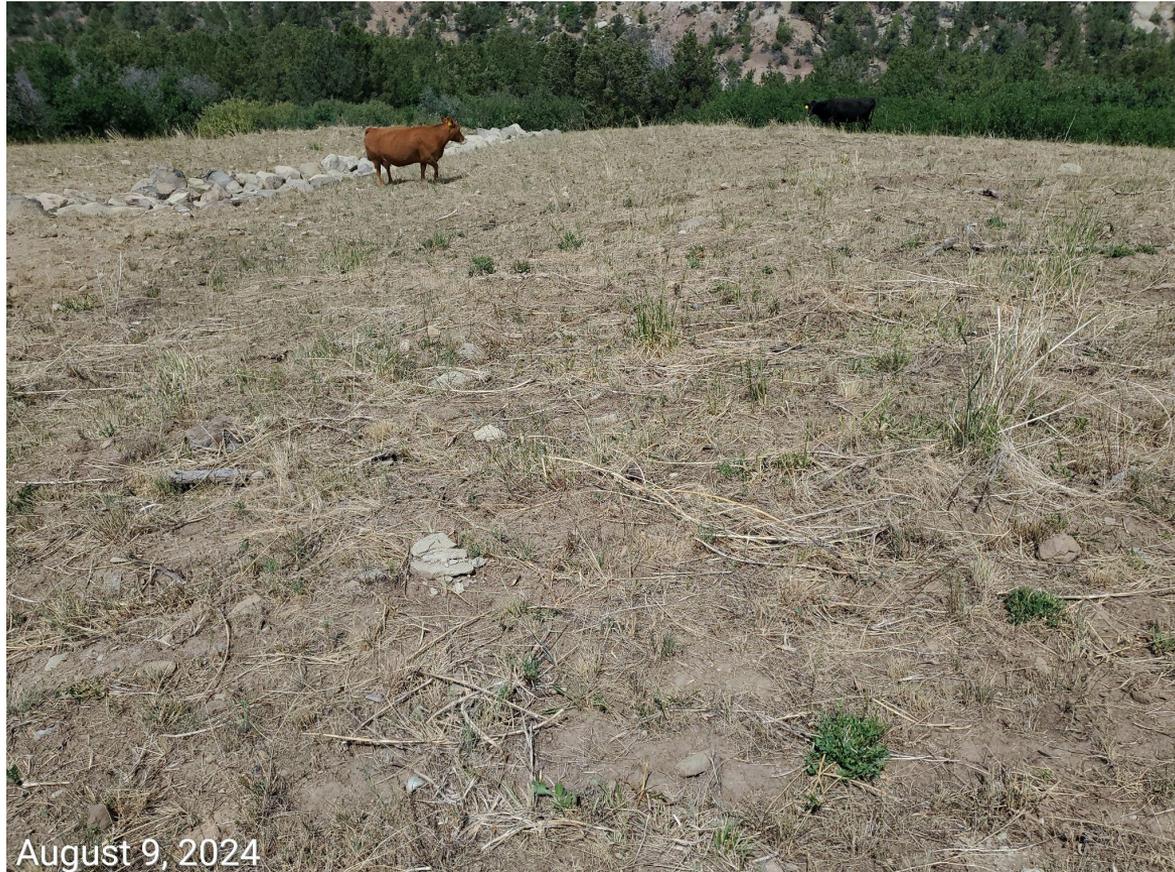
Photo 7: Photo taken from the interim areas. Heavy livestock grazing pressure evident within eastern and northern interim areas of the Location- continuous grazing will likely hinder reclamation, and may result in additional reclamation efforts being necessary to ensure the site progresses towards 1003 reclamation standards.

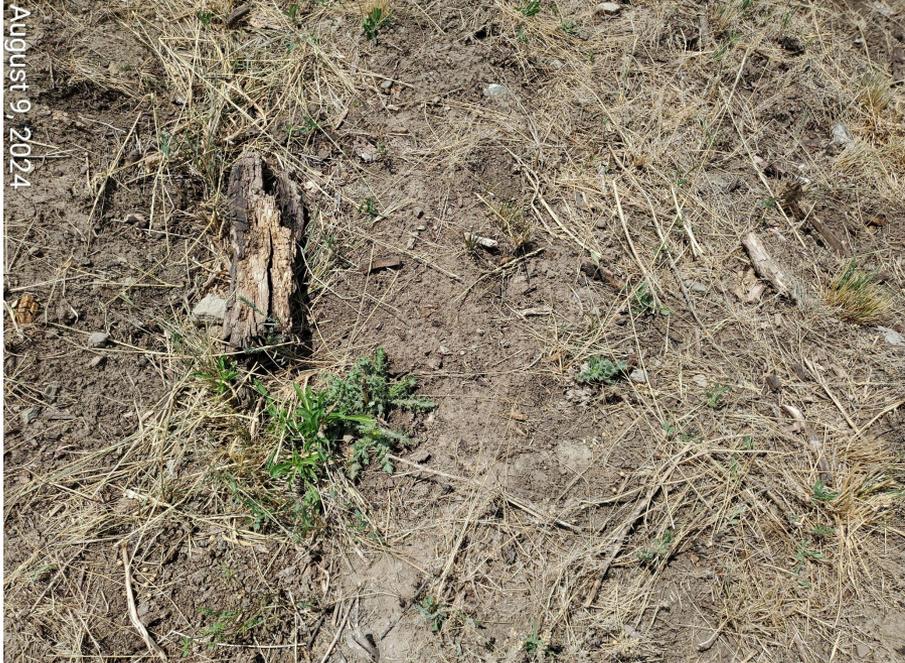
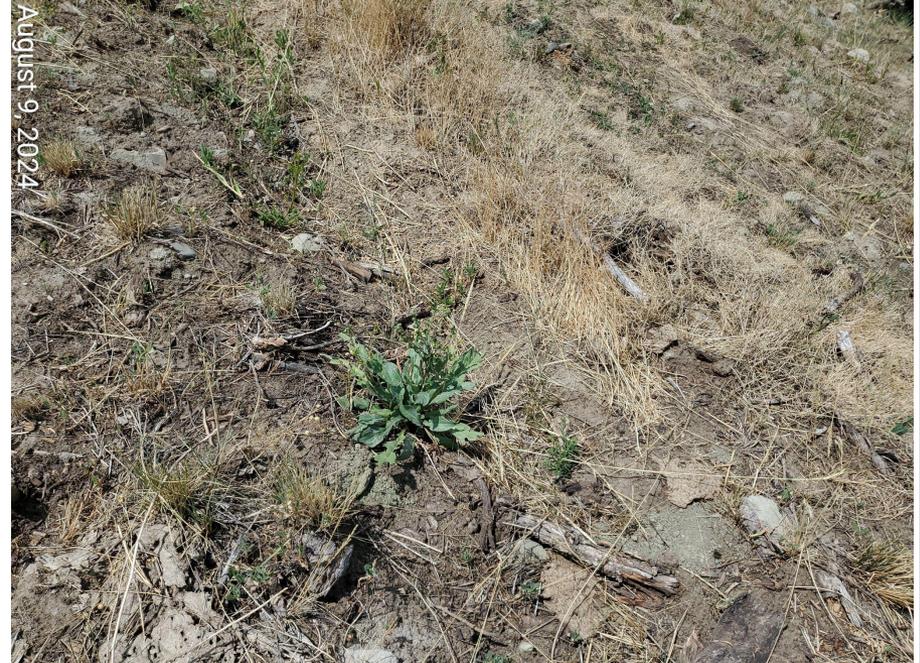
Photo 8: Photos examples of Noxious weeds (Canada thistle, Houndstongue) observed establishing within the interim areas. Houndstongue also observed establishing along access road.
