# Inspection Photos

**Operator:** TEP ROCKY MOUNTAIN LLC #96850

**Location ID:** 335052

**Inspection Doc:** 696206122

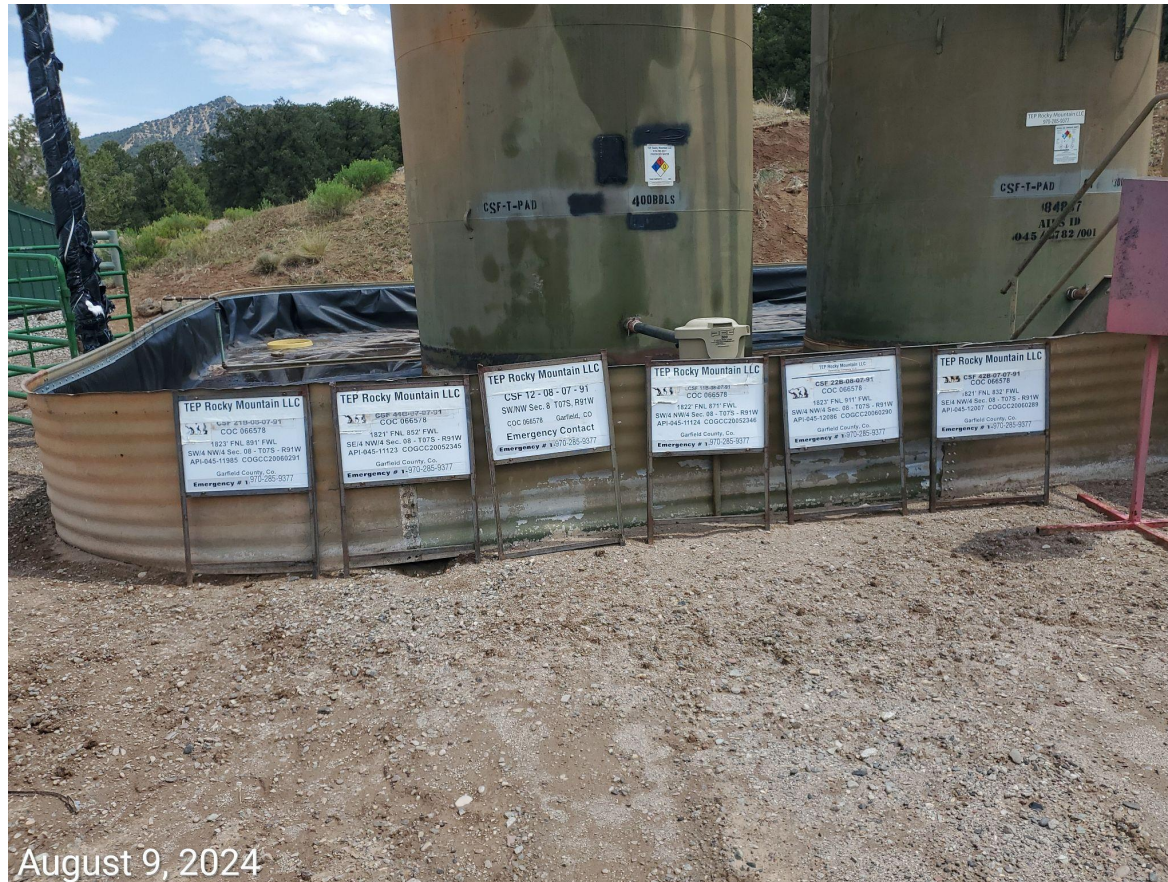
**Photo 1:** Signage at battery and tanks have been maintained.

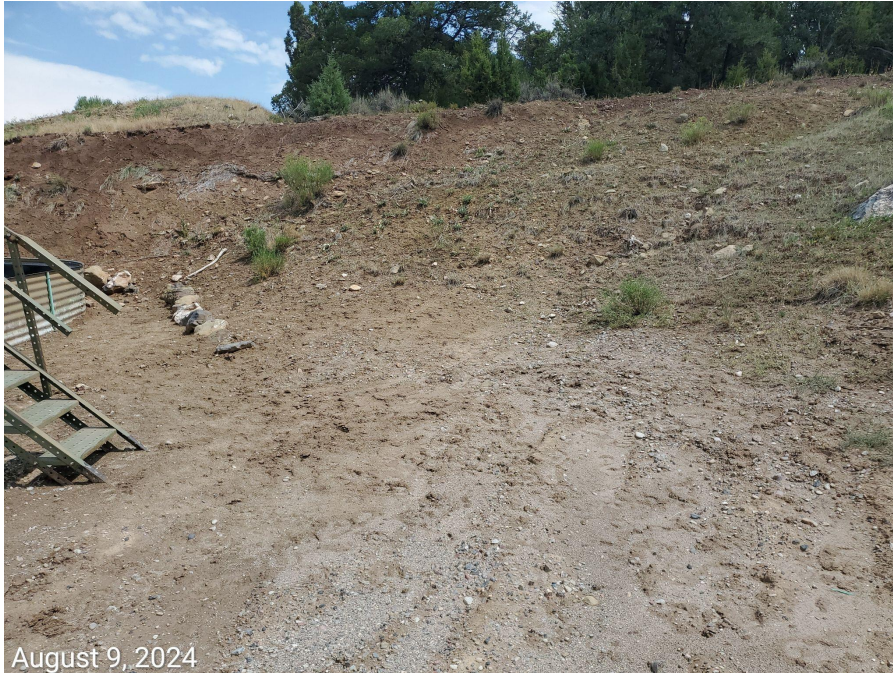
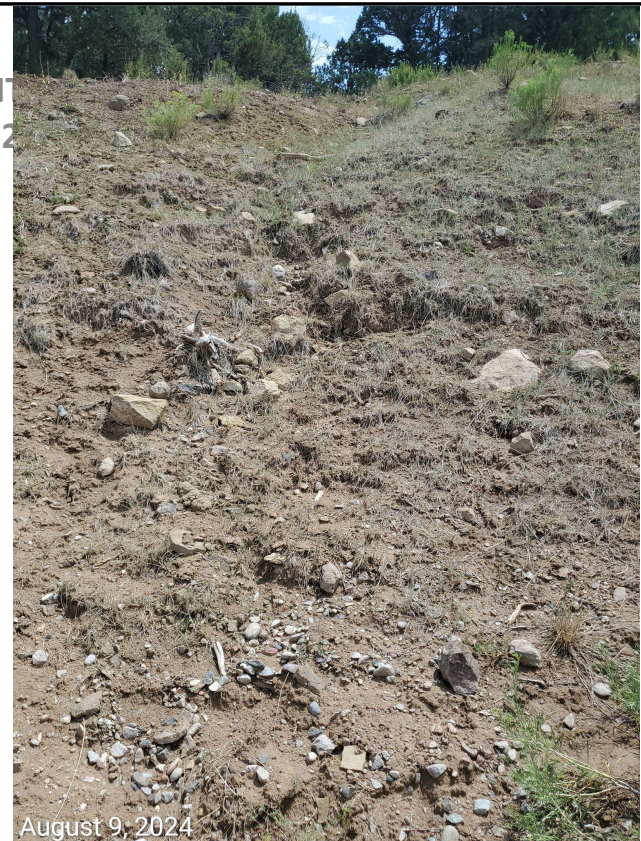
**Photo 2:** Photos taken from the east end of the Location. Photo shows areas not progressing towards 1003 standards; unable to find evidence that additional reclamation work has been performed. Photo also show erosion degradation has persisted; stormwater and erosion control BMPs have not been installed or maintained.

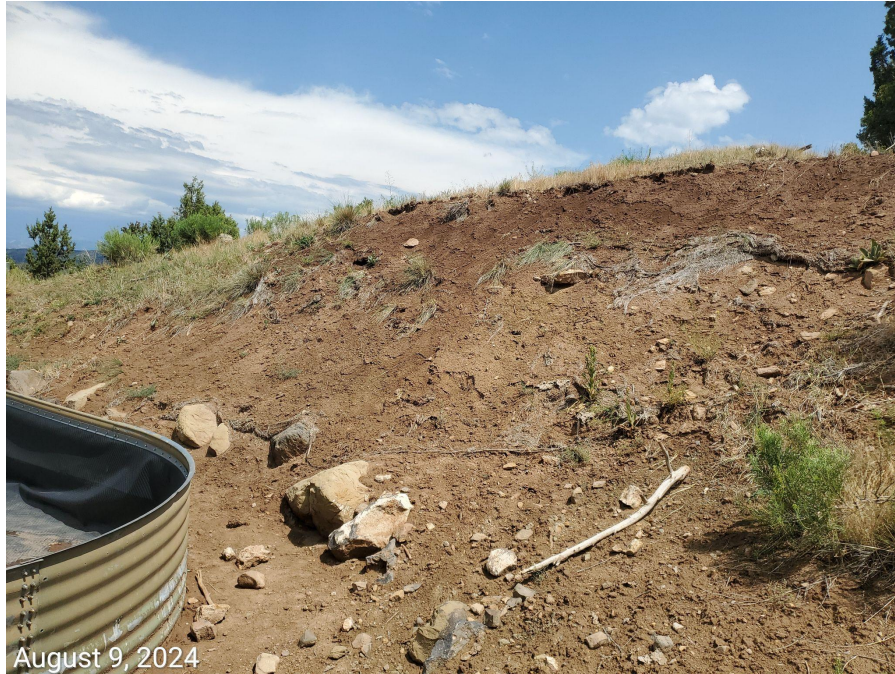
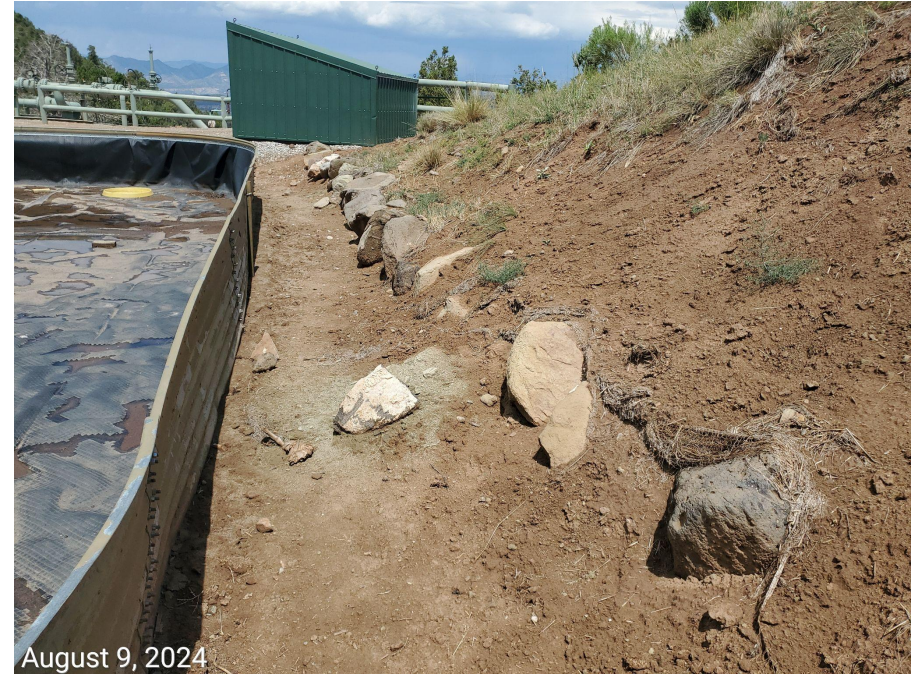
**Photo 3:** Continued from photo 2. BMPs to minimize erosion and degradation have not been implemented; erosion degradation has persisted. Additional reclamation efforts have also not been performed.

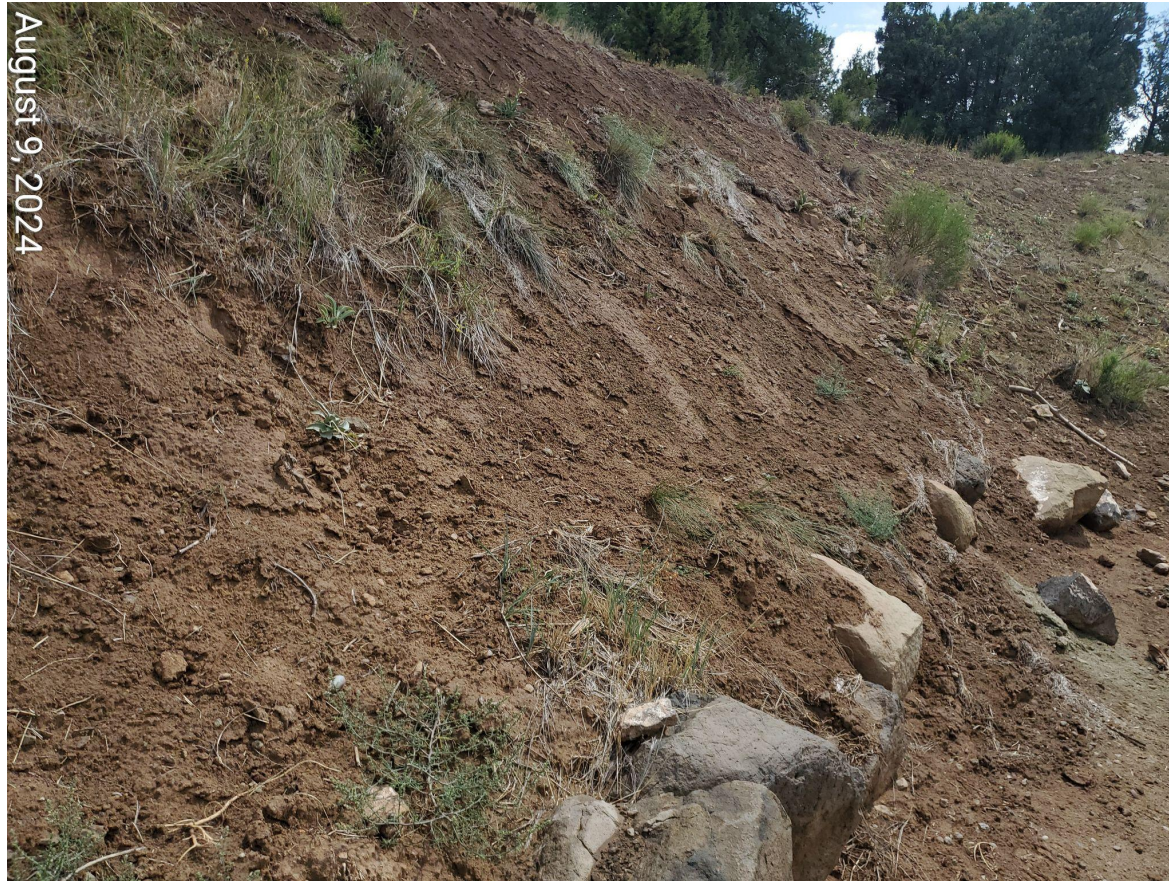
**Photo 4:** Continued from photo 2. BMPs to minimize erosion and degradation have not been implemented; erosion degradation has persisted. Additional reclamation efforts have also not been performed.

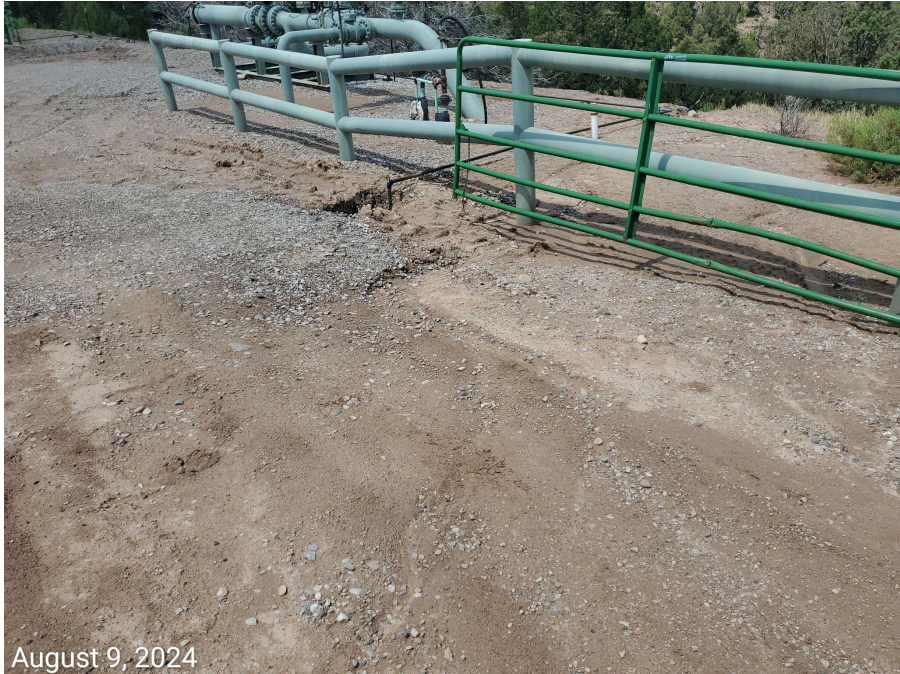
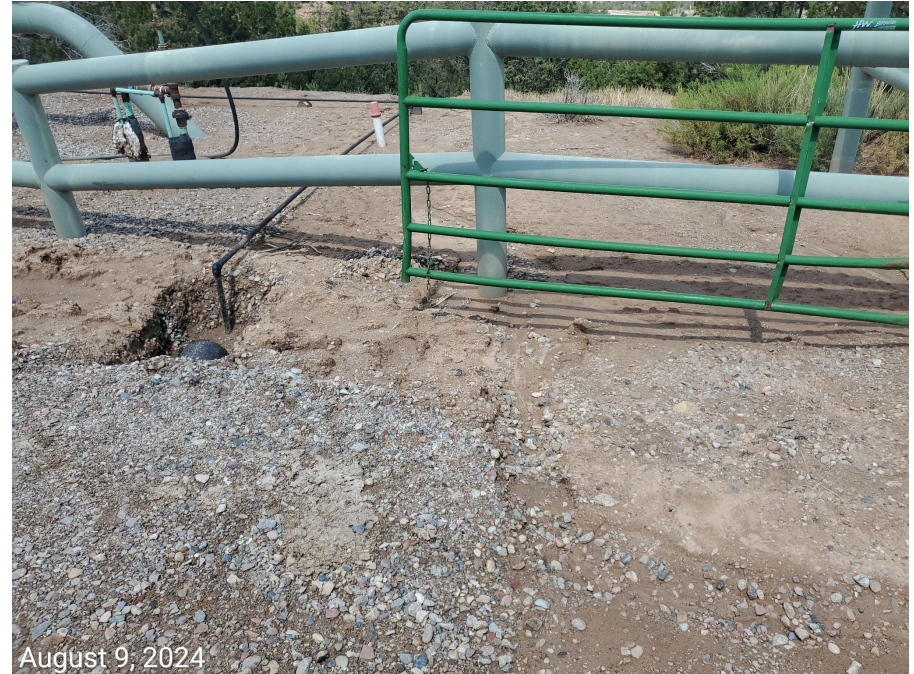
**Photo 5:** Photos taken from the northeast end of the Location. Stormwater erosion, degradation and sediment transport due to runoff has persisted on the Location. BMPs to manage stormwater have not been implemented or maintained.

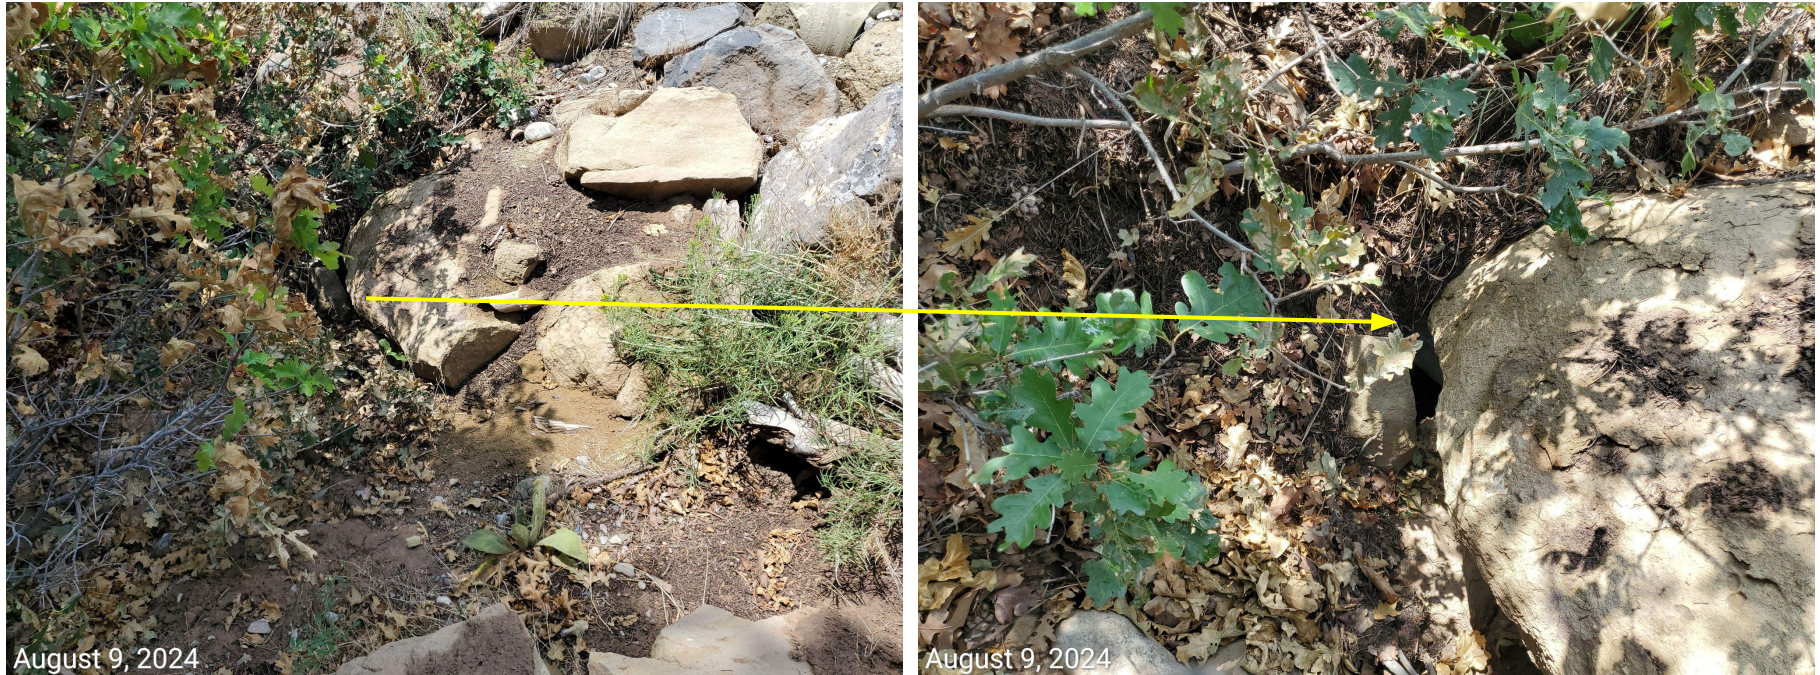
**Photo 10:** Photos show culvert on the southwestern location entrance has not been maintained.

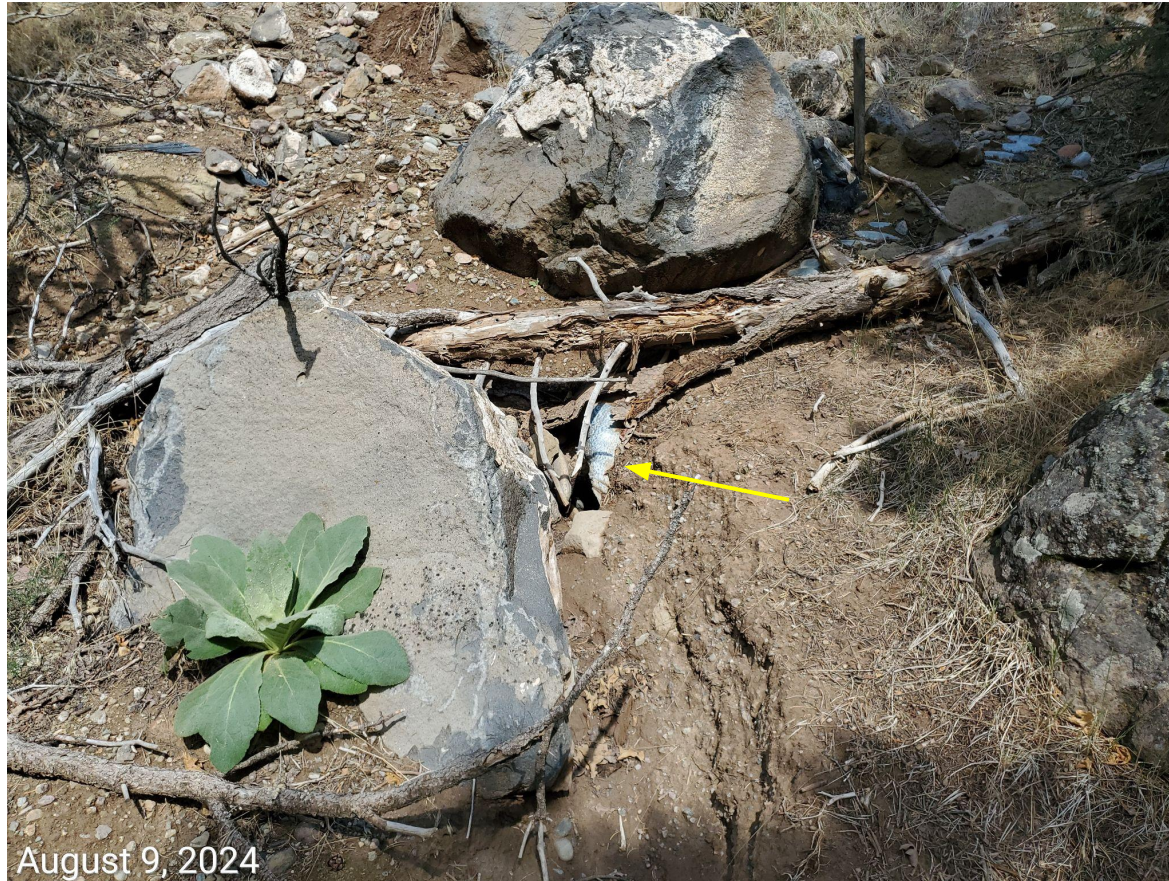
**Photo 11:** Continued from photo 10. Photo shows culvert outlet; culvert on the southwestern location entrance has not been maintained.

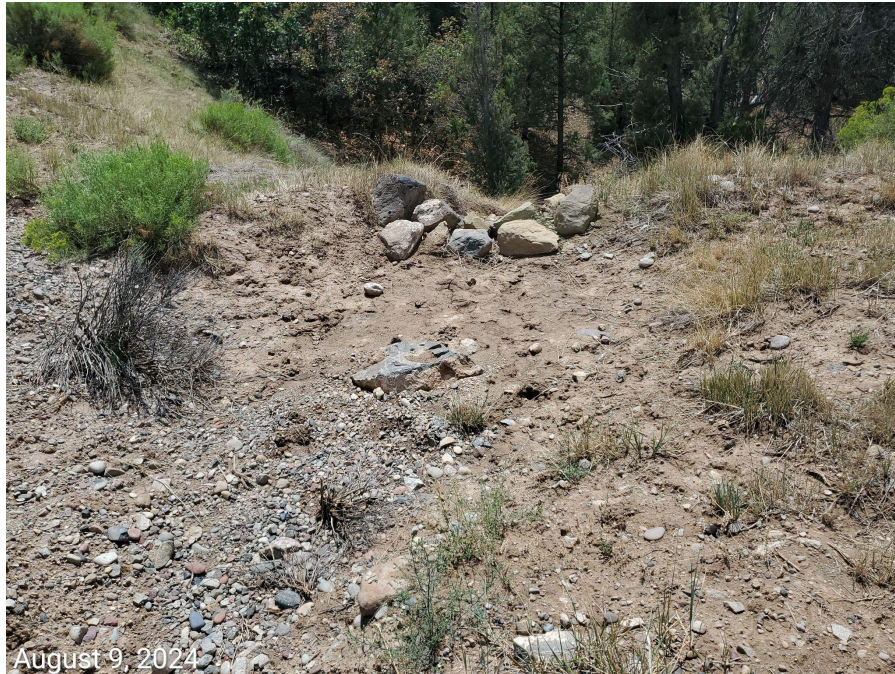
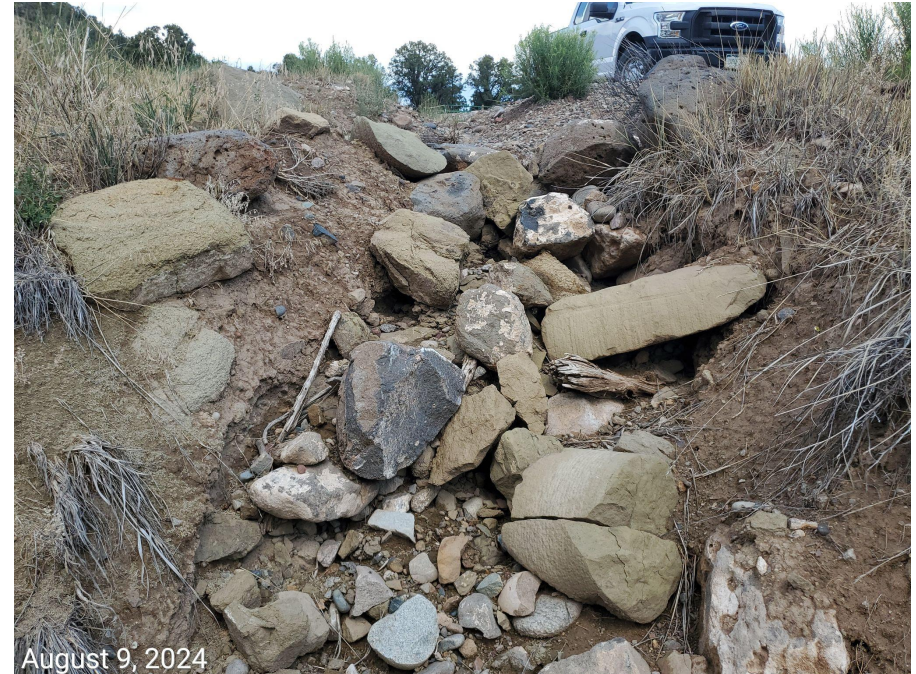
**Photo 12:** Photos taken from the sediment trap on the southwest end of the Location. BMP has not been installed or maintained in proper functioning condition; BMP has not been installed with a properly engineered outlet; geotextile lining in conjunction with the rip-rap material not observed; slopes within outlet lack stabilization and erosion degradation / sediment transport is evident.
