Operator: 8 North

Location Name: WELD-611N61W 28NENW

Loc ID: 310704

Inspection: 684905215

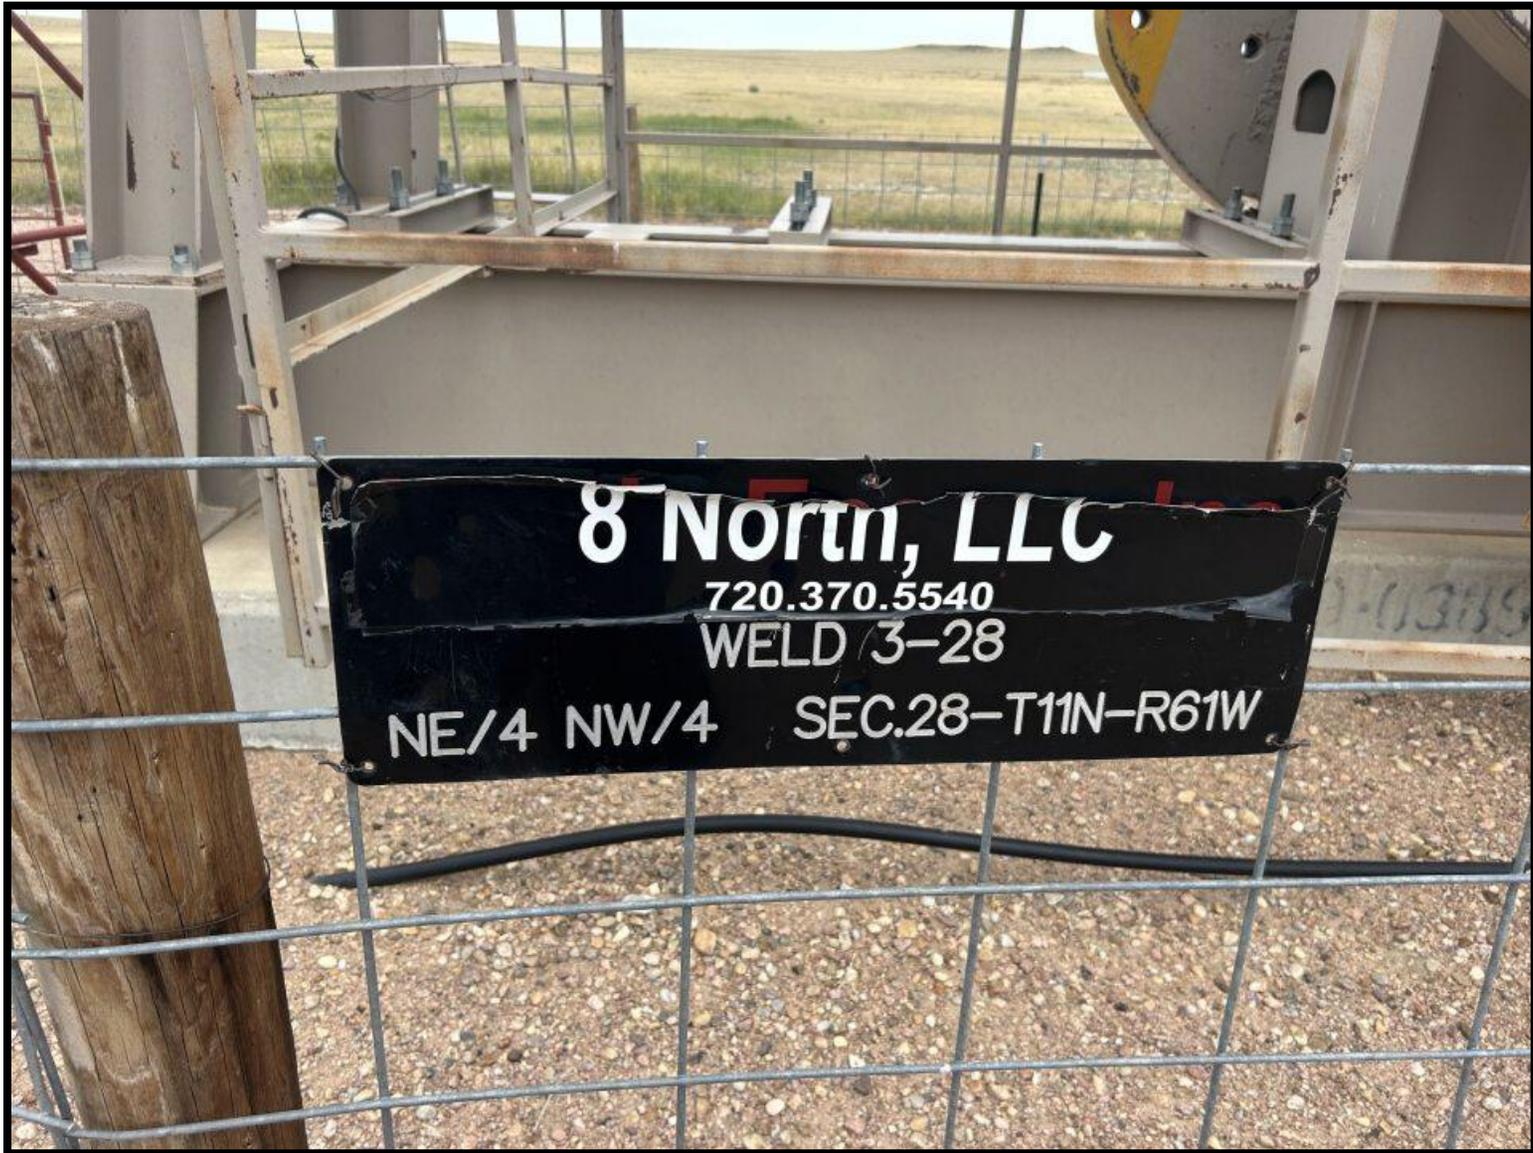
Exhibit A

CA: Stained soil at exhaust, in engine house- Comply with rule 603.f.

CA Resolution: Operator has provided photo evidence that the stained soil at exhaust, in engine house has been addressed in compliance with the 600 series.
