Interim Reclamation and Stormwater Inspection

Operator: CRESTONE PEAK RESOURCES OPERATING
LLC - 10633

Location ID: 331608

Inspection Document #: 708201512

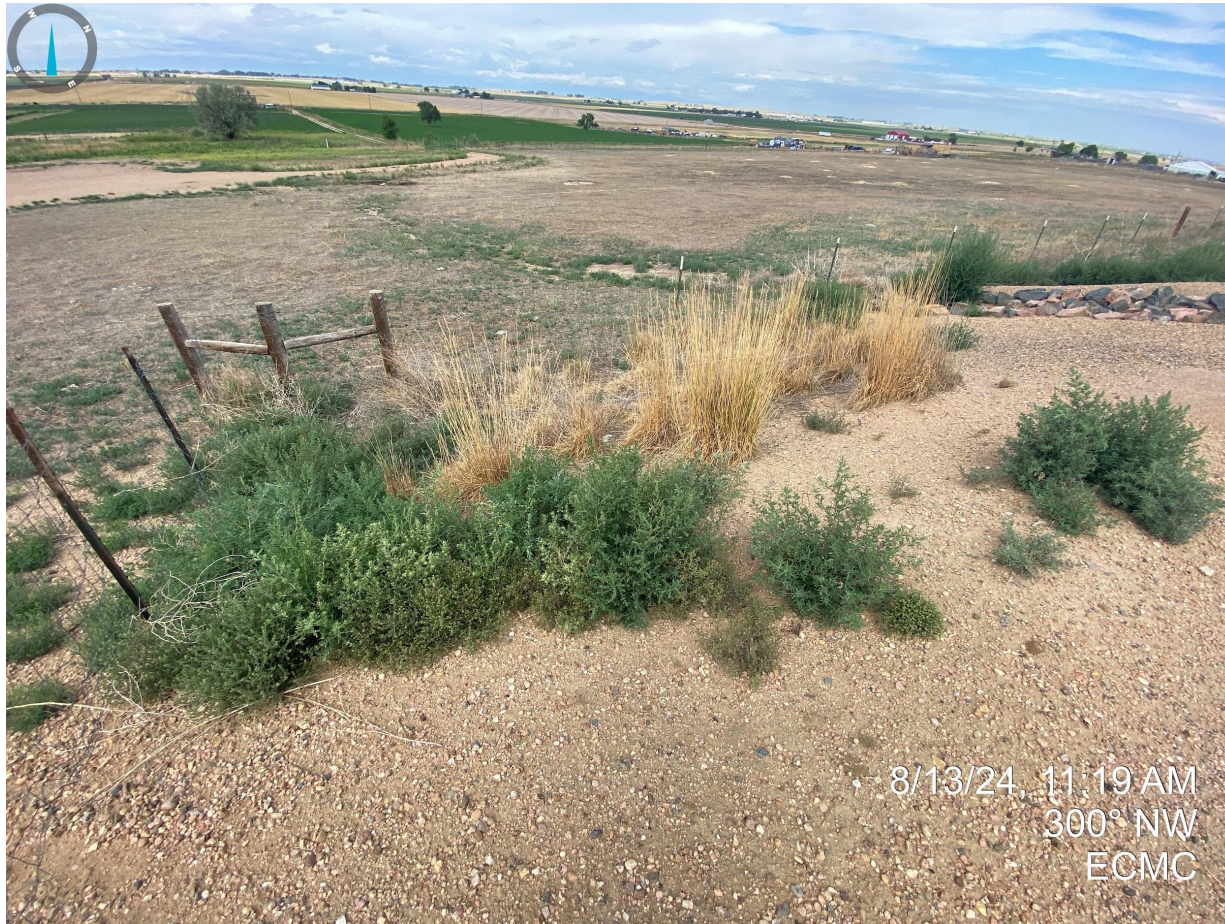
Photo 1. Undesirable vegetation (kochia and russian thistle) observed on the northwest portion of the tank battery.

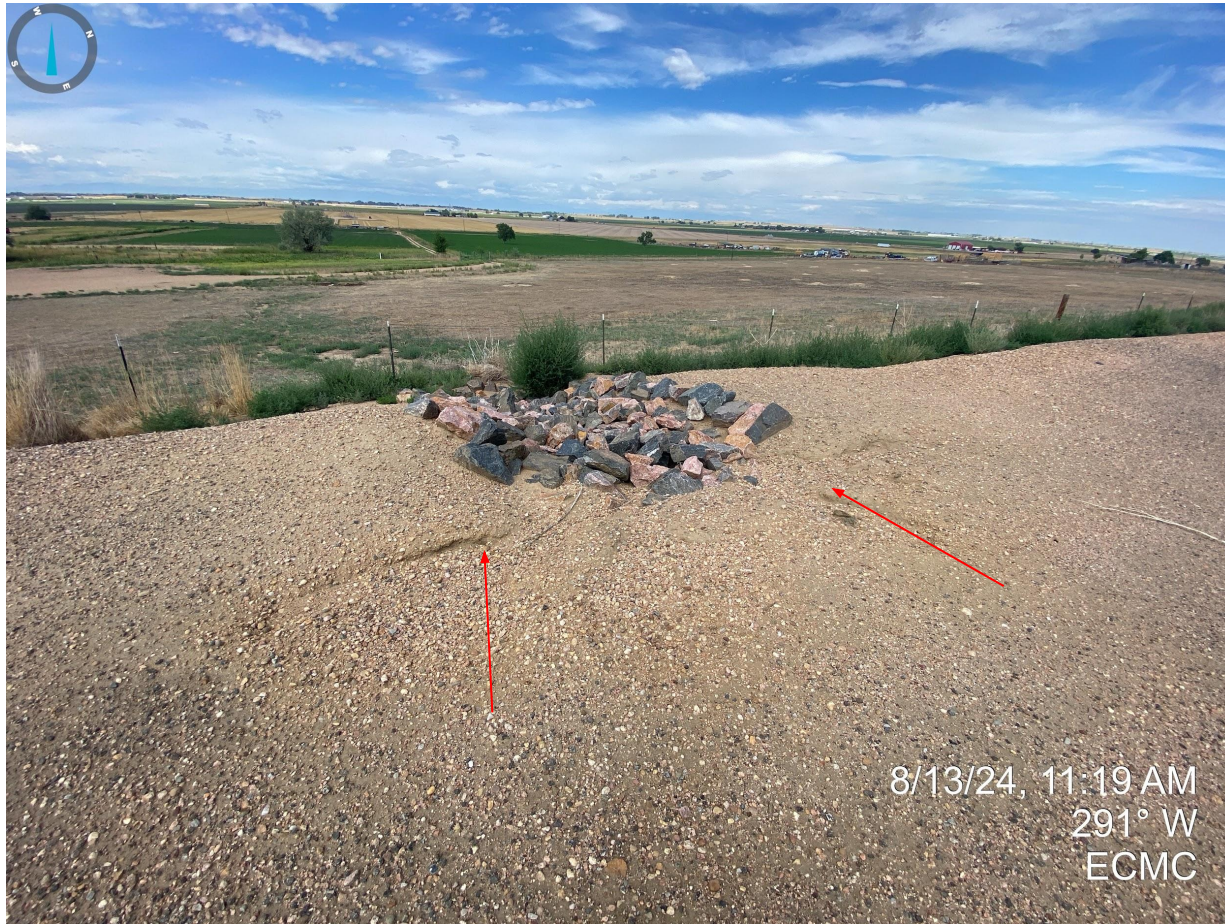
Photo 2. Erosion degradation (riling) observed on the northwest portion of the tank battery.

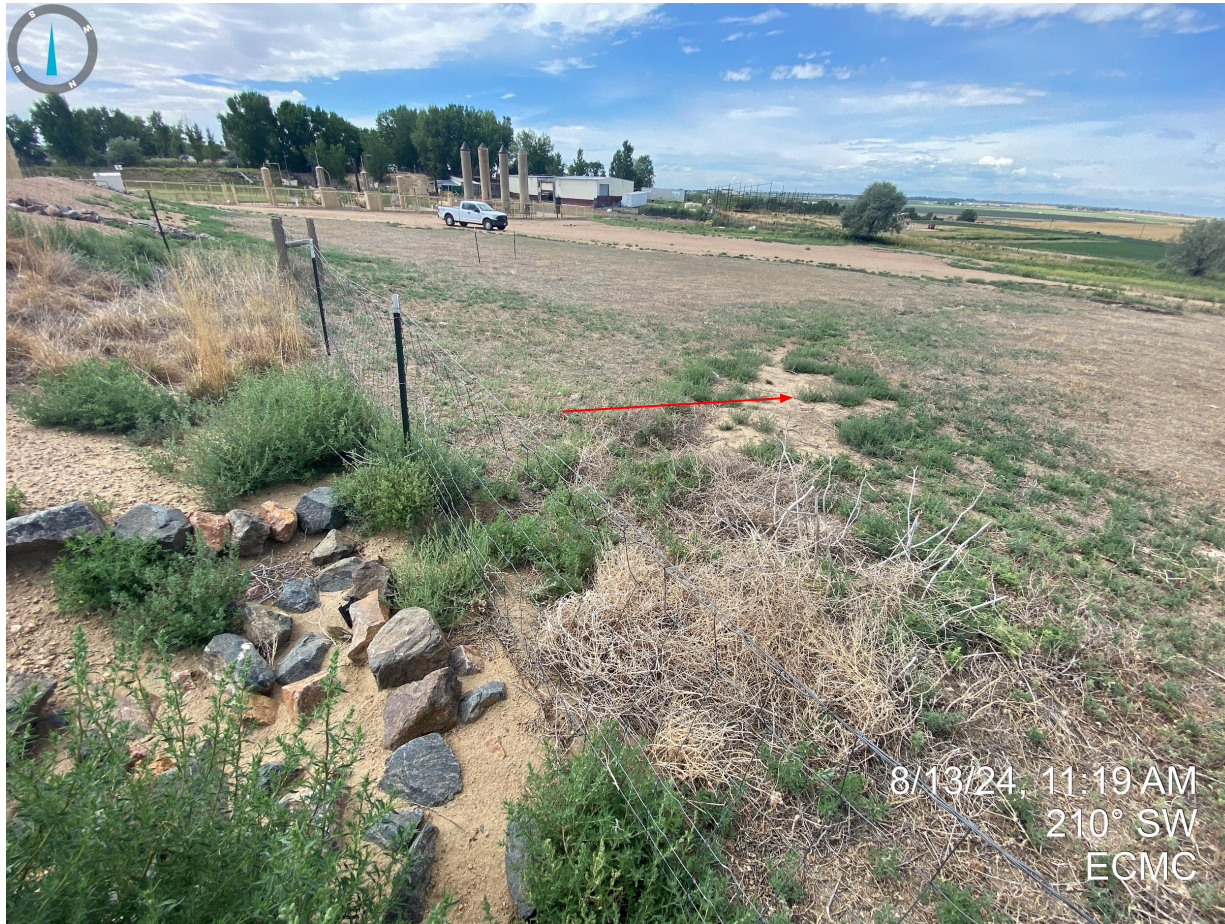
Photo 2. Continued from Photo 2. Evidence of sediment transport into the interim areas west of the tank battery.

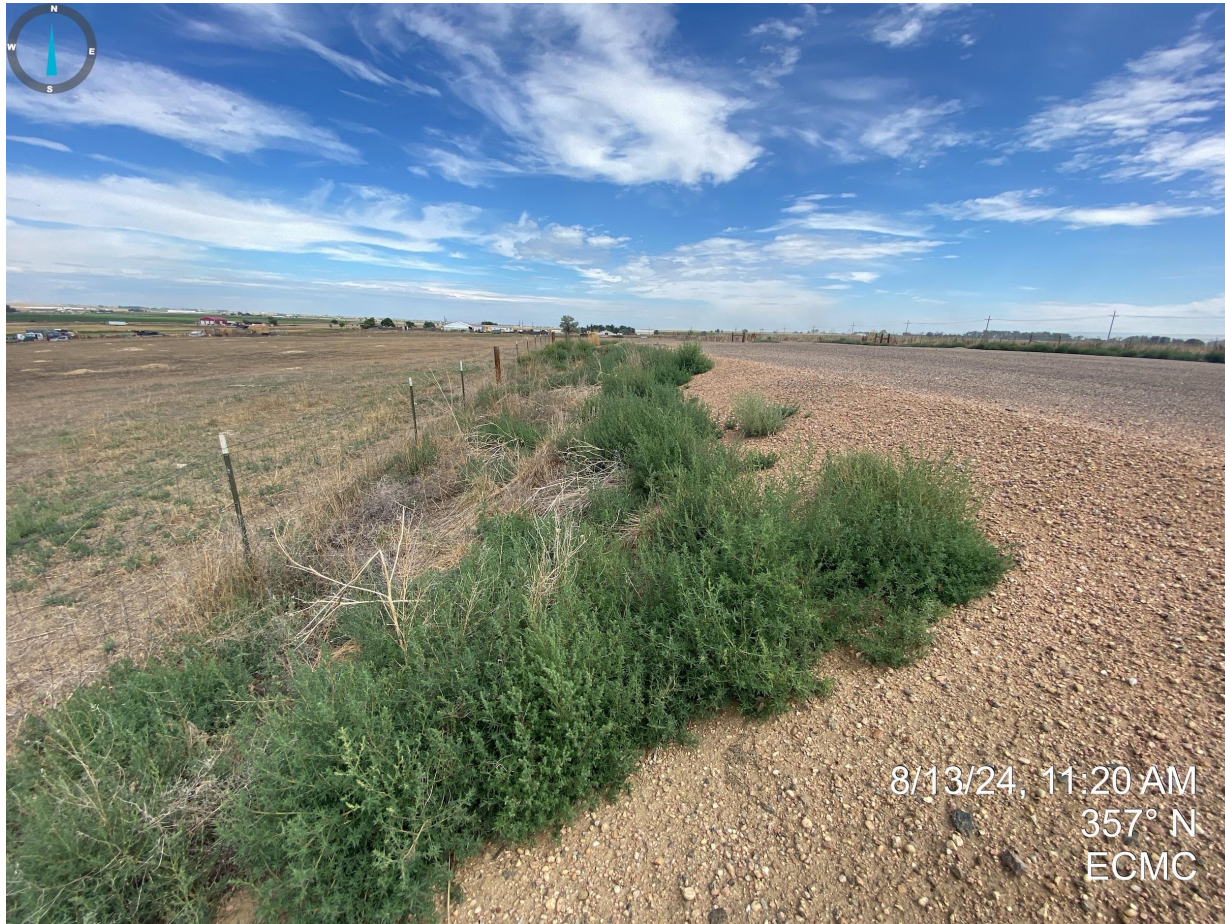
Photo 4. Undesirable vegetation (e.g. kochia and russian thistle) observed along the northwest portion of the tank battery.

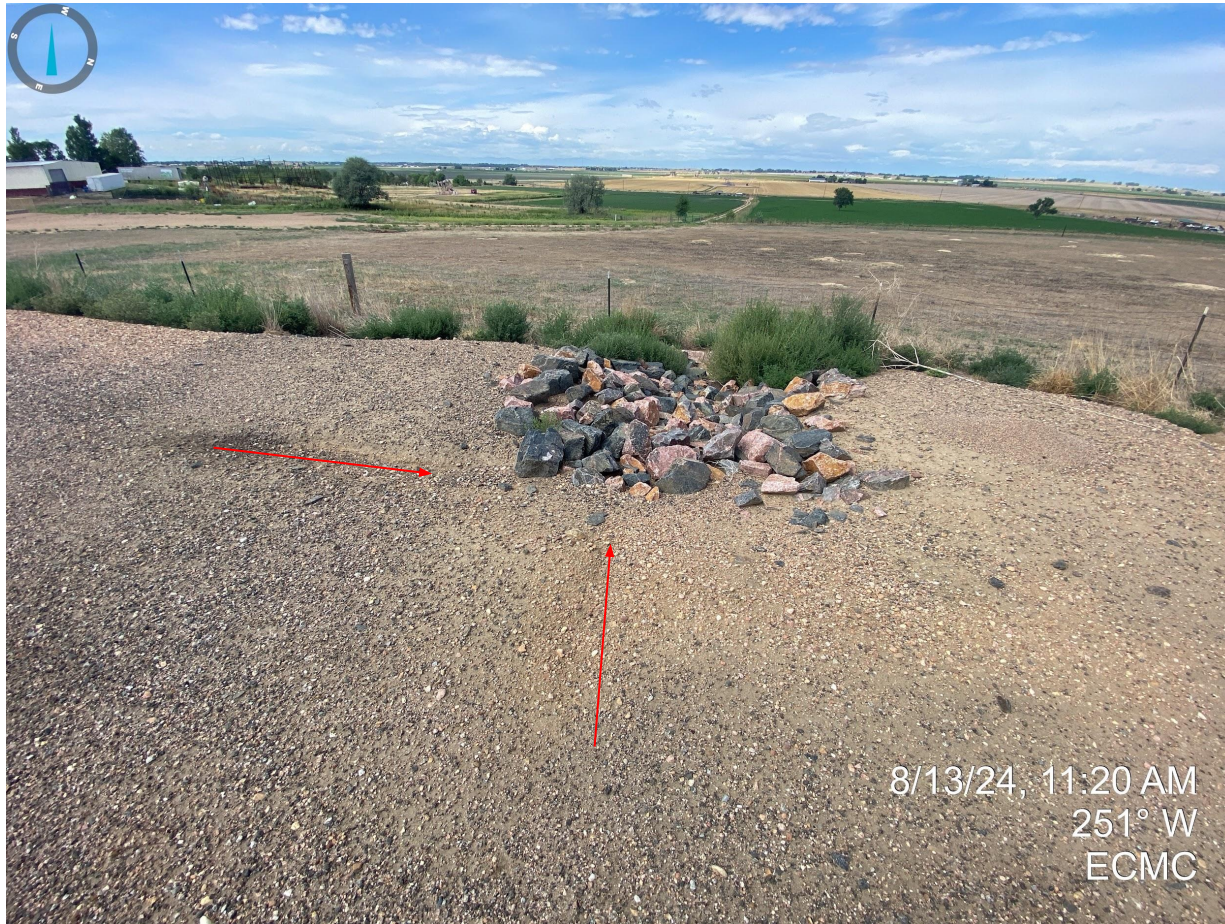
Photo 5. Erosion degradation (riling) observed on the northwest portion of the tank battery.

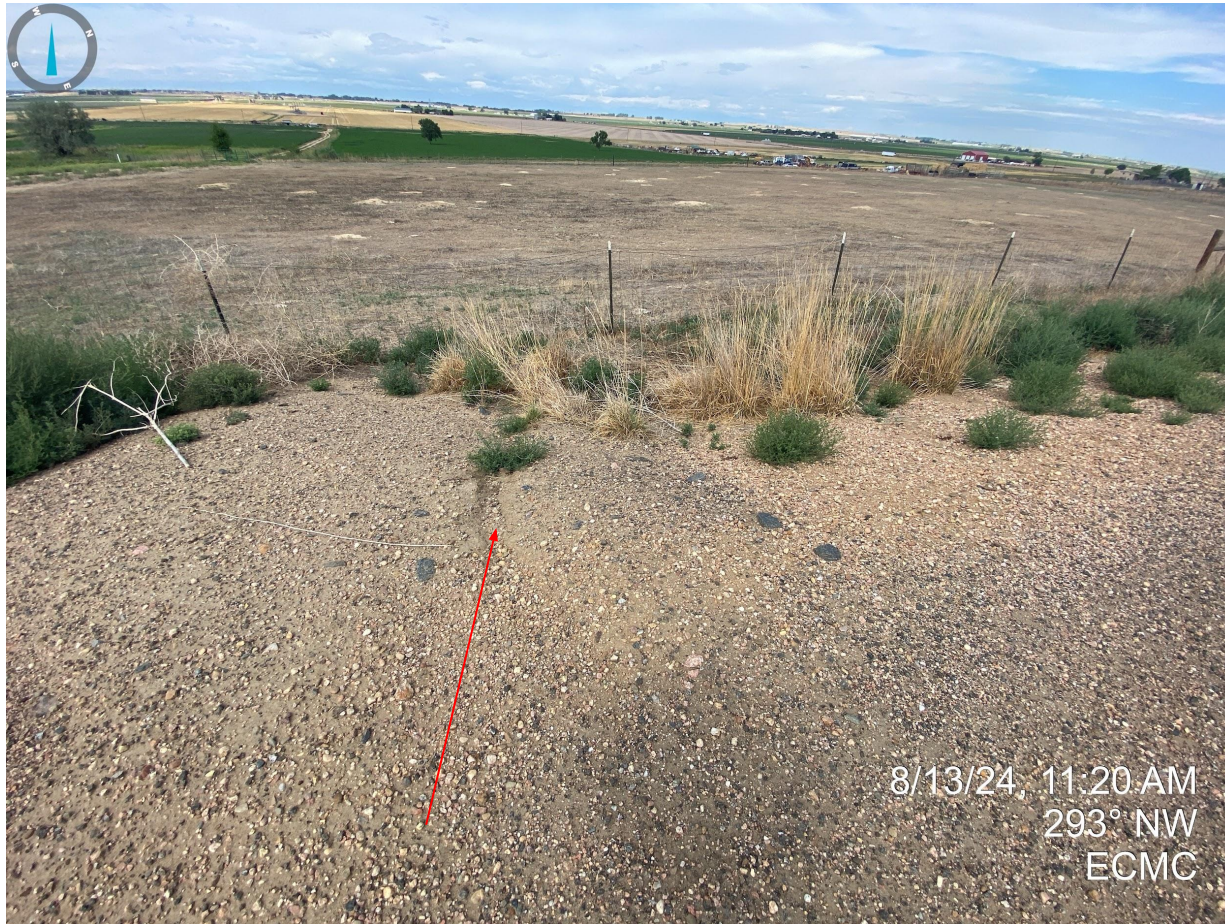
Photo 6. Erosion degradation (riling) observed on the northwest portion of the tank battery.

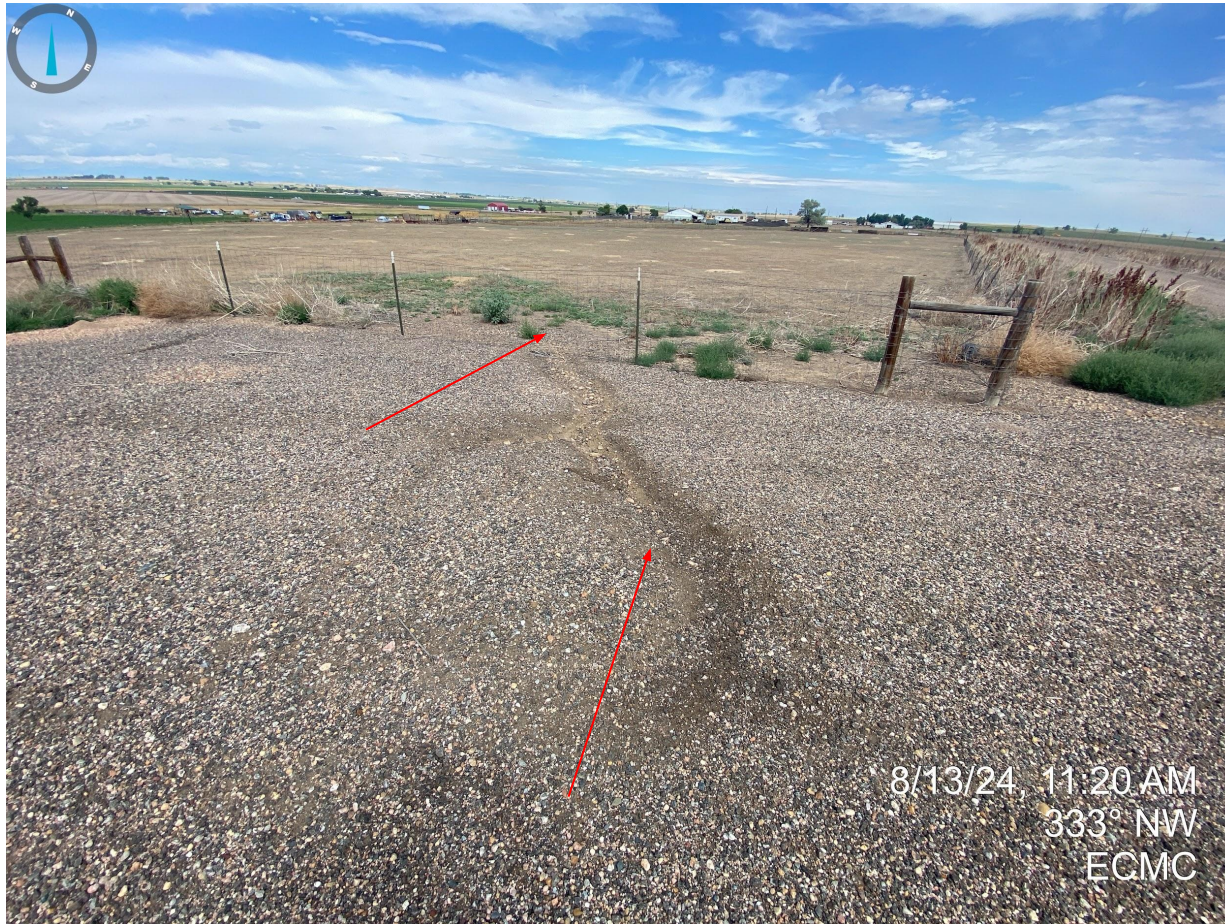
Photo 7. Erosion degradation (riling) and sediment transport into adjacent lands observed on the north portion of the tank battery.

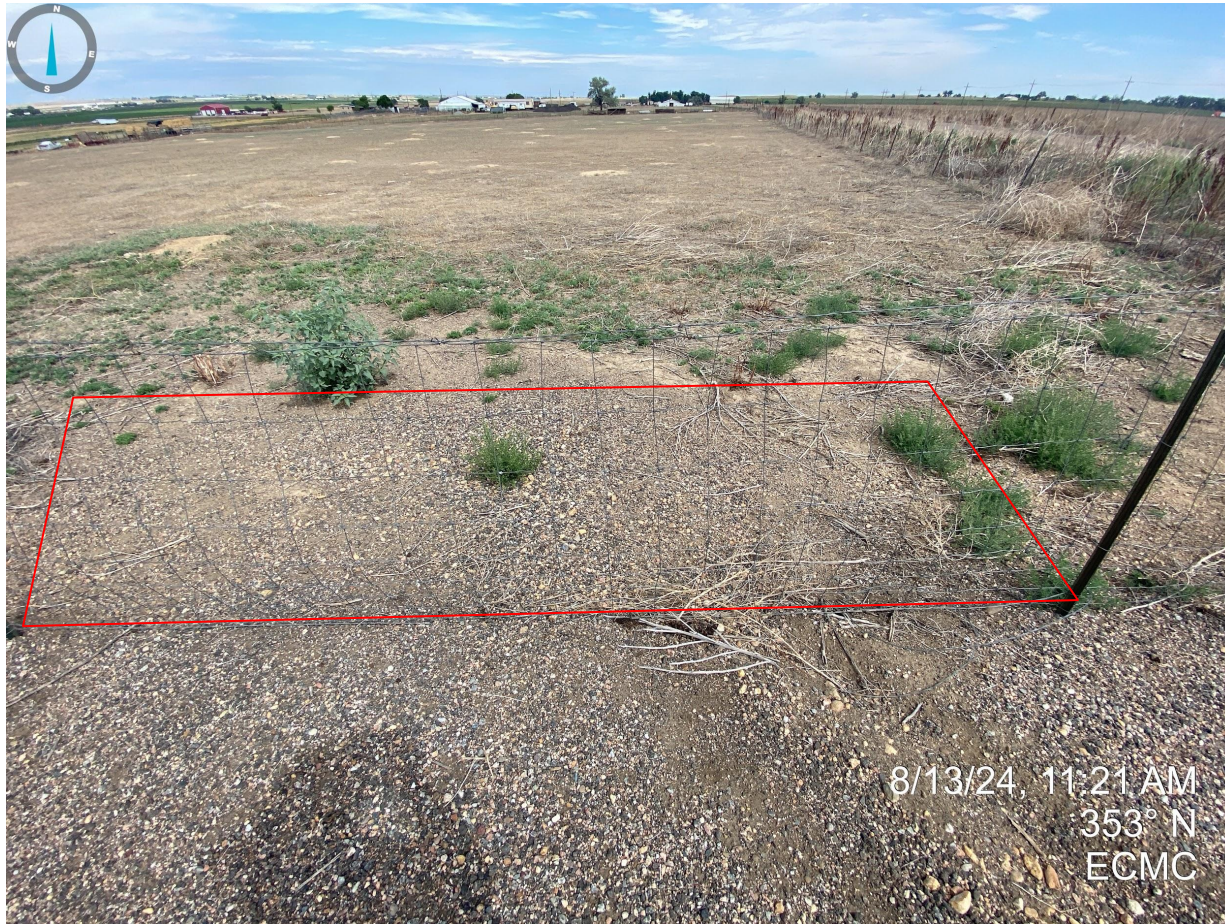
Photo 8. Continued from Photo 7; evidence of asphalt/road armour material on adjacent lands.

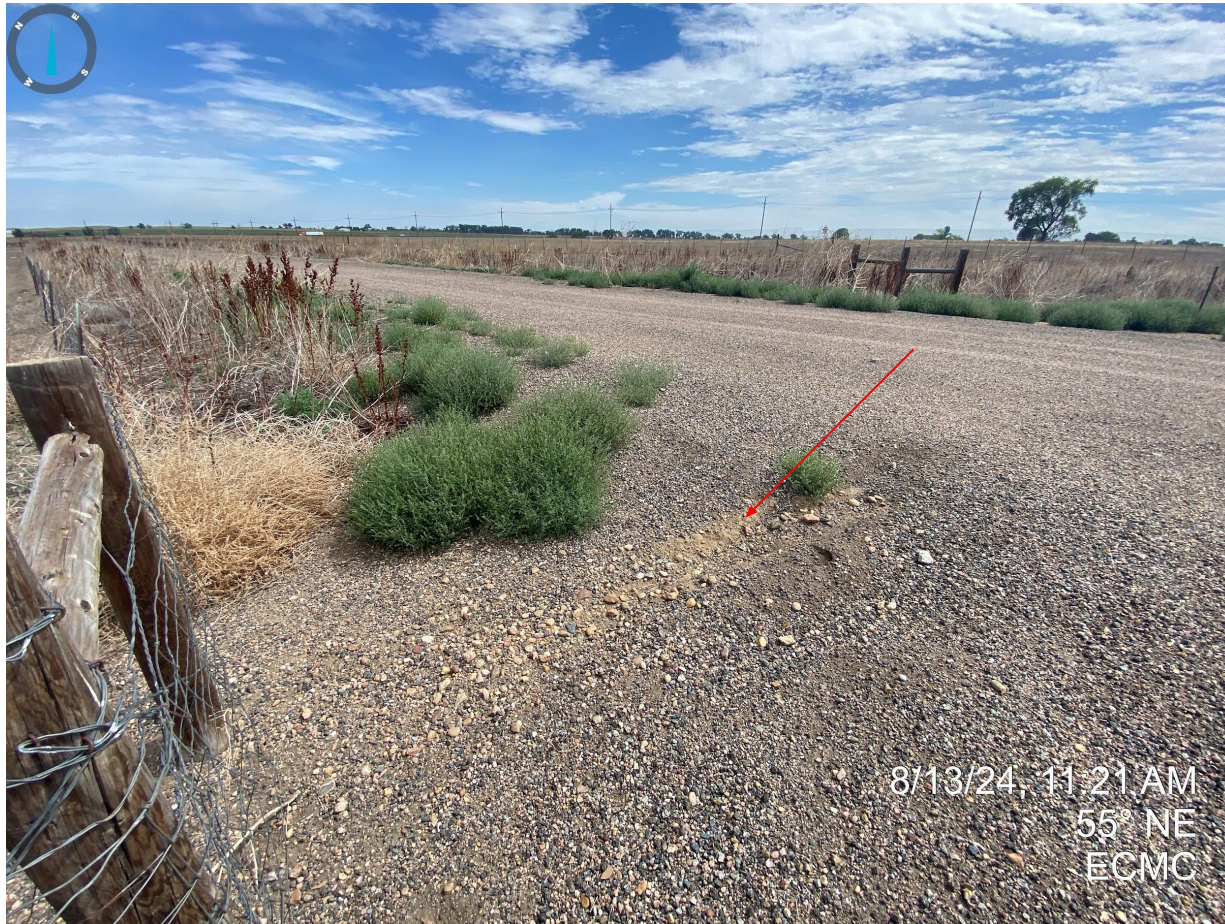
Photo 9. Erosion degradation and undesirable vegetation along the location's access road.

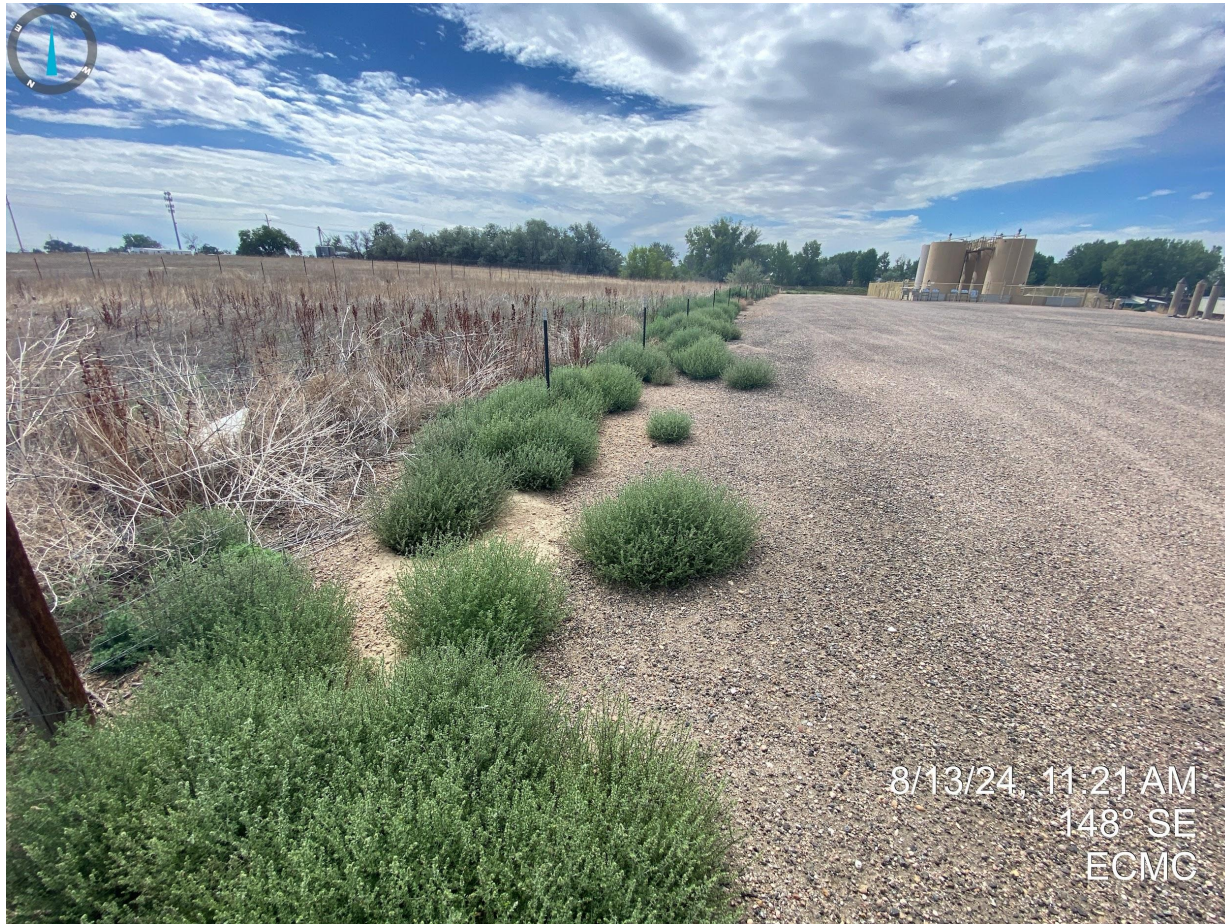
Photo 10. Undesirable vegetation (russian thistle) observed along the eastern portion of the tank battery.

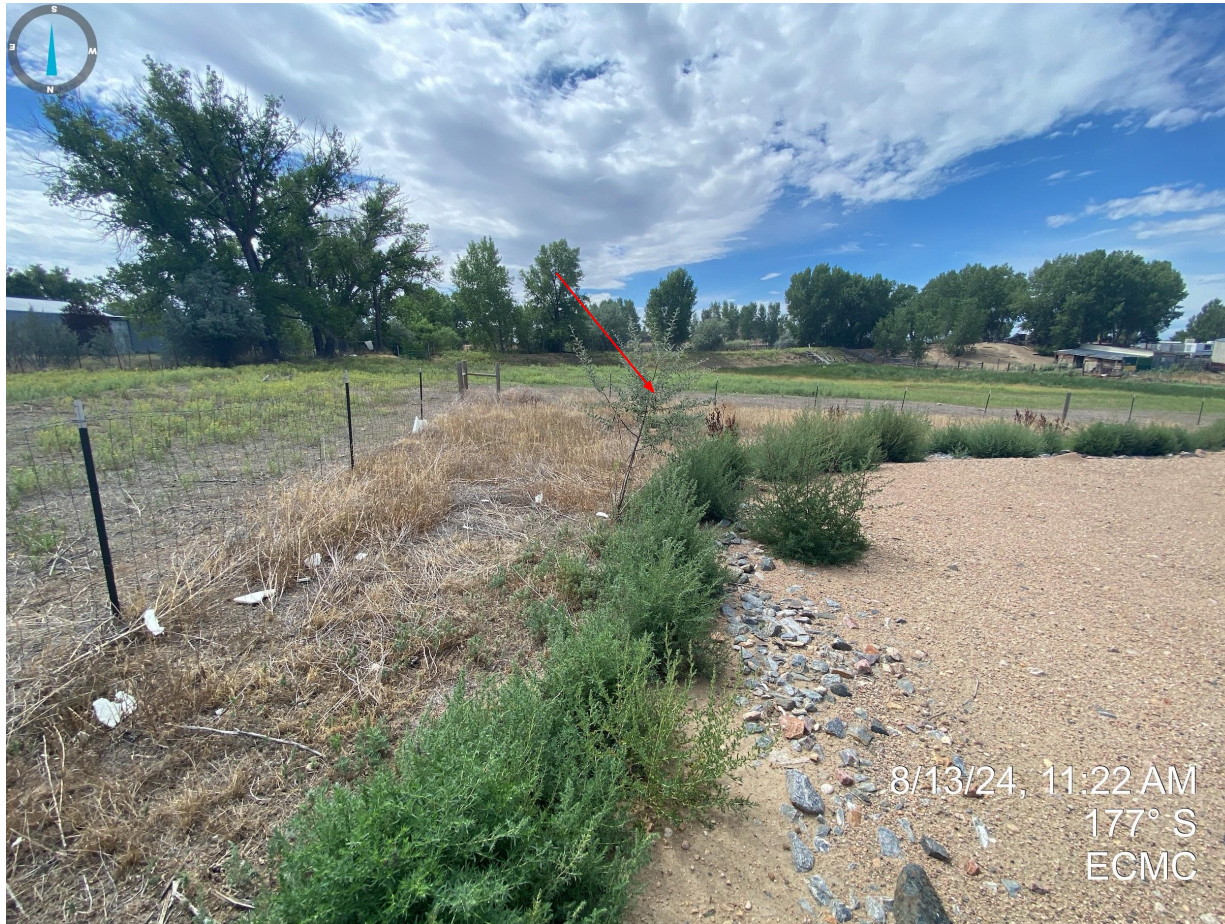
Photo 11. Russian olive (CO List B Noxious Weed) in red arrow; undesirable vegetation and trash observed near the southeast portion of the location.

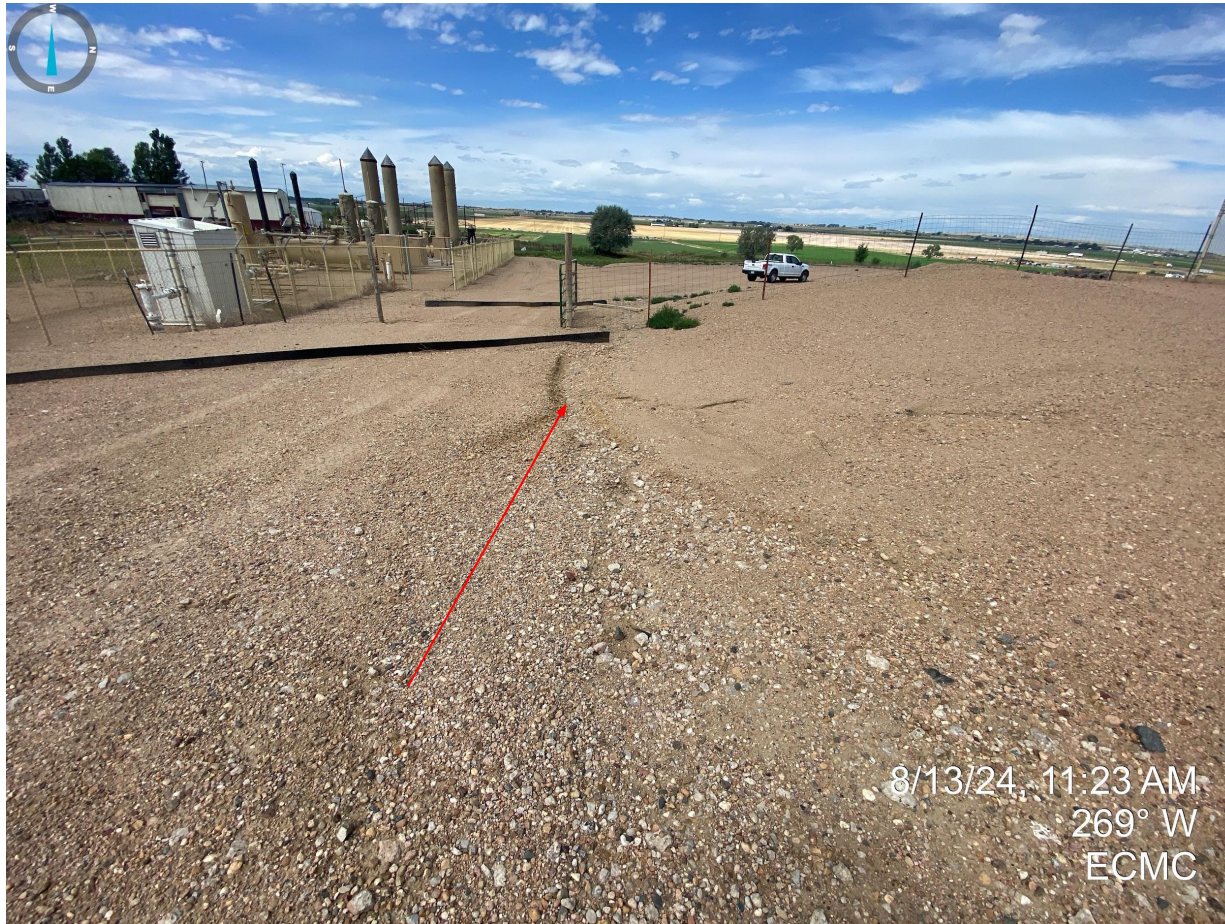
Photo 12. Erosion degradation observed south of the tank battery.

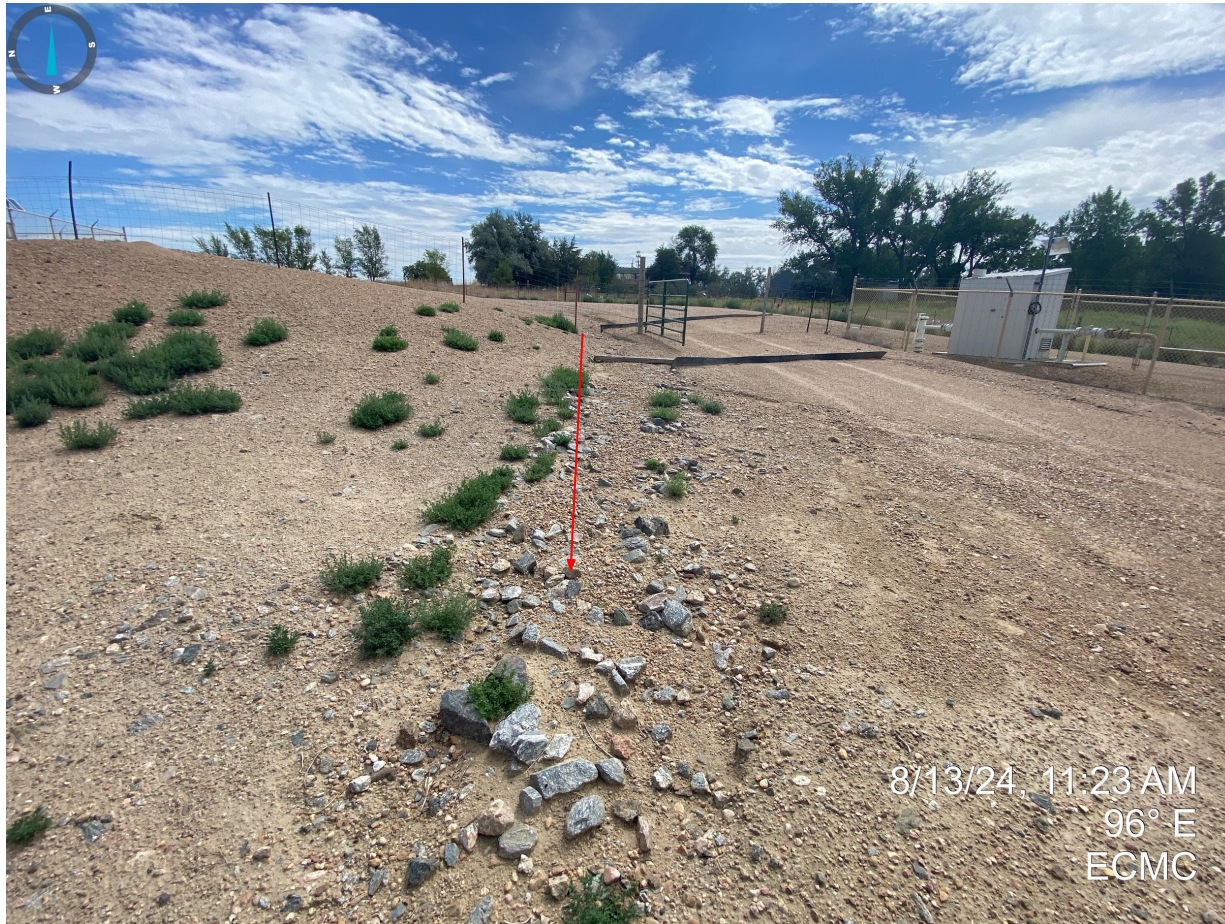
Photo 13. Continued from Photo 12; photo illustrates sediment transport onto lower portions of the access road/production areas.

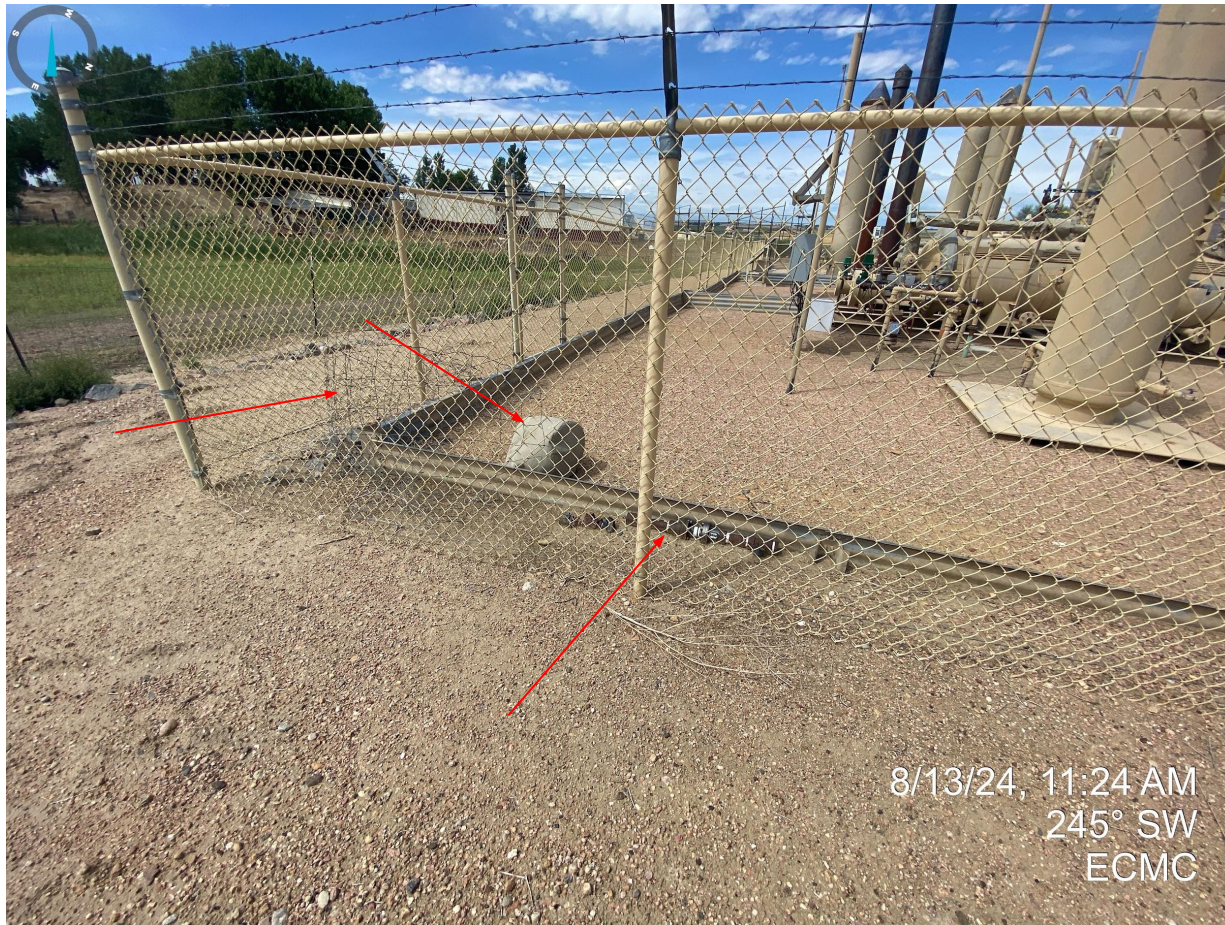
Photo 14. Unused equipment and debris observed within production equipment.

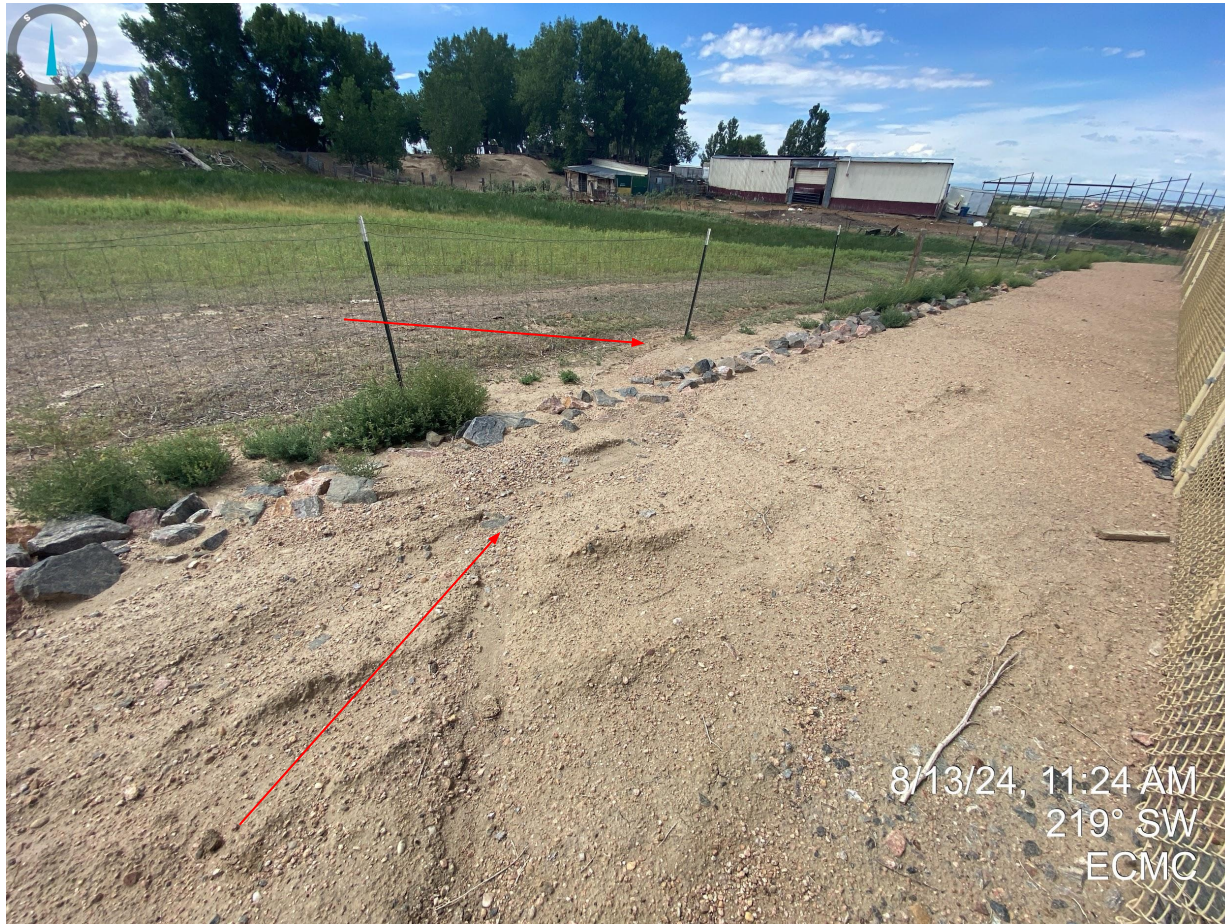
Photo 15. Erosion degradation (riling) along the southern portion of the location, near production equipment.

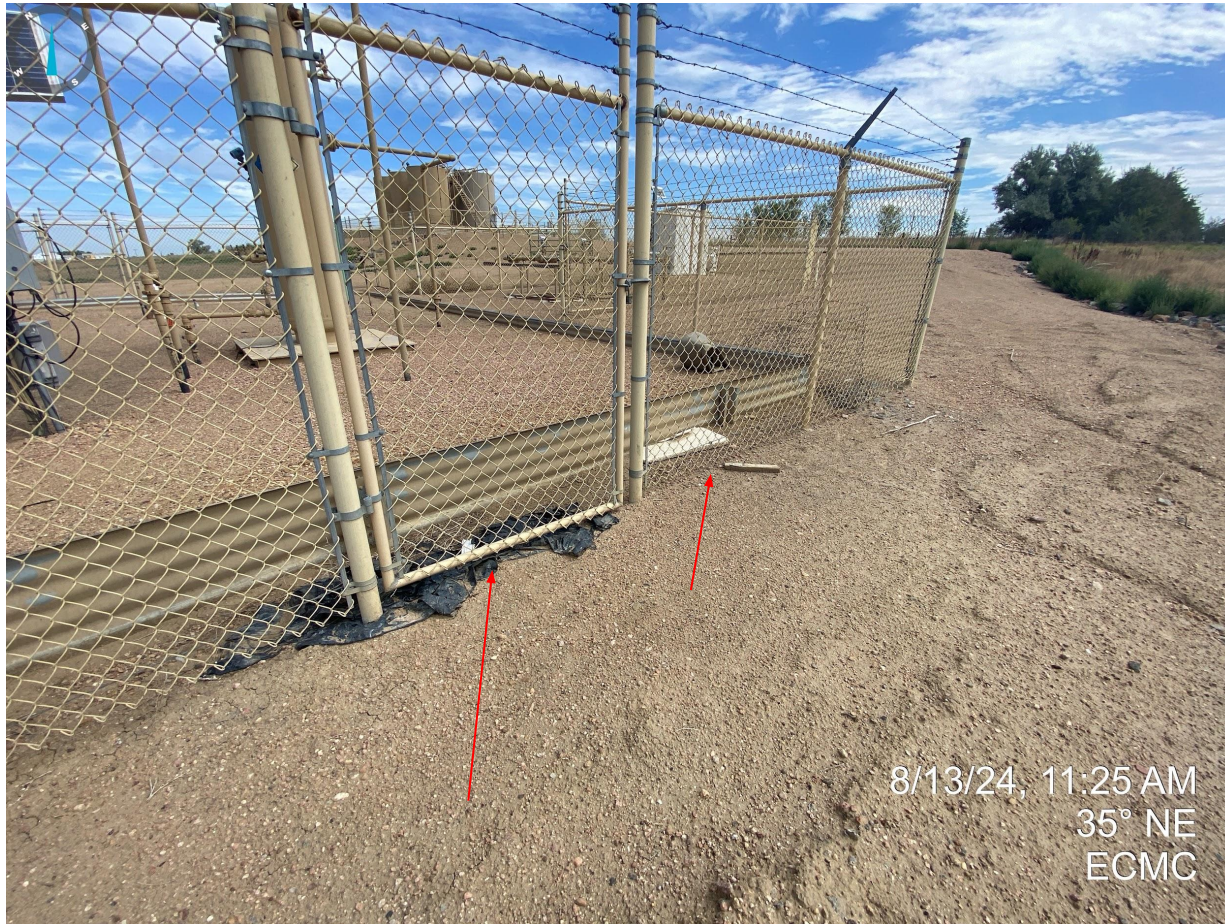
Photo 16. Trash and debris observed on the southern portion of the location.

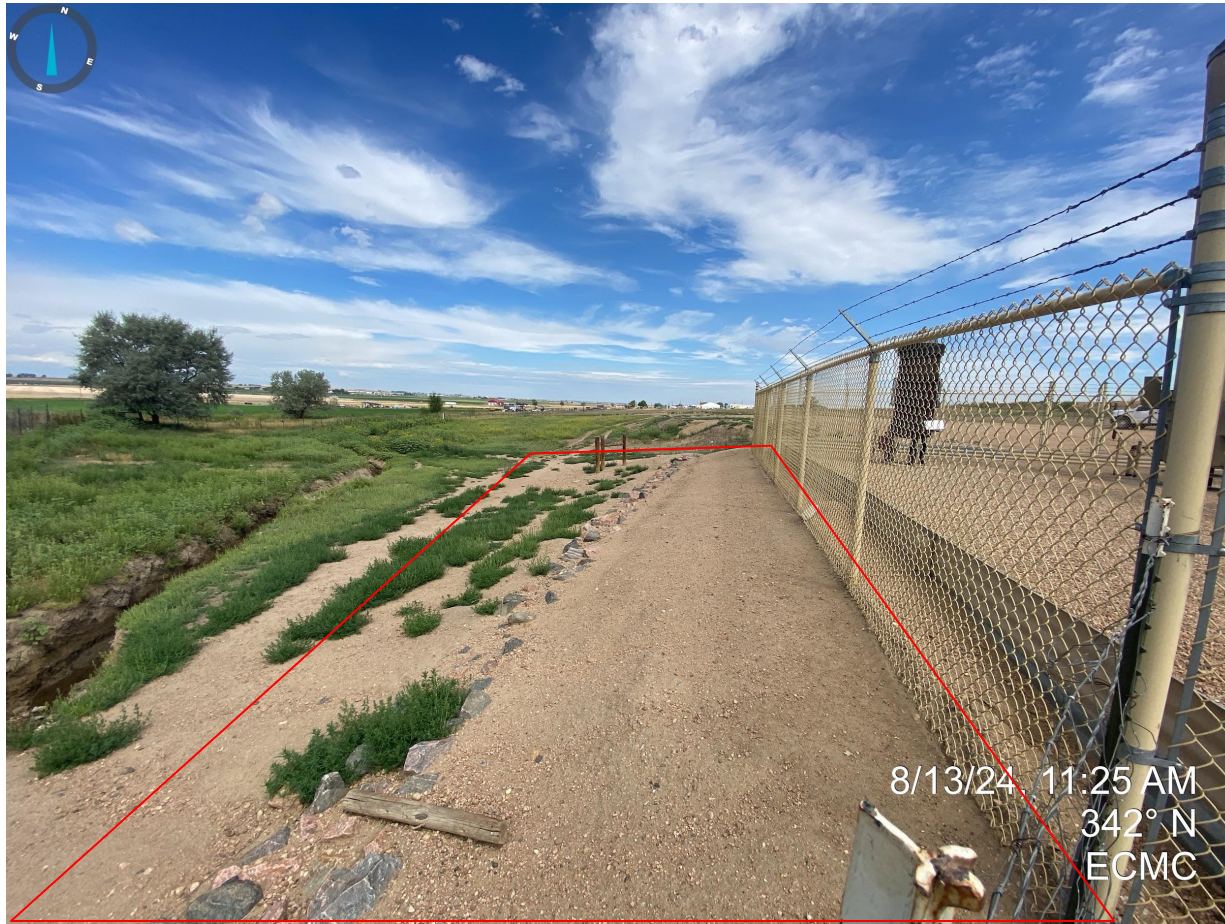
Photo 17. No apparent stormwater control measures observed on the southwest corner of the location, near adjacent irrigation ditch.

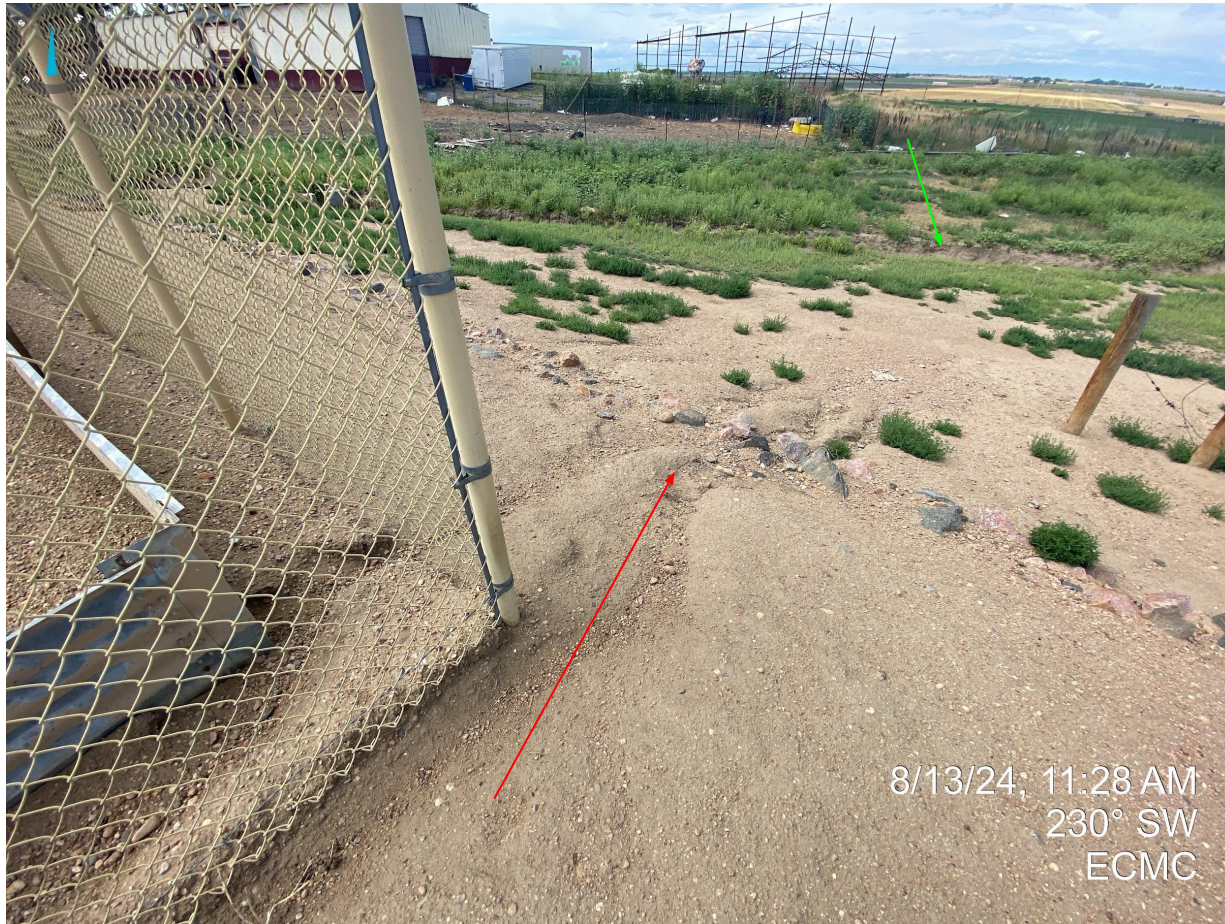
Photo 18. Erosion degradation observed on the northwest corner of fenced production equipment; no apparent stormwater control measures near adjacent irrigation ditch (green arrow).

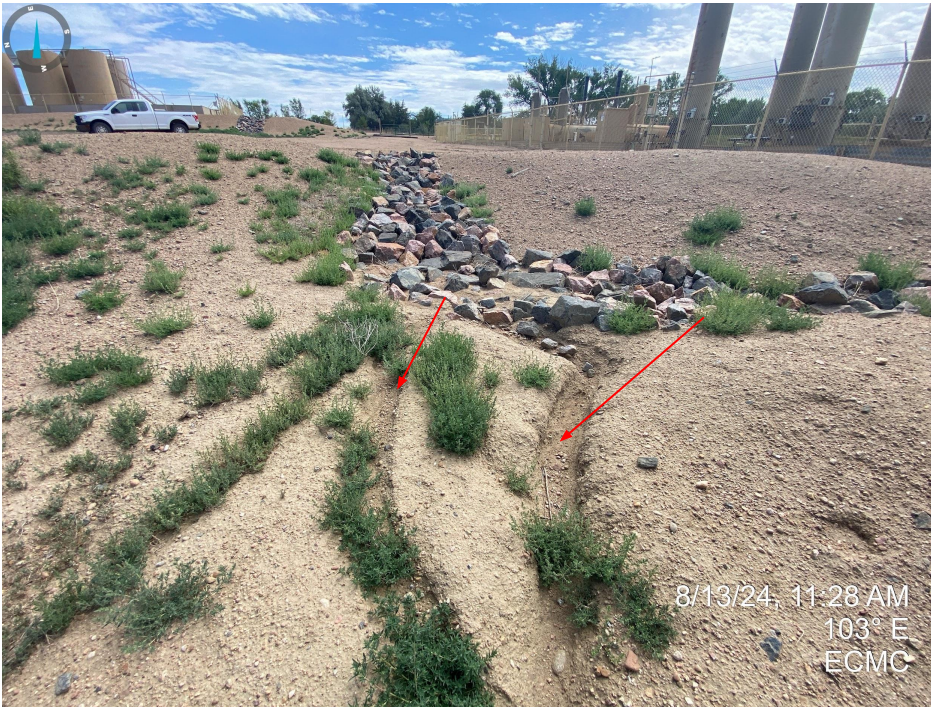
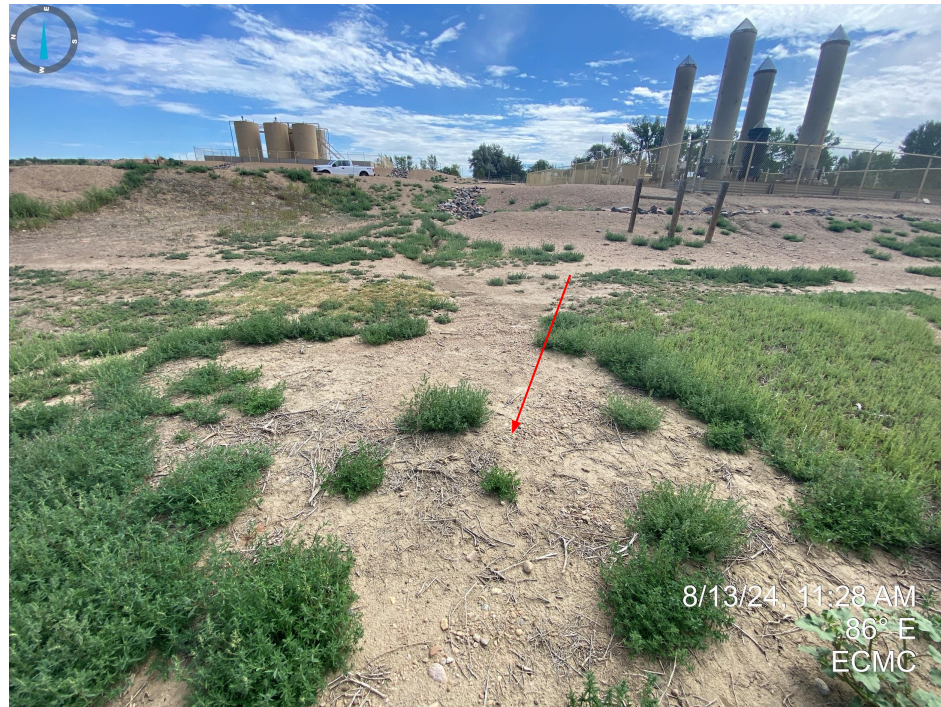
Photos 19 & 20. Erosion degradation and evidence of off location sediment transport observed on the northwest portion of the fenced production equipment.
