Interim Reclamation and Stormwater Inspection

Operator: CRESTONE PEAK RESOURCES OPERATING
LLC - 10633

Location ID: 331608

Inspection Document #: 708201512

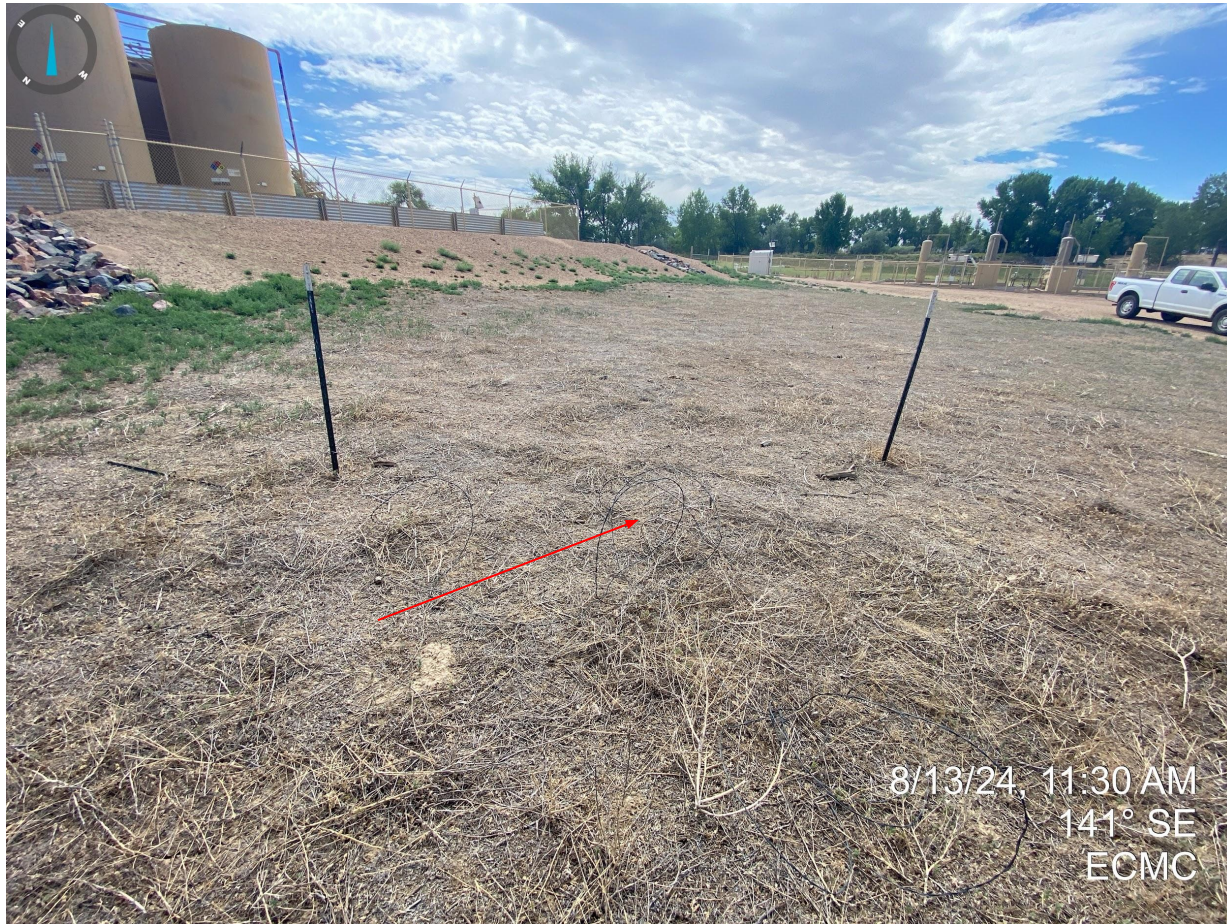
Photo 21. Unused equipment/debris observed on the northern portion of the interim areas (red arrow-fence). Additionally, the interim areas (background) do not appear to be progressing towards reclamation standards with no desirable perennial vegetation observed.

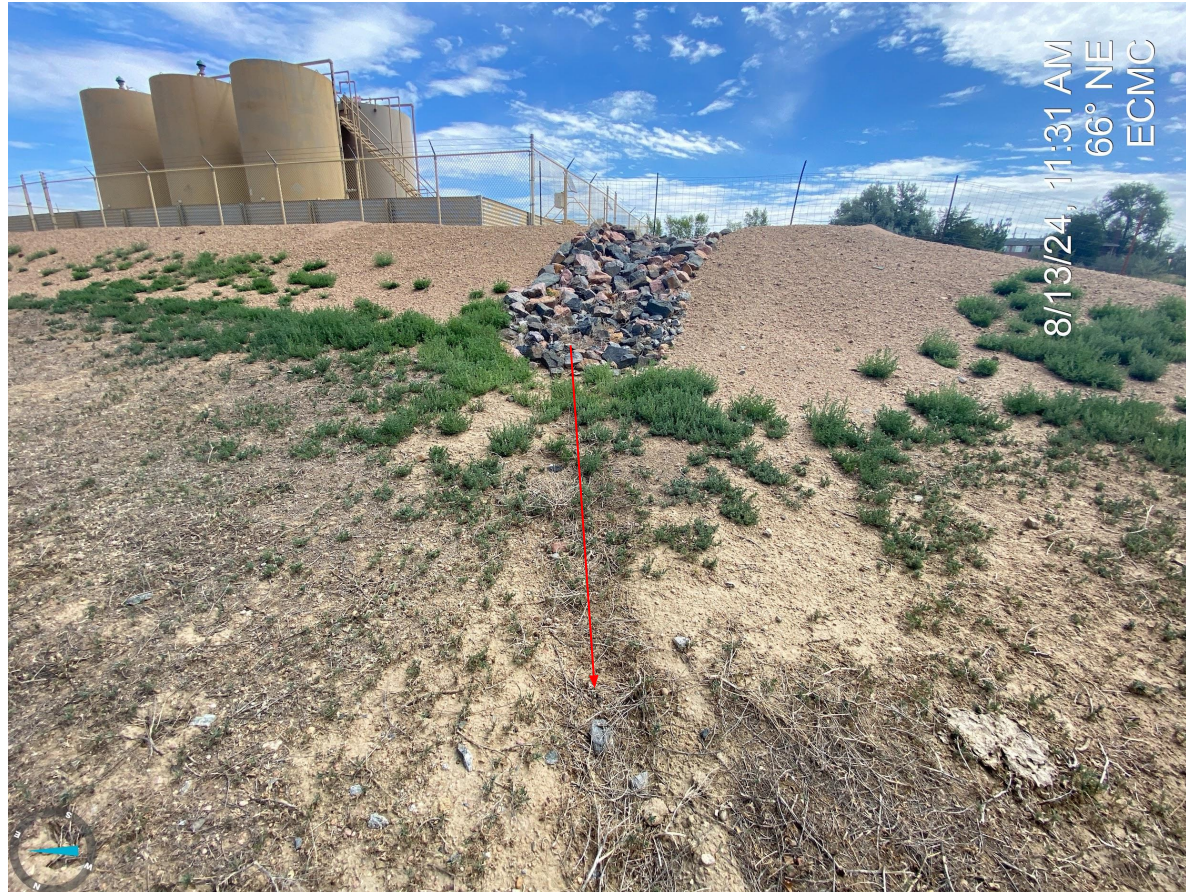
Photo 23. Erosion degradation observed at the outlet of control measure.
