Inspection Photos
Location Name: Frederick Unit A1
Location ID: 336452

Energy & Carbon Management Commission
40.11418, -104.94266, 4910.5ft, 129°
08/19/2024 12:34:37

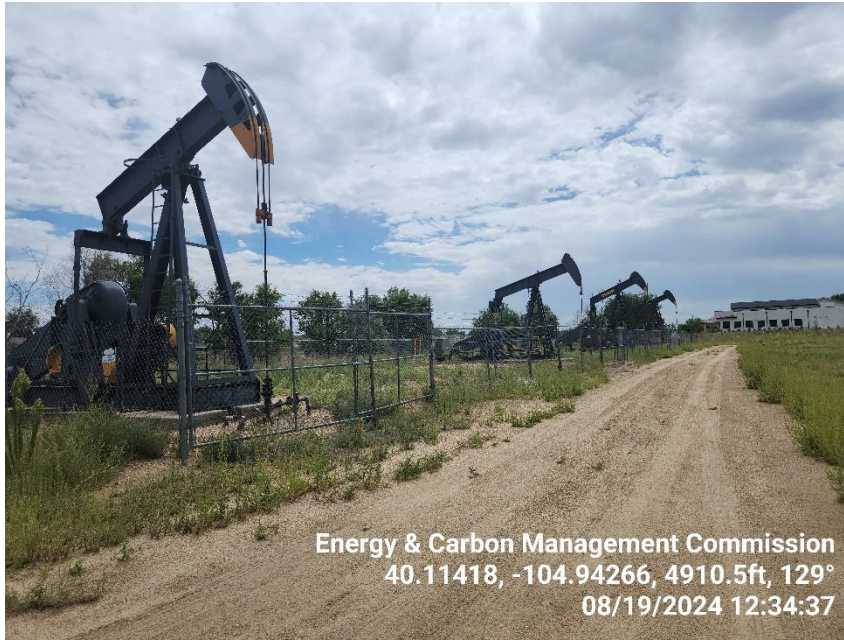
Photo 1 Location tall vegetation inside and outside of the fencing.

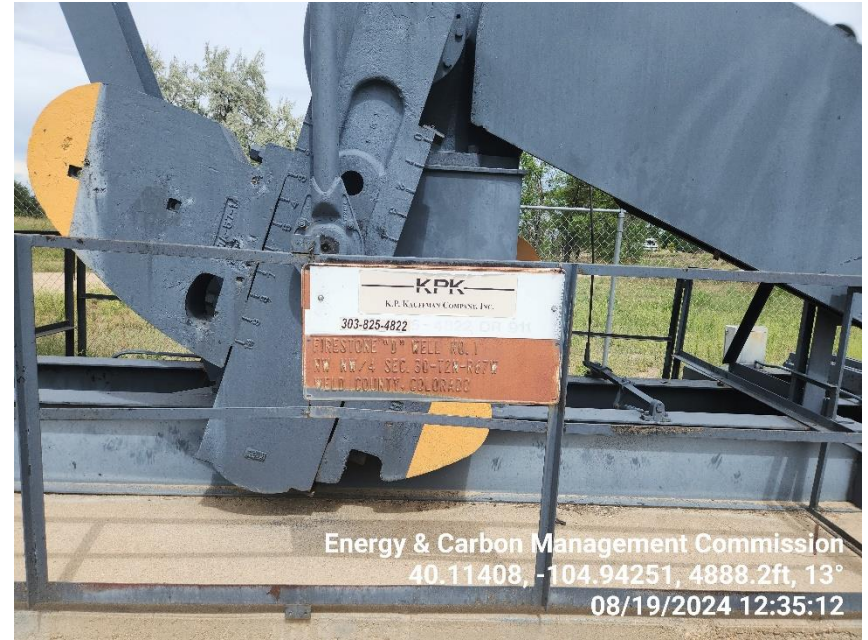
Photo 2 WH sign.

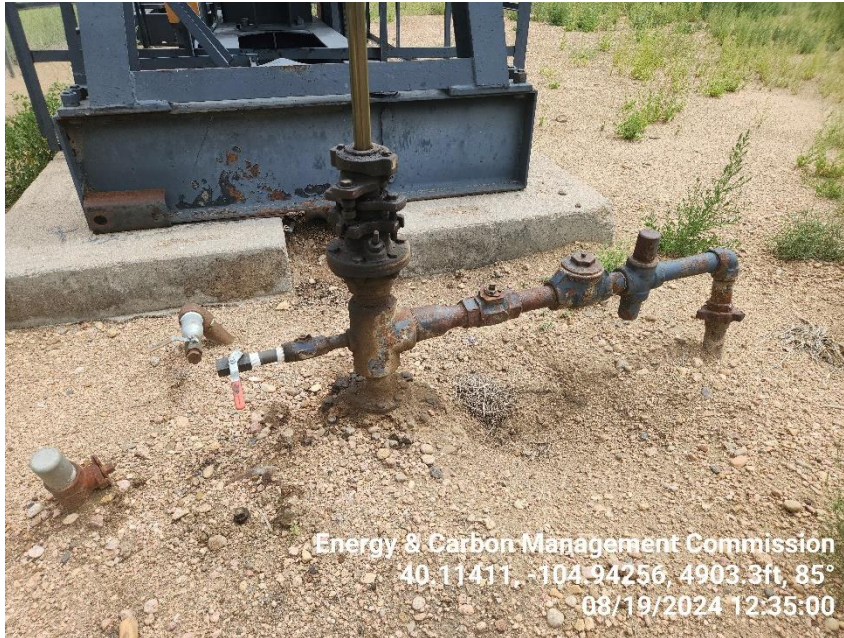
Photo 3 WH.

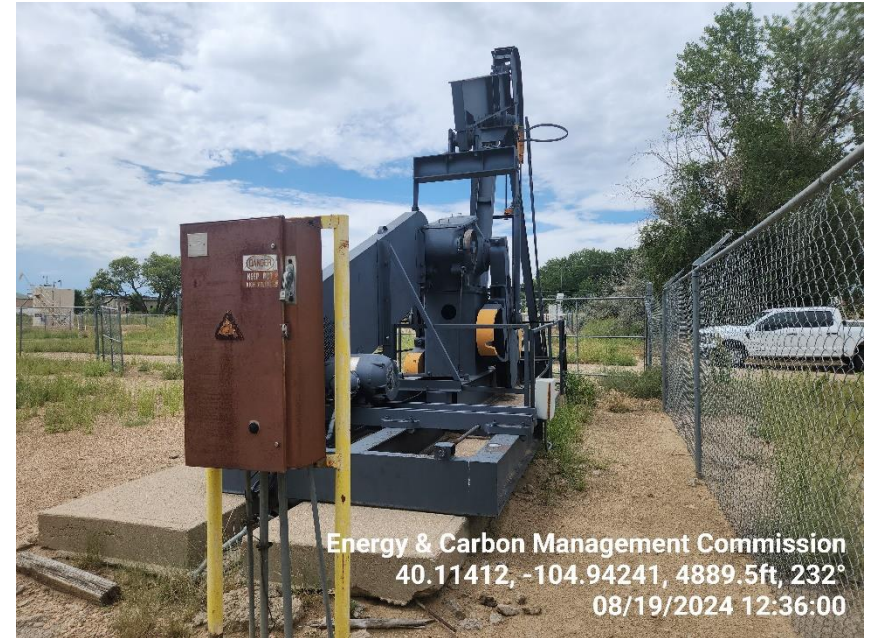
Photo 4 Electric panel and pump jack.

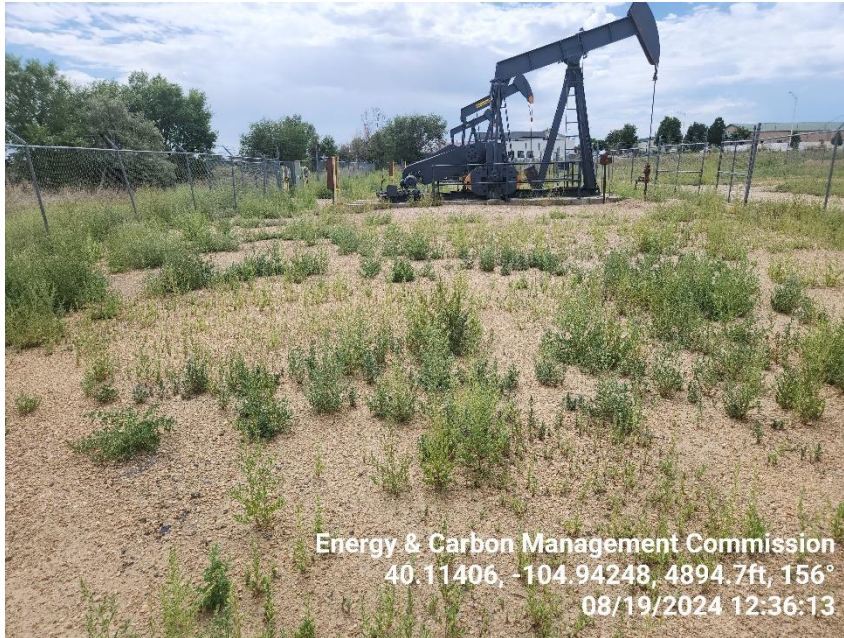
Photo 5 Tall vegetation throughout location.

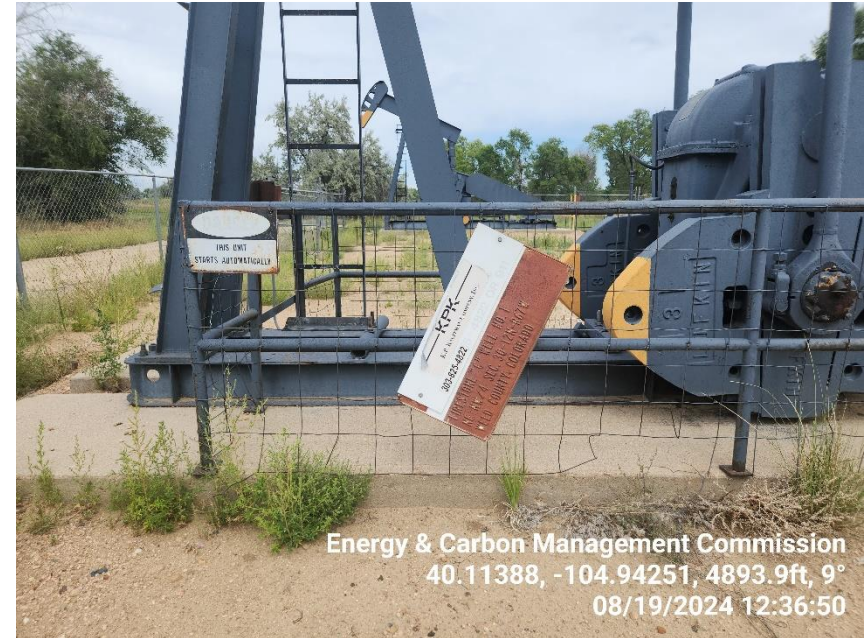
Photo 6 WH sign.

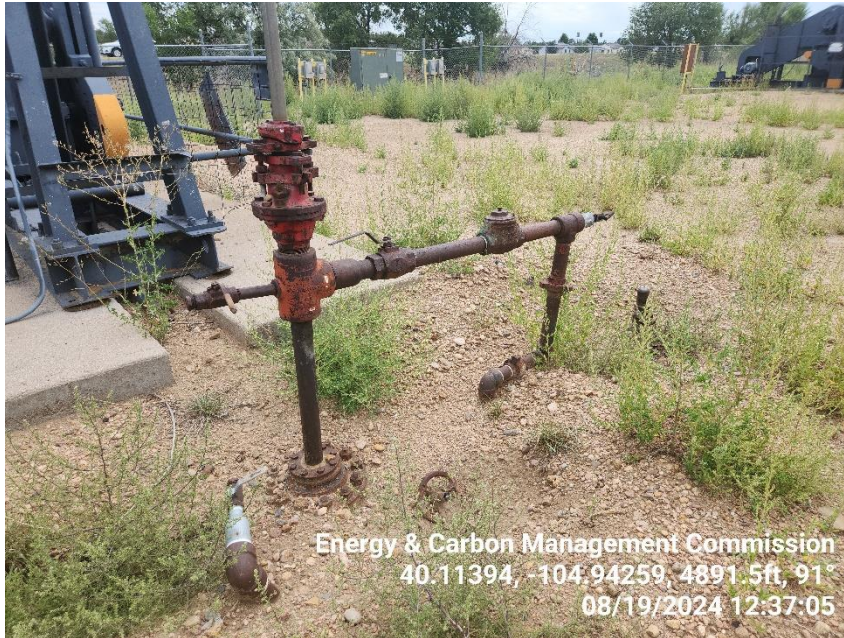
Photo 7 WH.

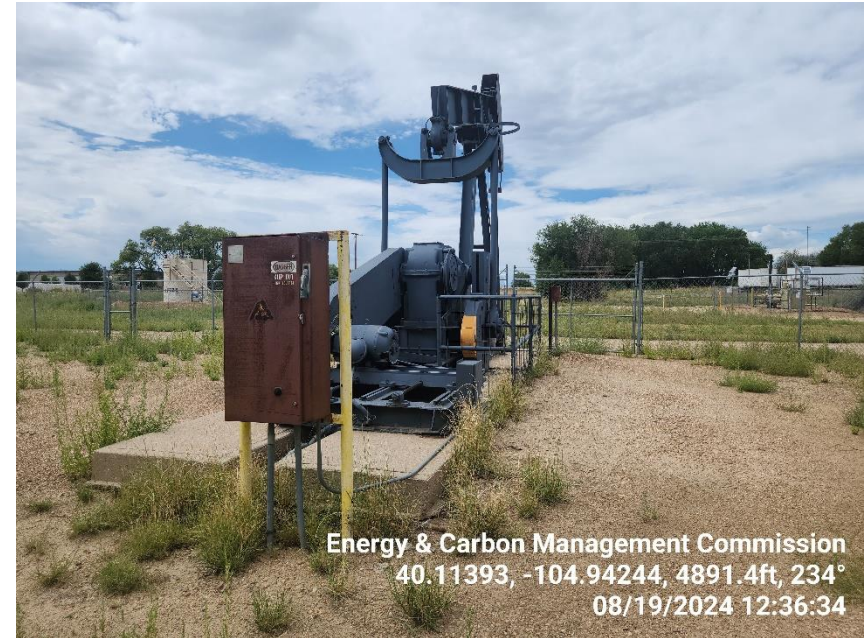
Photo 8 Electric panel and pump jack.

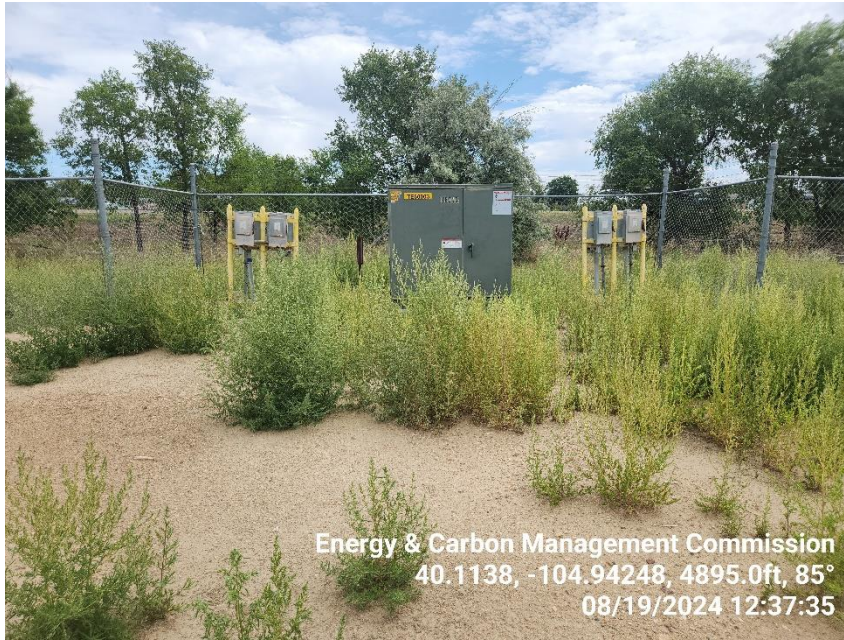
Photo 9 Transformers, meter boxes.

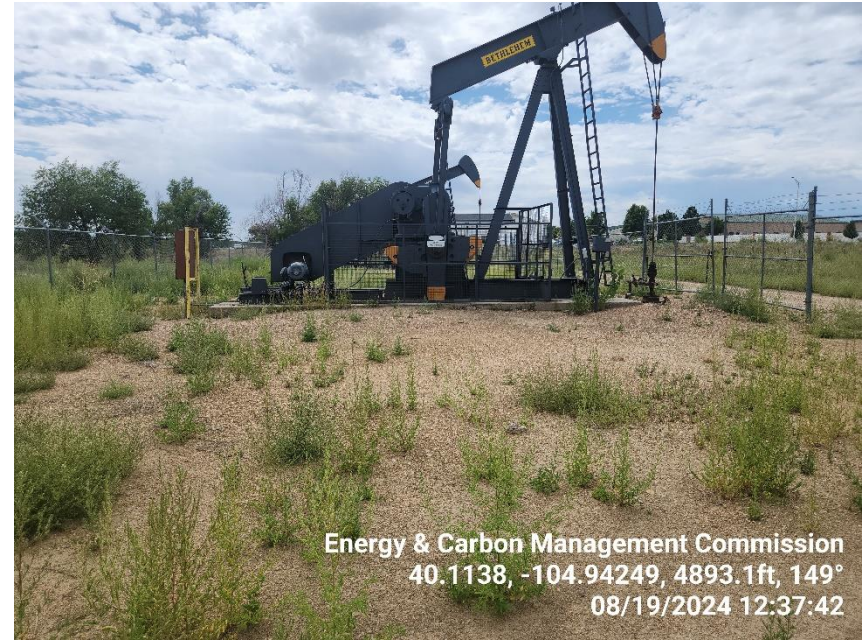
Photo 10 Tall vegetation throughout location.

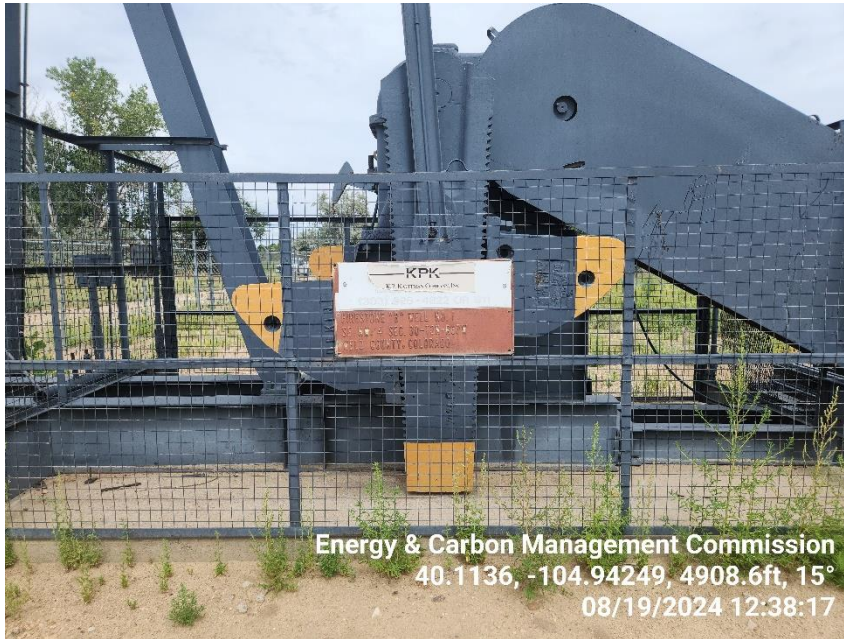
Photo 11 WH sign.

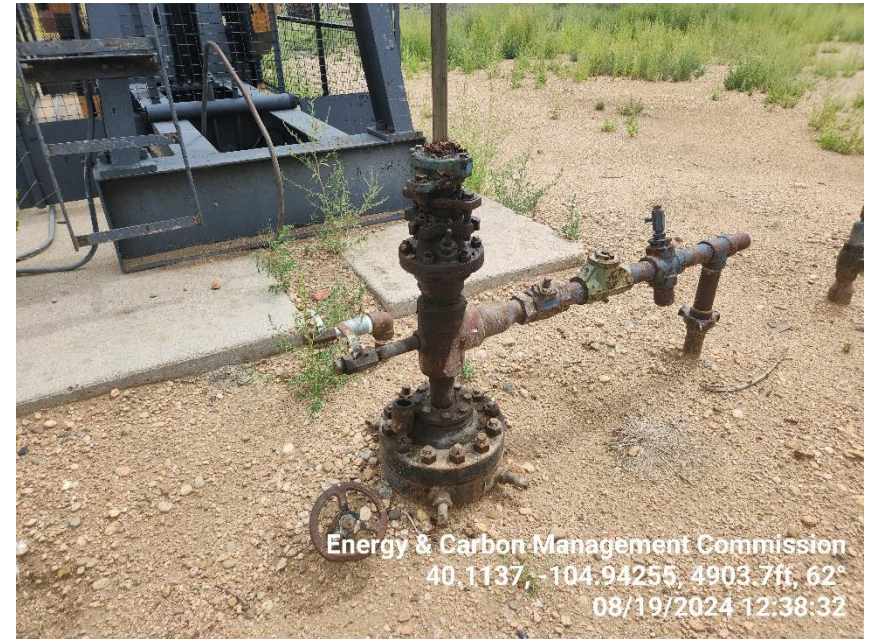
Photo 12 WH.

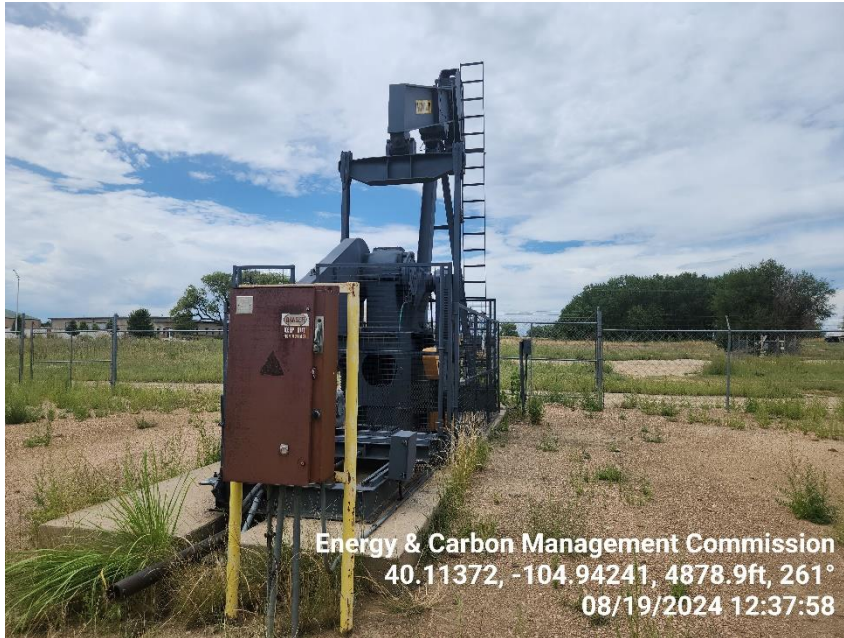
Photo 13 Electric panel and pump jack.

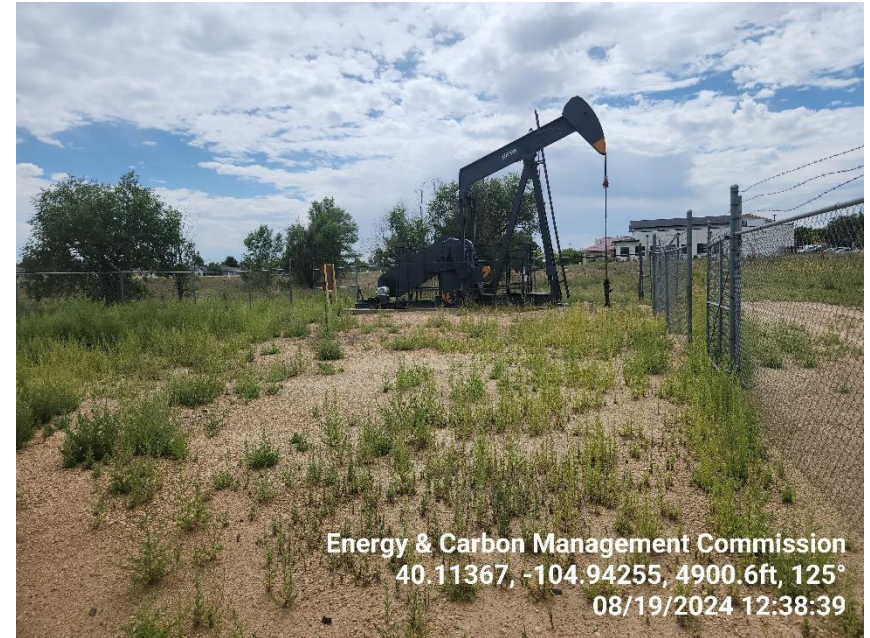
Photo 14 Tall vegetation throughout location.

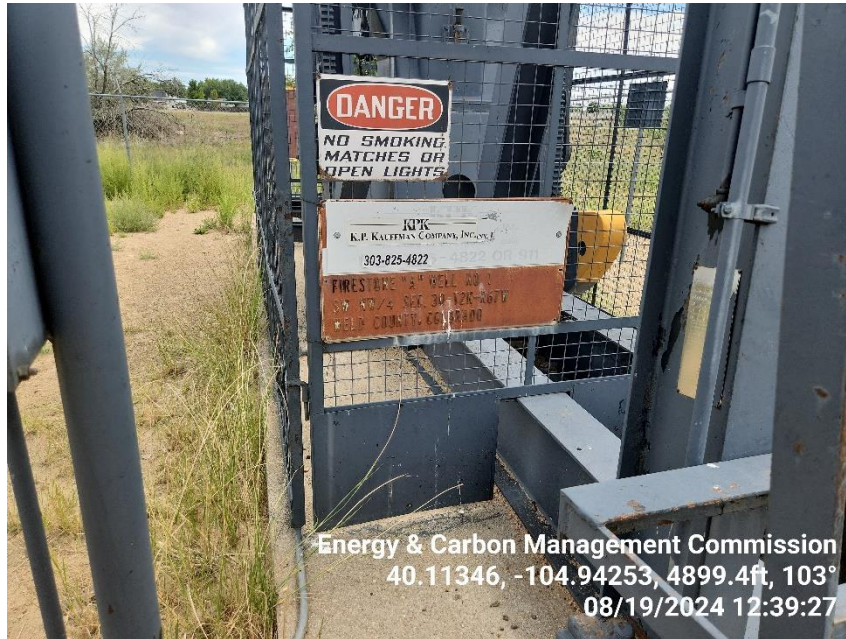
Photo 15 WH sign.

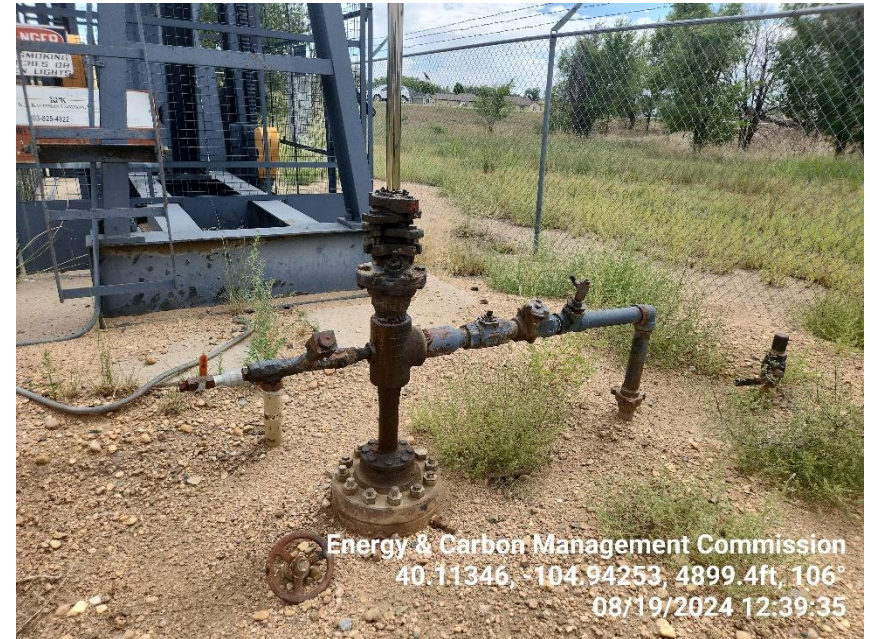
Photo 16 WH.

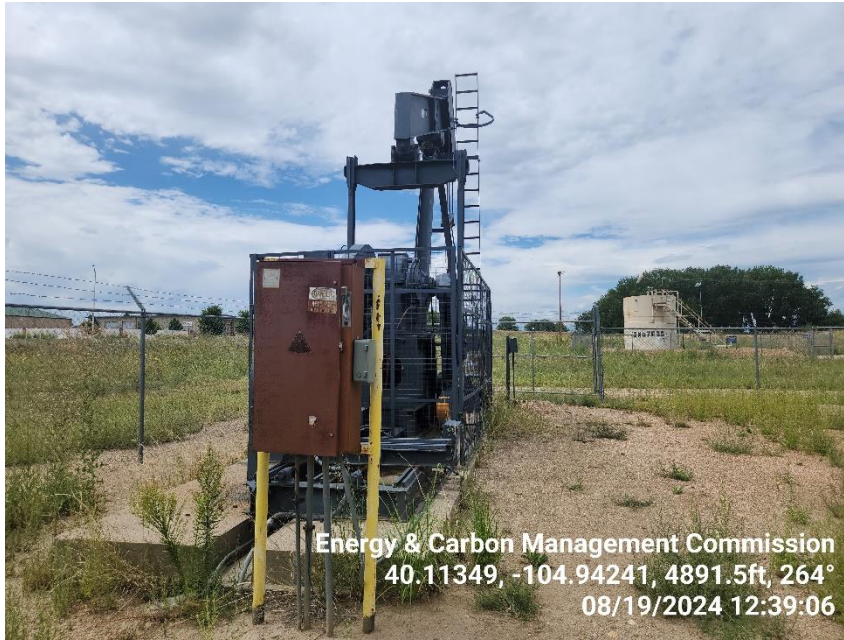
Photo 17 Electric panel and pump jack.

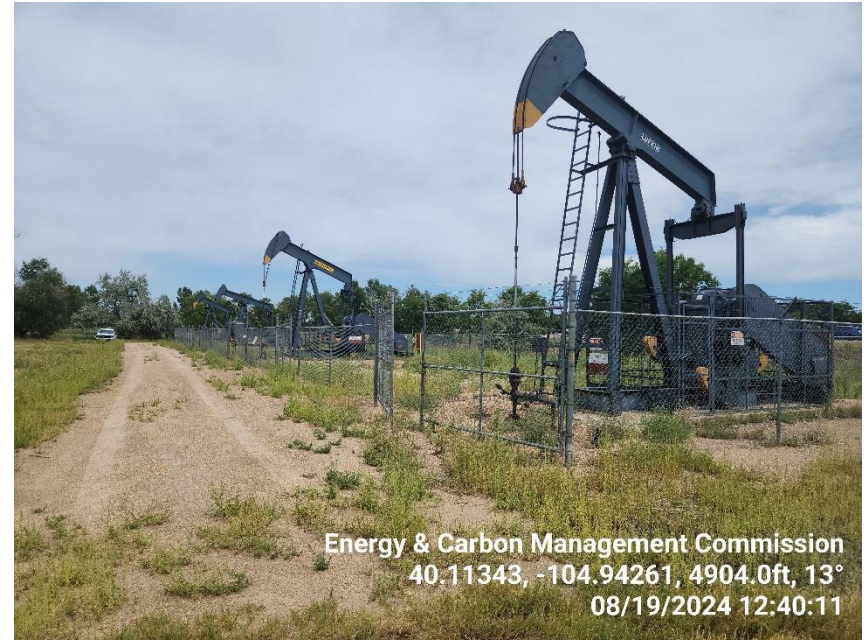
Photo 18 Location tall vegetation inside and outside of the fencing.
