Inspection Photos

Operator: TEP ROCKY MOUNTAIN LLC #96850

Location ID: 323916

Inspection Doc: 696206148

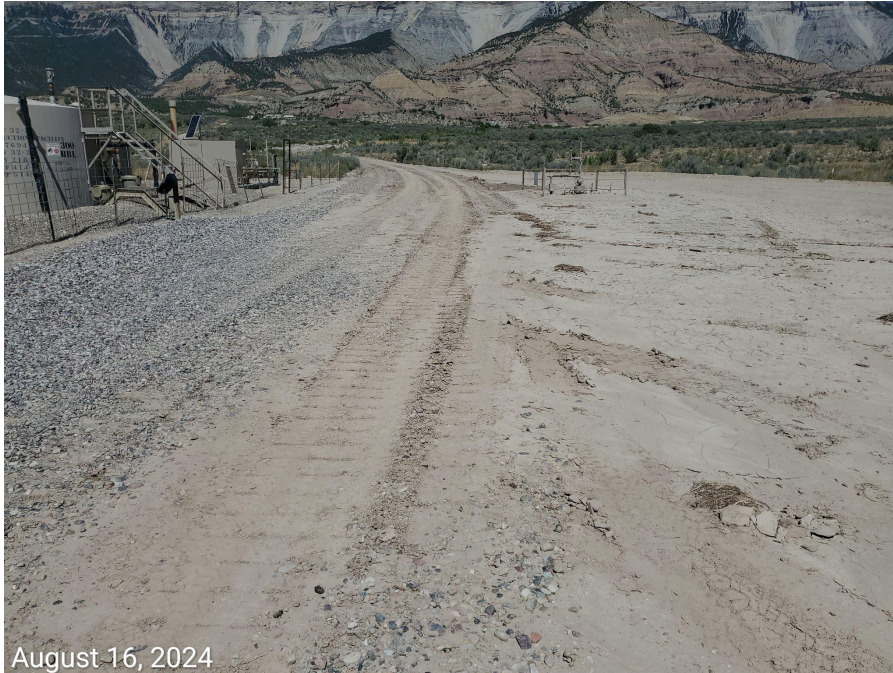
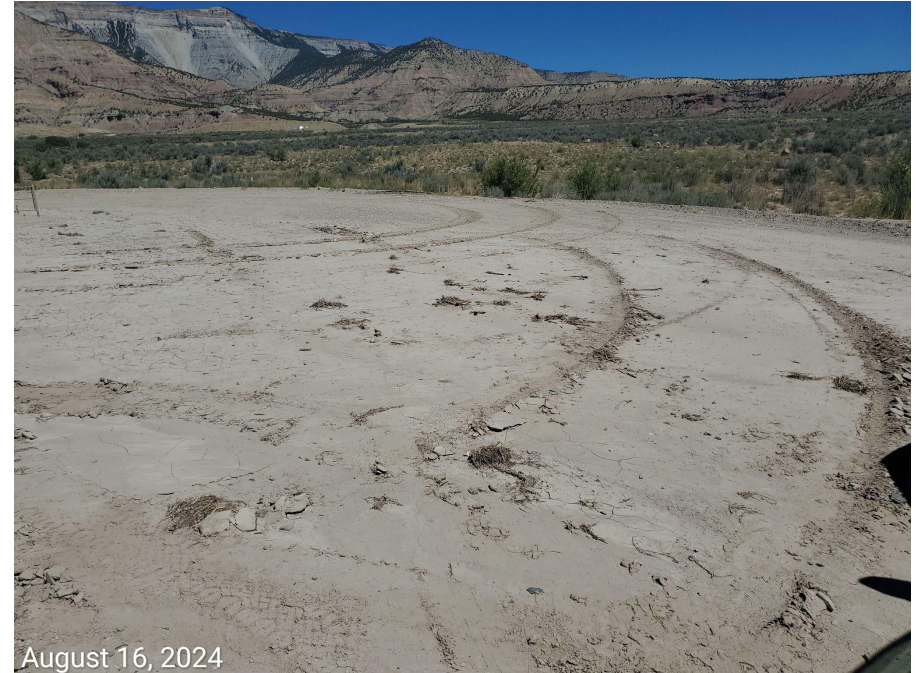
Photo 1: Photos taken from the Location entrance on the south end of the site, facing northwest and north. BMPs to stabilize, as well as to minimize tracking and sediment transport at the working pad surface of the Location remain missing or insufficient. Gravel appears to have only been implemented along the western areas of the site to address tracking and stabilization concerns; gravel has largely filled with sediment and has not been maintained; unable to observe evidence that BMPs had been implemented to address stabilization and tracking concerns within the eastern half of the working pad surface.

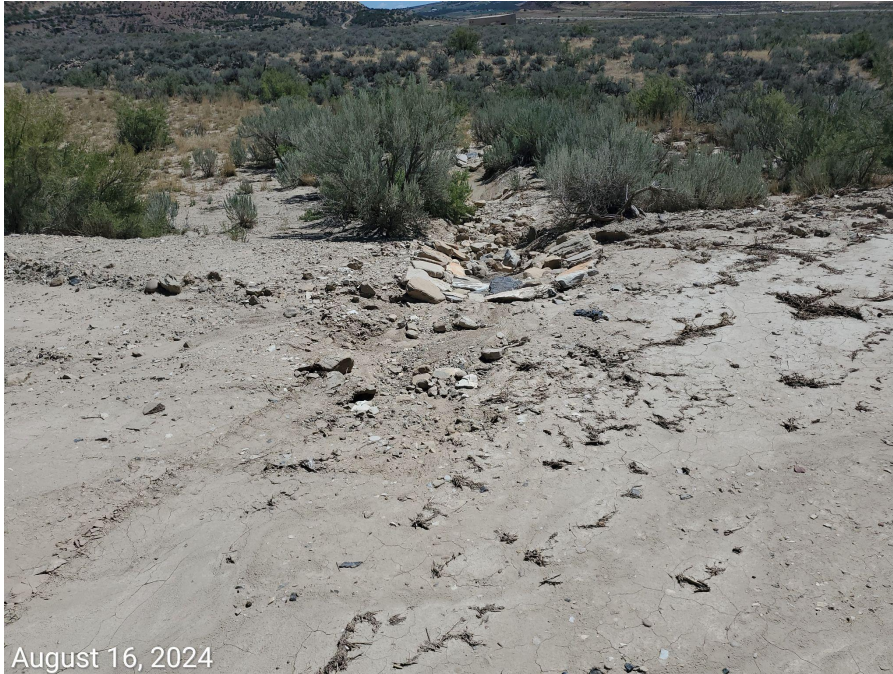
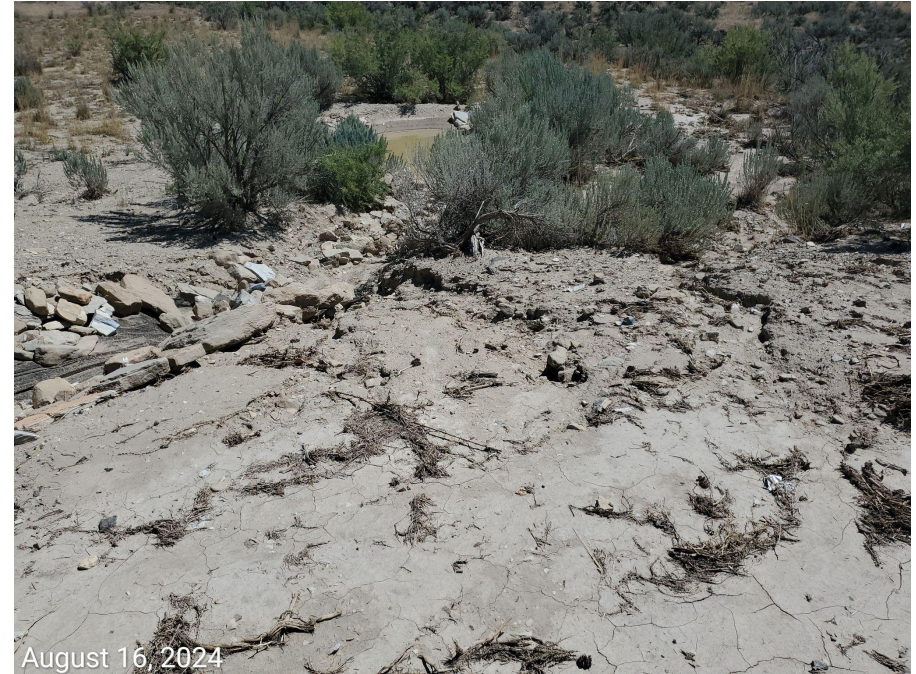
Photo 2: Photos 2-4 taken from the east end of the Location. Photos examples showing BMPs on the east end of the working pad surface to properly manage runoff remain inadequate. Outlets have not been installed or maintained per good engineering practices; BMPs to properly divert stormwater to the outlet and sediment trap are also insufficient and/or not per good engineering practice, resulting in persisting erosion, degradation and sediment transport.

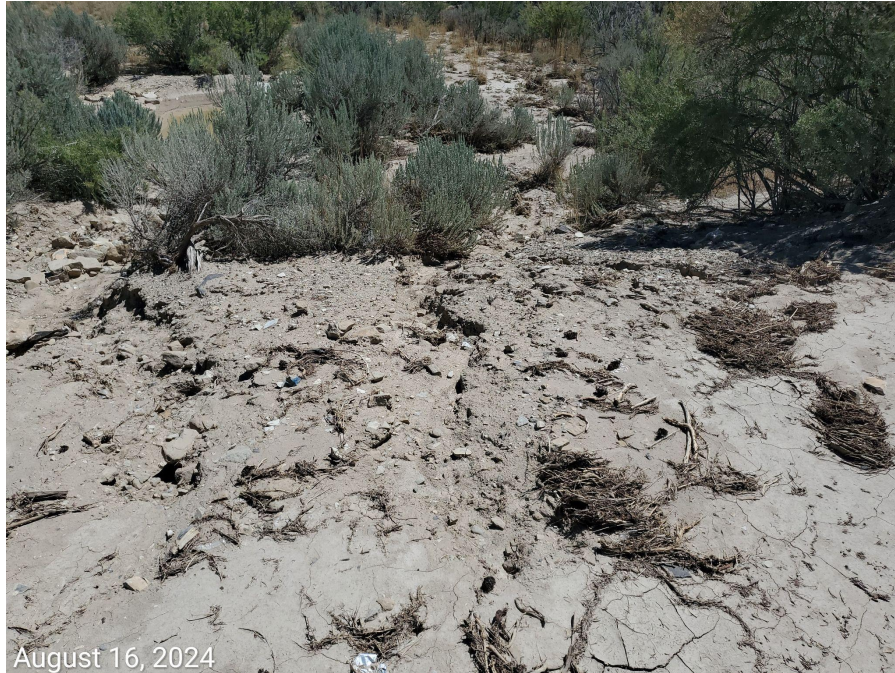
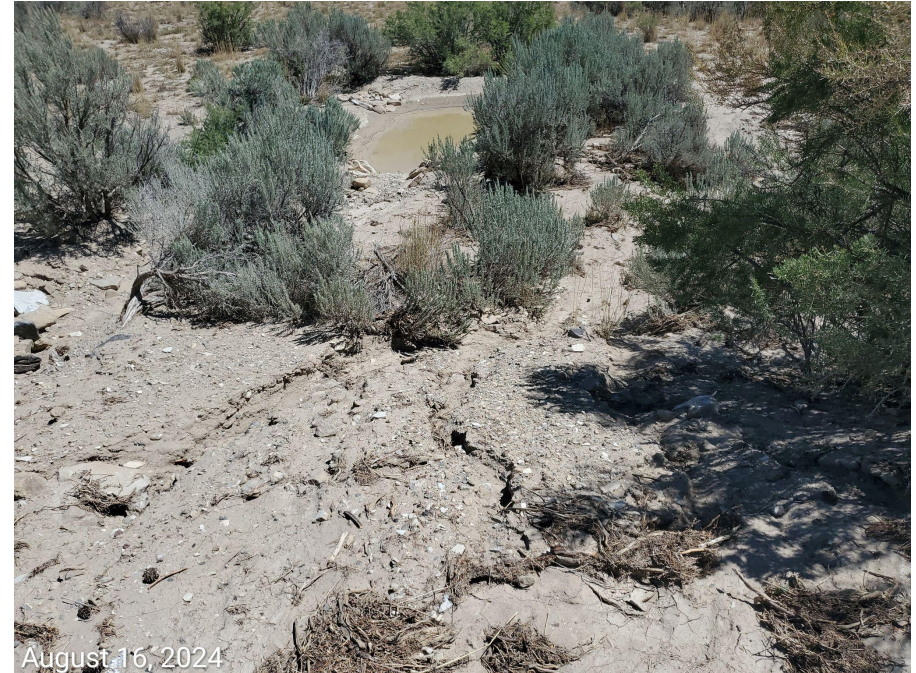
Photo 3: See comments under photo 2.

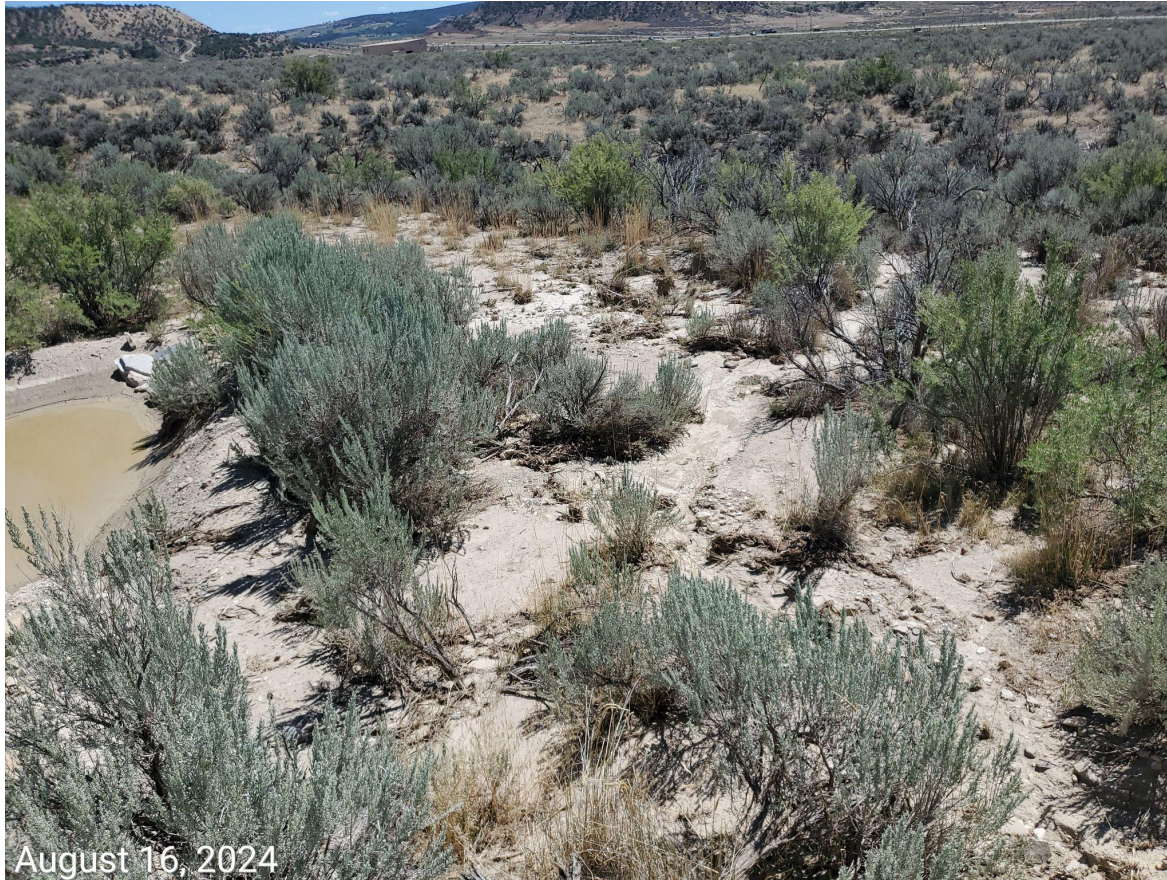
Photo 4: See comments under photo 2. Photo also shows off-site sediment deposition due to inadequate stormwater controls.

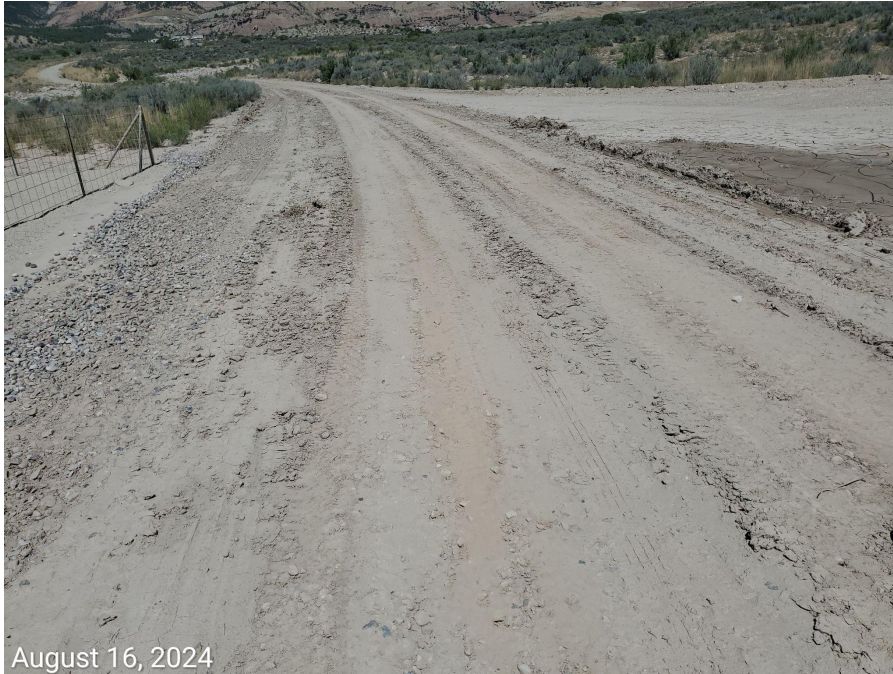
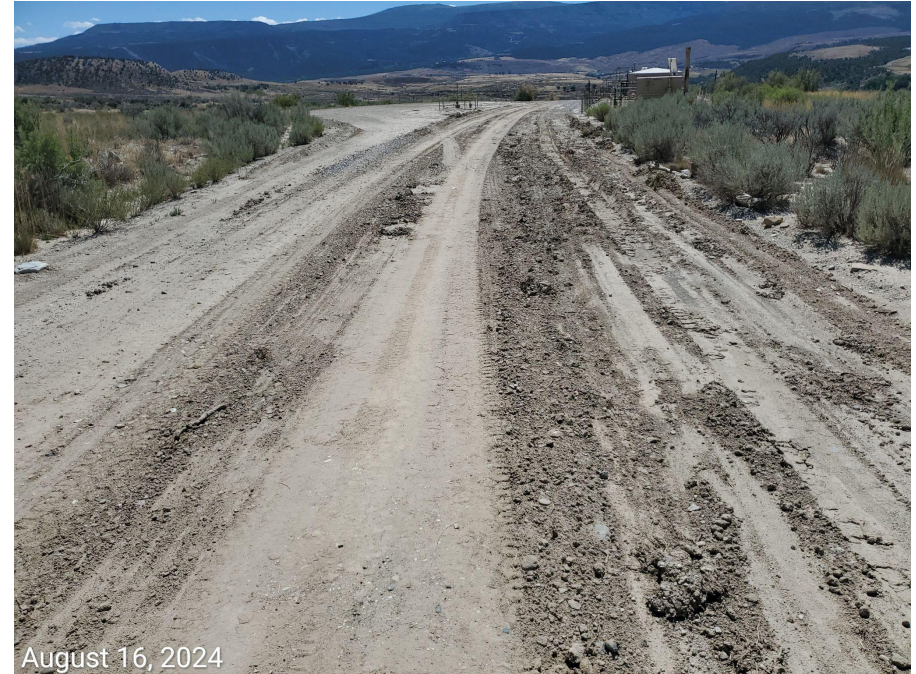
Photo 5: Photo left taken from the north end of the Location, facing north; photo right taken from the access road north of the Location facing south. BMPs to stabilize, as well as to minimize erosion, degradation and tracking along the access road have not been installed or maintained per good engineering practice; tracking and degradation issues have persisted along the access road. Operator only appears to have conducted grading operations at road resulting in sediment being pushed around; grading alone is insufficient.

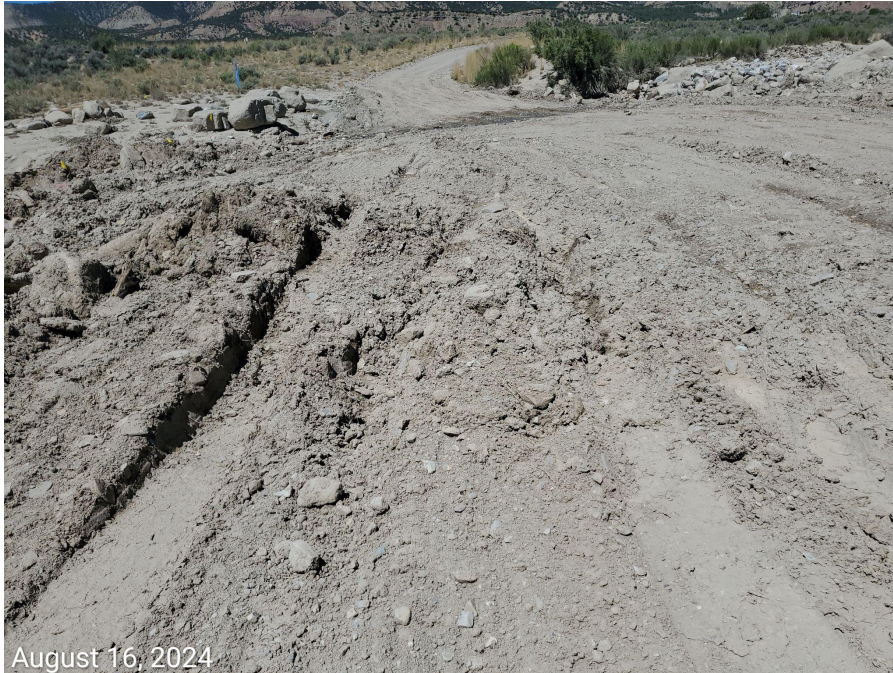
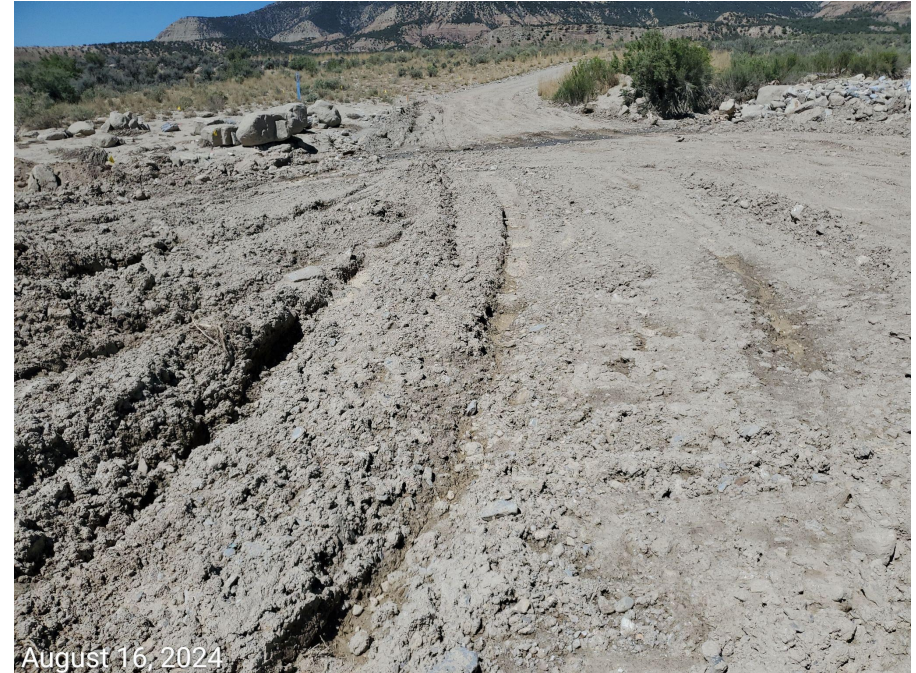
Photo 6: Photos 6-8 taken from the stream crossing along the access road north of the Location. Photos show that a properly engineered stream crossing, and other stormwater and erosion control BMPs, have not been installed or maintained along the access road, resulting in persisting degradation, tracking issues and impacts to a riverine system.

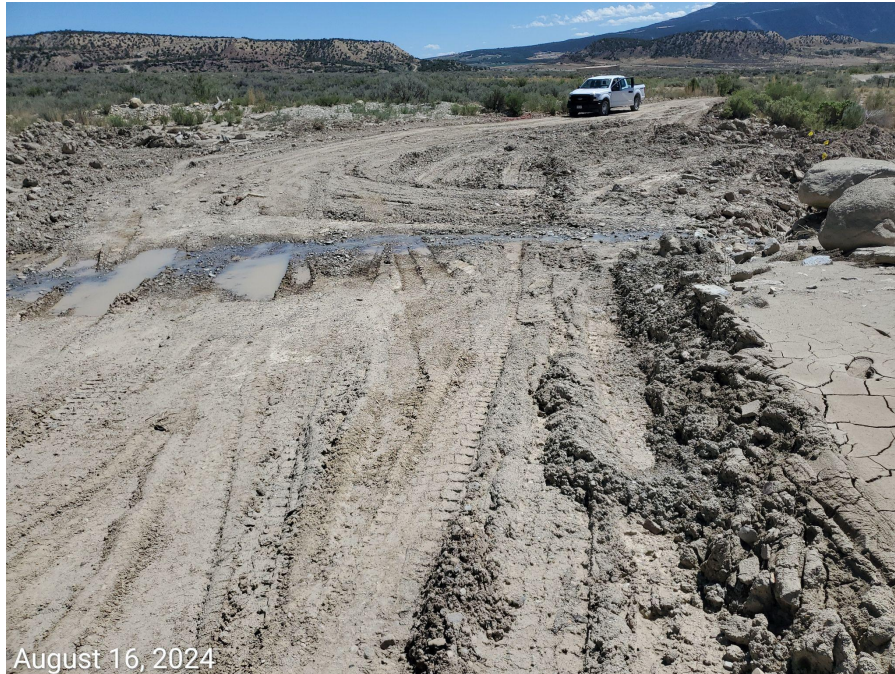
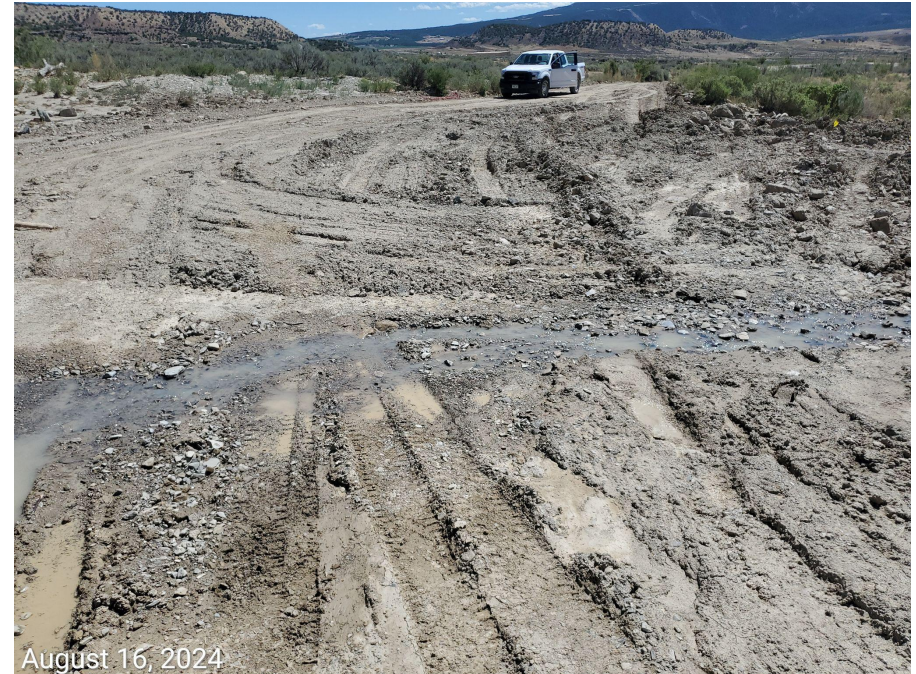
Photo 7: See comments under photo 6.

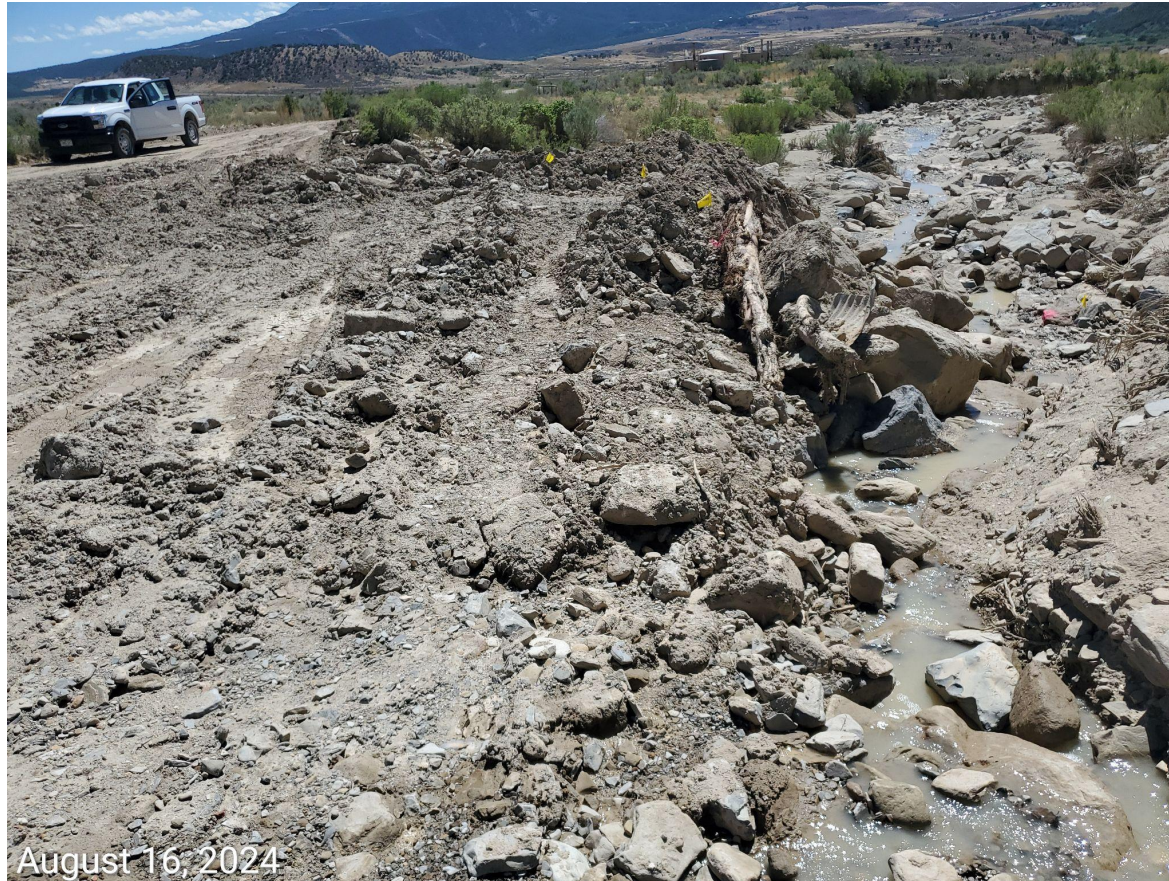
Photo 8: See comments under photo 6.
